# STAGE 2 DETAILED UXO RISK ASSESSMENT

| <b>Site Name:</b> | Glen Dimplex, Prescott | | |
| <b>Report Ref:</b> | DRA-25-1957-GlenDimplex,Prescot-TWNW25R | | |
| <b>Date:</b> | 21 <sup>st</sup> November 2025 | | |

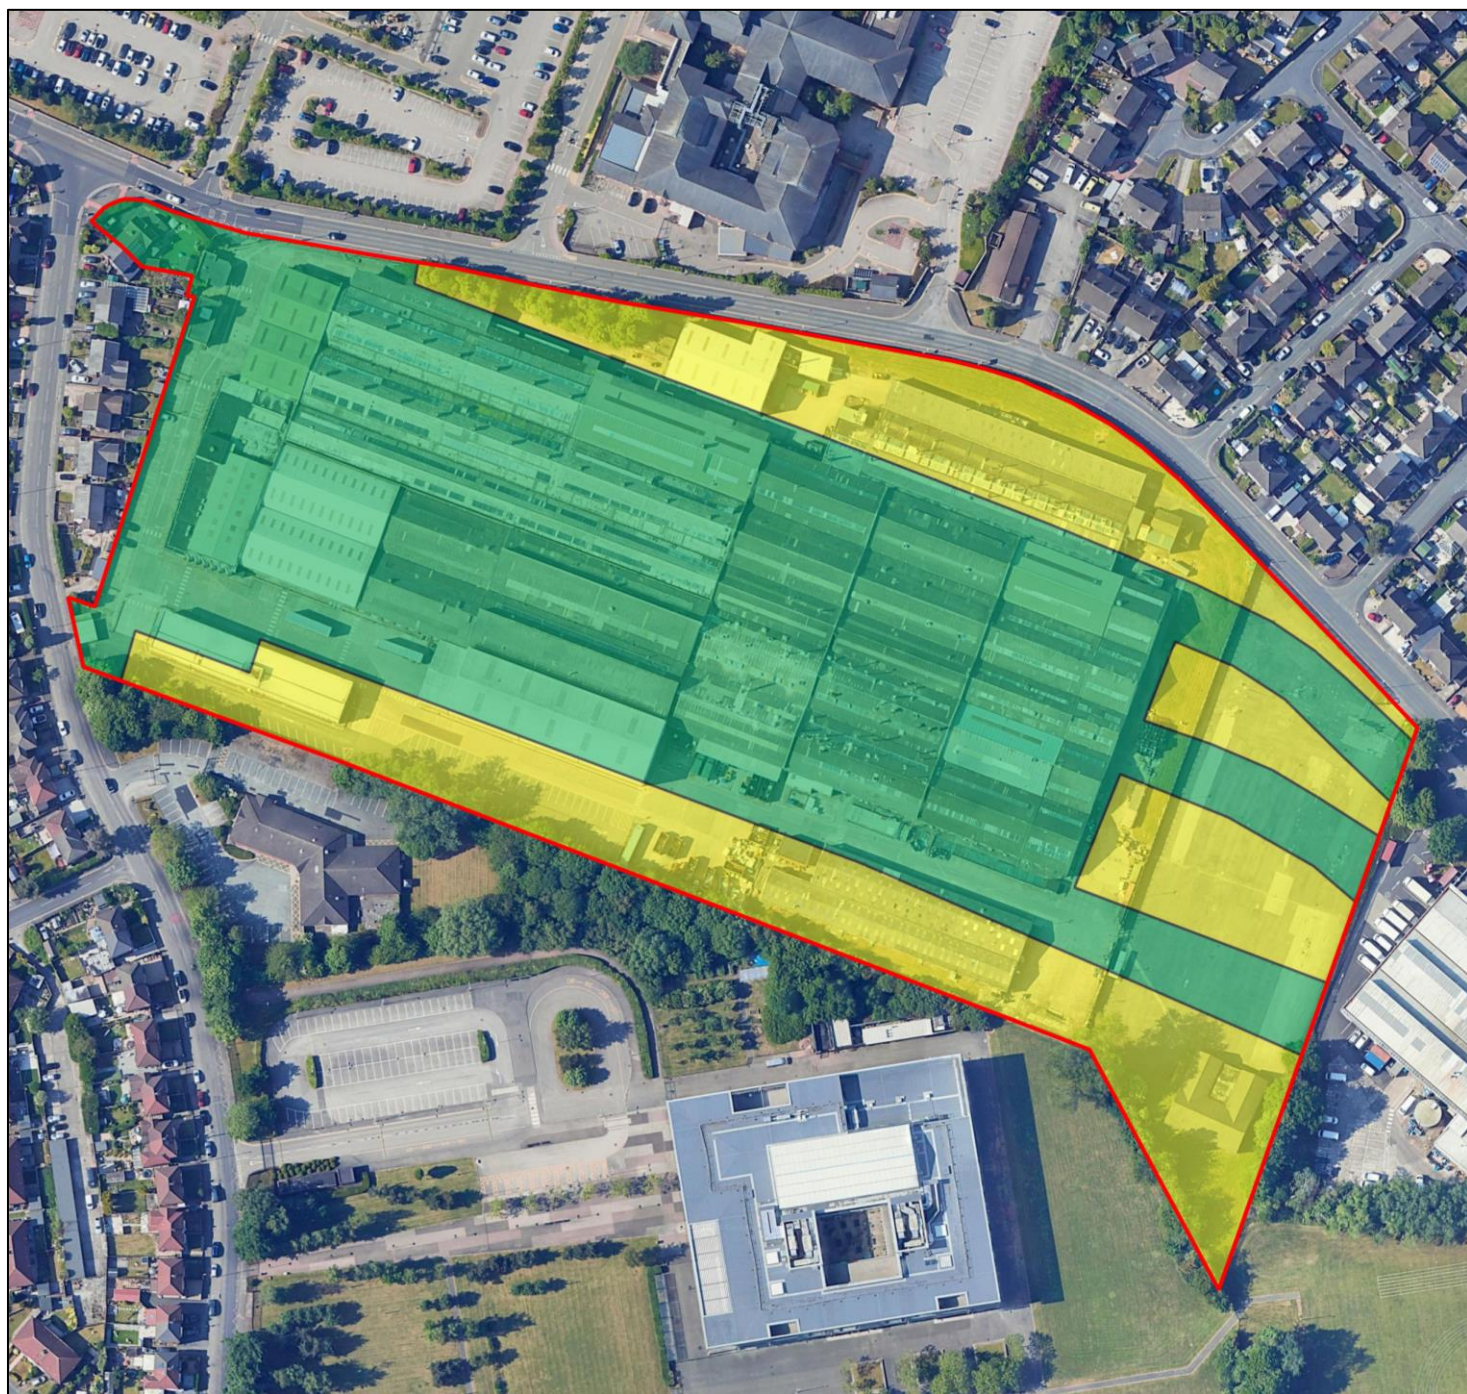
FIGURE: 7.2

**LOW RISK:** Low likelihood of German and British UXO remaining here.

**LOW-MODERATE RISK:** Slightly elevated likelihood of British UXO remaining here.

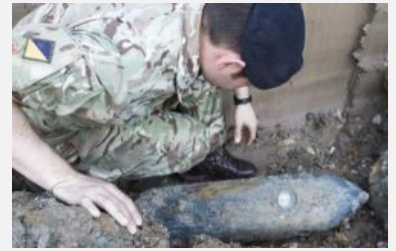
## SC 50

**Bomb Weight:** 40-54kg (110-119lb)  
**Explosive Weight:** 25kg (55lb)  
**Filling:** TNT, Amatol or Trialen  
**Charge/Weight Ratio:** 46%  
**Fuse Type:** Electrical impact fuse or mechanical delayed action fuse  
**Body Dimensions:** 1,100mm length x 200mm diameter  
**Appearance:** Bomb body and tail painted grey/green with a yellow stripe on the tail unit. Steel construction.  
**Variants:** 8 x variants. Additional fittings: Kopfring nose for limited penetration and Stabbo nose for dive-bombing.

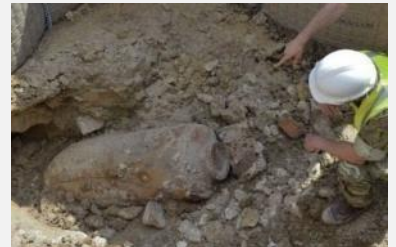
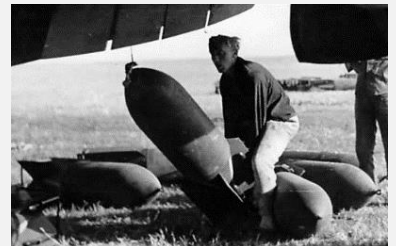
## SC 250

**Bomb Weight:** 245-256kg (540-564lb)  
**Explosive Weight:** 125-130kg (276-287lb)  
**Filling:** TNT, Amatol and Trialen mix  
**Charge/Weight Ratio:** 44%  
**Fuse Type:** 1 or 2 electrical impact fuse(s) or mechanical delayed action fuse(s)  
**Body Dimensions:** 1,173mm length x 368mm diameter  
**Appearance:** Bomb body and tail painted grey/green with a yellow stripe on the tail unit. Steel construction.  
**Variants:** 8 x variants. Kopfring nose for limited penetration. Stabbo nose for dive-bombing.

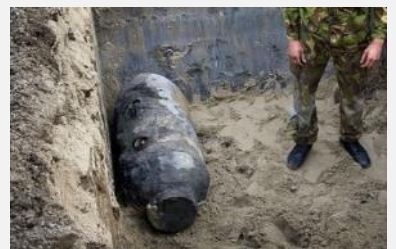
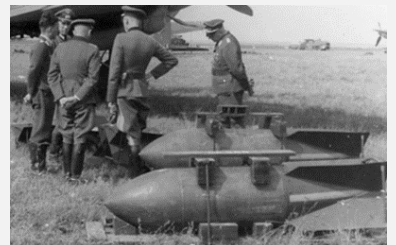
## SC 500

**Bomb Weight:** 480-520kg (1,058-1,146lb)  
**Explosive Weight:** 220kg (485lb)  
**Filling:** TNT, Amatol and Trialen mix  
**Charge/Weight Ratio:** 44%  
**Fuse Type:** 2 electrical impact fuses or mechanical delayed action fuses  
**Body Dimensions:** 1,423mm length x 470mm diameter  
**Appearance:** Bomb body and tail painted grey/green or buff with a yellow stripe on the tail unit. Steel construction.  
**Variants:** 3 x variants. Kopfring nose for limited penetration.

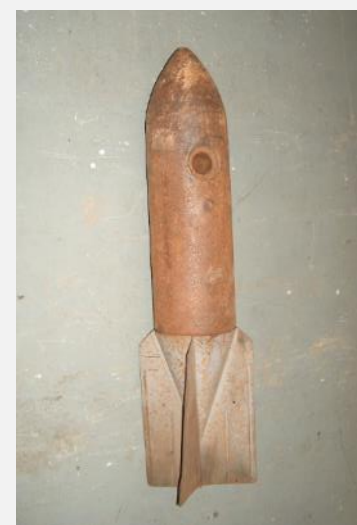
## Brand C50

| <b>Appearance:</b> | bomb body and tail painted grey or green with the rear of the bomb painted red and a red band around the centre of the body. |
| <b>Variants:</b> | C 50 B: 77% White Phos fill<br>C 250 A: 87.7% Petroleum, 11.7% Polystyrene, 0.5% White Phos (185kg version) |

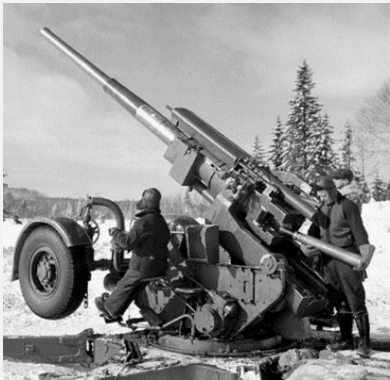
### HAA Battery - 3.7" QF Shell

- Shell Weight:12.7kg
- Shell Dimensions:94mm x 438mm
- Fill Weight:1.1kg
- Fill Type:TNT
- Fuse Type:Mechanical Time Delay fuse
- Appearance:Grey body, copper driving bands, brass neck
- Rate of Fire:10 - 20 rpm
- Ceiling:9,000 - 18,000m
- Variants:HE or shrapnel shells.  
Note, the 4.5" gun was also used in an HAA role throughout the UK.

British time fuses were poorly manufactured during WWII, and this led to high failure rate for HAA shells, up to 30%. Unexploded HAA shells had the potential to land up to 27km from their battery, although more typically landed within a 15km radius.

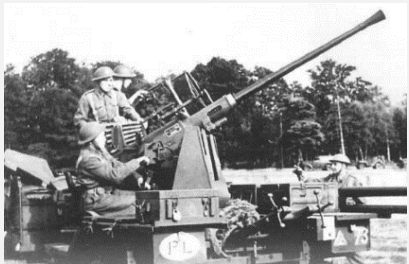
### LAA Battery - 40mm Bofors Shell

- Shell Weight:0.84kg
- Shell Dimensions:40mm x 180mm
- Fill Weight:70g
- Fill Type:TNT
- Fuse Type:Impact fuse
- Appearance:Grey body, copper driving bands, brass neck
- Rate of Fire:120 rpm
- Ceiling:7,000m
- Variants:HE or AP shells. Both with rear tracer compartment

SHELL, Q.F., HIGH EXPLOSIVE, 40 MM.

The 40mm Bofors gun could fire 120 x HE shells / minute to a ceiling of 1,800m. Each shell was designed to self-destruct if it didn’t strike an aircraft, however, inevitably some failed and fell back to earth.

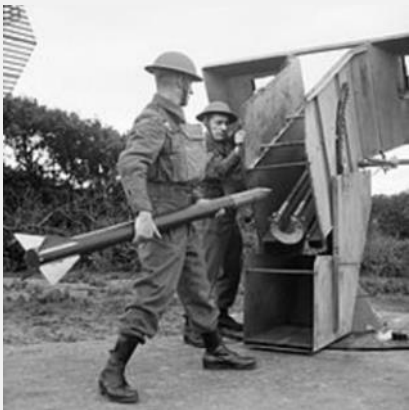
### Z Battery - 3" U.P Rocket

- Rocket Weight:24.5kg
- Warhead Weight:1.94kg
- Filling:TNT warhead. Black Powder solid fuel rocket motor.
- Fuse Type:Mechanical Time Delay fuse
- Rocket Dimensions:1,930mm x 76mm
- Ceiling:6,770m
- Operation:Fired from single, tandem and (later) 36 x rail launchers (Z Batteries). Limited use throughout the UK.
