*Kirkby Valley Golf Club*

# Protected Species Report (Bats): Buildings

Compiled by Ecology Services Ltd.

**February 2020 (updated August 2021)**

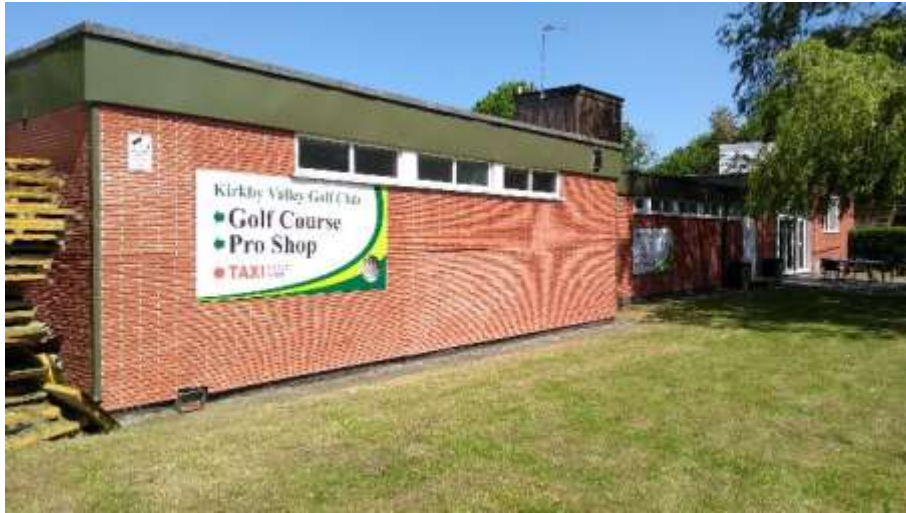
**Photo 1:** South-western elevation of Building 1. Where there are gap between cladding.

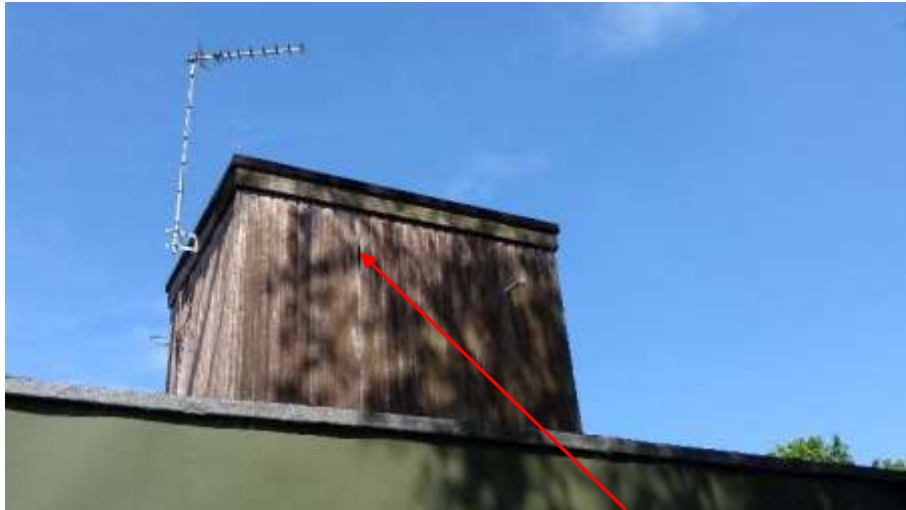
**Photo 2:** Centrally located wooden-clad stairwell shelter on Building 1. Arrow shows gap in cladding on the south-western elevation.

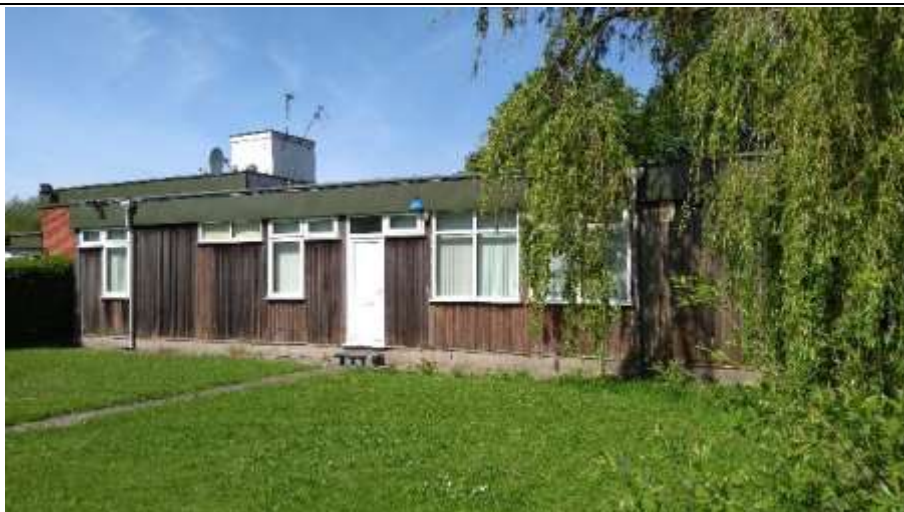
**Photo 4:** South-western elevation of Building 2.

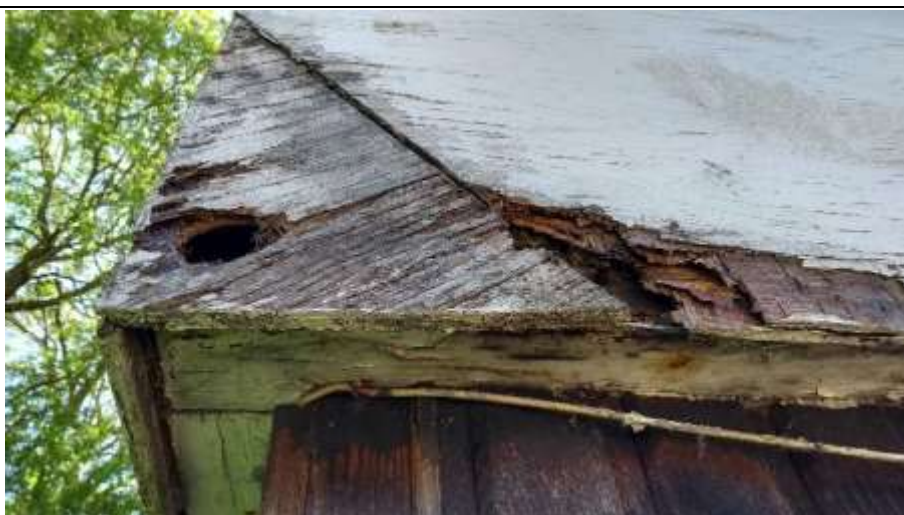
The wooden fascias on the buildings are in poor condition and large holes in these provide access into the space between the roof and inner ceilings. There are also access points into the rooms internally through gaps around doors. Gaps are present around the edges of the wooden board ceilings which provide access between the roof space and ceilings. There is also potential for breeding birds to use the cavities in the roof of the building.

**Photo 6:** Holes in wooden fascias near the eastern corner of Building 2.

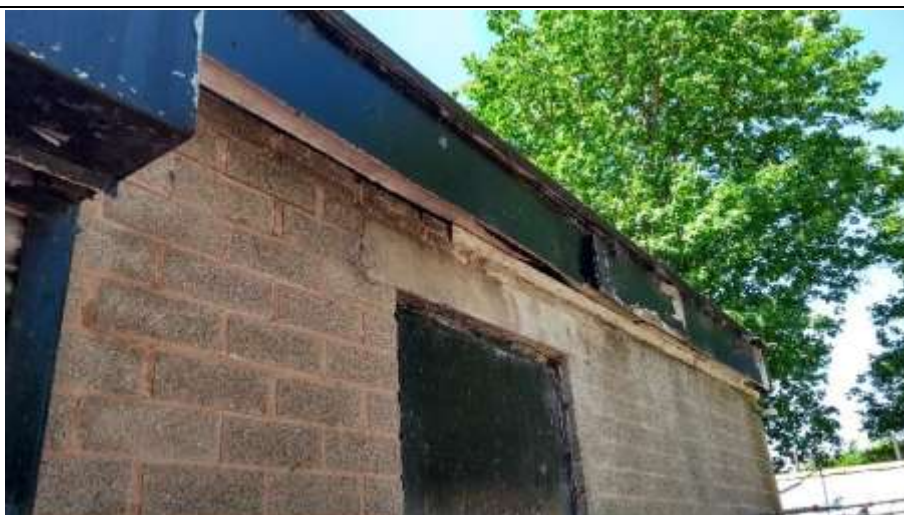
The 2020 update inspection survey found the building to be in the same condition as the previous survey and therefore is considered to be of **moderate** suitability for roosting bats.

**Photo 8:** Showing poor condition of fascias on Building 3.

- 5.5 Given that Buildings 1 and 3 have been assessed as having moderate or low potential to support roosting bats, it is recommended that a precautionary approach to building demolition is undertaken. In particular, wall and fascia cladding should be carefully removed under the supervision of a licenced bat ecologist along with the space between the roof and the internal ceilings within Building 3.

- 7.6 As a precautionary measure it is recommended that any areas of bat roost potential in Building 3, in particular, the wall and fascia cladding and the space between the roof and the internal ceilings are carefully removed under the supervision of a licensed bat Ecologist.

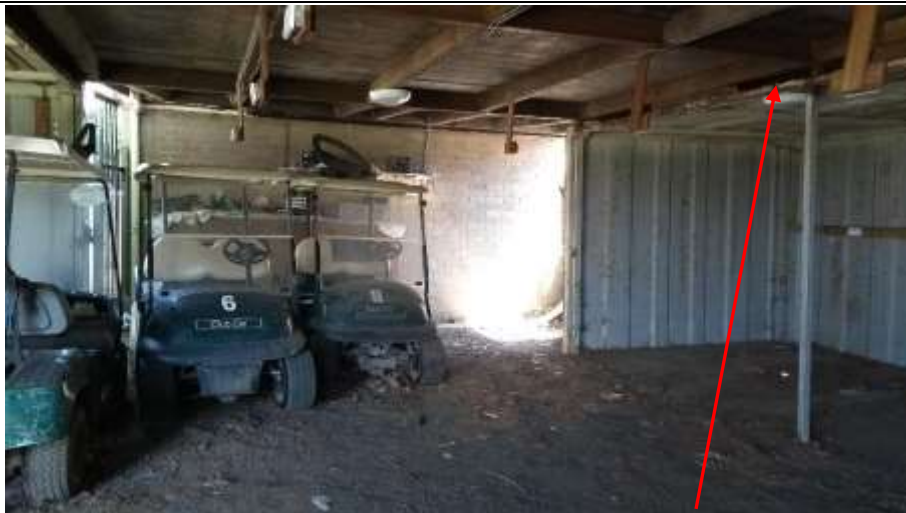
**Photo 11:** Internal area of Building 4. Arrow showing cavity between roof and shipping container.

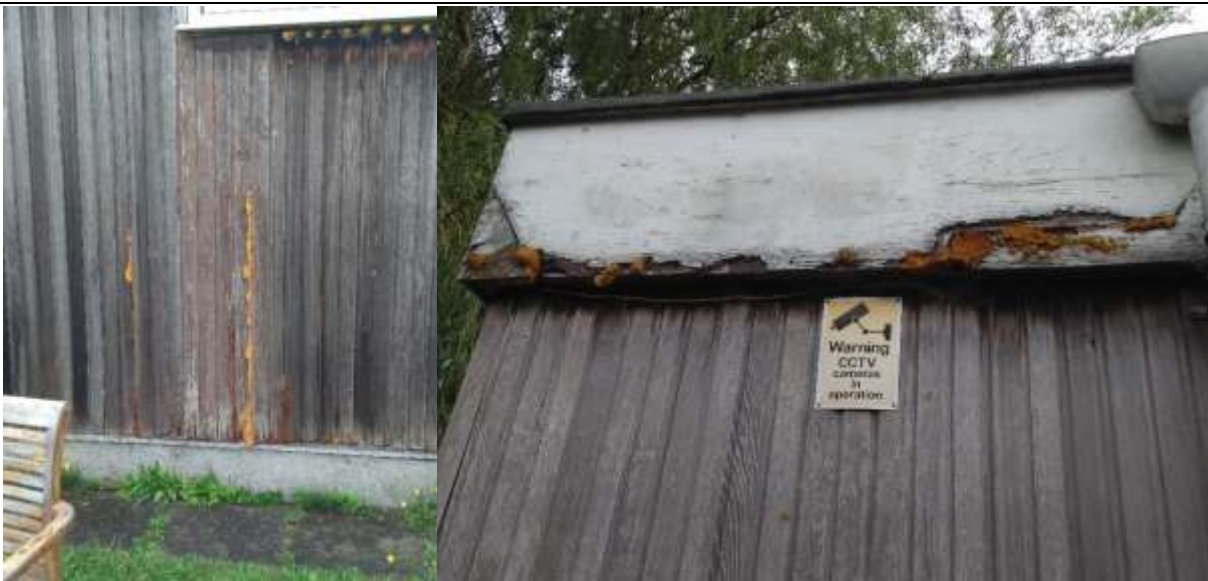
**Photo 12:** Building 2 (2020) showing the expanding foam on the south eastern and north western elevations.

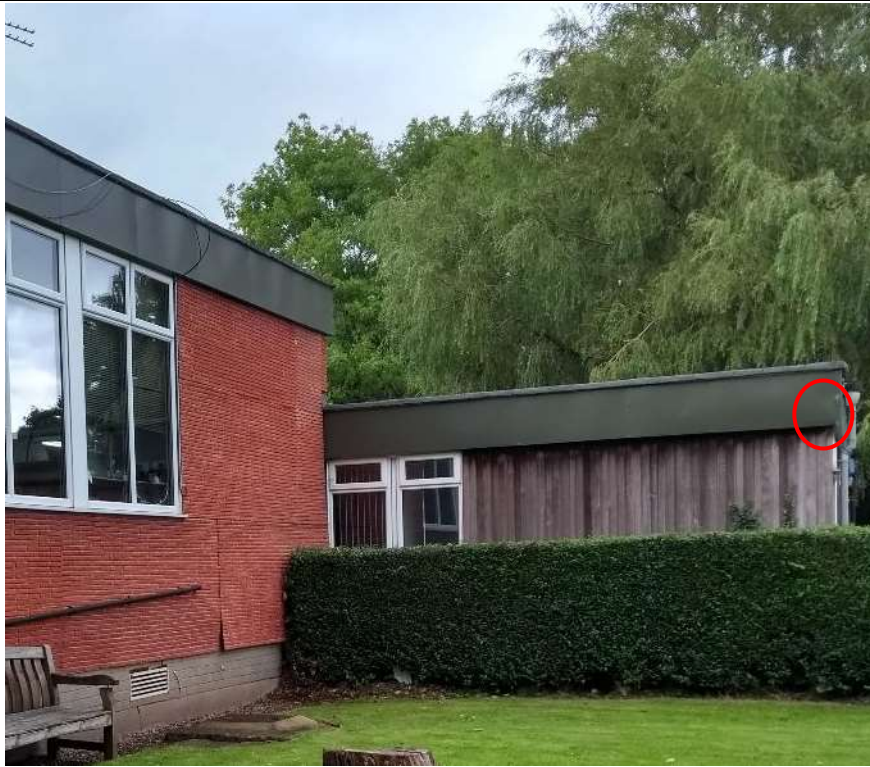
- 4.25 Evidence of bat re-entry was observed at 06:07:2020 by a common pipistrelle on the south western corner of Building 2. No other evidence of bat emergence or re-entry was identified.
- 4.26 No evidence of bat emergence or re-entry was recorded by any of the surveyors during the presence/ absence survey of Building 3.
- 4.27 There was occasional commuting and foraging activity by common pipistrelle throughout the survey with some noctule commuting and foraging activity towards the end of the survey. A couple of foraging/ commuting passes by soprano pipistrelles were also detected. There was near constant foraging by common pipistrelles along the tree line to the north west of Building 3 during the first half of the survey, with a maximum of three bats seen at any one time.

**Photo 13:** Building 2 showing the roost location on the south western elevation.

- 6.5 The mitigation scheme has been designed to provide a long-term replacement day roost used occasionally for crevice dwelling bats such as pipistrelle species. Enhancement is also proposed at the site for the loss of other potential roosting features.

- 6.16 The mitigation scheme proposed is considered to be appropriate for the type of roost identified, the common species found using the roost i.e. common pipistrelle and small number of bats (one confirmed). The compensation of one interim bat box as a replacement for the disturbance of the roost, whilst the development is taking place, is a suitable level of compensation without providing over-mitigation at the site.
