# Full Bat Survey Report

Aspinall Street, Prescott

Knowsley Metropolitan Borough Council

December 2021

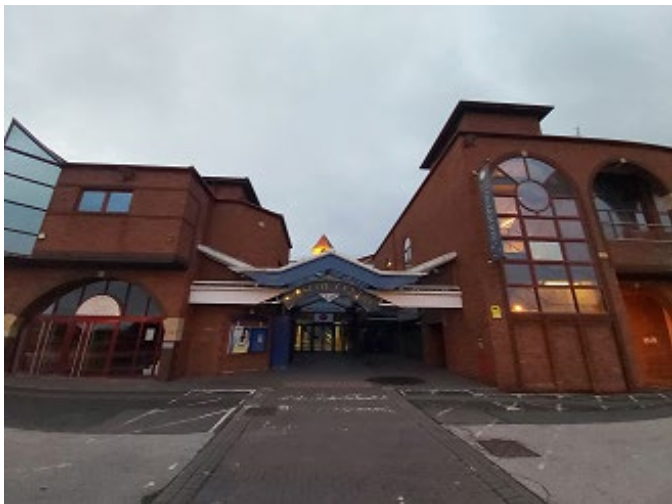
| Photo | Description |
|---|---|
| <p>Southern aspect of Prescott Shopping Centre</p> | <p><u>Exterior</u></p> <p>The main Prescott Shopping Centre building is of modern construction but includes soffits, pitched tiled/slate roofing with some gaps at eaves.</p> <p>The centre is in use as a shopping arcade with numerous units, but also houses the Prescott Library and Museum.</p> |

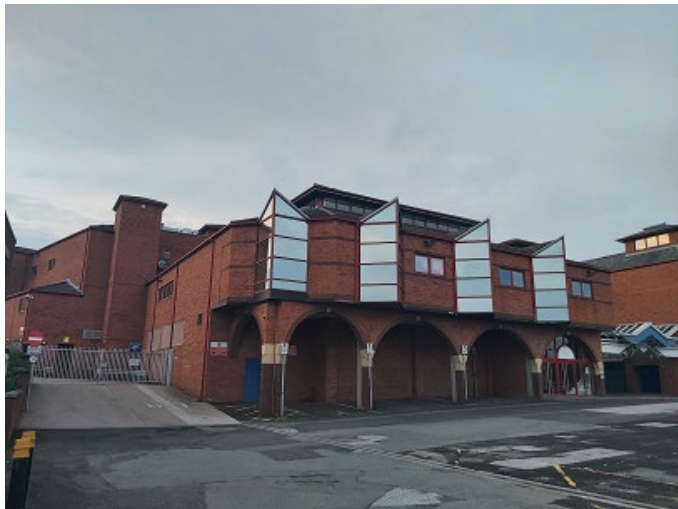
| Photo | Description |
|---|---|
| <p>South Western aspect of Prescott Shopping Centre</p> | <p>There are several units currently not in active use within the shopping arcade.</p> <p>A significant proportion of the structure is glazed or of glass construction (dome central roof and main shopping arcade).</p> |

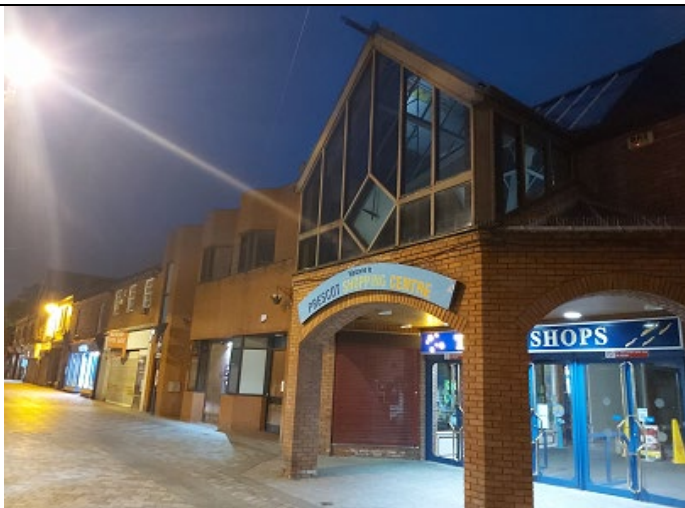
Shopping centre frontage to north (Eccleston St.)

There are floodlighting masts and security lights associated with the building that are likely to result in significant artificial light spill after dark.

The building is relatively modern and appears to be in very good condition with no notable damage.

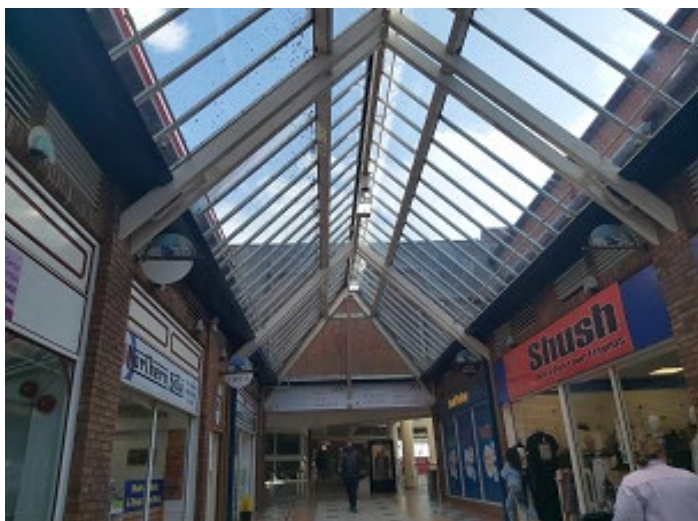
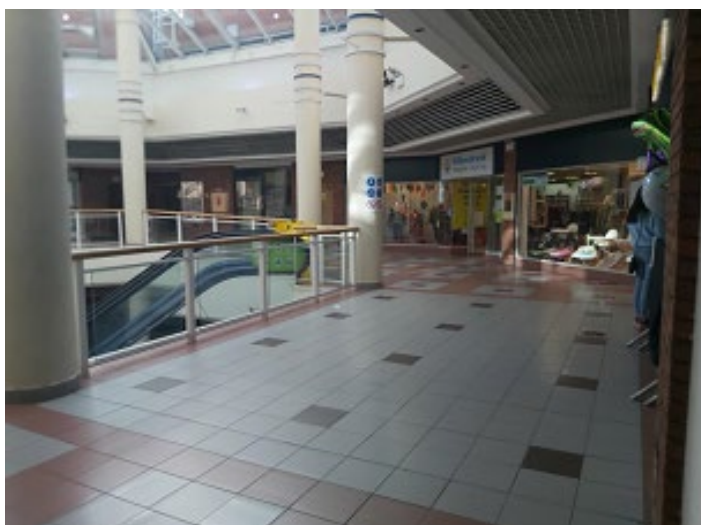
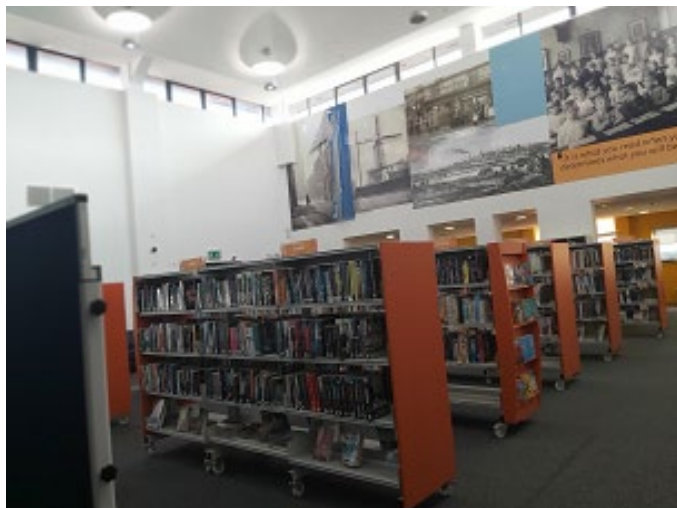
The building is quite large overall and as such possesses some potential roost features (PRFs) for bats, though limited in number and diversity given the size of the building.

No evidence (field signs) of the presence of bats was recorded at the time of survey.

Small number of gaps associated with slate/tile roofing and soffits, mainly to the southern aspect.

**Evidence:** None

**Bat Roost Assessment:** “Low Potential”.

Limited potential to support crevice dwelling species such as Common Pipistrelle.

In order to enhance the site for bats in the long-term, it is recommended that consideration is given to the use of bat bricks or bat boxes upon existing buildings or trees.

Bat bricks/boxes would need to be installed at a height of >4m, with a southerly aspect, and be unobstructed by lighting, windows or other features. This is to enhance the site by providing potential roost features for bats in the long term.

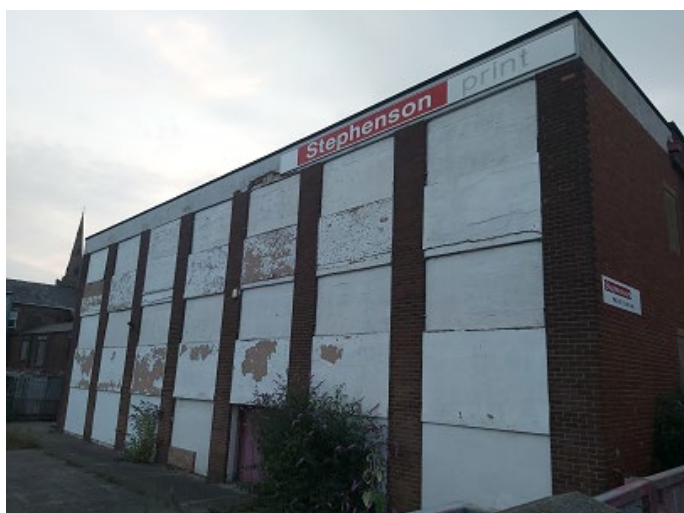
Disused Stephenson Print building to the west of the main shopping centre.

The Stephenson's Print Building is disused. The building is of brick construction and all doors and windows are boarded and sealed shut.

The brick work appears to be intact and there are no features associated with the roof which is flat with parapet wall.

There is very limited potential associated with plywood boarding/fascia to the upper edge of the building, but damage to this appeared to be superficial.

**Evidence:** None.

**Bat Roost Assessment:** “Low potential”.

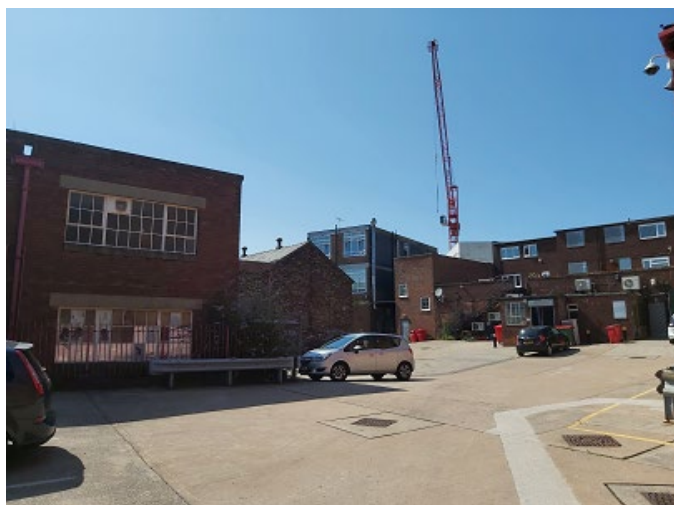
Loading area to the west of the shopping centre.

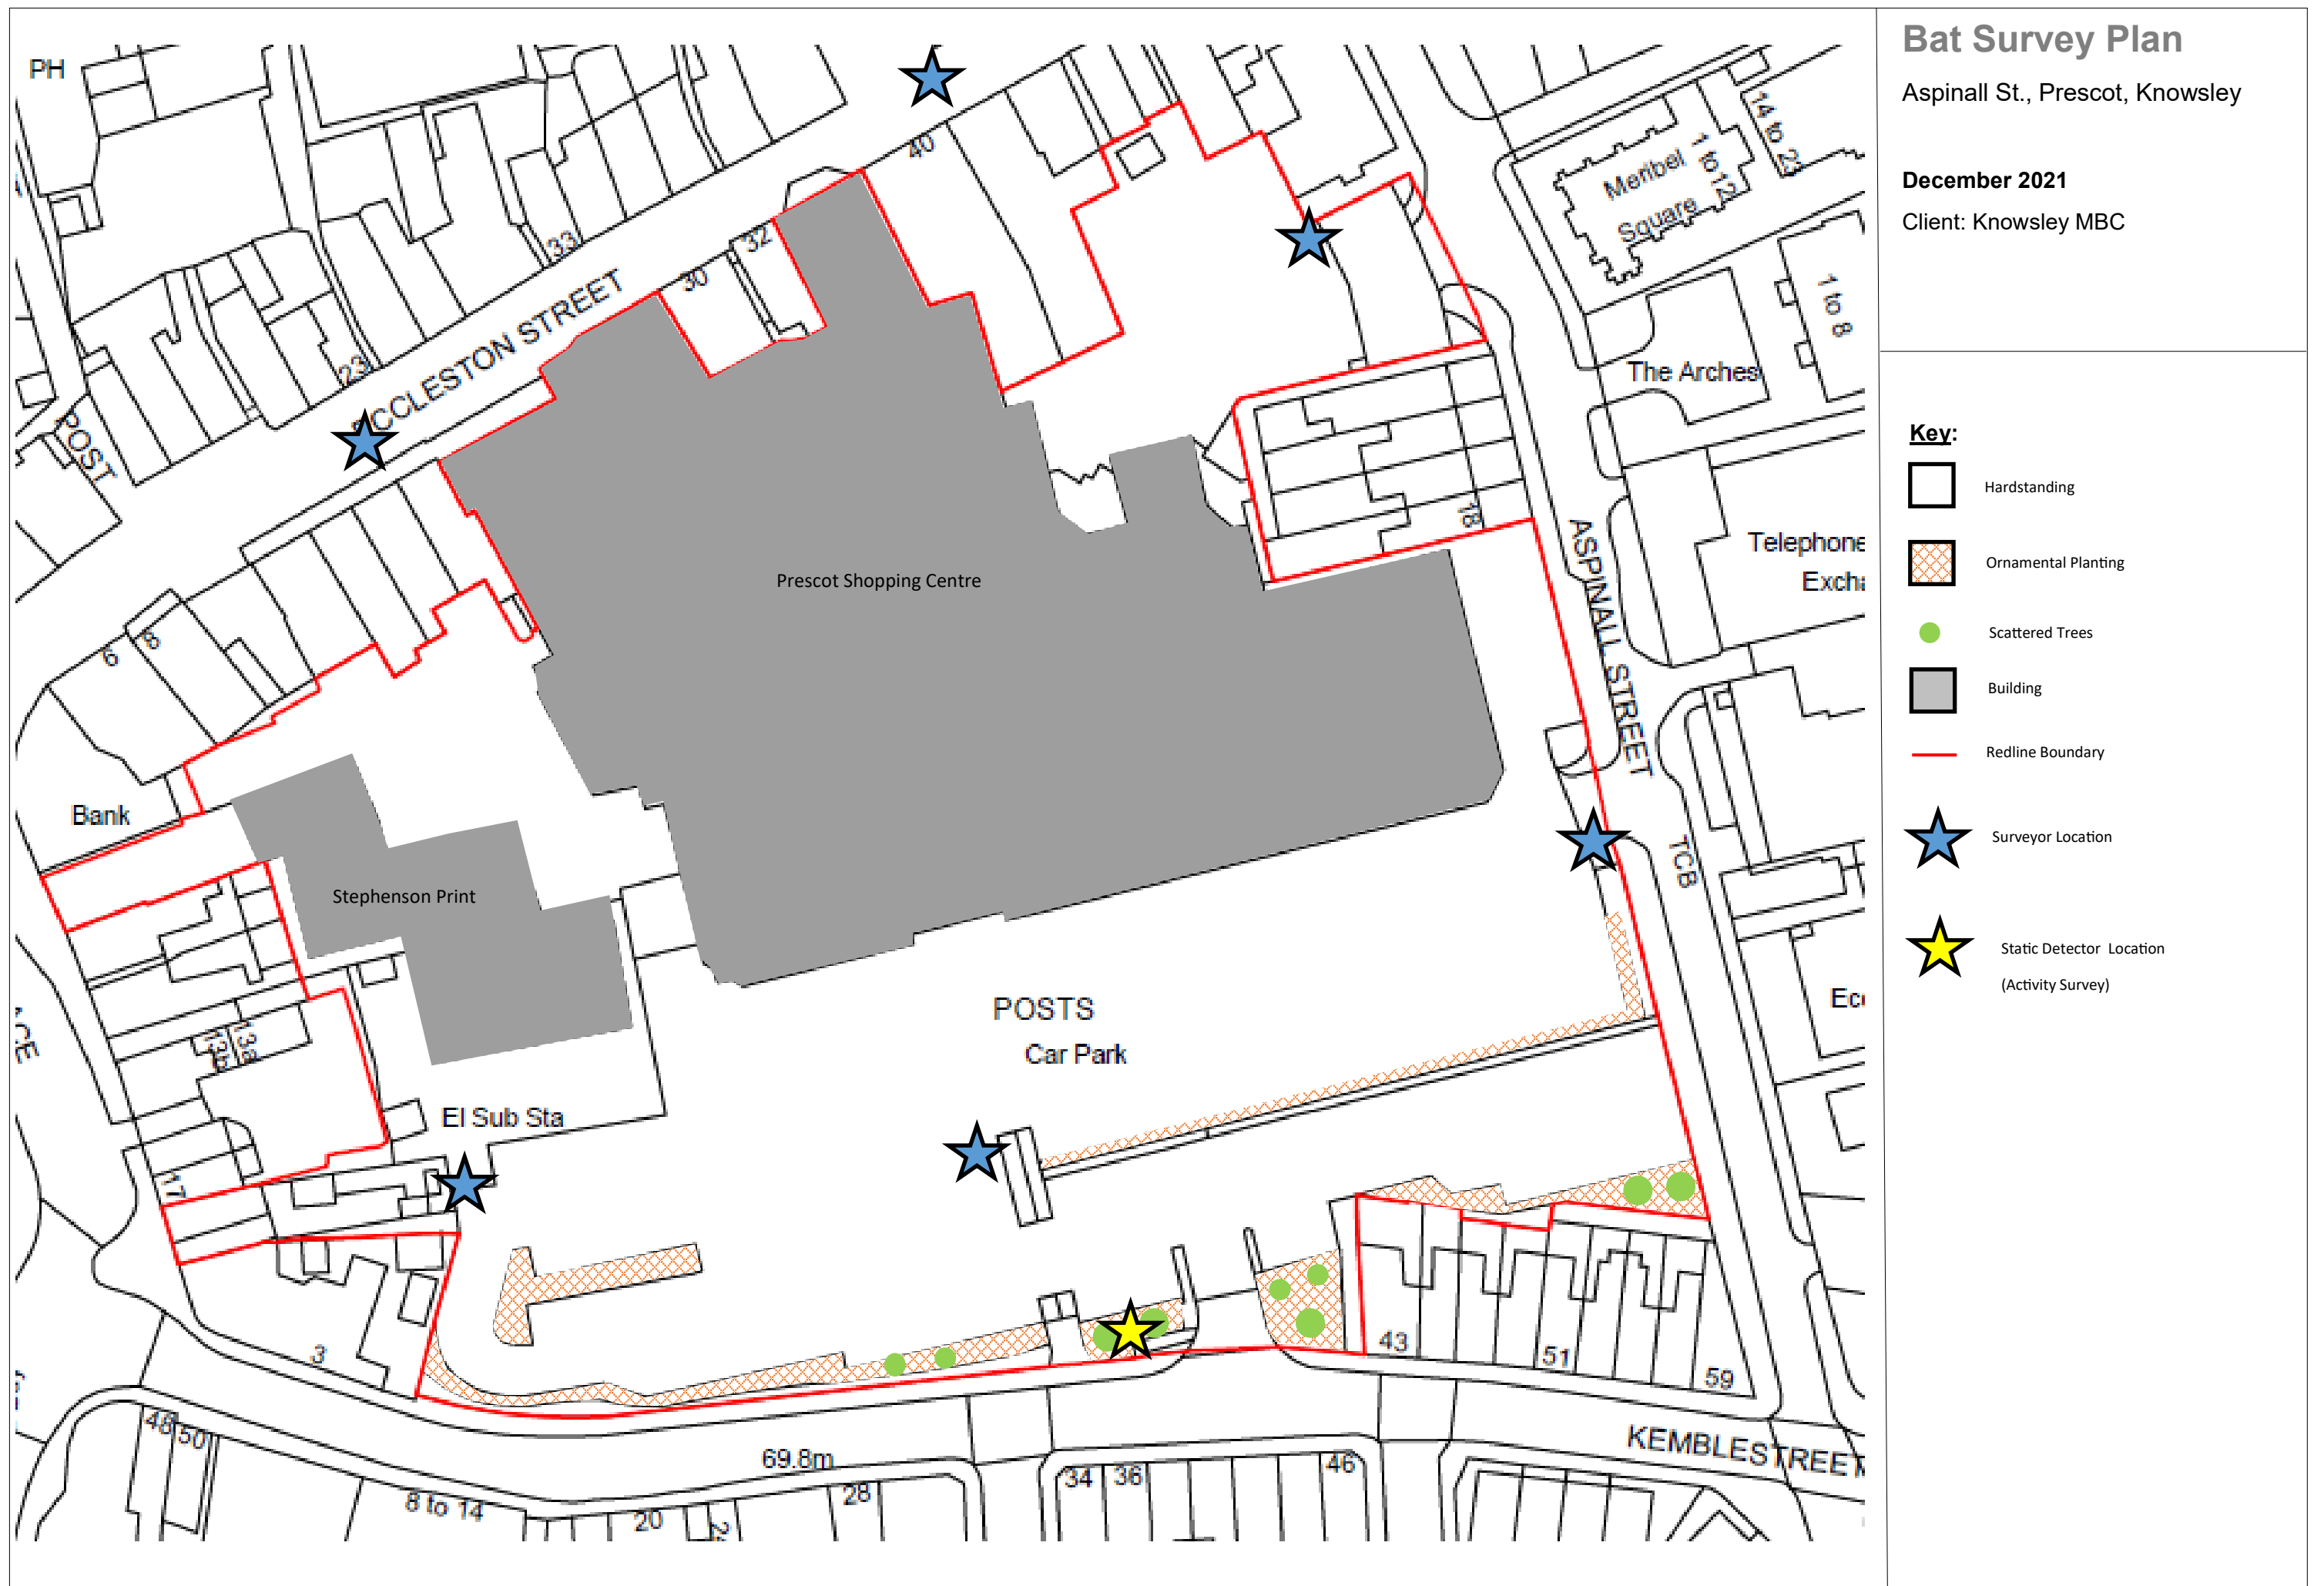
## **APPENDIX 3 - SURVEYOR LOCATION PLAN**

A plan indicating the locations of the surveyors in relation to the building is provided in Appendix 3 and full results of the survey are provided in Appendix 2.

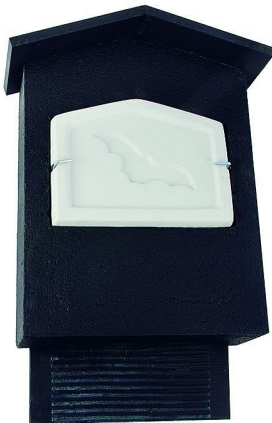
### CHILLON WOODSTONE BAT BOX

This FSC certified black cavity bat box is designed so that you can accommodate bat species that naturally roost in cavities. You can be confident in the design of this box as it takes into account 12 years of experience and has been developed as a result of customer feedback, expert advice, and scientific thinking.

Chillon Woodstone Bat boxes (or similar) (<https://www.wildcare.co.uk/vivara-pro-chillon-woodstone-11245.html>) are hardwearing and can be mounted in trees.
