# Development Report

On behalf of Mr J Culley

4/5/22      *Author: Paul Kurs*

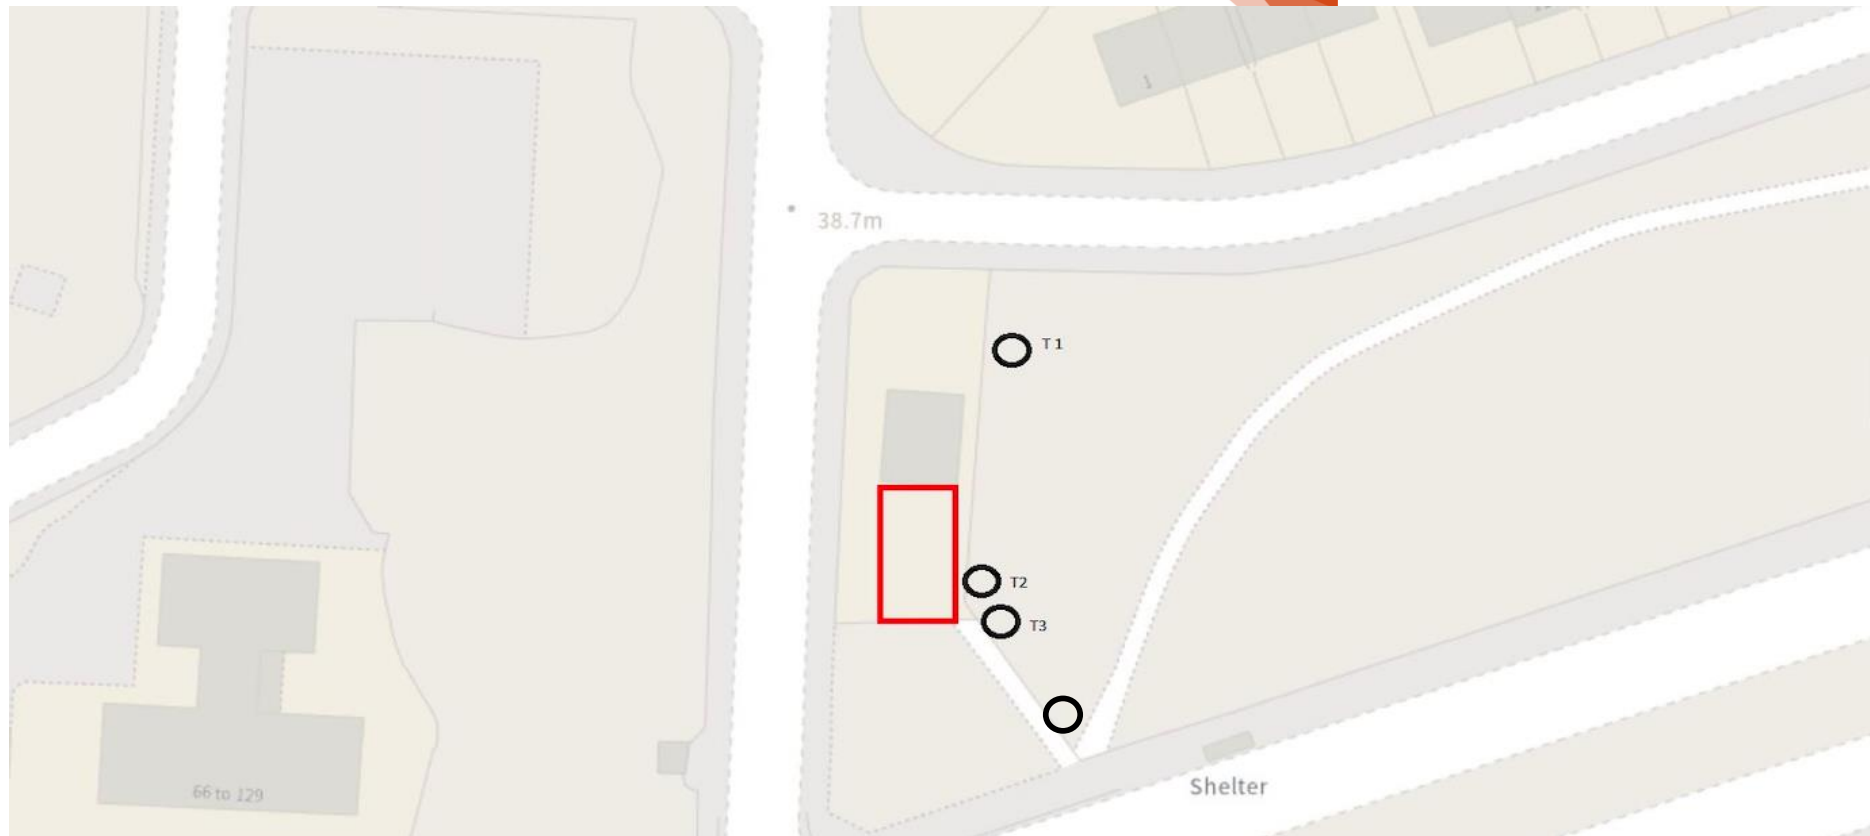
*Map 1 Footprint of proposed development and location of relevant tree/trees.*

(Black Circle) Identified trees on or near to proposed site (Red Rectangle) Footprint of proposed extension

**1.1** PK Environment was commissioned by Mr Culley to conduct a tree survey and Arboricultural Impact Assessment (AIA) at Primrose Road, Liverpool. Mr Culley required a new application from the Local Planning Authority (LPA) to carry out a proposed extension development. An overview of trees on site and proposed plan layout is shown above in Map.1 Tree Protection Plan (page 4).

The tree protection plan and proposed development are shown on (Map 1, page 4). After surveying all trees on and adjacent to site the resulting analysis is set out in table 3, below.

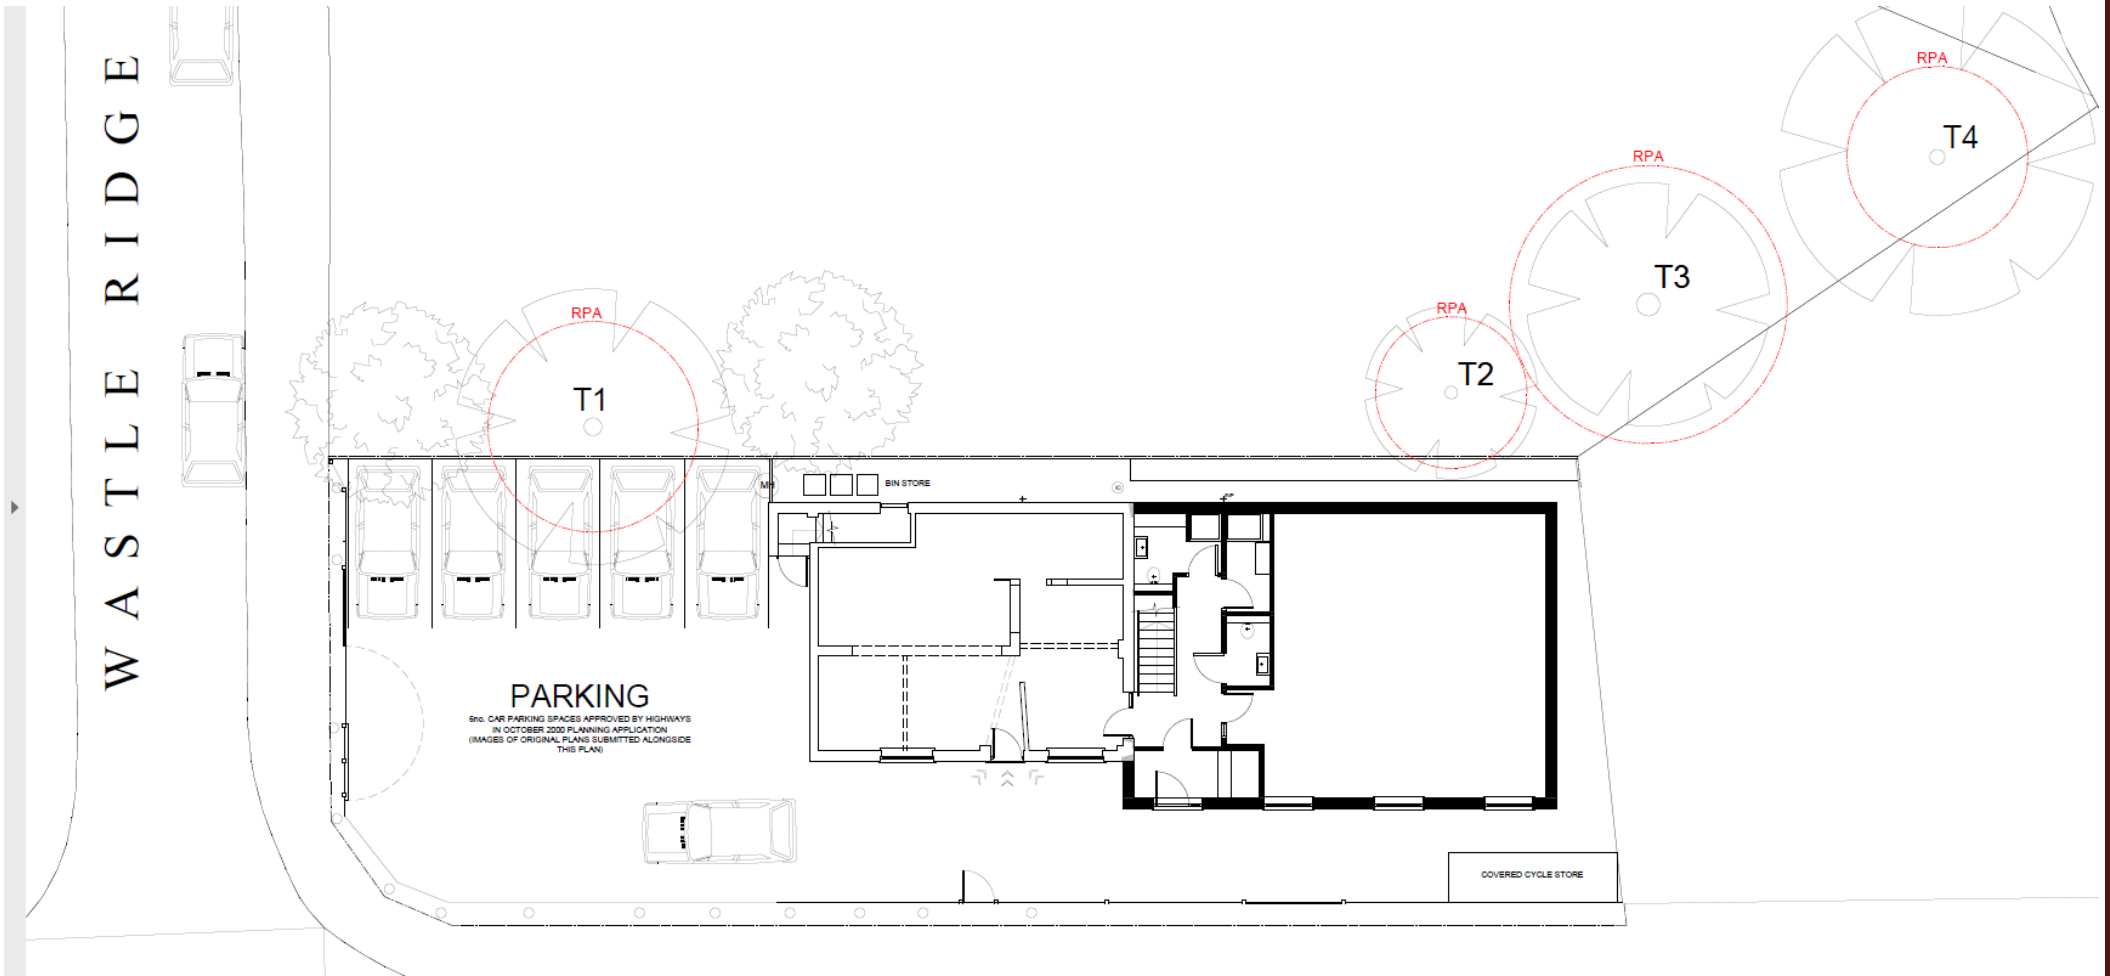
### Tree Constraints Plan - Map 2

**CAD DRAWING SHOWING RPAs Architect to add as below example (not as detailed as shown here)**

**6.1** Map 2 attached in appendix 1, shows the tree constraints plan. This illustrates the position of 3 trees, 2 of which are adjacent to the proposed siting of the extension. The canopy spread is displayed as is the Root Protection Area (RPA). The RPA is initially calculated as a circle radiating from the stem base at 12 x the diameter of stem taken at a height of 1.5m above ground level. Pre-existing site conditions can result in the shape of the RPA requiring modification. Underground structures, topography, drainage and soil type/structure shall be taken into account when calculating offset position of RPA (British Standards, 2012). Where a new hard surface is to be constructed a “no dig” construction method should be employed. This is used to reduce soil compaction in the rooting zone.

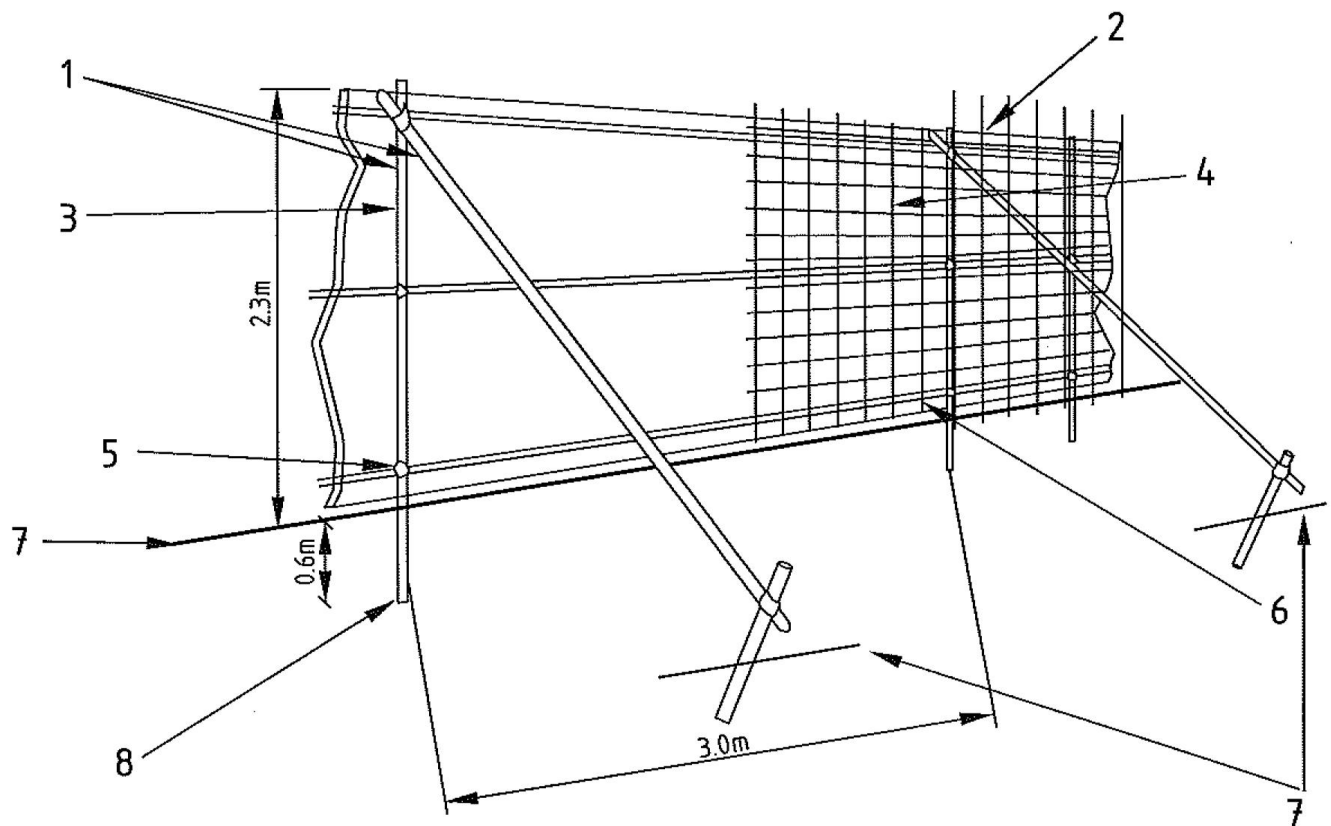
**Figure 2 — Protective barrier**

| 1 Standard scaffold poles | 5 Standard clamps |
| 2 Uprights to be driven into the ground | 6 Wire twisted and secured on inside face of fencing to avoid easy dismantling |
| 3 Panels secured to uprights with wire ties and where necessary standard scaffold clamps | 7 Ground level |
| 4 Weldmesh wired to the uprights and horizontals | 8 Approx. 0.6 m driven into the ground |

Fig 2 above shows an example of the protective fencing which will be installed at this site from *BS 5837:2012 Trees in Relation to Design, Demolition and Construction - Recommendations*

| <p><b><i>Protective fencing and root protection engineering:</i></b></p> | <p>1. Protective barriers are to be installed around the RPAs of trees; T1 &amp; T3. The design of the barriers is illustrated in appendix 3 “generic protective barrier” this design is outlined within (British Standards 2012).</p> <p>2. Ground protection for existing root areas within the working zone should be installed prior to commencement of any construction/demolition work on site. Specifications for root protection are outlined in (British Standards 2012, section 6.2.2.2).</p> |
