PRESCOT PICTURE PALACE  
DESIGN, ACCESS AND HERITAGE STATEMENT  
ISSUE 01  
MARCH 2023

*Knowsley Metropolitan Borough Council*

# PRESCOT PICTURE PALACE: DESIGN, ACCESS AND HERITAGE STATEMENT

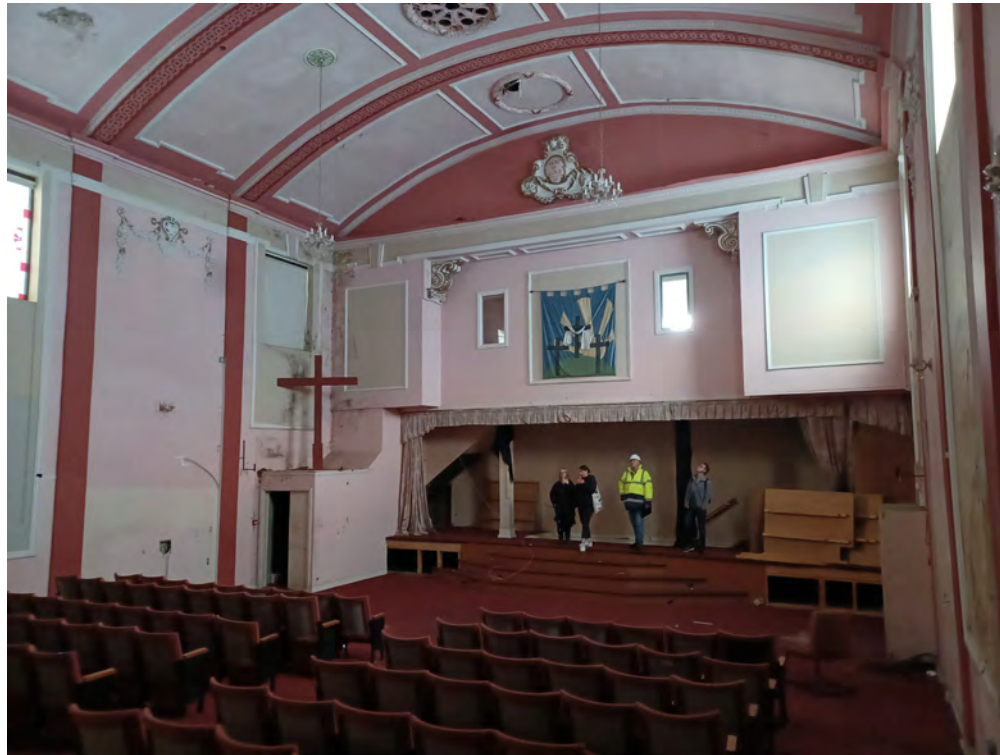
*The auditorium today with the boxing to the left a later alteration to install a staircase and room behind.*

In the 1990s the proscenium arch was modified, with the upper square headed arch retained but the lower stage replaced. The east arm of the balcony was then extended up to the south auditorium wall with a bridge connected between the arms giving access to a new stair inserted at the east side of the stage and a new first-floor fire-escape door with an external metal staircase.

By 1996 the ground floor cinema entrance doors were in-filled and the central window removed for a central entrance with arched windows either side. The auditorium balcony had its side arms removed, and the rear balcony modified with the addition of partition walls at ground floor and balcony level. A temporary partition was also inserted behind the proscenium arch to create a back-stage room.

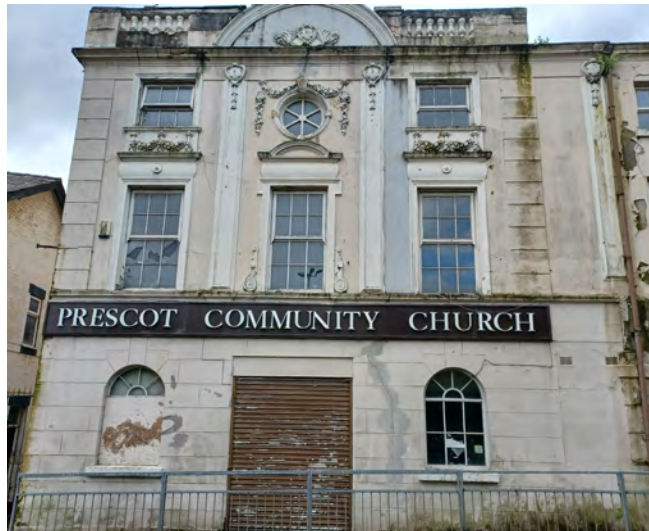
*Note the vertical crack on the parapet and at ground floor. This is possibly the original building line with everything to left the mid-late 19th century extension.*

The original arrangement of the earliest building is difficult to identify but the partial survival of the internal planform and the chimney locations allow the building's typology to be hypothesised, with it partially spanning into the current cinema façade. This makes the current window arrangement unsymmetrical which would be unusual, so it is possible that there was an additional bay of windows between the current cinema and the central building with it being a pair of terraces or a building similar to 10 Vicarage Place, Prescott (see image). Interestingly, a vertical crack runs from parapet to ground in the approximate location of the original building line further supporting this argument.

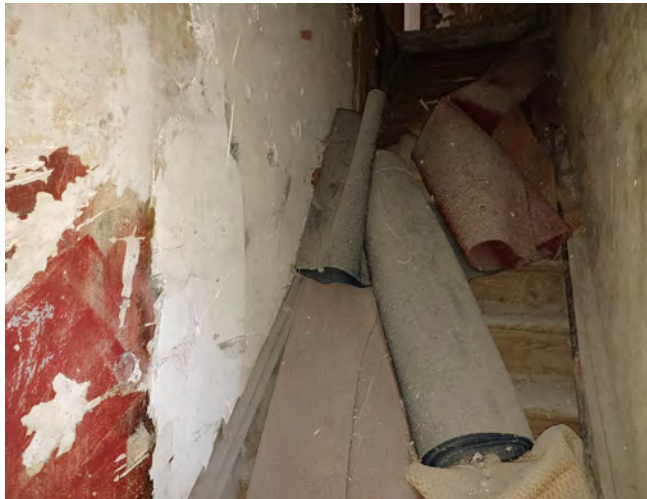
*A mid-late 19th century staircase between first and second floors*

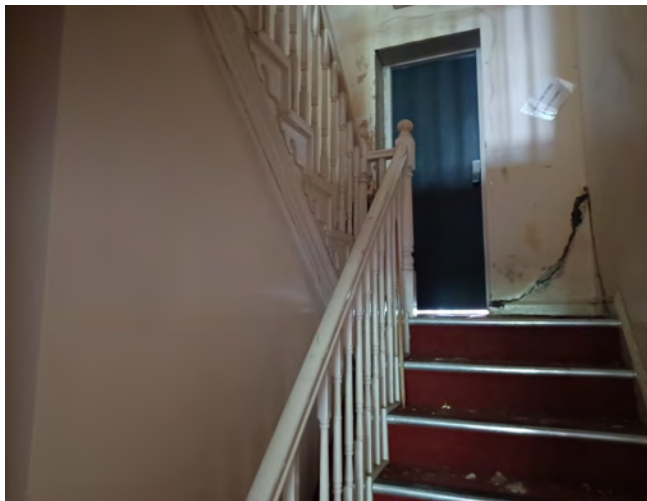
*The staircase to the rear of the central block. Likely to be mid-late 19th century*

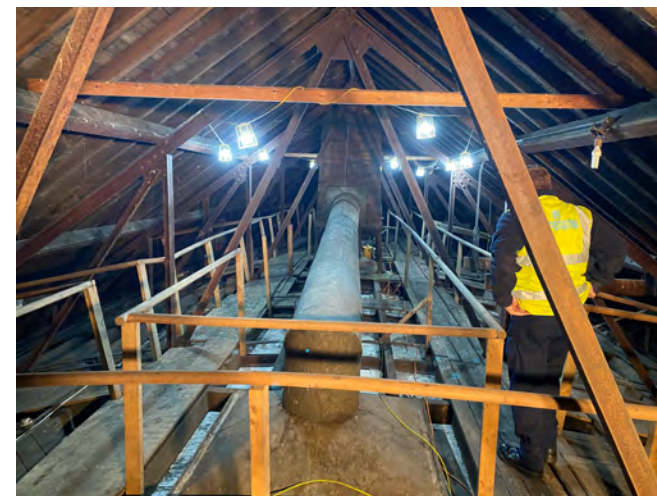
The roof space above the main auditorium

The roof structure of the auditorium also suggests it did not reuse any older fabric, with it being predominantly steel framed. Within the auditorium roof space is a large ventilation duct with a maker's mark of 'The Blackman Fan: James Keith and Blackman'. Blackman fans are primarily for ventilation and dust extraction with the company founded in 1823<sup>04</sup>. The name of the company became James Keith and Blackman from 1901 before changing to Keith Blackman in 1937 so the system will date from this period (1901-37) and likely dates from the auditorium construction as a means of ventilation, or extract for mechanical plant. Although not accessed due to safety concerns, there is said to be historic mechanical plant in the basement which is likely to be the original generator before the building was connected to mains electricity.

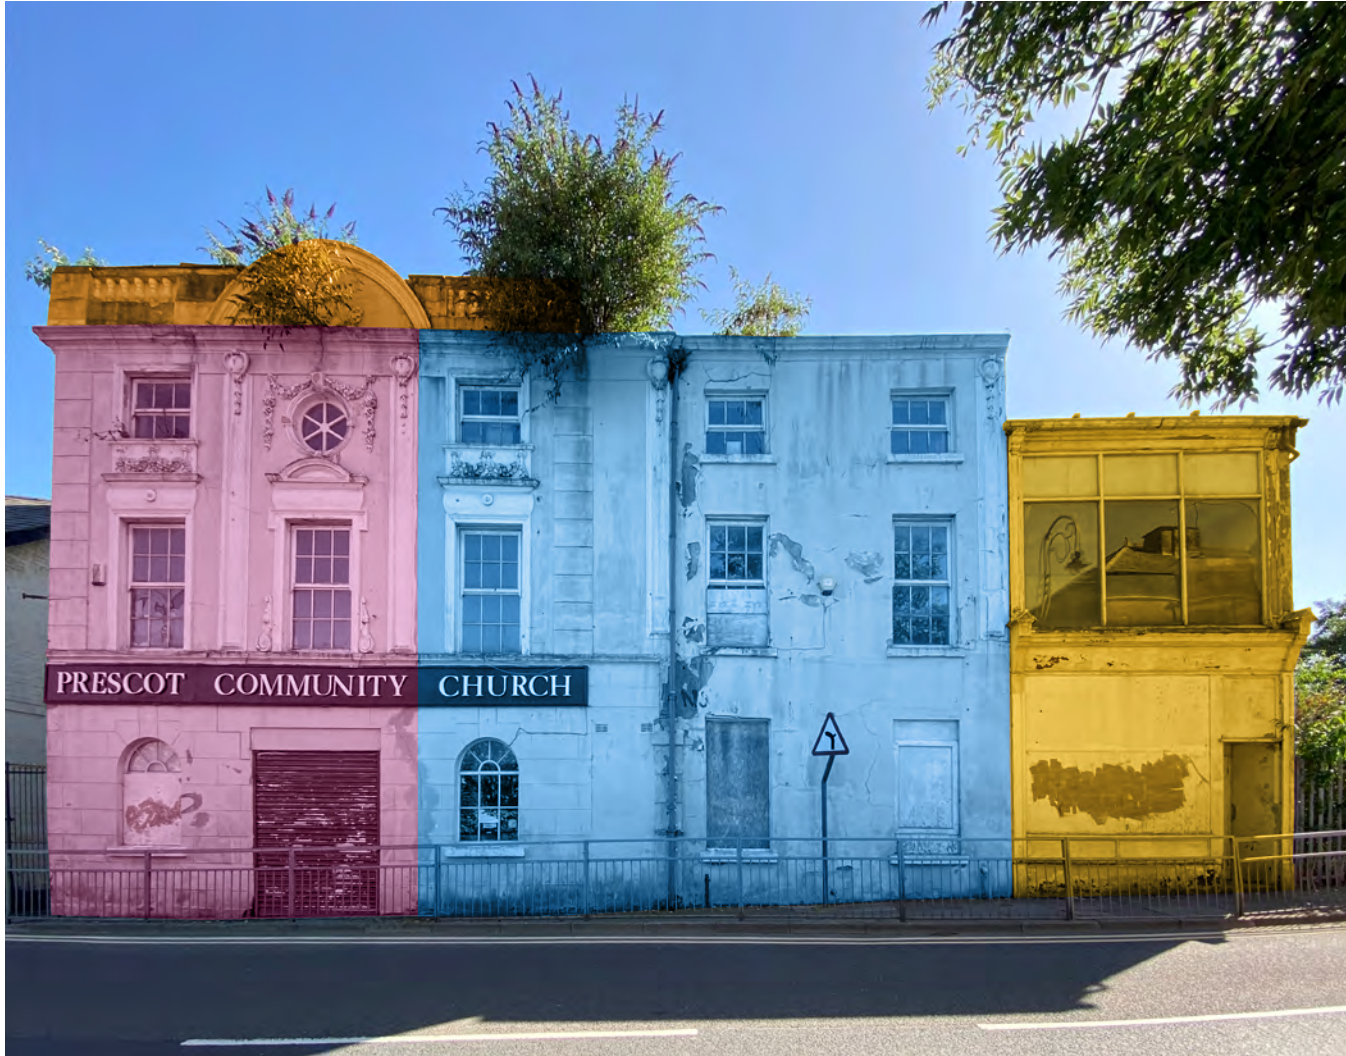
### THE ORIGINAL CONSTRUCTION DATES OF THE MAIN FACADE

#### PHASING PLAN

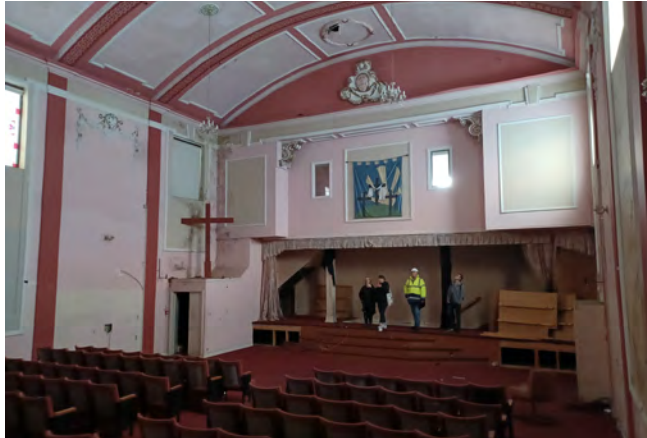
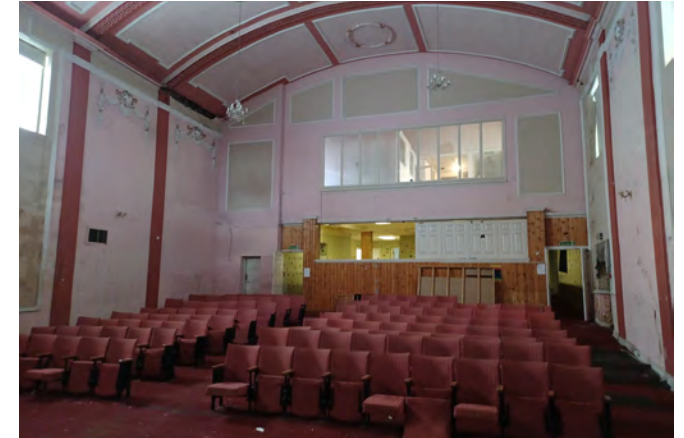
02

#### High Significance

Cast iron columns supporting balcony currently boxed in.
