**Huyton Business Park**

***Bat Survey Report***

**September 2021**

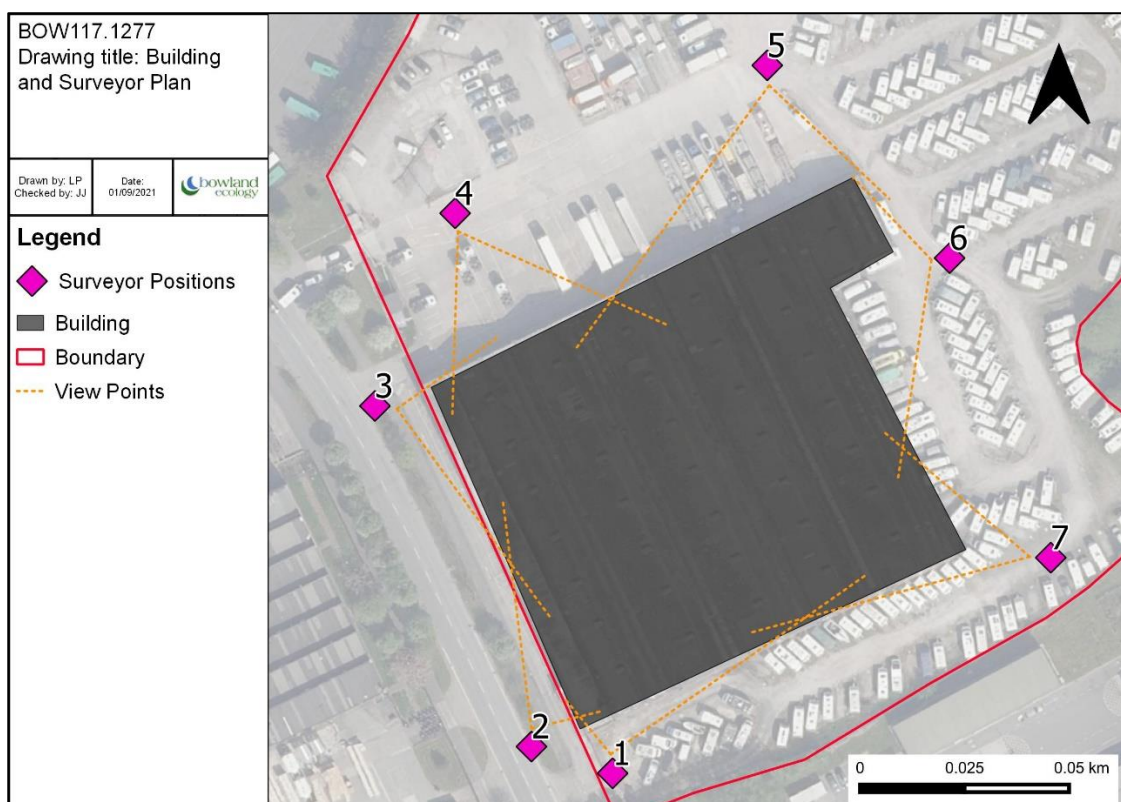
**Figure 1 – Plan showing locations of surveyors**

- 3.3 The surveyors were positioned at locations 1, 4, 5, and 7 (see Figure 1) during the first evening emergence survey (24<sup>th</sup> August). The results of the first survey were used to focus surveyor effort on areas of high potential (if any) on the subsequent survey. Surveyors were positioned at locations 2, 3, and 6 during the second survey (31<sup>st</sup> August).

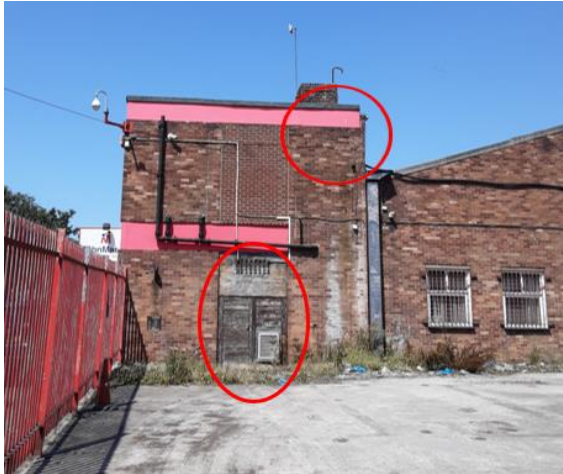
| Building & elevation | Description | Photograph |
|---|---|---|
| Office/warehouse,<br>South-eastern elevation | Primarily constructed from red brick with red PVC fascia, the structure of this building is in moderate condition. The roof is flat, with a felt covering. This appears in good condition with no lifting noted. The timber door, however, is in poor condition with missing slats forming potential roosting features (PRFs), along with a timber board covering the upper most half of the door and wall, which has several circular gaps allowing access to a small crevice between the wooden board and the wall. Other PRFs on this elevation include missing mortar on degraded brickwork near to the top of the building. | |

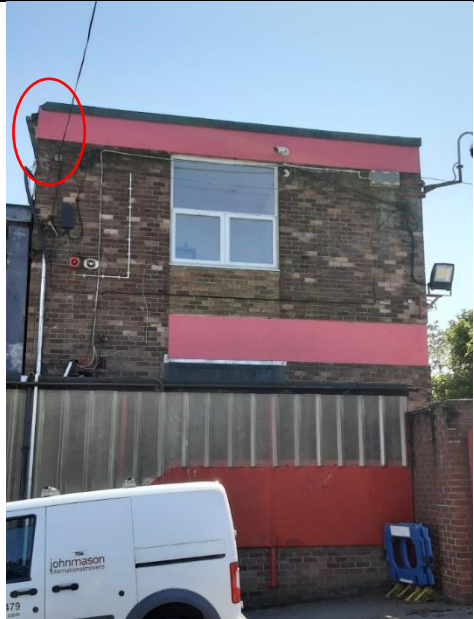
| Building & elevation | Description | Photograph |
|---|---|---|
| Office block, north-western elevation | Primarily constructed from red brick with red PVC fascia, the structure of this building is in moderate condition. The roof is flat, with a felt covering. This appears in good condition with no lifting noted, likewise the PVC window is well-sealed. A timber soffit located on the eastern elevation of this section (where the guttering is attached, overlooking the warehouse unit), appears degraded with several splinters and gaps presenting PRFs. Plastic corrugated sheeting is attached to the bottom half of the structure; whilst corrugated sheeting can provide PRFs for bats, in this case the transparent material is unsuitable, likely providing wide ranging temperature fluctuations and light levels. A large flood light is also present, likely lowering the suitability of the PRFs present. | |

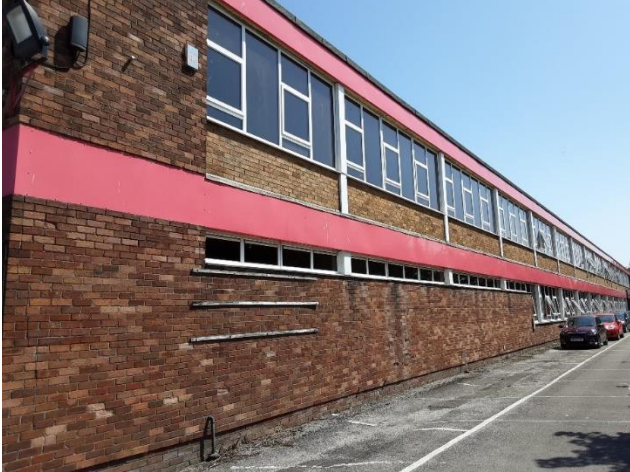
| Office block, western elevation | <p>This section of the building faces a relatively busy road, on a street lined with streetlamps; scattered semi-mature trees also line this section of the pavement. The building is primarily constructed from red brick with red PVC fascia's, the structure of this building is in moderate condition. The roof is flat, with a felt covering. This appears in good condition with no lifting noted, likewise the PVC windows all appear well sealed. No PRFs were noted on this elevation.</p> | |

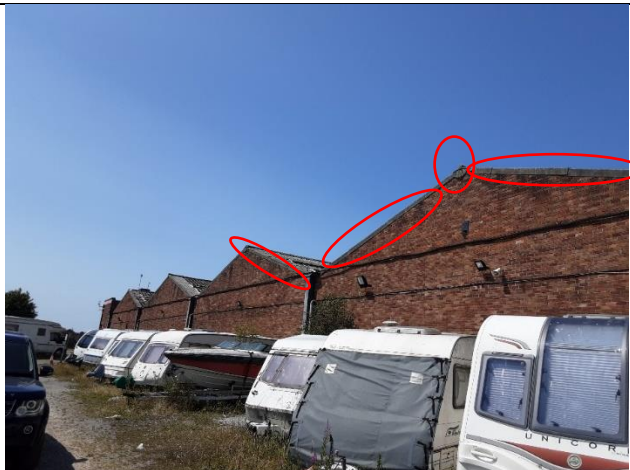
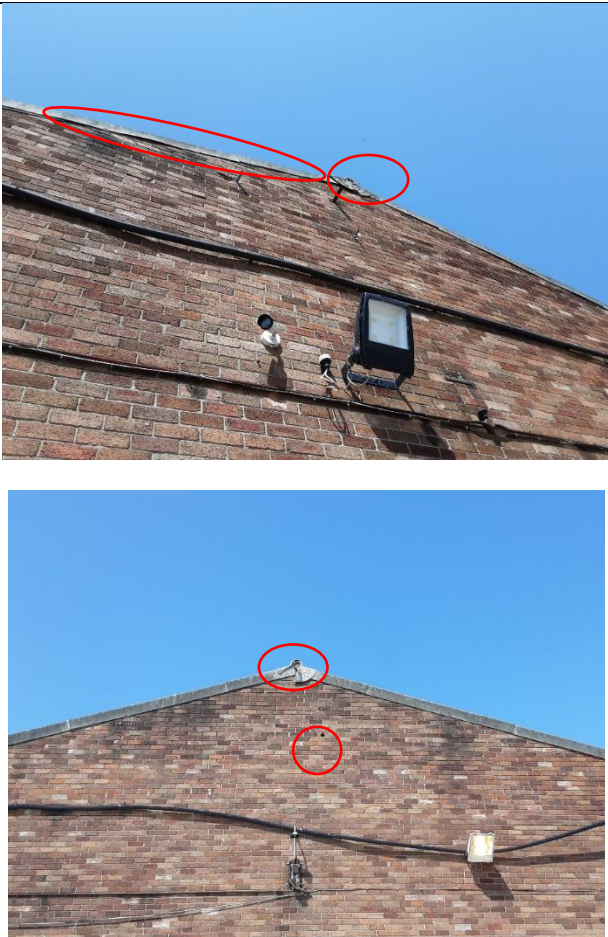
| Warehouse, south-eastern elevation | <p>This building is primarily constructed from red brick, with several pitched roofs on steel frames that are covered with asbestos sheeting. Some of the pitches have sky lights present; there is no loft space. The brickwork is in relatively good condition; however the roof structure/materials appear to be deteriorating. Several PRFs were noted across this elevation, including lifting lead flashing along the roof verges, Missing/damaged verge apex caps, and holes in the brickwork. However, extensive floodlighting across this elevation likely lowers the value of these features for roosting bats.</p> | |

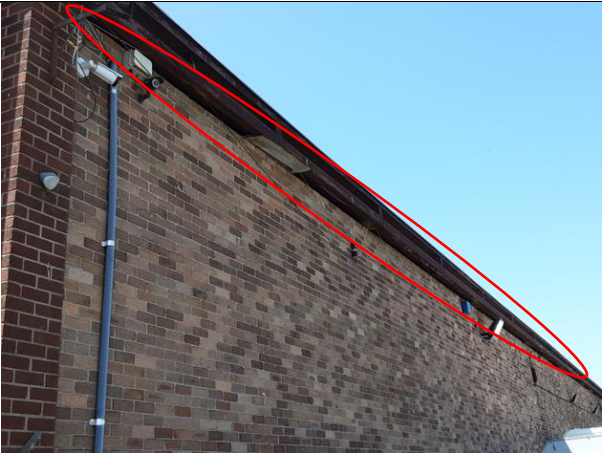
| Warehouse, eastern elevation | <p>This building is primarily constructed from red brick, there are several pitched roofs with steel frames that are covered with asbestos sheeting. Some of the pitches have sky lights present; there is no loft space. The brick work on this elevation is in excellent condition. There is a large gap between the top of the wall and the roof that spans the length of the building, here the steel frame is exposed. This provides entry into the building. However, due to the nature of the storage facility on site, the internal structure of the building is unsuitable for roosting void dwelling bats (brown long ear, maternity roosts) due to constant noise, light, and vibrational disturbance. Furthermore, floodlights present across the elevation will likely deter bat presence.</p> | |

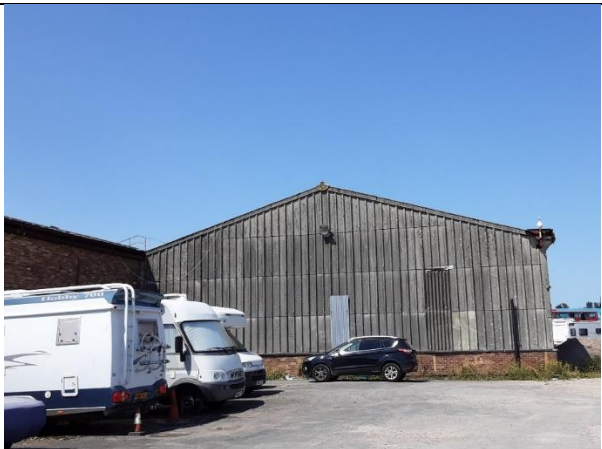
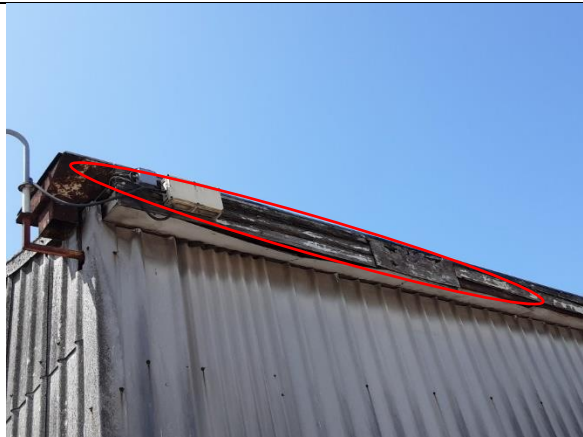
| Warehouse, south-eastern and eastern elevation. | <p>This section of the warehouse is constructed from a red brick base with asbestos sheeting both on the walls and roof structure. The roof is pitched with several skylights present. The building is in poor condition. Corrugated asbestos sheeting provides limited PRFs suitable for crevice dwelling bats. In addition, a splintered timber soffit on the eastern elevation provides a PRF. However, floodlights present across the elevations will likely deter bat presence.</p> | |

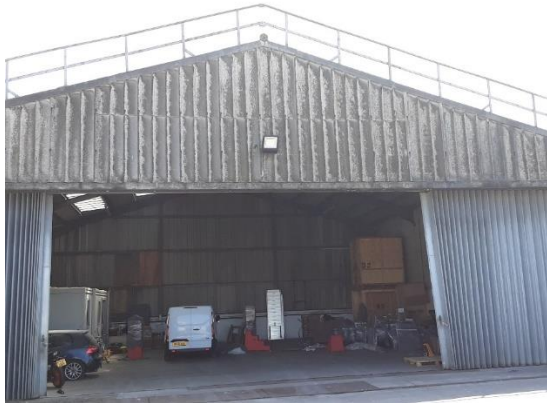
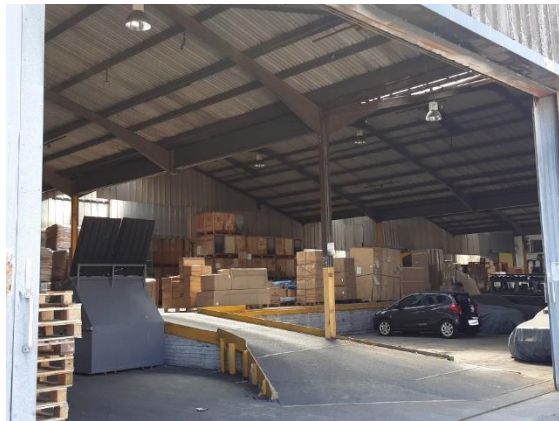
| Warehouse, north-eastern elevation | <p>This section of the warehouse is constructed almost entirely from asbestos sheeting on large steel frames, with metal concertina style shutter doors on the openings. These shutters are open for most of the day and there is constant activity inside the buildings. Asbestos sheeting provides limited PRFs. The potential of these features is lowered due to disturbance and the presence of flood lighting.</p> | <br> |

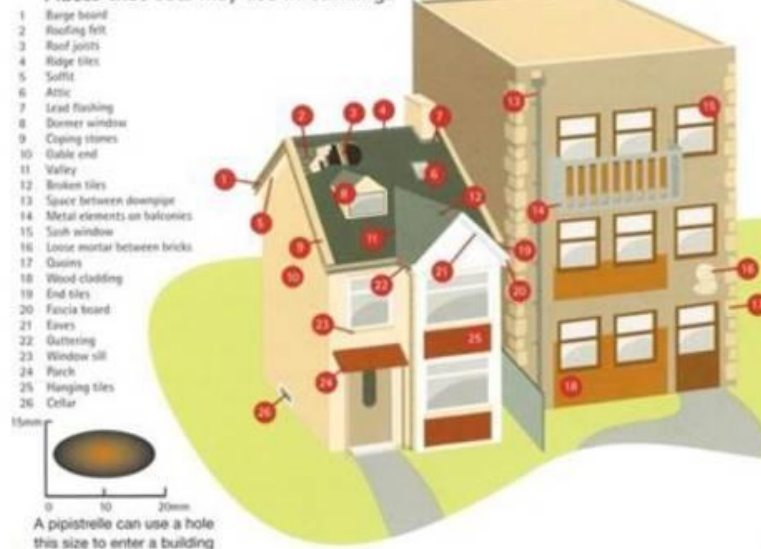
#### Places that bats may use in buildings

- The top of gable end or dividing wall;
- The top of chimney breasts;
- Ridge and hip beams and other roof beams;
- Mortise and tension joints;
- All beams/ceilings/pipework (free hanging bats);
- The junction of roof timbers, especially where ridge and hip beams meet;
- Behind purlins;
- Between tiles and the roof lining;
- Under flat felt roofs;
- In trees (cracks/holes/ivy cladding) ;
- Under barge boards;
- In cavity walls;
- In cracks in stone or concrete;
- Behind peeling paint/wall coverings;
- Gaps behind window and door frames;
- Between window panes and timber boarding.
