Headbolt Lane

Drawing Title  
Headbolt Lane New Station  
Car Park and Access  
Proposed Layout

Figure 1: Location of proposed Headbolt Lane station and engineering works, showing extent of survey area (red highlight) and local BAP deciduous woodland habitats (green polygons). Map screenshot from MAGIC maps (accessed on 27/07/2020).

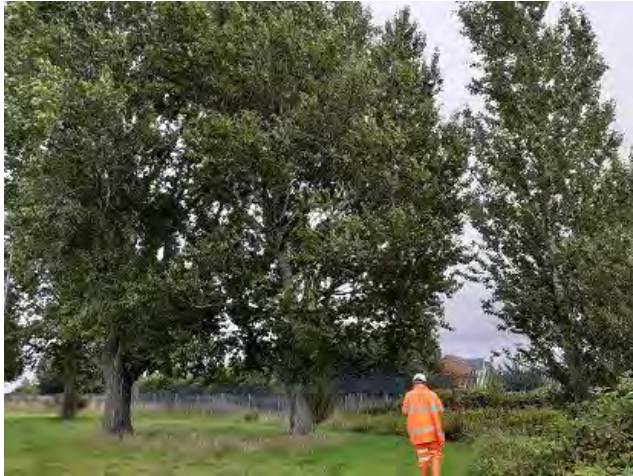
- 3.2.7 Mown amenity grassland (TN1, photograph 1) with Lombardy poplars (*Populus nigra 'Italica'*), one with a broken knot hole (photograph 2) with low bat roosting potential.
- 3.2.8 Mown amenity grassland (TN6, photograph 6) with white clover (*Trifolium repens*), ragwort, ribwort plantain, dandelion, Yorkshire fog, creeping buttercup, black medick (*Medicago lupulina*) and shining cranesbill (*Geranium lucidum*).
- 3.2.9 Mown amenity grassland (TN12, photograph 9), with infrequent thistle, ribwort plantain, Yorkshire fog, garlic mustard, feverfew, horsetail, white clover, greater plantain (*Plantago major*) and areas of bare ground.

Photograph 1. Mature Lombardy poplar trees (TN1); tree with knot hole seen to left hand side.

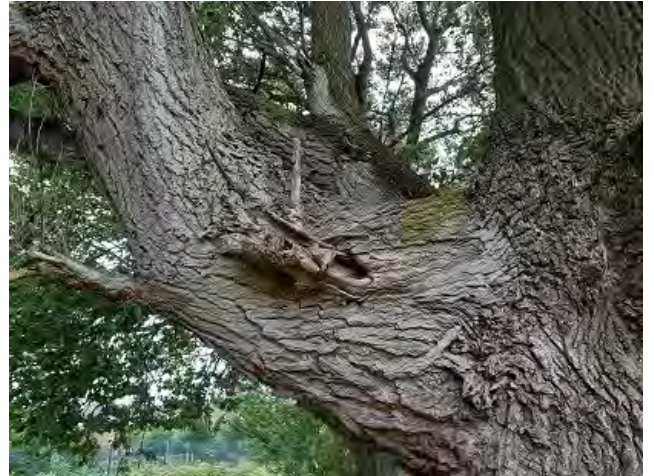
- 3.2.29 A mature Lombardy poplar is present adjacent to Headbolt Lane at SJ 41536 99849. The tree has a knot hole approximately 2.5m high, facing east (photograph 2). The extent of the knot hole could not be fully observed during the preliminary ground-level roost appraisal. Due to the potential of the features to support roosting bats and the suitable surrounding habitat, the tree has been assessed to hold a **moderate** bat roosting potential.

Photograph 2. Knot hole in Lombardy poplar with medium bat roosting potential (TN1).

- The soft felling will be carried out under the supervision of a bat licensed ecologist;
- Ideally carry out work on trees in autumn and spring (i.e. September to October and March to April), as this is when bats are least likely to be present;
- When preparing to cut a tree, look for evidence of bat occupancy – behind ivy stems; obvious holes, cavities and splits; dark staining on a tree below a hole; staining around a hole; maze of tiny scratch marks around the hole; noise coming from a hole; droppings within a hole;
- Bats may be behind partially detached ivy with stems in excess of 50mm, such features must be searched for evidence of bat occupancy before removal;
- Bats may be anywhere inside a hole, try to cut as far above a hole as possible. If in doubt if it is a roost, do not cut and seek ecological advice from the on-site ecologist;

- Bats may be inside cracks held open by the weight of a branch, which will close when the branch is taken off. Search such splits for bats before removing large limbs;

- Where possible, ring bark and leave up to 15m standing dead wood (trunk), with due regard to Health and Safety issues;
- If bats are found: if the roost(s) is still intact and bats are not injured, works will temporarily cease until the ecologist has assessed the situation and establish the most appropriate way forward. If necessary, Natural England will be consulted and a mitigation licence will be applied for. If the bat(s) is injured, the bat will be taken into care by a local bat group/bat carer – works should only recommence once the ecologist has said that it is safe and legal to do so;

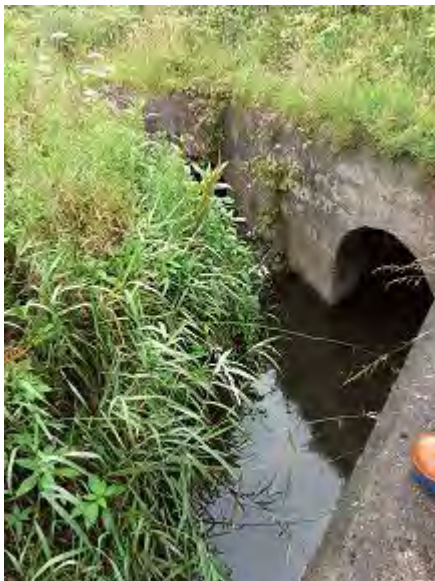
- 3.2.17 Very slow flowing stream (TN2, photograph 3) emerging from two culverts under the rail track, with a depth of 50cm and a width of 1.5m. Some glossy film was observed on the water's surface, and large pieces of litter were observed on the bed. Bankside vegetation included rosebay willowherb, Himalayan balsam, thistle, nettle, horsetail, cleavers, bindweed, Yorkshire fog, bramble, cow parsley and common reed (*Phragmites australis*), with immature oak.

Photograph 3. Slow-flowing culverted stream (TN2) running through the proposed Headbolt Lane station site.

- 4.3.1 All works will be conducted in line with Network Rail Environment Contract Requirements (NR/SP/ENV/015) and all industry standard best practice. This will avoid the risk of polluting the watercourse through chemical contamination or substrate run off.
- Any chemicals (if required) will be stored in designated places and banded to prevent leakages.
  - Spill kits will be on site to deal with any leakage of fuel, wet concrete or chemicals.
  - Vehicles will be inspected regularly to identify leaks, fuelling will be carried out off site.
  - On completion of the works, the working area will be reinstated on a like-for-like basis.

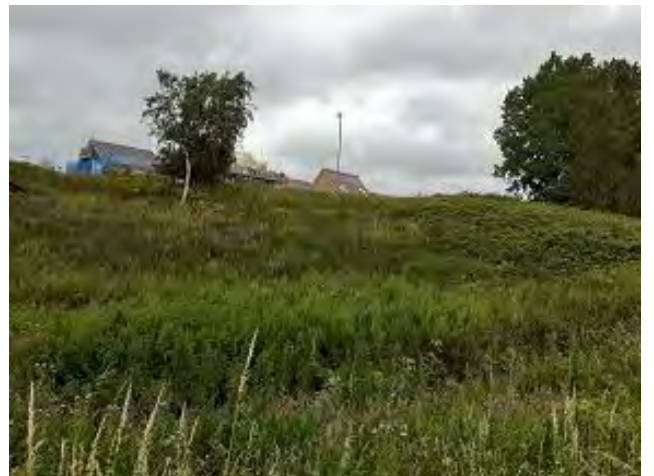
Photograph 5. Semi-improved neutral grassland (TN4) looking west.

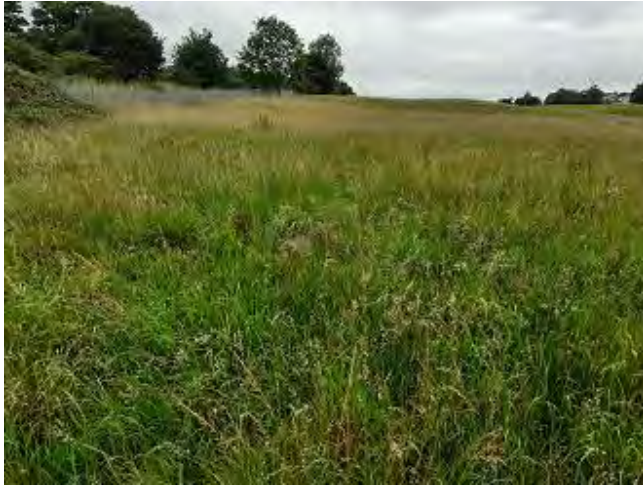
- 3.2.5 Unmown areas of semi-improved neutral grassland (TN7, photograph 6), with hawkbit, sweet vernal grass, sorrel, white clover, Yorkshire fog, thistle, dock, ribwort plantain, creeping buttercup, ragwort, weld (*Reseda luteola*), yarrow, bird's foot trefoil (*Lotus corniculatus*) and selfheal (*Prunella vulgaris*).

Photograph 6. Mosaic of semi-neutral grassland (left side, TN4), small cluster of immature trees (background left side, TN5), mown amenity grassland (foreground, TN6) and unmown grassland (right side, TN7).

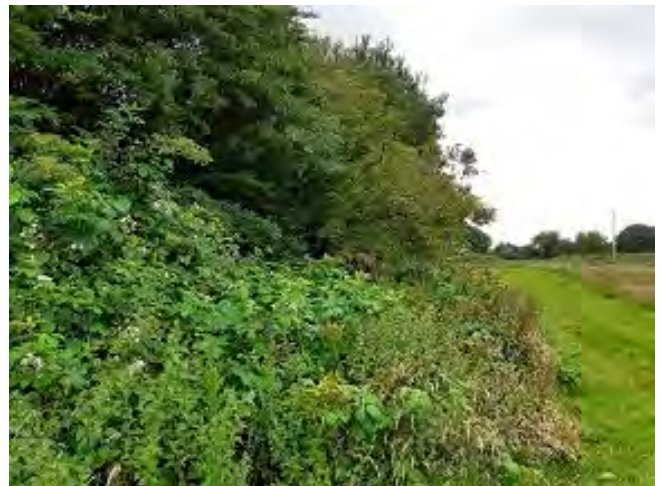
- 3.2.6 Semi-improved neutral grassland sloping down to embankment (TN11, photograph 9). Species include garlic mustard, thistle, feverfew (*Tanacetum parthenium*), rosebay willowherb, dock, sweet vernal grass, chickweed (*Stellaria media*), horsetail (*Equisetum sp.*), poppy (*Papaver somniferum*), great willowherb, bramble (*Rubus fruticosus*), ribwort plantain, hawkbit, common vetch (*Vicia sativa*), bindweed, red fescue (*Festuca rubra*), pineappleweed (*Matricaria discoidea*) and creeping buttercup.

Photograph 9. Scrub and semi-improved neutral grassland sloping down to culvert under railway embankment (TN11). Mown grassland (TN12) present to far right.

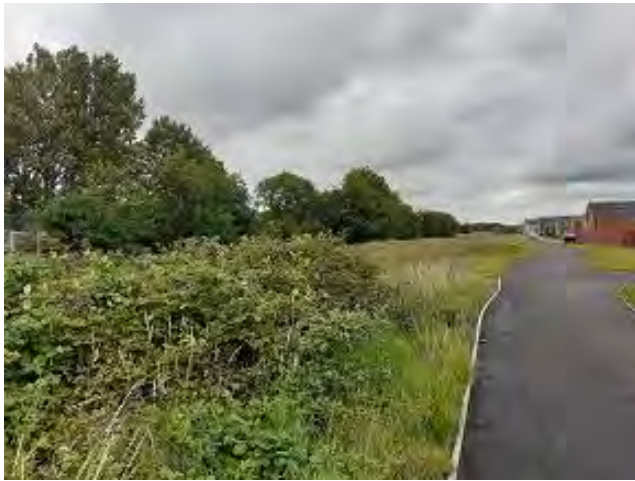
- 3.2.16 An area of bare ground (TN13, photograph 10), with buddleja, bramble, dock, rosebay willowherb, hop (*Humulus lupulus*) and Japanese knotweed (*Fallopia japonica*) present at security fence alongside track. Trees include field rose, sycamore, silver birch, hawthorn and cherry.

- 3.2.19 Himalayan balsam was identified along the banks of the stream running through Headbolt Lane (TN2, TN8). Japanese knotweed was identified near Kirkby station (TN13, photograph 10), in an area of bare ground proposed to be developed for a new substation.

Photograph 10. Japanese knotweed present on bare ground for proposed substation (TN13).

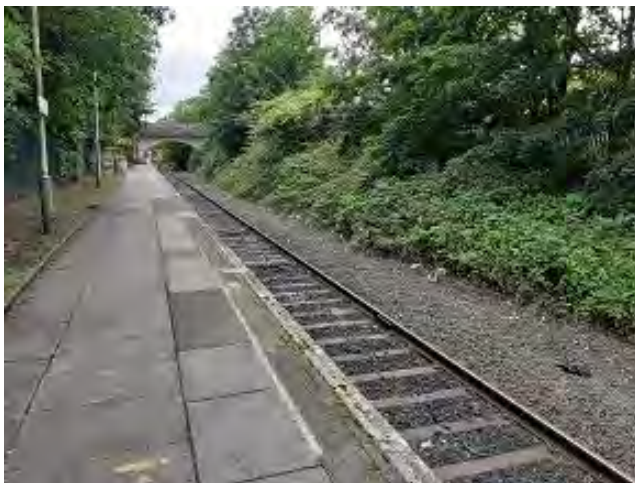
- 3.2.12 Railway embankment scrub vegetation east of Kirkby station (TN15, photographs 11 and 12), with species including oak, goat willow (*Salix caprea*), sycamore, silver birch, elder, common lime (*Tilia x europaea*), Lombardy poplar, field maple (*Acer campestre*), cherry, privet (*Ligustrum vulgare*), field rose, hawthorn, gooseberry (*Ribes uva-crispa*), cotoneaster (*Cotoneaster horizontalis*) and Leyland cypress (*Cupressus x leylandii*). Behind the northern platform, trees include laburnum (*Laburnum anagyroides*), sycamore, elder and laurel (*Laurus nobilis*). Ground flora includes horsetail, bramble, ragwort, cocksfoot, red fescue, rosebay willowherb, bindweed, nettle, cleavers, old man's beard (*Clematis vitalba*), bracken (*Pteridium aquilinum*), thistle, hawkbit, ivy (*Hedera helix*), yellow flag iris (*Iris pseudacorus*), goldenrod (*Solidago virgaurea*), raspberry, yarrow, variegated yellow archangel (*Lamium galeobdolon* subsp. *argenteum*), foxglove (*Digitalis purpurea*), common vetch, buddleja (*Buddleja davidii*), groundsel (*Senecio vulgaris*) and herb Robert.

Photograph 12. Embankment vegetation (TN15).

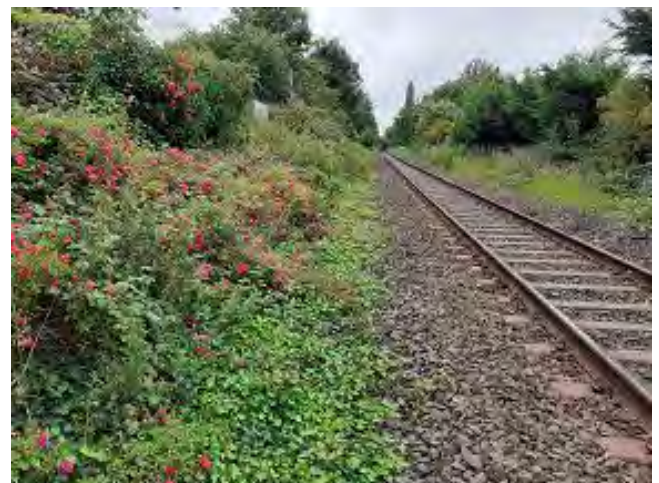
- 3.2.15 Railway embankment species adjacent to Headbolt Lane (TN17) include goat willow, bracken, tormentil (*Potentilla erecta*), yarrow, hawkbit, bindweed, sage (*Salvia officinalis*), common vetch, cherry species, apple species (*Malus* sp.), and wood forget-me-not (*Myosotis sylvatica*). A large mammal run was observed partway down the track on the southern embankment (photograph 13).

- 3.2.23 A cluster of shallow mammal holes were identified along the railway embankment at SJ 41369 99759 (photograph 14). Two mammal pathways, likely used by foxes or domestic cat, was identified the opposite side of the railway track at SJ 41275 99709 (photograph 13) and at SJ 40753 99478 through thick scrub vegetation. As the vegetation along the railway embankment and in some area of the proposed development at Headbolt Lane is dense, it is possible that other evidence of badger, rabbit or fox including mammal holes may have been missed. Therefore as a precaution, recommendations for badger, rabbit and fox are included within the Conclusion and Recommendations section, below.

Photograph 13. Mammal path (TN17) at SJ 41275 99709.

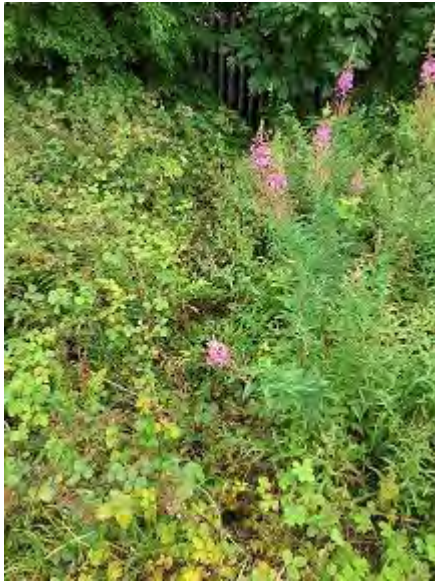
Photograph 14. Shallow mammal holes (TN17) at SJ 41369 99759.

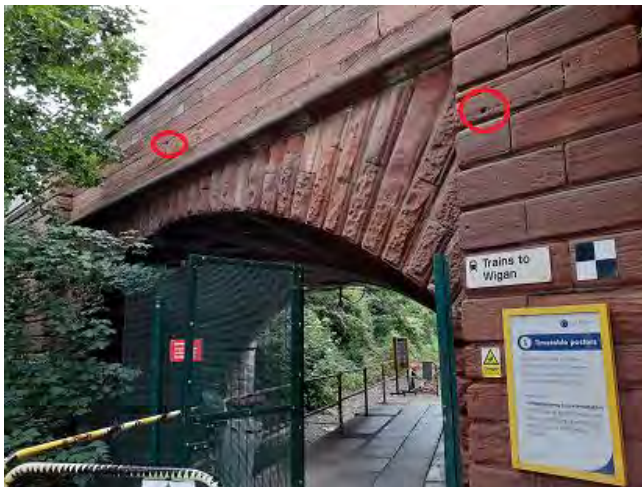
Photograph 15. Glovers Brow Bridge (eastern elevation) with crack to left and pockmark to right highlighted (red circles).

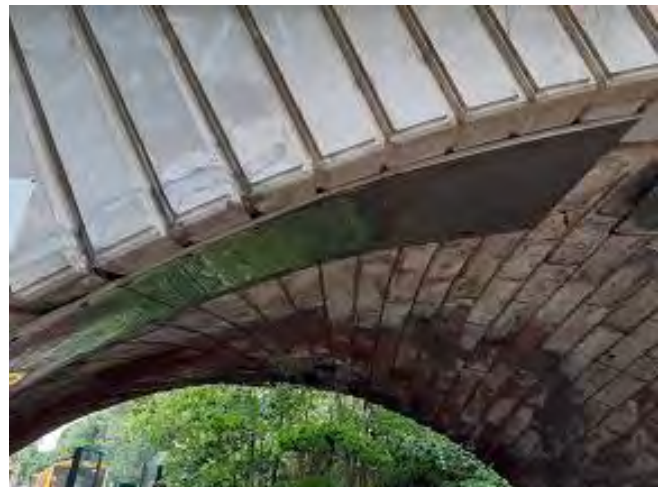
- 3.2.37 Glovers Brow Bridge is a solid concrete and sandstone construction, with a section of metal plating underneath the arch. Gaps are present between the concrete arch and metal plating (photograph 16) that may provide suitable roosting opportunities for bats, although cobwebs present suggest that these spaces have not been used recently. Some small pockmarks and cracks were present in the eastern sandstone elevation (photograph 15). No evidence of bat use, in the form of droppings, prey remains, staining on crevices by fur oils or urine, or bats themselves were identified across the bridge.
- 3.2.38 Glovers Brow Bridge was assessed as having **low** potential for roosting bats due to a lack of evidence of bat use, and the presence of only minor superficial roosting features.

Photograph 16. Metal plate underneath Glovers Brow Bridge with low bat potential.

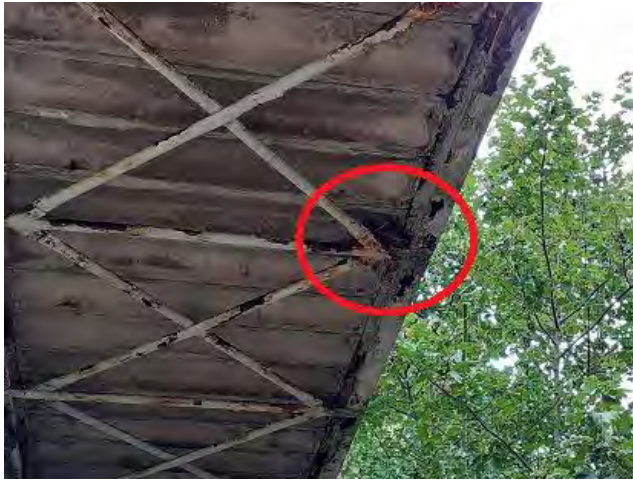
- 3.2.21 Opportunities for nesting birds are prevalent throughout the vegetation within the survey area, including railway embankments and bridges, where trees, scrub and tall ruderal vegetation are present. The dense bramble scrub within the proposed development is of notable value for nesting long tailed tit (*Aegithalos caudatus*), blackbird (*Turdus merula*) and dunnoek (*Prunella modularis*).
- 3.2.22 Old bird nests (photograph 17) from prior to the 2020 nesting season were observed underneath the steel crossbeams of a metal footbridge adjacent to Glovers Brow Bridge (SJ 40249 99256).

Photograph 17. Old bird nest present underneath Glovers Brow footbridge.

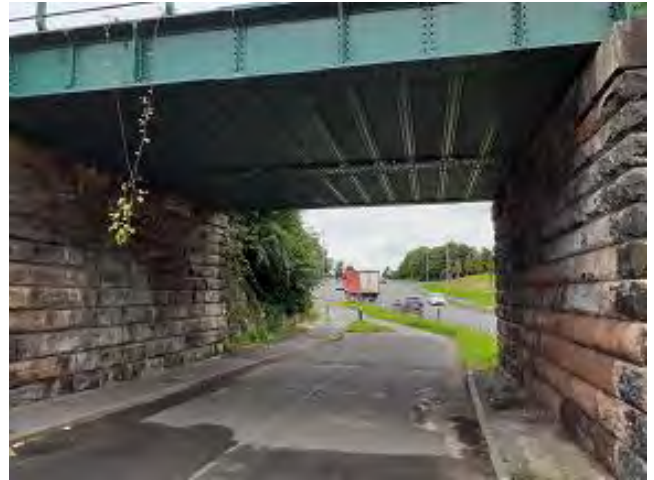
- 3.2.32 County Road Bridge is a reinforced steel and stone structure (photograph 18), with no signs of weathering or colonisation by plant species. There are no gaps or cracks present that could provide potential spaces for roosting bats. No evidence of bat use, in the form of droppings, prey remains, staining on crevices by fur oils or urine, or bats themselves were identified across the bridge.
- 3.2.33 Therefore County Road Bridge was assessed as having **negligible** potential for roosting bats due to a lack of evidence of bat use and the absence of any suitable roosting features.

Photograph 18. County Road Bridge with no bat potential.

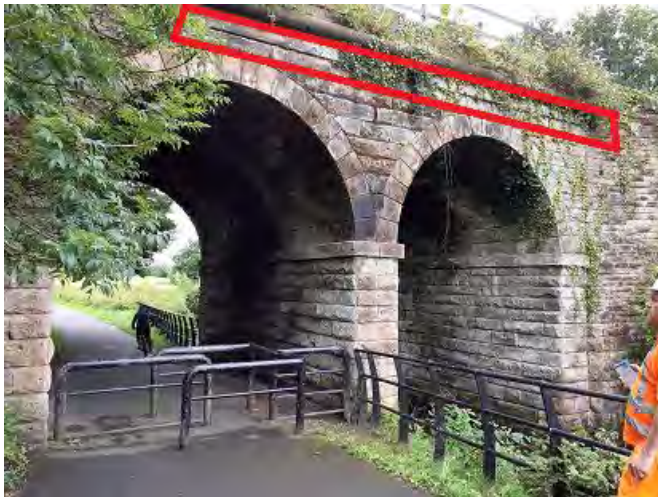
Photograph 19. Millbrook Bridge with gap present above arch ring.

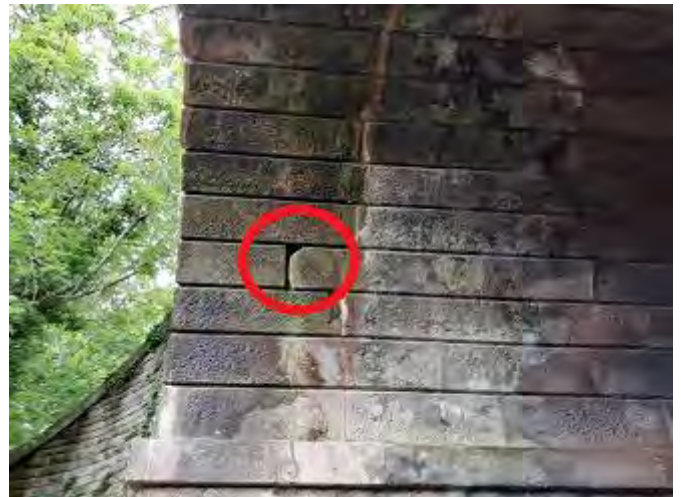
Photograph 20. Gap in arch of Millbrook Bridge near northern elevation, above footpath.

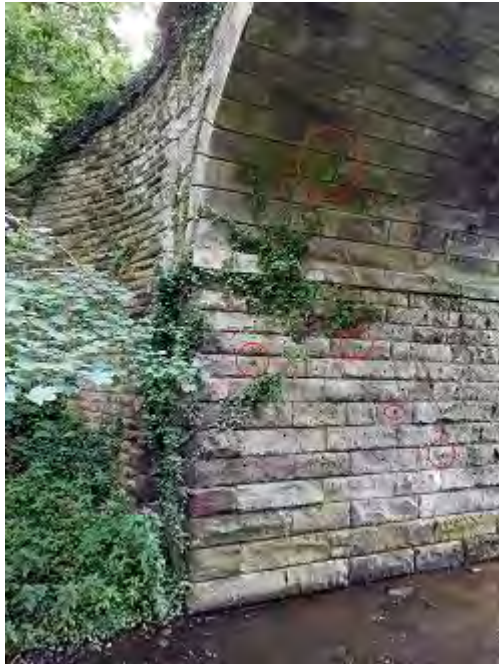
Photograph 21. Cracks and pockmarks in Millbrook Bridge over stream.
