# **Foxhill Farm, Ecological Impact Assessment**

**FINAL REPORT**

**Date: December 2022**

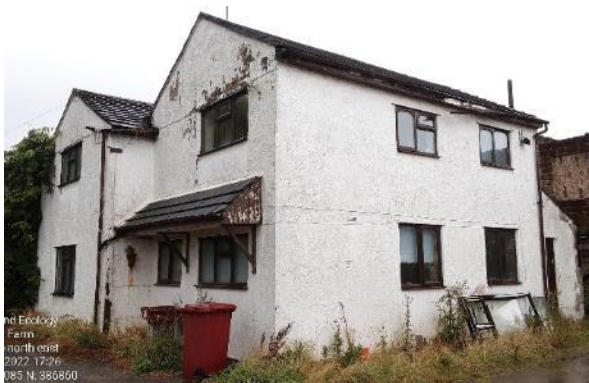
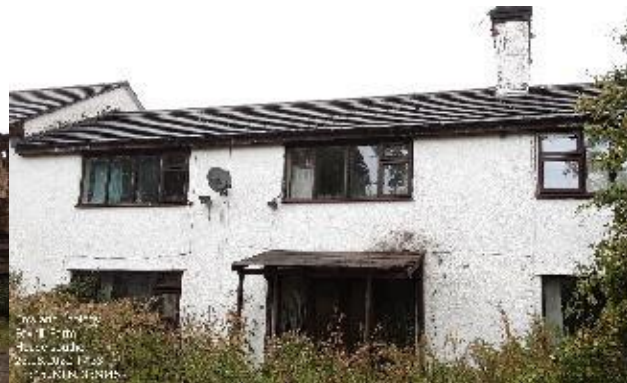
| Building Number | Description | Photographs |
|---|---|---|
| B1<br>(unoccupied) | <p><u>Overview</u></p> <p>A large two-storey neglected farmhouse with rendered breeze-block walls and two parallel double-pitched roofs, both orientated north-west to south-east (Plate 1). Both roofs are covered with interlocking tiles over a bitumen felt liner. The southern part of the farmhouse adjoins the cottage (B2) and the northern part has a lean-to extension located on its north-western elevation. The building has UPVC windows and features a small mono-pitched roof over the ground floor windows on the south-west elevation and a mono-pitched porch at the rear (Plate 2). A heavily degraded timber soffit box and associated guttering lines the roof verge along the north-east and south-west elevations. The gables are mortared and lack barge boards.</p> <p><u>External Inspection</u></p> <p>The ridge along the northern elevation appears to be well sealed, although there are some gaps beneath the roof tiles close to the roof verge, where bats could potentially roost under or gain access to the loft void. The soffit is also rotten in many places along the roof verge, with large gaps creating potential access points for bats along the main roofs and the lean-to extension (Plates 3 and 4).</p> <p>At the apex of the south-eastern gable there is a gap below the ridge tile, providing a PRF (potential roosting feature) for bats (Plate 5). The wooden porch on the same elevation is rotting, and the gaps between the wood and tiles may provide opportunities for crevice dwelling bats. Similar gaps are present at uncovered gable verges and the edge of the lean-to roof along the north-western elevation (Plate 6).</p> <p>The roof tiles on the south-western elevation are generally well sealed, although the soffit is very rotten in places with large gaps. There is a brick chimney with lead flashing surrounding the base, which has a small gap in the brickwork towards the base. Viewed from the north, there are also several small gaps along the ridgeline and the soffit above the alleyway between the two buildings is very rotten with large gaps (Plate 6).</p> <p><u>Internal Inspection</u></p> <p>Internally, the ground floor appeared to have been recently used. All the doors and windows across both floors are well sealed and in good condition (Plate 7). At the entrance of the building, the ceiling joists are exposed, however no obvious gaps with suitability for bats were present (Plate 8). The lean-to extension of the north-western elevation has a pitched ceiling and does not feature a roof void. On the first floor, there is a small hole in the ceiling above the hot water tank, potentially providing an access point from the loft space above. However, as the building is unoccupied and likely unheated, this would be unlikely to attract bats. In general, the interior space across both floors is well lit from uncovered windows and is unlikely to provide suitable roosting opportunities or access points for bats.</p> <p>There are two access hatches into the roof voids on the first floor; both voids could not be accessed fully as they were not boarded. Insulation was present between joists across the majority of the visible loft space. The southern (larger) loft void above the bedrooms is divided into sections by brick walls. A small hole was noted along the ridge with some light ingress just above the ridge beam, which may provide possible access for bats. The roof is lined with traditional bitumen felt, which is generally well-sealed although some sections are starting</p> | <p>Plates 1 and 2: External views of the farmhouse (front and rear elevations)</p> <p>Plates 3 and 4: Degraded soffit box along main roof and lean-to extension</p> <p>Plates 5 and 6: Gap at south-eastern gable end below ridge tile gaps at roof verges on north-west elevation</p> |

- 3.14 Full building inspection results are presented in Appendix D. In summary, the farmhouse (B1) and the bungalow (B4) offer **high** suitability for roosting bats. Both buildings have been uninhabited for some time and have fallen into a poor state of repair. Potential roosting features (PRFs) for bats include:

- Slipped and missing roof tiles; and
  - Numerous gaps along the roof verge, including apex gaps (on dormer roofs at the bungalow) and degraded soffit boxes/fascia boarding.

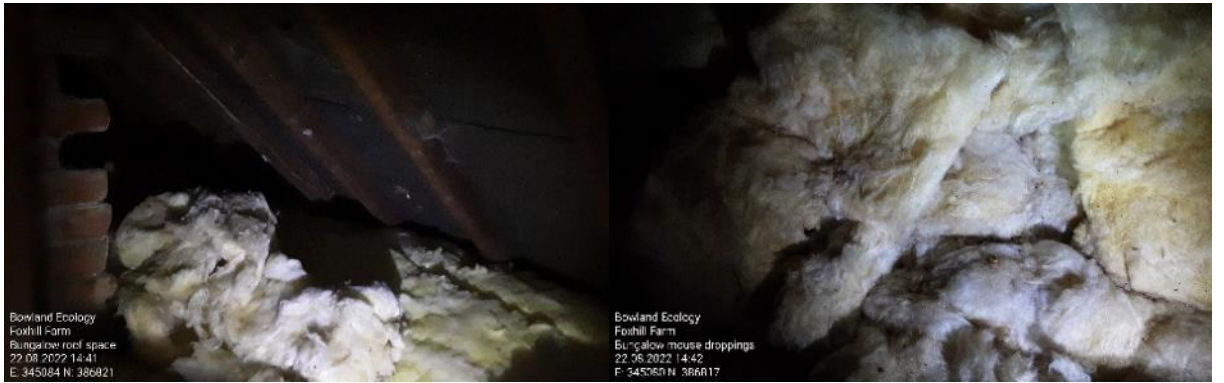
On the first floor there are two rooms, surrounded by a sloping roof void which was be viewed through open hatches (Plates 27 and 28). It was noted that the upper rooms were significantly warmer than the rooms on the ground floor. The underside of the main roof is lined with tradition bitumen felt which was degraded in some areas, with torn sections and gaps between overlapping layers. Wooden rafters extend to meet large wooden beams with trusses where they meet the internal walls. No light ingress could be seen, although insulation covered the floor of the void. Mice droppings were observed within the crawl space. No bats or evidence of bats was observed.

Overall, the bungalow is considered to have **high** suitability for roosting bats.

Plates 27 and 28: Loft voids (crawl space around upper rooms)

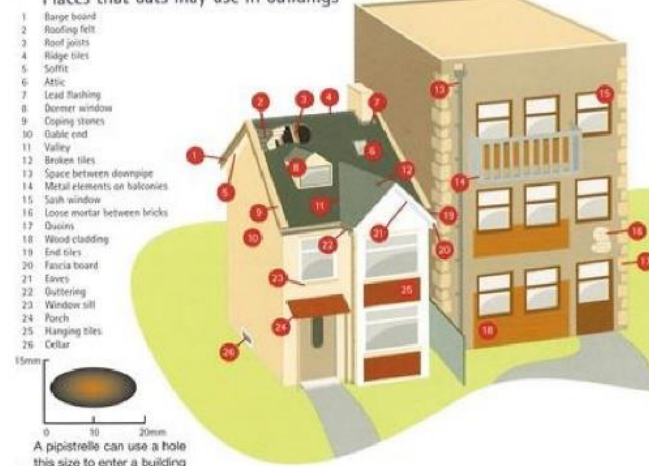
### Places that bats may use in buildings

Schematic from [www.bats.org.uk](http://www.bats.org.uk)

- The top of gable end or dividing wall;
- The top of chimney breasts;
- Ridge and hip beams and other roof beams;
- Mortise and tension joints;
- All beams/ceilings/pipework (free hanging bats);
- The junction of roof timbers, especially where ridge and hip beams meet;
- Behind purlins;
- Between tiles and the roof lining;
- Under flat felt roofs;
- Under barge boards;
- In cavity walls;
- In cracks in stone or concrete;
- Behind peeling paint/wall coverings;
- Gaps behind window and door frames;
- Between window panes and timber boarding.
- In trees (cracks/holes/ivy cladding).
