Witherslack Group

**Lakeside School, Liverpool**

**Arboricultural Assessment**

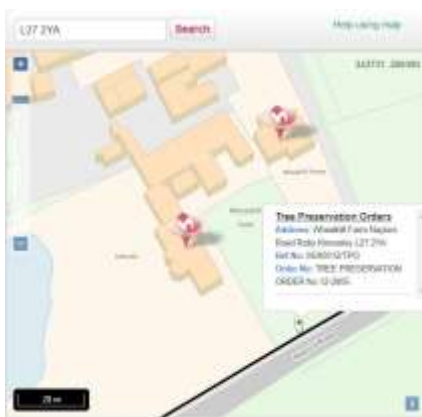
**Figure 1: Location of Tree Preservation Order**

- 5.16 The following figure highlights where trees are included in the Knowsley Council Tree Preservation Order (TPO), Wheathill Farm Naylor's Road Roby Knowsley L27 2YA, No 12-2005. Exact details of which trees are within the TPO have been confirmed by Knowsley Council and the tree within the TPO is protected by law from felling or uprooting, pruning including 'topping/lopping' and willful damage or destruction.

- 5.17 The granting of full planning permission would override the protection afforded by the Tree Preservation Order to those trees shown as removed to facilitate the proposals within the approved plans.
- 5.18 If full planning permission is not present, prior to any tree surgery and / or felling of protected trees it will be necessary to apply to the relevant local planning authority to gain consent for the works. For more information regarding Conservation Areas and Tree Preservation Orders it is advised that contact is made with the Local Planning Authority's arboricultural officer, or other such relevant person.

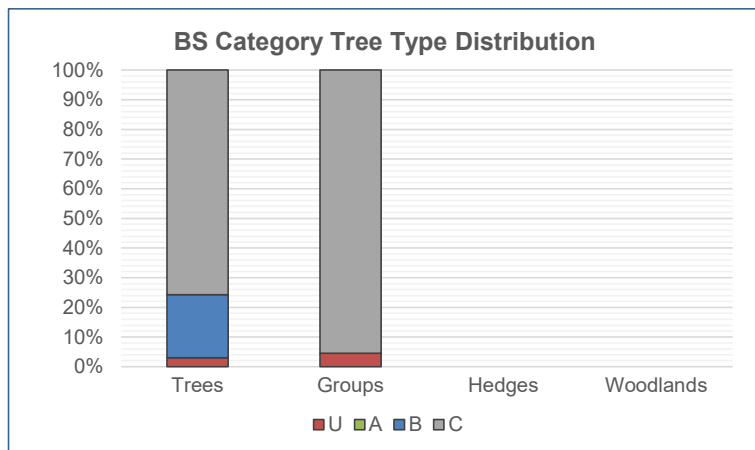
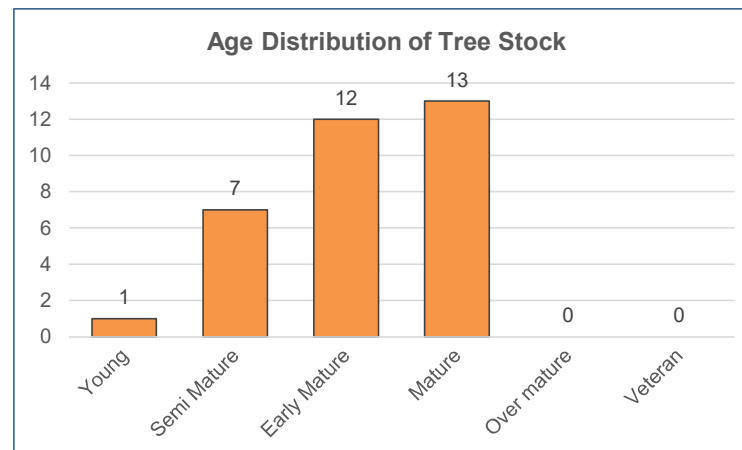
**BS Category Tree Type Distribution** displays the proportion of trees assessed in each type to enable a better understanding of the category distribution.

**Age Distribution of Tree Stock** shows the number of trees in each age category across the tree stock allowing assessment of their longevity to be made.
