# **Arboricultural Constraints Appraisal**

in Relation to Proposed Light Industrial Development at

**35 Wilson Road, Huyton Business  
Park, Huyton, Merseyside, L36 6AE**

**ARBORICULTURAL CONSTRAINTS APPRAISAL  
35 WILSON ROAD, HUYTON**

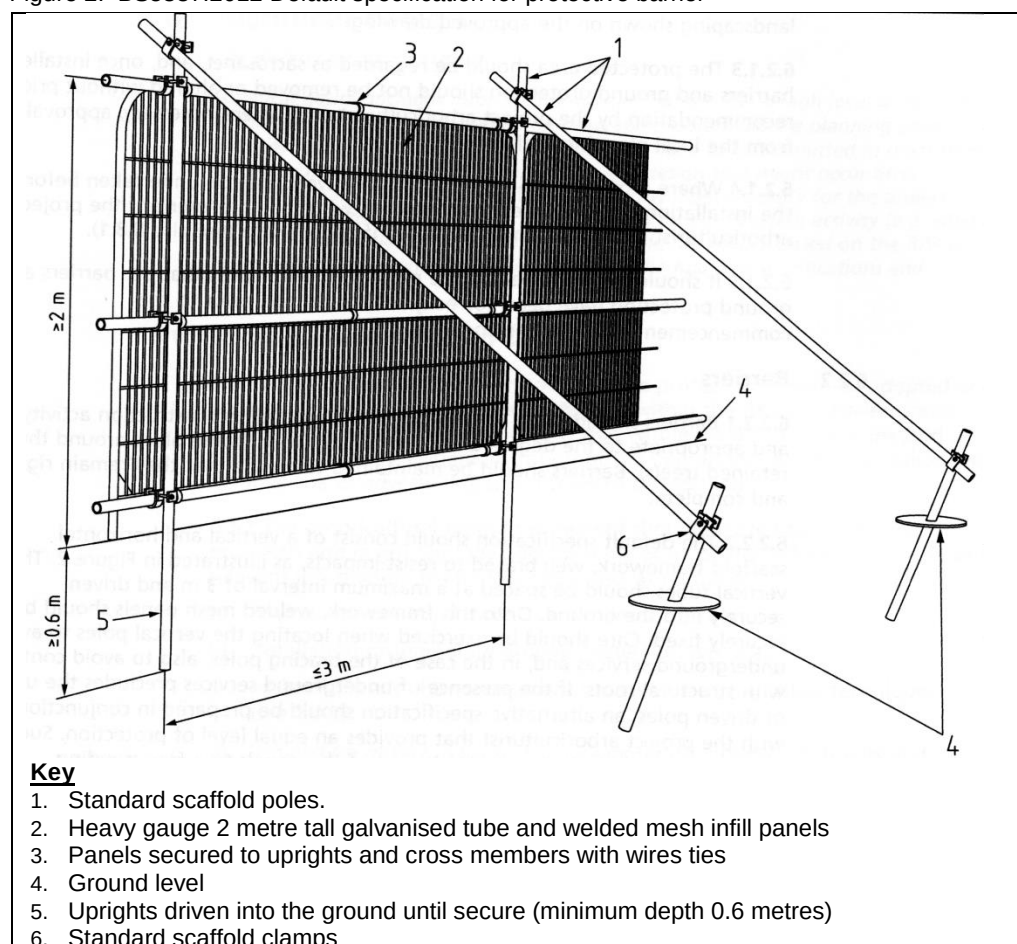
Figure 2: BS5837:2012 Default specification for protective barrier

6. No fixing shall be made to any tree and all possible precautions shall be taken to prevent damage to tree roots when locating posts.
7. A 600mm x 300mm warning sign reading "TREE PROTECTION AREA KEEP OUT" (see Figure 1) shall be fixed to every 10.0 metre length of protective fencing.

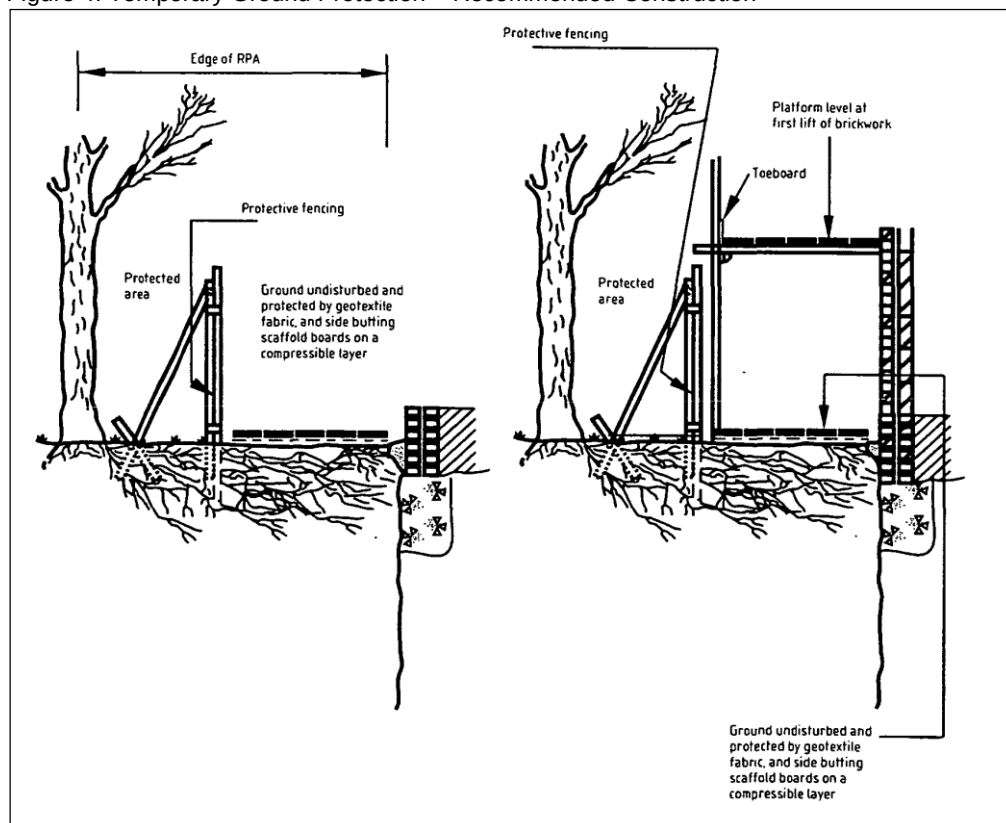
Figure 4: Temporary Ground Protection – Recommended Construction

### Temporary Ground Protection

1. Any necessary Temporary Ground Protection areas shall conform to Figure 4, below, unless otherwise agreed with the LPA.
2. The Ground Protection Area shall be left undisturbed and covered by a semi-permeable geotextile membrane which shall, in turn, be covered by a compressible layer consisting of a material such as woodchip.
3. Side-butting scaffold boards shall then be fitted to cover the Ground Protection Area.
4. On completion of installation, and prior to any demolition or construction works, site preparation, excavation or delivery of plant and materials, the Consulting Arboriculturist or the LPA Tree Officer, as agreed, shall inspect the Temporary Ground Protection.
5. The Temporary Ground Protection shall remain in place until completion of the project and only removed following receipt of written permission from the LPA.

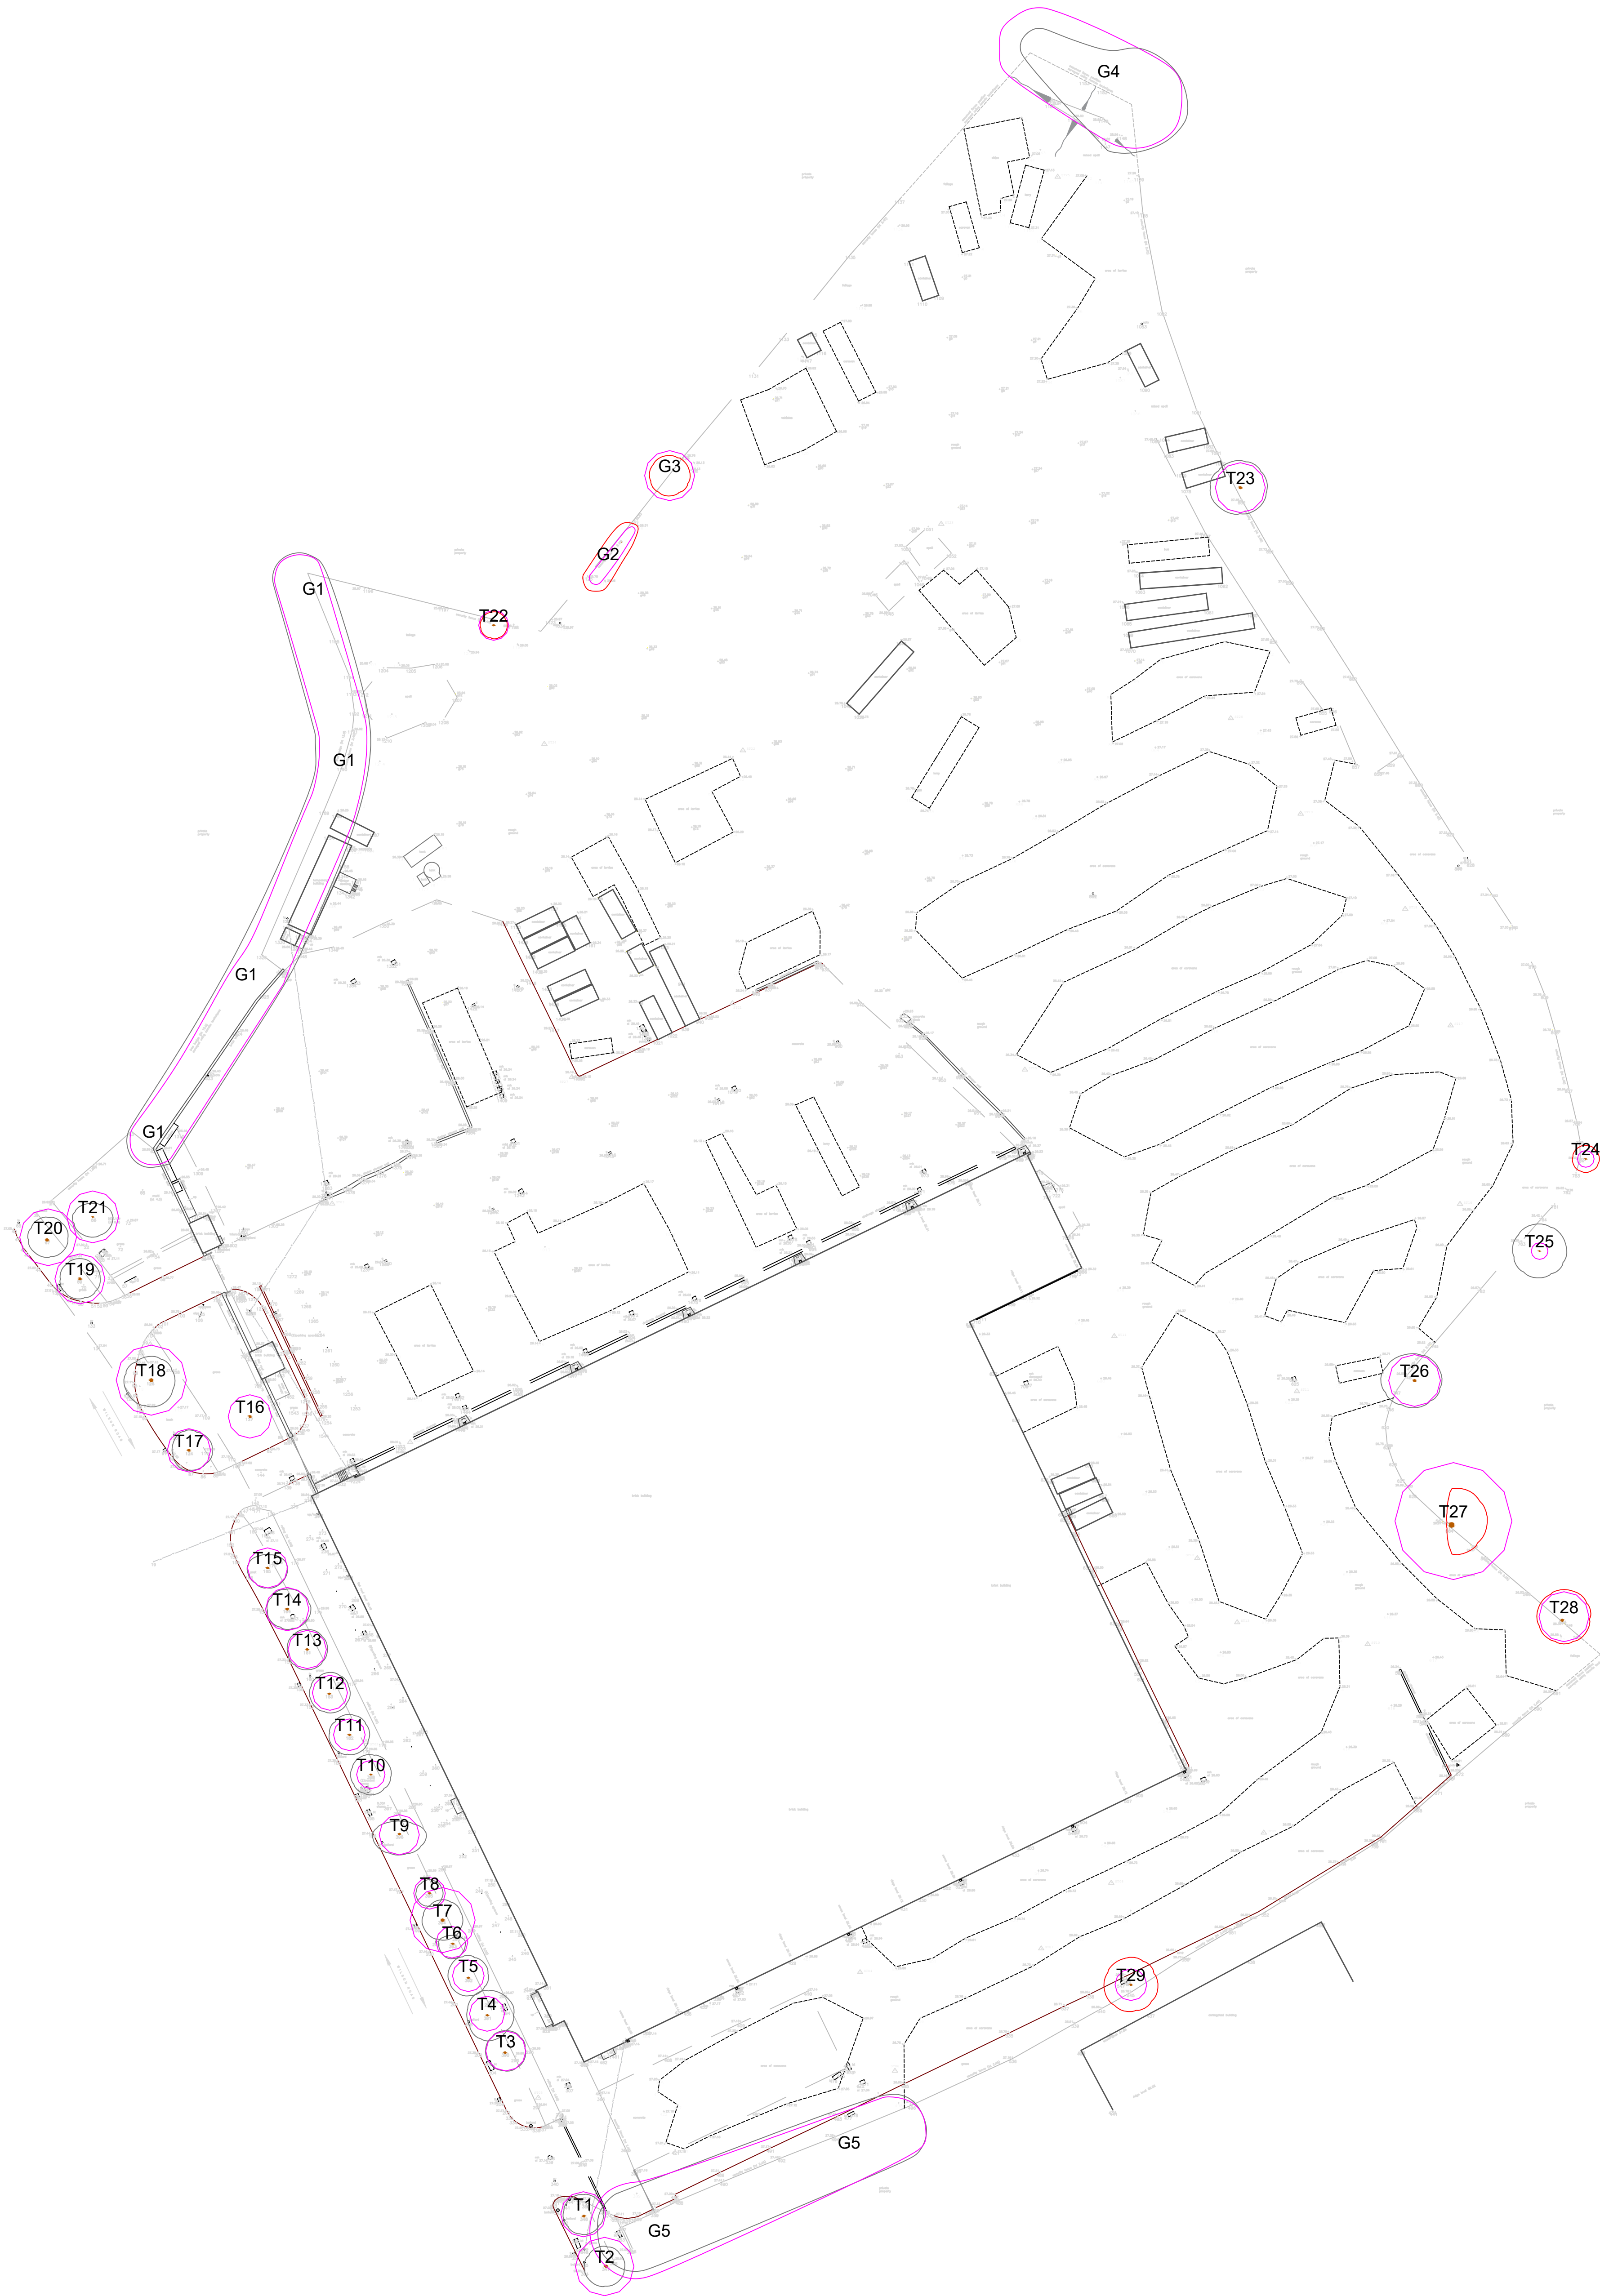
KEY

T = Individual Tree  
G = Group of Trees

- Category 'U' Tree/Group**  
Those in Such a Condition that they Cannot Practically be Retained as Living Trees in the Context of the Current Land Use for Longer Than 10 Years
