## DESK STUDY/PRELIMINARY RISK ASSESSMENT AND COAL MINING RISK ASSESSMENT REPORT

35 Wilson Road  
Huyton  
Liverpool  
L36 6AE

**Report Title:** Desk Study/Preliminary Risk Assessment and Coal Mining Risk Assessment Report for 35 Wilson Road, Huyton, Liverpool, L36 6AE

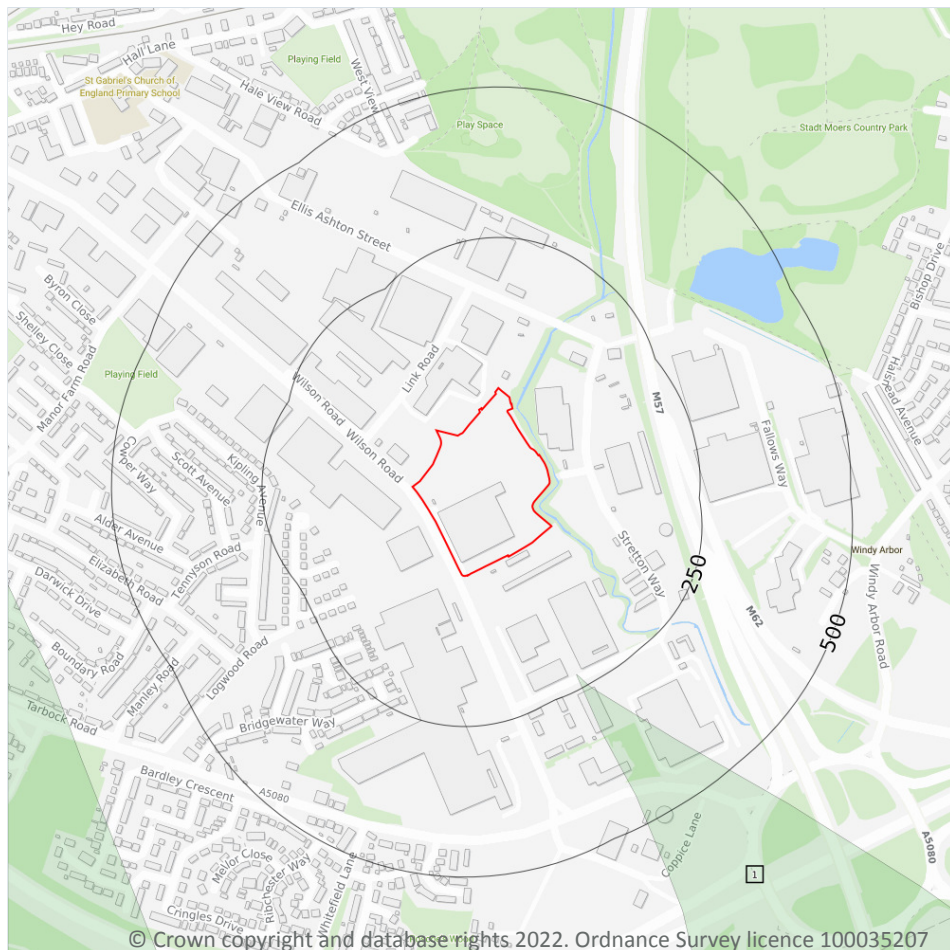
## Abstractions and Source Protection Zones

- Site Outline
- Search buffers in metres (m)**
- Source Protection Zone 1  
Inner catchment
- Source Protection Zone 2  
Outer catchment
- Source Protection Zone 3  
Total catchment
- Source Protection Zone 4  
Zone of Special Interest
- Source Protection Zone 1c  
Inner catchment - confined aquifer
- Source Protection Zone 2c  
Outer catchment - confined aquifer
- Source Protection Zone 3c  
Total catchment - confined aquifer
- Drinking water abstraction licences  
Polygon features
- Drinking water abstraction licences  
Linear features
- Groundwater abstraction licence (point)
- Groundwater abstraction licence (area)
- Groundwater abstraction licence (linear)
- Surface Water Abstractions (point)
- Surface Water Abstractions (area)
- Surface Water Abstractions (linear)

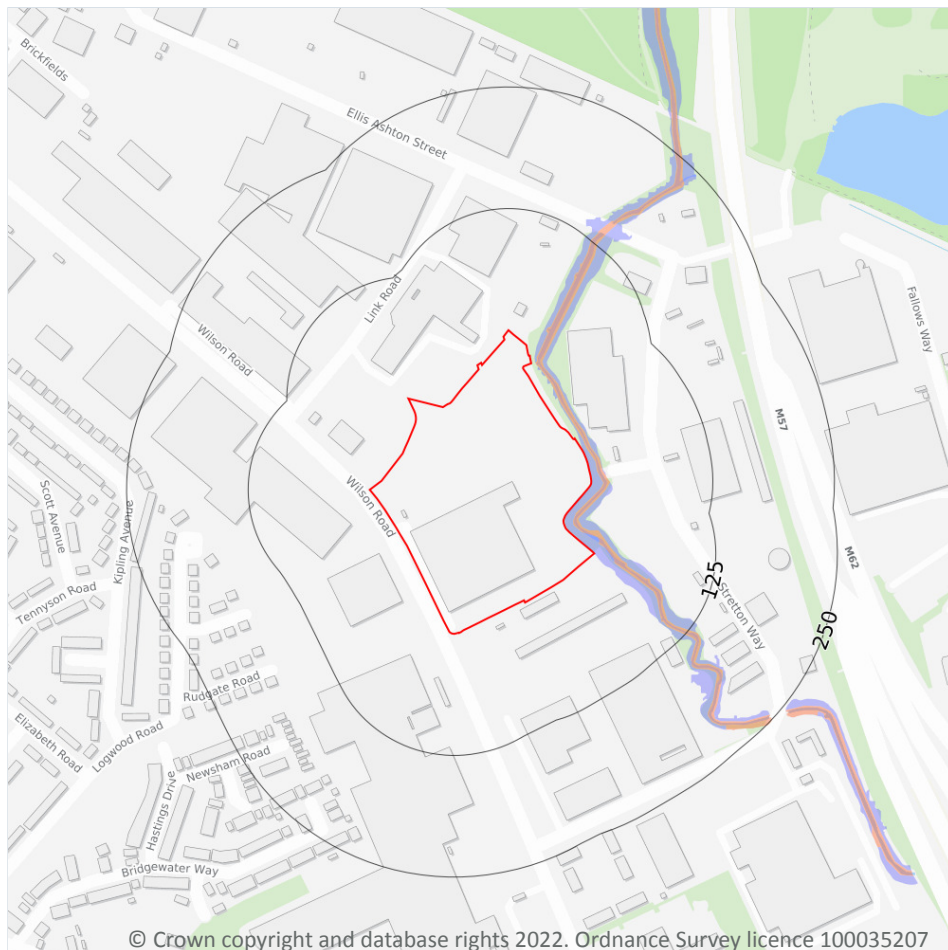
## 7 River and coastal flooding

- Site Outline
- Search buffers in metres (m)
- River and coastal flooding:
- High
- Medium
- Low
- Very Low
- Historical Flood Events
- Areas Used for Flood Storage
- Areas Benefiting from Flood Defences
- Flood Defences

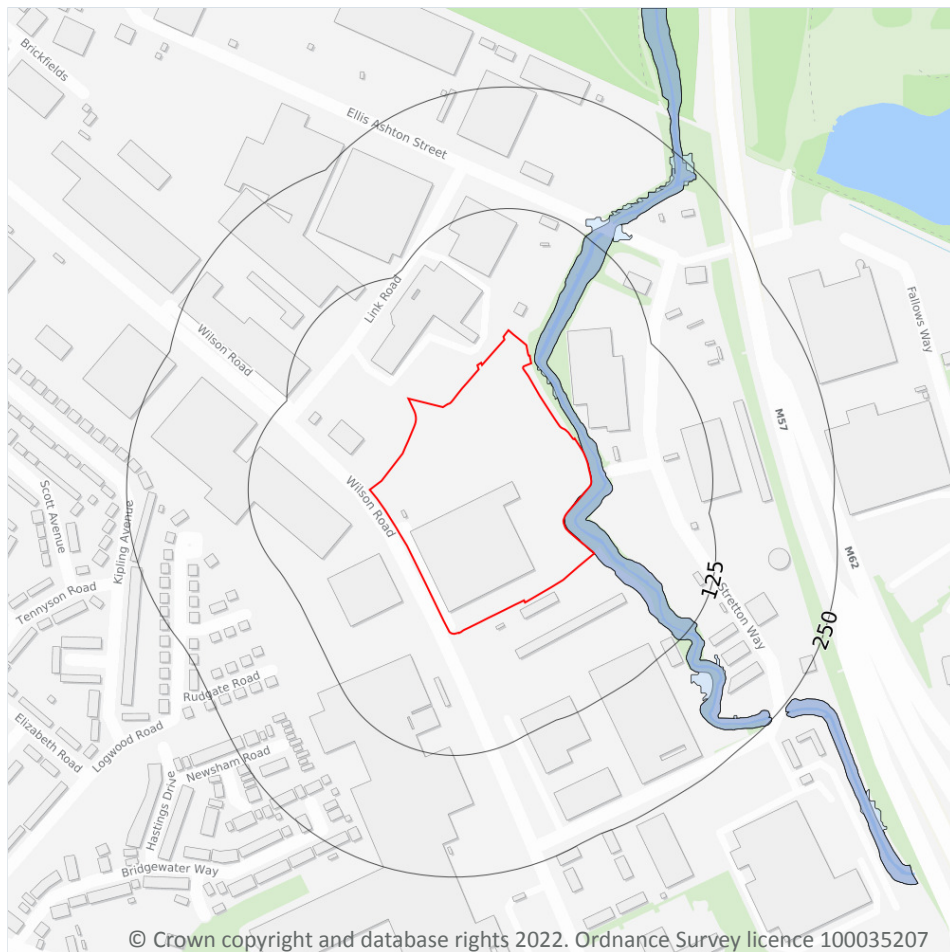
## River and coastal flooding - Flood Zones

- Site Outline
- Search buffers in metres (m)
- Flood zone 2
- Flood zone 3

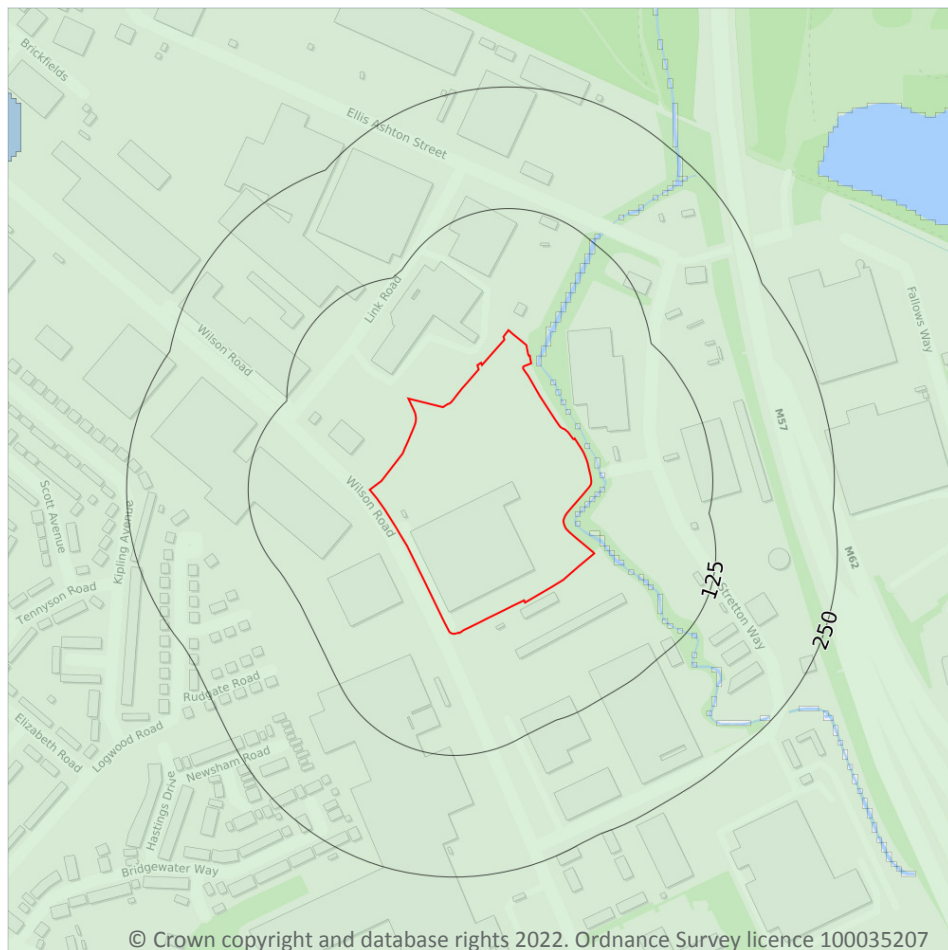
## 9 Groundwater flooding

- High
- Moderate - High
- Moderate
- Low
- Negligible

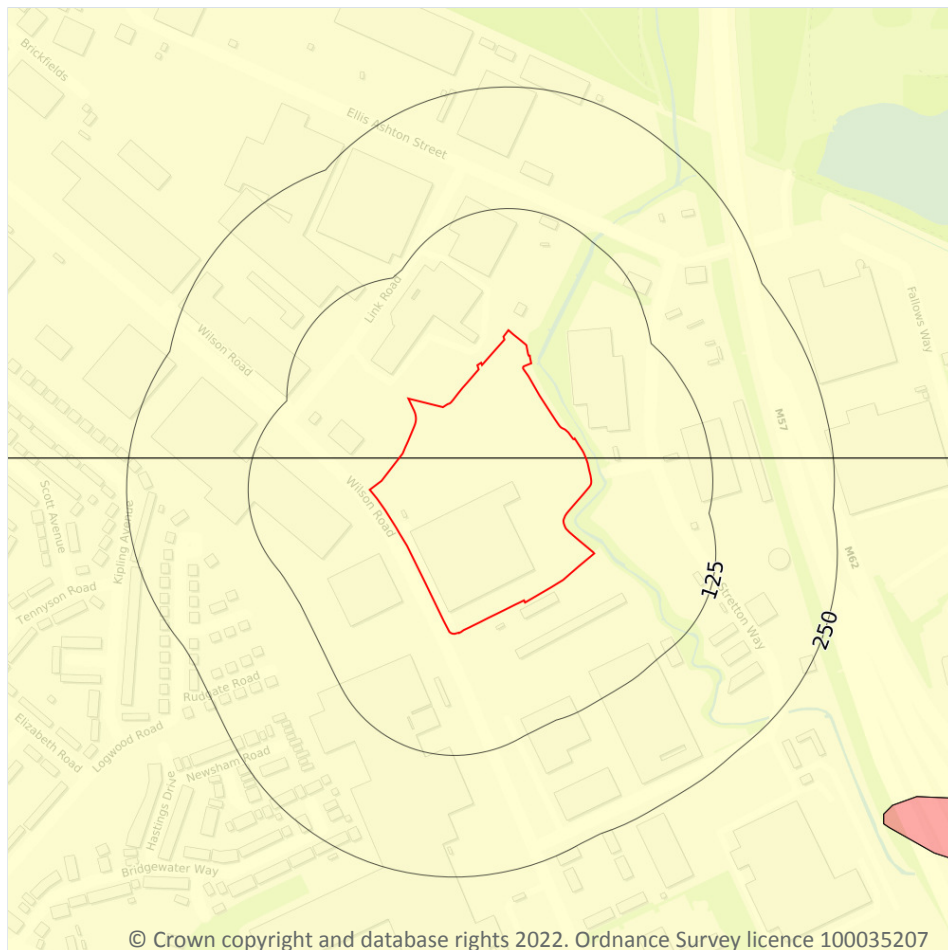
## Natural ground subsidence - Compressible deposits

- Site Outline
- Search buffers in metres (m)
- ☐ No data
  - ☐ Negligible
  - ☐ Very low
  - ☐ Low
  - ☐ Moderate
  - ☐ High

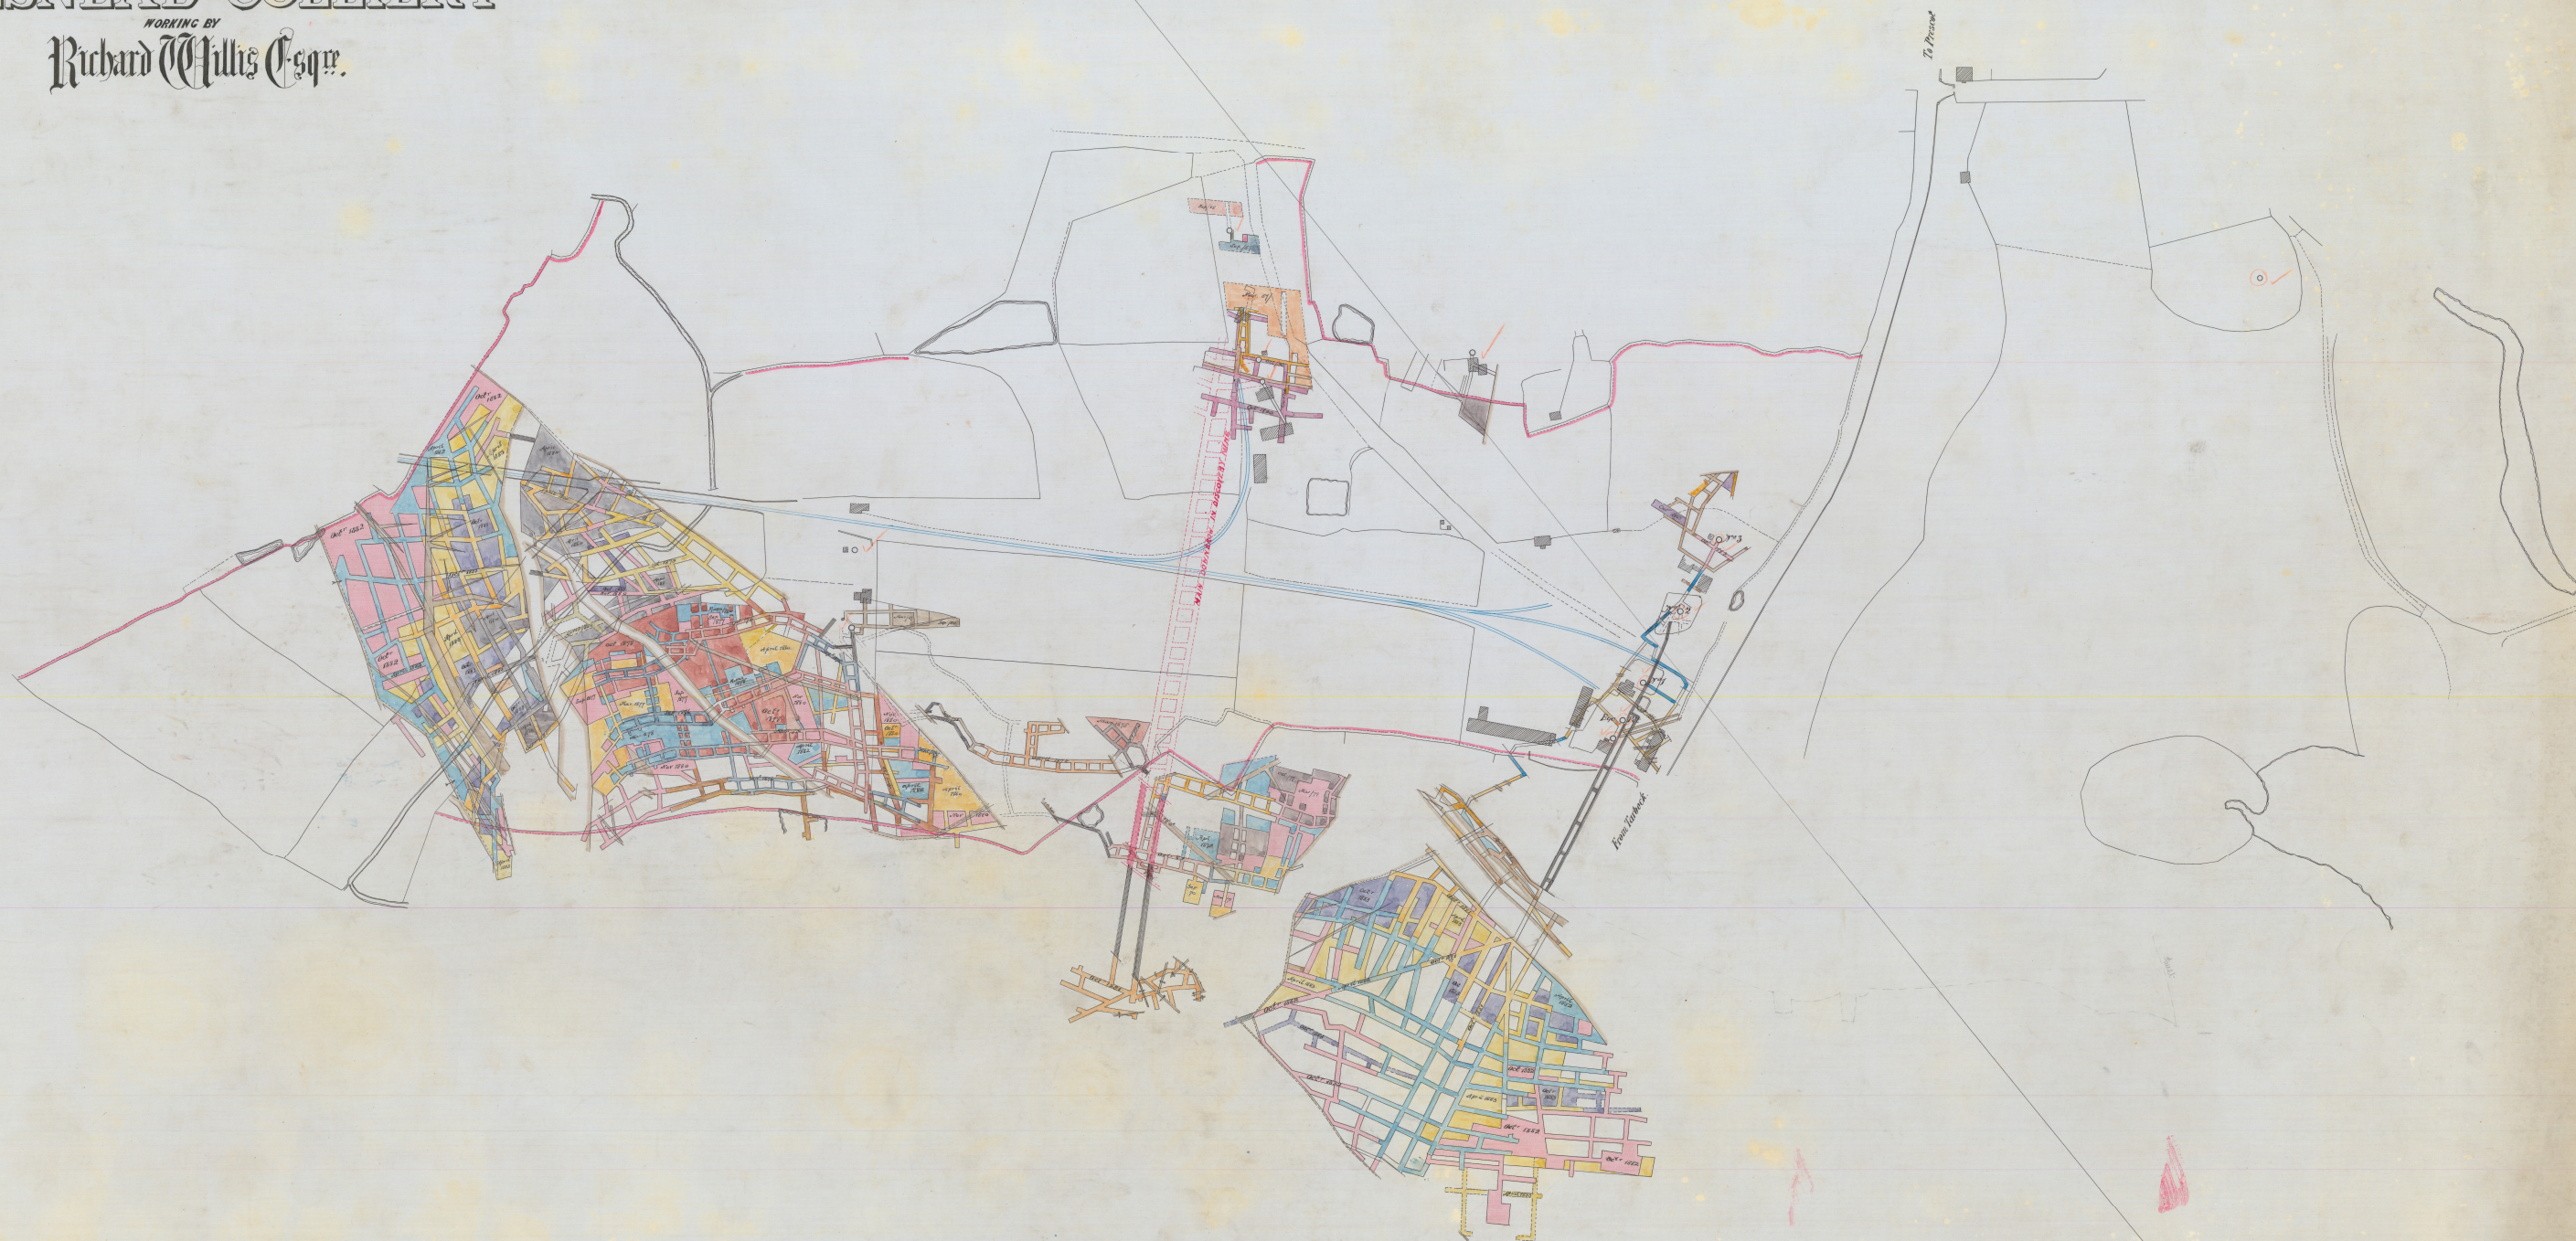
PLAN  
OF THE **FELCROFT MINE** AT THE  
**HALSNEAD COLLIERY**  
WORKING BY  
**Richard Willis Esqr.**

32 Yds to one Inch

- 2.8.7 The report states that the site is within the likely zone of influence on the surface from workings in 1 seam of coal at 70m depth, the last date of working being 1876, but that ground movement should be now have ceased.
- 2.8.8 A shaft (ref. 345398-008) was reported approximately 5-10 east of the site [~115m south of Jomas' study site]. The shaft was searched for in 1969 but no evidence of it was found.
