**SITE INVESTIGATION SCHEME**

**SANDY BROW LANE, KNOWSLEY**

**BALANCE POWER**

August 2023

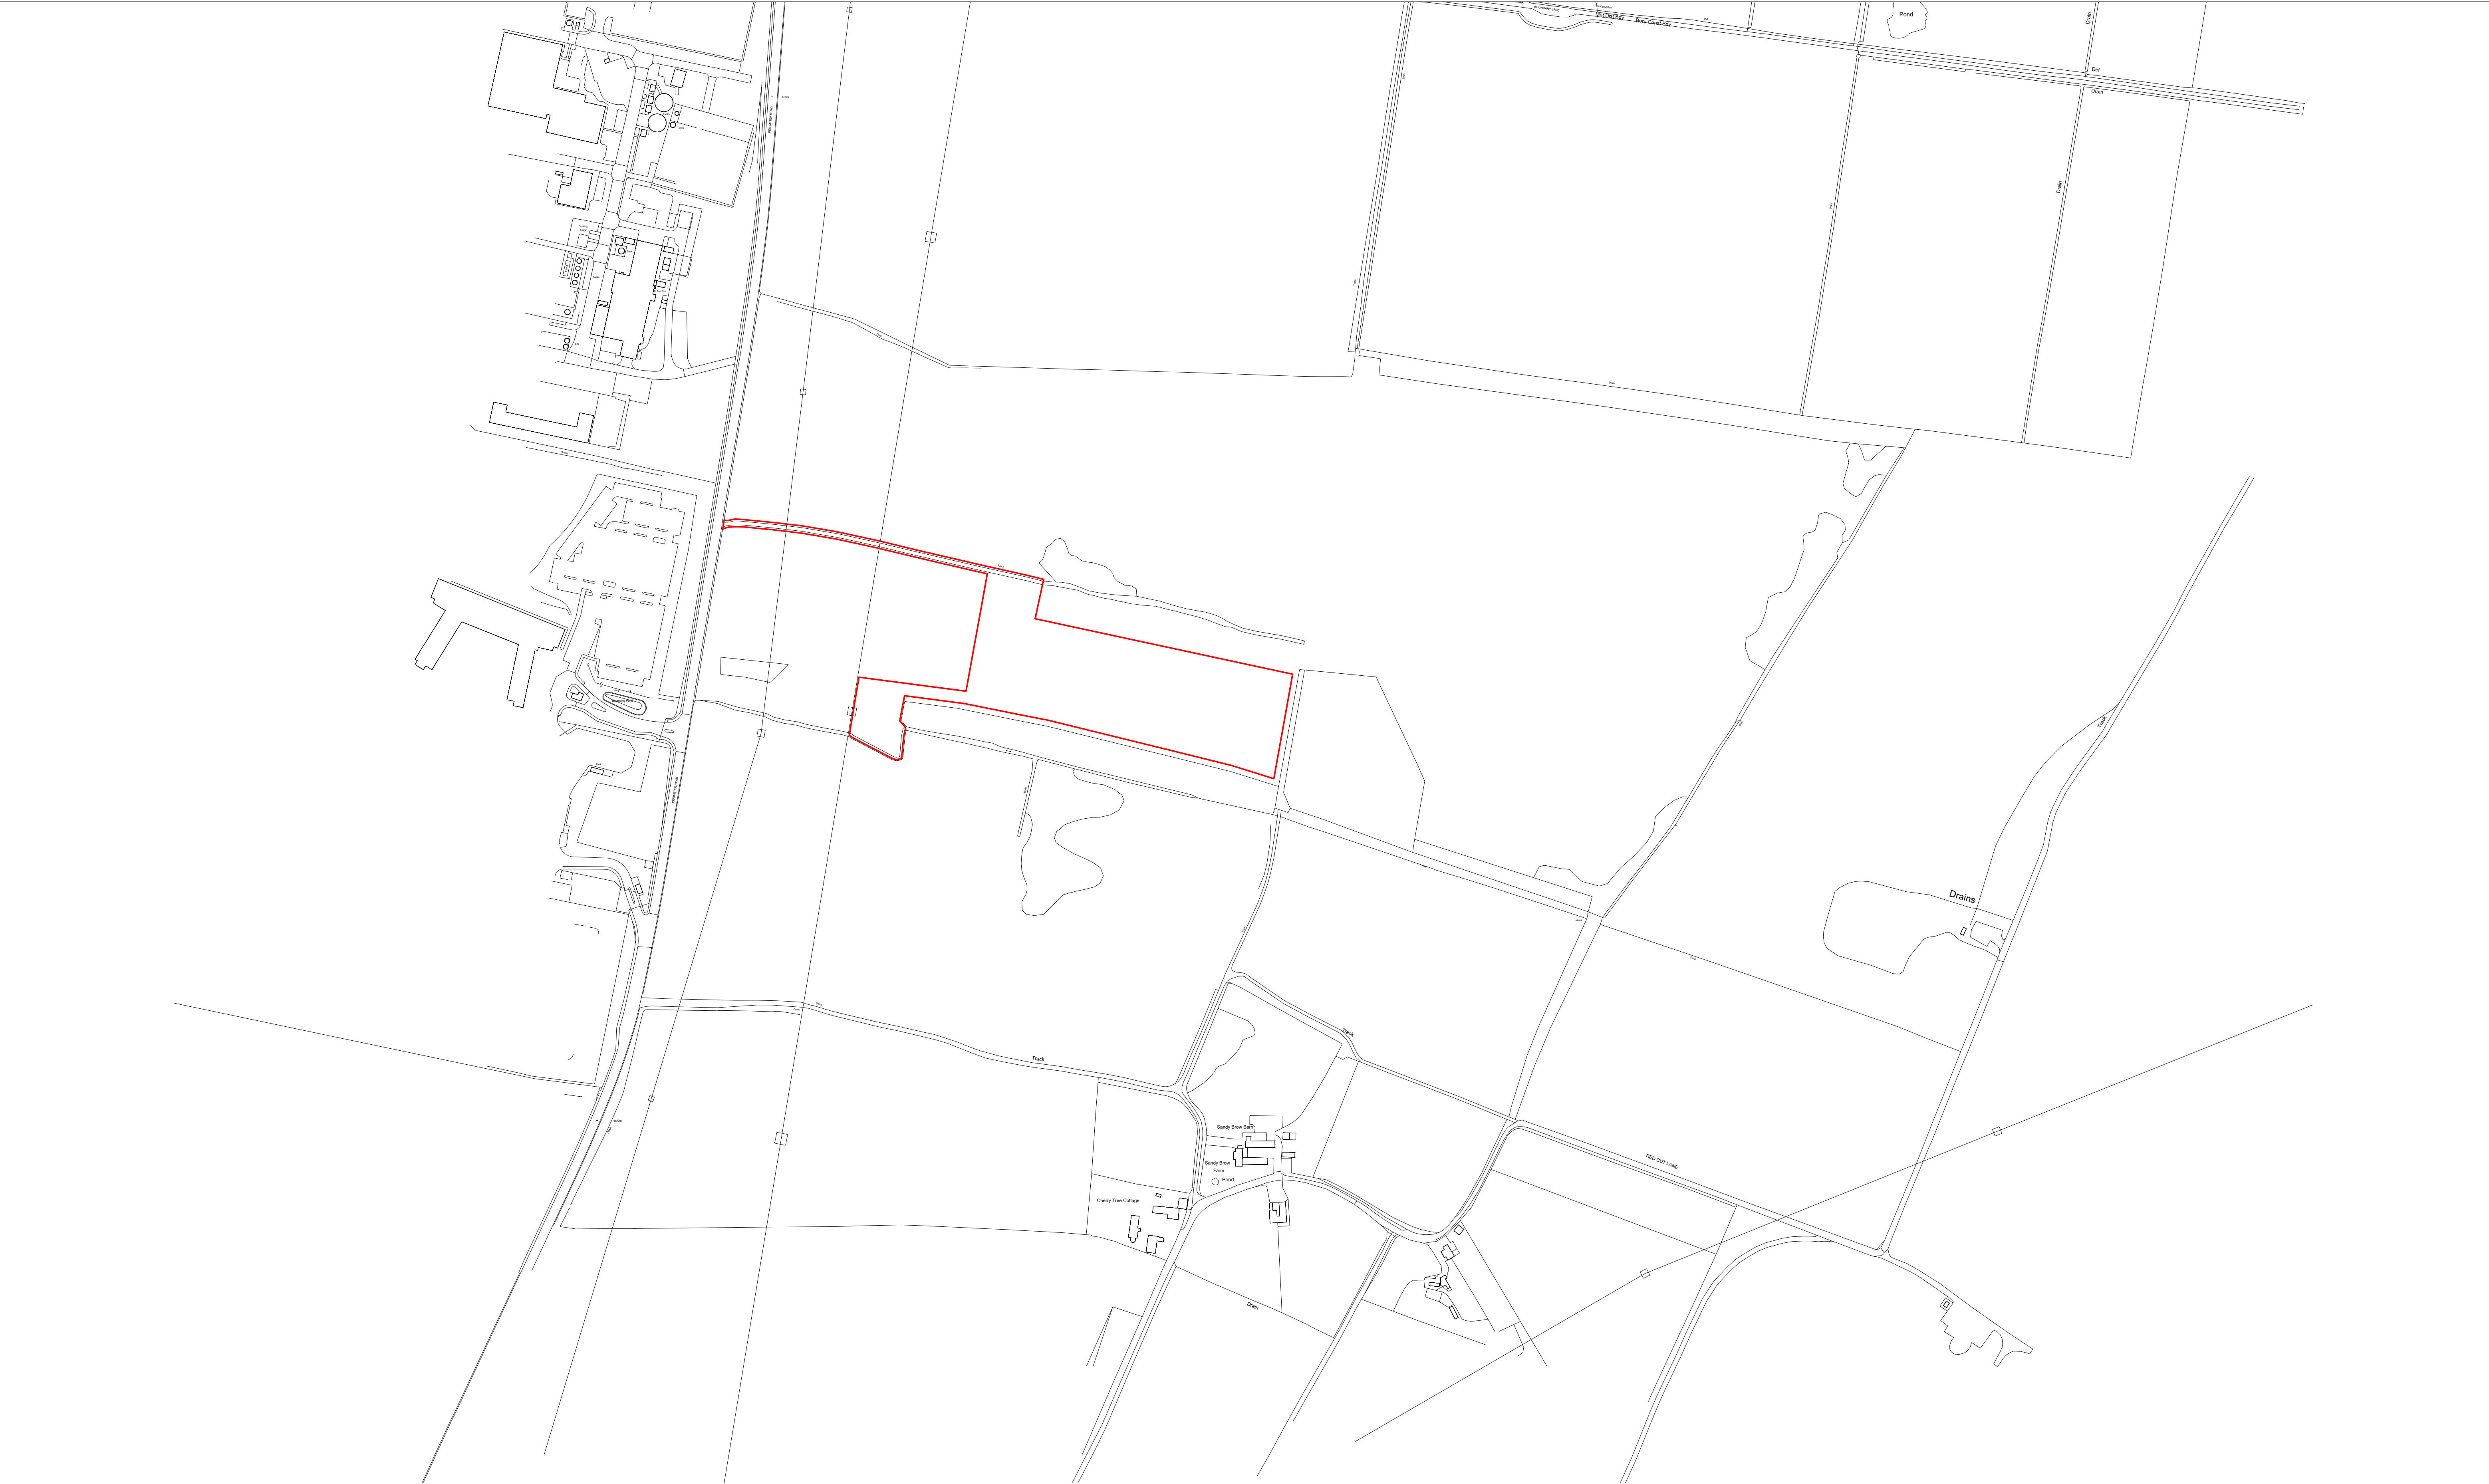
**FIGURE 1 – SITE LOCATION PLAN**

Ridge and Partners LLP (Ridge) was commissioned by Balance Power (the Client) to produce a Site Investigation Scheme for land at Sandy Brow Lane, Knowsley centred on 344459, 398401 (hereafter referred to as 'the site'). A site location plan is included as Figure 1. The development area is defined on Figure 2.
