## HALSNEAD FARM

### PHASE 2 GROUND INVESTIGATION REPORT

**Curtins Ref:** 087052-CUR-XX-XX-T-GE-00003

Issue Date: 17 October 2025

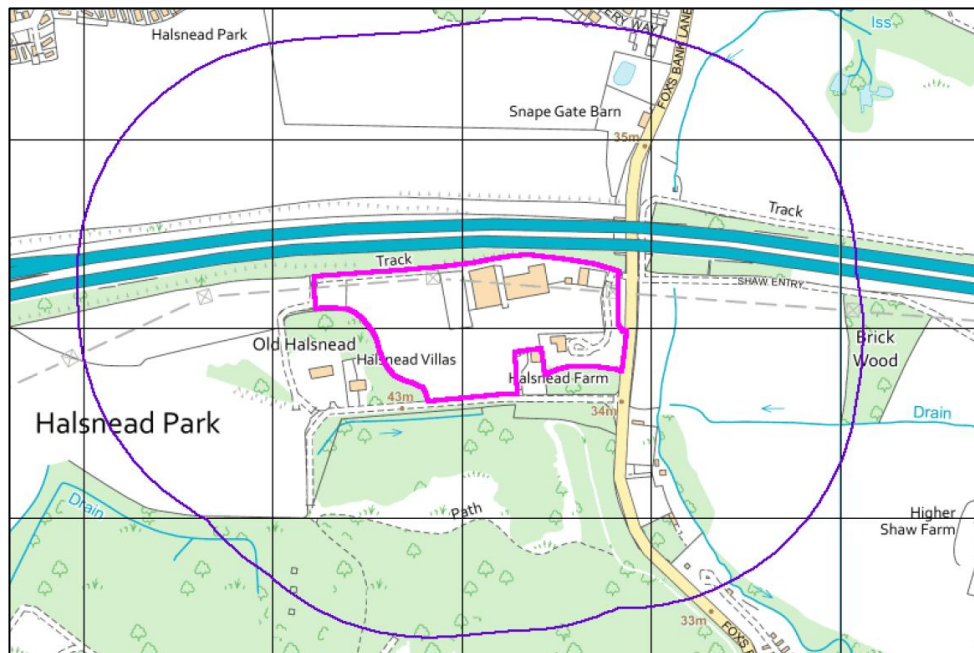
Figure 1 – Site Location Plan, site boundary shown in pink, 250m buffer in purple.  
(Ref. Envirocheck)

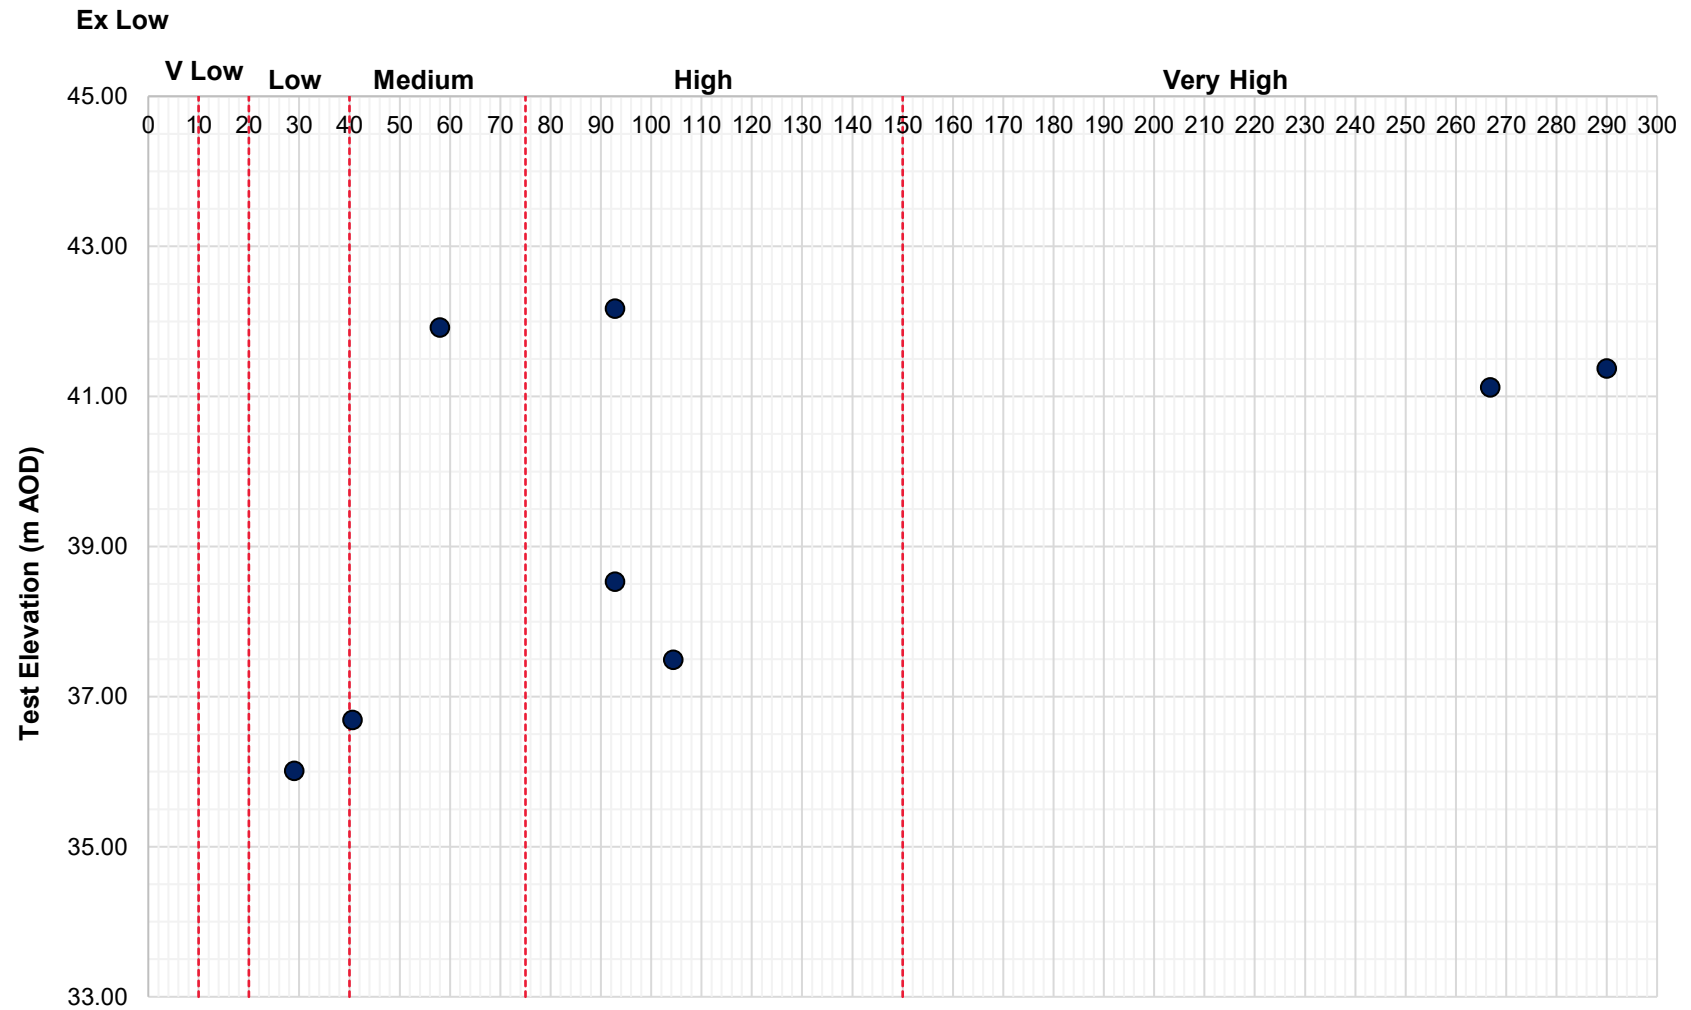
Strength classification in  
accordance with  
BS5930:2015+A1:2020

**Estimated Undrained Shear Strength ( $c_u$ ) (kPa)**

A conservative, characteristic  $c_u$  of 40kPa is recommended.

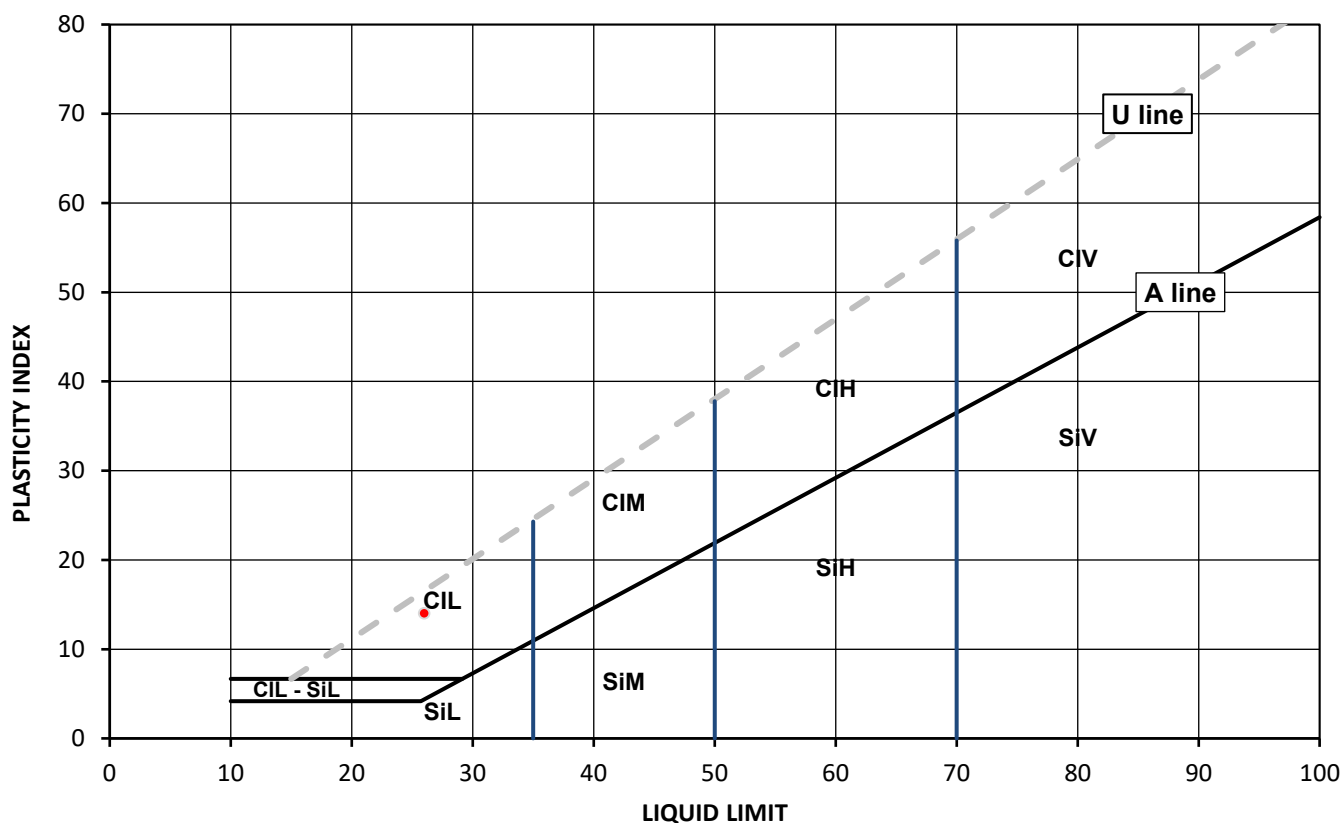
| As Received Water Content [W] % | Liquid Limit [WL] % | Plastic Limit [Wp] % | Plasticity Index [Ip] % | Liquidity Index [IL] % # | Consistency Index [IC] % # | % Passing 425µm BS Test Sieve |
| 11.8 | 26 | 12 | 14 | 0.00 | 1.00 | 100 |

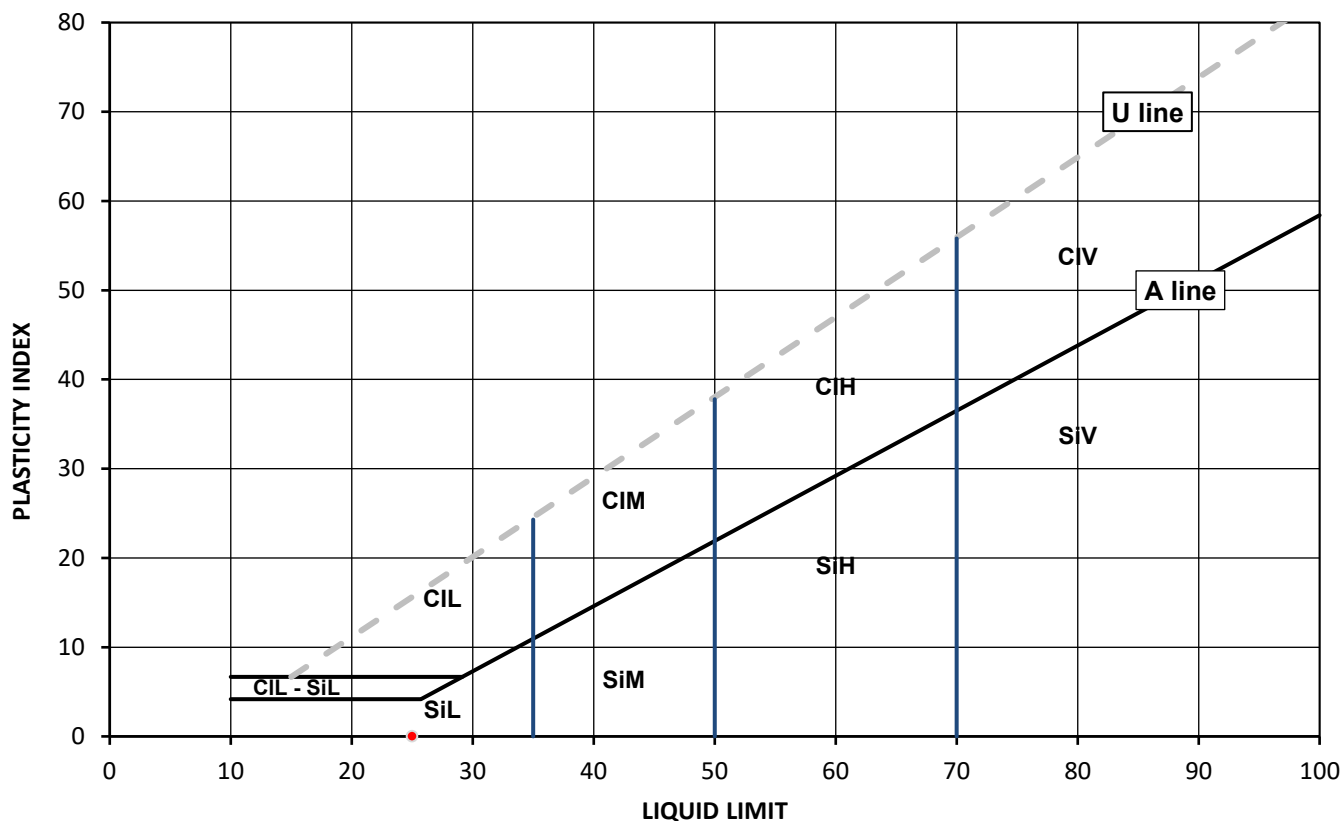
| As Received Water Content [W] % | Liquid Limit [WL] % | Plastic Limit [Wp] % | Plasticity Index [Ip] % | Liquidity Index [IL] % # | Consistency Index [IC] % # | % Passing 425µm BS Test Sieve |
| 12.5 | 25 | NP | NP | N/A | N/A | 100 |

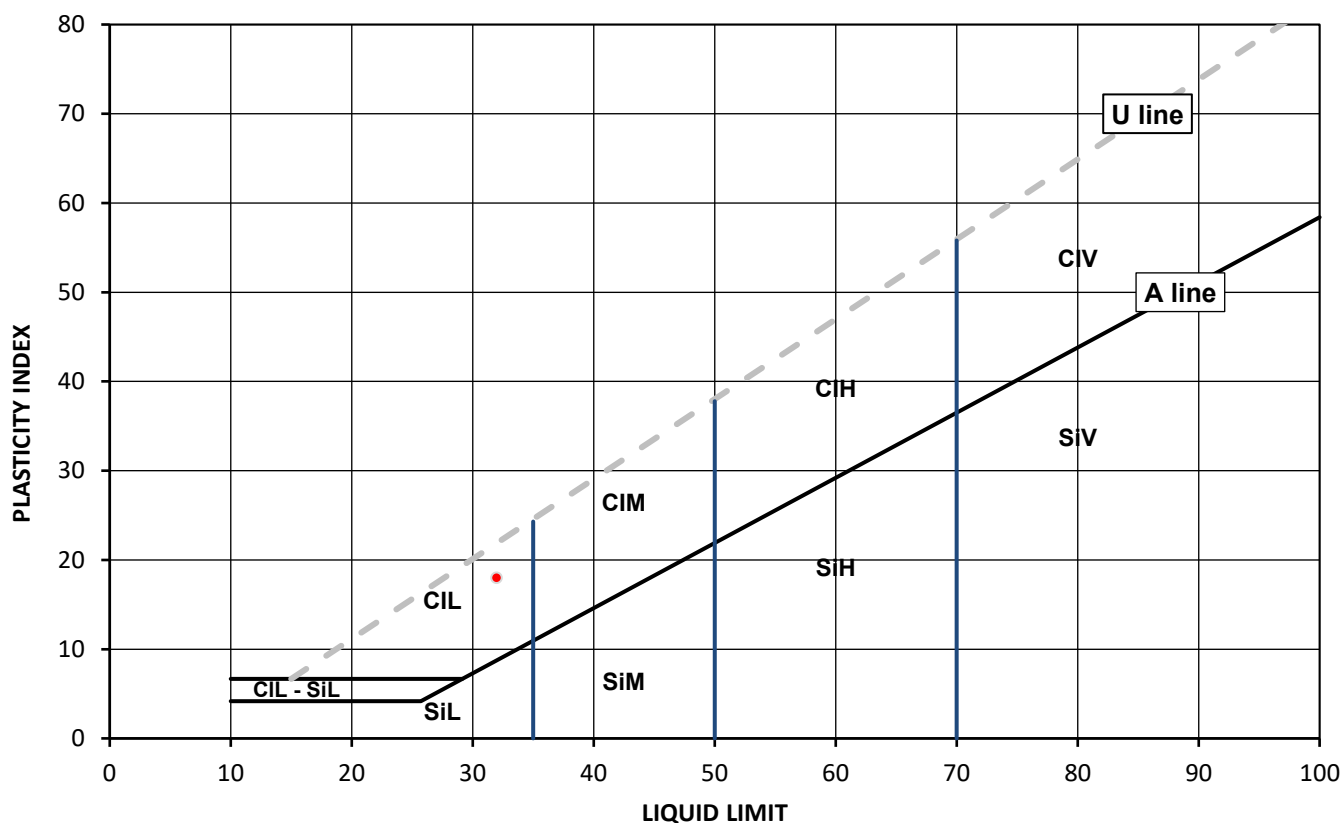
| As Received Water Content [W] % | Liquid Limit [WL] % | Plastic Limit [Wp] % | Plasticity Index [Ip] % | Liquidity Index [IL] % # | Consistency Index [IC] % # | % Passing 425µm BS Test Sieve |
| 13.2 | 32 | 14 | 18 | -0.06 | 1.06 | 90 |

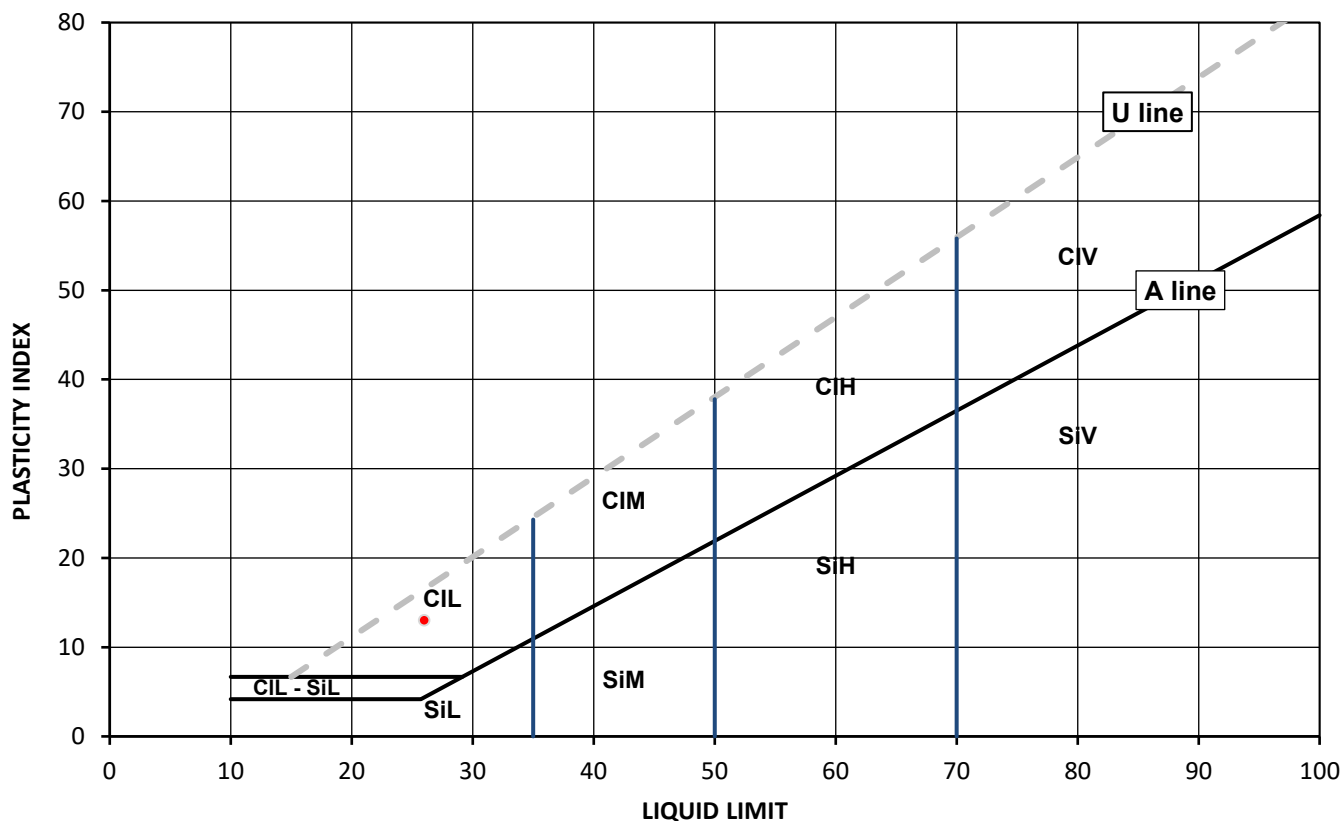
| As Received Water Content [W] % | Liquid Limit [WL] % | Plastic Limit [Wp] % | Plasticity Index [Ip] % | Liquidity Index [IL] % # | Consistency Index [IC] % # | % Passing 425µm BS Test Sieve |
| 16.9 | 26 | 13 | 13 | 0.31 | 0.69 | 91 |

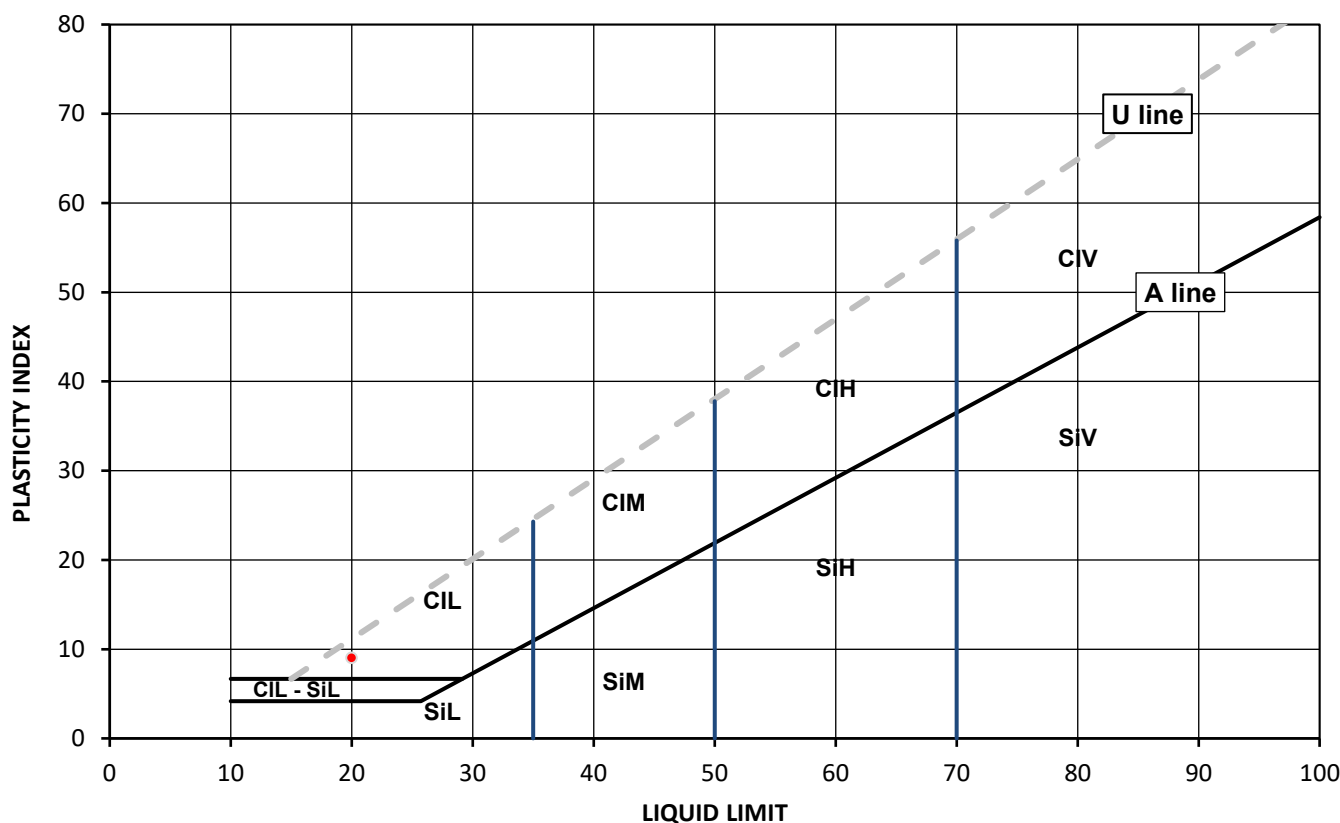
| As Received Water Content [W] % | Liquid Limit [WL] % | Plastic Limit [Wp] % | Plasticity Index [Ip] % | Liquidity Index [IL] % # | Consistency Index [IC] % # | % Passing 425µm BS Test Sieve |
| 10.0 | 20 | 11 | 9 | -0.11 | 1.11 | 92 |

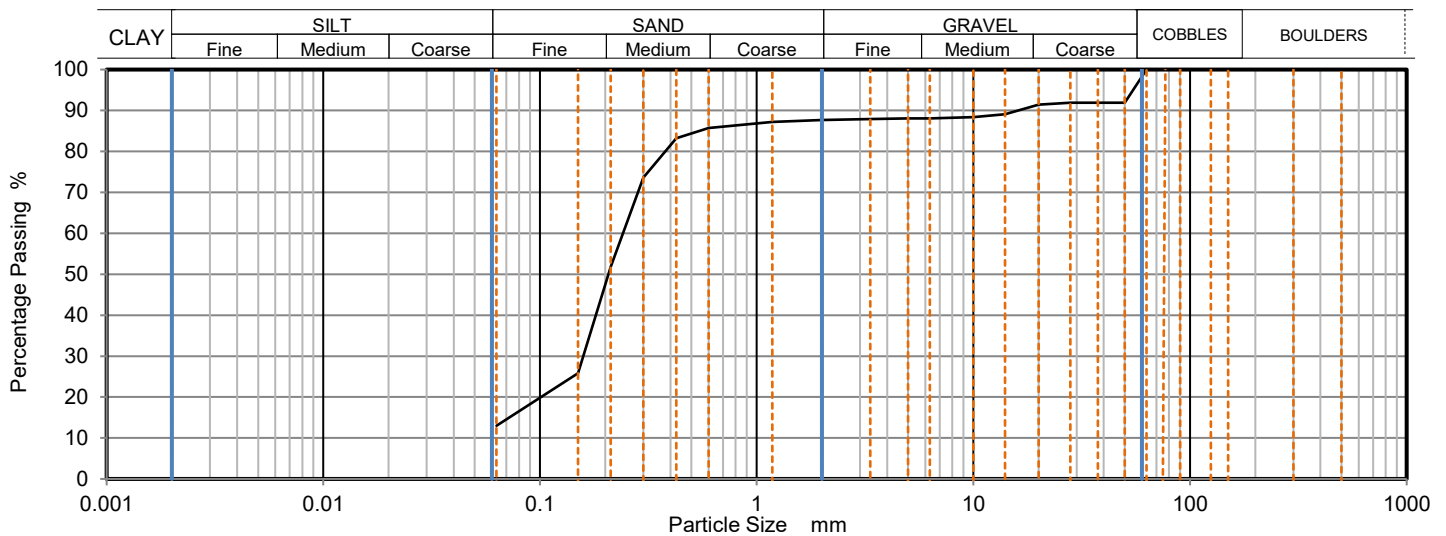
**Test Results:**Laboratory Reference: 615598  
Hole No.: WS02  
Sample Reference: Not Given  
Sample Description: Brown gravelly clayey SAND  
Sample Preparation: Sample was whole tested, oven dried at 108.5 °C and broken down by hand.Depth Top [m]: 0.70  
Depth Base [m]: 1.00  
Sample Type: B

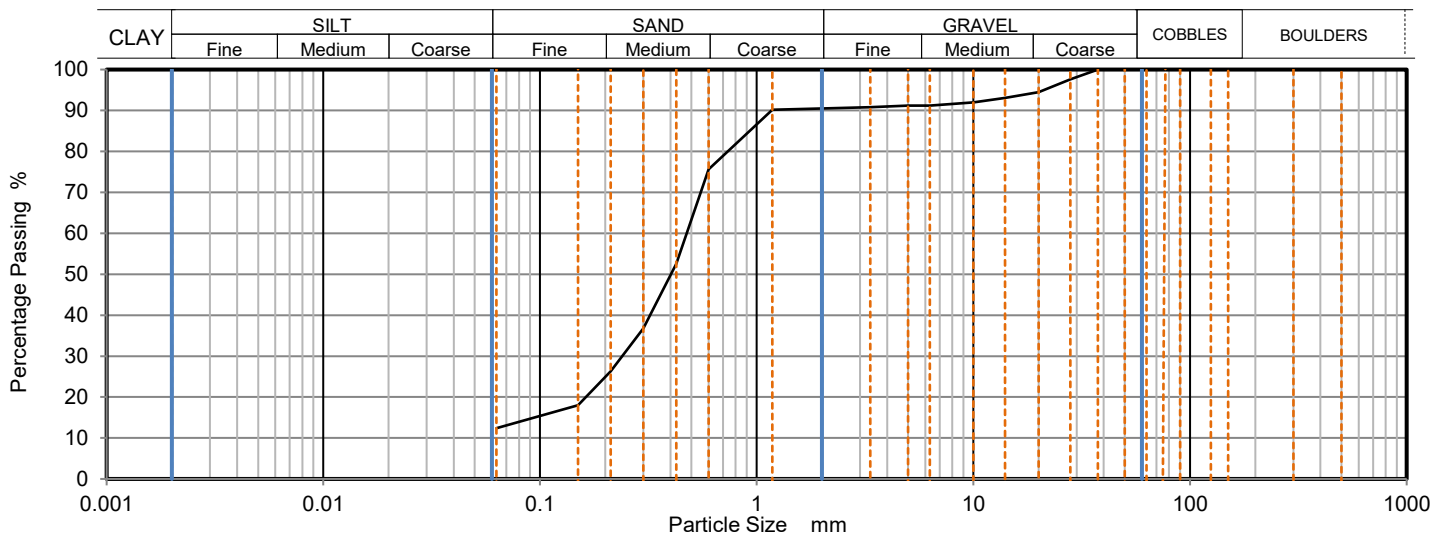
**Test Results:**Laboratory Reference: 615600  
Hole No.: WS05  
Sample Reference: Not Given  
Sample Description: Orangish brown gravelly clayey SAND  
Sample Preparation: Sample was whole tested, oven dried at 108.5 °C and broken down by hand.Depth Top [m]: 0.50  
Depth Base [m]: 0.90  
Sample Type: B

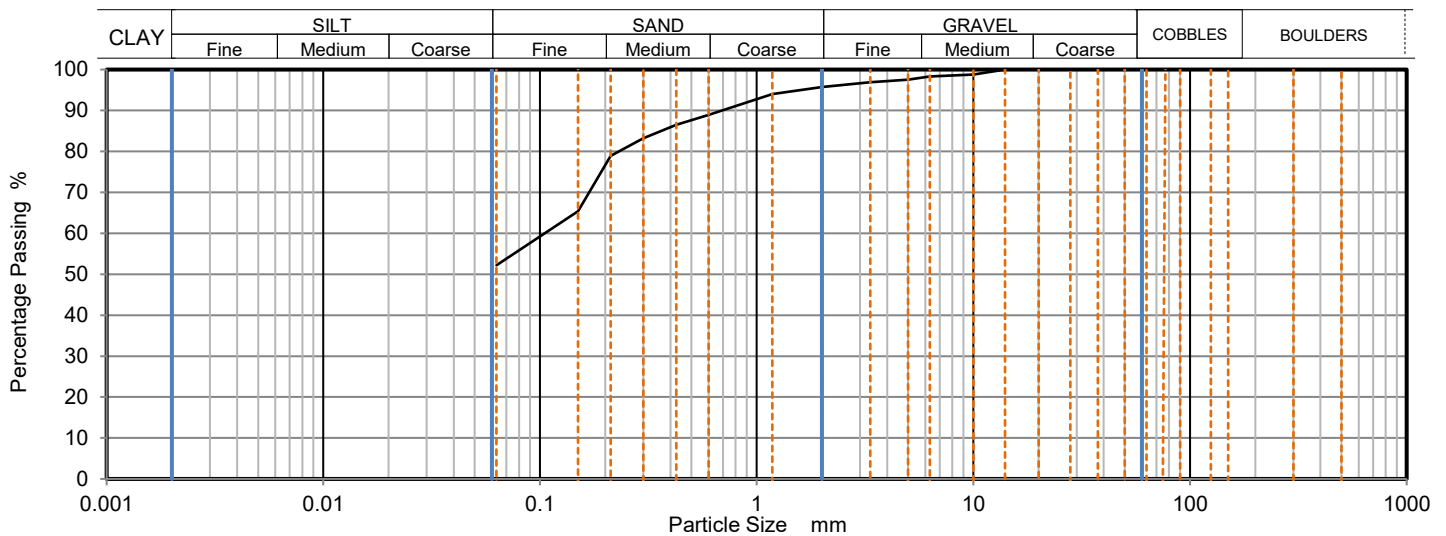
**Test Results:**Laboratory Reference: 615601  
Hole No.: TP02  
Sample Reference: Not Given  
Sample Description: Reddish brown slightly gravelly sandy CLAY  
Sample Preparation: Sample was quartered, oven dried at 108.1 °C and broken down by hand.Depth Top [m]: 1.60  
Depth Base [m]: 1.90  
Sample Type: B

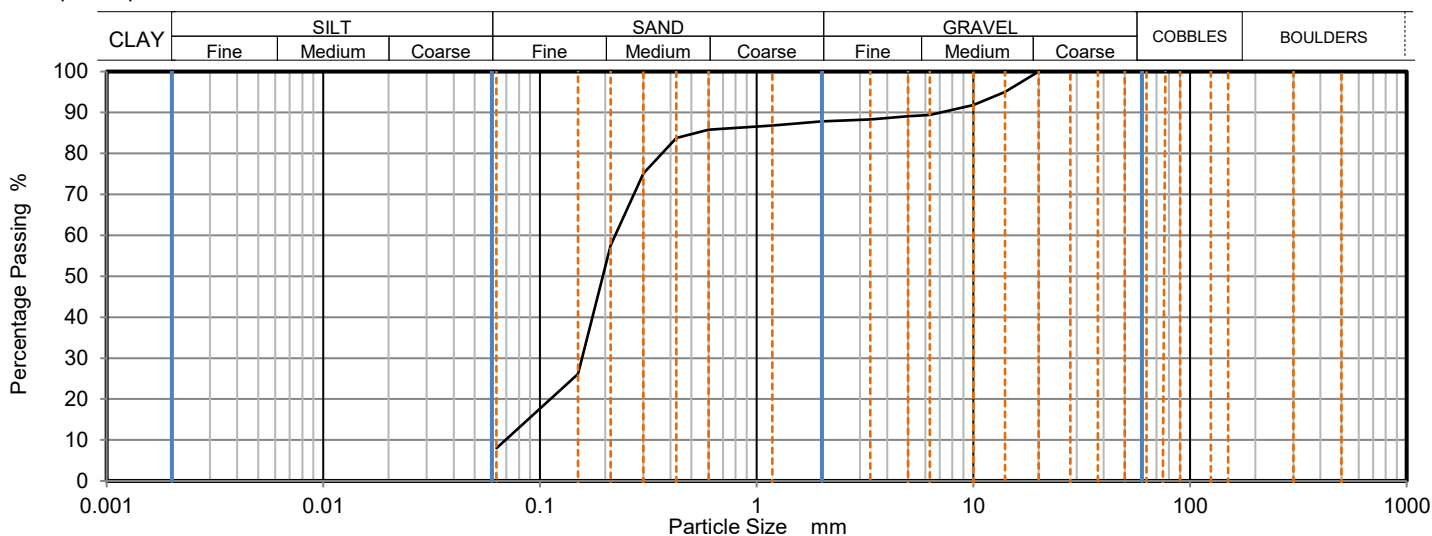
Laboratory Reference: 615602  
Hole No.: TP05  
Sample Reference: Not Given  
Sample Description: Brown gravelly clayey SAND  
Sample Preparation: Sample was quartered, oven dried at 108.5 °C and broken down by hand.

Depth Top [m]: 1.50  
Depth Base [m]: 1.70  
Sample Type: B

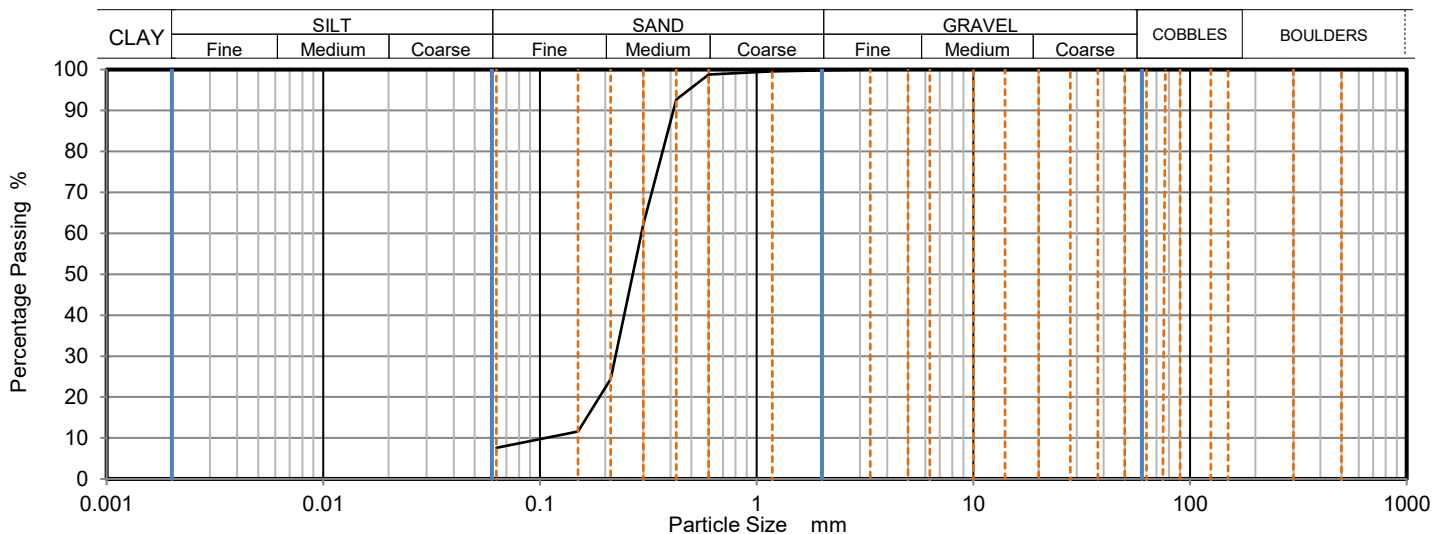
Laboratory Reference: 615603  
Hole No.: TP08  
Sample Reference: Not Given  
Sample Description: Orangish brown clayey SAND  
Sample Preparation: Sample was quartered, oven dried at 108.5 °C and broken down by hand.

Depth Top [m]: 1.70  
Depth Base [m]: 2.00  
Sample Type: B
