**FORMER COACH ROAD FARM, CUT LANE, KNOWSLEY, L33 3AQ**

**STRUCTURAL SURVEY OF DUTCH BARN TO FORM CONVERSION TO DWELLING & PIGGERY**

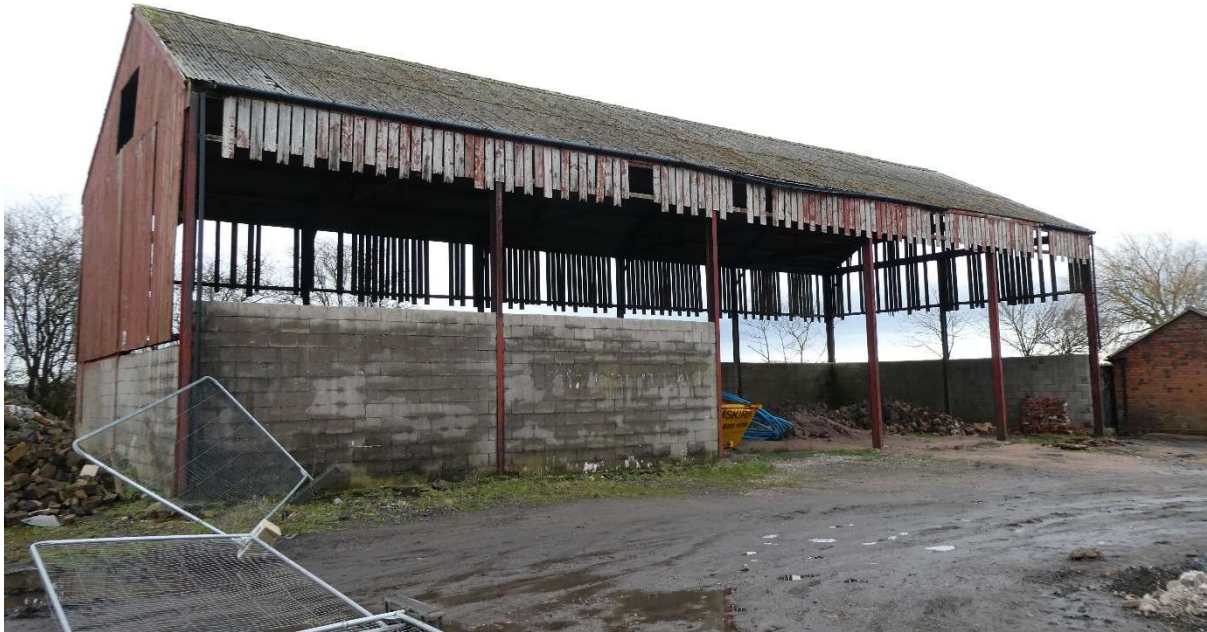
- 2.1.1 The barn is a standalone structure and would appear to have been constructed within the mid-20th century, and from local knowledge has been in use for at least the last 70+years.
- 2.1.2 The lower portion of the external structure is constructed of 225mm thick blockwork showing no signs of settlement or movement.

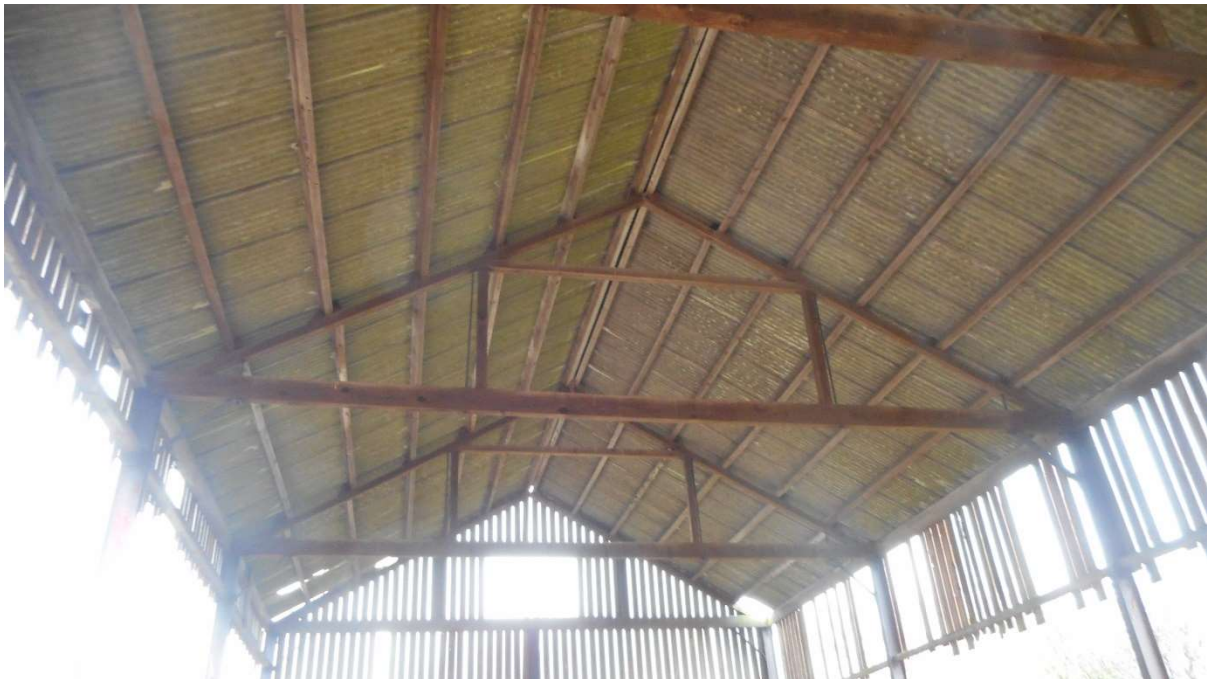
- 2.1.3 The barn is a steel framed structure with timber trusses and roof purlins, the roof being clad with asbestos /cement corrugated sheeting 8mm thick. The barn is partially open and the enclosed elevations are clad with timber sheeting supported by

timber sheeting rails which span horizontally between the supporting columns, with 225mm thick concrete block masonry, tied into the columns ,at the lower level.

- 2.1.6 The steel columns are on concrete foundations average 900mm deep.
- 2.1.7 The roof is supported off 14No. 8" x 4" RSJ (equivalent to a 203 x 102 x 23kg universal beams as columns, set in around the external at an average of 4.6m centres. The columns shows signs of light surface rusting only with no loss of section.

- 2.1.8 A close inspection showed there were no visual signs of decay, wet rot or beetle attack to the timber trusses and there is no signs of distortion or distress in any of the roof truss members.

- 2.1.9 The timber roof purlins are average 1200mm centres and support the roof cladding and spanning between the main trusses. The timber roof purlins are at regular centres support (average 1.2m). .

- 2.1.20 The corrugated roof sheets would appear to be of asbestos/cement and would require removal in a controlled manner and taken to an appropriate waste disposal site. These do not provide any structural support.

- 2.1.21 The slab, steel structural frame and roof structure are considered to be permanent and substantial construction, external cladding and roof covering will require replacement as part of the conversion work, this would not amount to a rebuild.

- 2.3.1 The existing super structure to the Dutch Barn will be retained.
- 2.3.2 The lower blockwork walls would all be retained and overclad with facing brick as per the architect's drawings.
- 2.3.3 It is concluded that all of the existing structure that forms the Barn is capable of carrying the loads imposed.

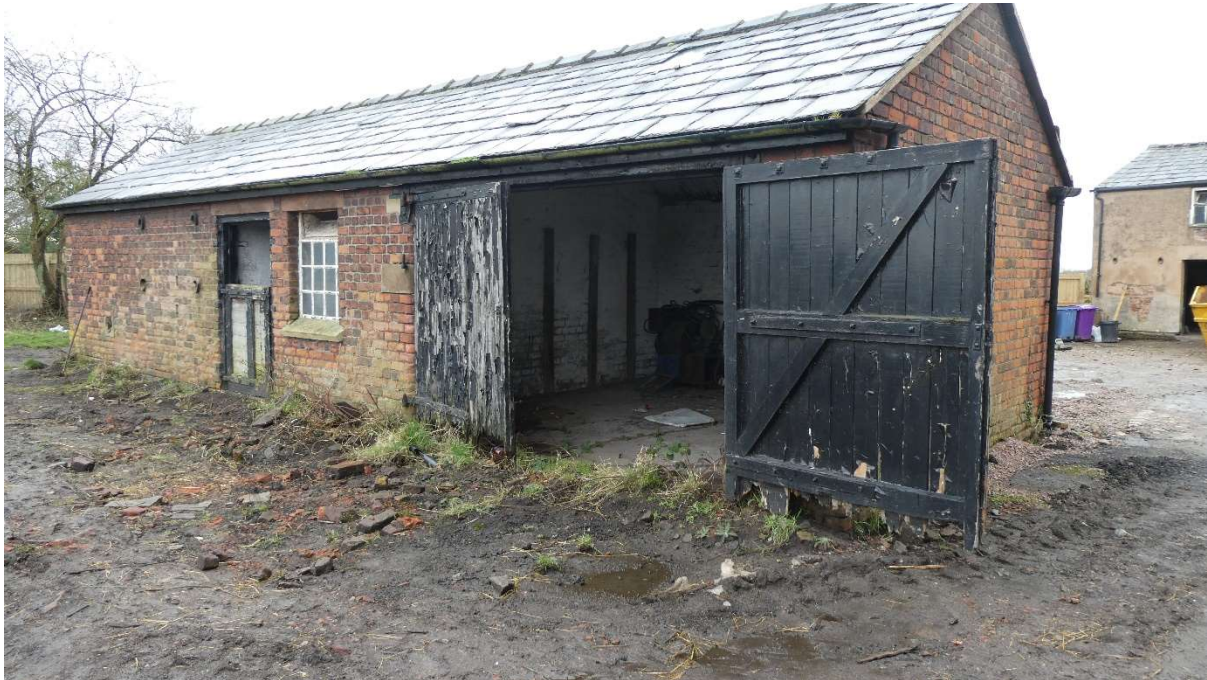
The building appears to have been built at the same time as the original farmhouse and has been used as both a piggery and a garage for farm vehicles.

Overall there is little or no sign of movement or settlement, the brickwork being in good condition considering it's age.

The walls are constructed of 235mm thick brickwork built off brick thickened out foundations.

The roof is a slate roof on timber t & g boards on 150 x 75 timber purlins and ridge pole supported at the open end on steel posts.

The floor is a concrete slab of unknown thickness and shows no sign of damp or cracking.

The roof may require support from new rafters between the existing purlins to support any insulation layer proposed.

The overall structure of this building is suitable for the proposed use of a garden room and outside toilet/shower.
