# **SOVEREIGN INDUSTRIAL ESTATE, HUYTON**

## **PRELIMINARY RISK ASSESSMENT**

**OCTOBER 2023**

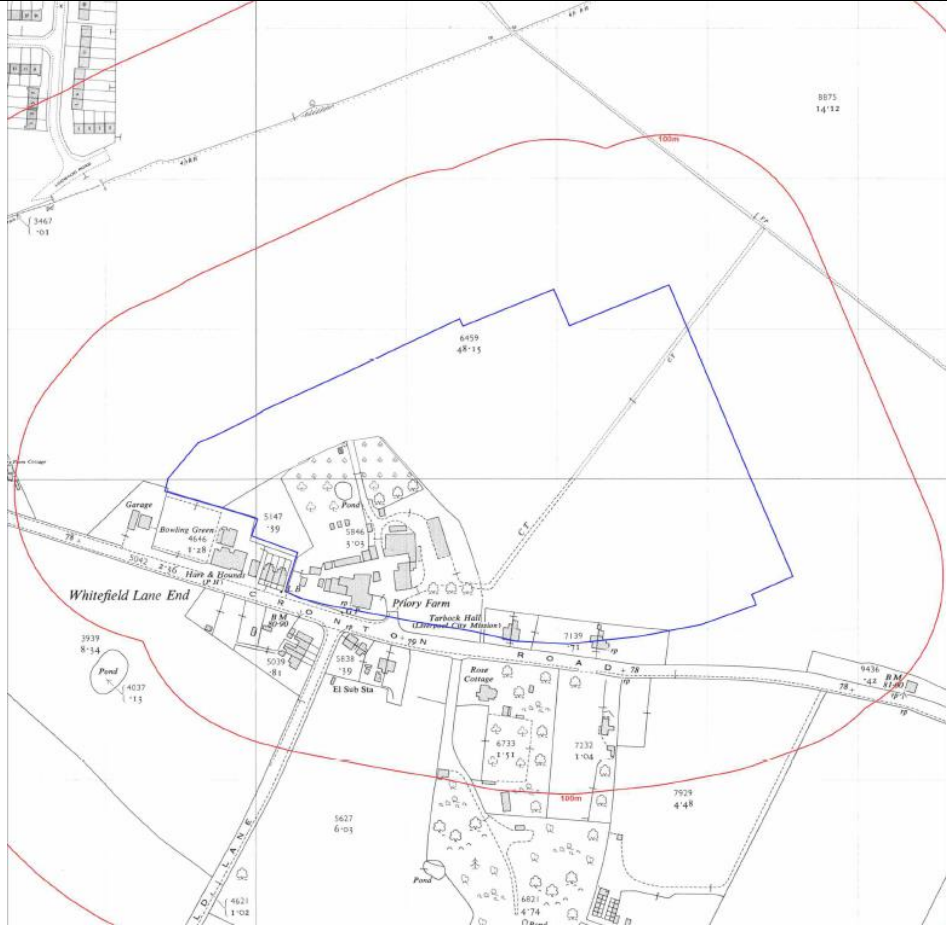
| Date / Scale | Onsite | Offsite | Historical Map Visual Different |
|---|---|---|---|
| <p>County Series, 1955-1956</p> <p>1:10,560</p> <p>County Series, 1957</p> <p>1:2,500</p> | <p>Reconfiguration of Priory Farm building layout.</p> <p>Mission Room now labelled as Tarbock Hall.</p> | <p>The road running adjacent to southern site boundary is now labelled as Cronton Road.</p> <p>Notable additions to surrounding area consist of a <b>garage</b> (40m W) and <b>electricity substation</b> (60m S).</p> <p>A residential development is now located 250m NW.</p> <p>The pond associated with Rose Cottage (40m S) is no longer present and considered to have been <b>infilled</b>.</p> <p>Tank (5m S) no longer noted.</p> | |

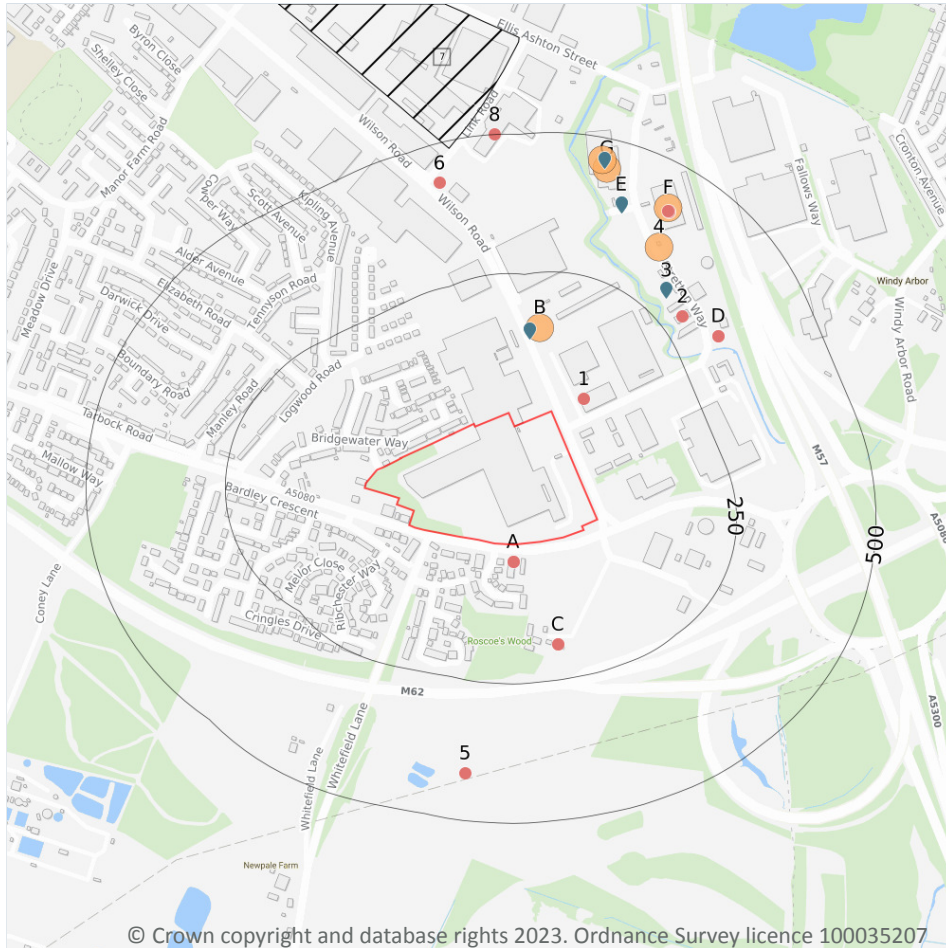
## 3 Waste and landfill

- Site Outline
- Search buffers in metres (m)
- Historical landfill (EA/NRW)
- Historical waste sites
- Licensed waste sites
- Waste exemptions
