**Client Ref:** 156463\_-\_Home\_Bargains\_Huyton  
**Report Ref:** GS-4AZ-KYF-GDR-ZG9\_1250\_1\_1  
**Grid Ref:** 345398, 389509

### **Site Photographs**

Desk Study Report

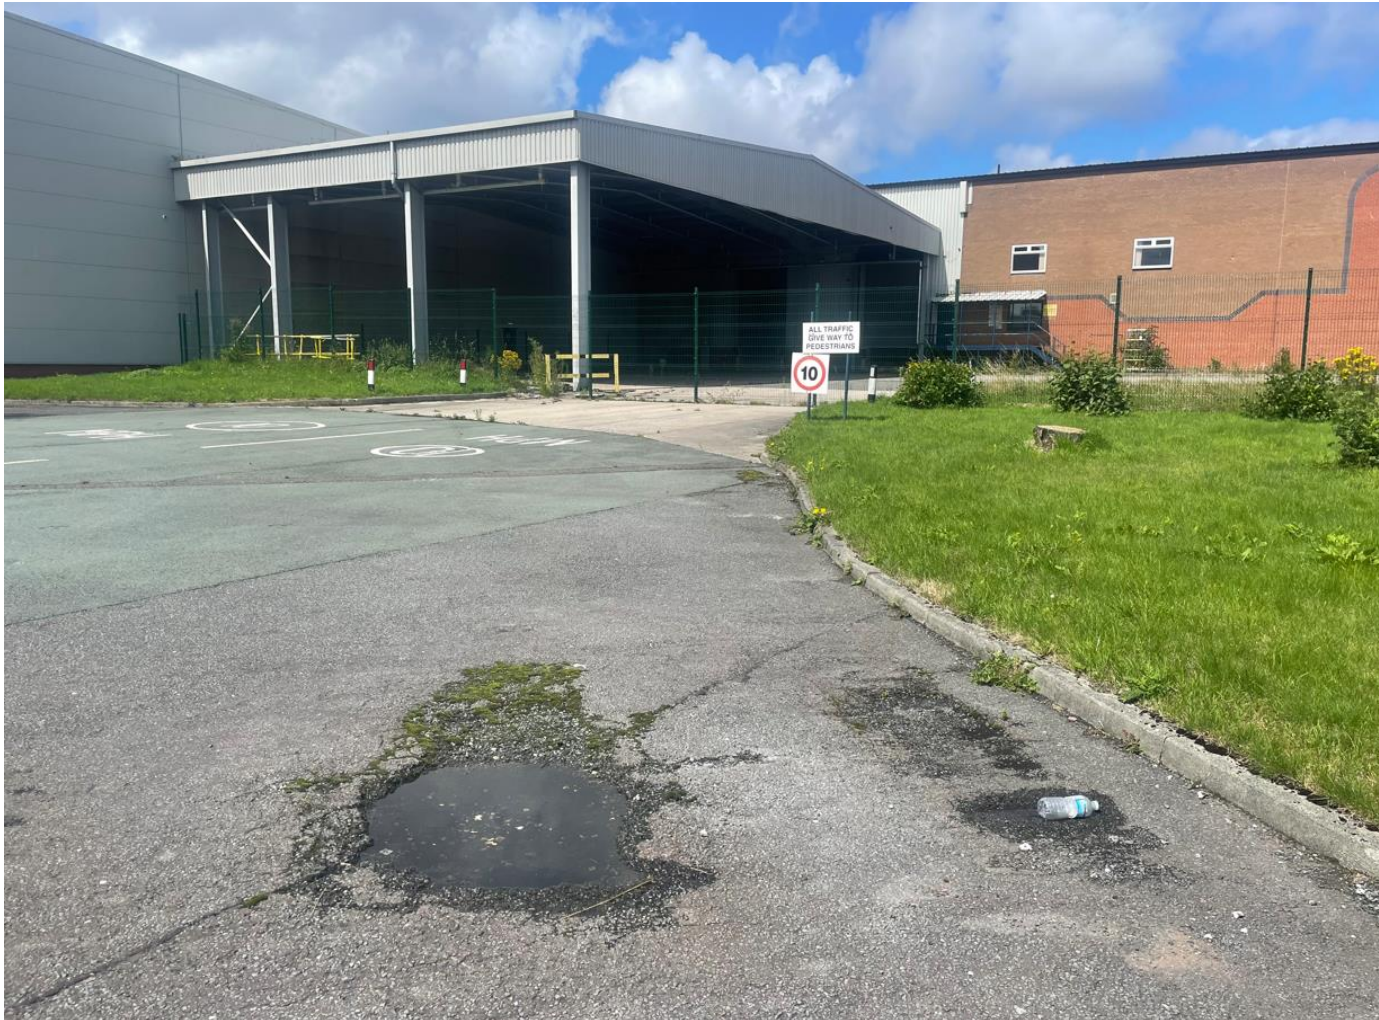
**Photo 1:** View looking north fo localised deterioration of hard surfacing on access road in north eastern part of site. The buildings beyond the palisade fencing are offsite. Soft landscaping areas partially border the northern site boundary on the eastern side.

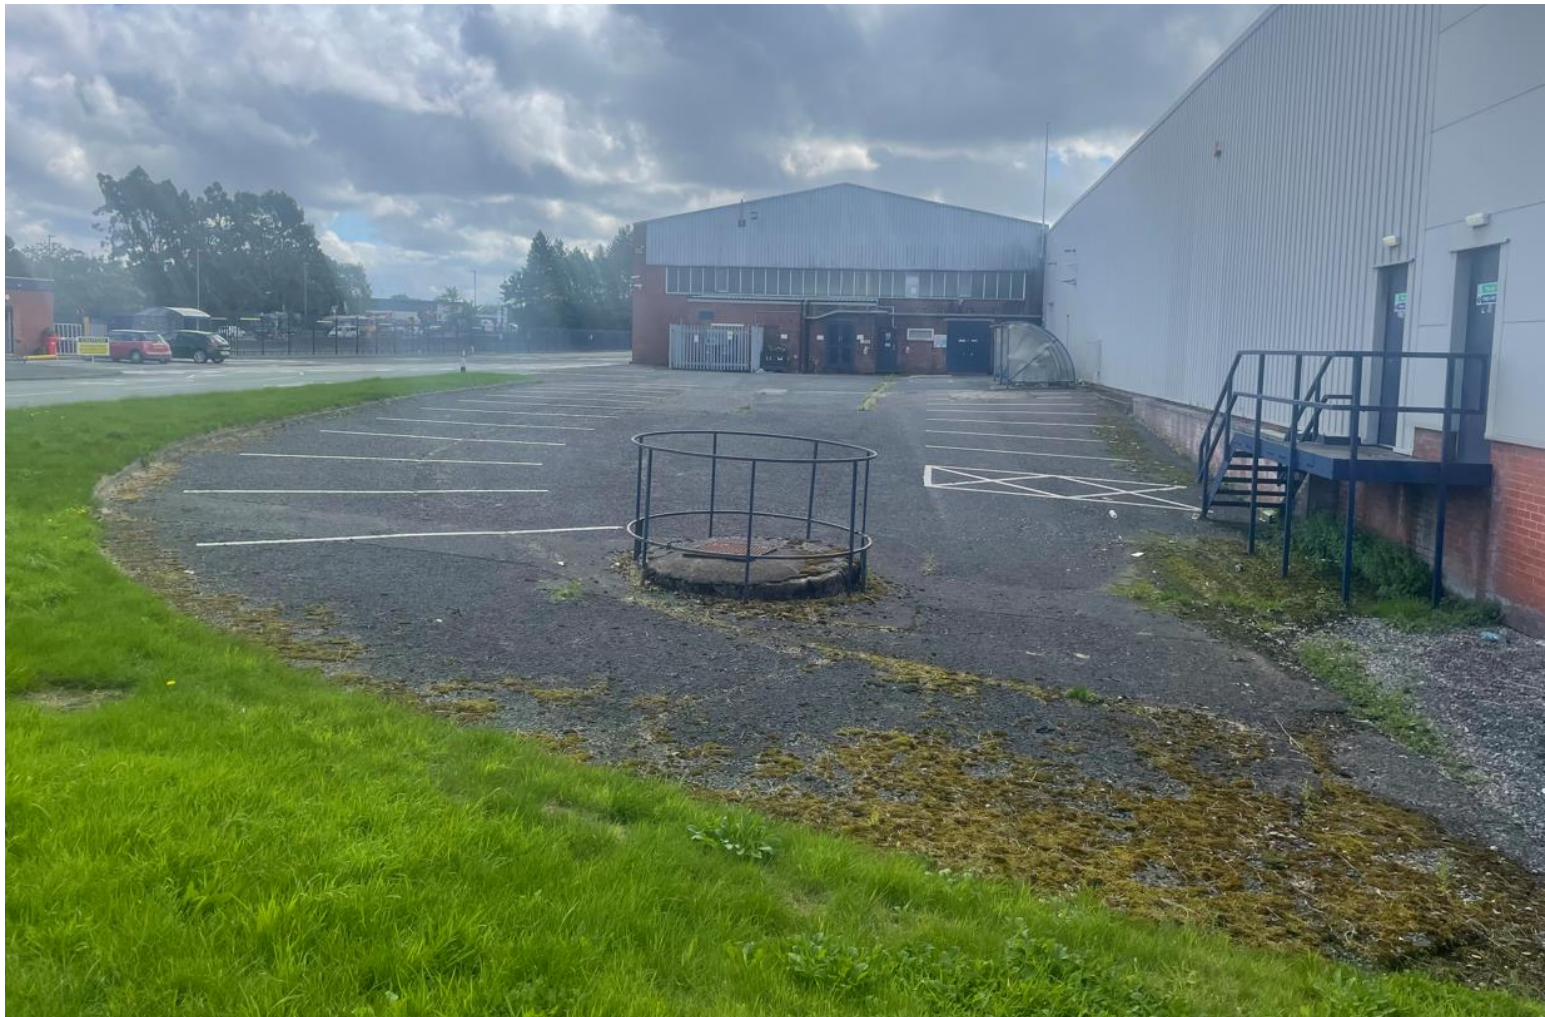
**Photo 2:** View looking south along the eastern side of the buildings. The car park is located in the northern part of the site. A wet well is present, protruding above ground.

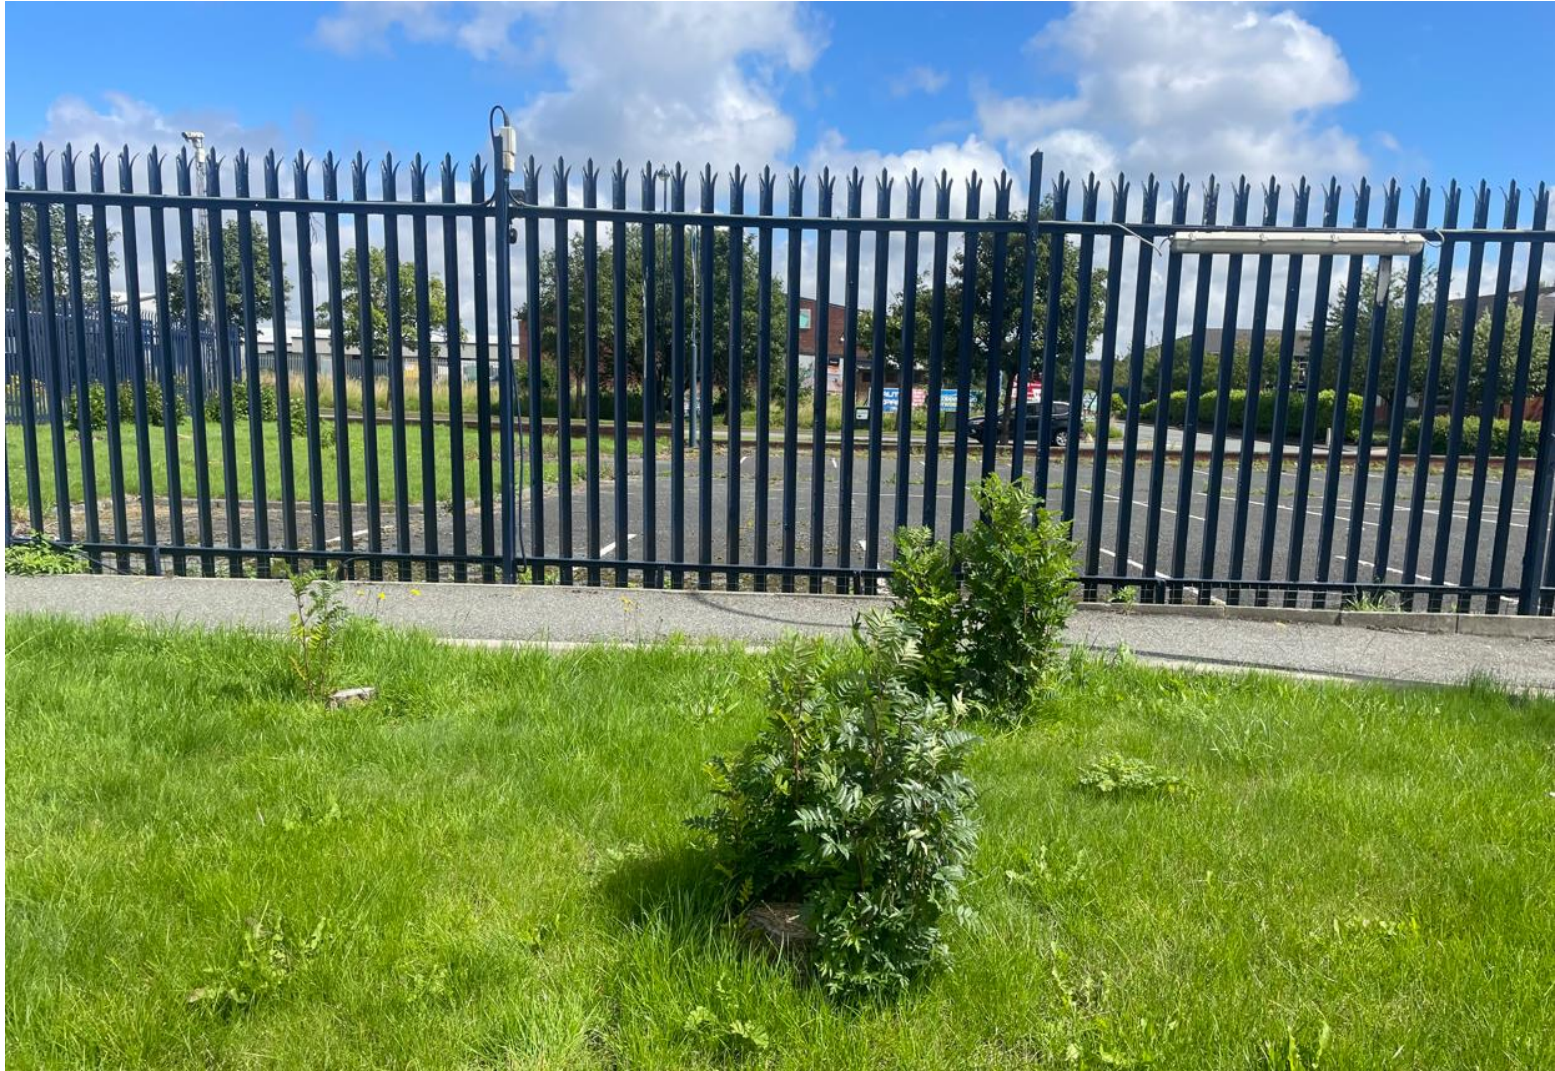
**Photo 3:** Palisade fencing creates barrier between onsite car park in eastern side of the site and access road visible in Photo 2. View is looking east.
