**FAIRHURST**

Desk Study Report

Site Photo Plan and Photos

156463 – Home Bargains, Huyton

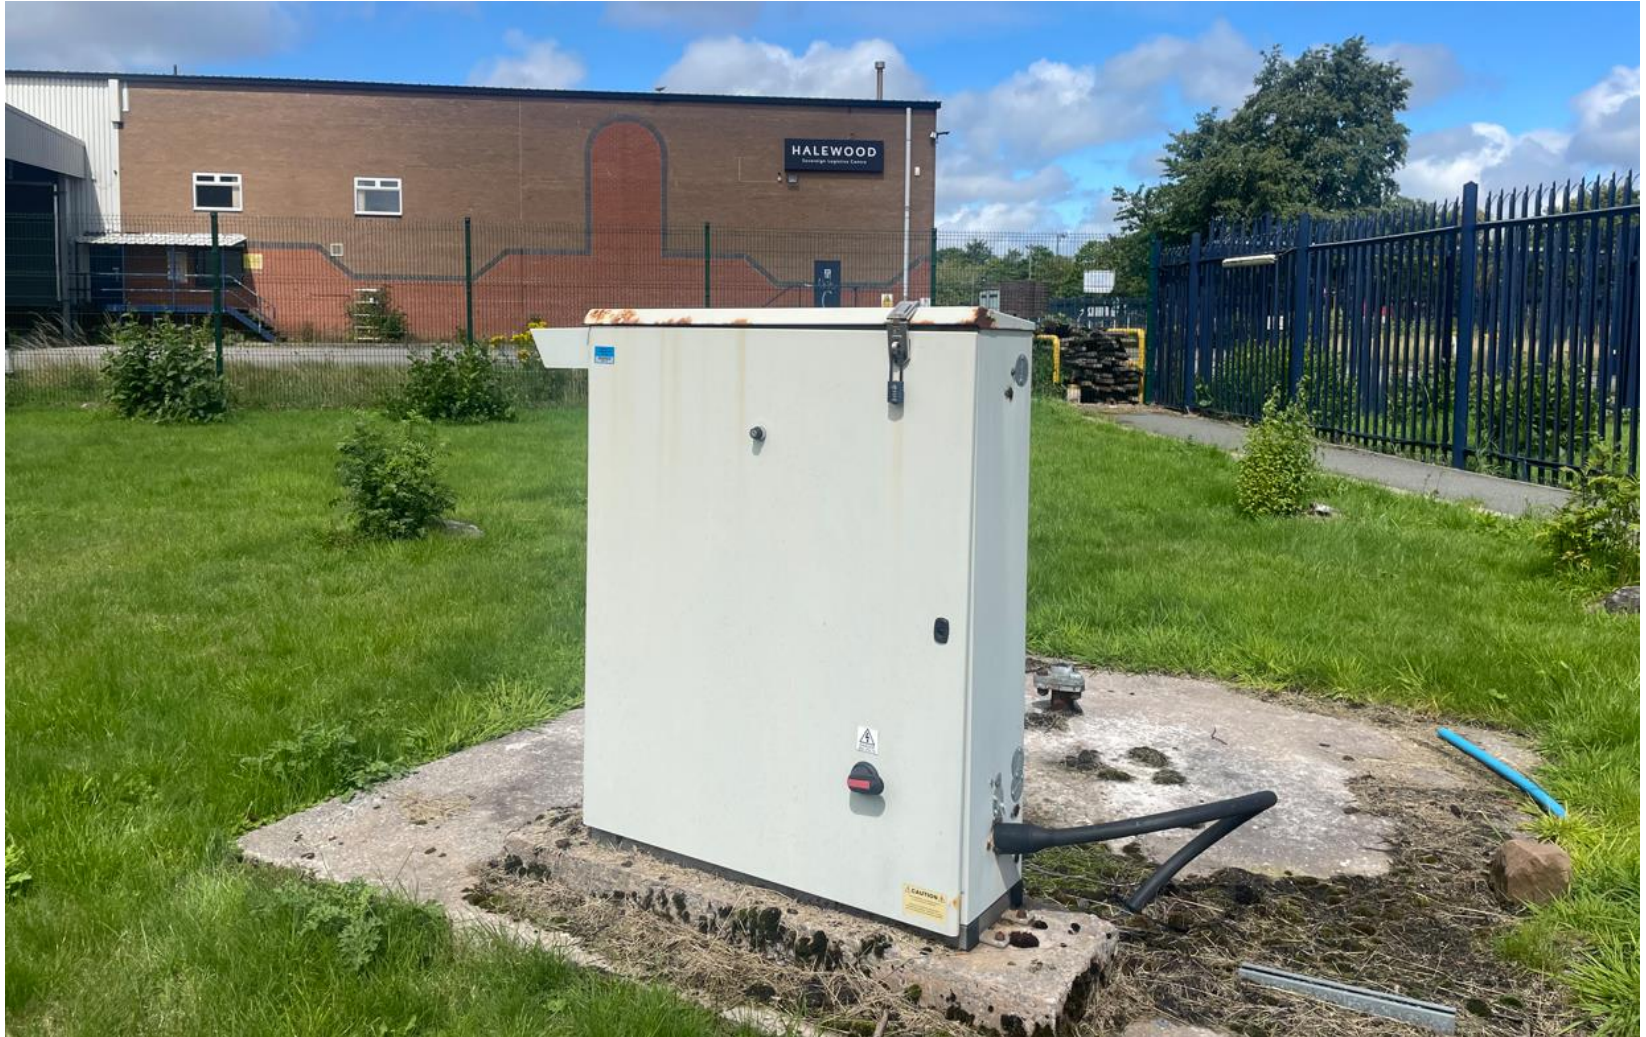
**Photo 4:** Possible electric box on concrete slab located in the north eastern part of the site.

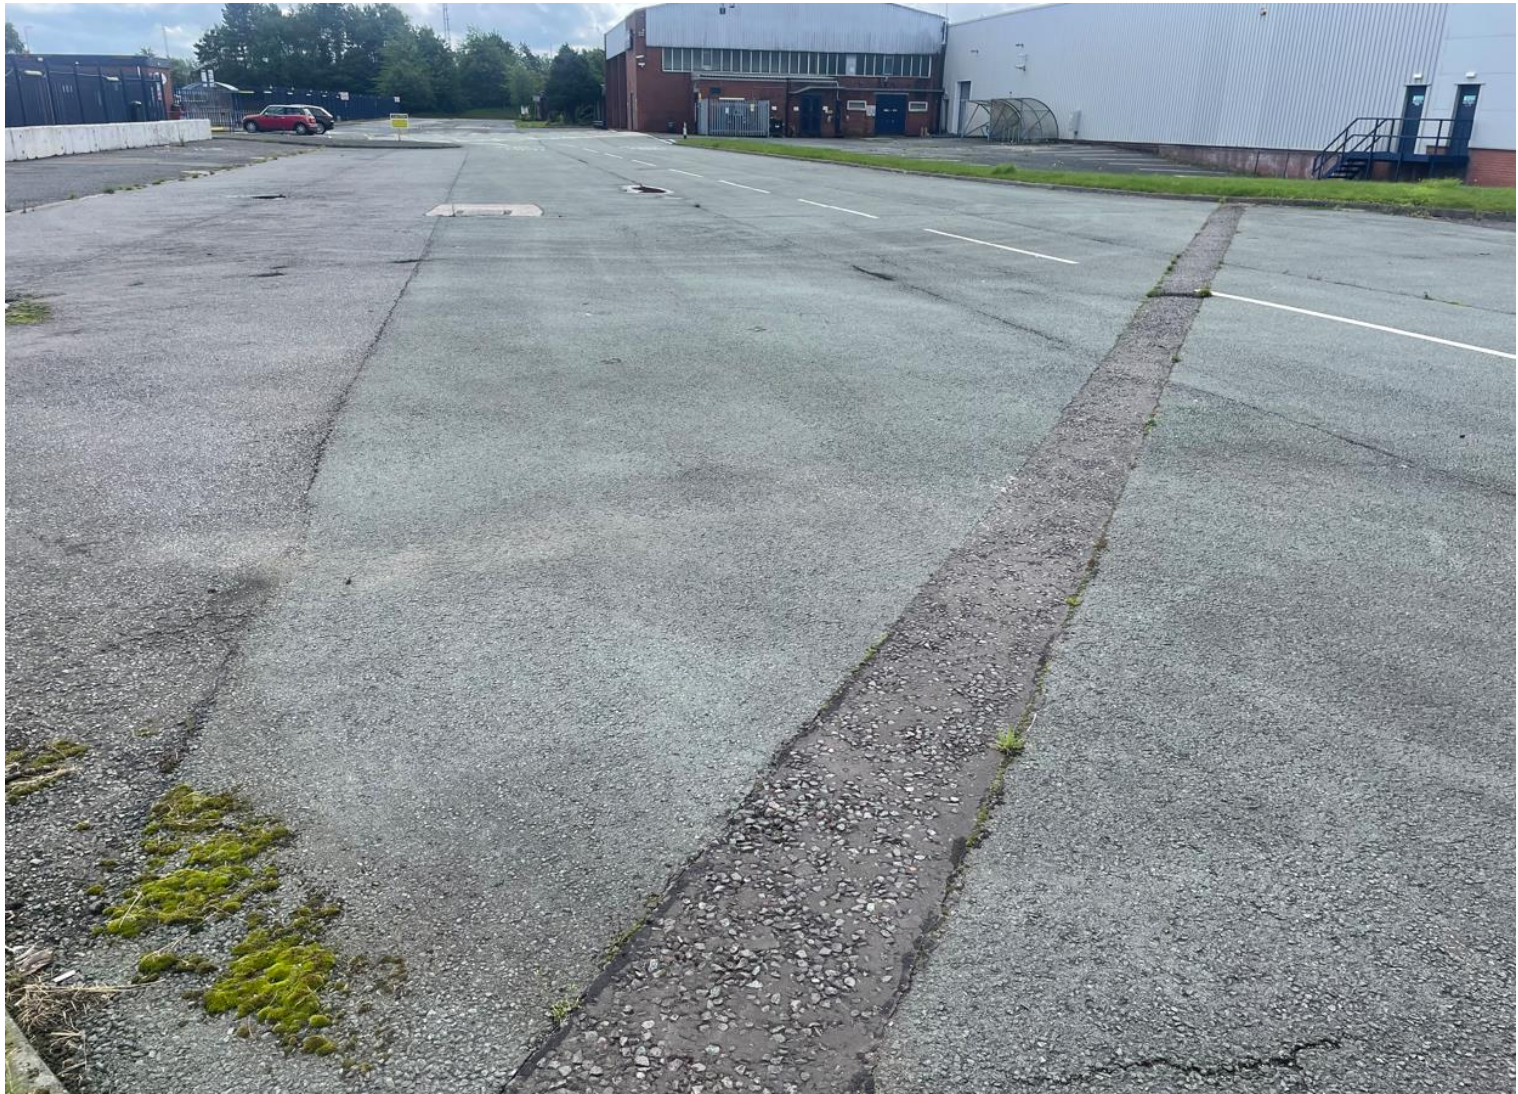
**Photo 5:** Possible buried services are indicated by scars in asphalt surfacing, located in north eastern parts of site.

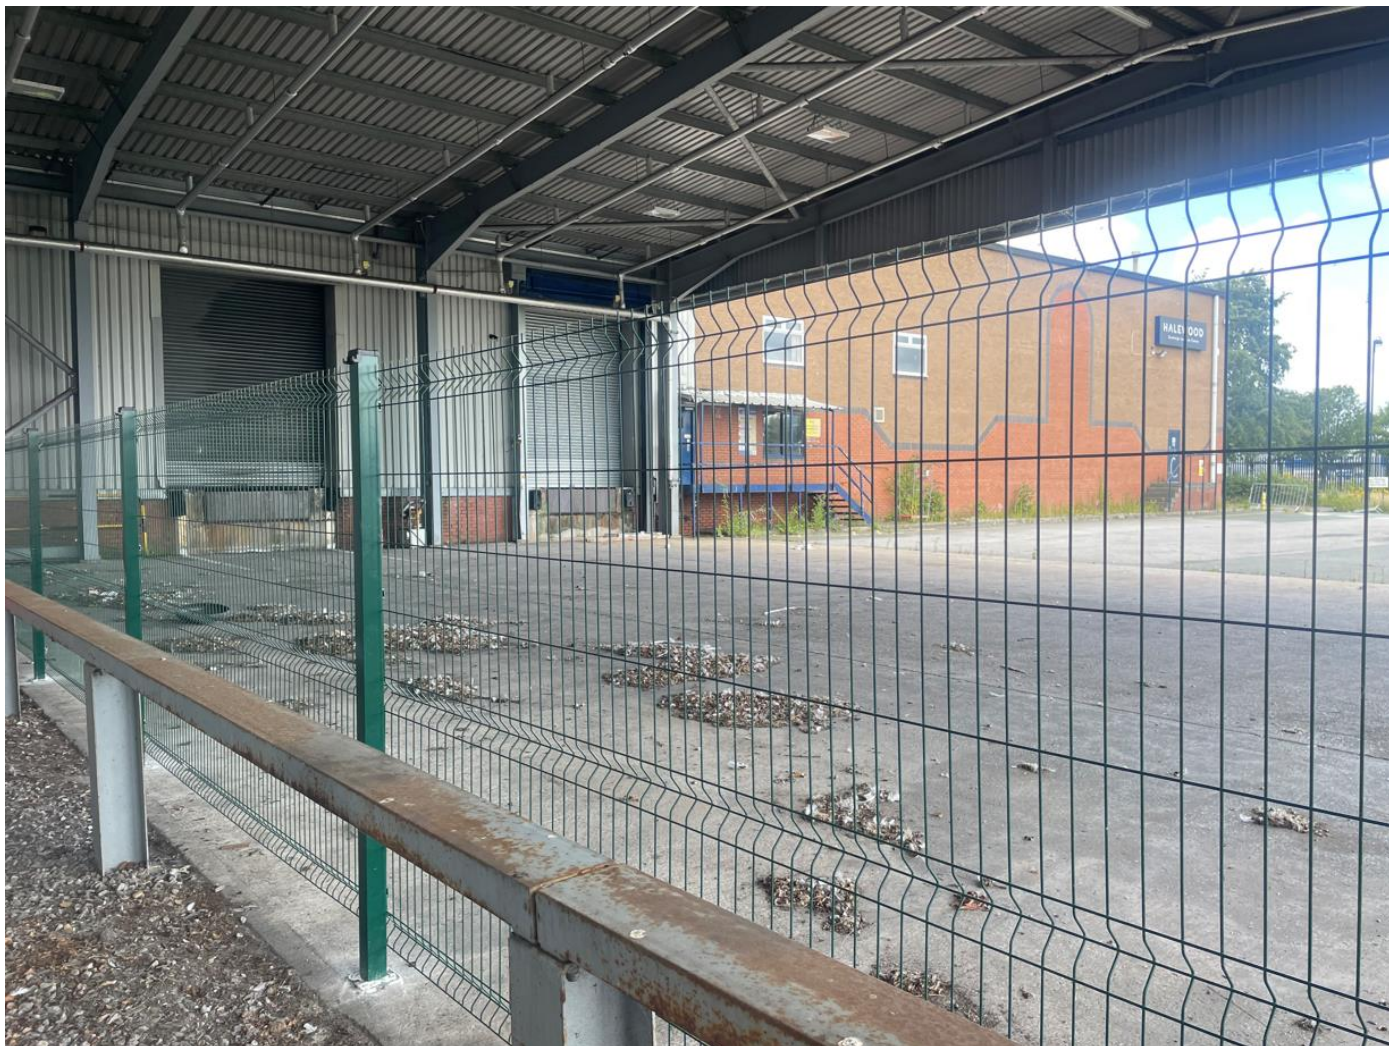
**Photo 6:** View looking north east. Area beyond fencing is an offsite yard space associated with the adjacent Halewood International building.

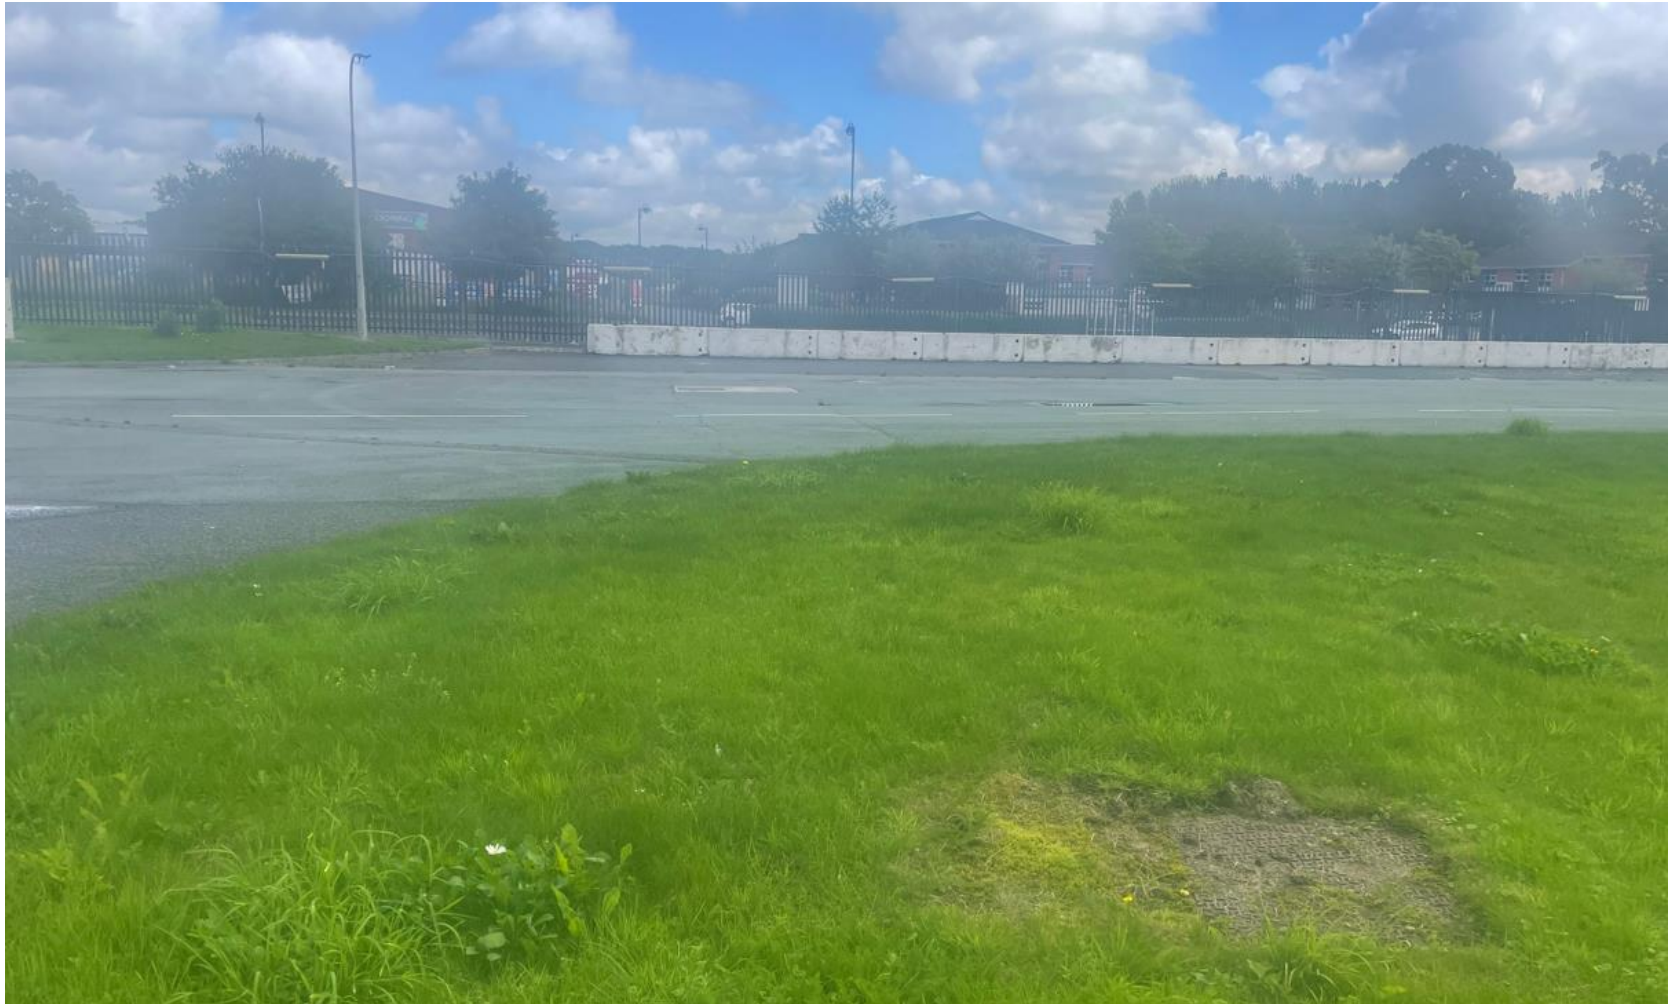
**Photo 7:** View of Wilson Road which bounds the eastern site boundary.

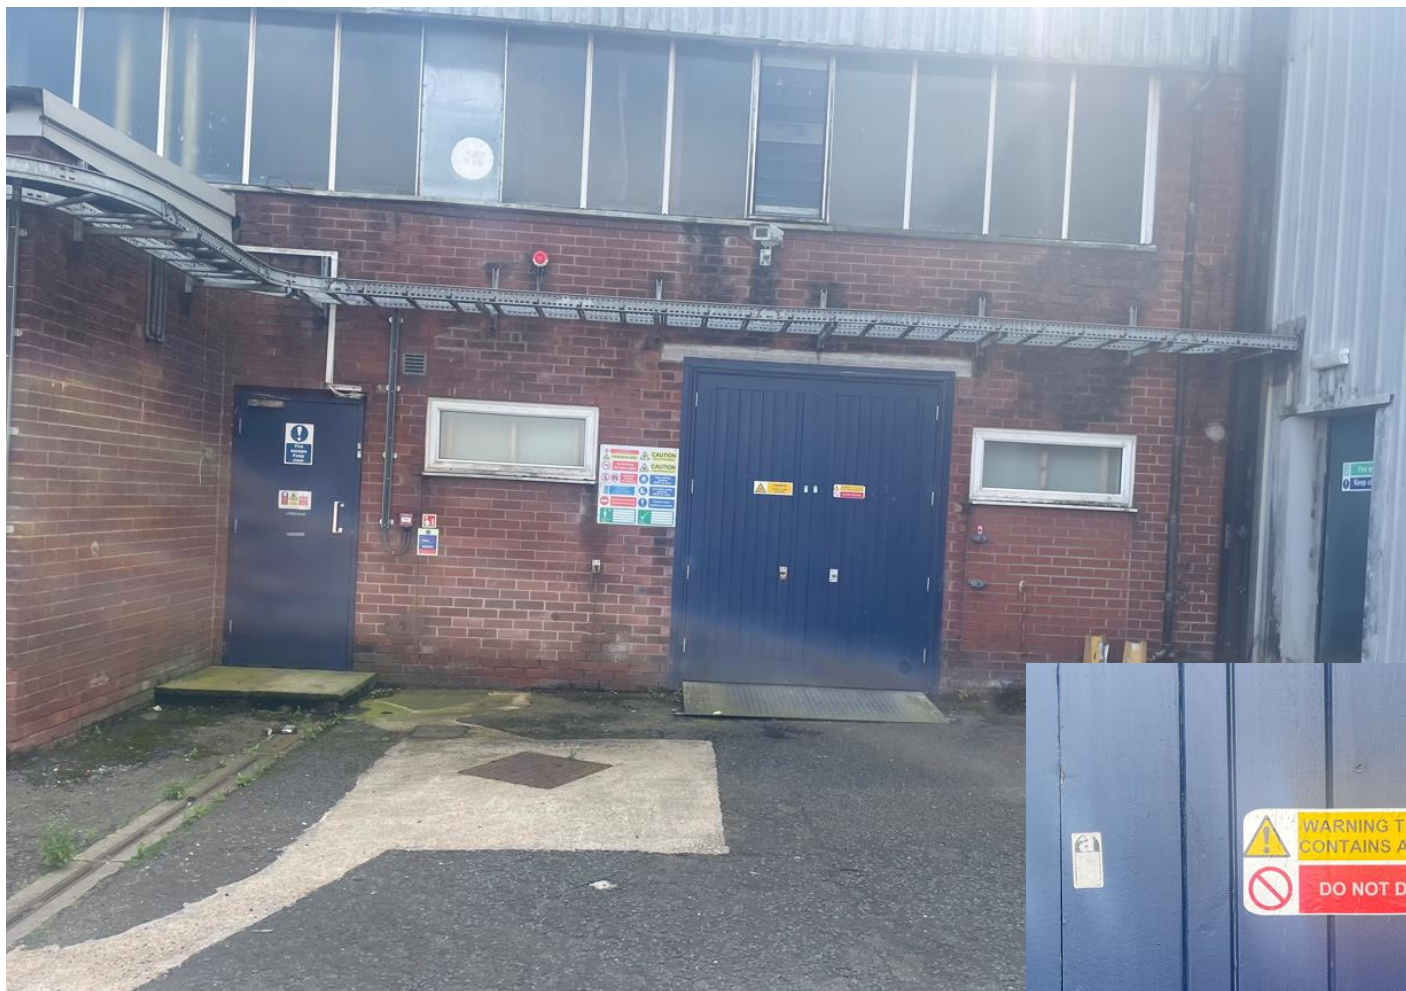
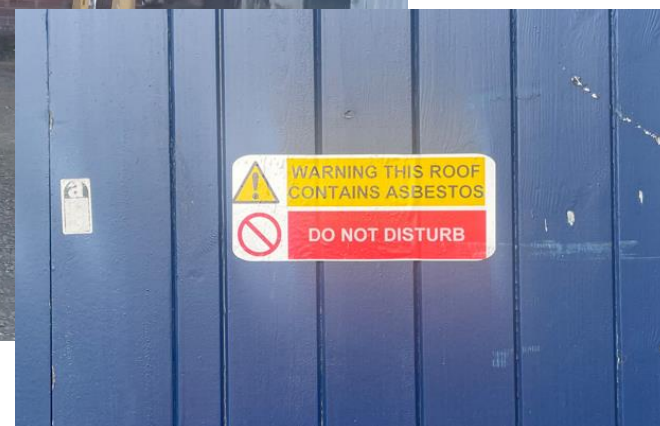
**Photo 8:** View looking south at external area of building on eastern side of the site. A radiation warning pole is located in the right corner. Asbestos warnings regarding the roof are on doors.

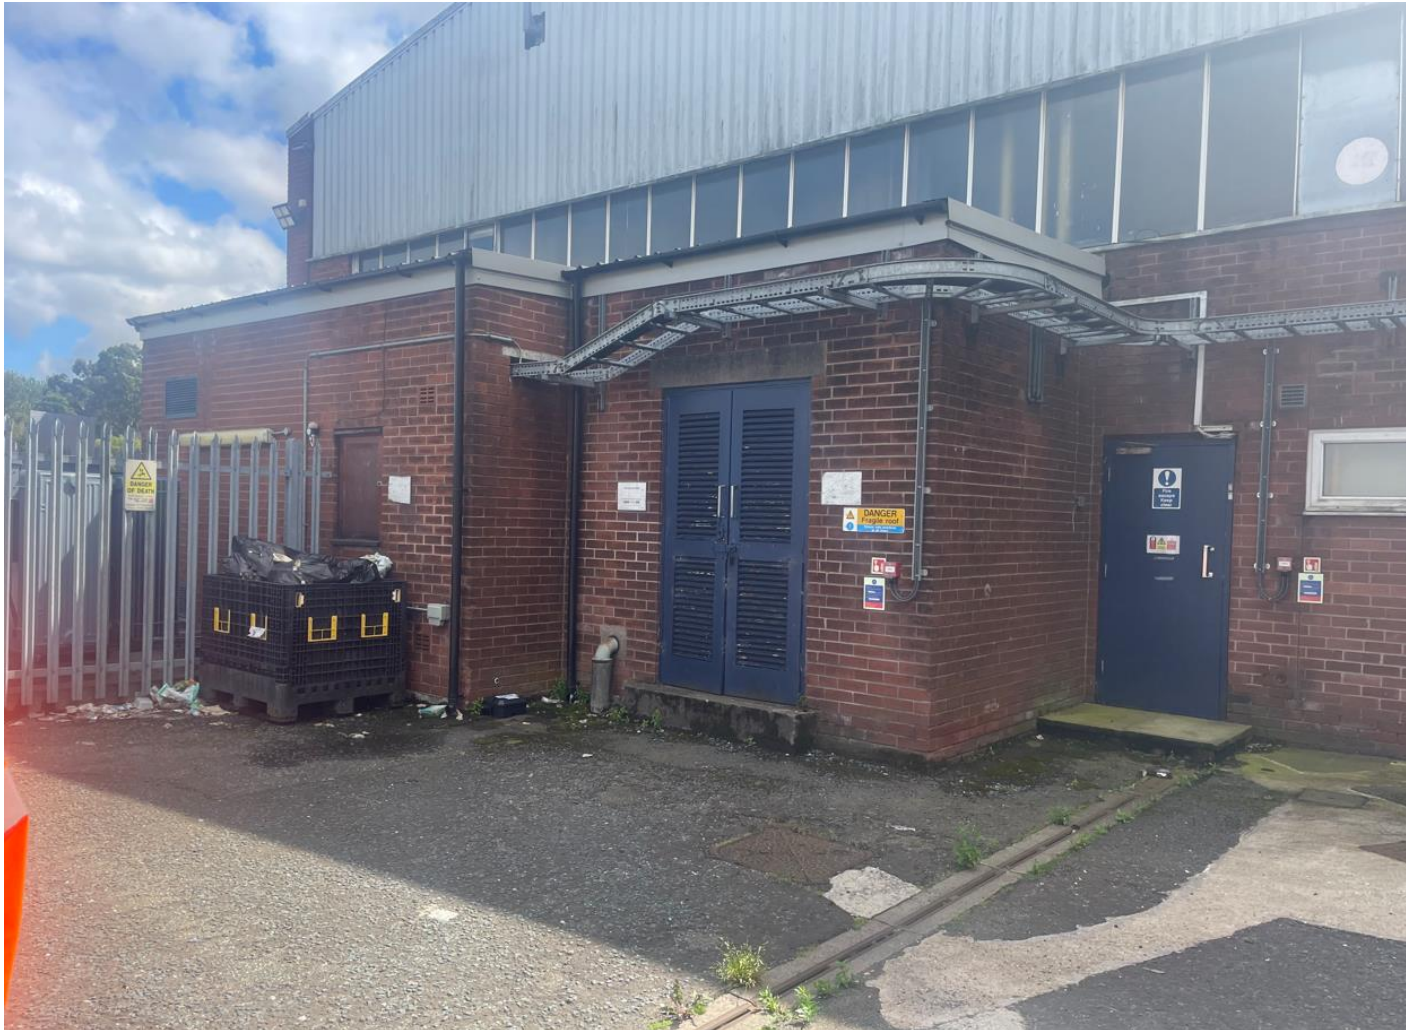
**Photo 9:** Gas inlet room with asbestos warning sites on building. Electricity substation is located in the left of photo.

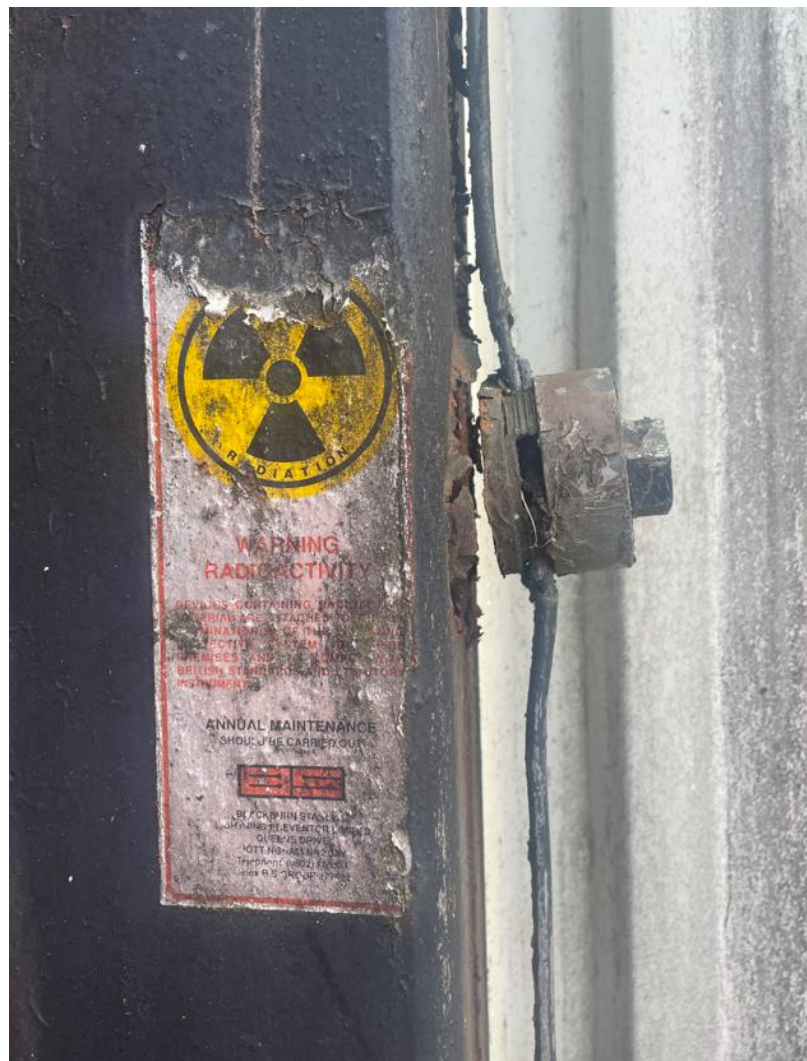
**Photo 10:** Dated radiation warning label on pole noted in Photo 8, likely electromagnetic. This may be associated with components of a former alarm system.

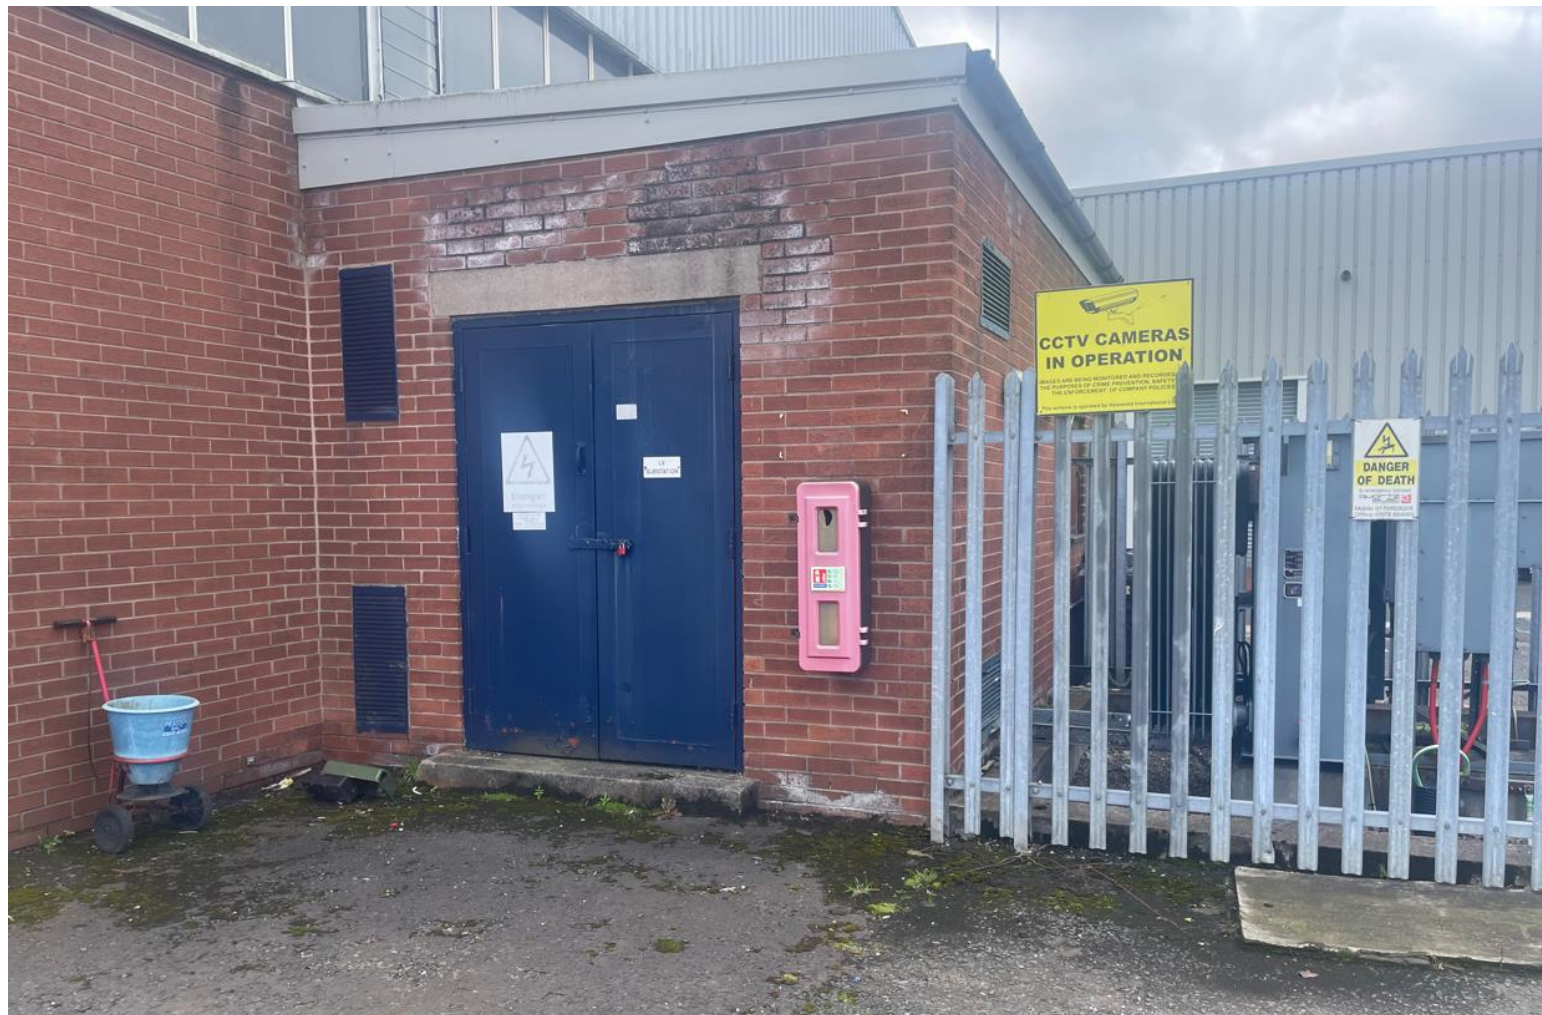
**Photo 11:** Electricity substation to the right of photo has warning signs of sulphur hexafluoride. LV building to the left of photo.

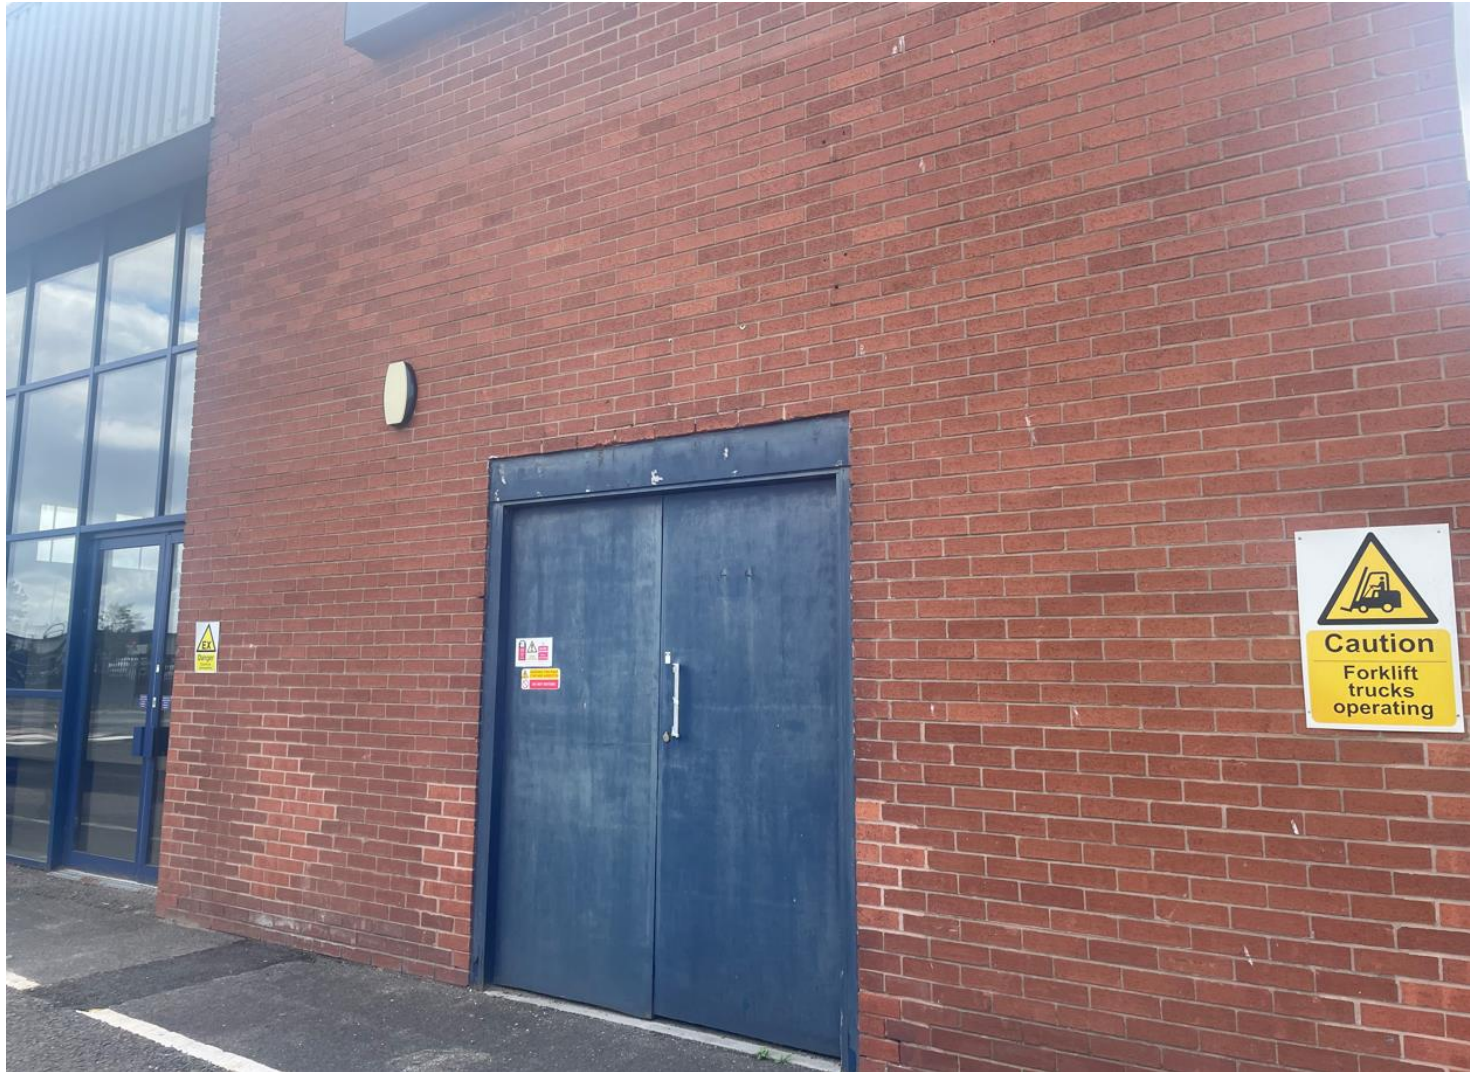
**Photo 12:** Access point to eastern side of building.

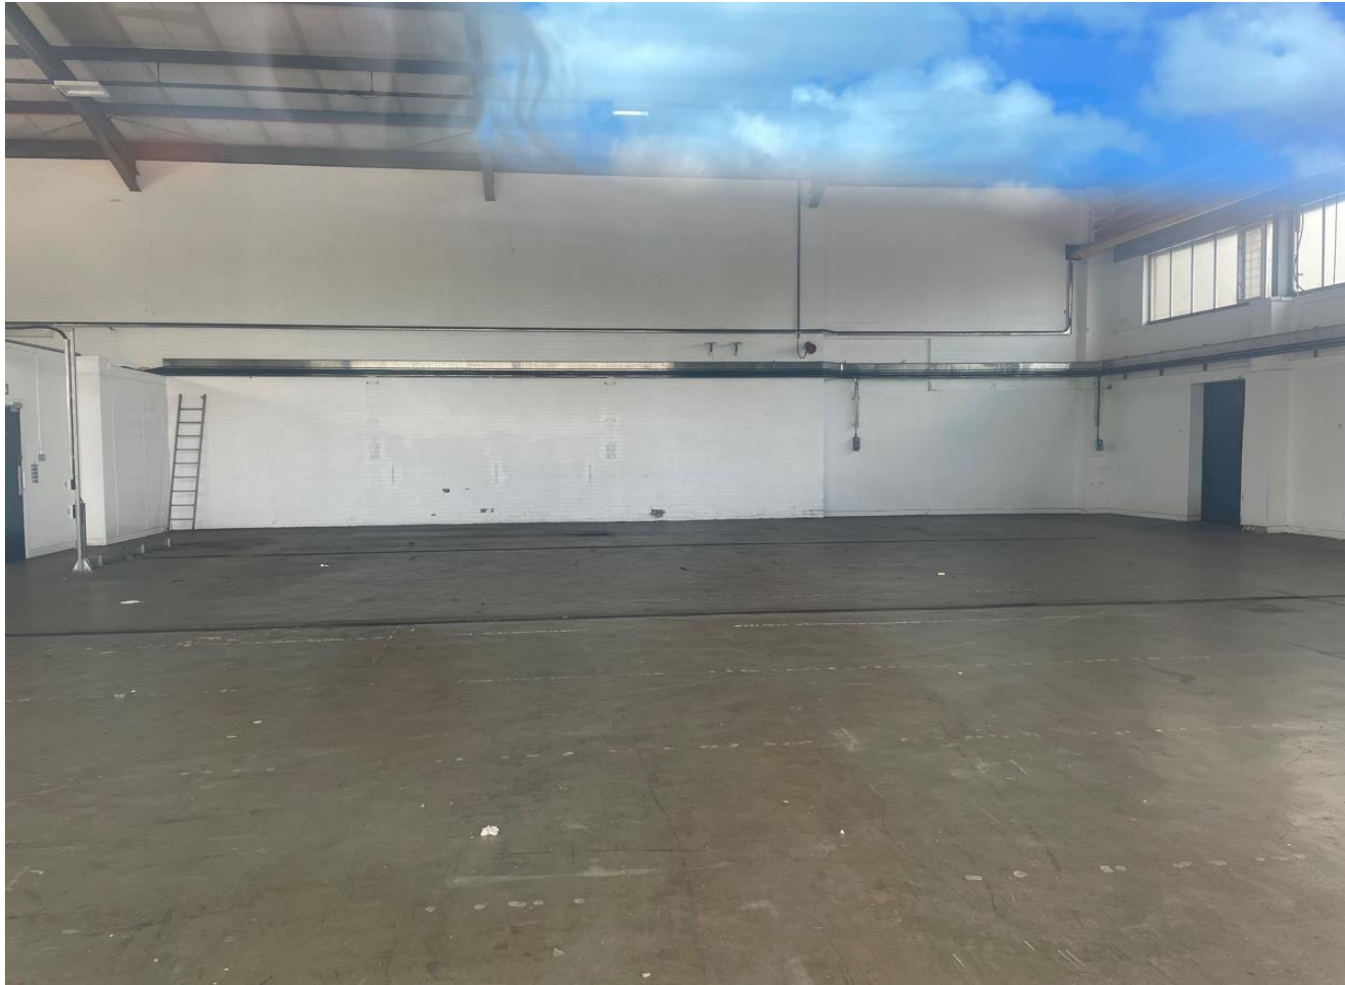
**Photo 13:** View through windows on eastern side of the building. Shows warehouse area to be empty.

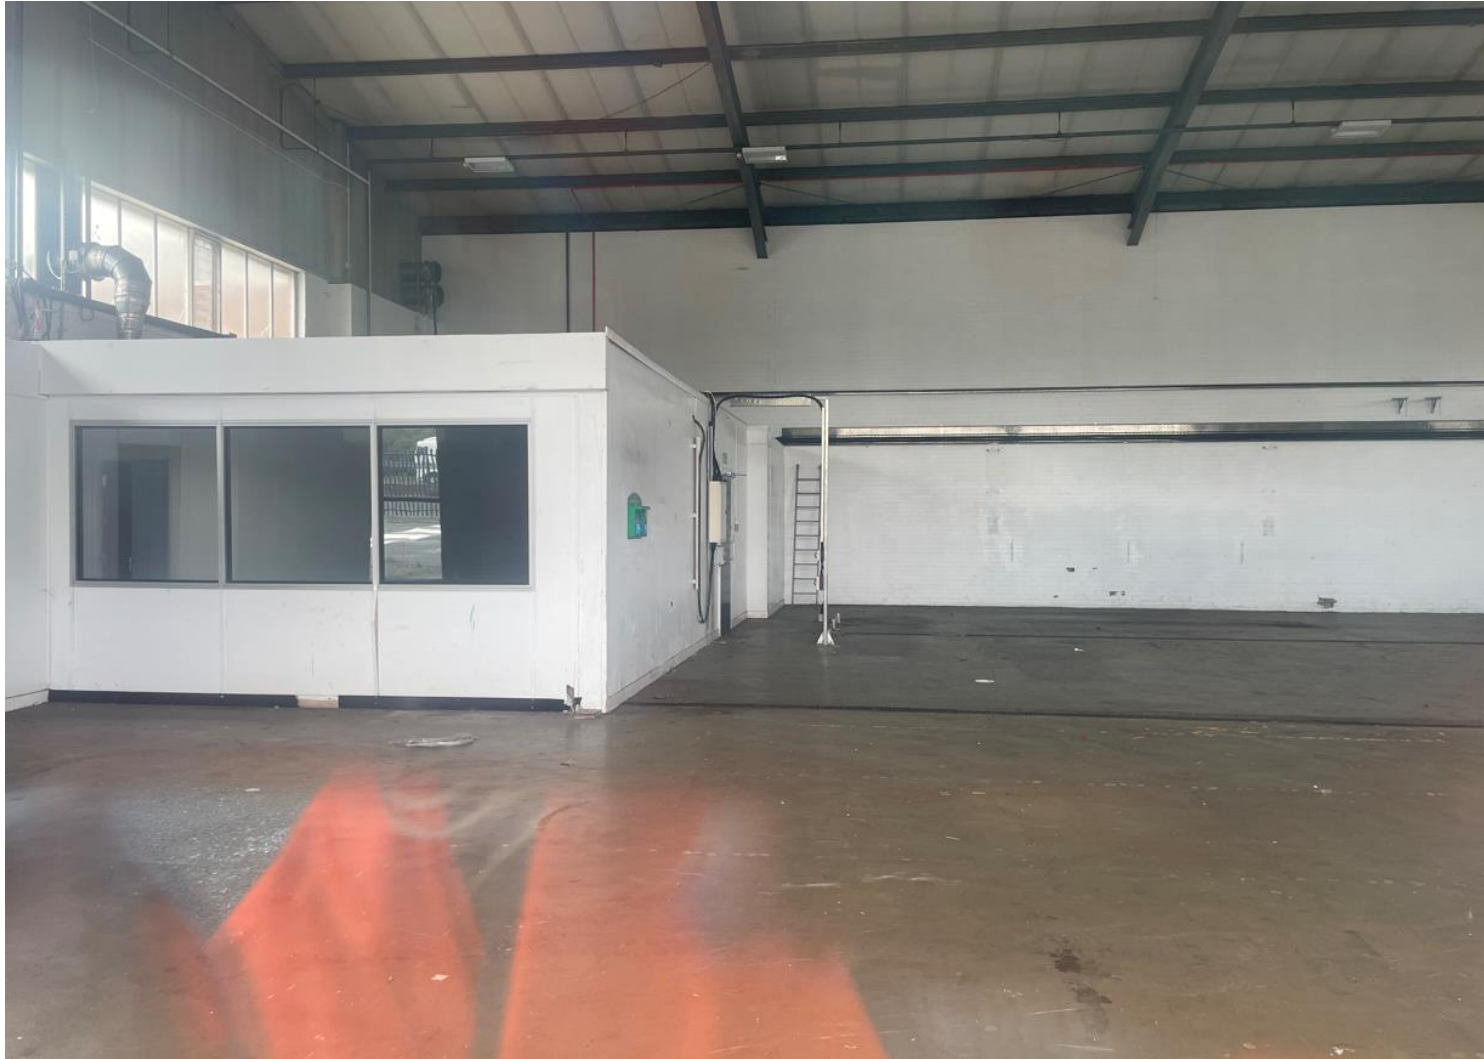
**Photo 14:** View through windows on eastern side of the building. Shows area to be empty.

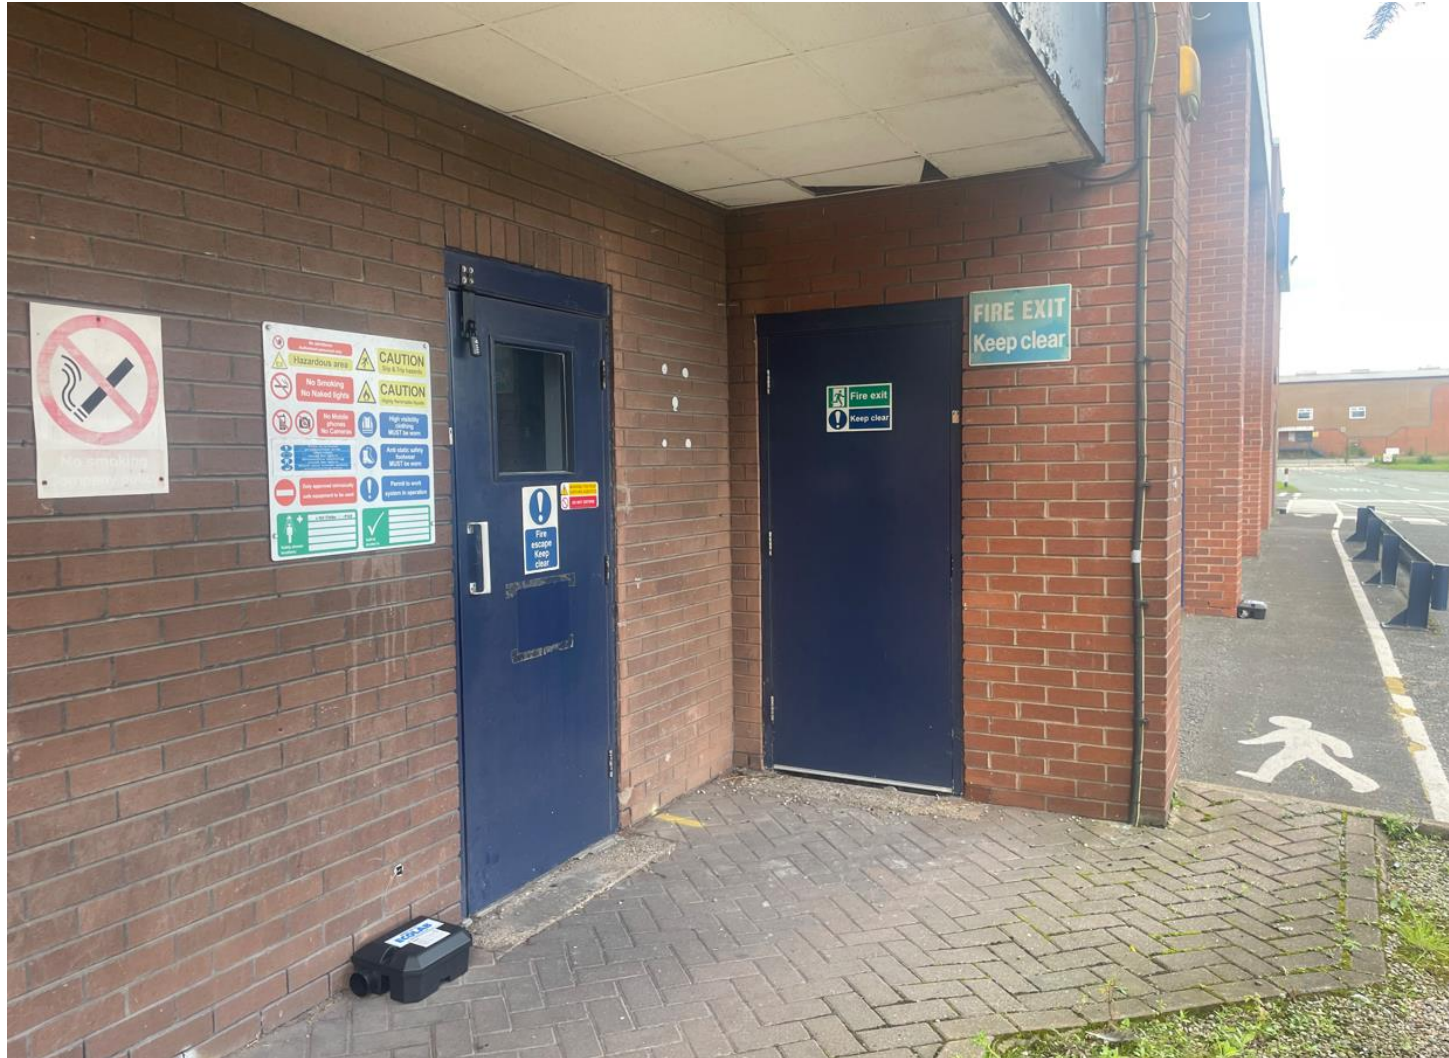
**Photo 15:** Access points into the eastern side of the building, outside an office area.

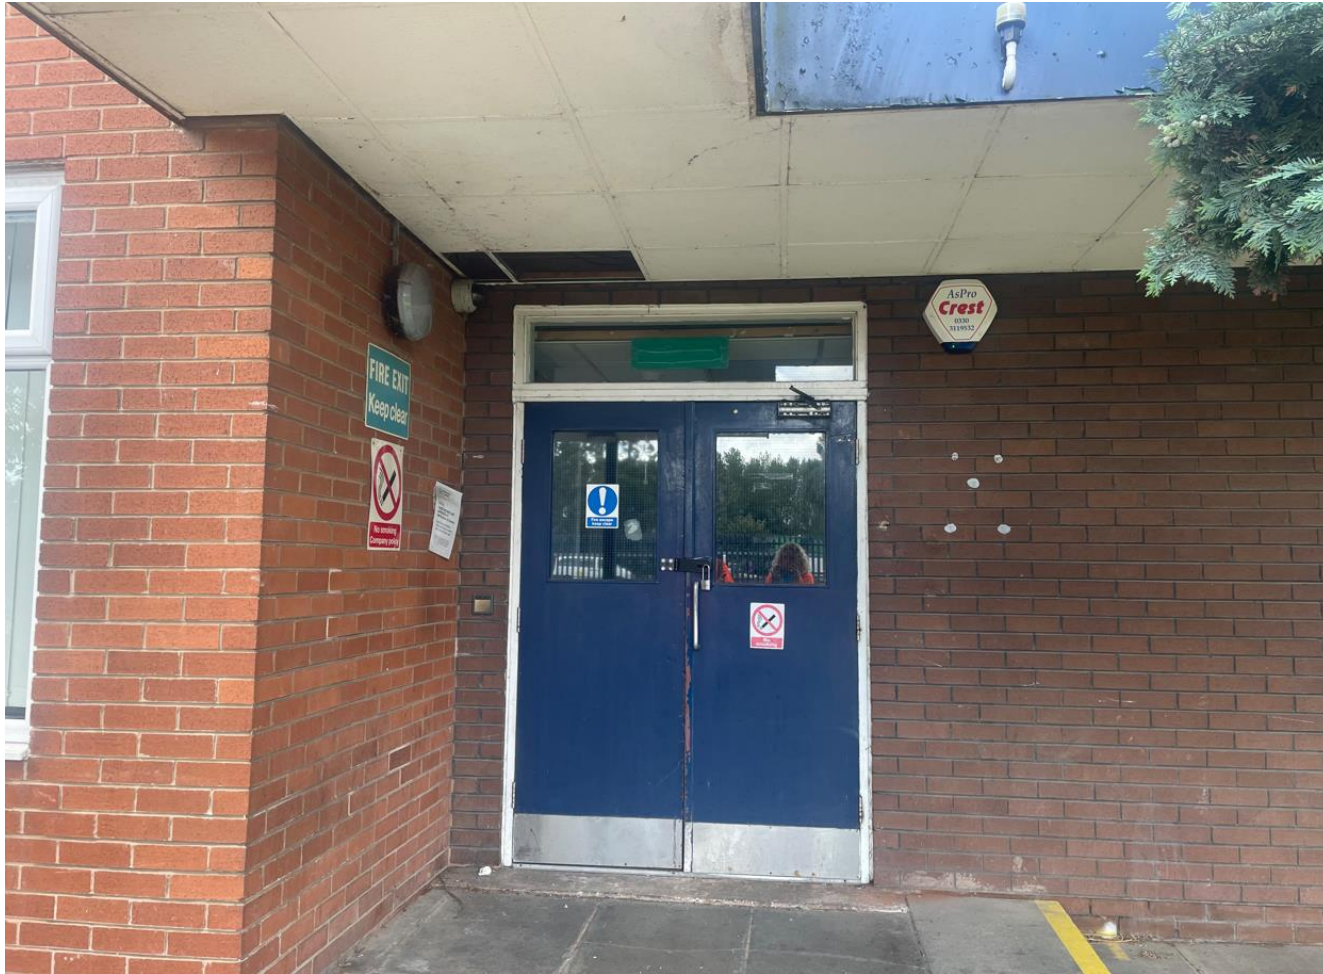
**Photo 16:** Additional access point into the eastern side of the building.

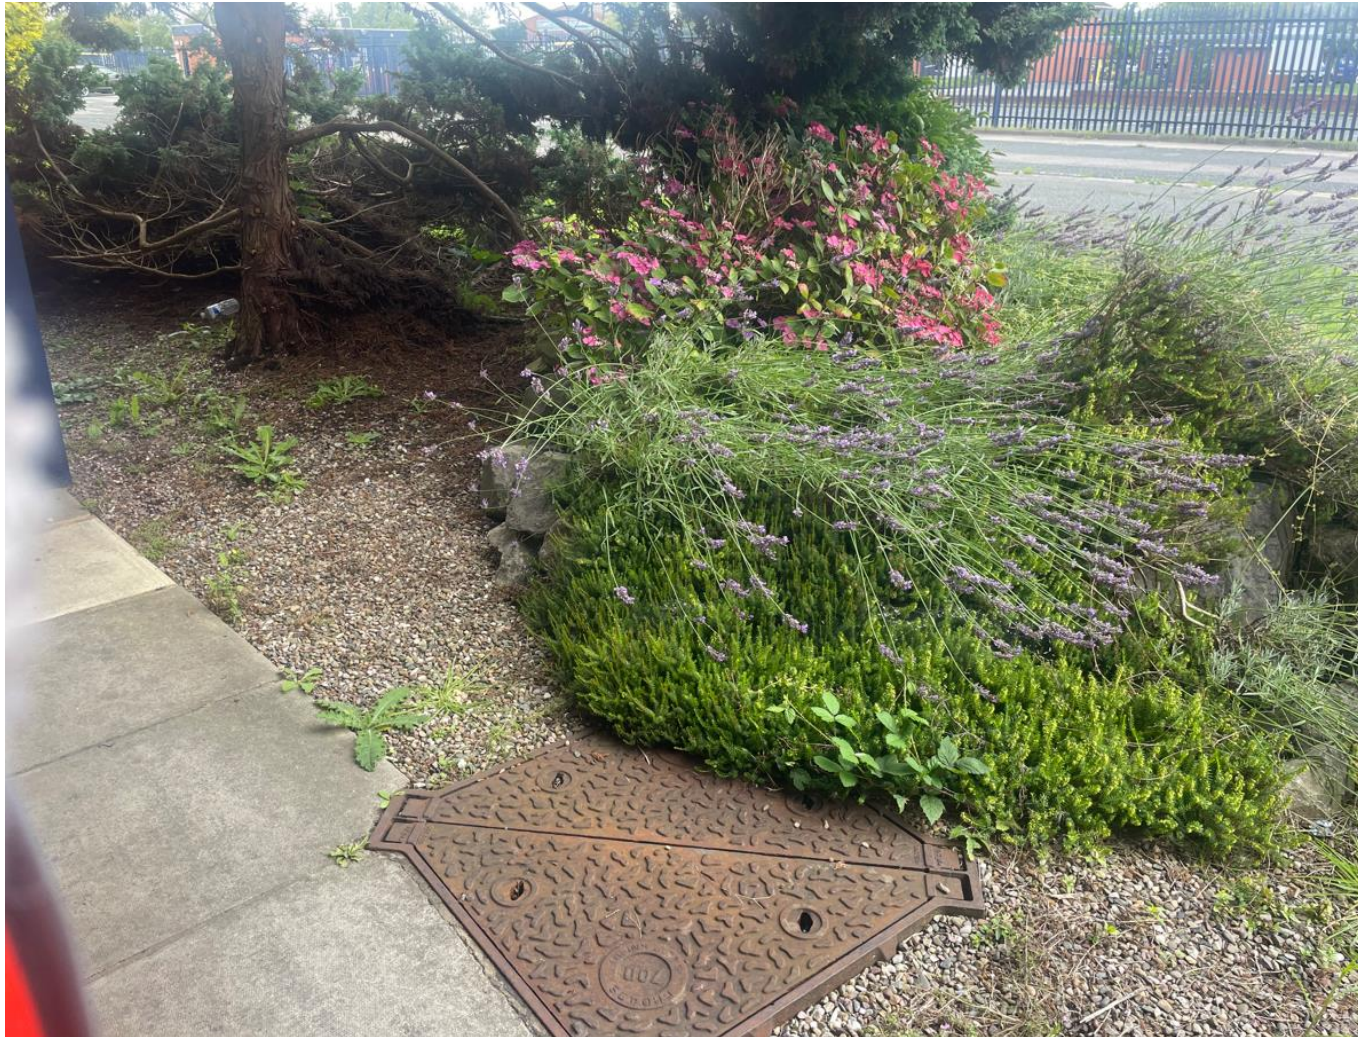
**Photo 17:** Soft landscaping area, including small trees and bushes, outside the front of the eastern side of the building. A drain cover is present.

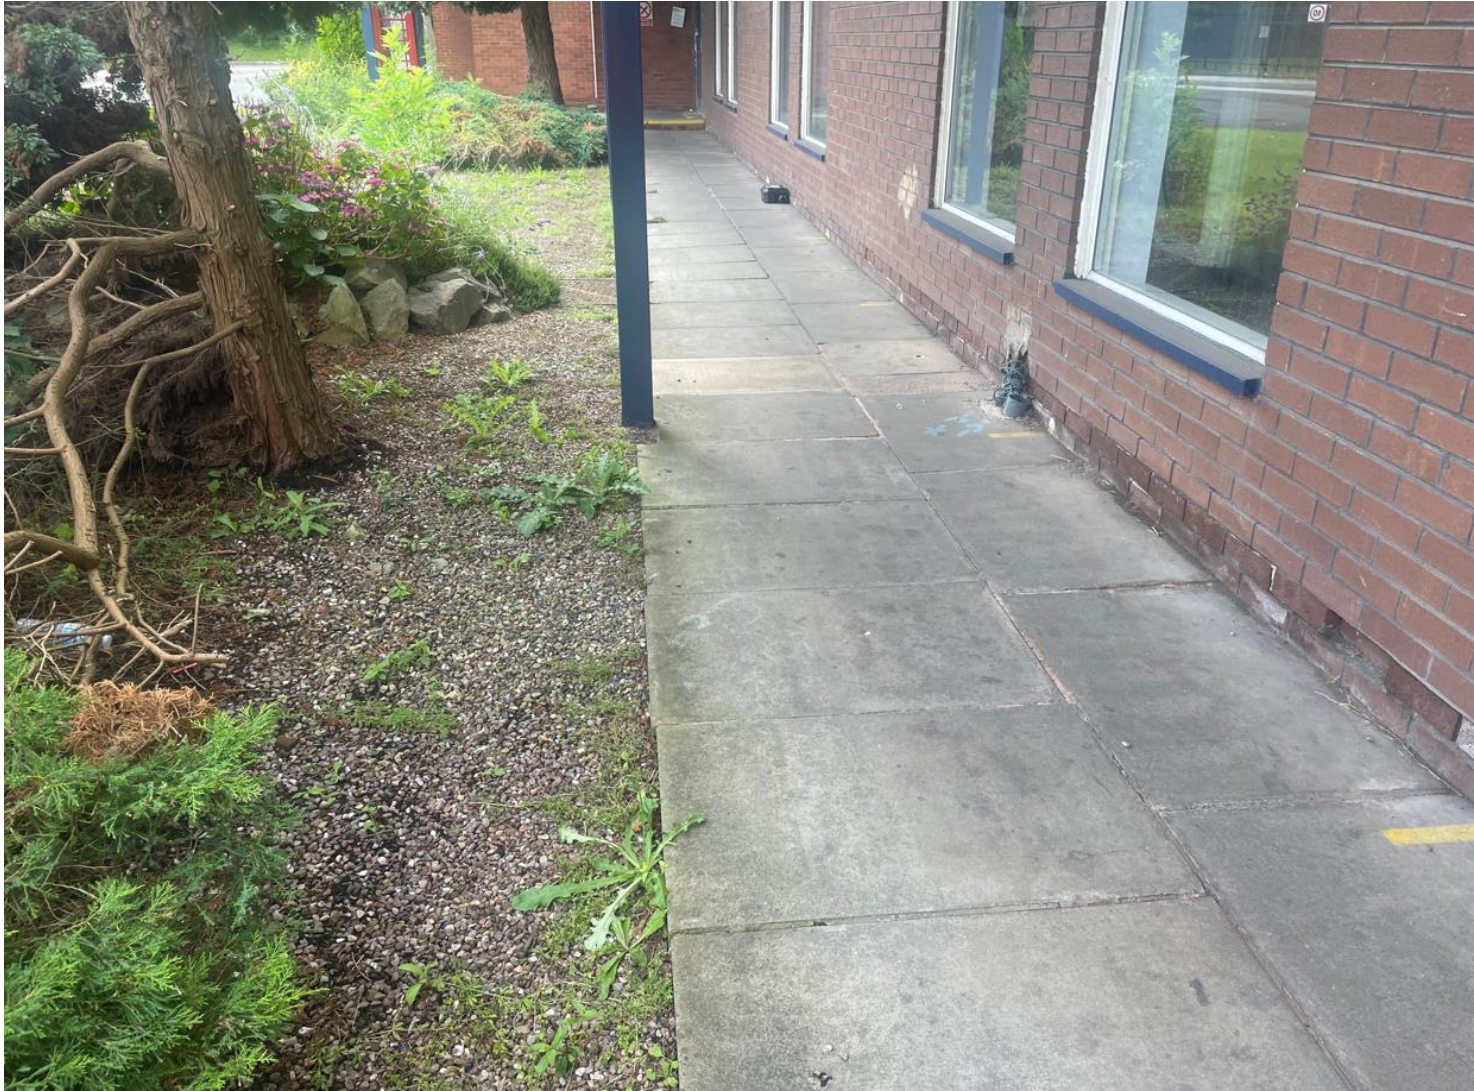
**Photo 18:** Soft landscaping to the left, including small tree. A concrete slab pathway runs along eastern side of building.
