**FAIRHURST**

Desk Study Report

Site Photo Plan and Photos

156463 – Home Bargains, Huyton

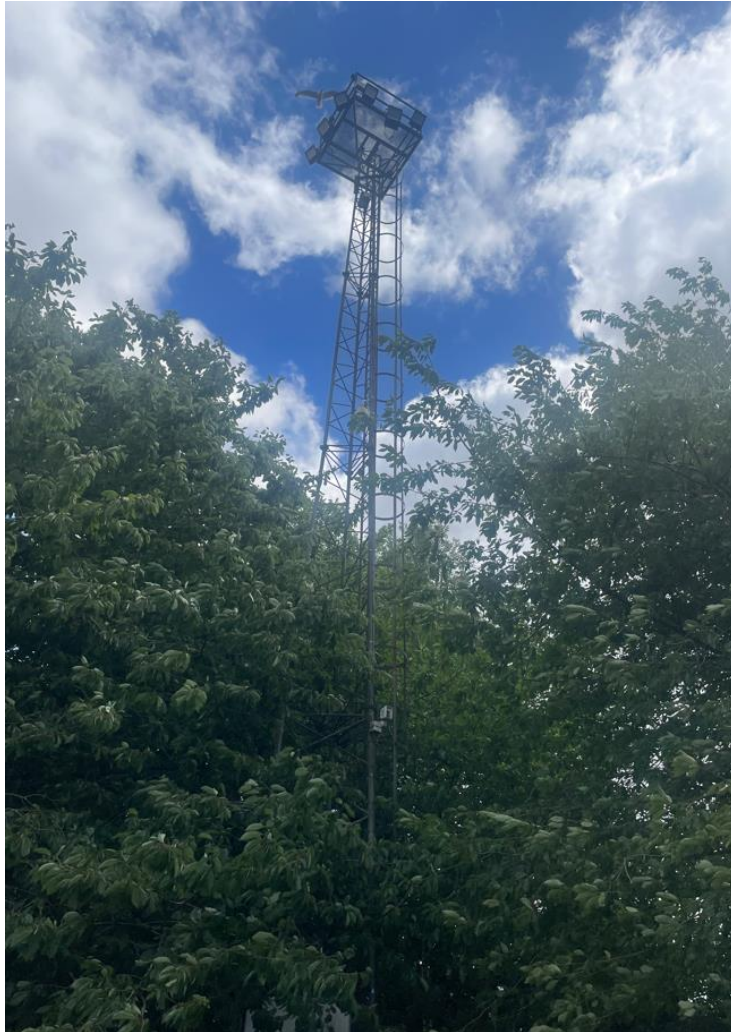
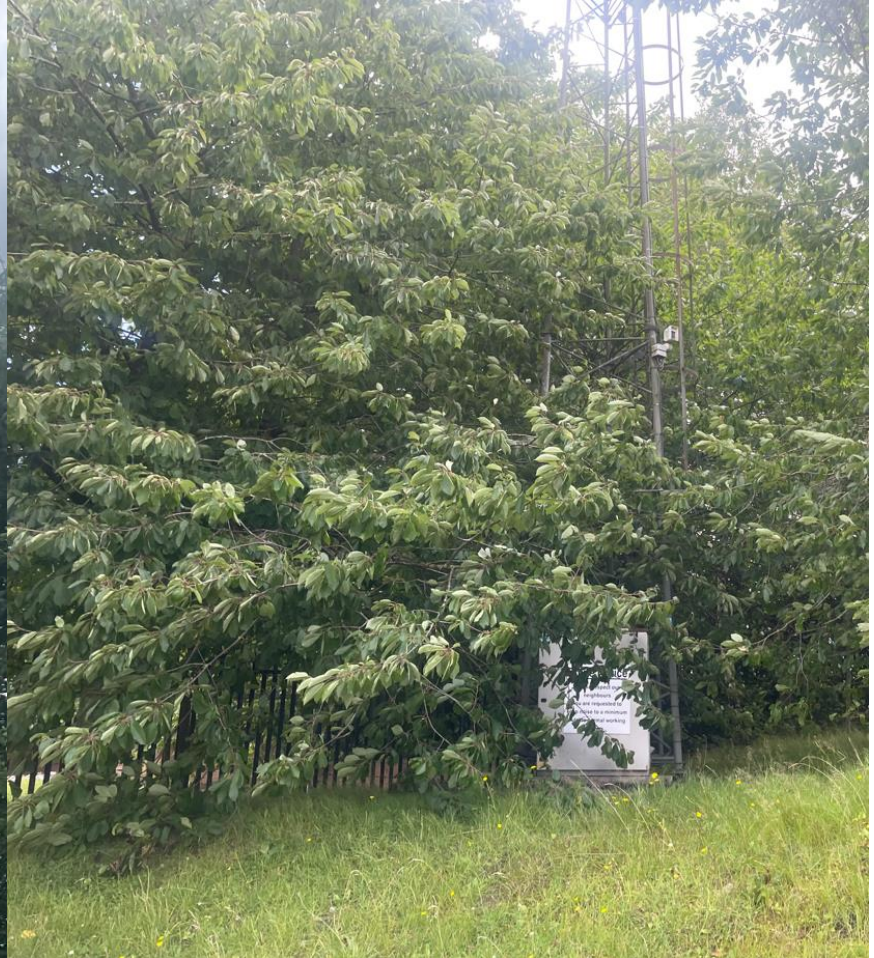
**Photo 19:** Flood light tower position on southern site boundary. Tall mature trees are also present.

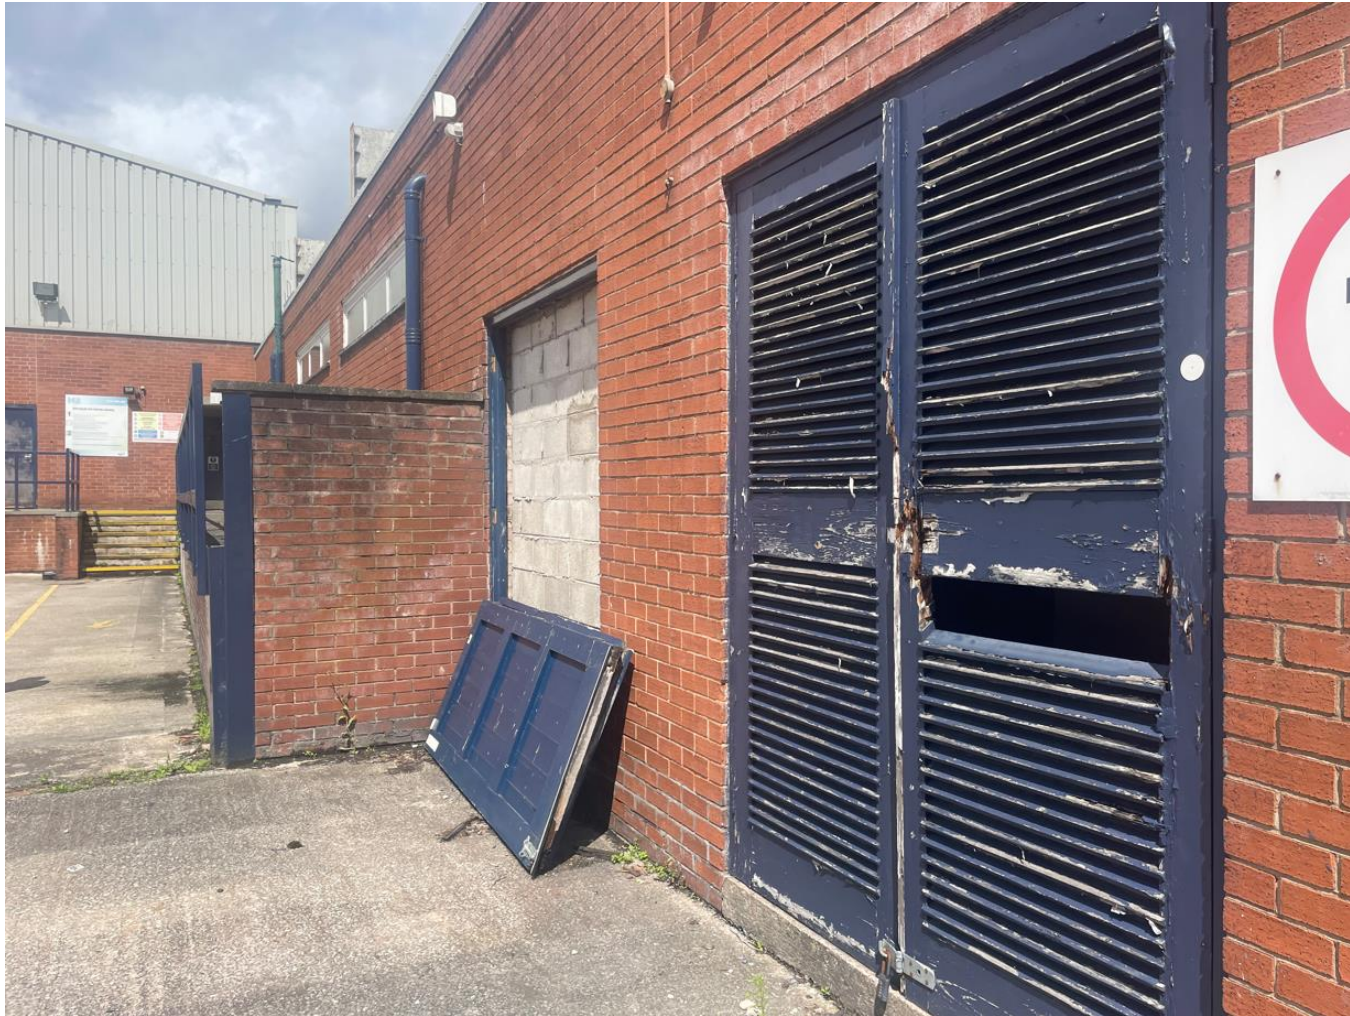
**Photo 20:** Southern end of the red brick building looking west. The doors to boiler house are to the right of the photo.

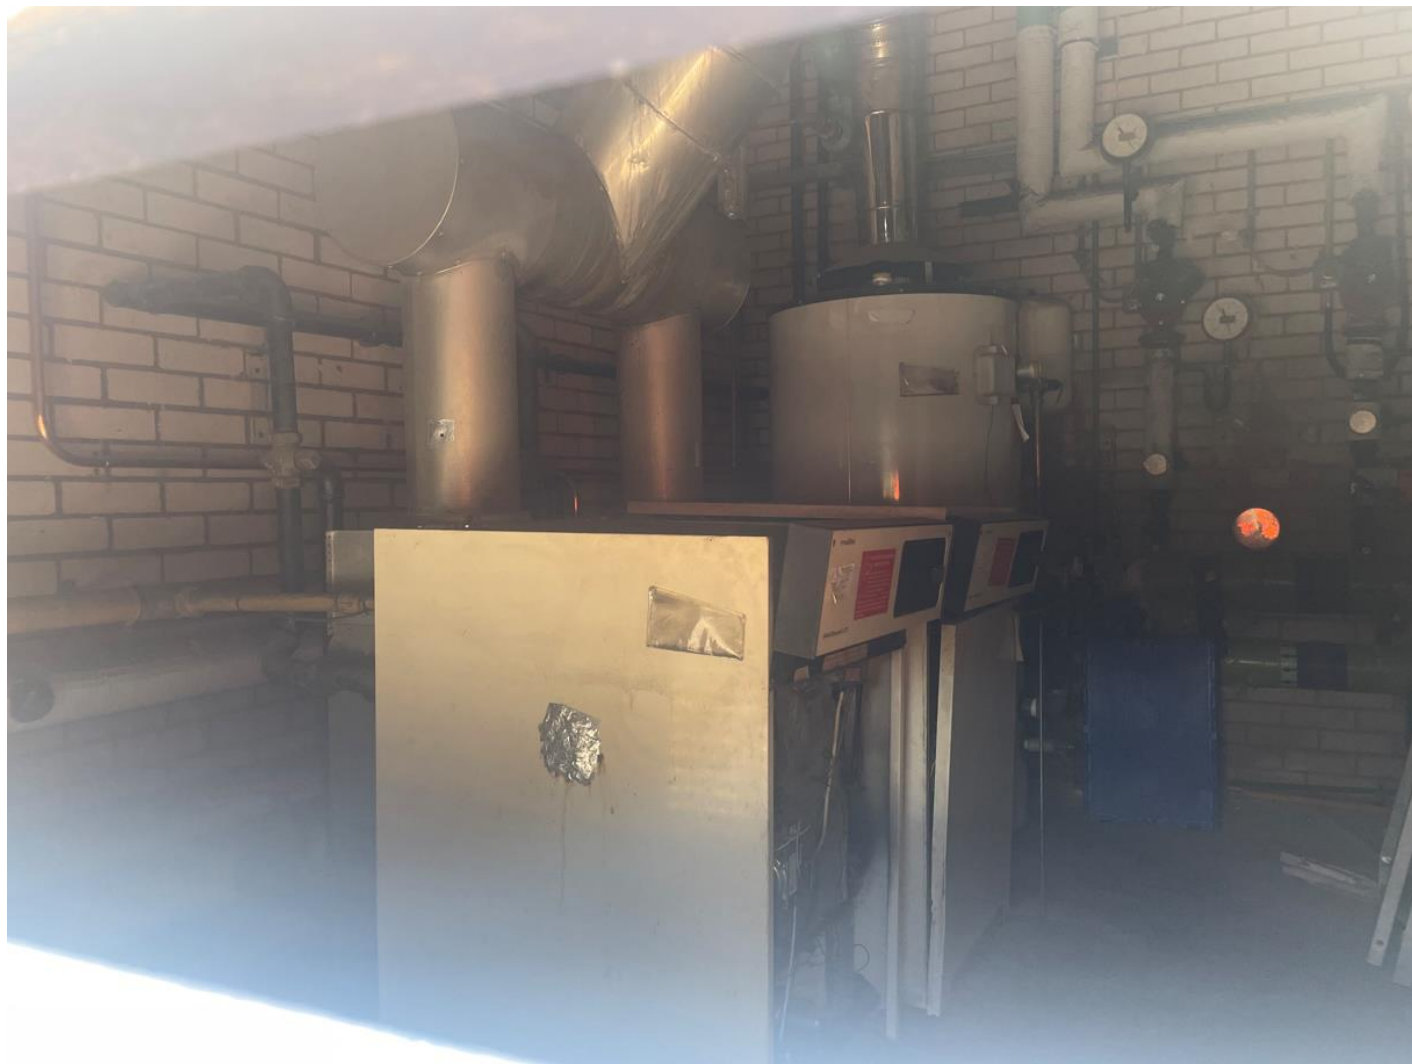
**Photo 21:** View into boiler house through broken section of door. Access into the boiler house was not granted, therefore a review of any potential tanks could not be undertaken.

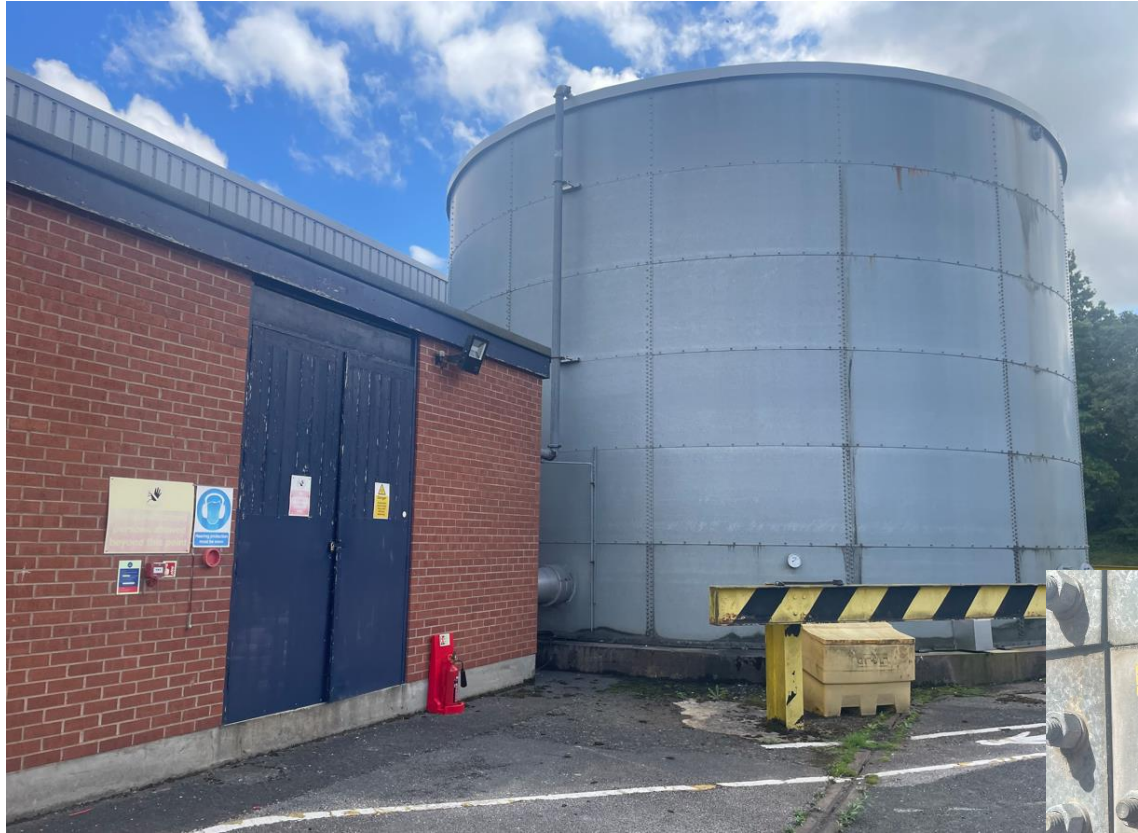
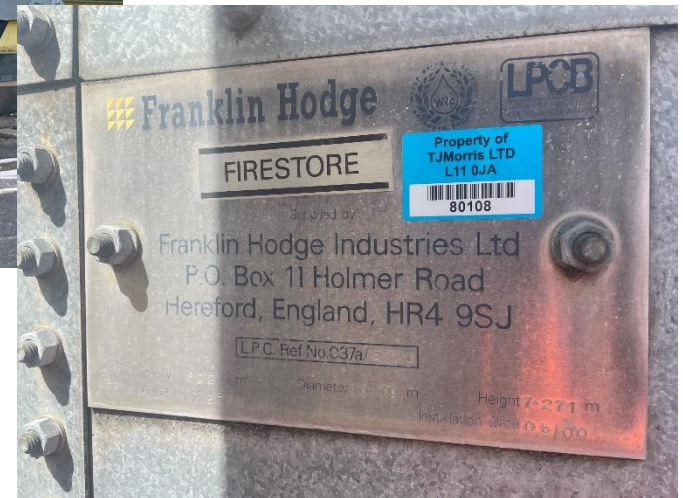
**Photo 22:** Large 'firestore' tank, likely filled with water or foam and used for fire suppression. Building to the left is likely to be a pump house with diesel pumps/generators for fire suppression system.

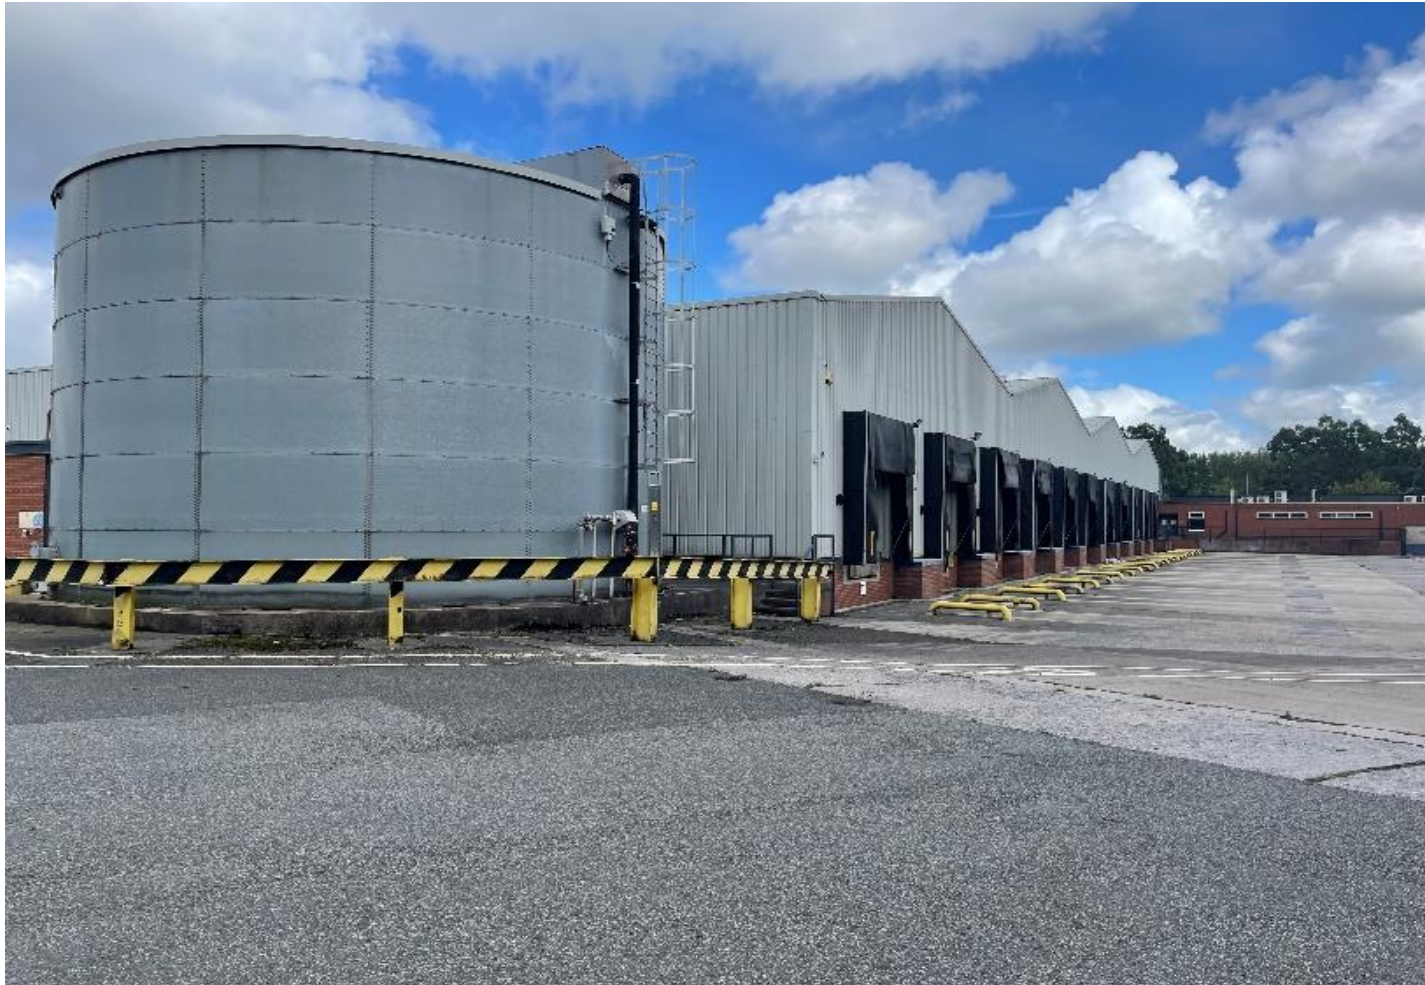
**Photo 23:** Lorry loading/unloading bays to the right of the phot and the fire suppression tank located on southern side of building.

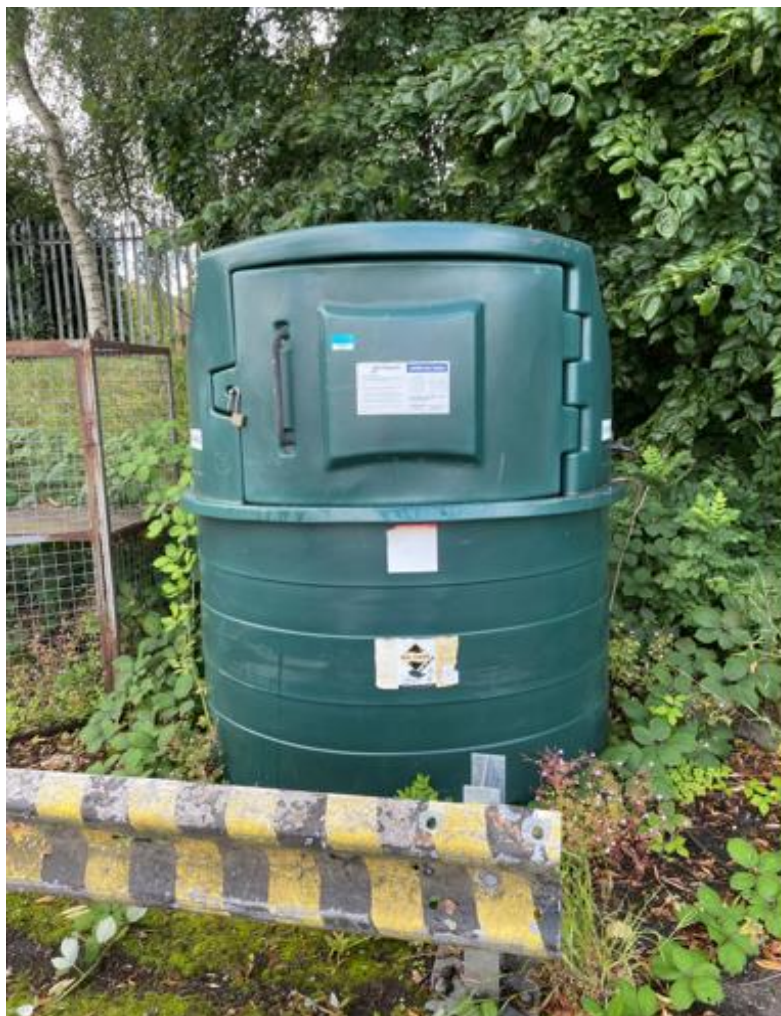
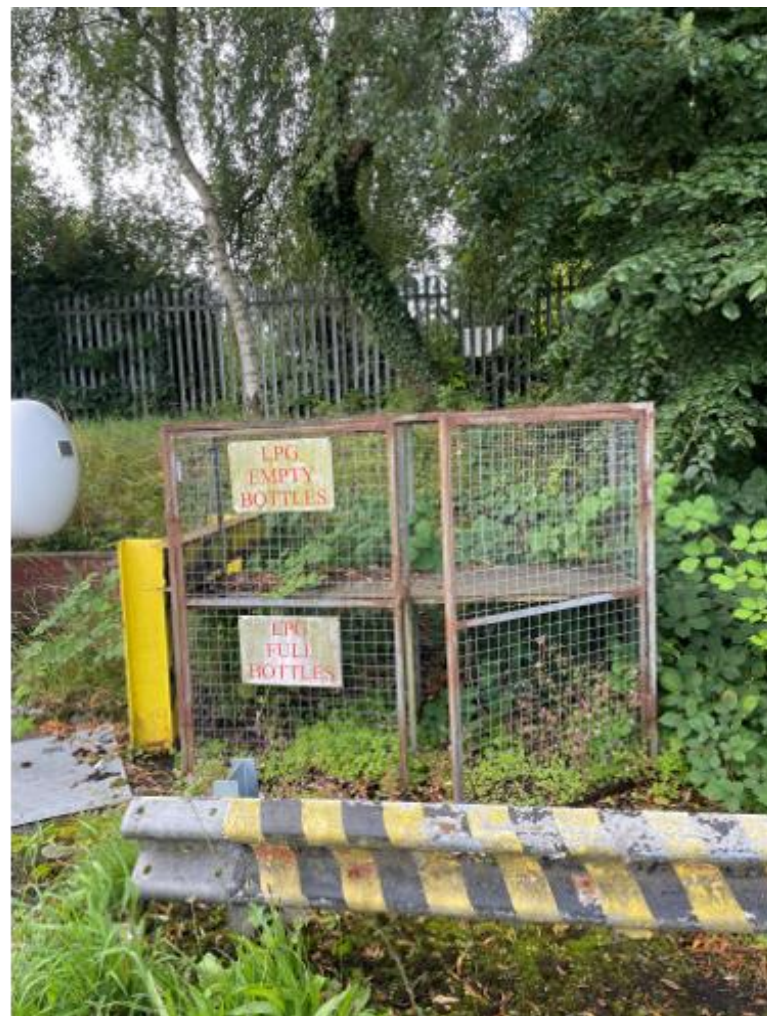
**Photo 24:** Diesel tank (smells strongly of hydrocarbons) and old crate for liquid petroleum gas, located towards the southern site boundary.

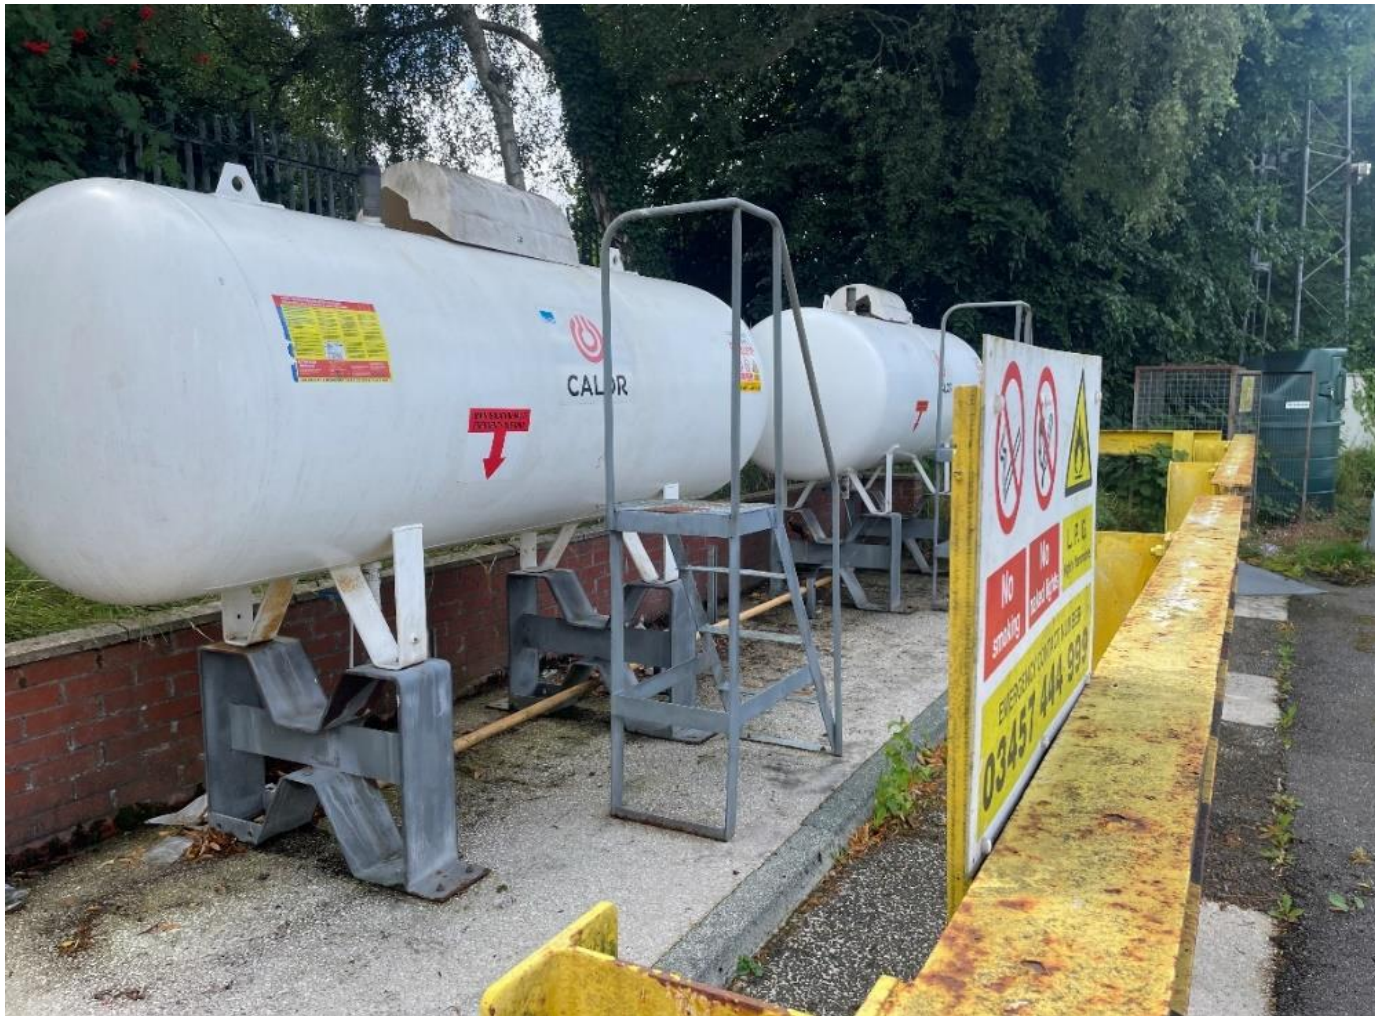
**Photo 25:** 2 No. Propane tanks (appear to be used for filling forklifts), located towards the southern site boundary.

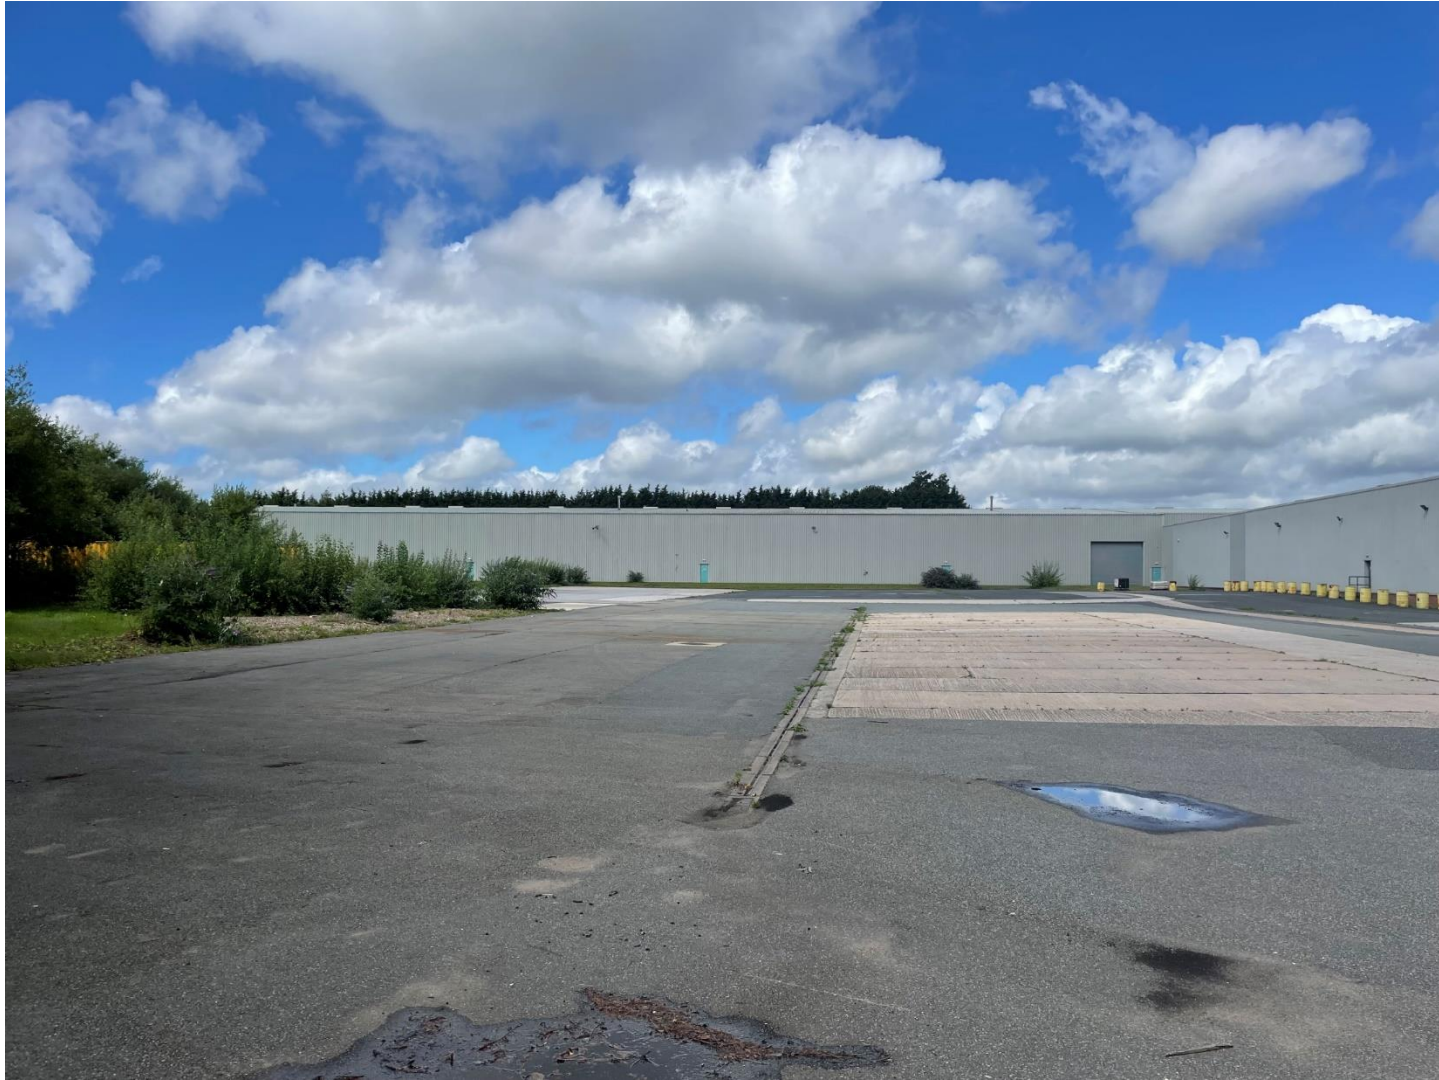
**Photo 26:** View looking north of the yard space area. Soft landscaping area in the left of the photo. Surface water drainage present in centre of hard surfacing.

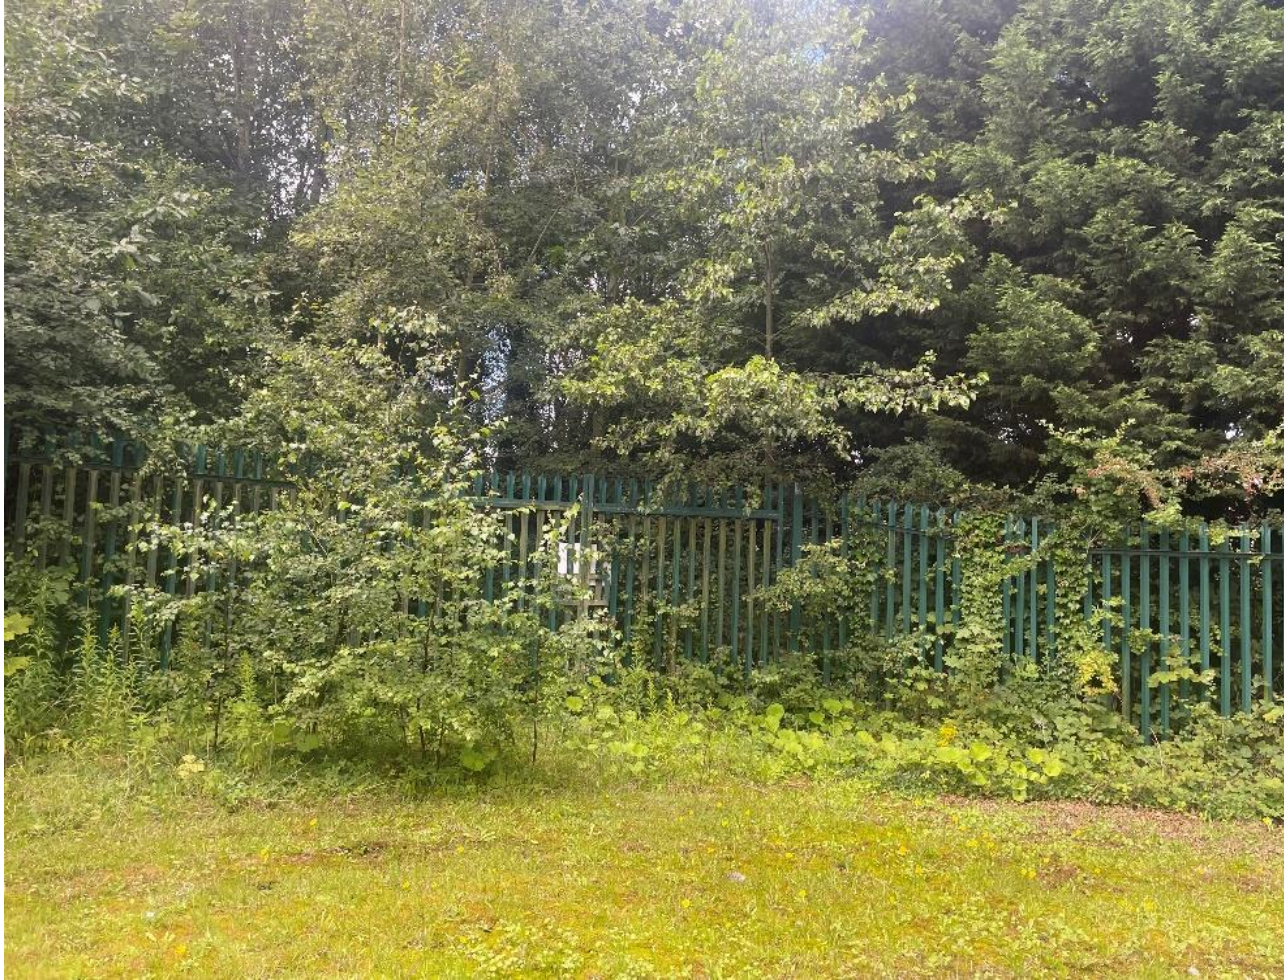
**Photo 27:** Palisade fencing along the western side and overgrown gate at the far west point of the site.

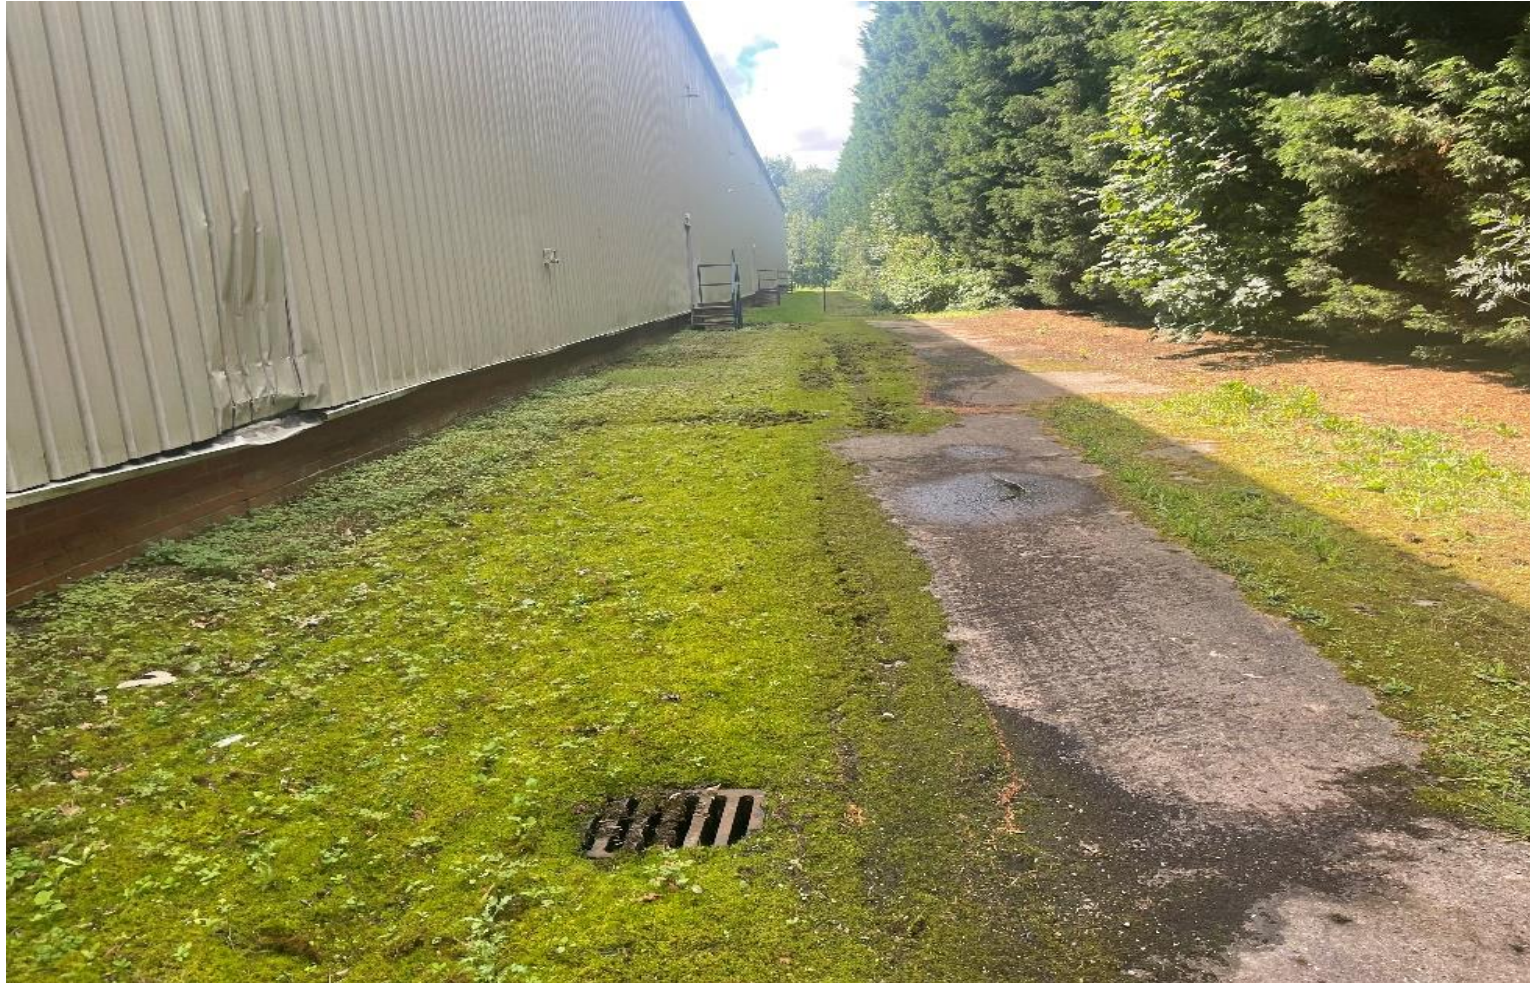
**Photo 28:** Tracking runs between the warehouse and northern site boundary (view is looking west). A surface drain and damage to the warehouse cladding is visible.

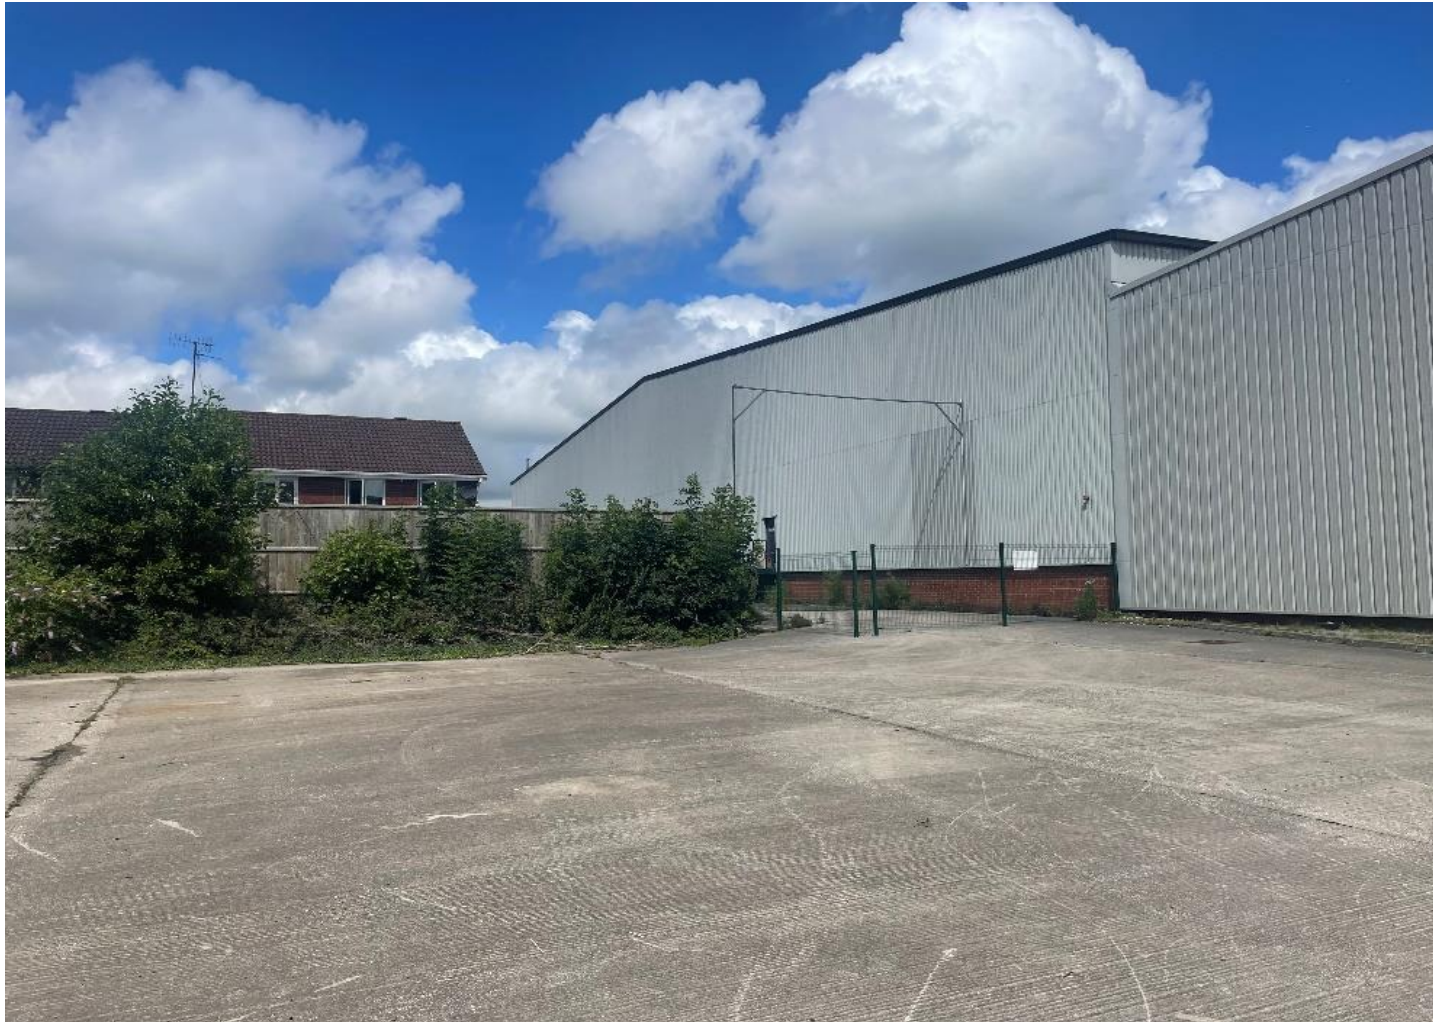
**Photo 29:** View is looking north. Concrete hard surfacing located in northern portion of the site. Access to adjacent sites have been fenced off.

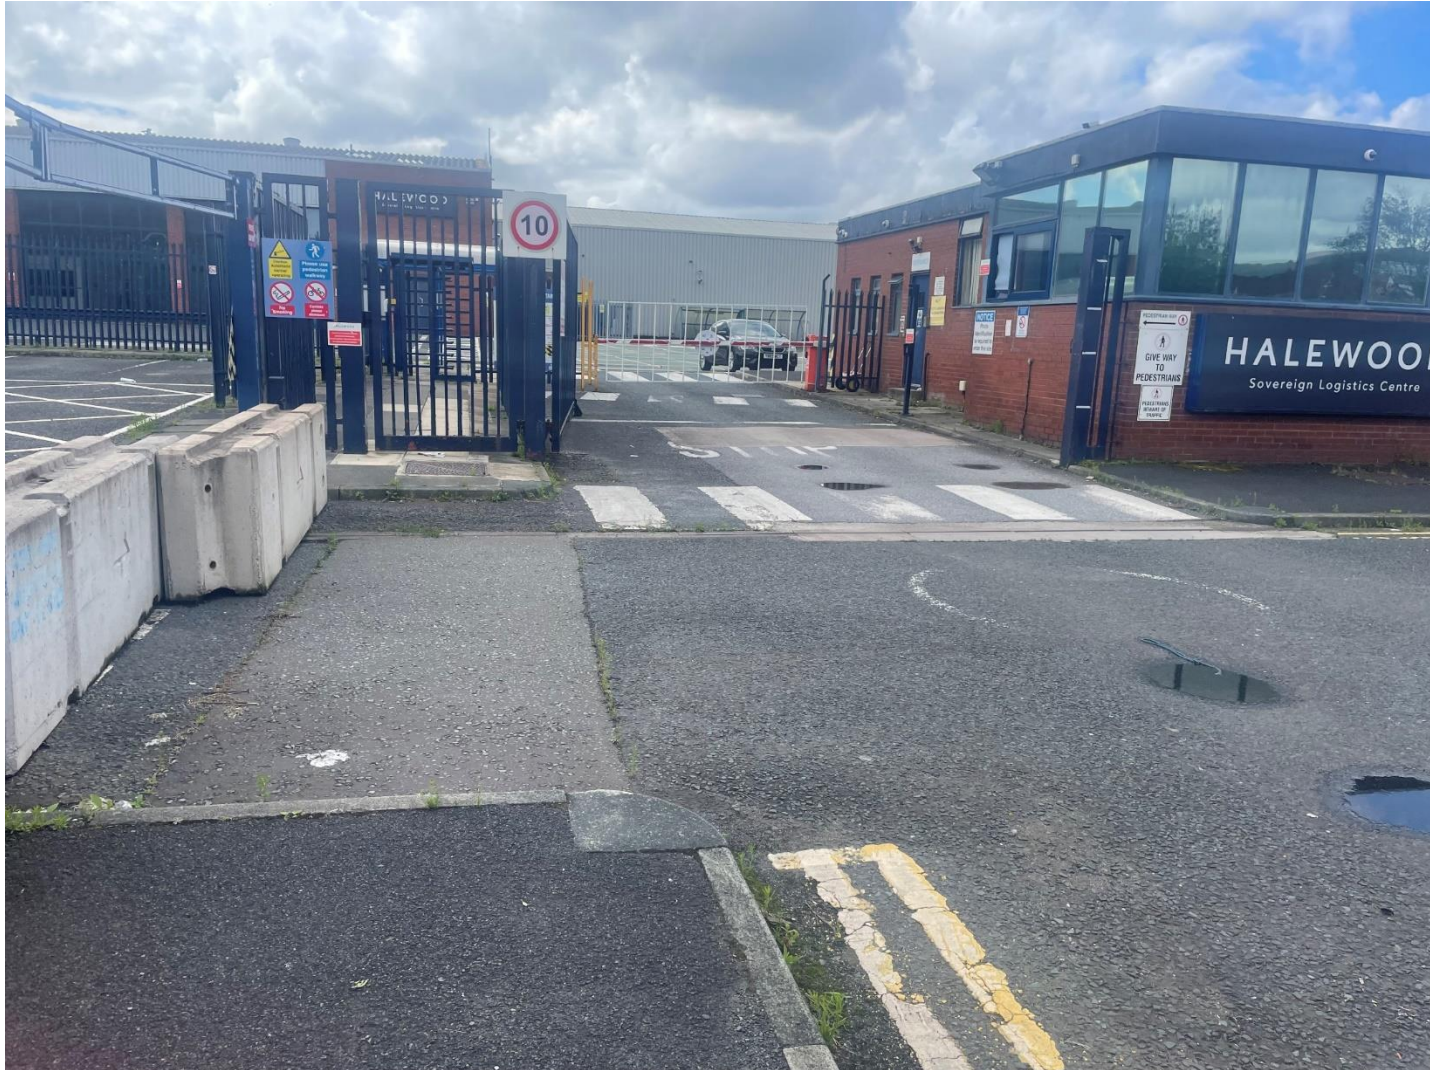
**Photo 30:** Gated access to the main portion of the site. Access to the carpark in the south eastern part of the site has been blocked off by concrete barriers.

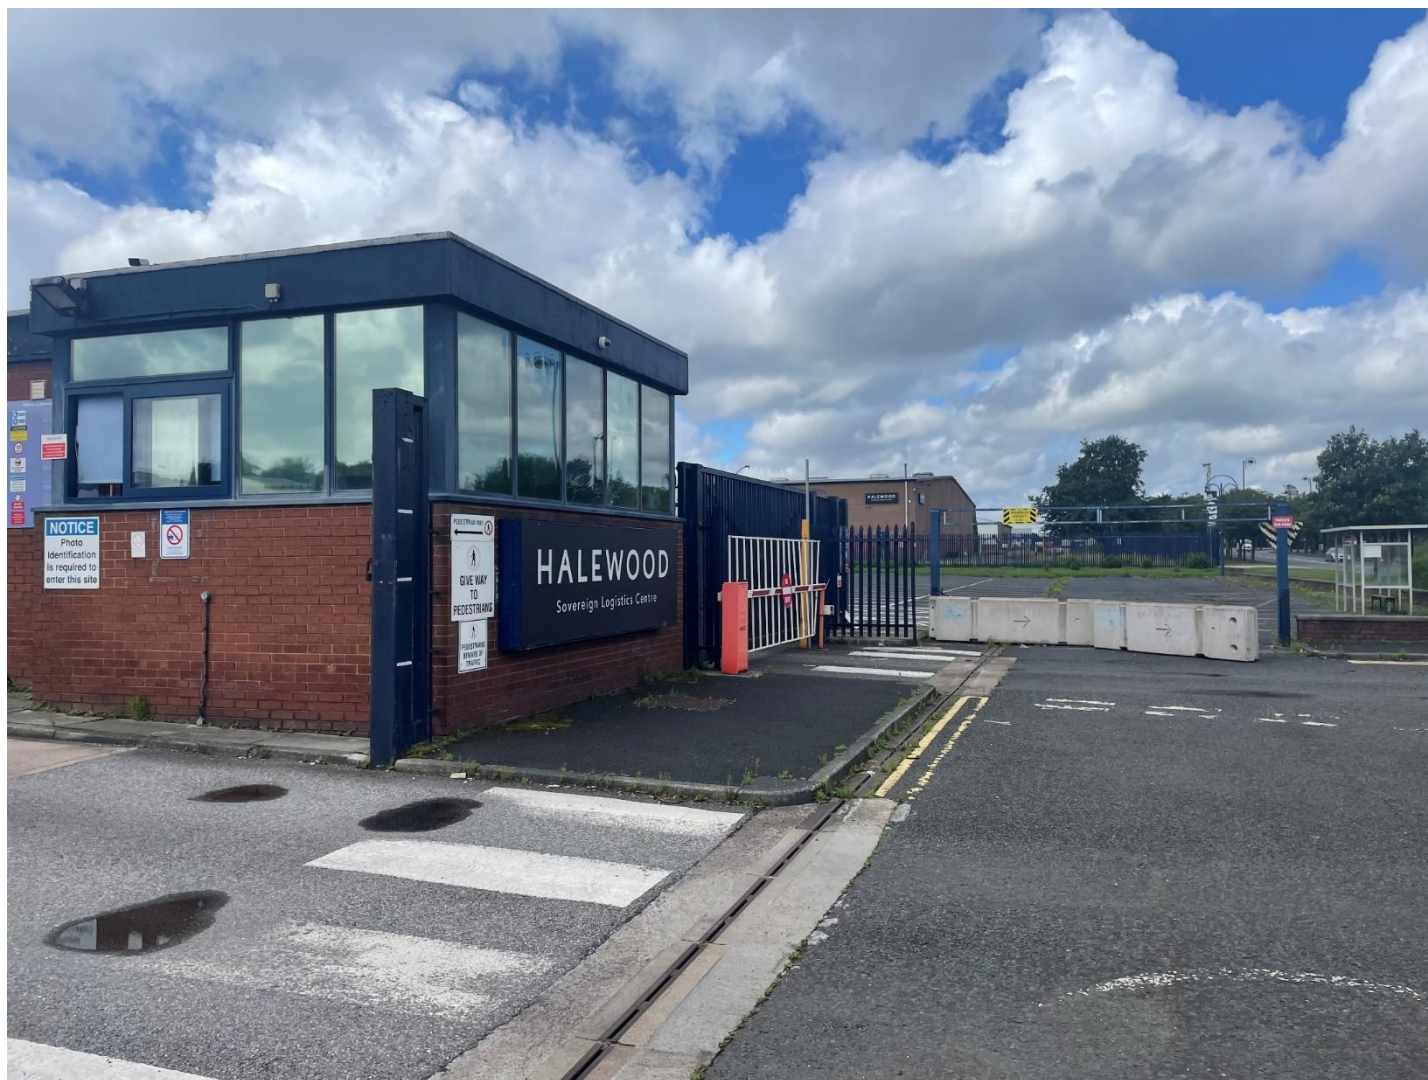
**Photo 31:** Access to the north eastern side of the site has been blocked off by concrete barriers.

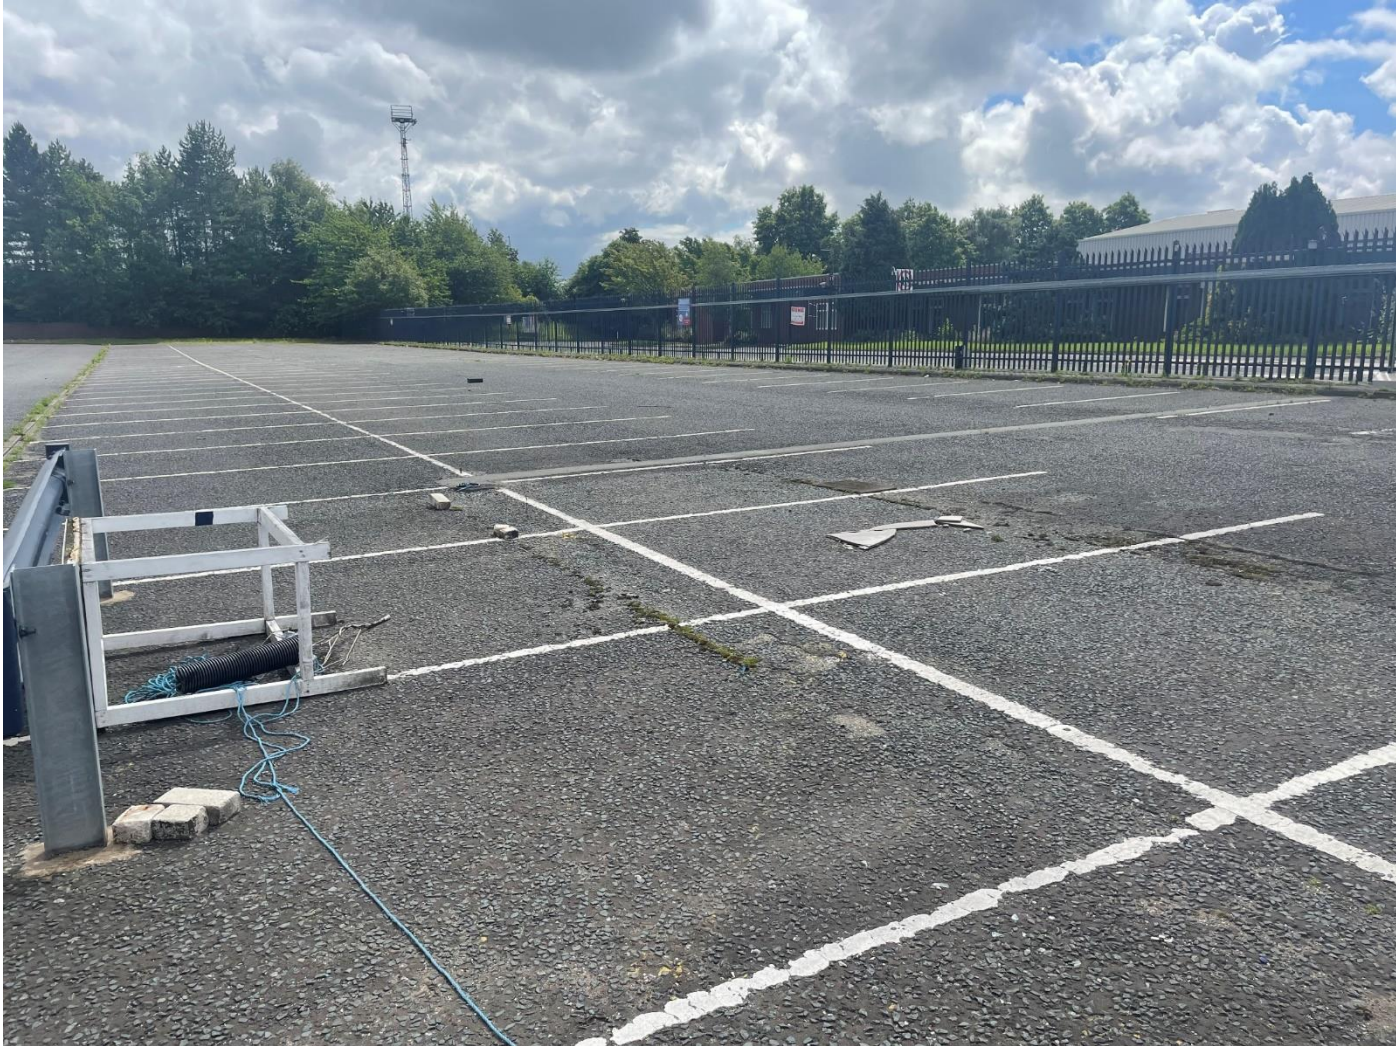
**Photo 32:** Car park in south eastern side of the site, looking south.

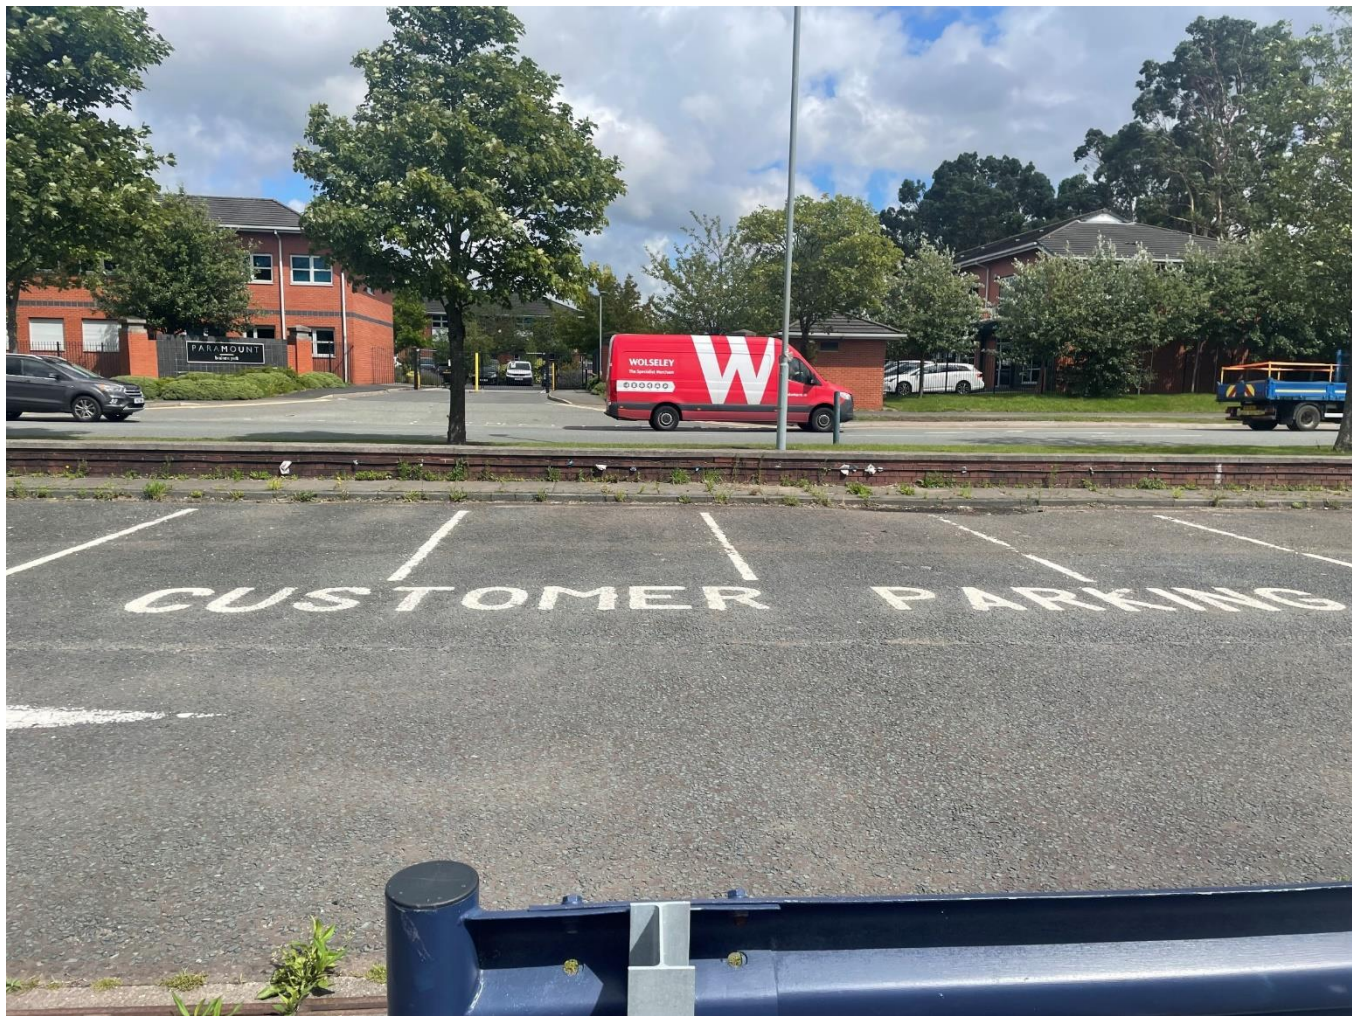
**Photo 33:** Car park in south eastern side of the site, looking east.
