# **BROMODEDECANE SPILLAGE INVESTIGATION, CONTRACT CHEMICALS SITE, KNOWSLEY**

## **1. Introduction**

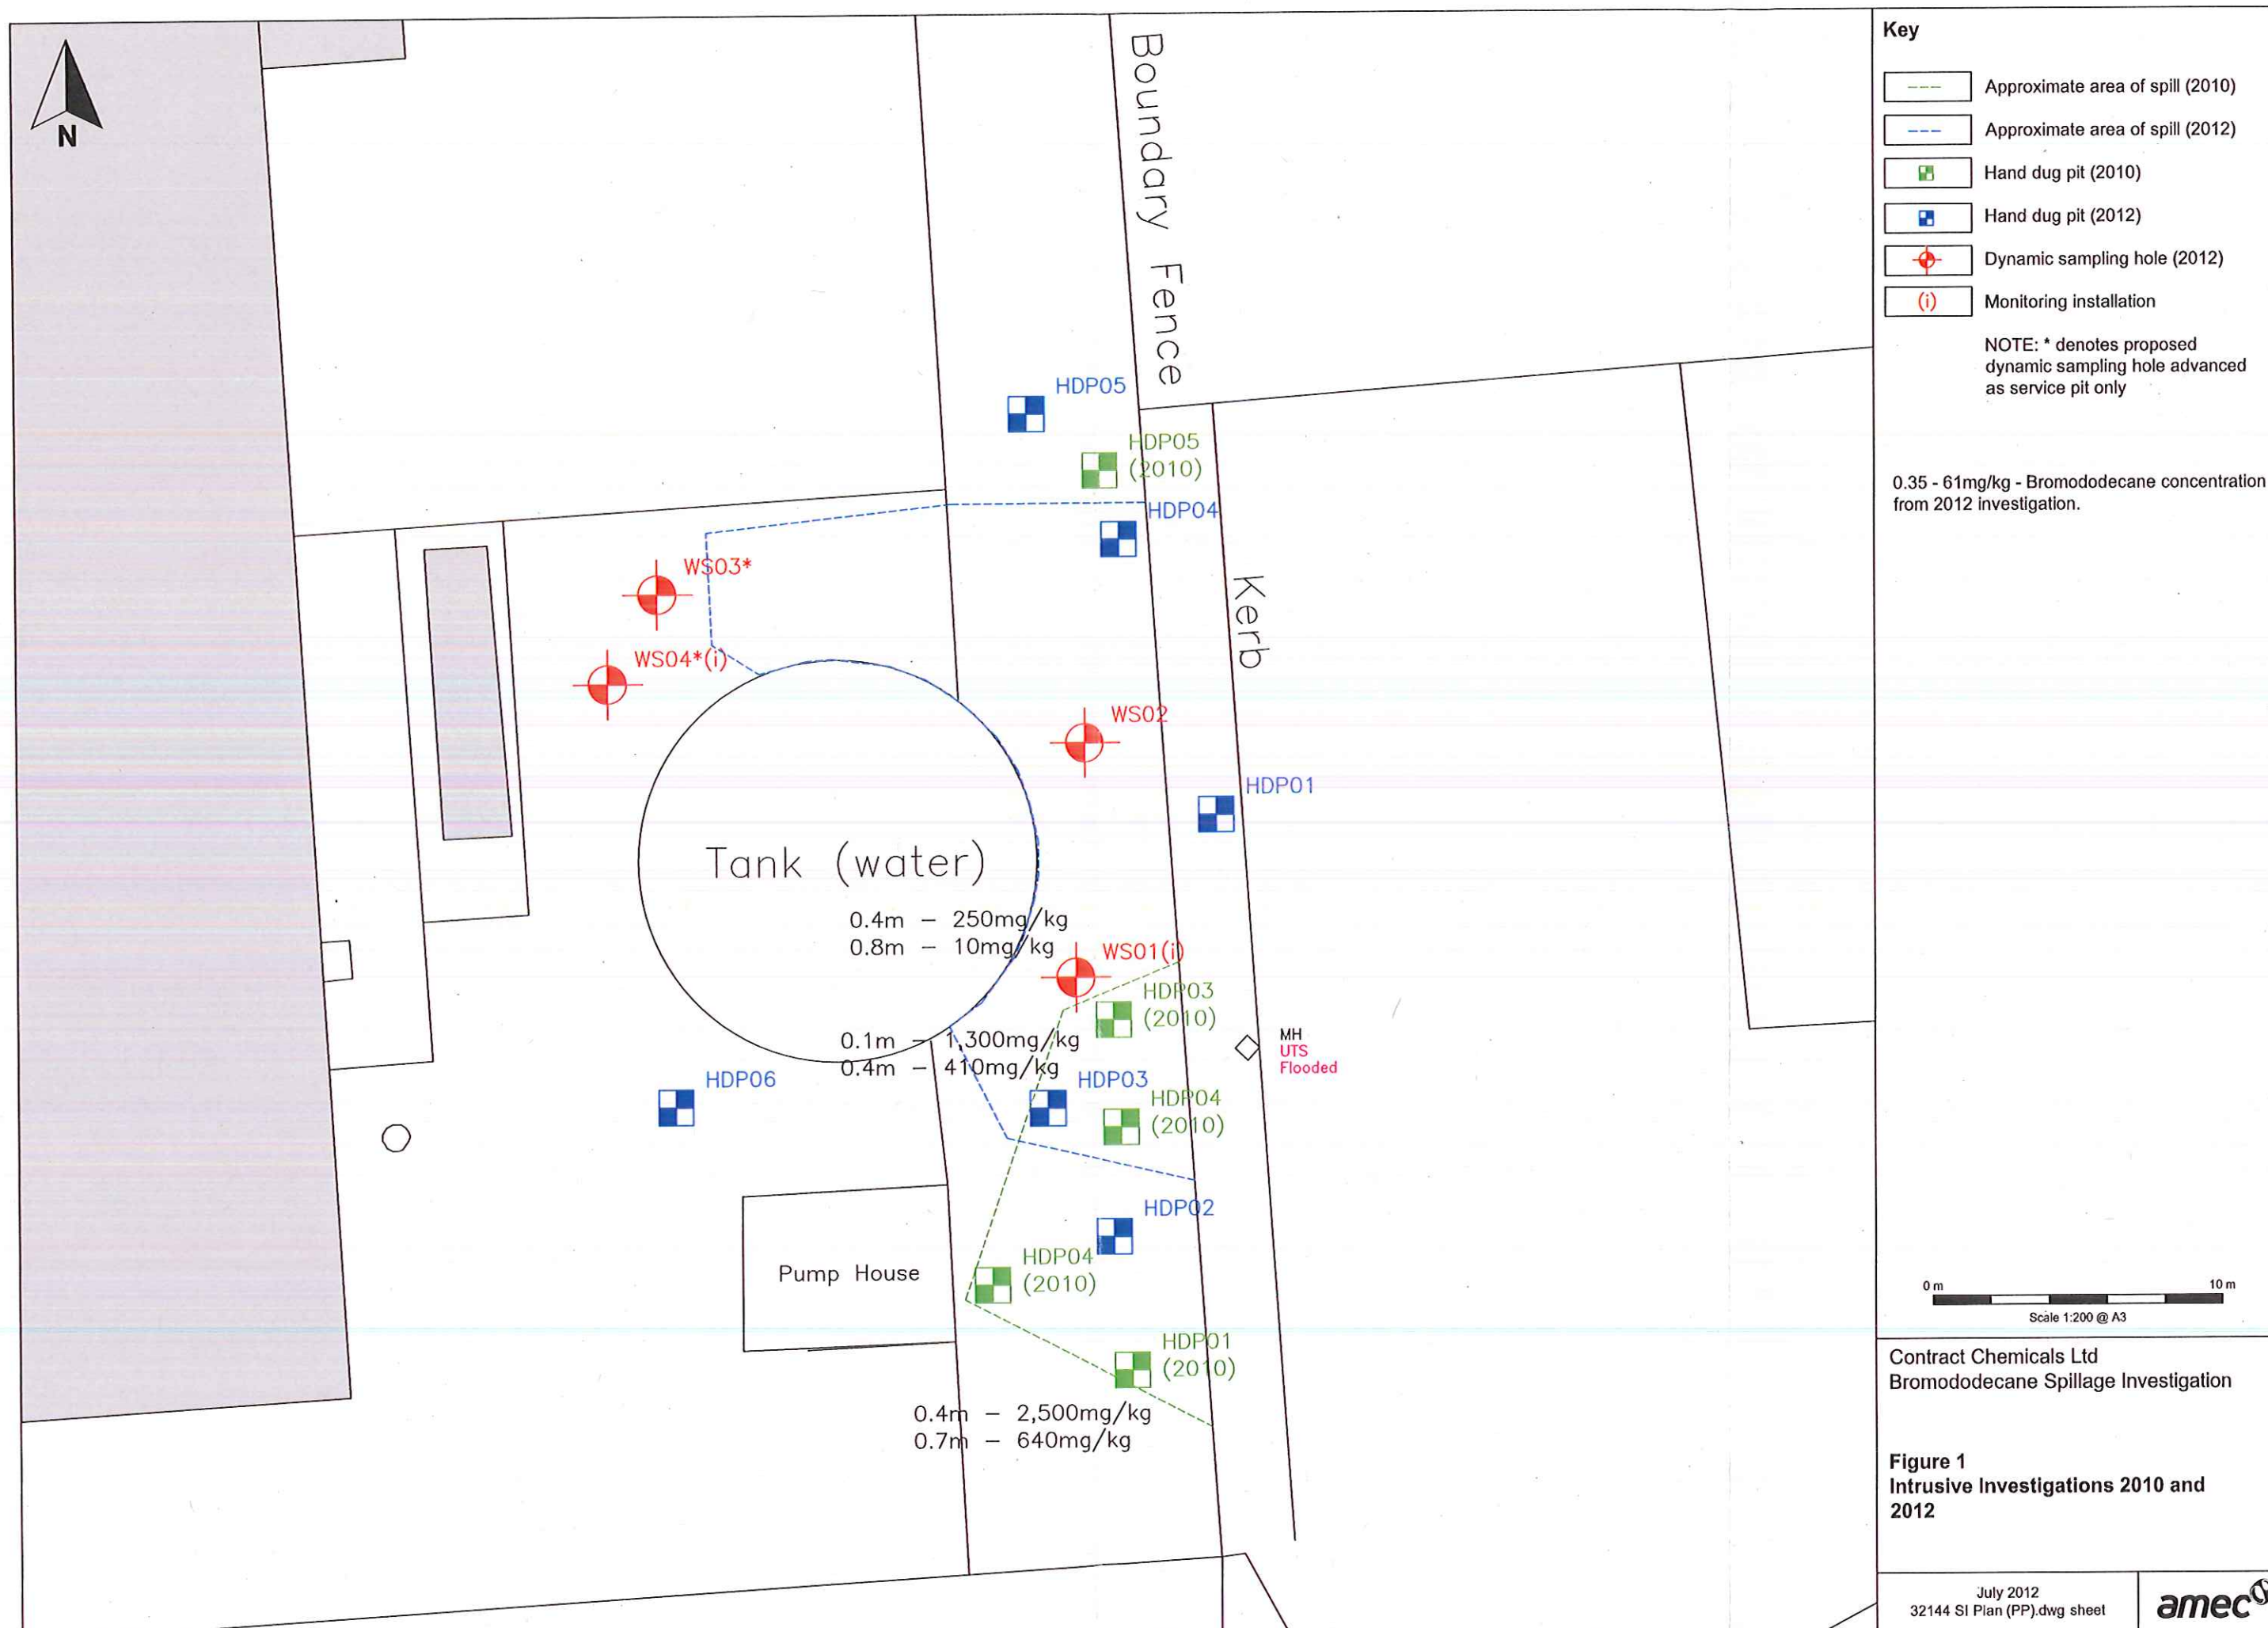
## Figure

A plan showing the exploratory hole locations is provided as Figure 1.

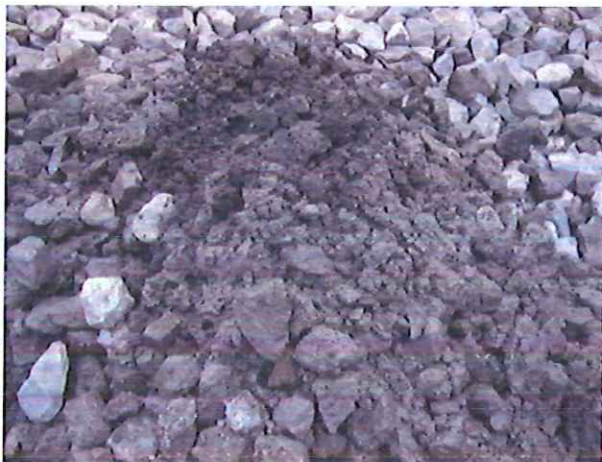
Soil arisings at HDP01 were noted to have a light to strong chemical odour from throughout the exploratory hole (from surface to 0.70m bgl).

Arisings from HDP01

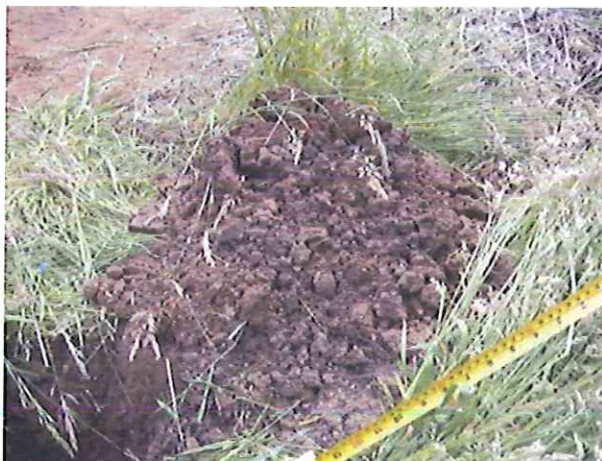
Arisings from HDP02

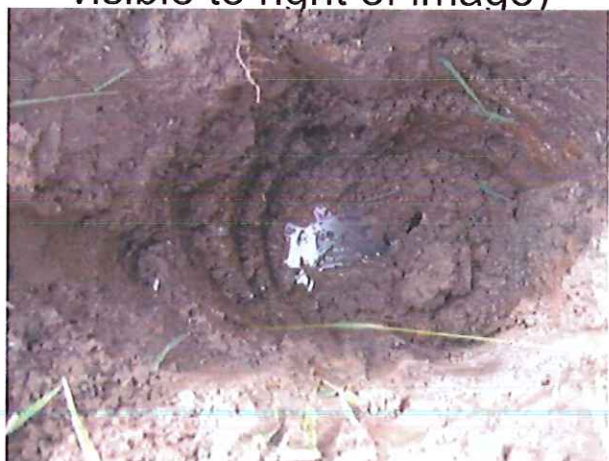
Black plastic ducting was noted at 0.50m bgl in the centre of hand dug pit HDP02, trending approximately north-south. This was considered likely to be associated with the perimeter sensors, however was not identified during service clearance. No damage was done to the ducting during excavation. It was noted that the orientation of the duct appeared to lead directly beneath the marked position of HDP03, which was subsequently repositioned approximately 1m towards the south to avoid damage to the duct. No other exploratory holes were required to be repositioned as a result of the duct.

HDP02 excavation  
(black duct visible)

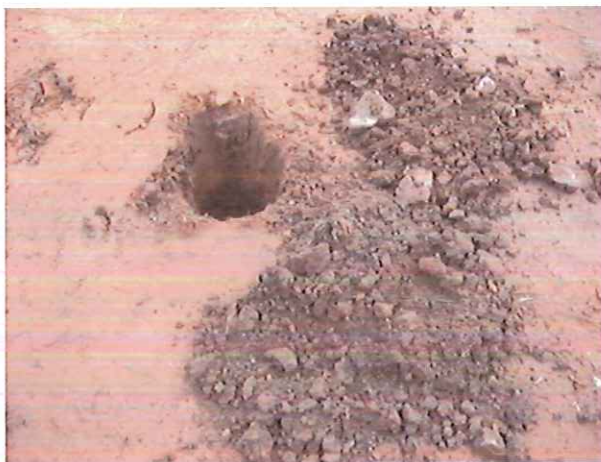
Arisings from HDP03

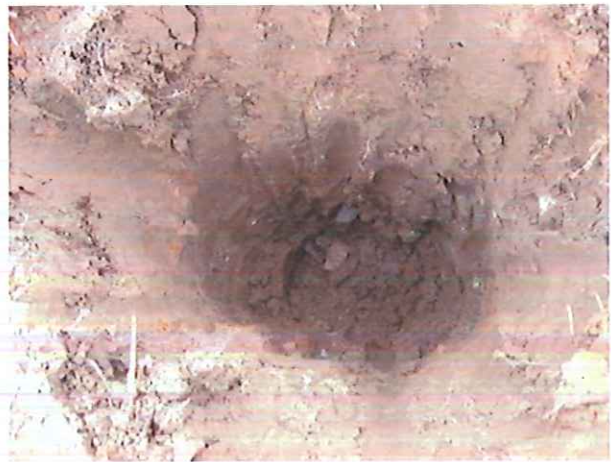
HDP03 excavation

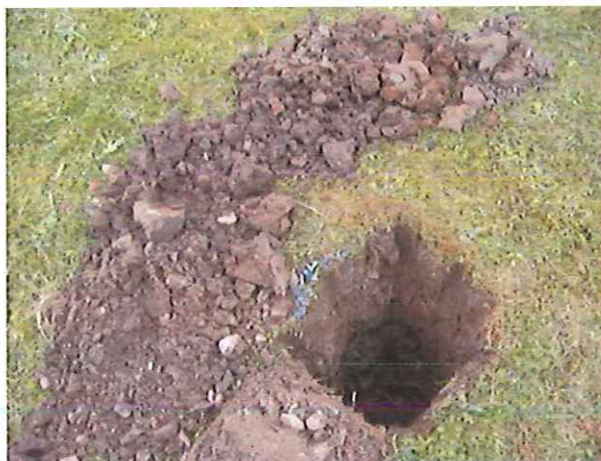
Soil arisings from HDP04 between surface and 0.20m bgl were noted to have a possible chemical odour.

Arisings from HDP04

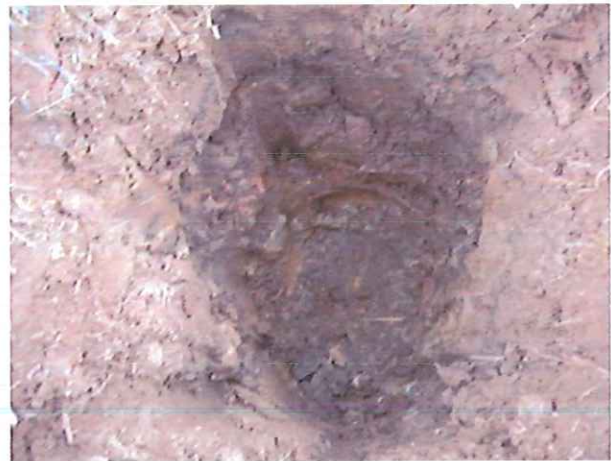
HDP04 excavation

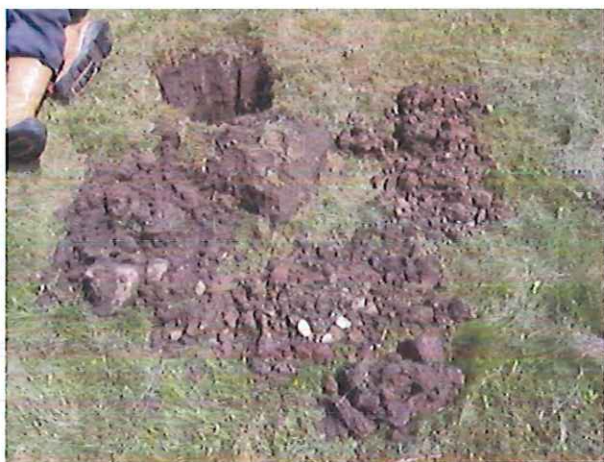
Arisings from HDP05

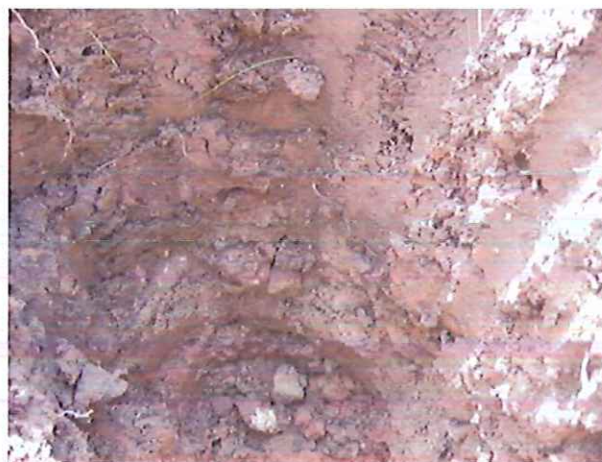
HDP05 excavation

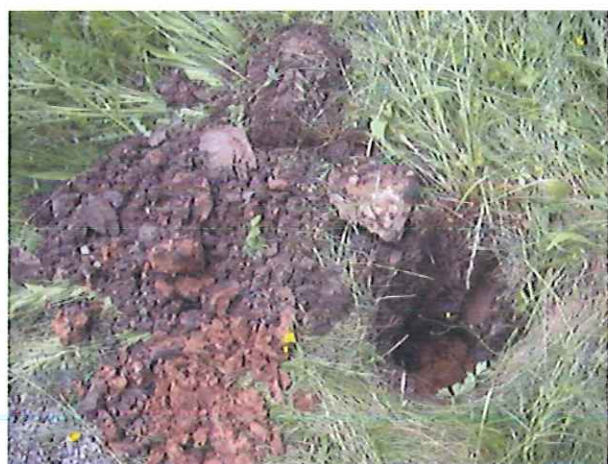
Arisings and excavation  
HDP06

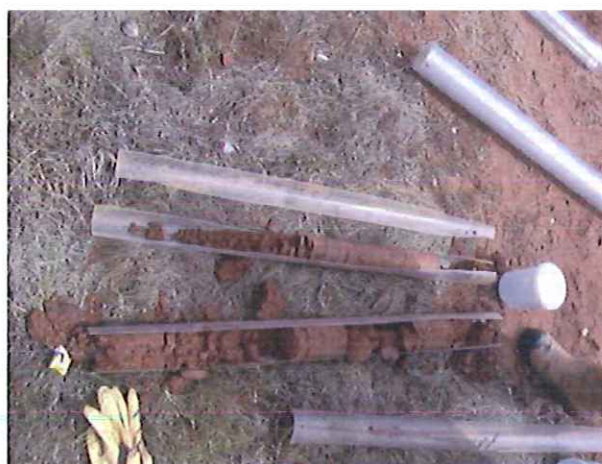
Soil arisings from WS01 taken from between the surface and 0.60m bgl were noted to have a chemical odour.

Arisings from WS01

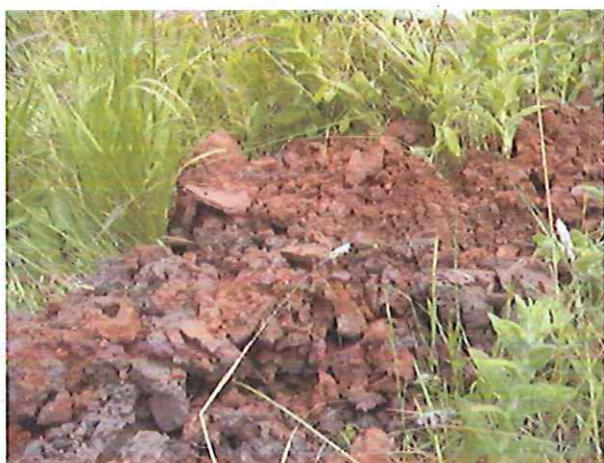
Deep arisings from  
WS01

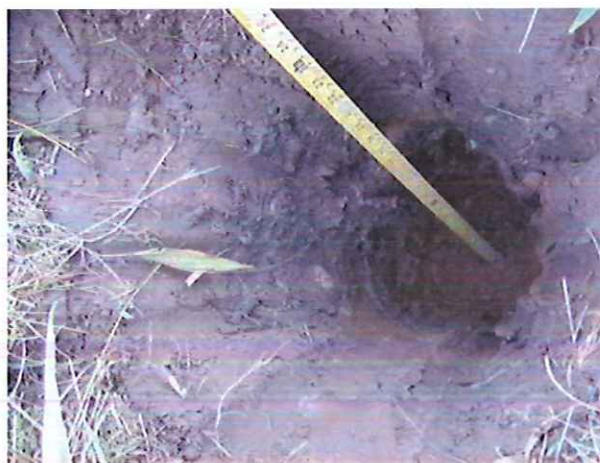
WS01 excavation

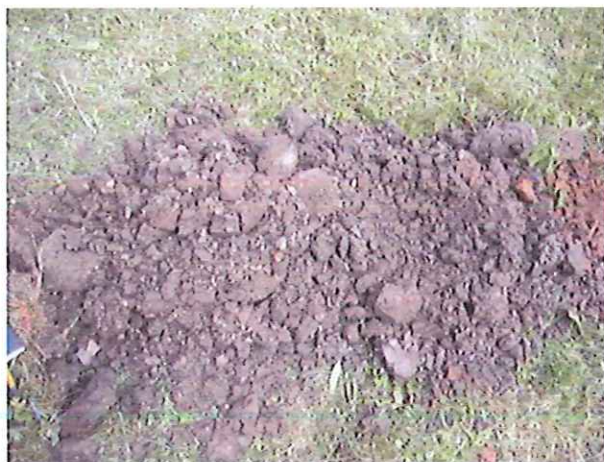
Shallow arisings from  
WS02

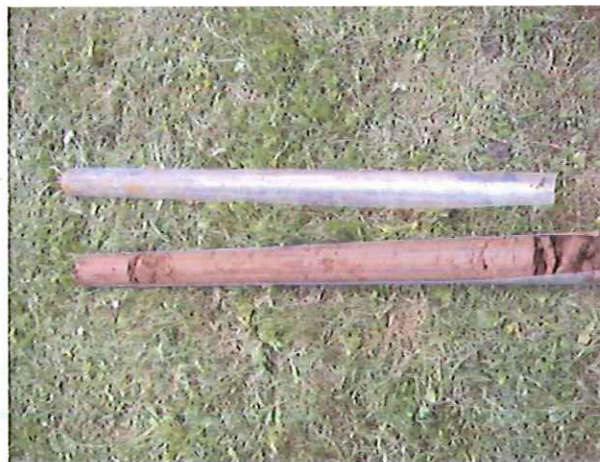
Deep arisings from  
WS02

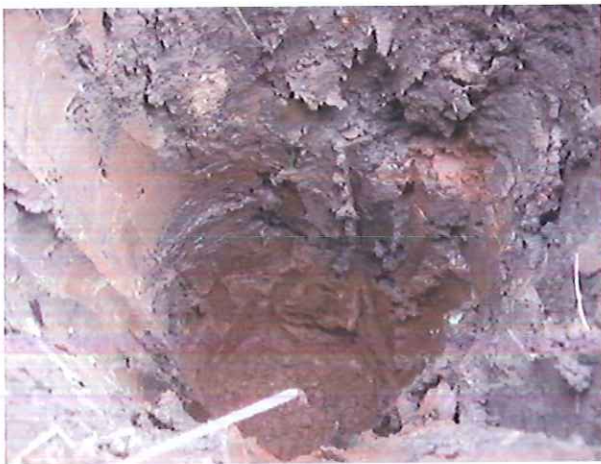
WS02 excavation

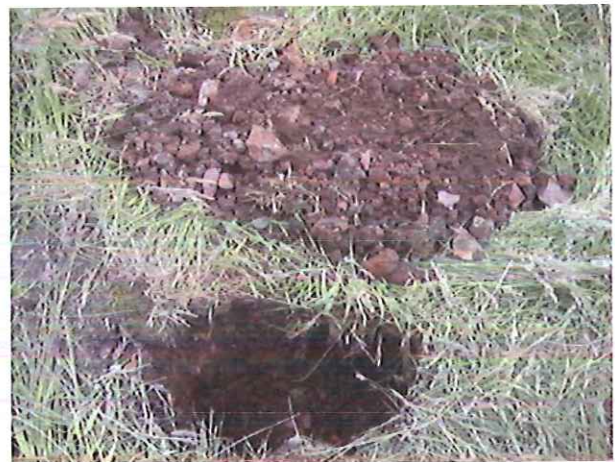
Proposed dynamic window sampling hole WS03 was intended to be installed for groundwater sampling. However, due to ground conditions making hand excavation difficult, the service inspection pit was halted at 0.40m bgl. As the service inspection pit was of insufficient depth, the hole was not advanced by mechanical means.

WS03 excavation and  
arising

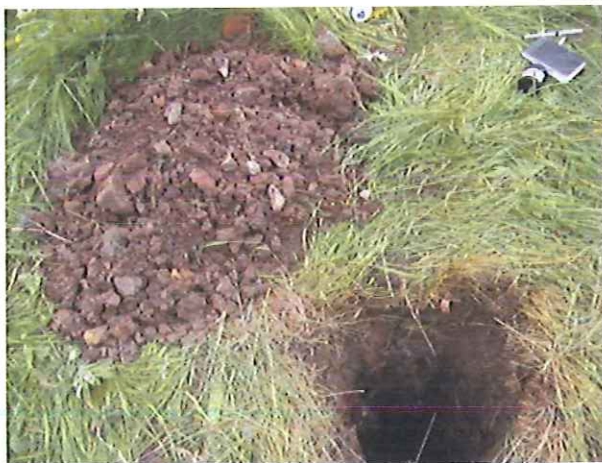
WS04 arising

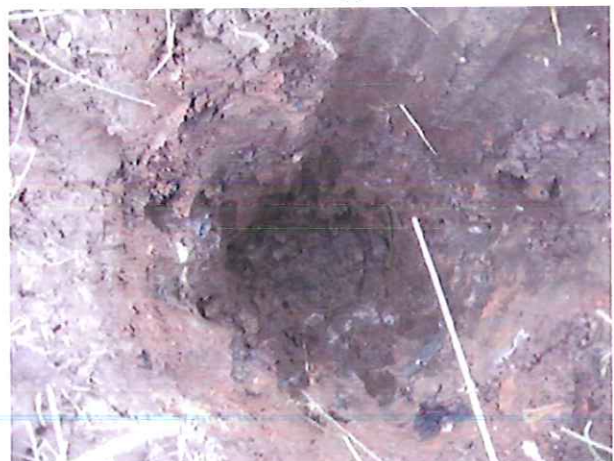
Sampling location WS04 was originally intended to be advanced as a hand dug pit, but following the abandonment of WS03 as a dynamically sampled hole this was selected as a substitute. Ground conditions, although enabling easier excavation than those at WS03, were also difficult and it was not possible to advance the service inspection pit past 0.80m bgl. This was considered to be insufficiently protective to allow for continuation of the hole by dynamic window sampling methods, however, was of sufficient depth to allow the installation of a monitoring standpipe.

WS04 excavation
