# **The Fairways, Westhoughton**

## **Phase 2 Geo-Environmental Investigation Report**

For: Bellway Homes (Manchester) Ltd

Ref: 3430 - 02  
Job: 3430  
Rev: F  
By: AJ

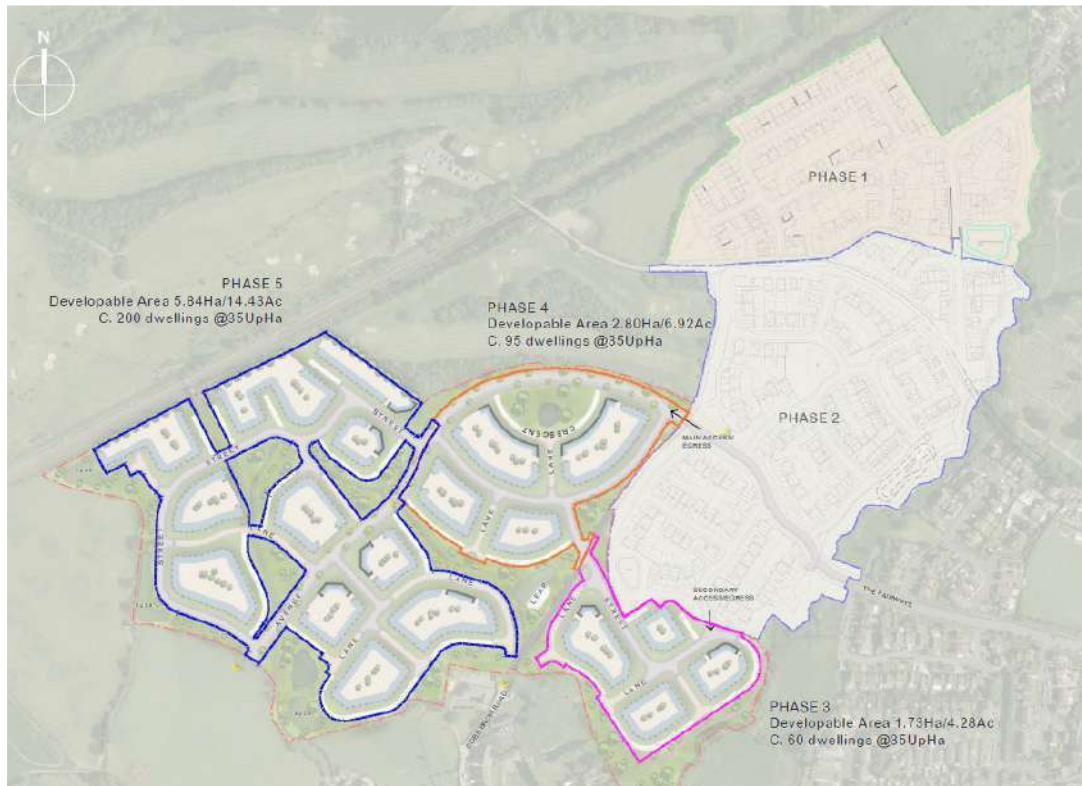
This report pertains to a c. 14Ha site located to the west and east of Dobb Brow Road, Westhoughton, c. 500m south west of Westhoughton town centre. The approximate postcode for the site is BL5 2BA and the National Ordnance Survey Grid Reference for the centre of the site is 364742E, 405757N. The site is part of a wider Bellway Homes development and pertains to Phases 3 – 5 of the masterplan shown below:

Figure 1 - Extract from Bellway Homes drawing 'Westhoughton; Further Phases – Scheme Parameters' (dated: Nov 2020)

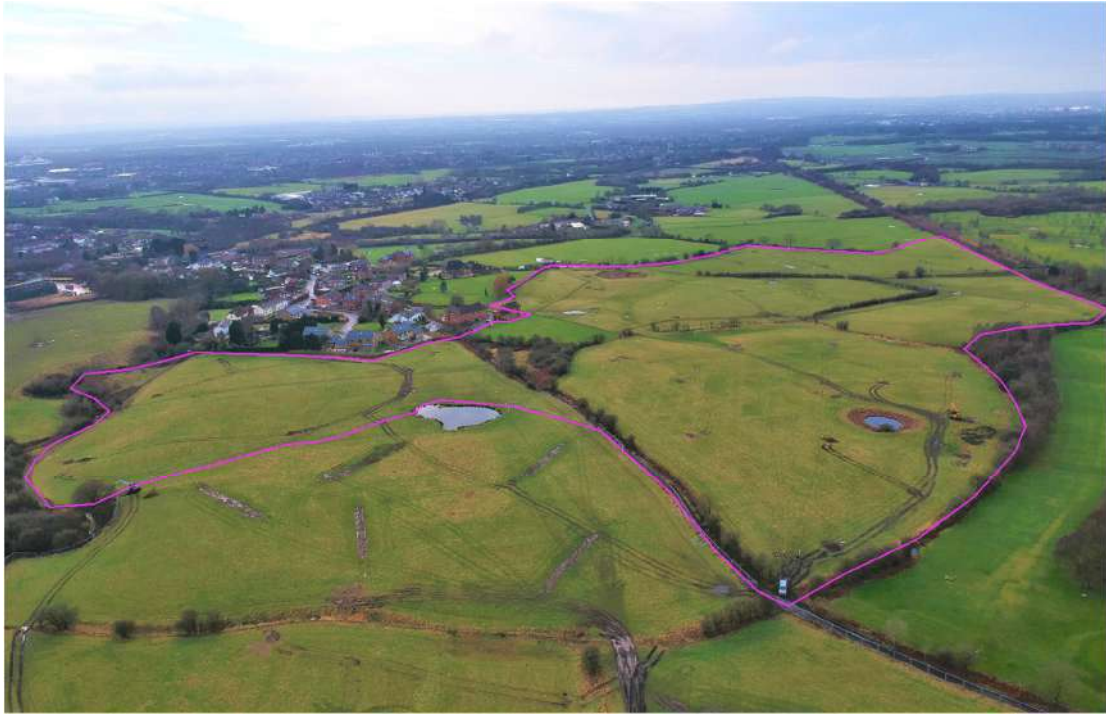
Figure 2 - Aerial image of the site dated February 2021. The site boundary is highlighted in magenta.

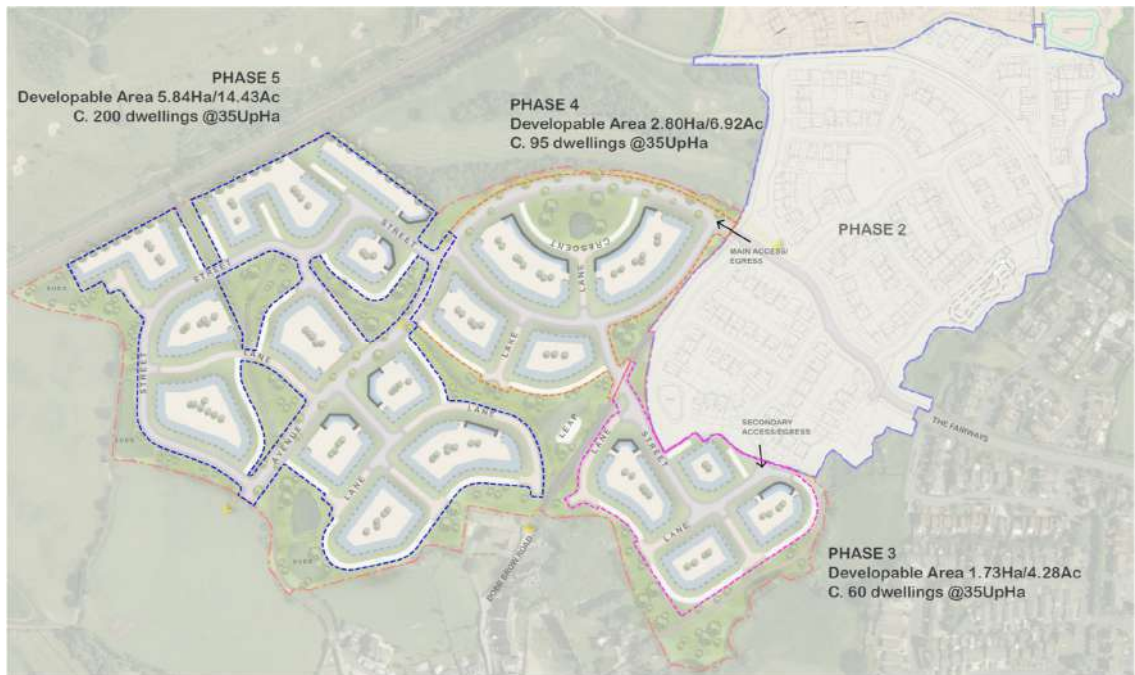
The site investigation works have revealed that the ground conditions at the site were relatively consistent with variation in strata mainly being present within development phase 4. Generally, across the site, the ground conditions comprised topsoil underlain by cohesive glacial till with the exception of phase 4 where granular glacial till was encountered.

Figure 6 – Development Phase Plan for the site.

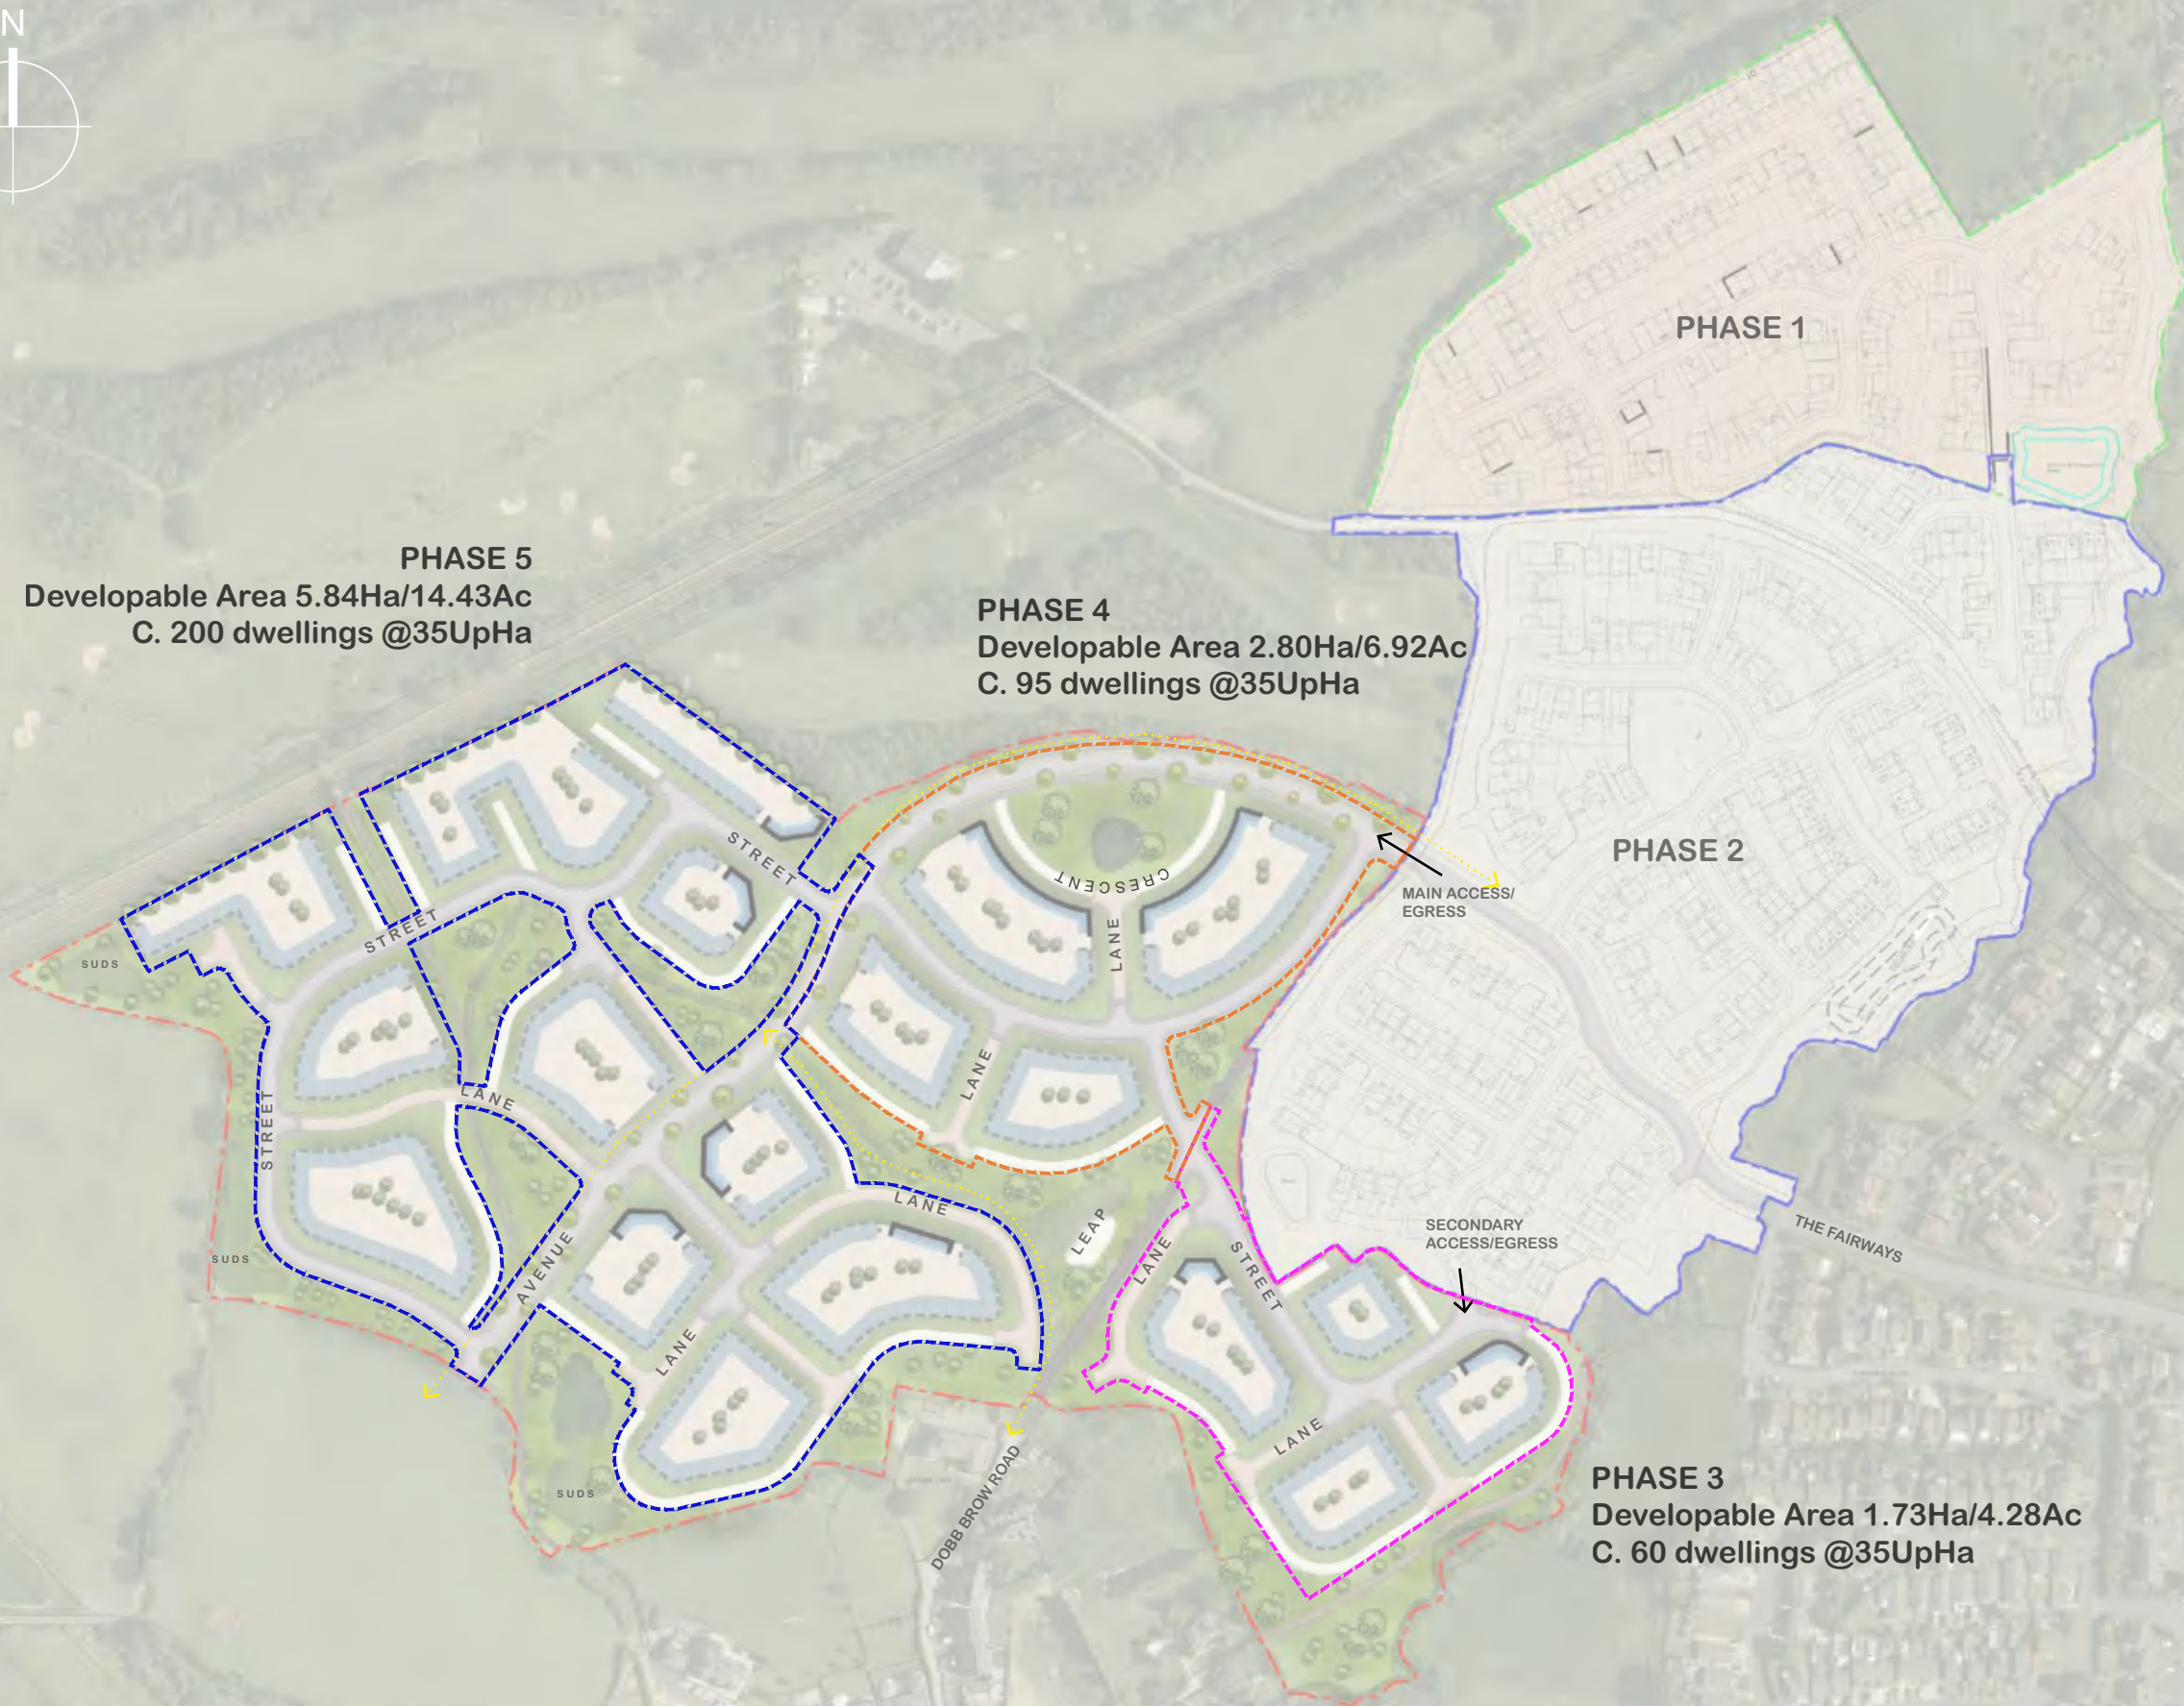
# WESTHOUGHTON

Further Phases - Scheme Parameters

**PHASE 5**  
Developable Area 5.84Ha/14.43Ac  
C. 200 dwellings @35UpHa

**PHASE 4**  
Developable Area 2.80Ha/6.92Ac  
C. 95 dwellings @35UpHa
