# PRELIMINARY ROOST ASSESSMENT AND DUSK EMERGENCE SURVEY REPORT

**Chapel Brook**  
Wilson Road,  
Tarbock Green,  
L36 6AD

| Title: | Preliminary Roost Assessment and Dusk Emergence Survey Report | | | | |

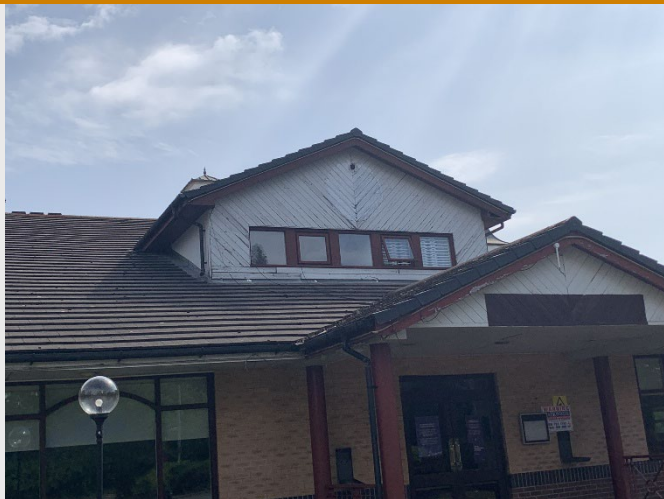
Photograph 1: Western aspect view of Building B1.

- 4.2.1.2 The building is constructed of brick, with a low-pitched tiled roof and several features that could offer potential roosting opportunities. It is currently in moderate condition, exhibiting only minor signs of deterioration and damage.

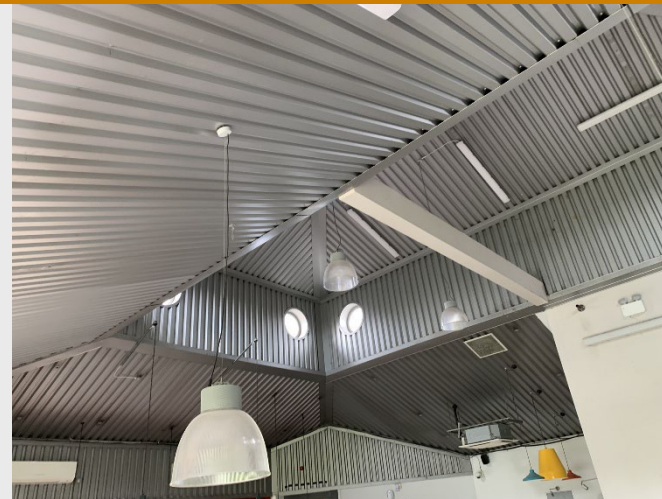
Photograph 2: Internal metal ceilings within B1.

- 4.2.1.7 The internal two-storey building comprises a disused restaurant on the ground floor, including kitchen amenities and seating areas, as well as an indoor children's play space. The children's play area features high metal beam ceilings, while the remainder of the ground floor has flat plaster ceilings.
- 4.2.1.8 The first floor comprises a vacant apartment space in moderate condition, with plaster ceilings throughout.
- 4.2.1.9 The loft spaces contain exposed wooden beams, which could provide potential roosting opportunities; however, no signs of bat activity such as droppings or insect wings were observed during the survey.
- 4.2.1.10 Overall, the building, including the internal loft spaces, was assessed as being in moderate condition.

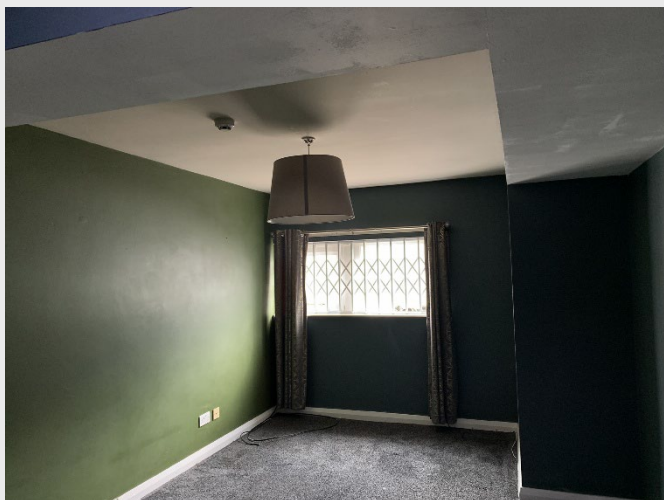
Photograph 3: Example of apartment space on the first floor of B1.

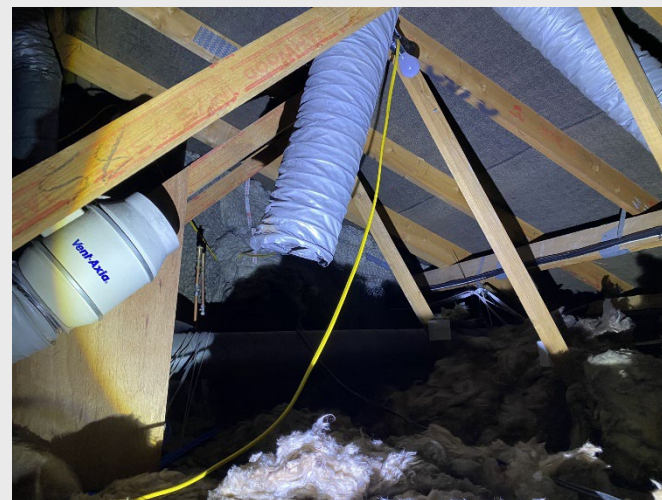
Photograph 4: Example of loft space within B1 with wooden ceiling beams.

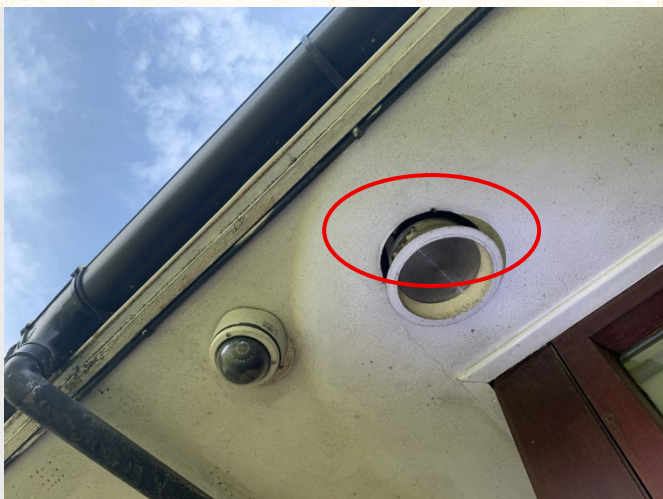
Photograph 5: Damaged light fixture with access into crevice, identified as a PRF.

- 4.2.1.3 Three Potential Roosting Features (PRFs) were recorded during the external inspection of the building, all located along its western aspect.
- 4.2.1.4 The northernmost PRF comprises a damaged light fixture that has partially detached, leaving an opening into the soffit board it is mounted to.

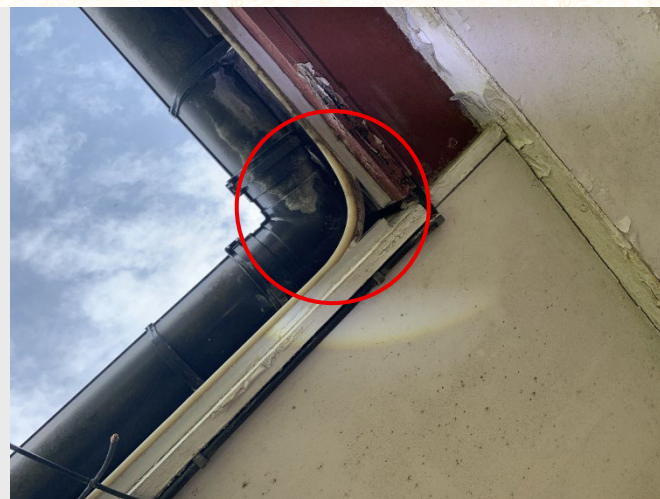
Photograph 6: Gap in-between soffit board of B1 with access into crevice, identified as a PRF.

- 4.2.1.5 A PRF was also noted at a gap between a corner fascia board and the guttering. Although inspection was limited by the height of the feature, it appeared to provide access to a small crevice within the soffit board.

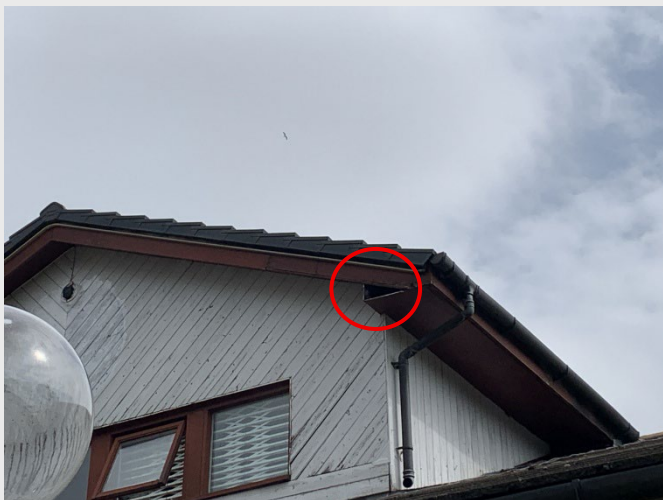
Photograph 7: Gap in roof gable verge, identified as a PRF

- 4.2.1.6 The southernmost PRF is located at the roof's gable end, where a gap in the gable verge offers access into a potential crevice.
