## GeoEnvironmental Investigation

Brook Hey Drive, Kirkby

**Report Ref: A3677/20**

**SEPTEMBER 2020**

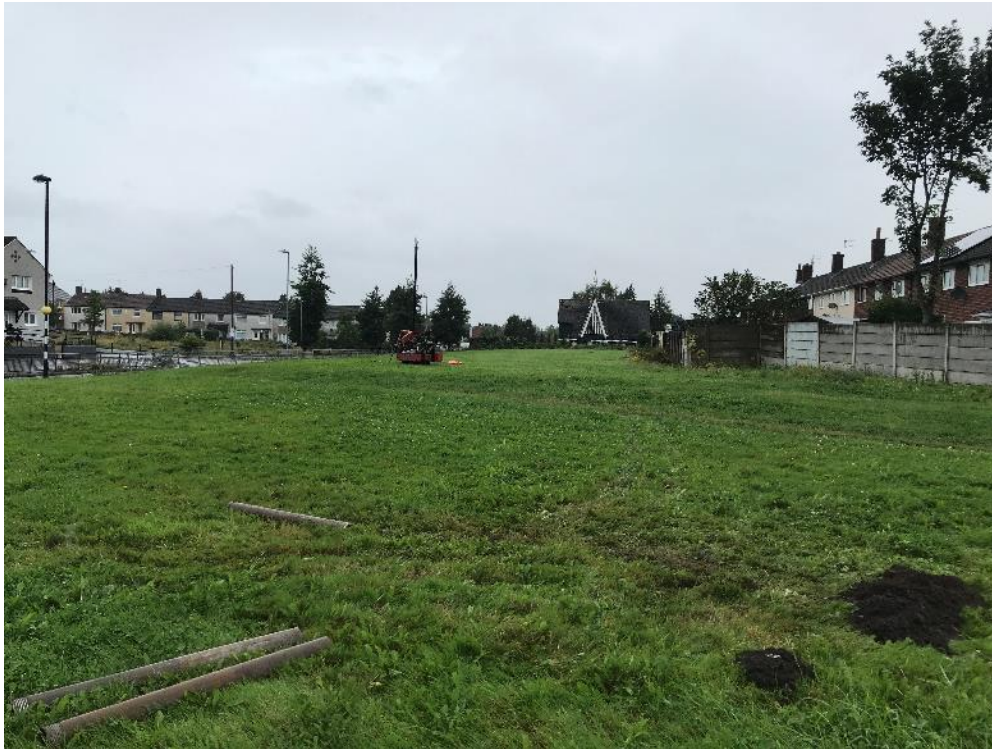
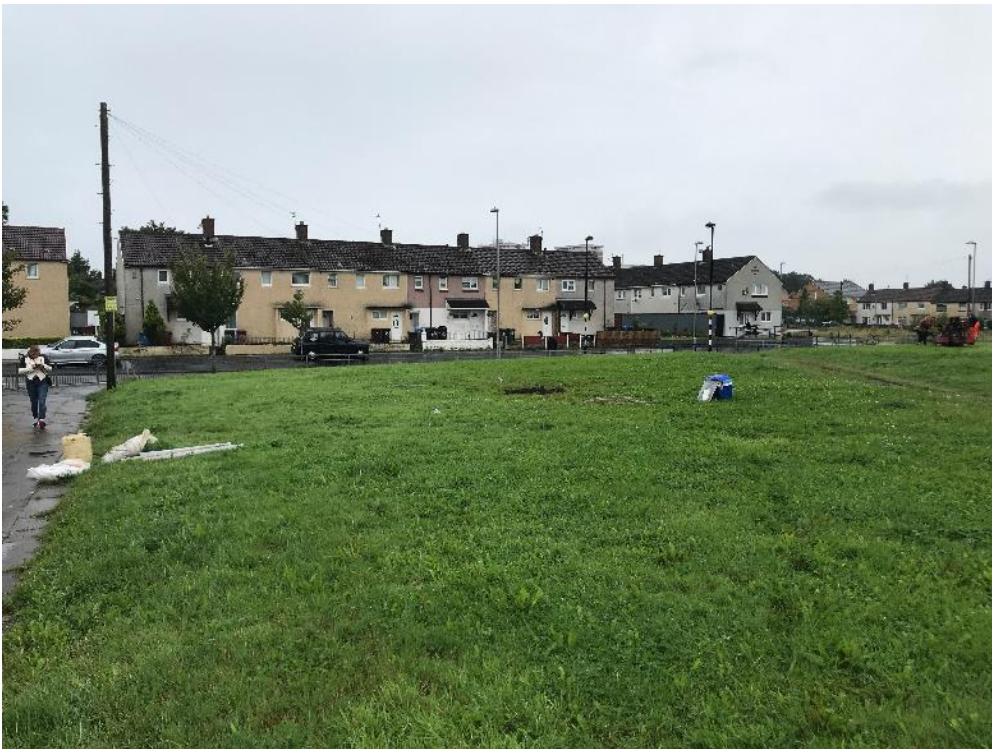
**Figure 2: General Site Photographs**

Photograph taken looking across site looking east

Photograph taken across site during the ground investigation looking south

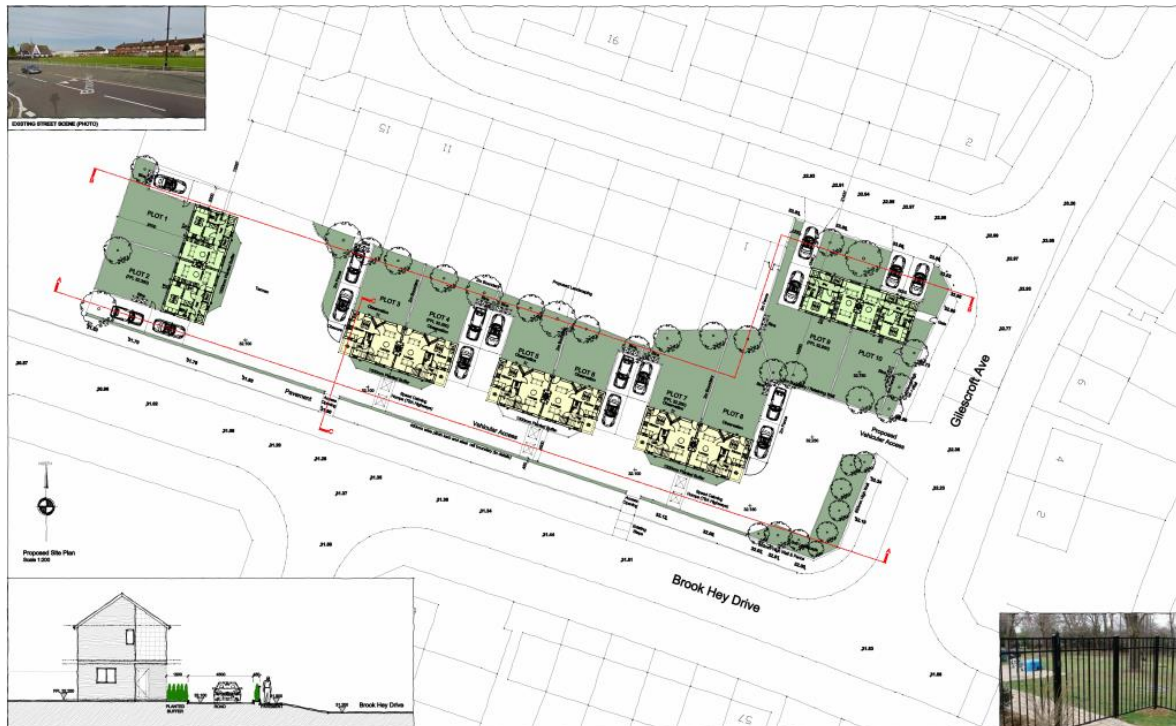
**Figure 3: Proposed Development Plan**

It is understood that the Client intends to build 10no. semi-detached residential properties on site with associated soft landscaping and parking. Access will be provided via Gilescroft Avenue.

The proposed development layout details are shown in Figure 3 below.

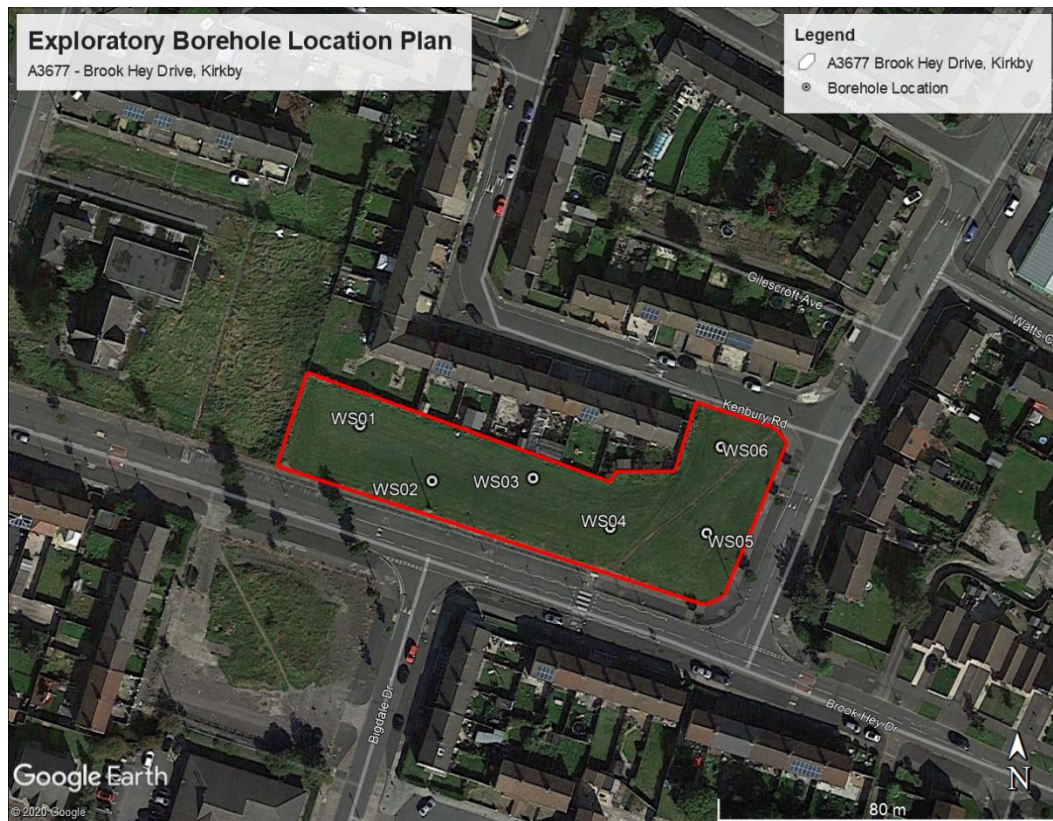
**Figure 4: Exploratory Hole Location Plan**

An Exploratory Hole Location Plan is presented as Figure 4, overleaf.
