21 Huyton Church Road,  
Huyton

Ecological Scoping Survey

22<sup>nd</sup> August 2021

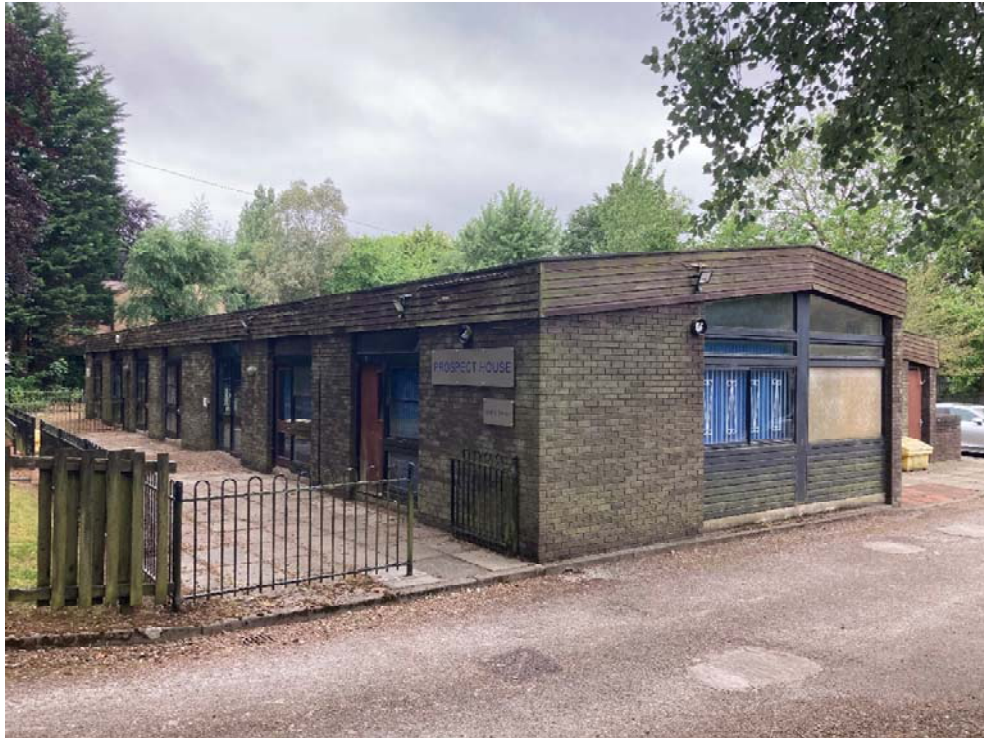
The main building at the site (Prospect House) is a modern, single storey office building. It is constructed of brick and has a shallow pitched roof clad in mineral felt.

No obvious potential bat roosting habitat was identified associated with the building. Therefore, the building is considered to be of 'negligible' suitability for roosting bats

*Photograph 1- View of Prospect House*

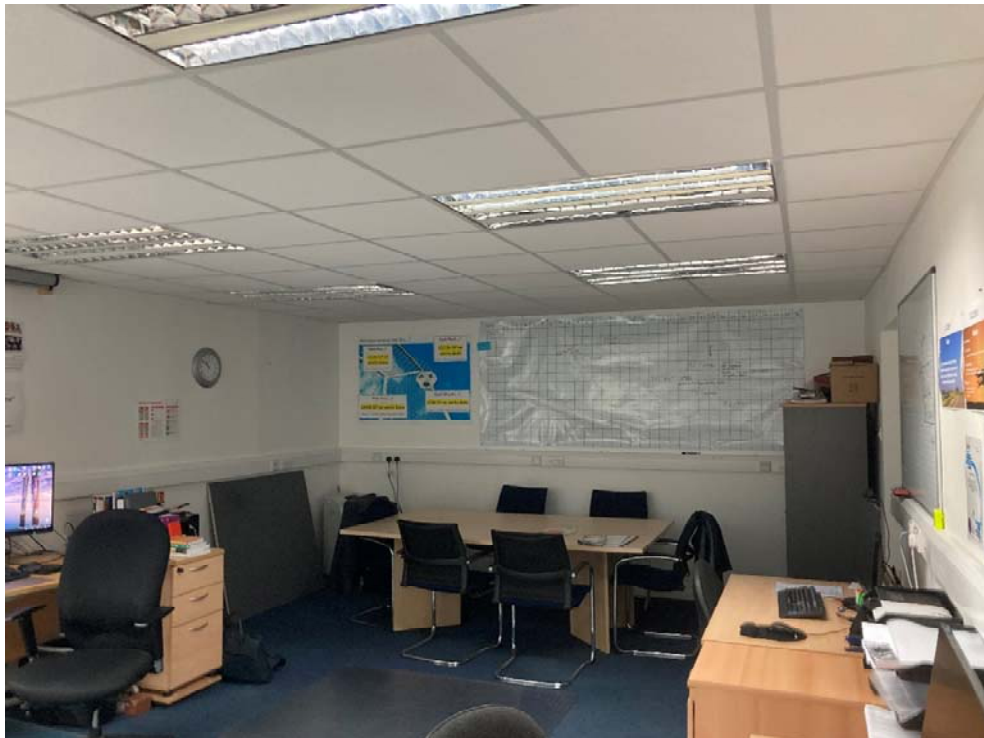
The building is still in active use as an office. The building does not have any separate roof void and the interior of the building is brightly lit and suffers frequent disturbance. The interior of the building is considered to be unsuitable for roosting bats.

*Photograph 2- Interior of Prospect House*

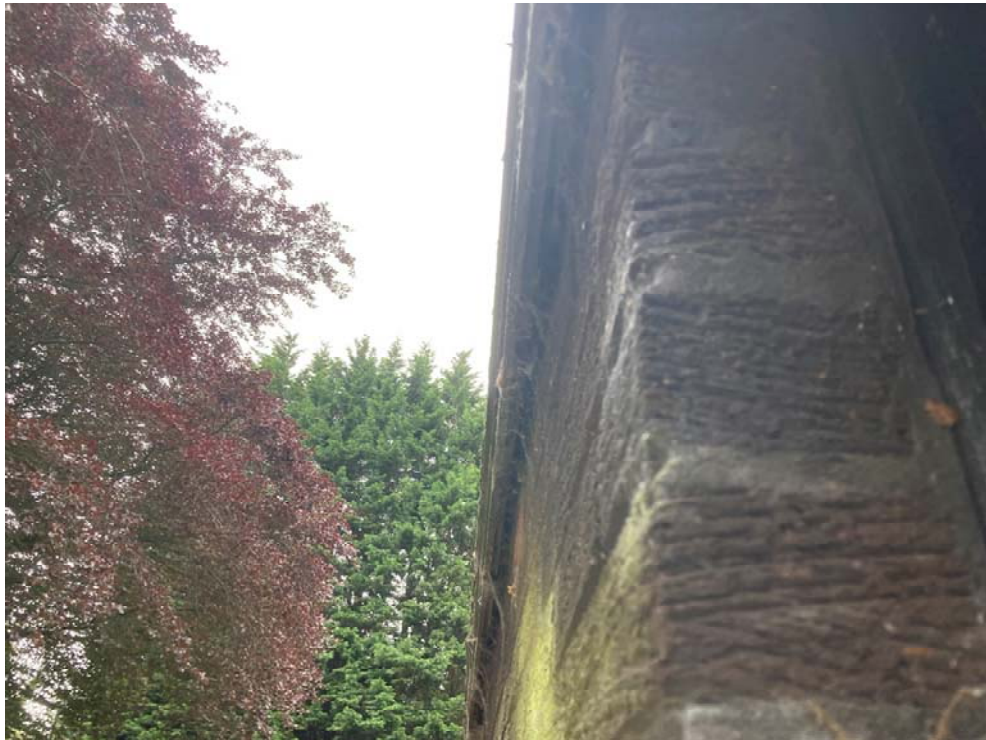
Externally, the building has a short parapet which extends above the height of the felt roof. The building has a band of wooden cladding (approximately 0.75m in width) running beneath the roof. There is a 2cm-wide crevice running beneath the cladding which extends back approximately 4cm before becoming closed off. The crevice was inspected with a torch and is considered to be of limited suitability for bats. Furthermore, it was observed to be cobwebbed over along its full length.

The office building is generally well sealed and in good condition with no obvious access points to the building's wall cavities. The building has a flat roof and does not have a loft void. Externally, there are some shallow crevices beneath areas of wooden cladding however, these were observed to be cobwebbed over. No other obvious potential bat roosting features were identified.

*Photograph 3- Cobwebbed crevices under wooden cladding*

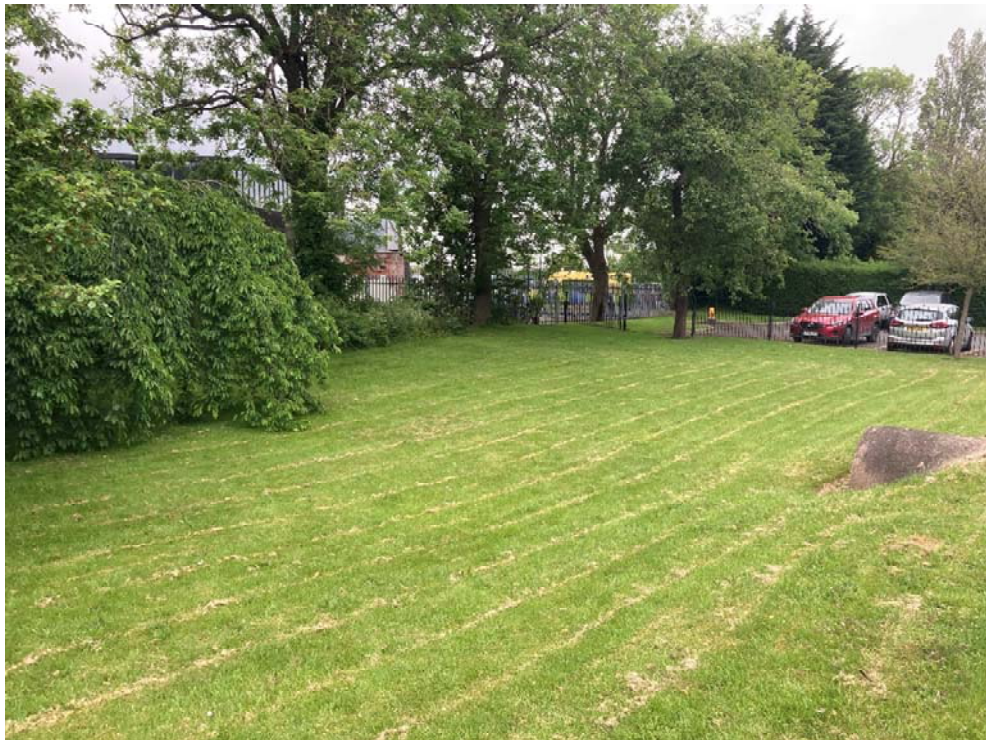
| Target Note | Description |
|---|---|
| 2 | There are areas of mown amenity lawn surrounding the office building and the carpark. The rear of the site comprises of an area of lawn which has previously been used as a play area with concrete piping present for children to play in. Plant species within the lawn area include Yorkshire fog, annual meadow grass, rough meadow grass, sweet vernal grass and water bent with typical herbs including cat's ear, creeping buttercup, common ragwort and daisy. There are scattered ornamental trees around the lawn area including semi-mature pear, apple, cherry and hawthorn. |

*Photograph 4- Habitats at Target Note 2*

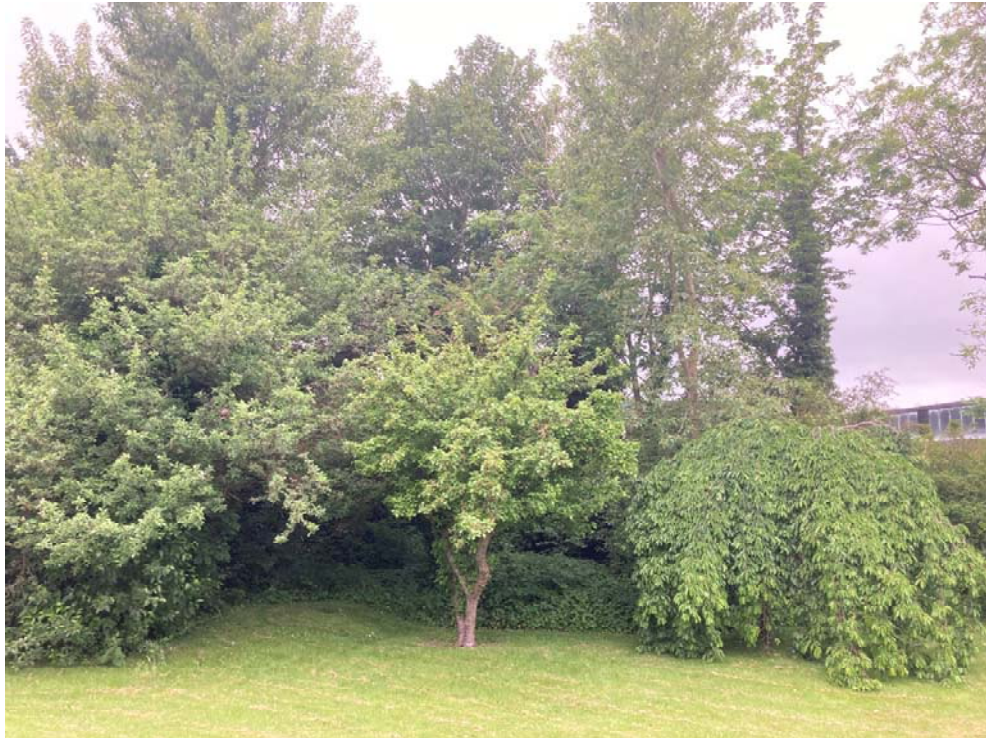
| Target Note | Description |
|---|---|
| 3 | There is a band of ruderal vegetation and scrub/shrubbery with trees at the western corner of the site comprising of willow, sycamore, hawthorn and elm saplings with privet, rose and bramble. Ruderal species include cow parsley, cleavers, nettle, ivy and creeping thistle. There are three mature sycamore trees (Trees 1-3 on Figure 2) in this area which have some light ivy growth around their main trunk. The ivy growth offers low value potential bat roosting habitat. |

*Photograph 5- Habitats at Target Note 3*

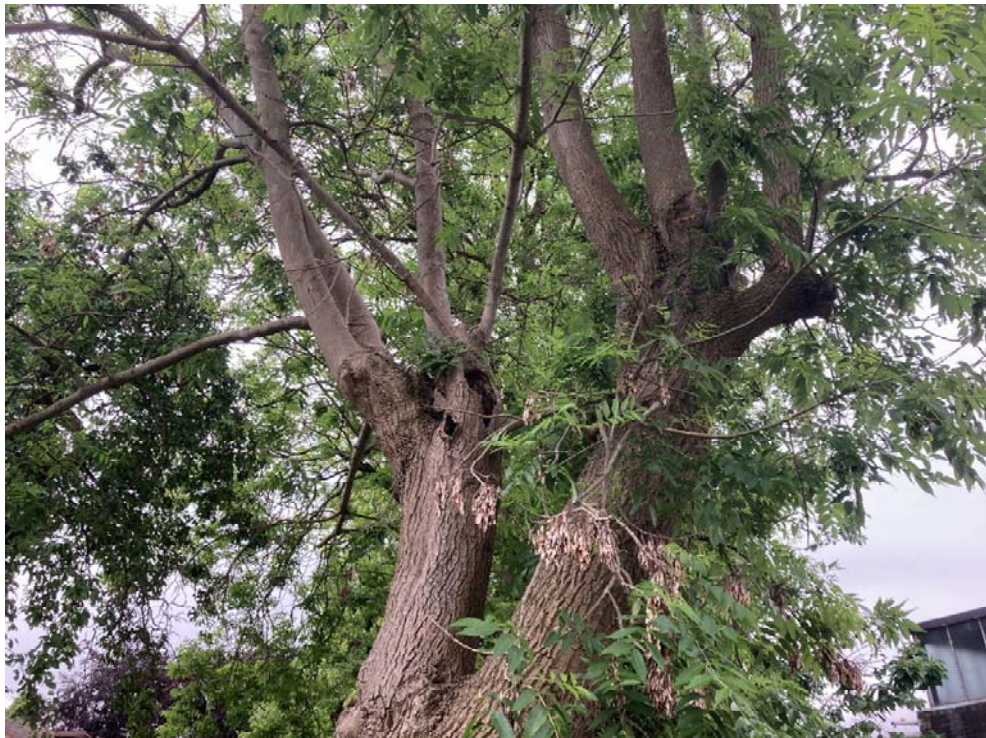
| Target Note | Description |
|---|---|
| | some light ivy growth (Tree 4) and one tree (Tree 6) has lost two limbs at a height of 5-6m. The limb wounds face upwards and so are very exposed to rain etc. Both trees 4 and 6 are considered to offer a 'low' bat roosting potential. The site boundary is marked by a palisade fence. |

Development proposals will require the removal of trees along the northwest boundary of the site. Several of these trees were identified as offering 'low' bat roosting potential within areas of light ivy growth (Trees 1, 2, 3 and 4); and an ash tree (Tree 6) was also identified as offering some 'low' suitability potential bat roosting habitat within some limb wounds at a height of 5-6m. The features are very exposed and so unlikely to be used by roosting bats (see Table 1, Target Note 4).

*Photograph 6- Low suitability bat features at Tree 6*

It is recommended that any removal of these trees are undertaken following a Method Statement of Reasonable Avoidance Measures.

Such measures should include a requirement that trees are carefully felled and then the ivy clad sections and the areas of identified dead wood are left intact for at least 48 hours before being chipped so that any unidentified bats roosting within the trees can escape.

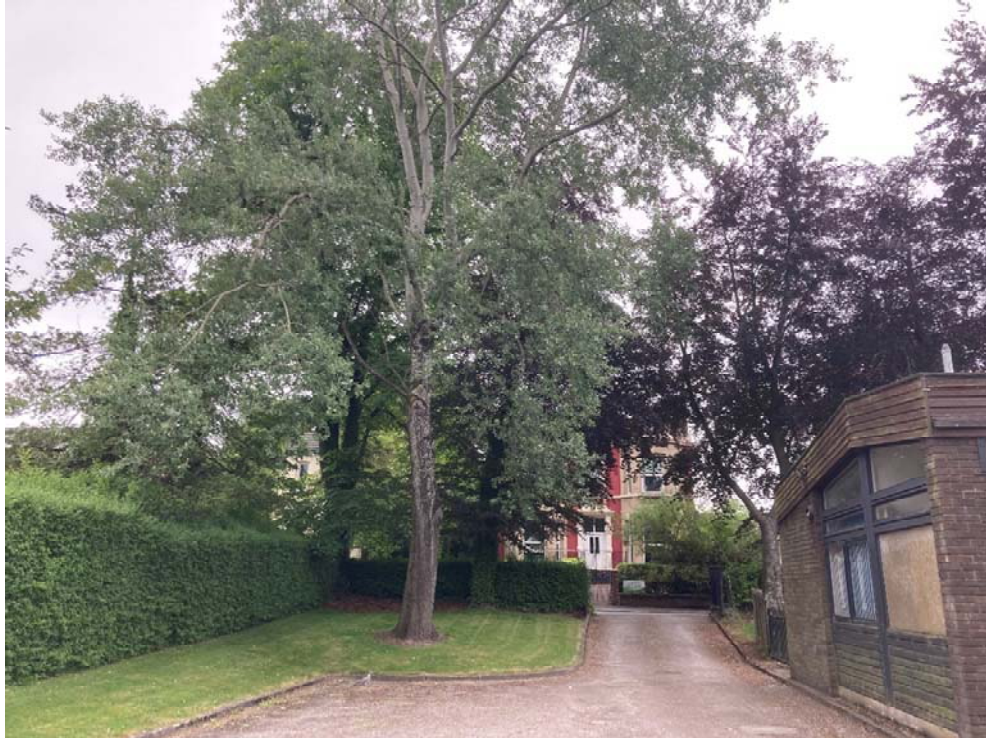
| Target Note | Description |
|---|---|
| 5 | The northeast boundary of the fence is marked by an ornamental privet hedge. There are scattered cherry trees alongside the hedge and there is a mature white poplar (Tree 8). |

*Photograph 7- Tree 8 and habitats on northern boundary of site*

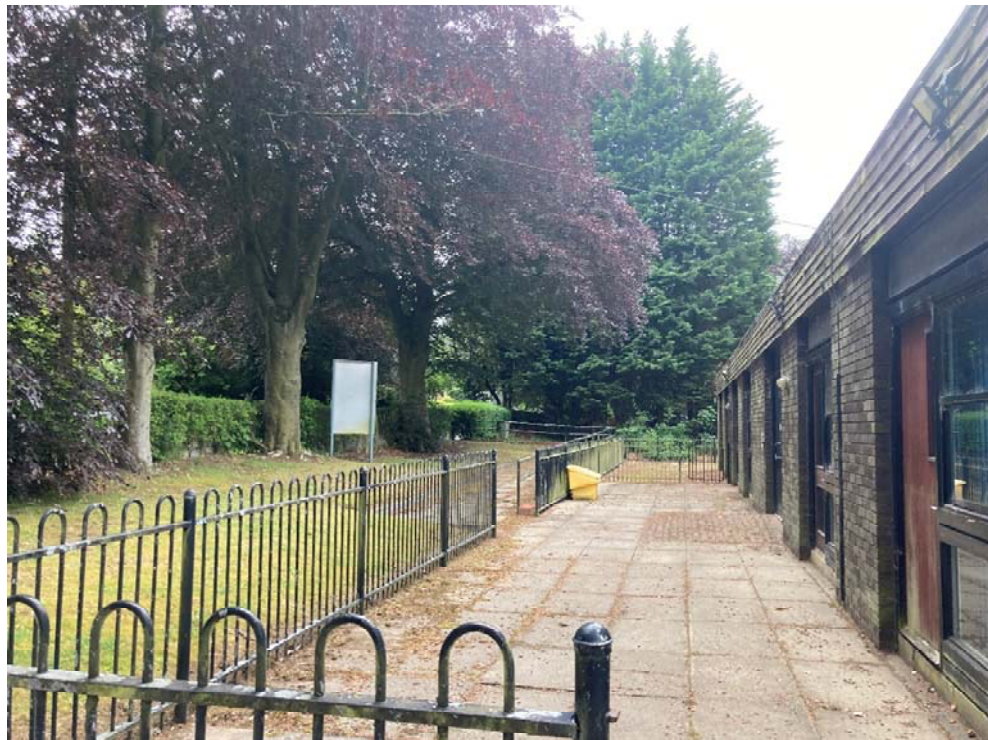
| Target Note | Description |
|---|---|
| 6 | The south east boundary of the site runs along Huyton Church Road. The boundary is marked by a privet hedge with a row of 6 x mature copper beech (Trees 10-15) and a common lime (Tree 9). |

All other trees at the site were assessed as offering a 'negligible' bat roosting potential. The trees running along Huyton Church Road on the site's eastern boundary (Trees 9-15) would be retained.

*Photograph 8- Beech trees on eastern boundary of the site*

The bat and bird boxes can be built into the brick walls of the proposed buildings so as to remain visually unobtrusive. Further bird boxes for common garden bird species can be installed on retained mature trees at the site's eastern boundary.
