**Headbolt Lane**

Figure 1.2: Extended Phase 1 Habitat Plan

## APPENDIX 2: TARGET NOTES

### APPENDIX 3: PHOTOGRAPHIC PLATES

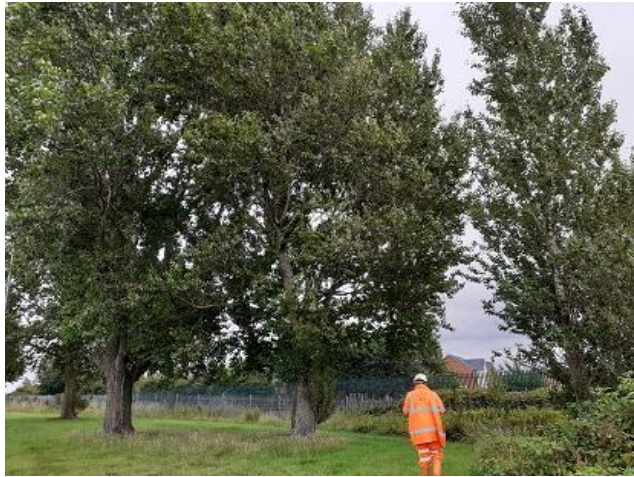
| Target note (TN) | Description |
|---|---|
| 1 | Mown amenity grassland with Lombardy poplars ( <i>Populus nigra 'Italica'</i> ), one with a broken knot hole with low bat roosting potential. |

Photograph 1. Mature Lombardy poplar trees (TN1); tree with knot hole seen to left hand side.

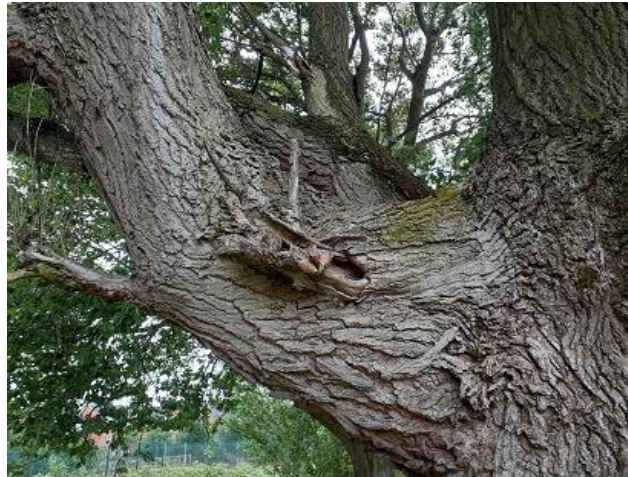
Photograph 2. Knot hole in Lombardy poplar with moderate bat roosting potential (TN1).

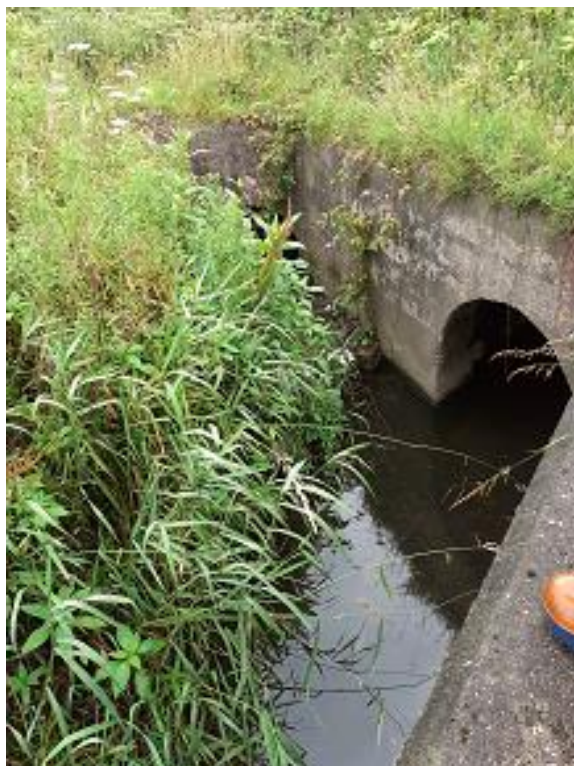
| Target note (TN) | Description |
|---|---|
| 2 | Very slow flowing stream emerging from two culverts under the rail track, with a depth of 50cm and a width of 1.5m. Some glossy film was observed on the water's surface, and large pieces of litter were observed on the bed. Bankside vegetation included rosebay willowherb ( <i>Chamaenerion angustifolium</i> ), Himalayan balsam ( <i>Impatiens glandulifera</i> ), thistle ( <i>Cirsium arvense</i> ), nettle ( <i>Urtica dioica</i> ), horsetail ( <i>Equisetum</i> sp.), cleavers ( <i>Galium aparine</i> ), bindweed ( <i>Convolvulus arvensis</i> ), Yorkshire fog ( <i>Holcus lanatus</i> ), bramble ( <i>Rubus fruticosus</i> ), cow parsley ( <i>Anthriscus sylvestris</i> ) and common reed ( <i>Phragmites australis</i> ), with immature oak ( <i>Quercus robur</i> ). |

Photograph 3. Slow-flowing culverted stream (TN2) – Kirkby Brook which runs through the proposed Headbolt Lane station site.

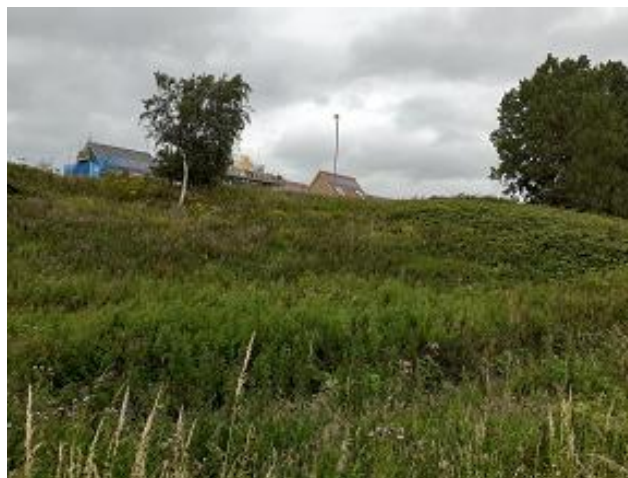
| Target note (TN) | Description |
|---|---|
| 3 | Tall ruderal grassland with ragwort ( <i>Jacobaea vulgaris</i> ), red campion ( <i>Silene dioica</i> ), immature silver birch ( <i>Betula pendula</i> ), immature oak, nettle, Himalayan balsam, rosebay willowherb, cow parsley, hogweed ( <i>Heracleum spondylium</i> ) and rapeseed ( <i>Brassica napus</i> ). |

Photograph 4. Tall ruderal (TN3) with potential for herptiles.

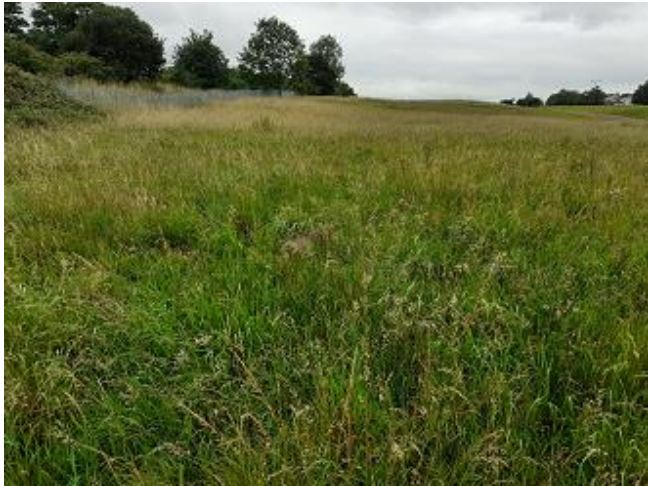
| Target note (TN) | Description |
|---|---|
| 4 | Semi-improved neutral grassland, with lesser stitchwort ( <i>Stellaria graminea</i> ), great willowherb ( <i>Epilobium hirsutum</i> ), ragwort, sorrel ( <i>Rumex acetosa</i> ), thistle, nettle, yarrow ( <i>Achillea millefolium</i> ), sweet vernal grass ( <i>Anthoxanthum odoratum</i> ), cocksfoot ( <i>Dactylis glomerata</i> ), ribwort plantain ( <i>Plantago lanceolata</i> ), dandelion ( <i>Taraxacum</i> sp.), hogweed ( <i>Heracleum spondylium</i> ), creeping buttercup ( <i>Ranunculus repens</i> ), cleavers, dock ( <i>Rumex</i> sp.), rosebay willowherb, white dead-nettle ( <i>Lamium album</i> ), hawkbit ( <i>Leontodon</i> sp.), bindweed, borage ( <i>Borago officinalis</i> ) and garlic mustard ( <i>Alliaria petiolata</i> ), with two ash ( <i>Fraxinus excelsior</i> ) trees. |

Photograph 5. Semi-improved neutral grassland (TN4) looking west.

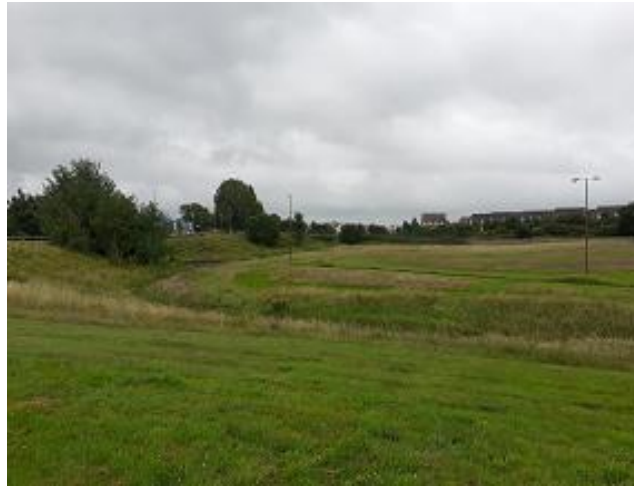
Photograph 6. Mosaic of semi-neutral grassland (left side, TN4), small cluster of immature trees (background left side, TN5), mown amenity grassland (foreground, TN6) and unmown grassland (right side, TN7).

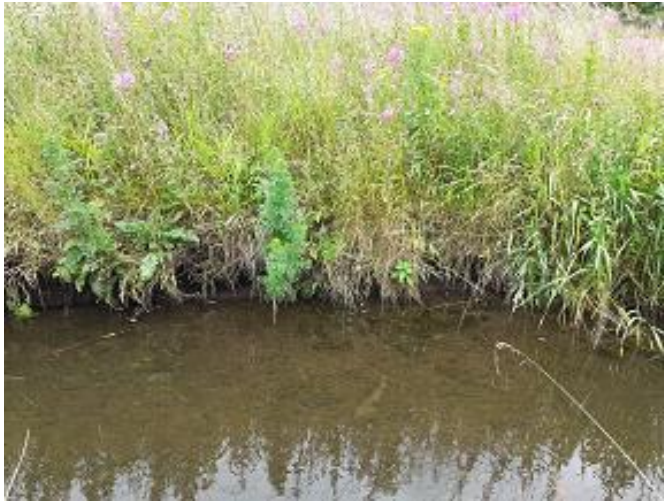
| Target note (TN) | Description |
|---|---|
| 8 | A generally slow-flowing stream, at a width of 1m or more, and a depth of 30cm. Some shallower sections have a faster current. The bed is silty, and banks varying between a height of 20cm to 1m, and heavily vegetated. Some undercutting of river banks from current present at points, but no mammal or crayfish holes visible. Bankside vegetation includes Himalayan balsam, rosebay willowherb, ragwort, thistle, nettle, common reed, yarrow, sorrel, cocksfoot ( <i>Dactylis glomerata</i> ) and creeping buttercup, with areas of bare ground. |

Photograph 7. Undercutting of stream banks (TN8).

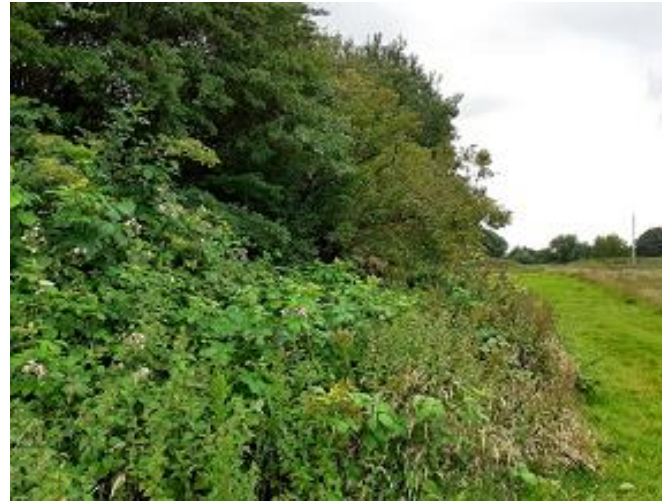
| Target note (TN) | Description |
|---|---|
| 10 | Very dense scrub along the railway boundary. Species include hawthorn ( <i>Crataegus monagyna</i> ), cherry ( <i>Prunus</i> sp.), elder ( <i>Sambucus nigra</i> ), ash, field rose ( <i>Rosa arvensis</i> ) and oak, with an understorey of bird's foot trefoil, bindweed, bramble, nettle, creeping buttercup, cocksfoot, rosebay willowherb, raspberry ( <i>Rubus idaeus</i> ), hogweed, ragwort, and dock. |

Photograph 8. Thick bramble scrub outside of railway embankment (TN10).

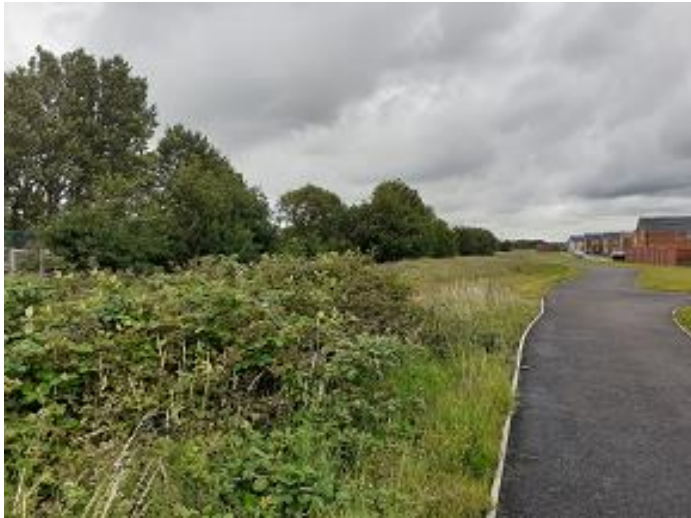
| Target note (TN) | Description |
|---|---|
| 11 | Semi-improved neutral grassland sloping down to embankment. Species include garlic mustard, thistle, feverfew ( <i>Tanacetum parthenium</i> ), rosebay willowherb, dock, sweet vernal grass, chickweed ( <i>Stellaria media</i> ), horsetail, poppy ( <i>Papaver somniferum</i> ), great willowherb, bramble, ribwort plantain, hawkbit, common vetch ( <i>Vicia sativa</i> ), bindweed, red fescue ( <i>Festuca rubra</i> ), pineappleweed ( <i>Matricaria discoidea</i> ) and creeping buttercup. |

Photograph 9. Scrub and semi-improved neutral grassland sloping down to culvert under railway embankment (TN11). Mown grassland (TN12) present to far right.

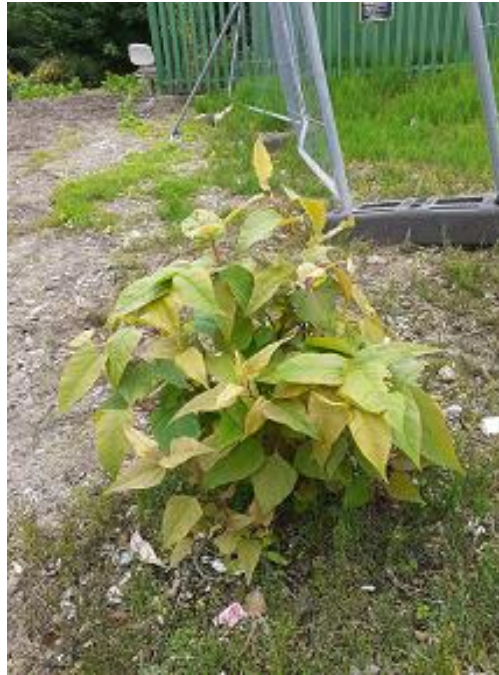
| Target note (TN) | Description |
|---|---|
| 13 | An area of bare ground, with buddleja ( <i>Buddleja davidii</i> ), bramble, dock, rosebay willowherb, hop ( <i>Humulus lupulus</i> ) and Japanese knotweed ( <i>Fallopia japonica</i> ) present at security fence alongside track. Trees include field rose, sycamore, silver birch, hawthorn and cherry. |

Photograph 10. Japanese knotweed present on bare ground for proposed substation (TN13).

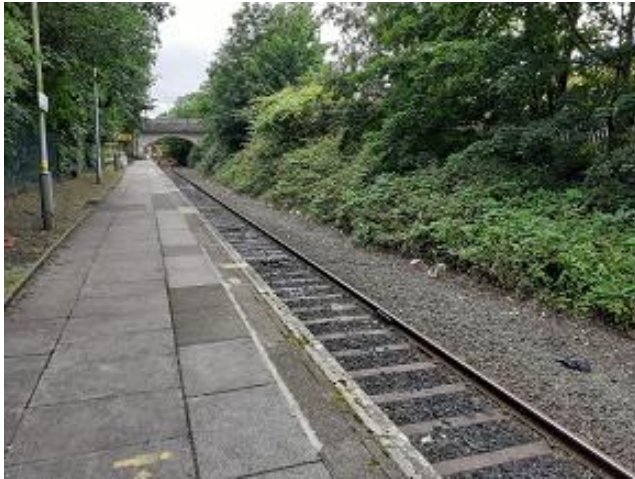
Photograph 11. Northern platform of Kirkby (TN15), with bankside vegetation opposite including Japanese knotweed at base of bare ground for substation (TN13).

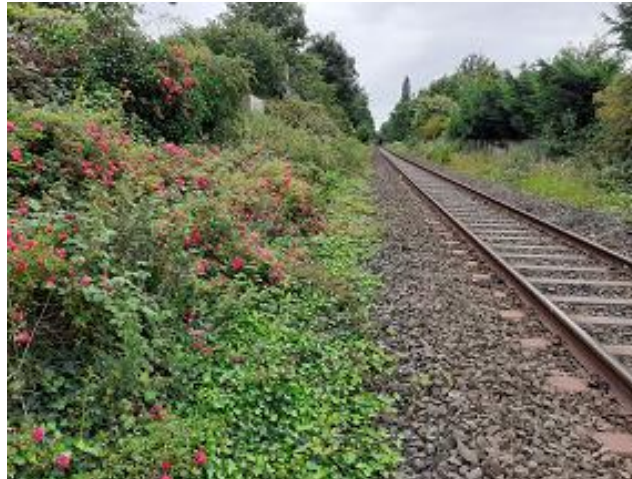
| 15 | Railway embankment scrub vegetation east of Kirkby station, with species including oak, goat willow ( <i>Salix caprea</i> ), sycamore, silver birch, elder, common lime ( <i>Tilia x europaea</i> ), Lombardy poplar, field maple ( <i>Acer campestre</i> ), cherry, privet ( <i>Ligustrum vulgare</i> ), field rose, hawthorn, gooseberry ( <i>Ribes uva-crispa</i> ), cotoneaster ( <i>Cotoneaster horizontalis</i> ) and Leyland cypress ( <i>Cupressus x leylandii</i> ). Behind the northern platform, trees include laburnum ( <i>Laburnum anagyroides</i> ), sycamore, elder and laurel ( <i>Laurus nobilis</i> ). Ground flora includes horsetail, bramble, ragwort, cocksfoot, red fescue, rosebay willowherb, bindweed, nettle, cleavers, old man's beard ( <i>Clematis vitalba</i> ), bracken ( <i>Pteridium aquilinum</i> ), thistle, hawkbit, ivy ( <i>Hedera helix</i> ), yellow flag iris ( <i>Iris pseudacorus</i> ), goldenrod ( <i>Solidago virgaurea</i> ), raspberry, yarrow, variegated yellow archangel ( <i>Lamium galeobdolon</i> subsp. <i>argentatum</i> ), foxglove ( <i>Digitalis purpurea</i> ), common vetch, buddleja, groundsel ( <i>Senecio vulgaris</i> ) and herb Robert. |

Photograph 12. Embankment vegetation (TN15), large numbers of garden escape shrubs are present between Kirkby Station and the Mill Brook crossing (bridge 56).

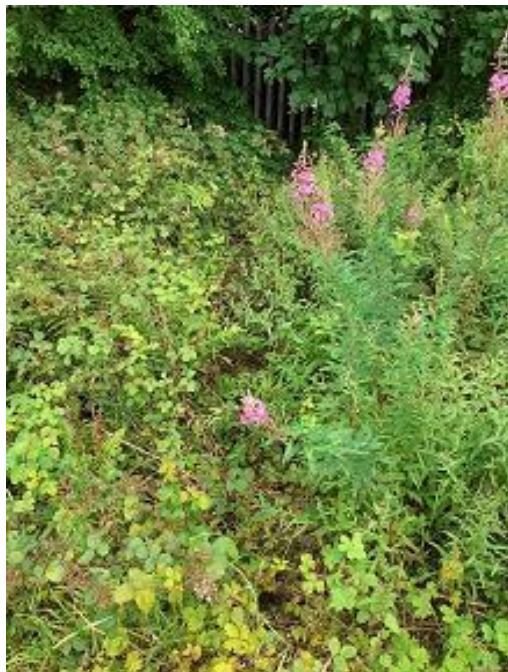
| 17 | Railway embankment species adjacent to Headbolt Lane include goat willow, bracken, tormentil ( <i>Potentilla erecta</i> ), yarrow, hawkbit, bindweed, sage ( <i>Salvia officinalis</i> ), common vetch, cherry species, apple species ( <i>Malus</i> sp.), and wood forget-me-not ( <i>Myosotis sylvatica</i> ). A large mammal run was observed partway down the track on the southern embankment. |

Photograph 13. Mammal path (TN17) at SJ 41275 99709.

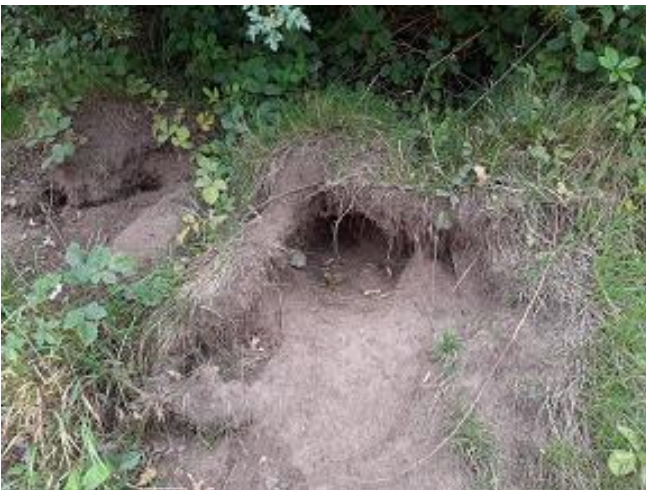
Photograph 14. Shallow mammal holes (TN17) at SJ 41369 99759.

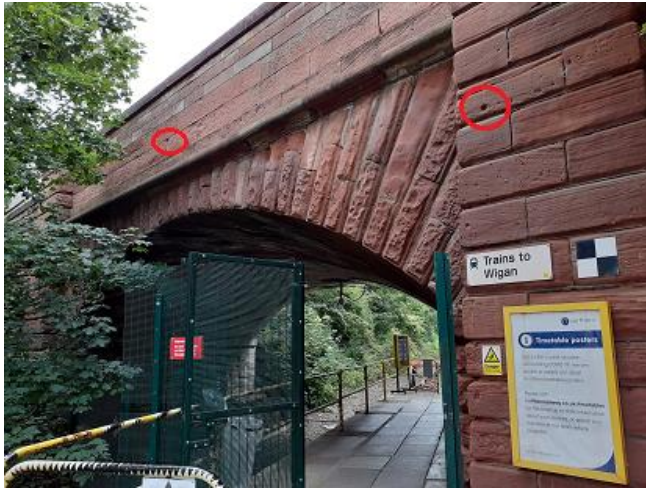
Photograph 15. Glovers Brow Bridge (eastern elevation) with crack to left and pockmark to right highlighted (red circles).

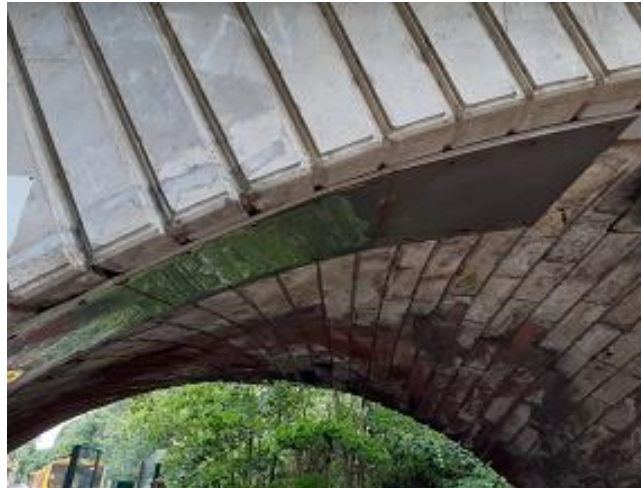
Photograph 16. Metal plate underneath Glovers Brow Bridge with low bat potential.
