## Hallmark Developments (NW) Ltd

Former William Hill Betting Office, Dragon Lane, Whiston

## Level 2 Historic Building Survey

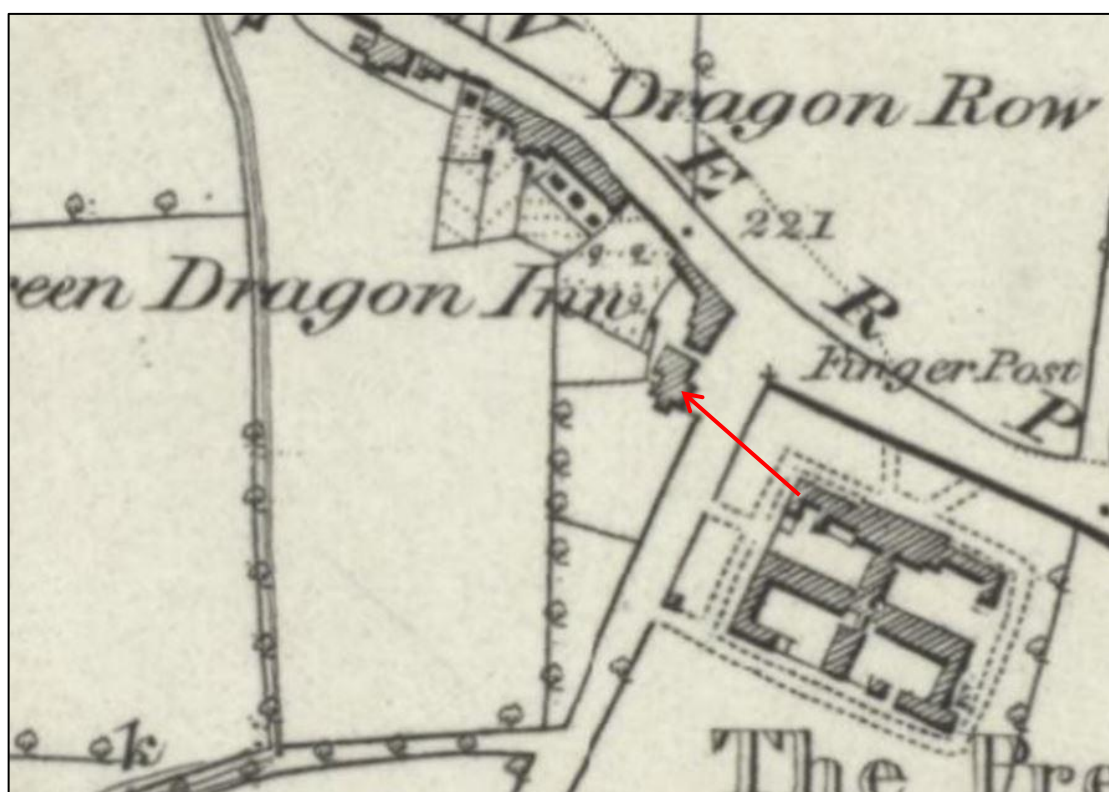
Figure 4: 1841 Tithe map of Whiston

- 5.5 The 1842 Tithe map shows the buildings for the first time in detail. The Green Dragon appears as a rectangular building, aligned north – south, with an extension to the northwest, along Warrington Road. To the south is the former bookmakers building; a similar building, rectangular and aligned north – south and roughly the same size. The plan shows projections to south end of the east elevation and a pair of small extensions to the west elevation. Both fall within plot 90, along with the land to the west, although the southern gable of the former bookmakers butts against plot 91 to the south. These plots are shown to be owned by William Ackers and occupied by William Ball. Plot 90 is listed as “House and Garden” with 91 as “Bowling Green and Garden. This suggests that the former bookmakers was an outbuilding of the Green Dragon, rather than as a house itself. Knowles (1988, 54) suggests that this building was erected as a stable and coach house, with living accommodation. It is worth noting that the ‘Green Dragon’ is not listed by name, and is listed as a house, rather than a public house.

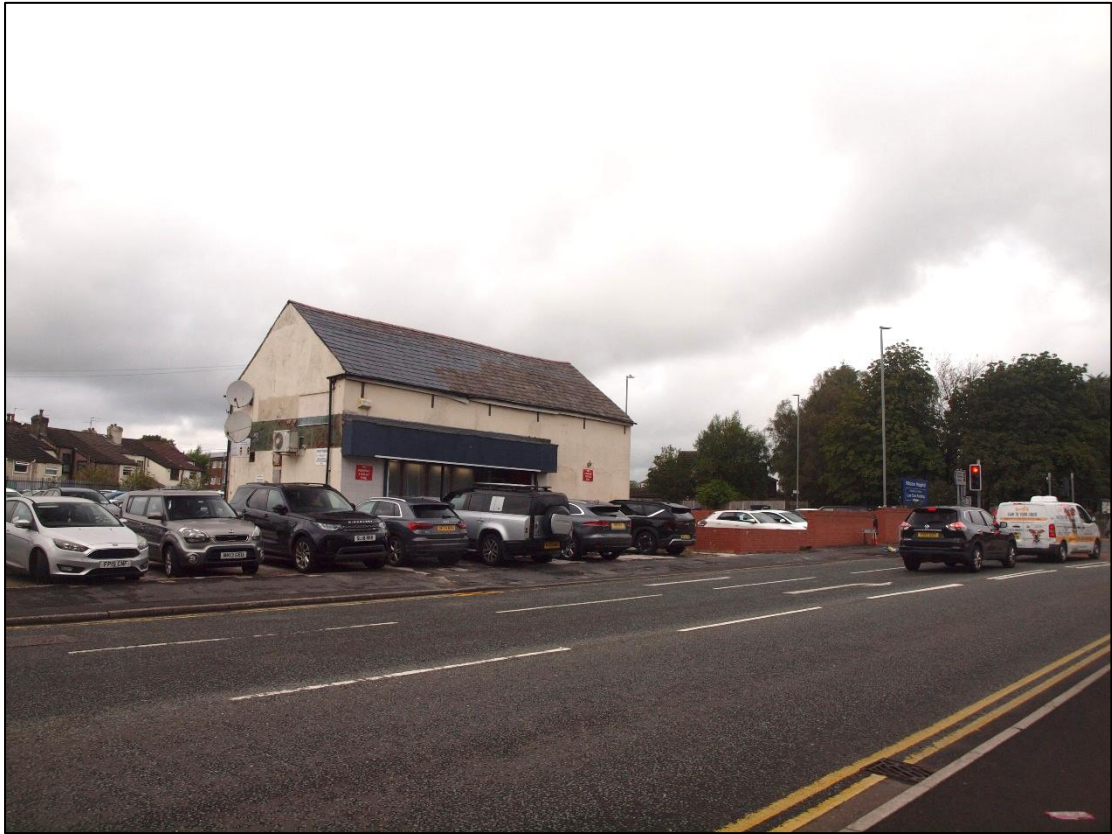
Plate 1: General shot of building

- 6.1 (Plate 1) The building is a two story building aligned north – south with a Welsh slate roof and no chimney stacks. It is constructed of brick in a variation of English Garden Wall bond, with stretchers within the header course. A lean-to extension has been added to the north end of the west elevation, with a small 20th century flat roofed extension added to it.

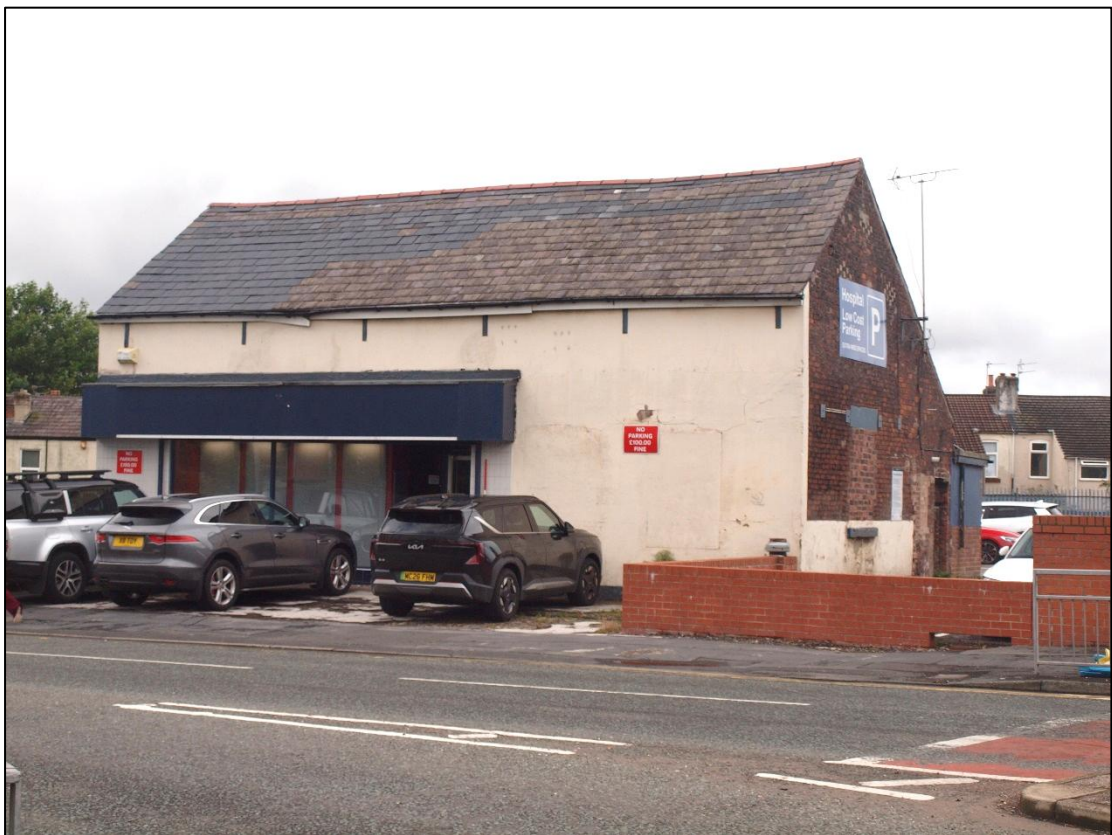
Plate 2: East elevation

- 6.2 East elevation (Plates 2 - 5). This forms the main frontage of the building. The southern end of the face is taken up by the large modern shop front, with tall windows and personnel doorway at the northern end, below a modern sign. To the north the face is rendered and featureless, although a pair of blocked windows are evident where the render has cracked.

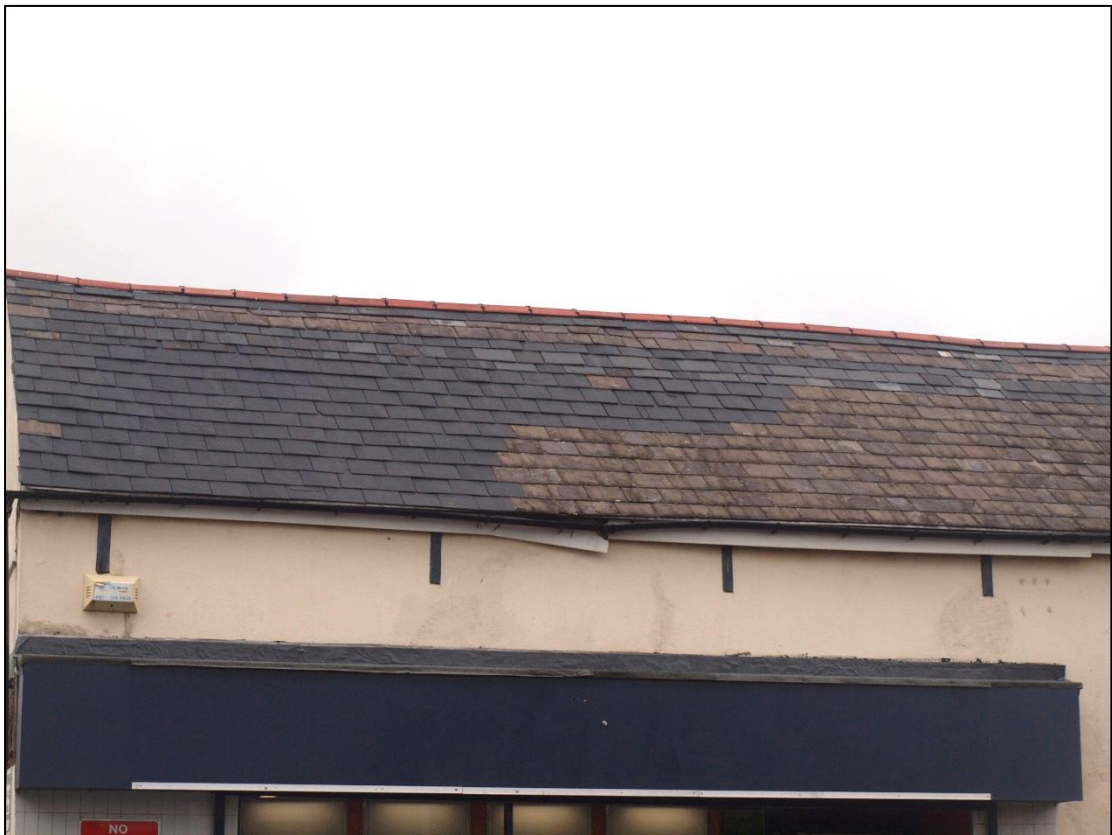
visible, as was a pitching eye. A blocked circular pitching eye also appears to have been present towards the centre of the east elevation.

Plate 4: East elevation showing ghost of blocked pitching eye and roof

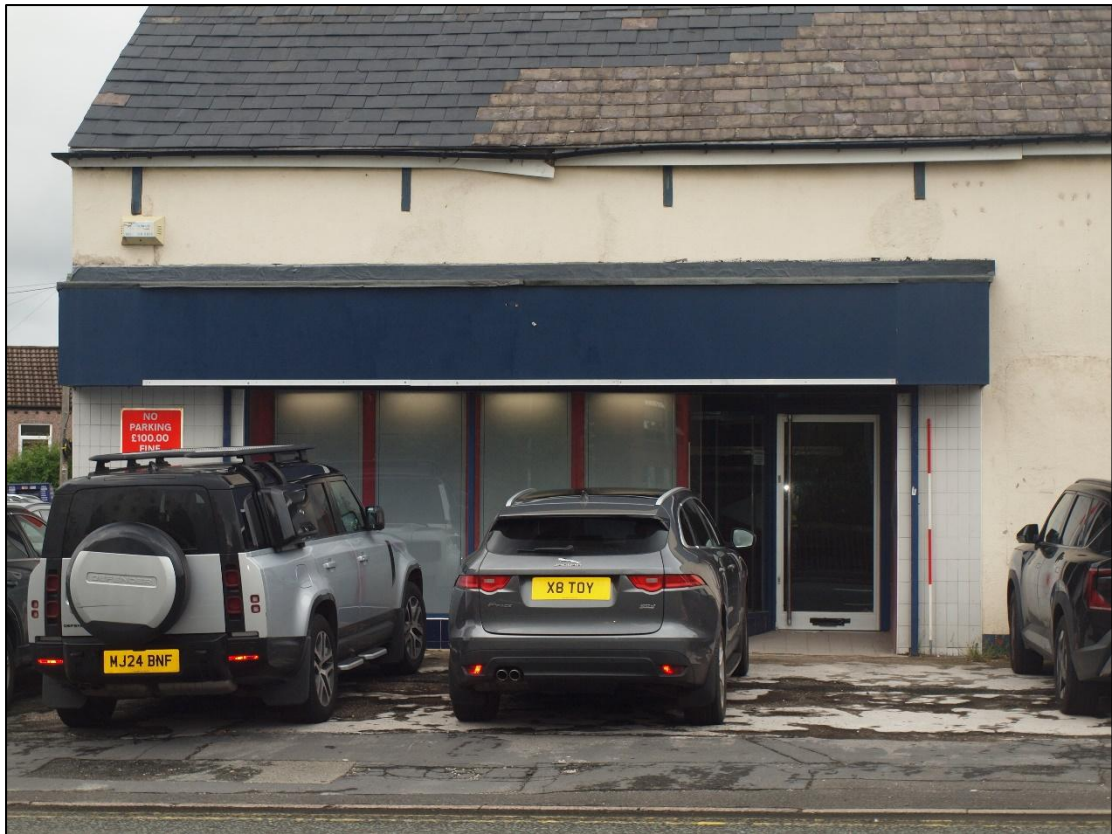
- 7.2 The insertion of the large shop front window has removed any evidence of the former openings in this area. A pair of blocked windows lie to the north of these. These are likely later insertions and were possibly related to its use prior to the betting shop. Both of the large openings to the rear (west) elevation, have concrete lintels, suggesting that they also were inserted and blocked at a later date. However, a blocked doorway is also present which appears to be an original opening. A further original opening lies at the western end of the northern gable, although this was a part of the lean-to extension.

Plate 5: Modern shop front window

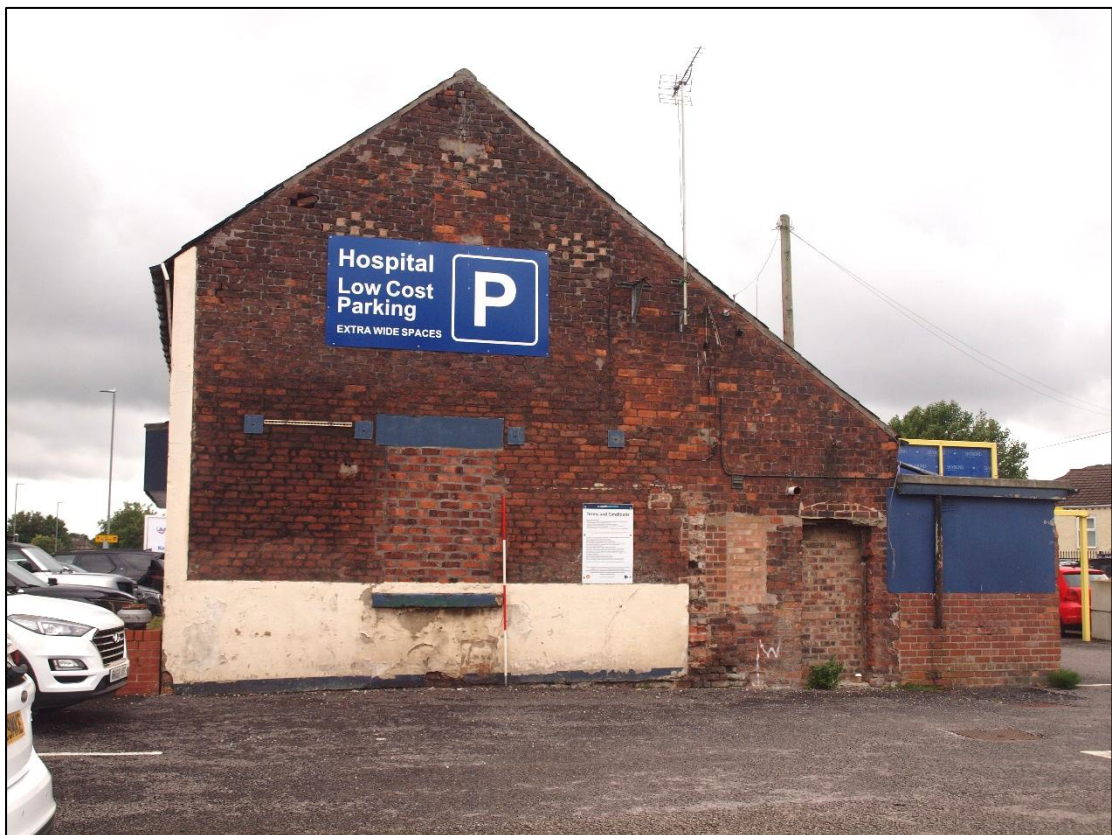
Plate 6: Northern gable

- 6.3 North elevation (Plates 6 - 12). This forms the gable end of the building and is unrendered, showing the English bond construction. At ground floor level, slightly east of centre, is a blocked portrait window, with large sandstone lintel and sandstone cill. A smaller blocked window, possibly a pitching eye, is located at first floor level, in the centre of the gable, although covered by a modern sign. Flanking this, and above it, are diamond shaped vent holes, blocked. To the west, at ground floor level, is a portrait window, blocked, with a depressed arch lintel of brick. A straight joint lies in the centre of this blocking, with differing brickwork to each side, suggesting it was first narrowed before becoming fully blocked. The eastern jamb shows evidence of a wall scar, likely a removed boundary wall up to the Green Dragon Inn. Above this the brickwork changes, marking the location of the lean-to extension, constructed in English Garden Wall bond. West of the window is a blocked personnel doorway, with a matching lintel. The small modern extension lies to the west, with a pair of small, blocked windows in the face, although these have been covered with timber.

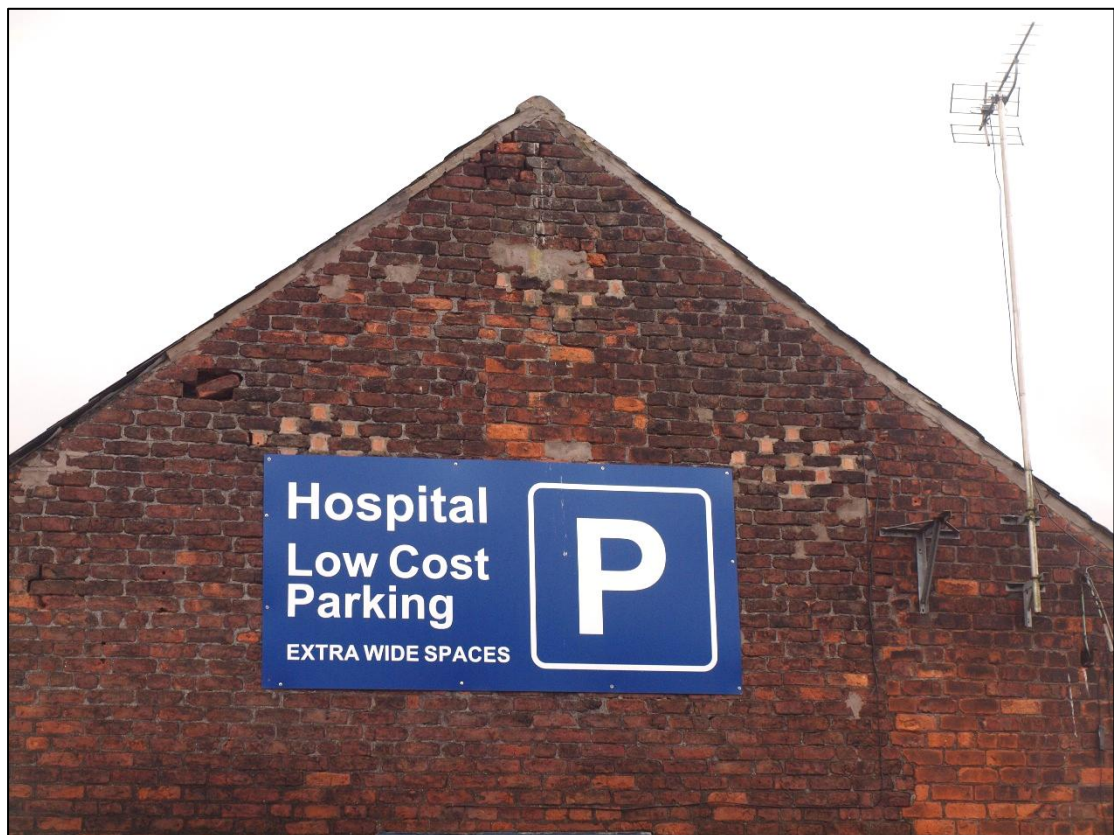
Plate 8: Top of gable showing diamond ventilation slots

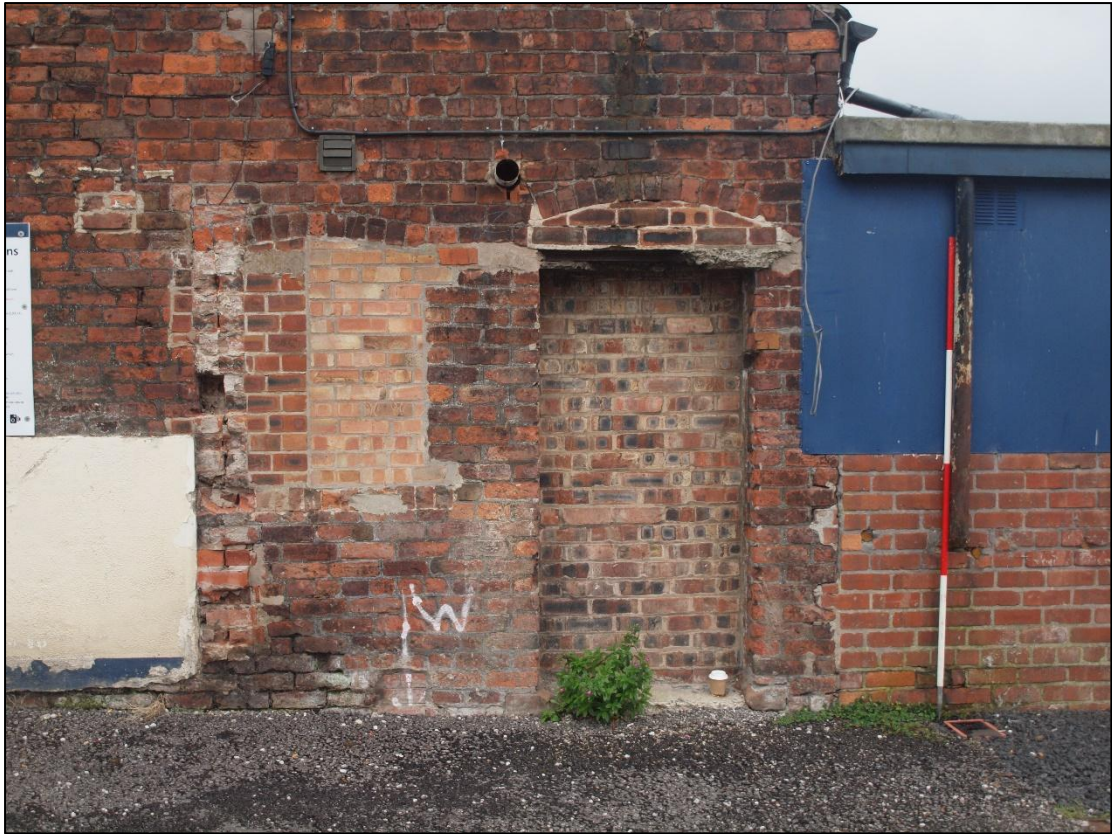
Plate 9: Blocked window and blocked doorway to lean-to extension

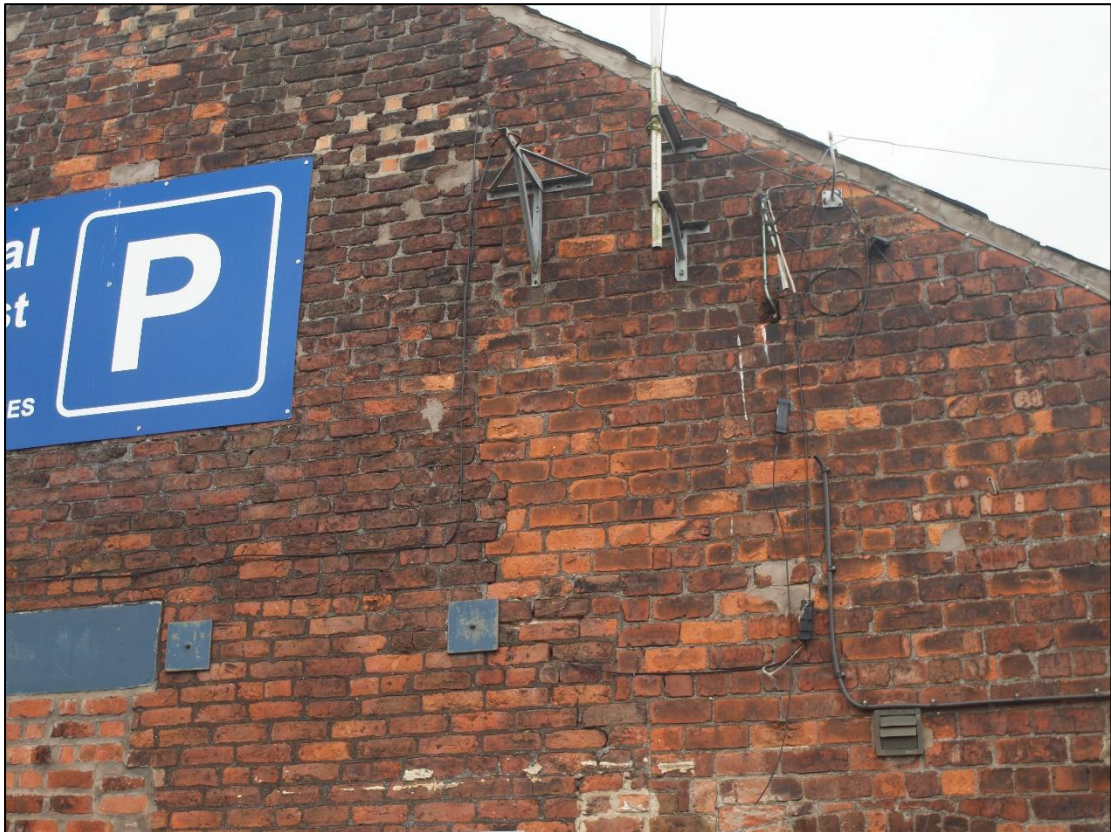
Plate 12: Change of brickwork showing lean-to extension joint

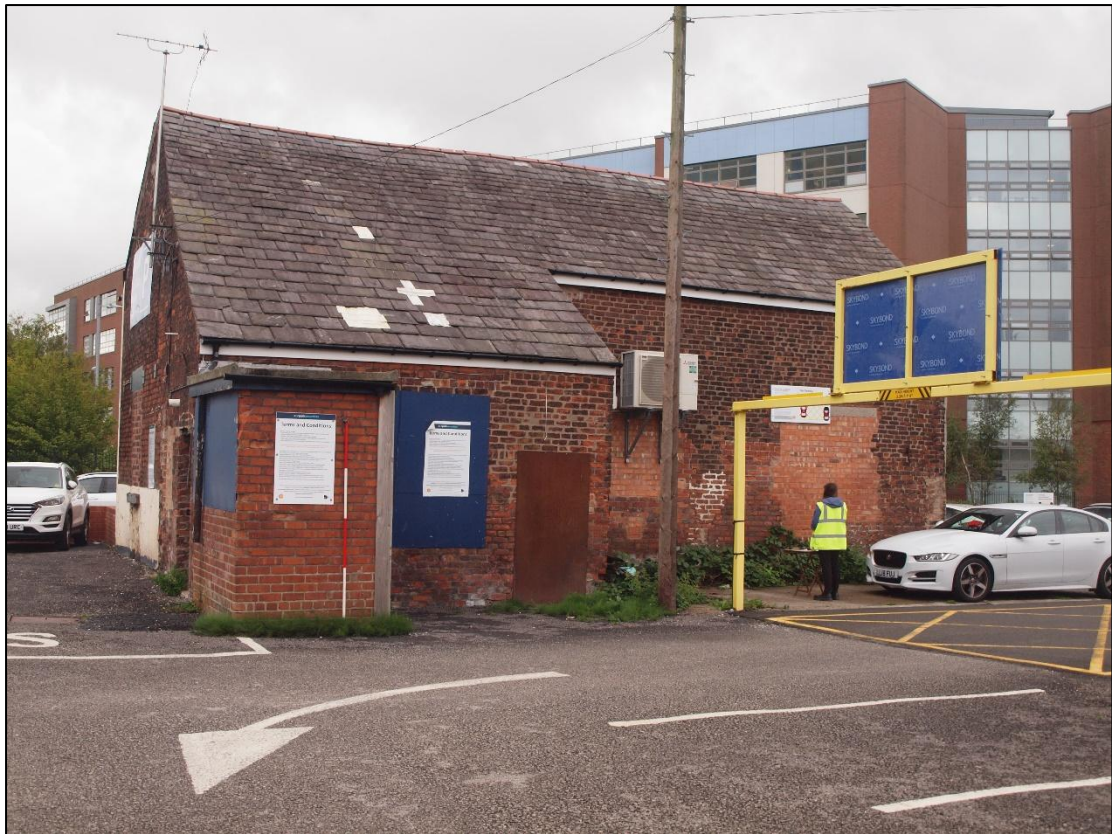
Plate 13: West elevation

- 6.4 West elevation (Plates 13 - 20). This forms the rear of the building and is unrendered, showing the brown handmade brick construction. At the northern end is the featureless elevation of the modern extension. South of this is the face of the lean-to. This contains a large square window, boarded over, with a doorway adjacent to it, likewise covered. South is the face of the building proper. At the northern end is a blocked window with concrete cill, south of which a rough joint is present, suggesting a wider opening was originally present here. South of this is a blocked doorway and the southern jamb forms the rough joint or a large, blocked opening to the south. A concrete lintel again lies above,

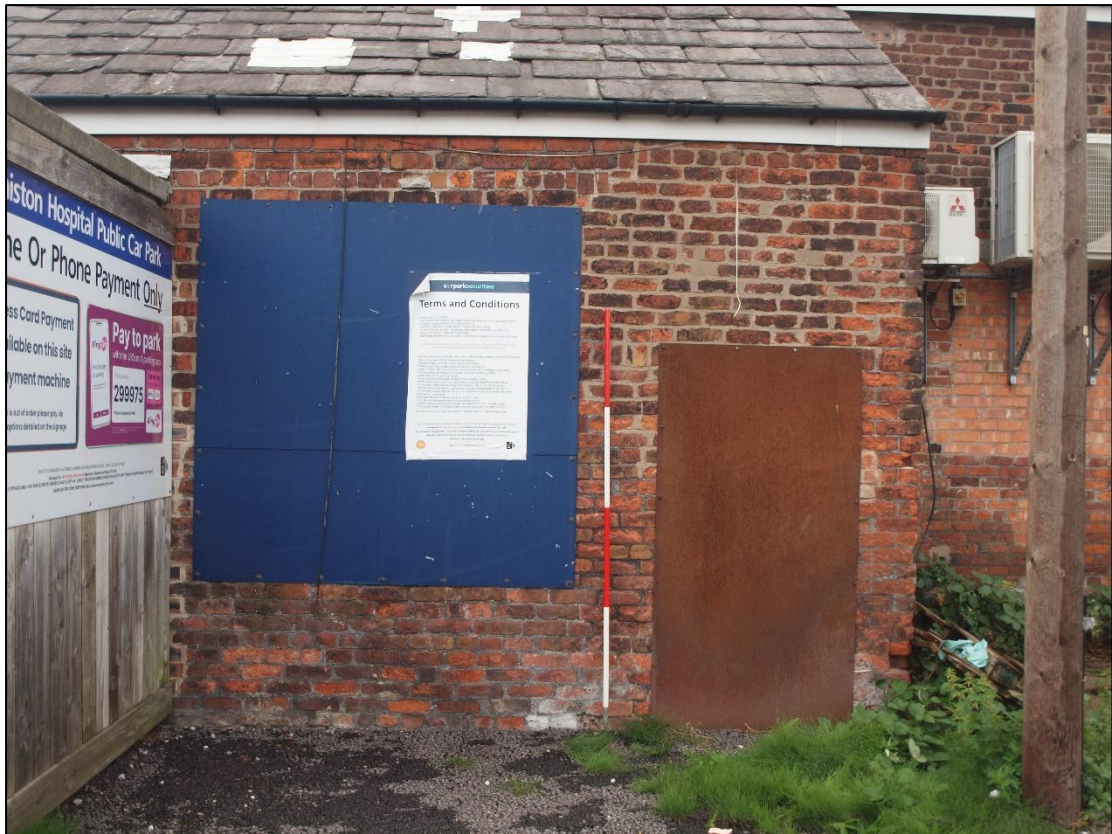
Plate 15: West elevation of lean-to showing blocked doorway

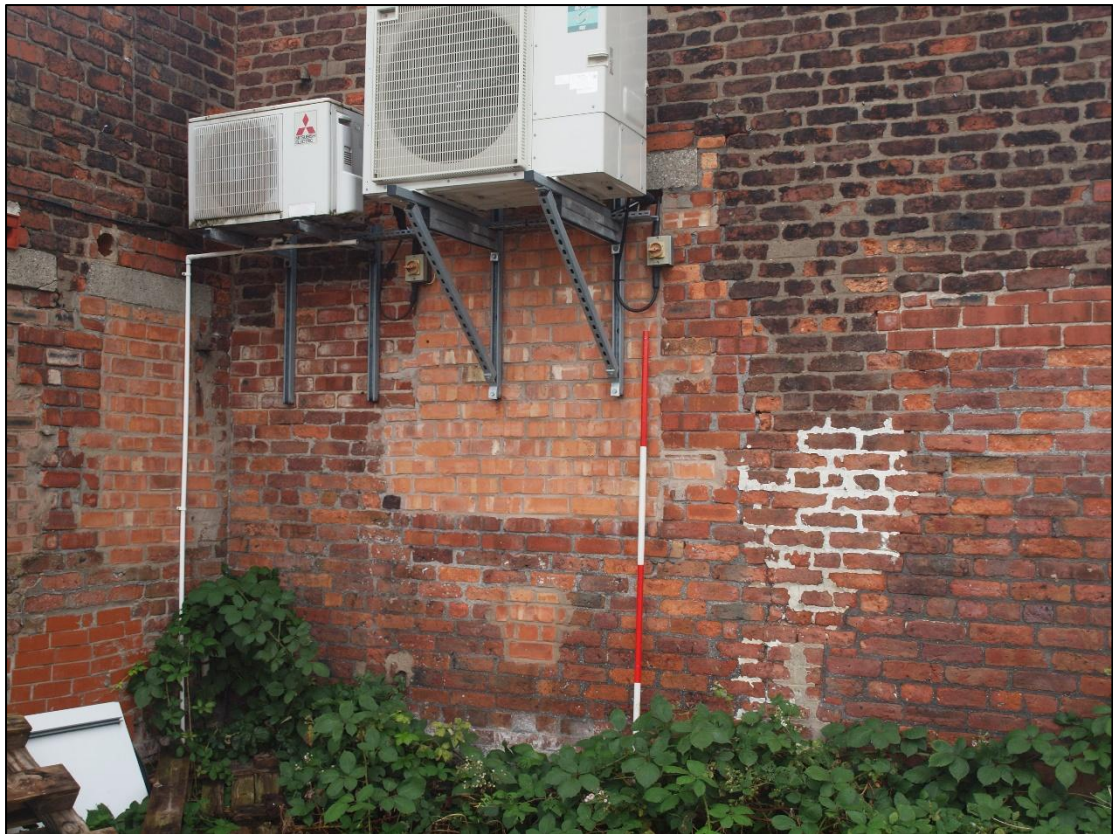
Plate 17: Blocked window with concrete lintel to north end

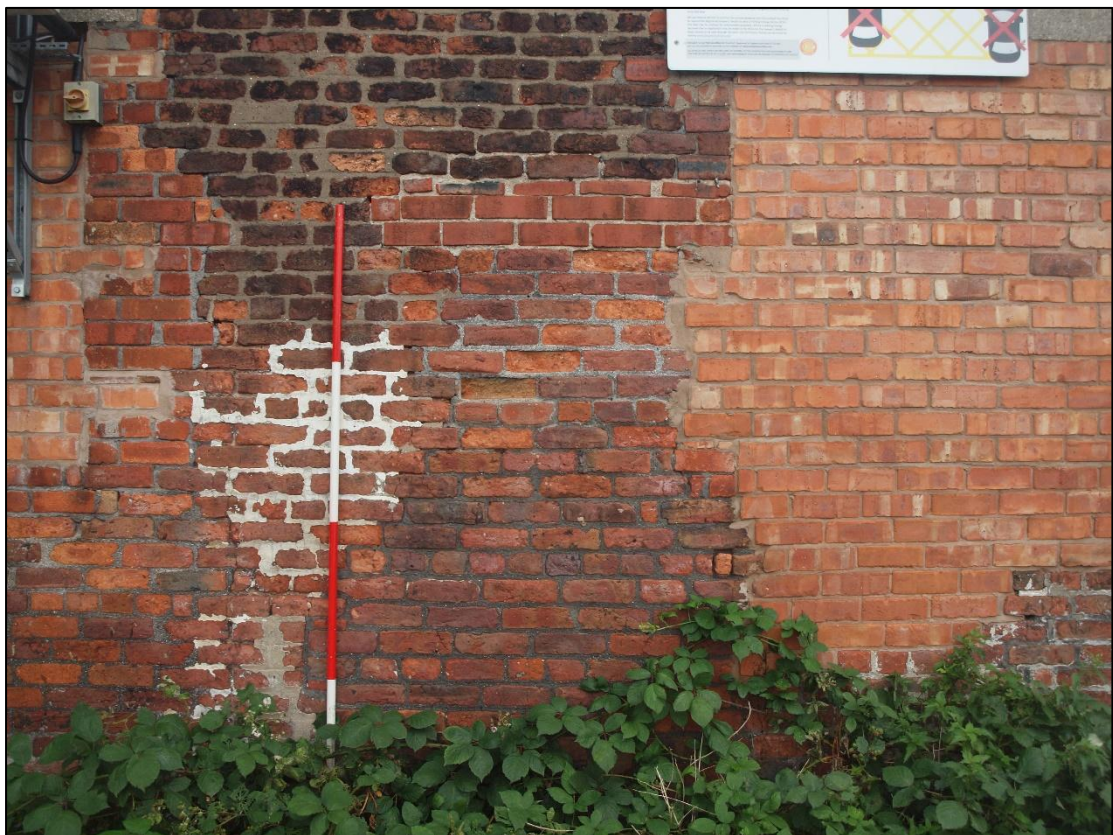
Plate 18: Blocked doorway south of blocked window

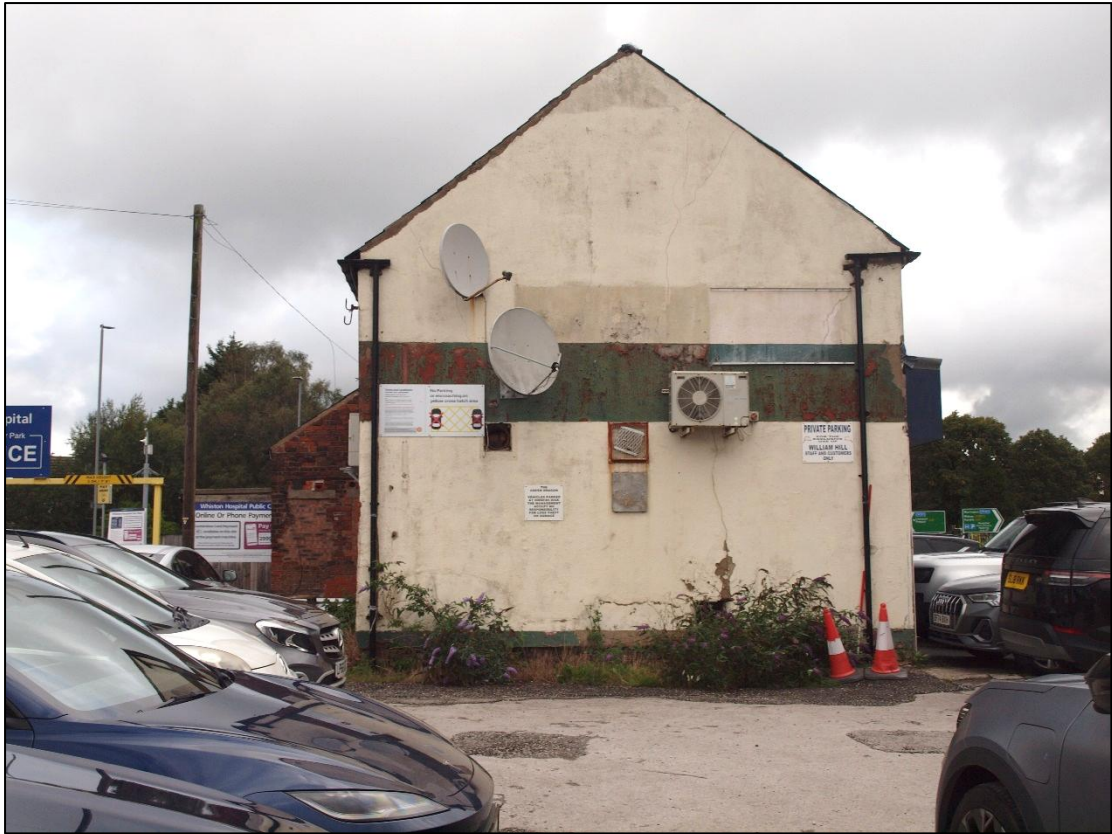
Plate 21: South elevation

- 6.5 South elevation (Plates 21 - 25). This forms the other gable end of the building and is rendered. It is featureless with a painted green band across the face. To the west is the projecting face of the lean-to. This contains a pair of inserted and later blocked portrait window, each with a concrete lintel.

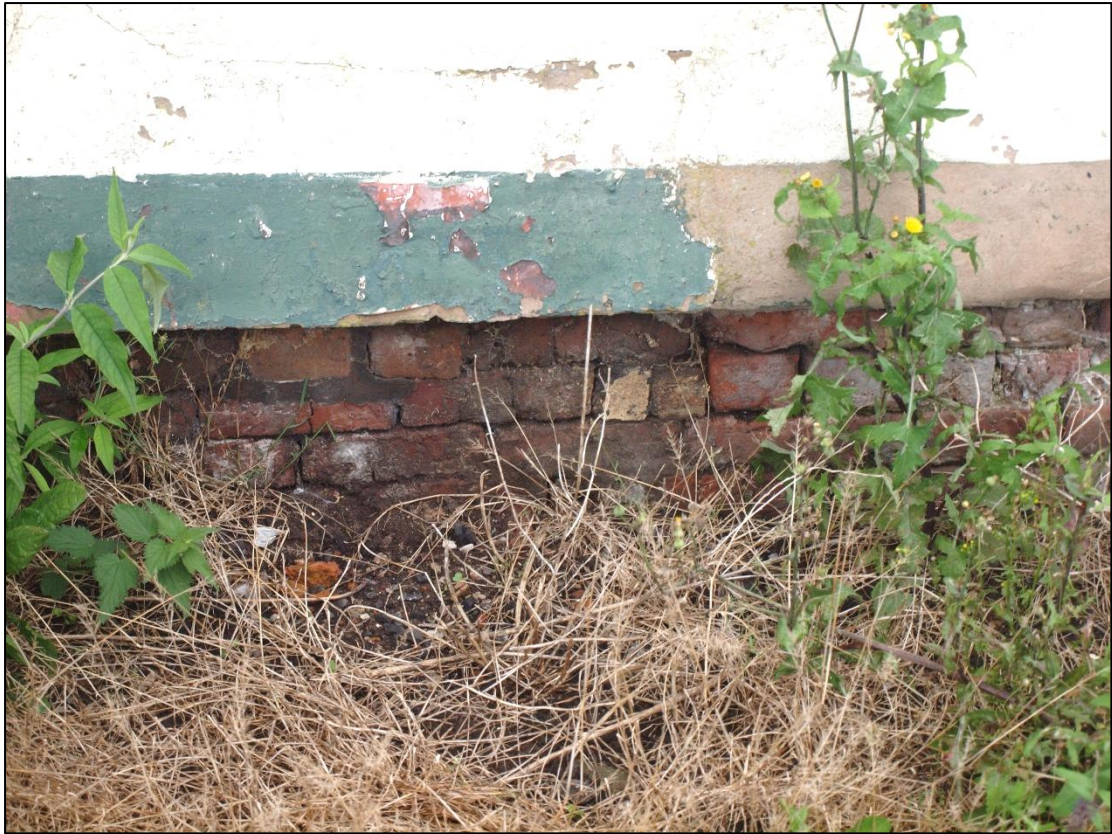
Plate 23: Brickwork visible below render

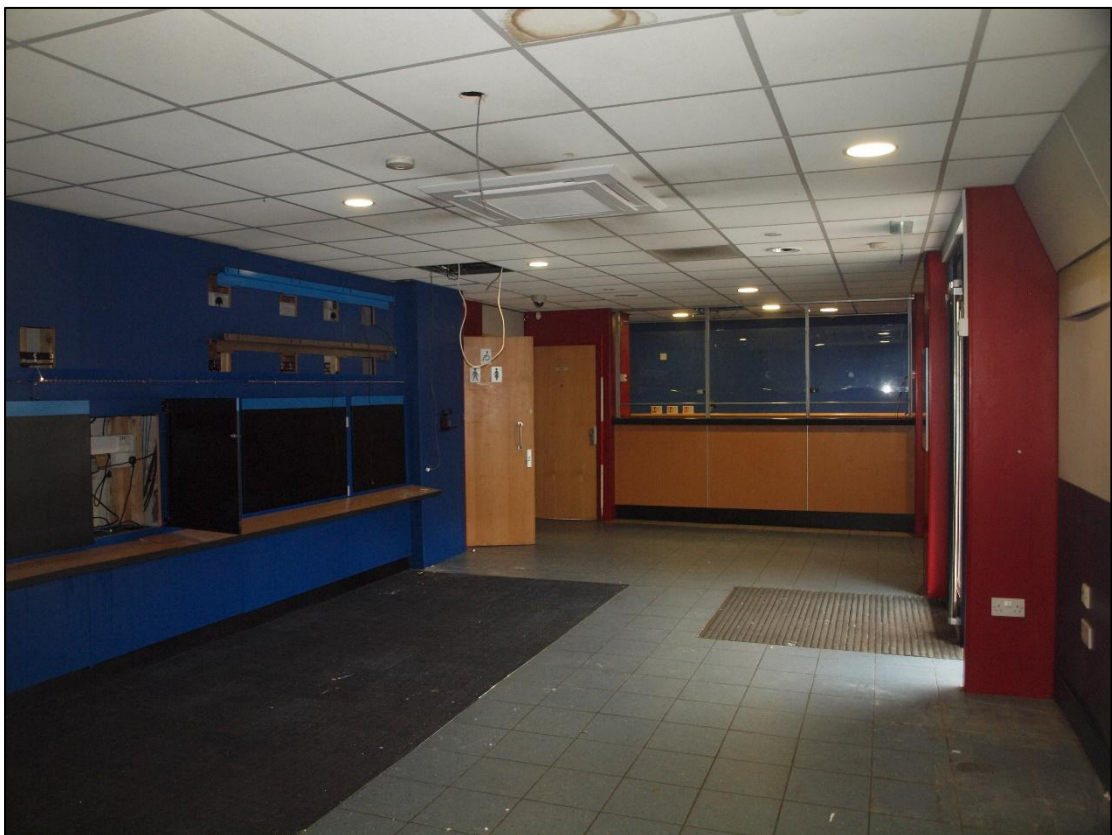
Plate 26: Interior

- 6.6 (Plates 26 – 35) The ground floor is completely modernised and fitted out as a bookmaker. The false ceiling masks the timber joists and floorboards of the floor above. These appear to be modern machine cut timber at the northern end, although older to the south. No original features were visible.

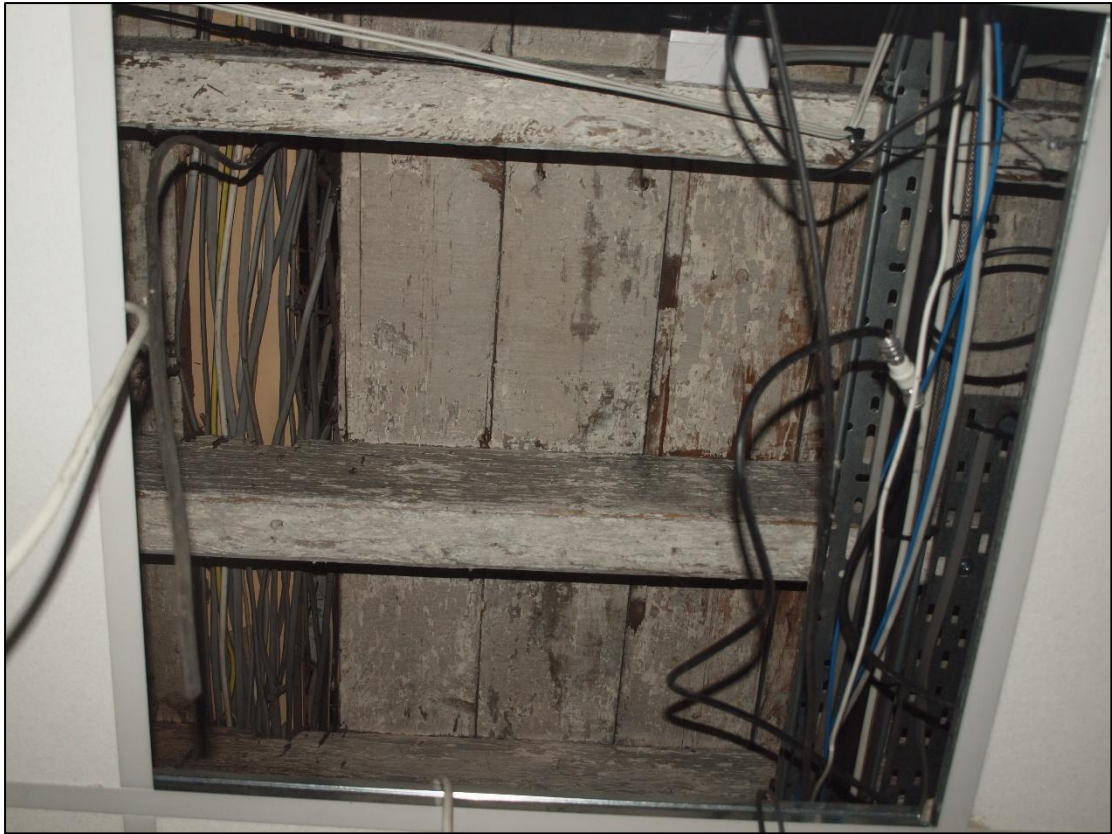
Plate 35: Timber beams and boards of first floor

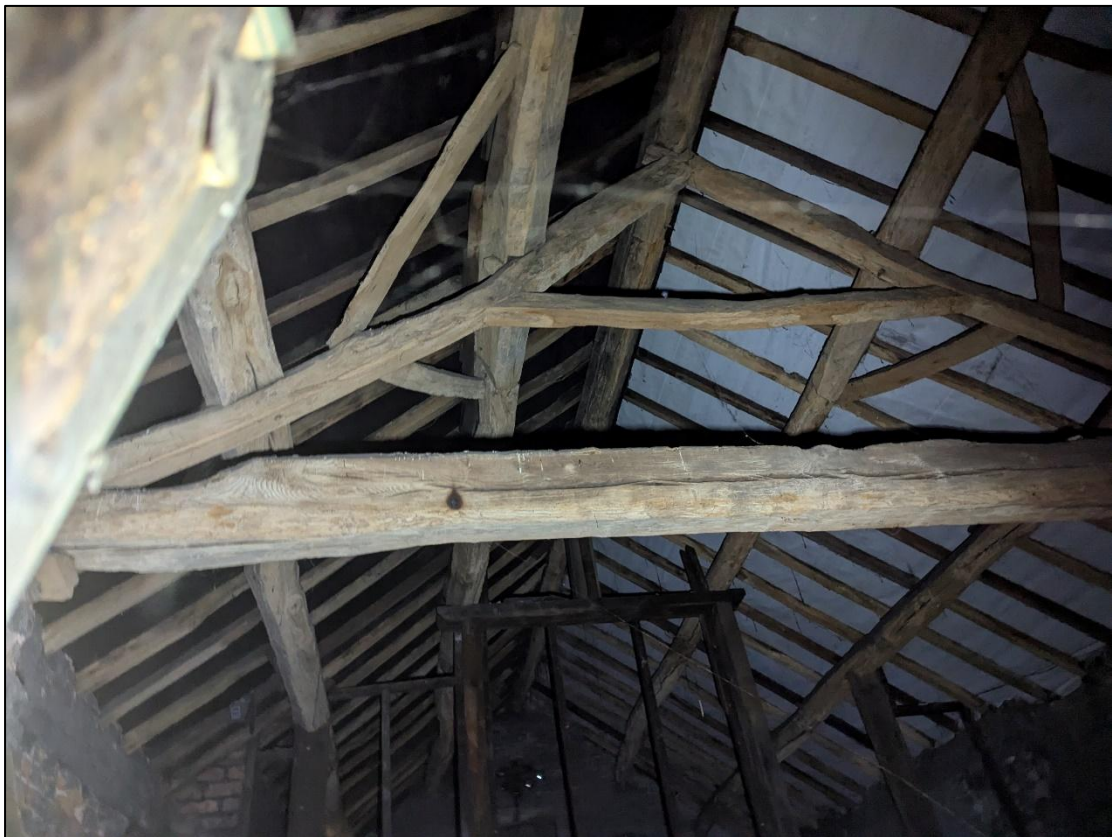
- 6.7 (Plates 36 – 42) The first floor was inaccessible, although holes in the floor allowed limited visual access. The floor was timber boards, and the walls appeared to be whitewashed brick. An A-frame truss supported the roof to the southern end; all of the timber appeared to be hand cut, including the two purlins to either side. Straight wind braces were also present between the purlins and the principal rafters. To the north side was the remains of a timber frame partition. In the northern gable, the diamond shaped ventilation lights were

Plate 36: First floor showing truss with timber partition beyond

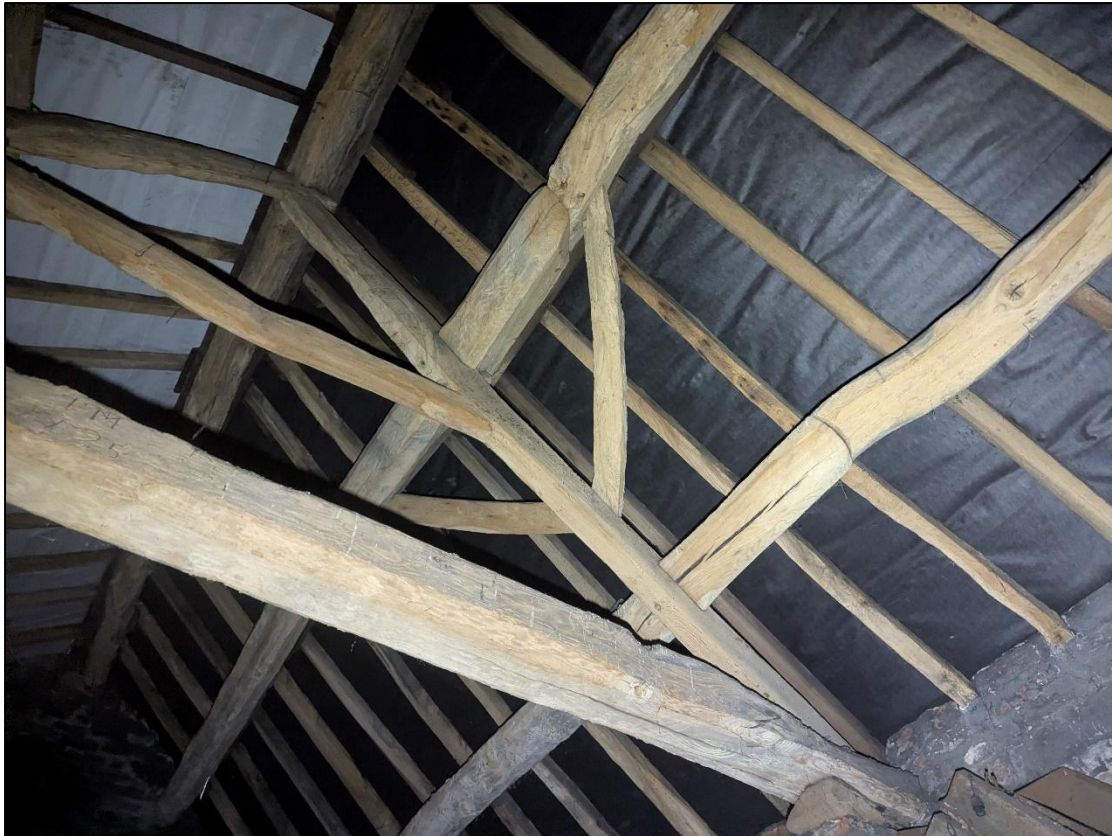
Plate 37: Detail of above showing wind braces

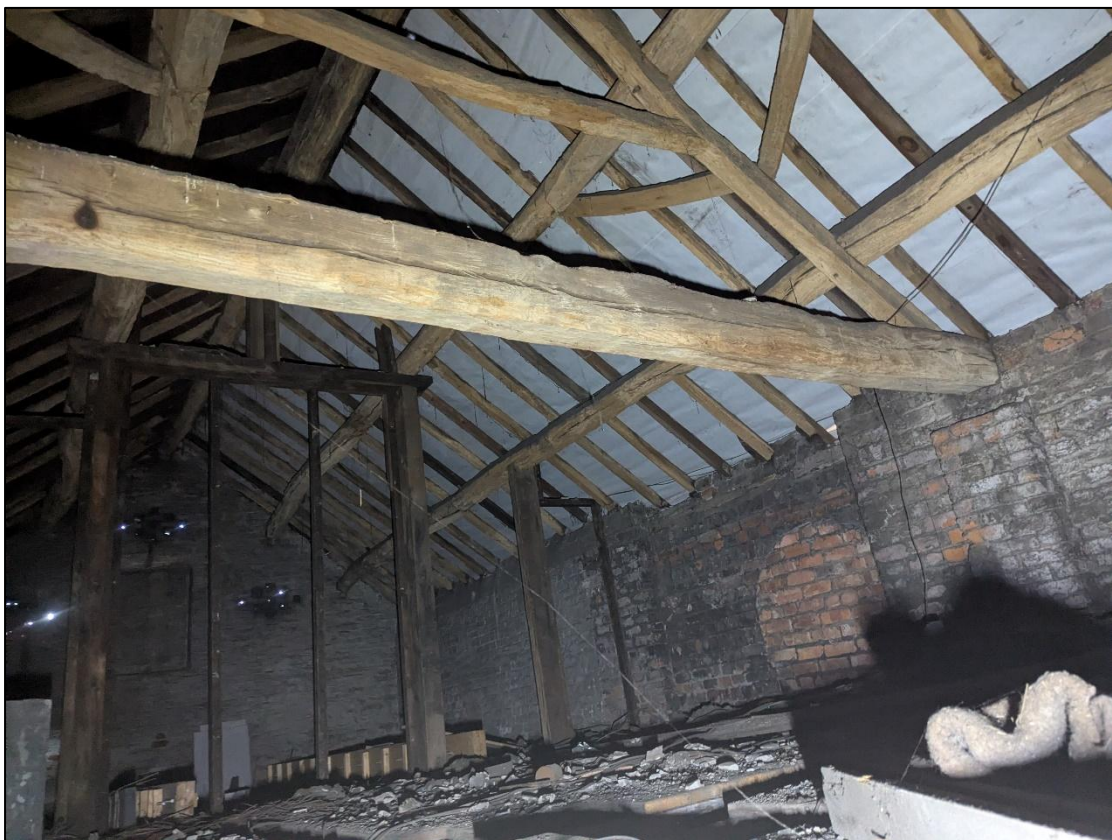
Plate 38: Blocked pitching eye and timber partition

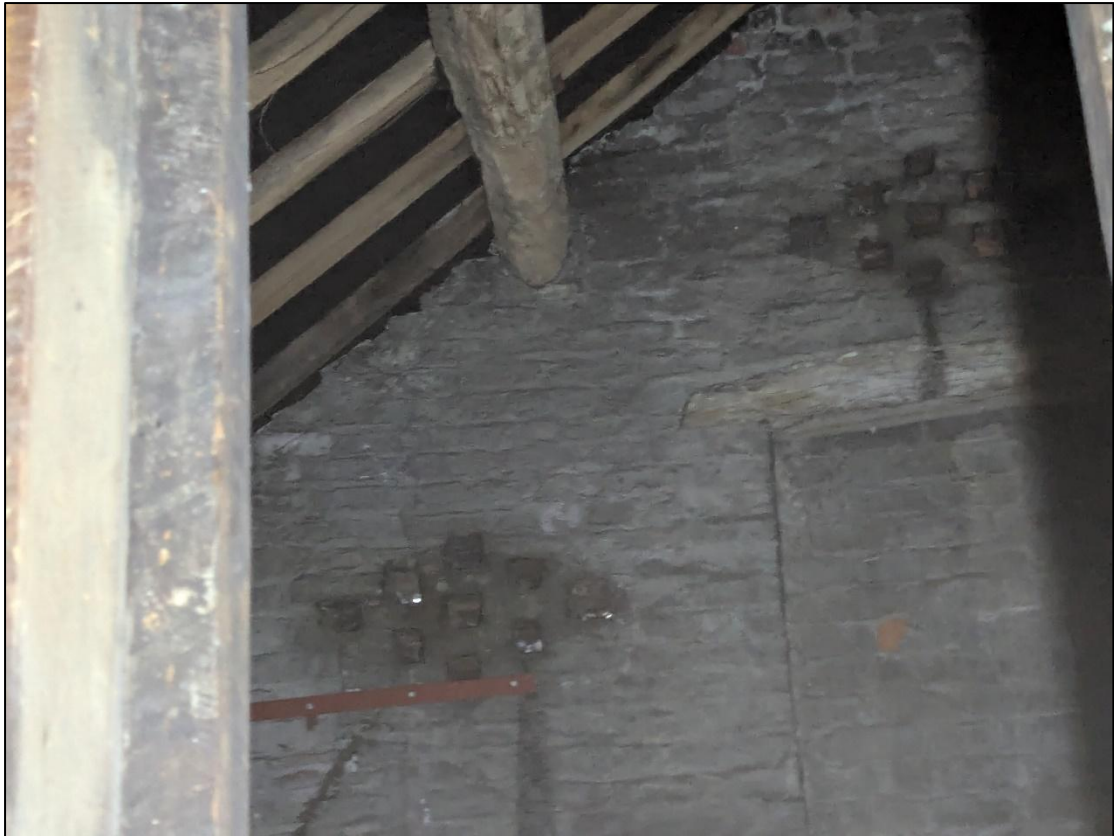
Plate 41: Northern gable showing blocked pitching window and ventilation slots

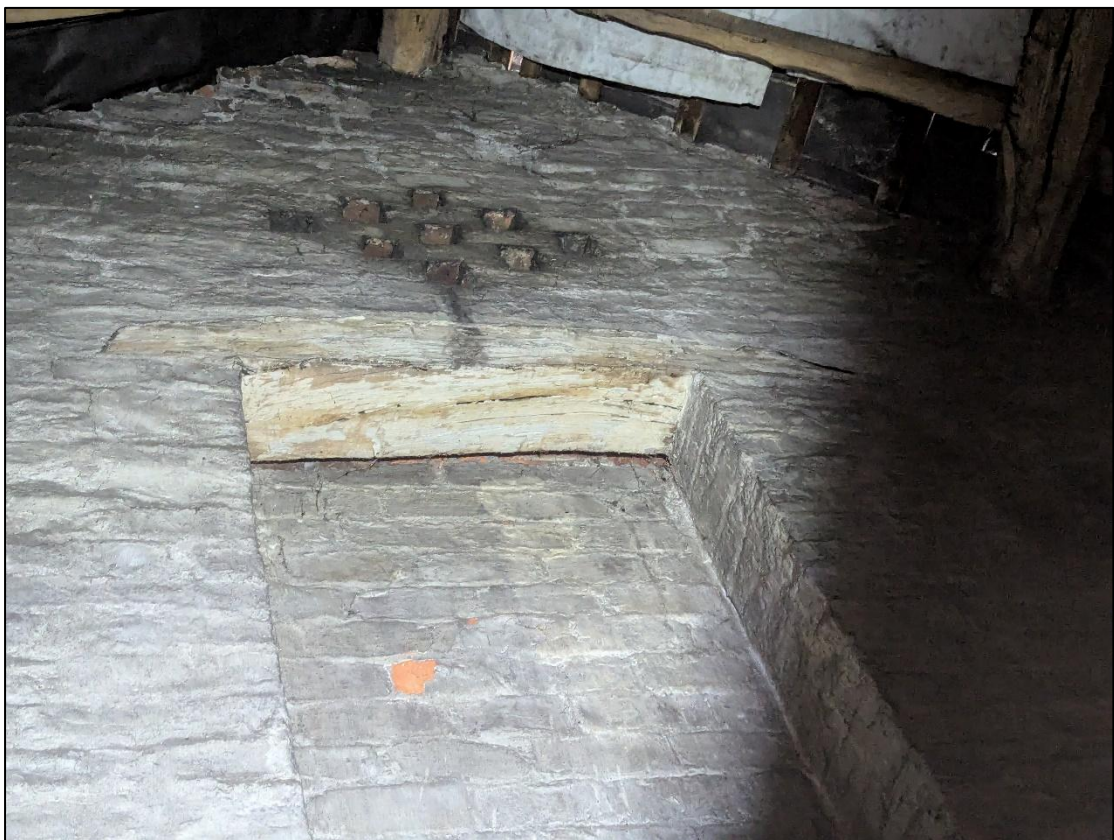
Plate 42: Detail of blocked pitching window and ventilation holes above
