# BUILT HERITAGE STATEMENT

Former Prescott Police Station, Derby Street, Prescott, Merseyside

HER00049  
v.2  
18 March 2024

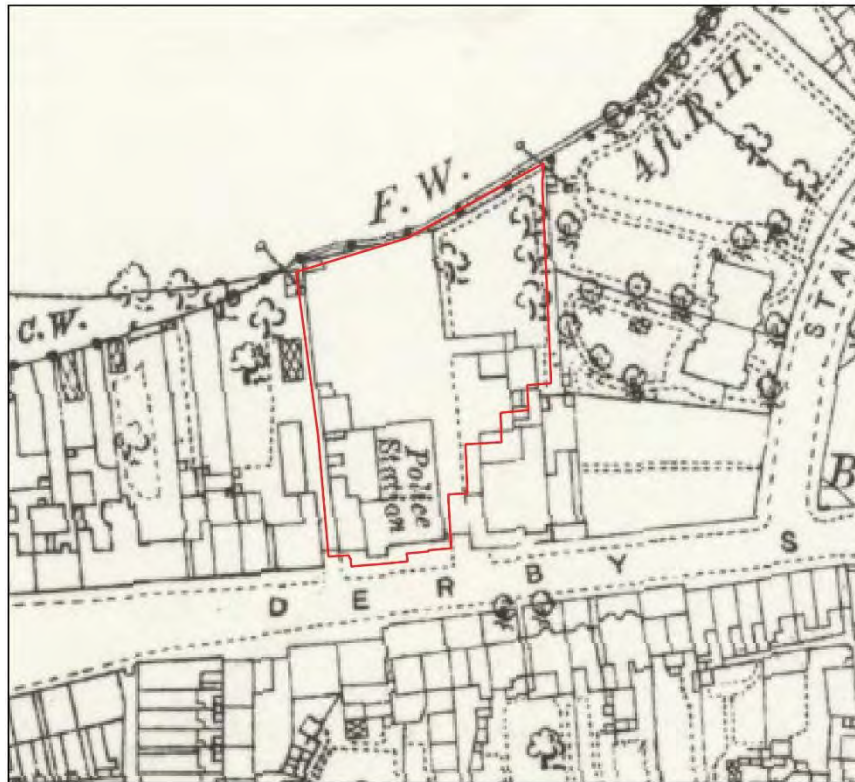
*Figure 6. Extract of 1893 Ordnance Survey, scale 1:2500*

To the rear of the western building a small rectangular building is located in the yard formed by a wall running west from the rear of the larger building to the east.

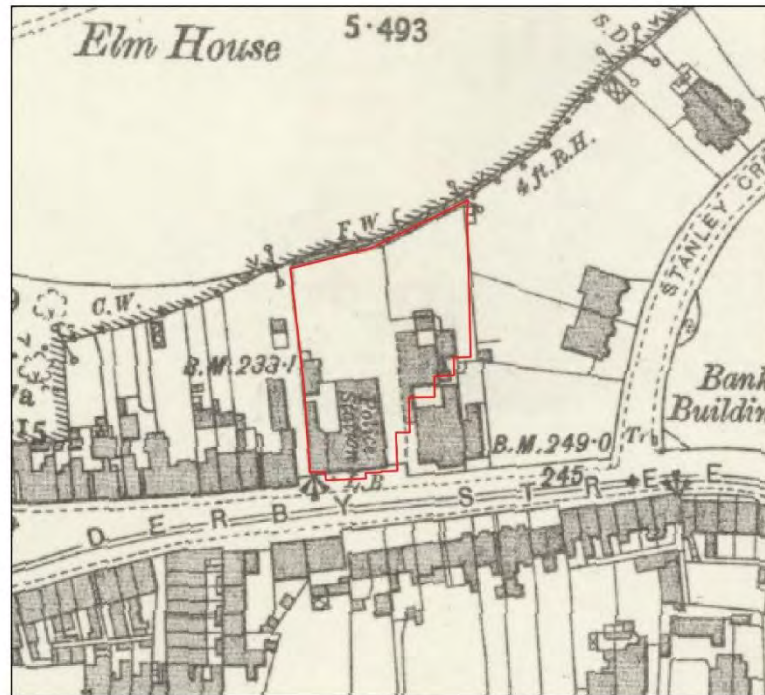
Figure 7. Extract of 1908 Ordnance Survey map of Lancashire, Sheet CVII.7; scale 1:2500

On the 1908 map (Figure 7), the building to the west appears to encompass one of the smaller buildings to the rear. The outbuildings to the rear of the western building have been mostly amalgamated into larger structures. The projection to the south of the larger of the two buildings fronting onto Derby Street is no longer in evidence. An OS bench mark is shown on the south-western corner of the western building.

To the east, in the adjacent plot to the rear of No 41 (the Superintendent's residence) the outbuildings to the rear are more clearly shown, the western boundary of the largest one closest to the police station is indicated with a dotted line which continues to the street frontage. The garden to the rear is no longer shown with trees, but this may be stylistic.

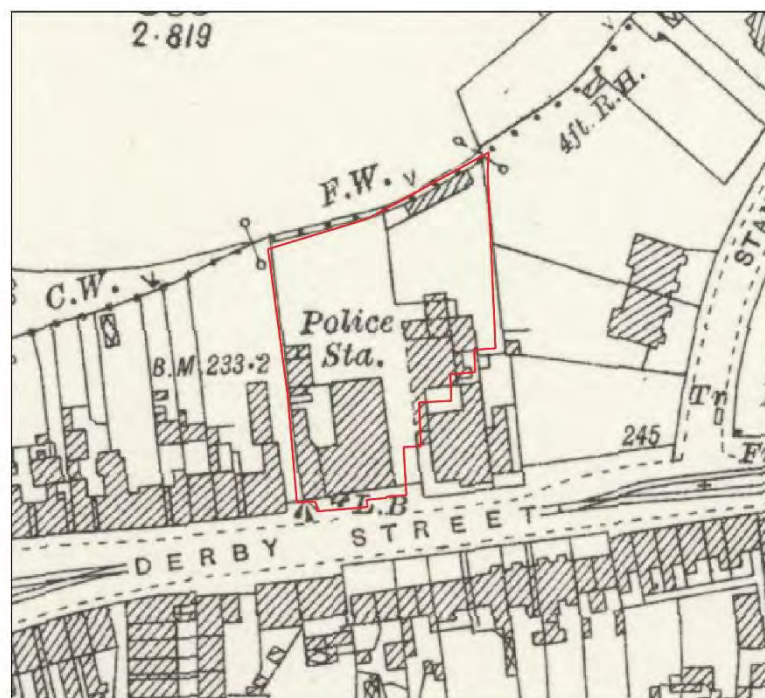
Figure 8. Extract of 1927 Ordnance Survey map of Lancashire, Sheet CVII.7; scale 1:2500

By 1927 (Figure 8), there appears to be a porch added to the frontage of the larger police station building, facing onto the Derby Street in the location of that marked on the 1893 map. The only other obvious change by 1927 is an addition to the east of the northernmost building on the western side of the development.

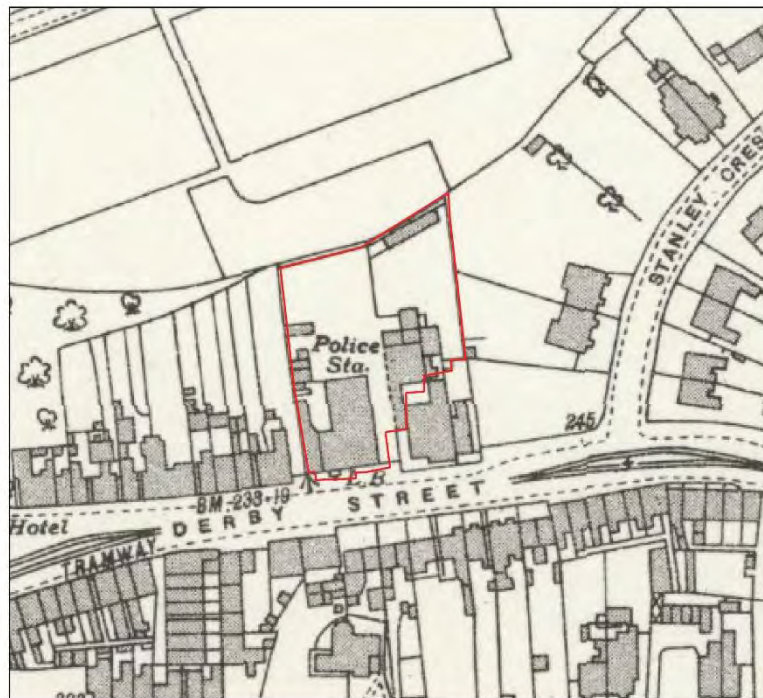
*Figure 9. Extract of 1939 Ordnance Survey map of Lancashire, Sheet CVII.7; scale 1:2500*

Another small building has been added in this area by 1939 (Figure 9), as well as a longer rectangular building (orientated east-west) to the north of this.

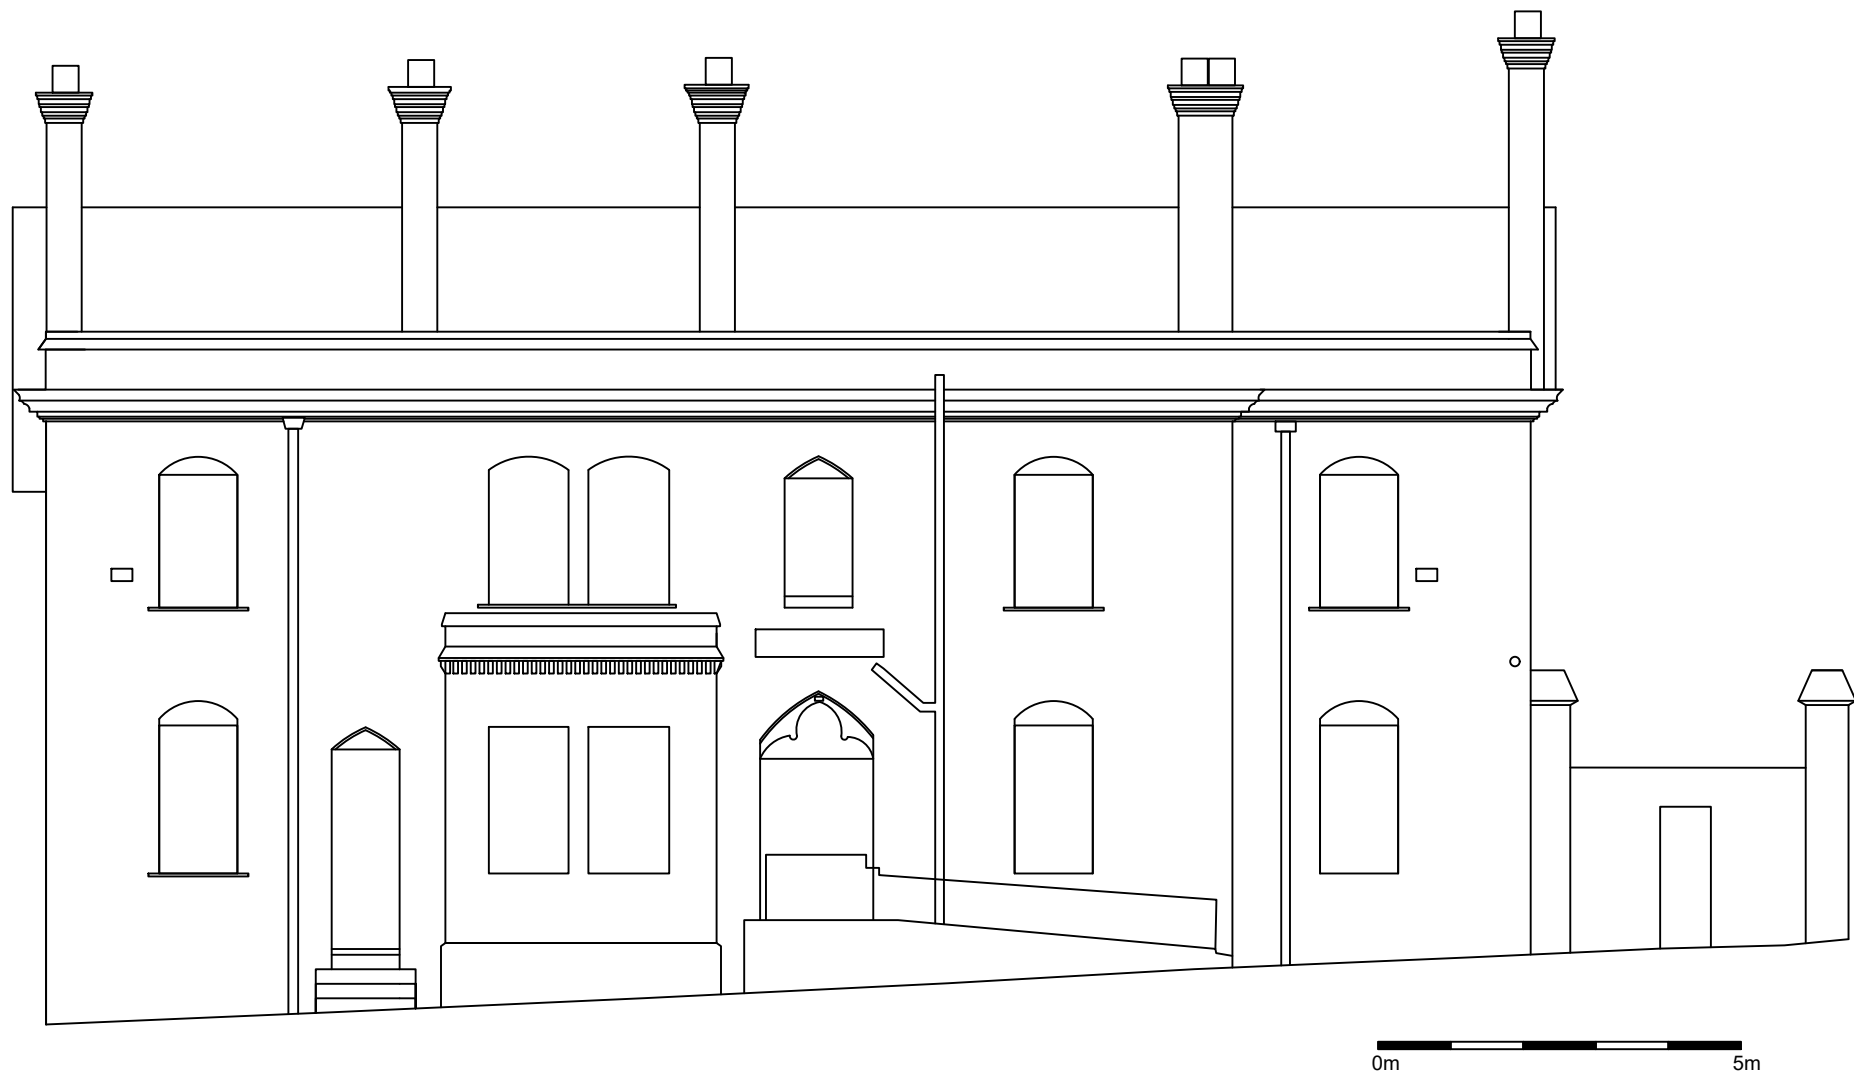
*Figure 15. South facing elevation of police station  
reproduced and adapted from Survey Solutions drawing no. 64179BWLS-01)*

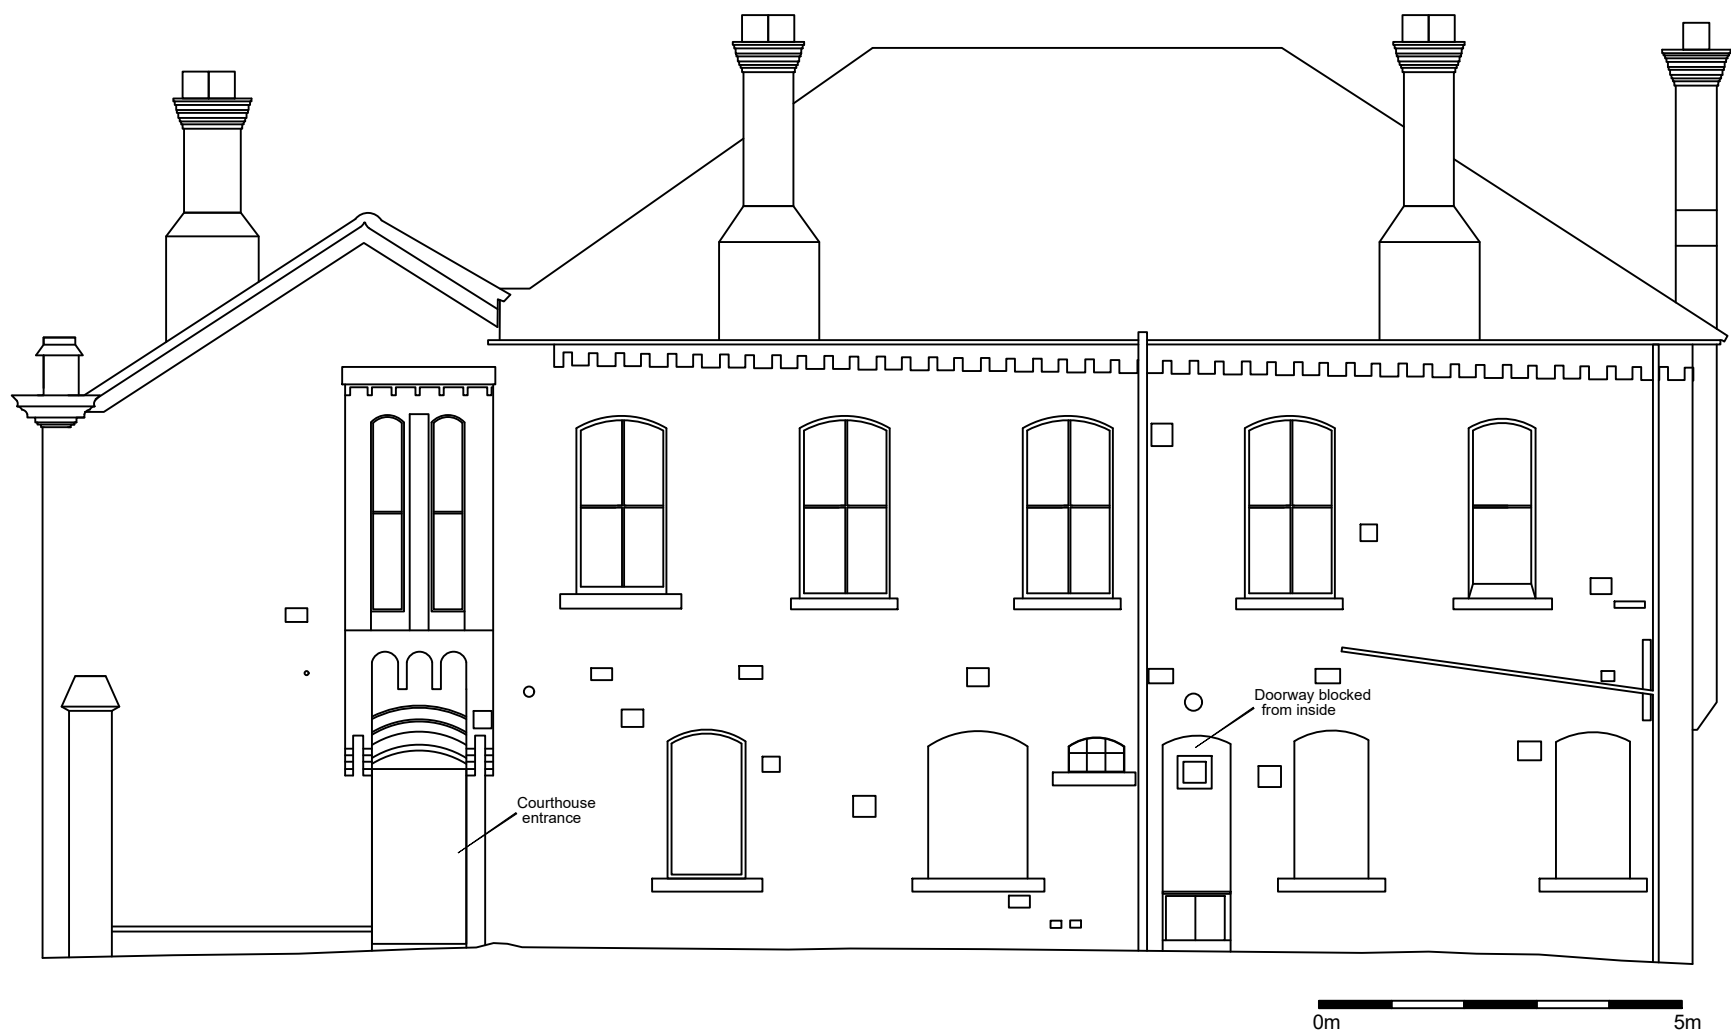
*Figure 16. East facing elevation of police station and courthouse wing  
reproduced and adapted from Survey Solutions drawing no. 64179BWL5-01)*

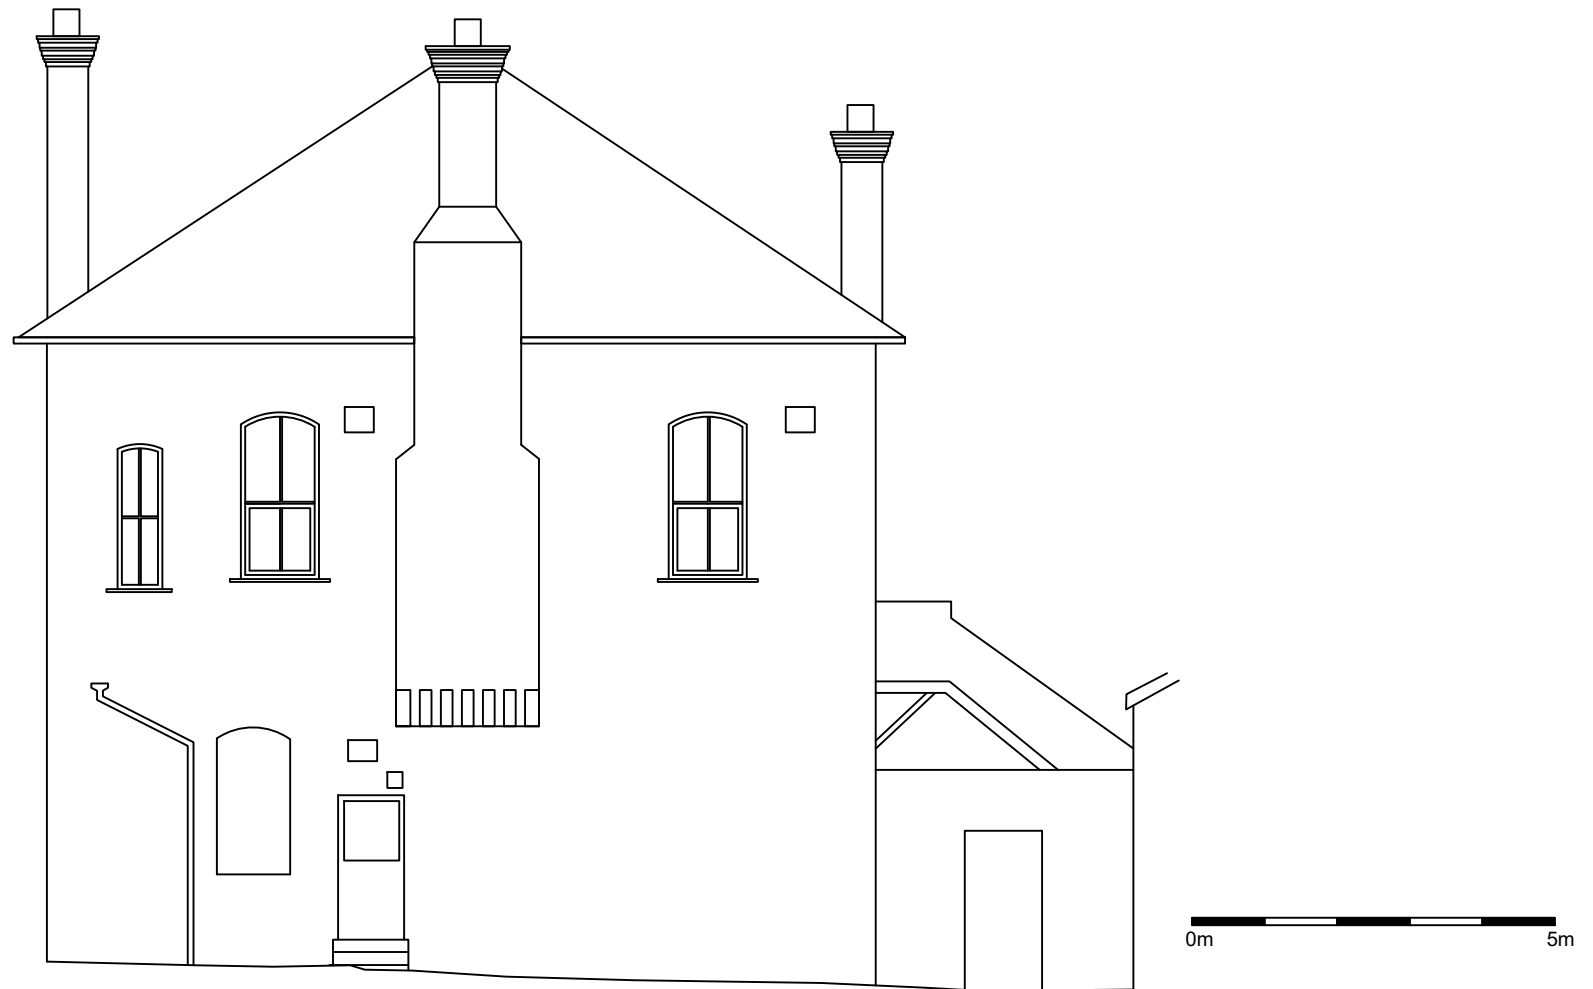
*Figure 17. North facing elevation of courthouse wing  
reproduced and adapted from Survey Solutions drawing no. 64179BWL-01)*

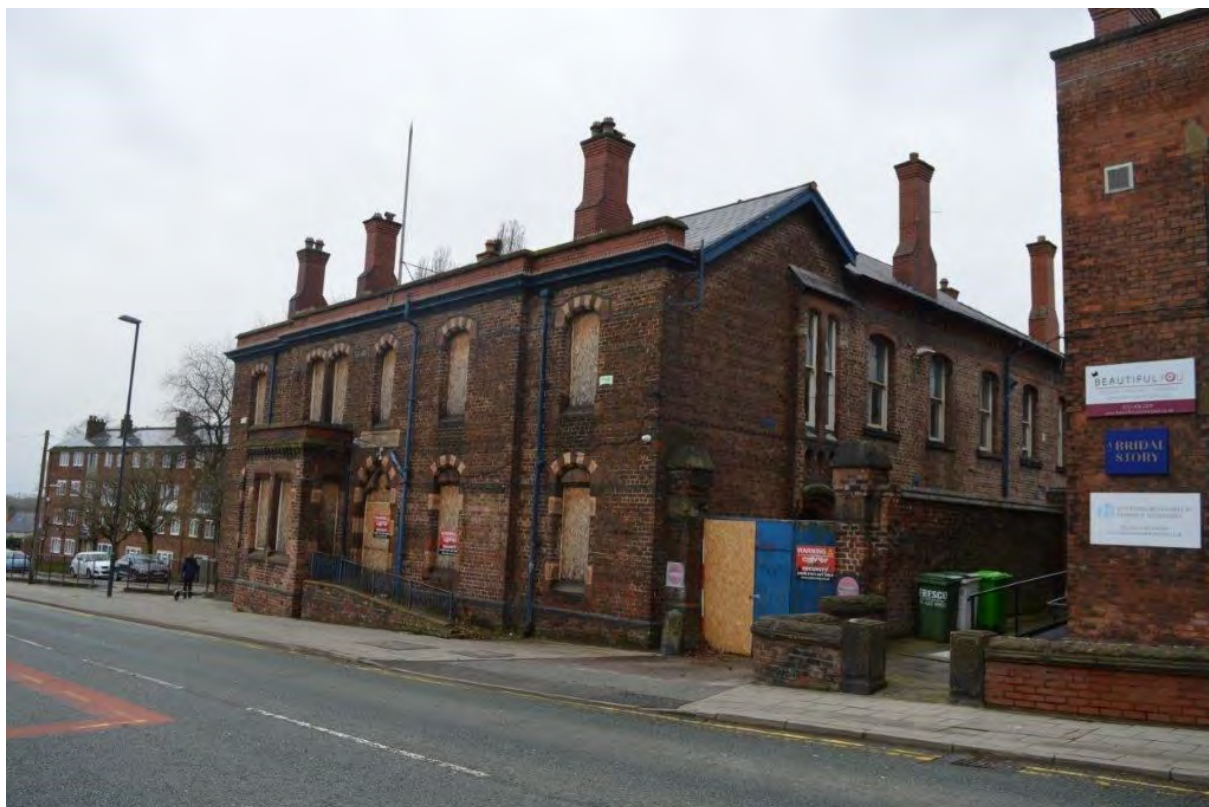
The building is of brick with slate roofs (Plate 1). The main body comprises the original police station with living quarters above, on the frontage of Derby Street with a gabled roof, the ridge of which is orientated approximately east-west. From the eastern side of this, a wing projects to the rear, formerly housing a secure area with cells at ground level with the large courtroom above, since divided into offices (Plate 2). This wing has a Dutch Gable (or Gablet) roof with louvred gables, the ridge of which is higher than that at the frontage with a decorative finial at the southern end. The external woodwork and ironwork was painted mid navy blue at the time of the survey.

Plate 1. The former Prescott Police Station from Derby Street, view north-west

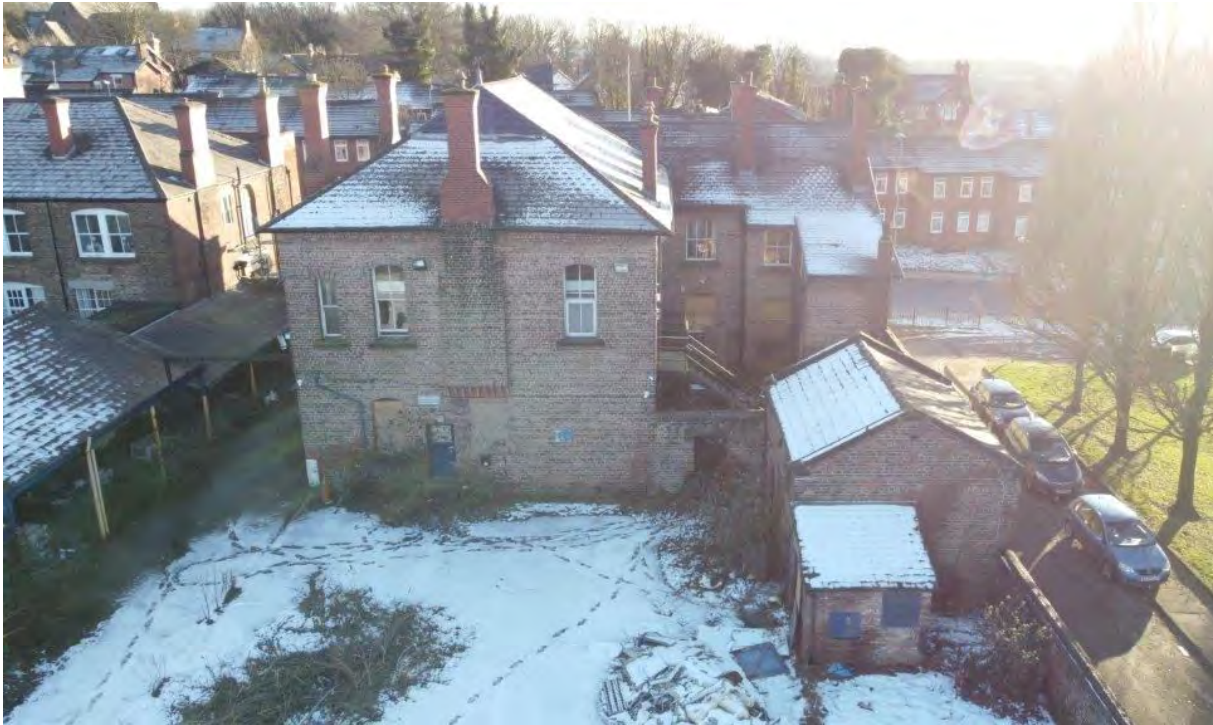
At the northern end of the Courthouse wing, a wall continues westward to meet the western boundary, forming a small courtyard in the north-western quadrant (Plate 3). A two-storey structure projects northward from the western end of the police station wing with a catslide roof, partially encroaching on this and abutting a single storey boiler house. Part of the northern wall of the courtyard is the southern end of a rectangular two-storey brick building with a gabled slate roof which was formerly the stables.

Plate 3. Low level aerial view of rear of building, view south

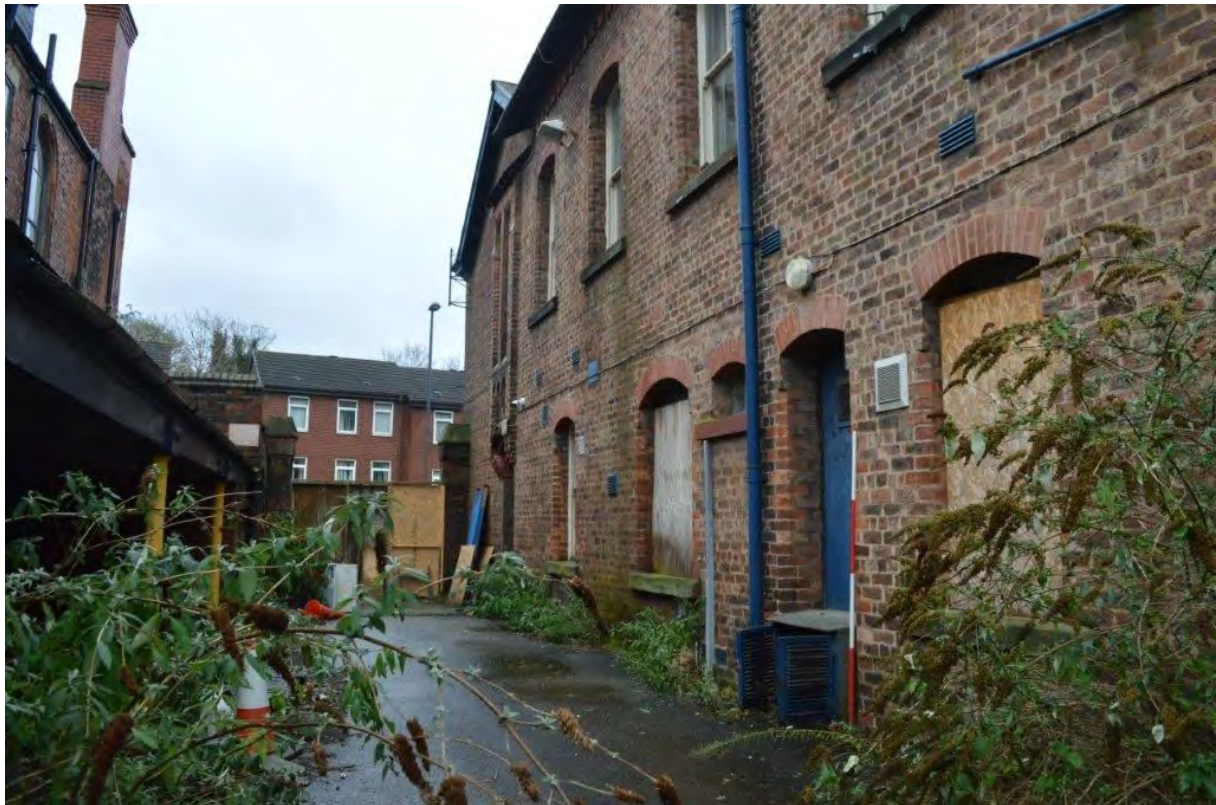
The area to the rear of the police station is accessed from the road by a driveway between the east side of the building and a brick wall, capped with two rows of coping bricks, which forms the boundary to the adjacent property (Plate 4). Along the frontage there are brick pillars, the western set with a partial moulded stone coping against the police station wall and the eastern, with a complete coping, at the south end of the boundary wall. Each has a projecting course at the height of the wall, below which is a stone facing panel on three sides and a plinth at the base (Plate 5). At the time of the survey the ledged and boarded, wooden double gates had been removed and laid on the ground nearby.

Plate 4. Accessway at east of building, view south, scale 2m

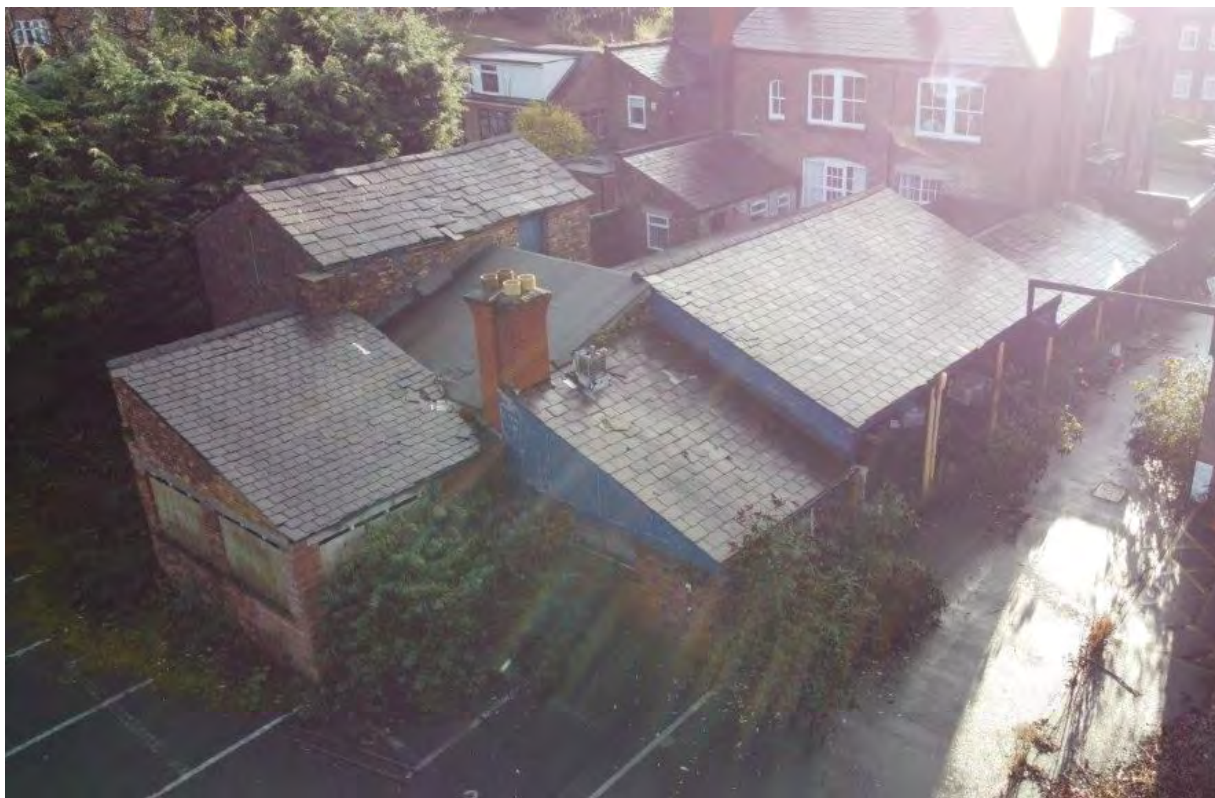
Immediately north of the eastern pillar is the wall between the police station and adjacent property. To the east of this accessway is a group of abutting outbuildings and a large, canopied area (Plate 6). The area to the rear of the building is largely covered with tarmac onto which numbered parking

Plate 6. Low level aerial view of Buildings A-G, view south-east

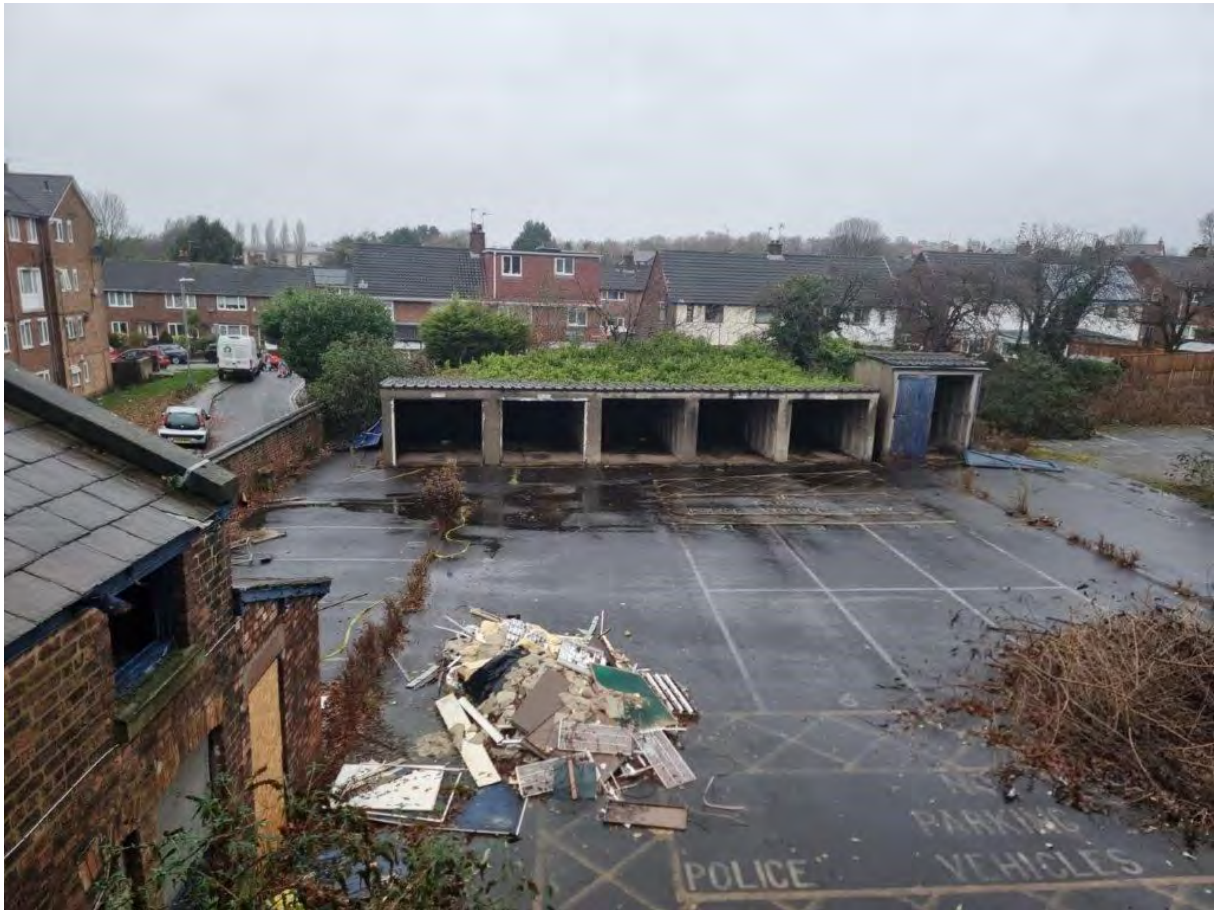
places have been painted as well as yellow boxes to maintain access (Plate 7). A set of garages and a shed stand at the northern boundary of the property.

Plate 7. View of car parking area to rear of building, view north, stables (Building J) to left

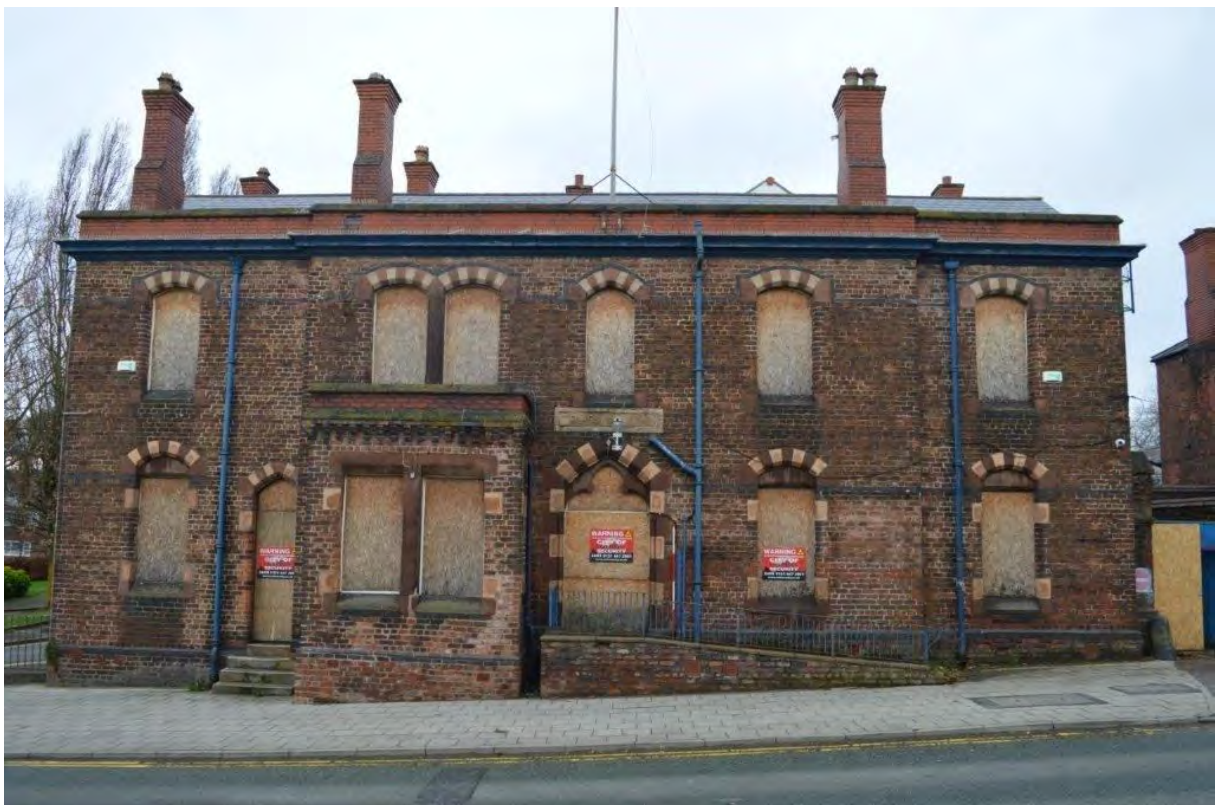
The frontage of the building faces onto Derby Street (Plate 8). Here the ground level falls to the west and this slope is compensated by the wall to the west being taller than to the east. The wall is dark reddish/grey brick set in English Garden wall bond with headers every fourth row, bonded with a lime mortar.

Plate 8. South facing elevation of police station, view north, scale 2m

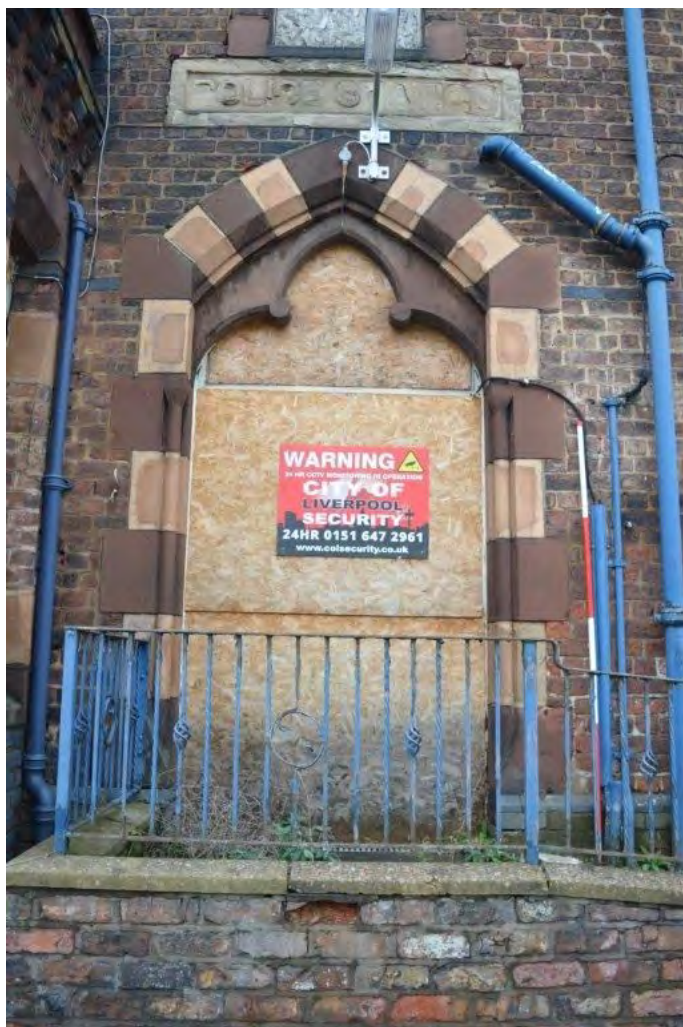
Plate 9. Front door of police station and ramp,  
view north, scale 2m

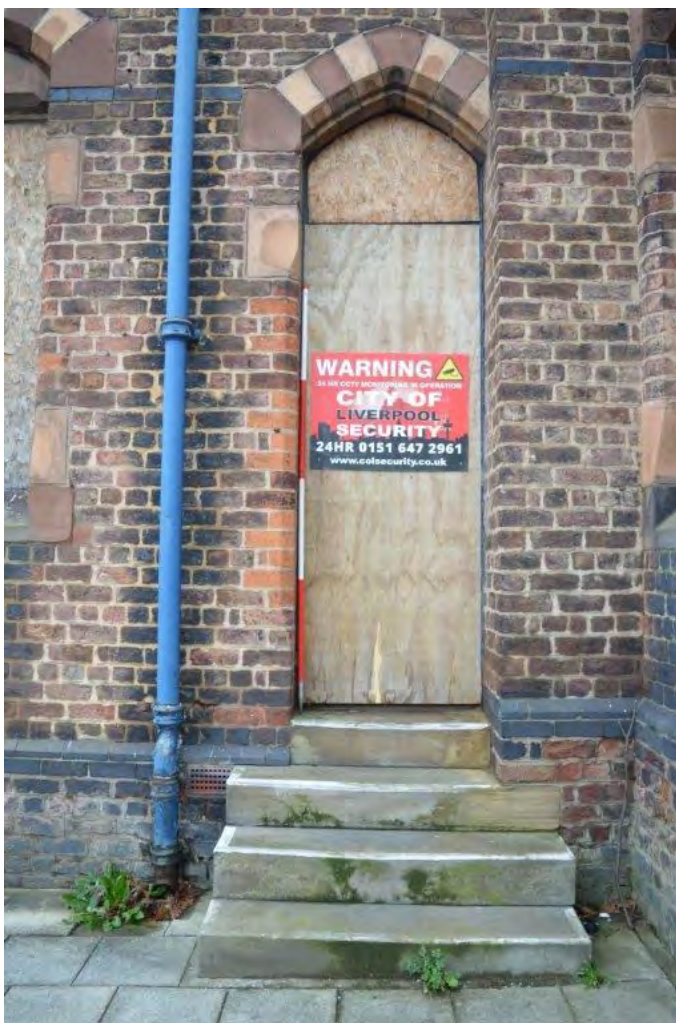
Plate 10. Narrow doorway in front elevation of  
building, view north, scale 2m

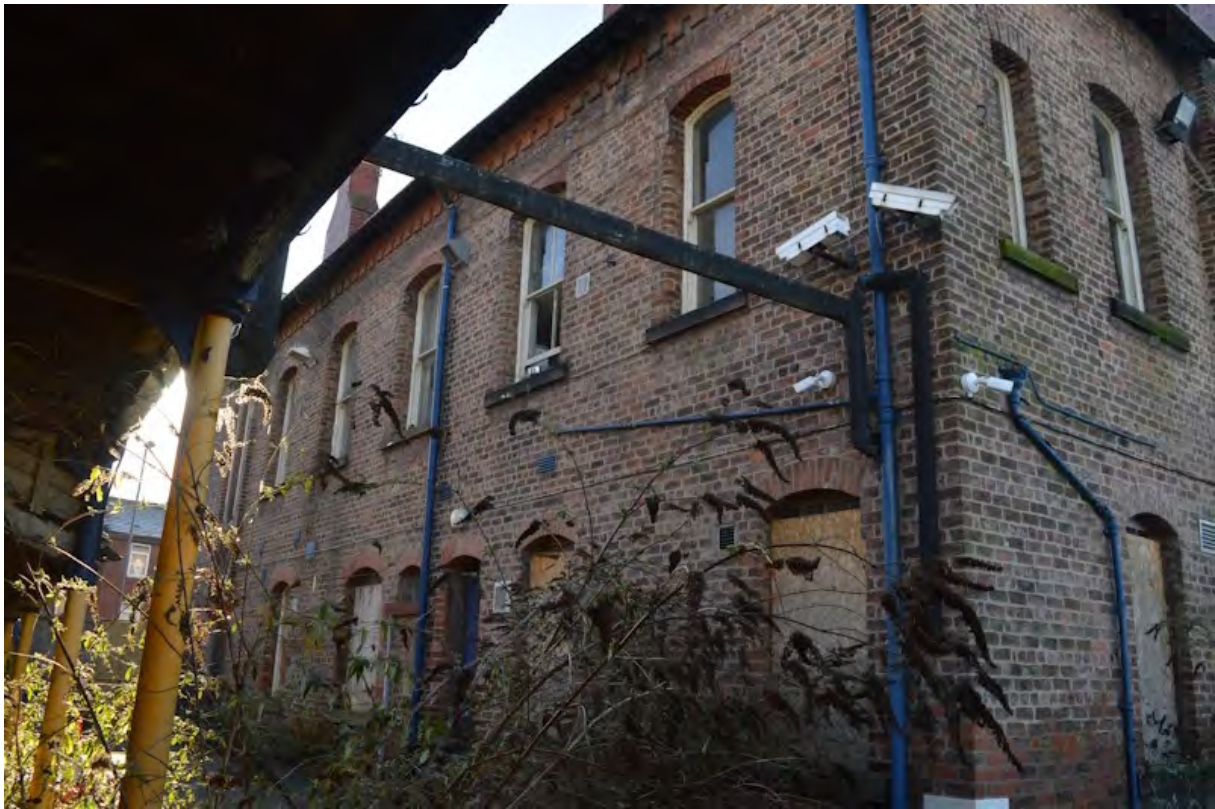
Plate 11. East facing elevation of courtroom wing, view south-east

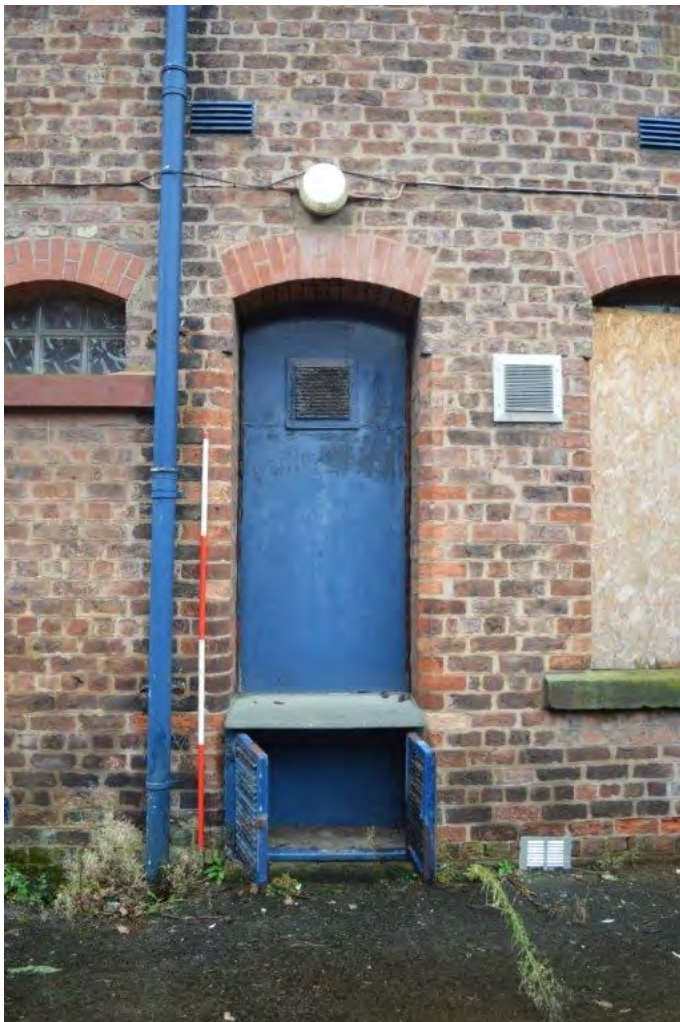
Plate 14. Doorway to RG21 (blocked from inside), view west, scale 2m

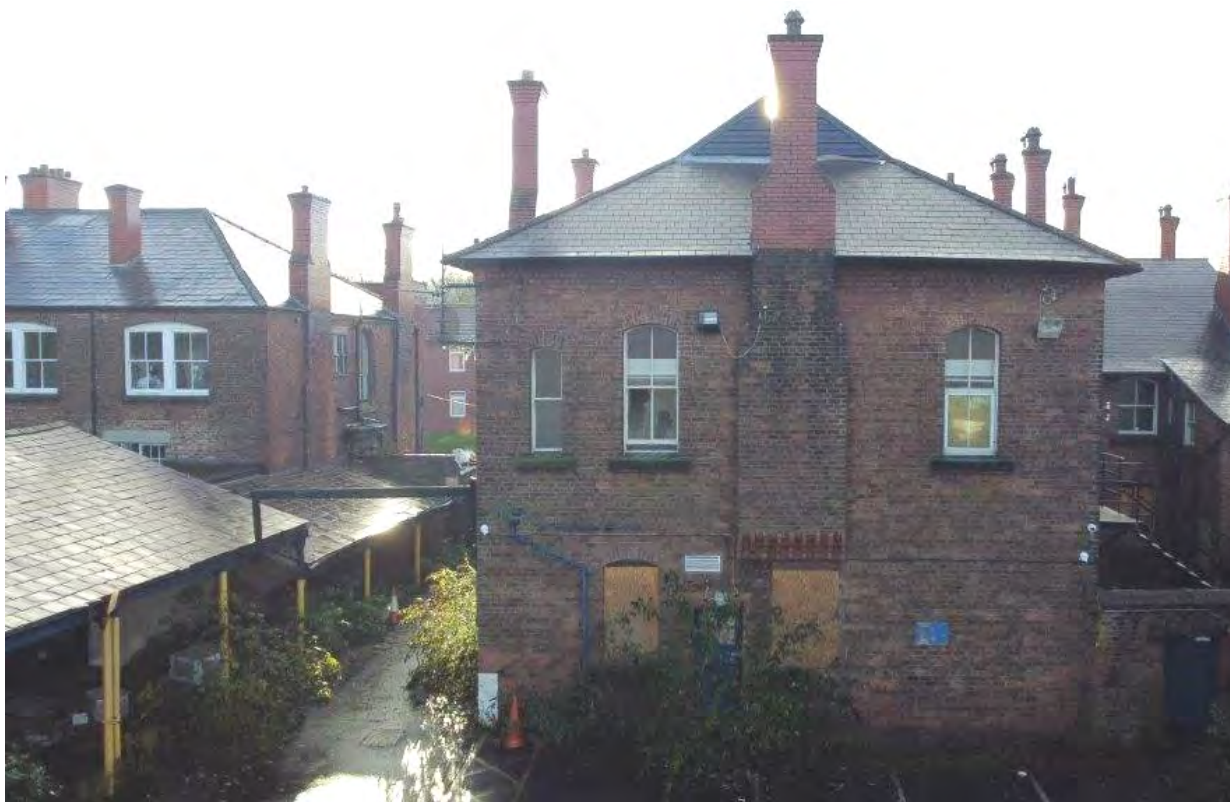
Plate 15. North facing elevation of courtroom wing, view south

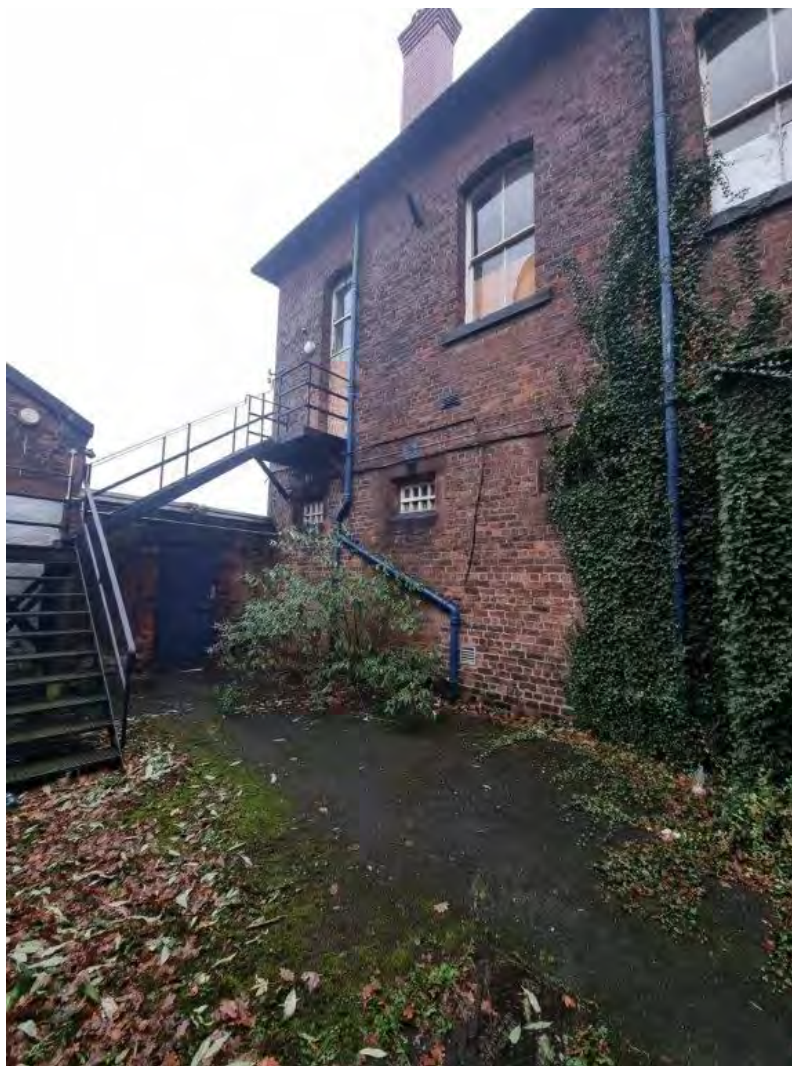
On ground floor level in the courthouse wing are three small rectangular windows of two rows of four-light reinforced glass windows with chamfered sandstone surrounds (Plate 18). These are the windows to cells RG26-28. A slight rectangular projection to the south of these is the western end of Room RG15, latterly a male toilet and a modern addition, with a two-light fixed, frosted window in the western end. South of this is a small sash window, adjacent to a doorway accessed by three concrete steps with a rail of plain metal tubing (Plate 19). This doorway leads to Room RG14.

Plate 18. External view of window to cell RG28

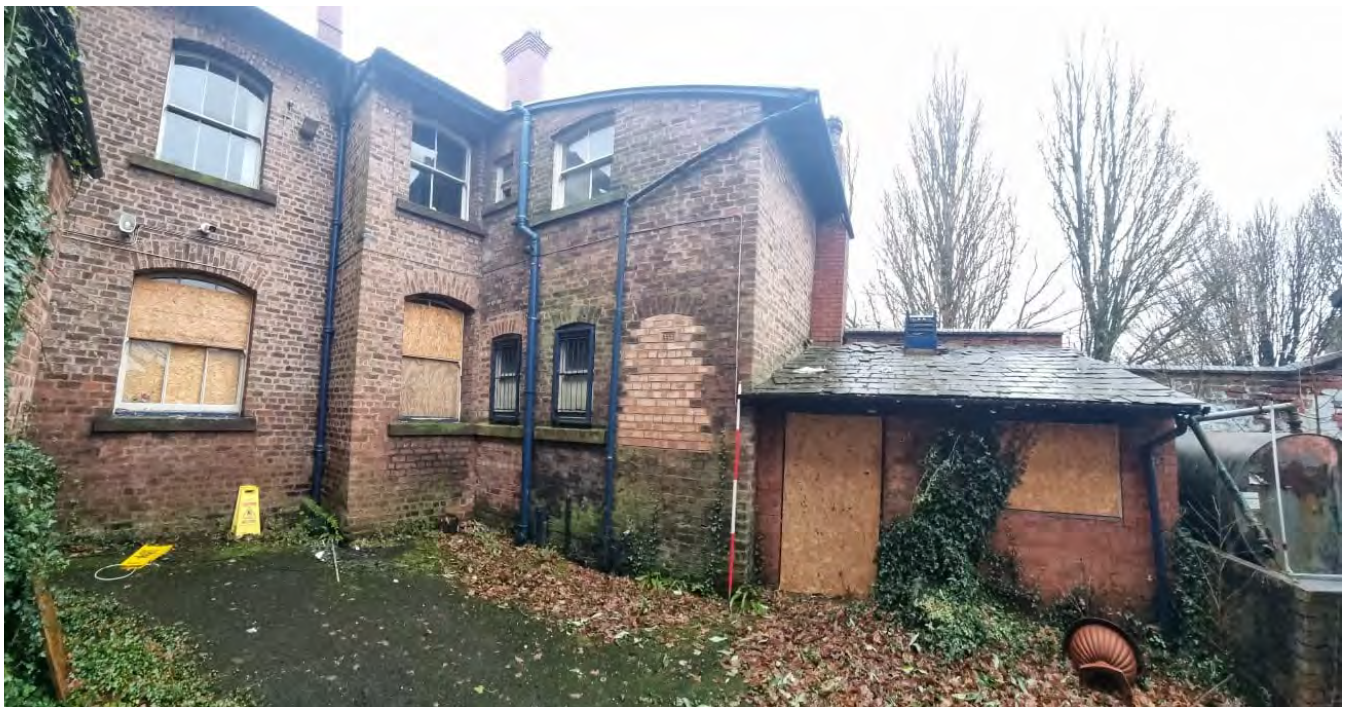
Plate 20. Northward projection section of police station west of courtyard and boiler house, view south-west

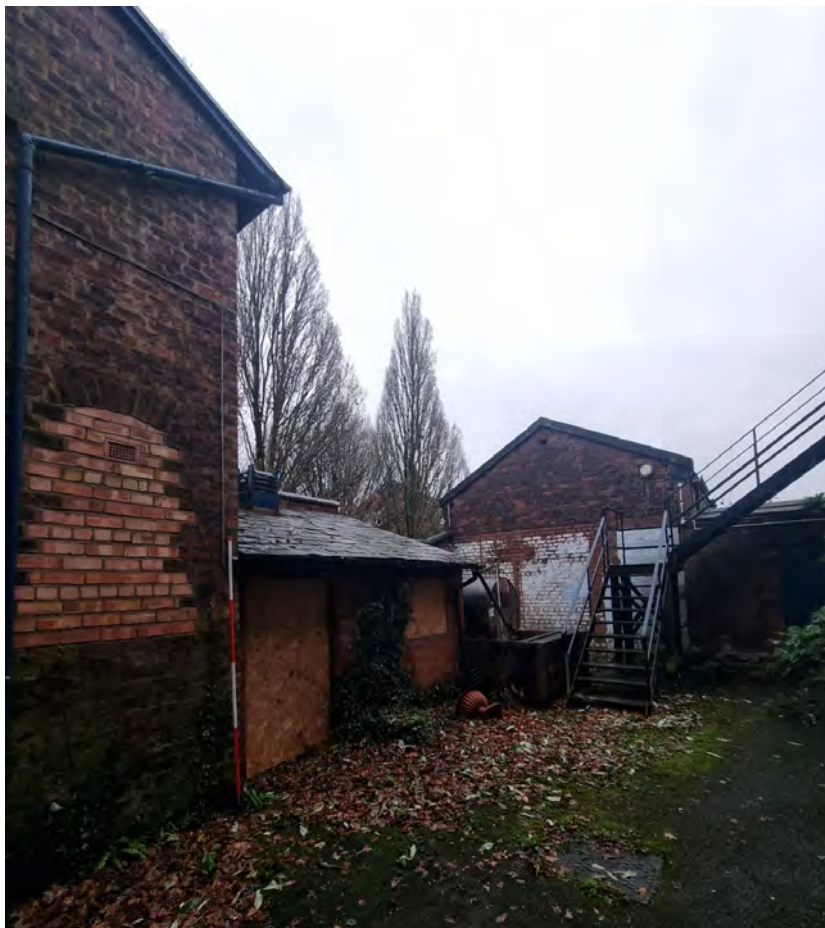
Plate 21. The courtyard view north-west, scale 2m

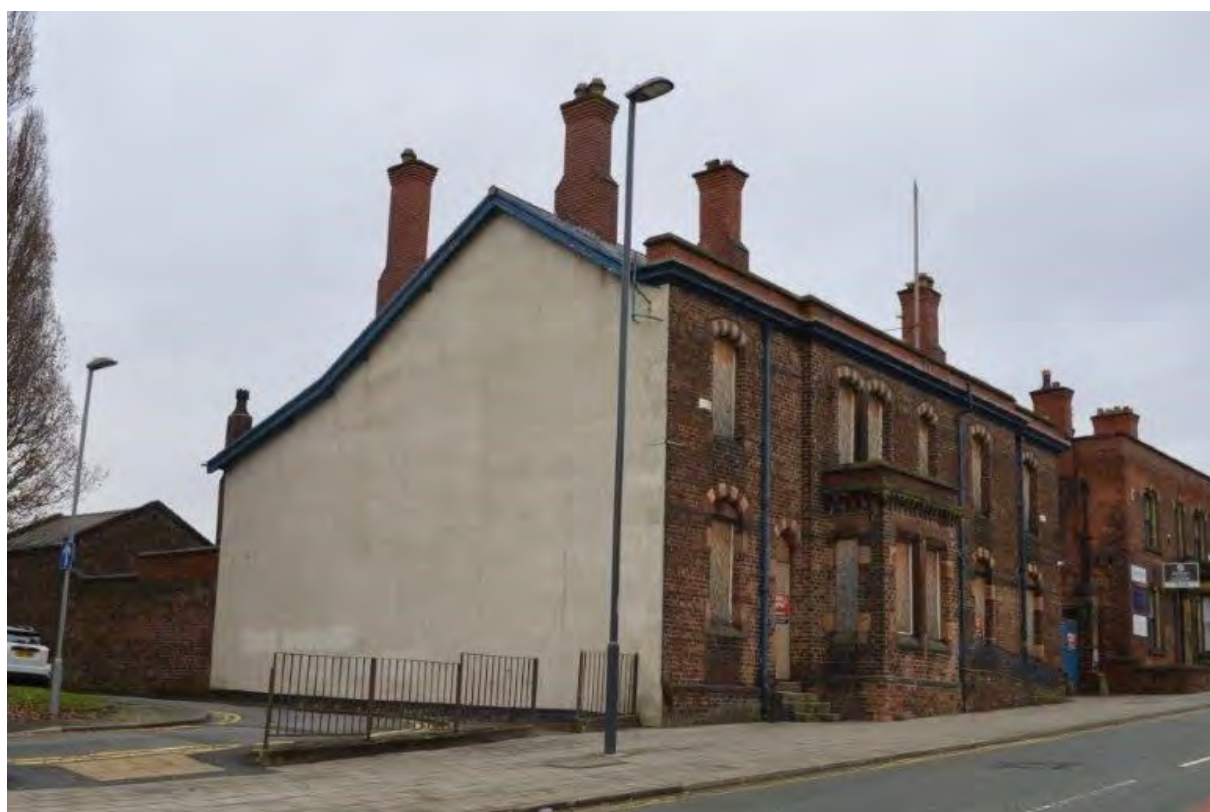
Plate 22. South and west facing elevations of building from Derby Street, view north—east
