# BUILT HERITAGE STATEMENT

Former Prescott Police Station, Derby Street, Prescott, Merseyside

HER00049  
v.2  
18 March 2024

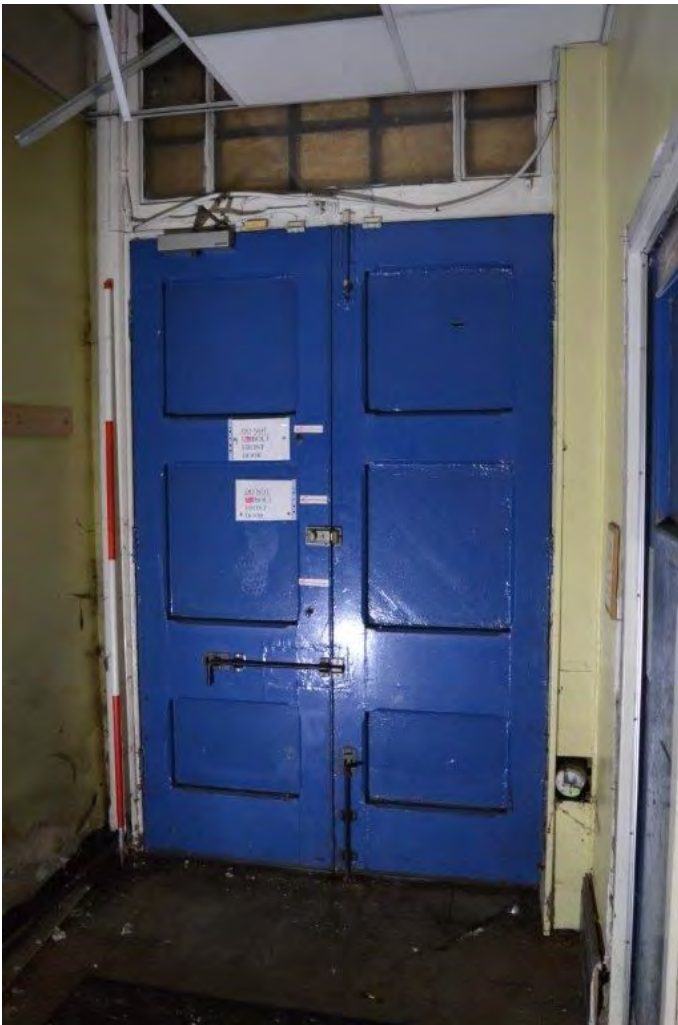
Plate 23. Rear of front doors from lobby RG01  
view SSE, scale 2m

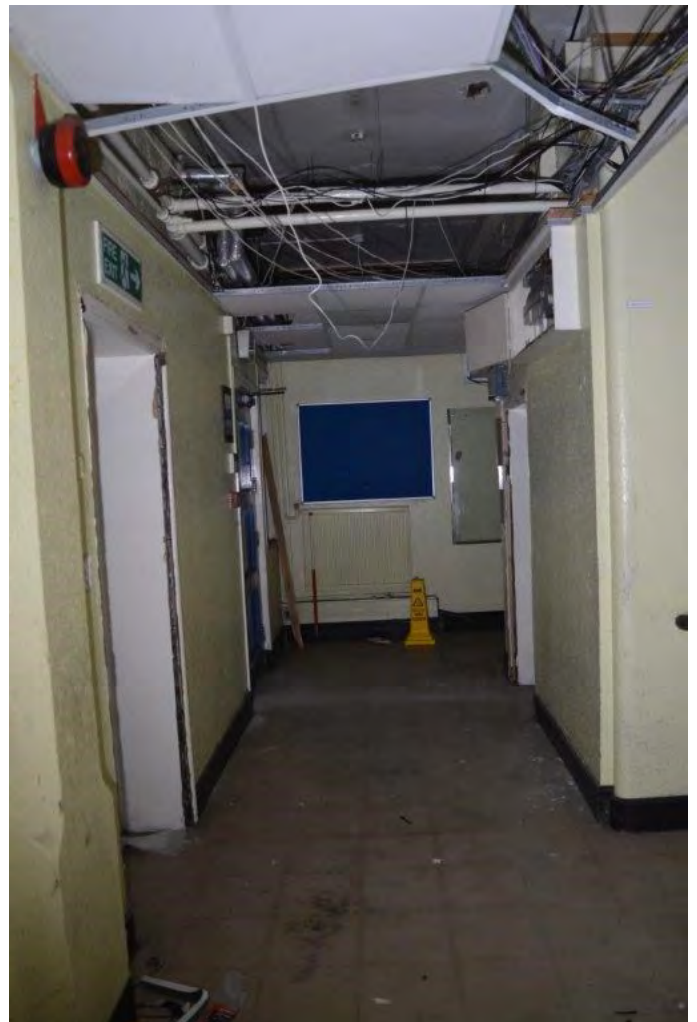
Plate 24. Corridor RG01, view north

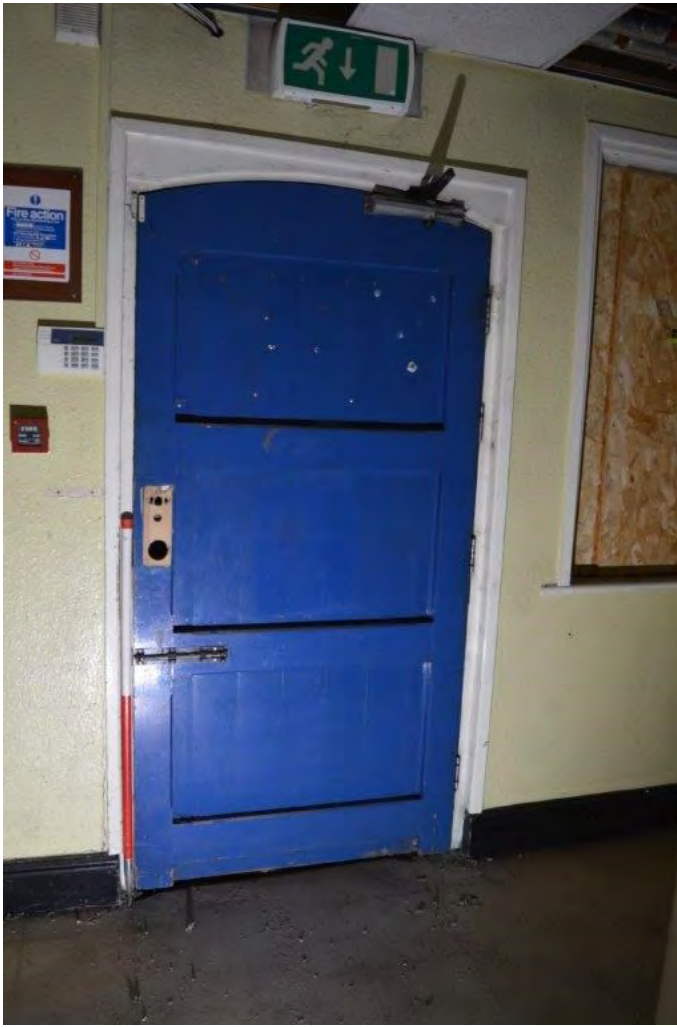
Plate 25. Rear of door to courtyard from RG01, view west, scale 1m

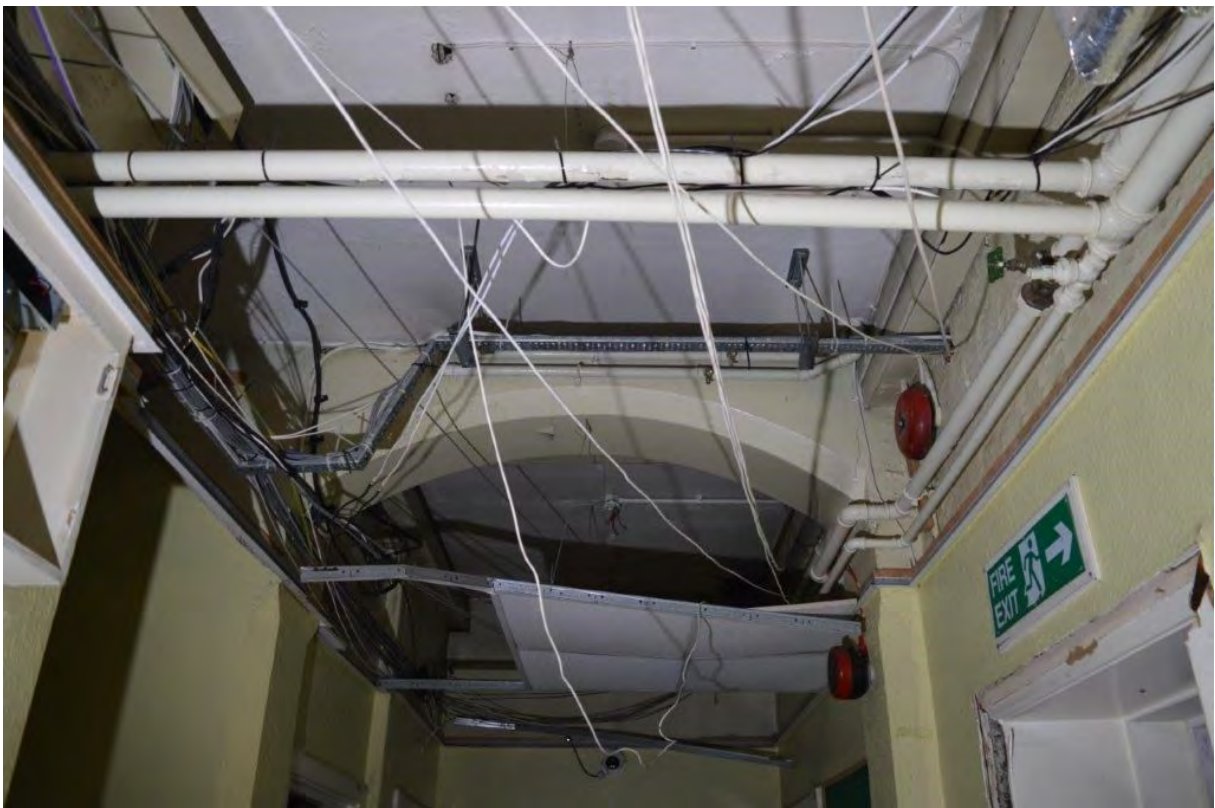
Plate 26. Arch over central section of RG01 adjacent to stairwell RG11, view south

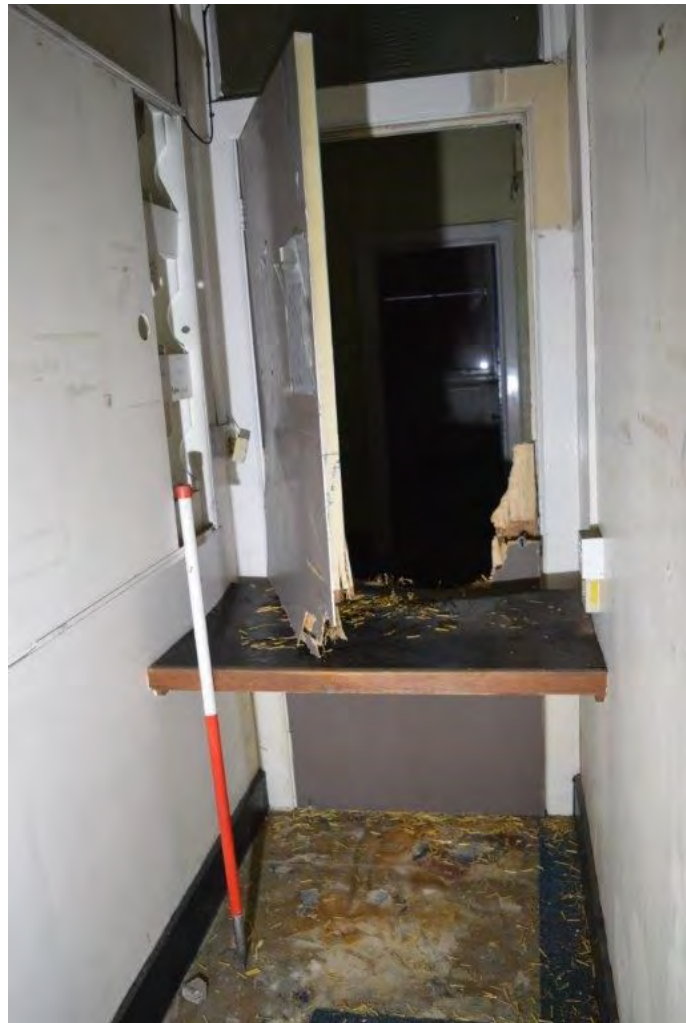
Plate 24. Cell call system and panic alarm system console in RG02, view west

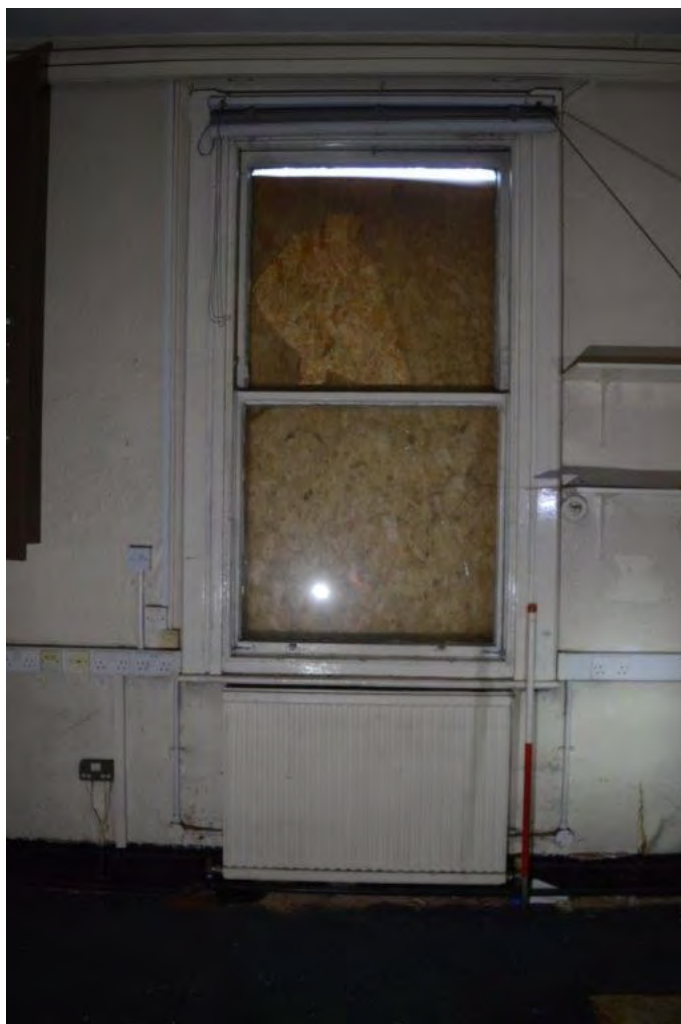
Plate 37. Single hung sash window in south wall of RG03 facing Derby Street, view south, scale 1m

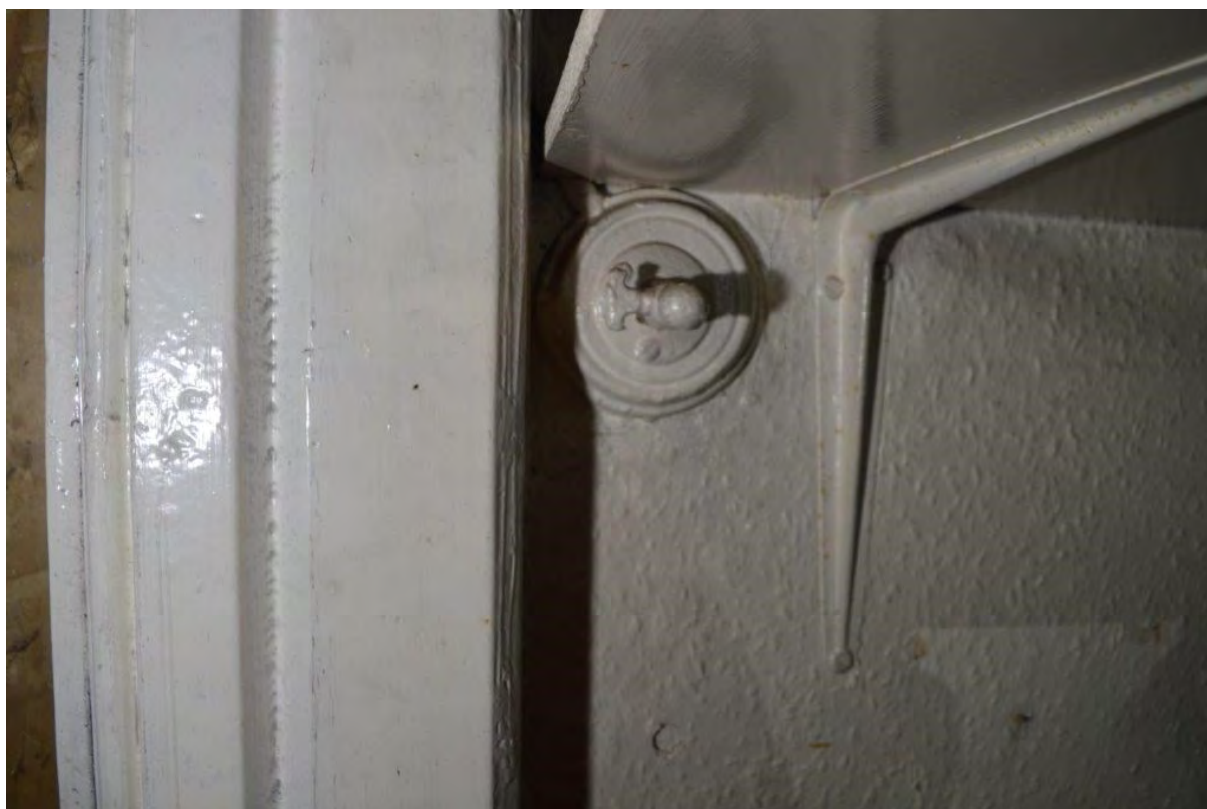
Plate 38. Light switch adjacent to window

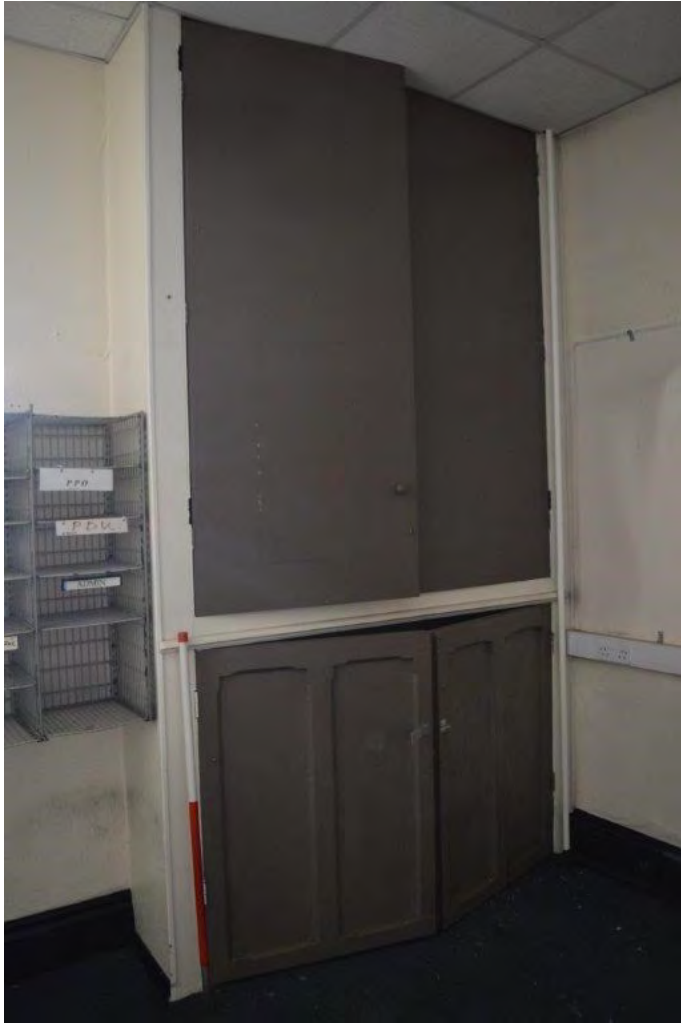
Plate 39. Built in cupboards in north-east corner of RG04, view north-east, scale 1m

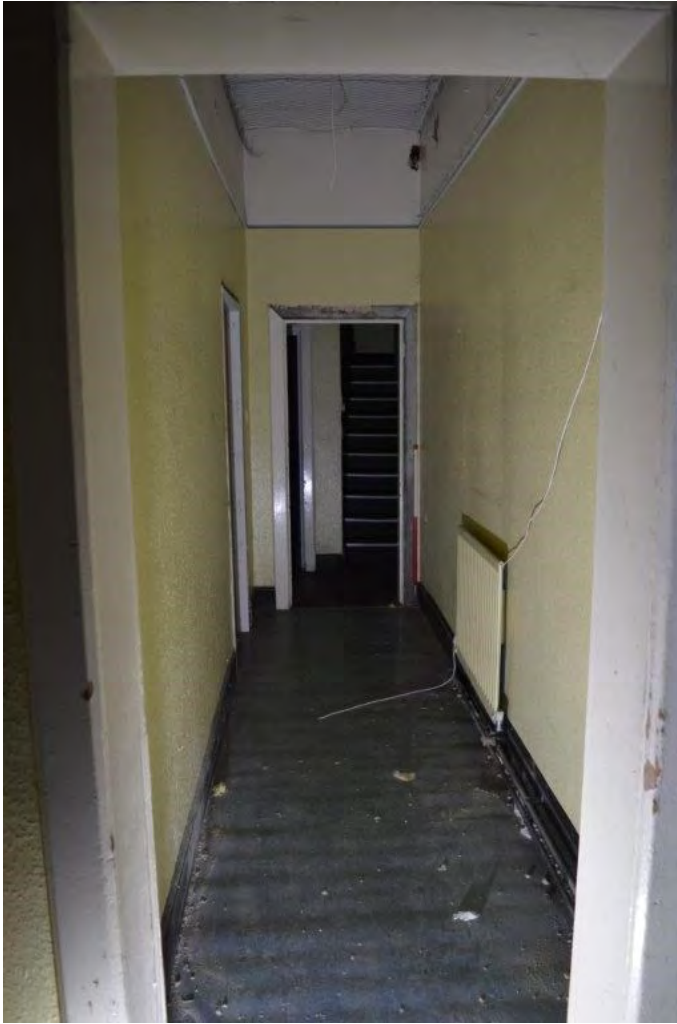
Plate 41. Corridor RG05 facing west, scale 1m

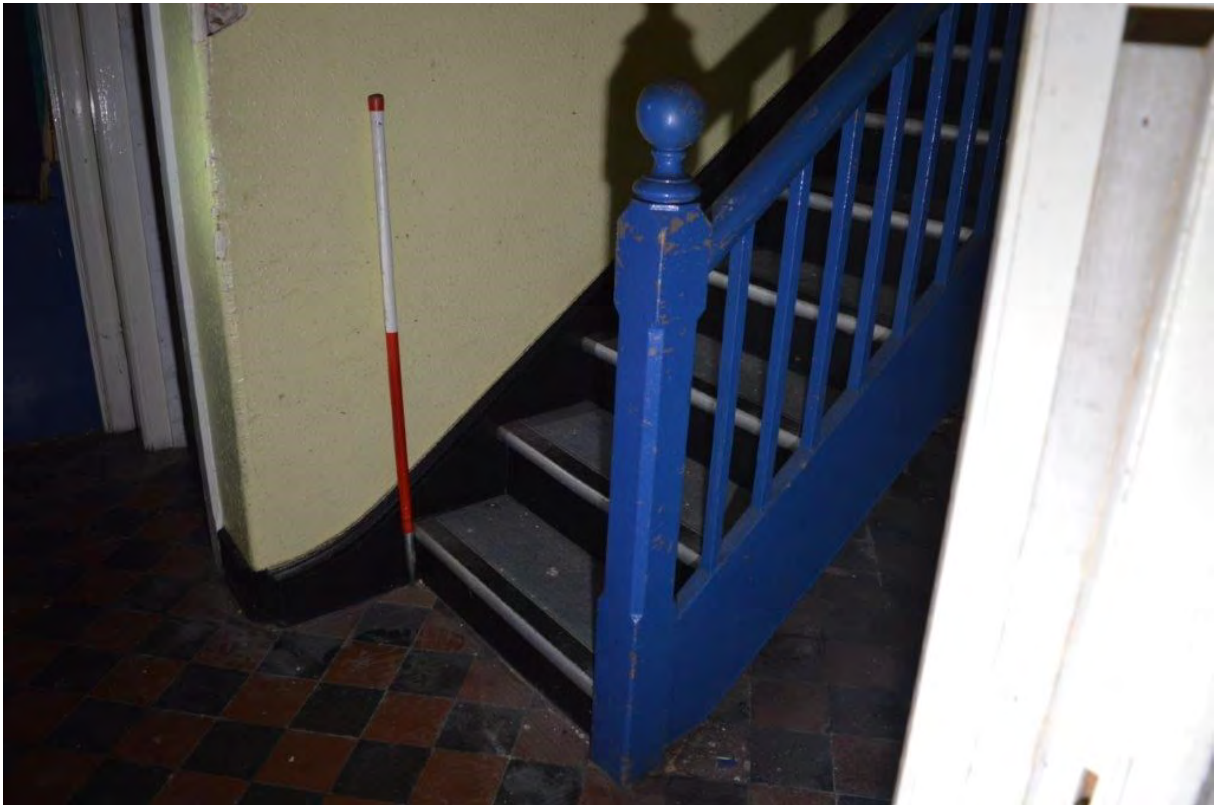
Plate 42. Base of stairwell RG06, view south-west

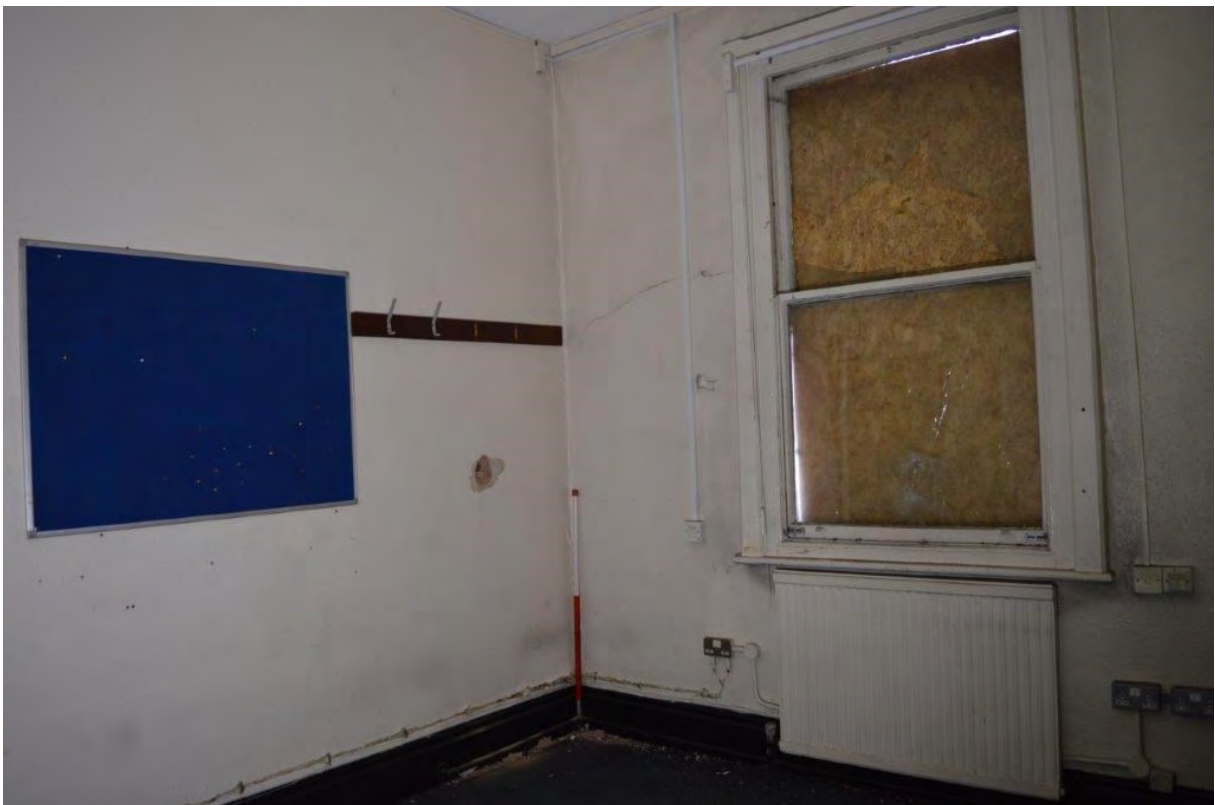
Plate 44. View south-east in RG07, scale 1m

- 3.40 In general terms, some original fireplaces survive as do most original windows, though those have had their frames, at some point, removed and reset at a different angle in their embrasures [see, as an example, Plate 44, Appx A]. Many are rotting, have no surviving weights or sash ropes and do not operate due to the strange angle of resetting or have been fixed shut, with many over-painted. A different style of sash windows is seen in the small rear wing to the former western accommodation element [RG08 & 09], suggesting that these are later replacements.

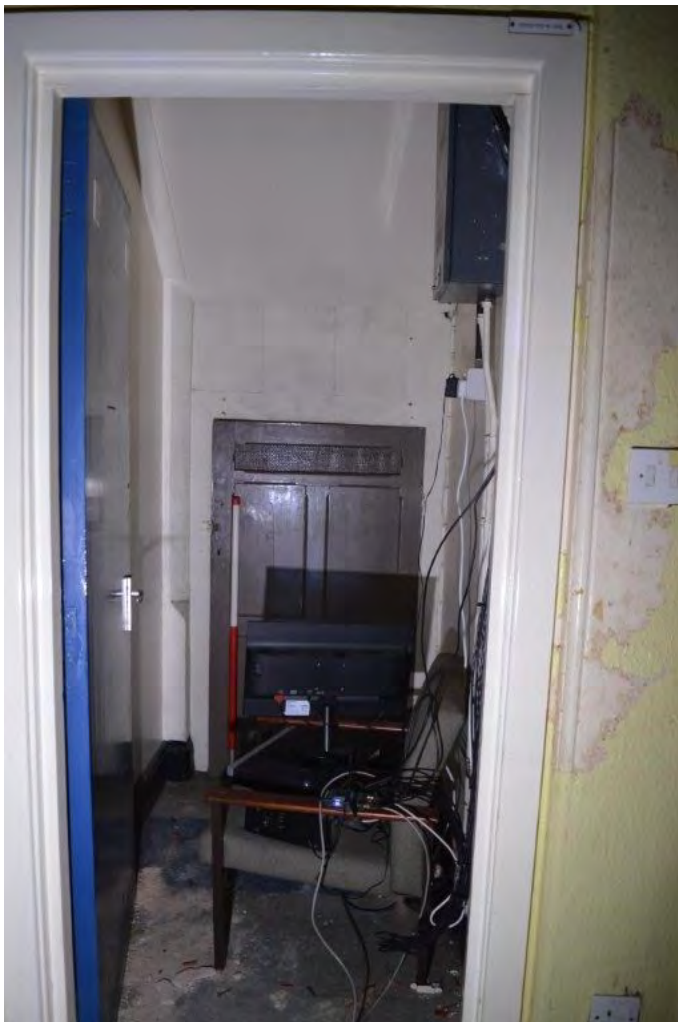
Plate 54. View east into RG12, a space below stairwell RG11, scale 1m

The wall to the north is solid, the stairs partially obscuring the top of a blind arch (Plate 107), the base of which is visible in cupboard RG12 below and the rear of which is at the base of the stairs (RG11, Plate 54). There is a suspended panel ceiling, but where the panels are missing the roof structure is visible, the slope rising southwards demonstrating that the staircase is within the main section of the police station rather than part of the Courtroom (Plate 108). The skirting on both sides of the staircase is moulded.

Access directly from the police station to the courtroom would have been afforded by stairs RG11/RF13. These stairs partially obscure the top of a blind arch visible at the base of the stairwell (Plate 53) and in the cupboard below (Plate 54). This was later blocked with hardboard or similar material implying that it was once open and that the stairs are a later insertion. However given that the wall to the north of the stairwell is solid to the height of the ceiling as well as the quality and continuity of workmanship, including an archway at which the chamfers are stopped above the floor level of the landing, it is thought that, despite the slightly incongruous arrangement, that the stairwell may be an original feature.

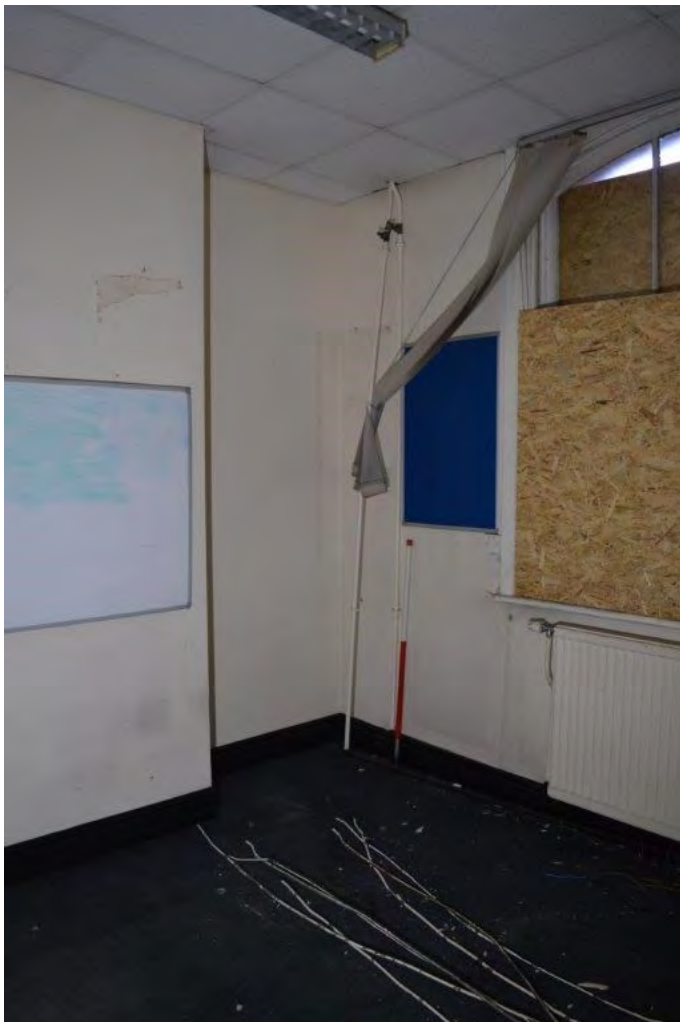
Plate 56. View north-west in RG13, scale 1m

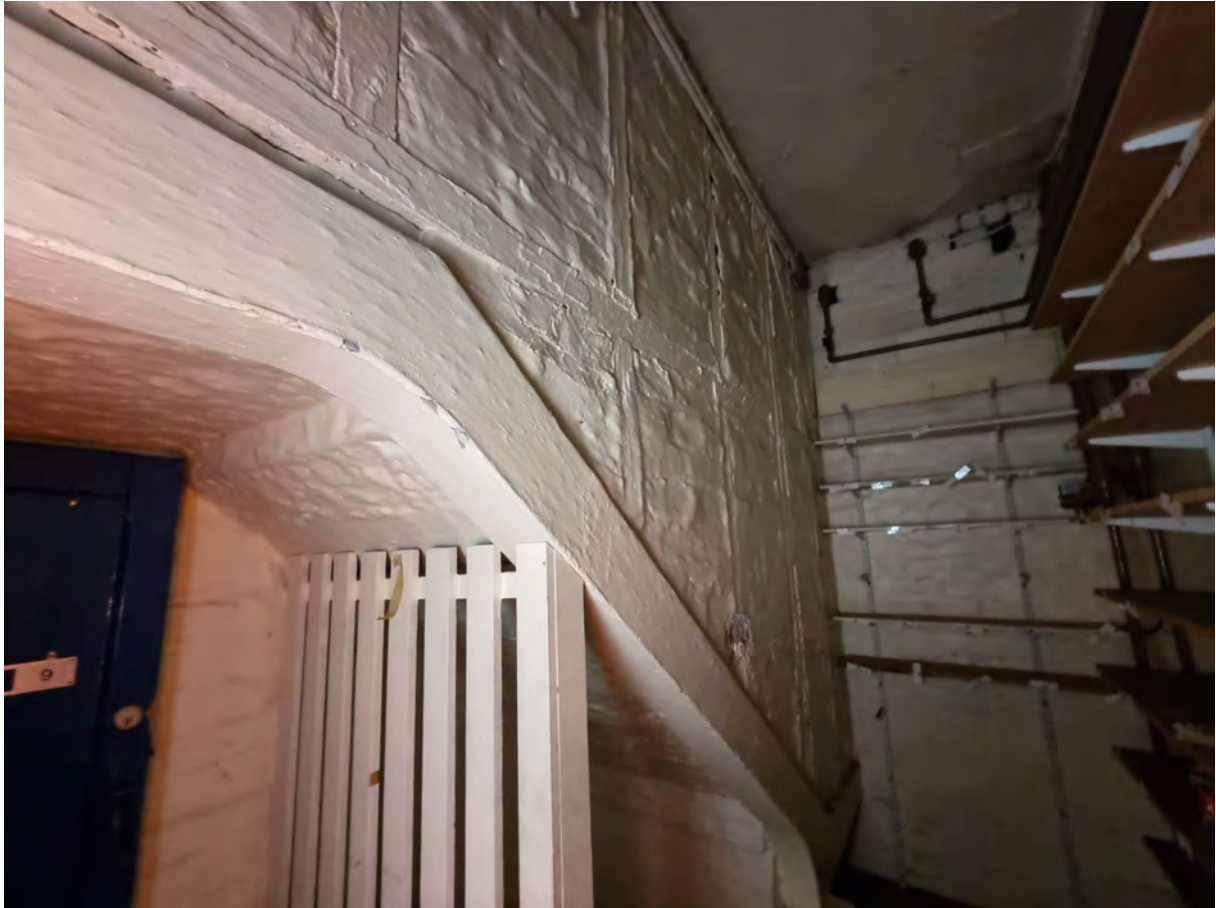
Plate 59. Bonded timbers in south wall of former stone staircase to dock, view north-east

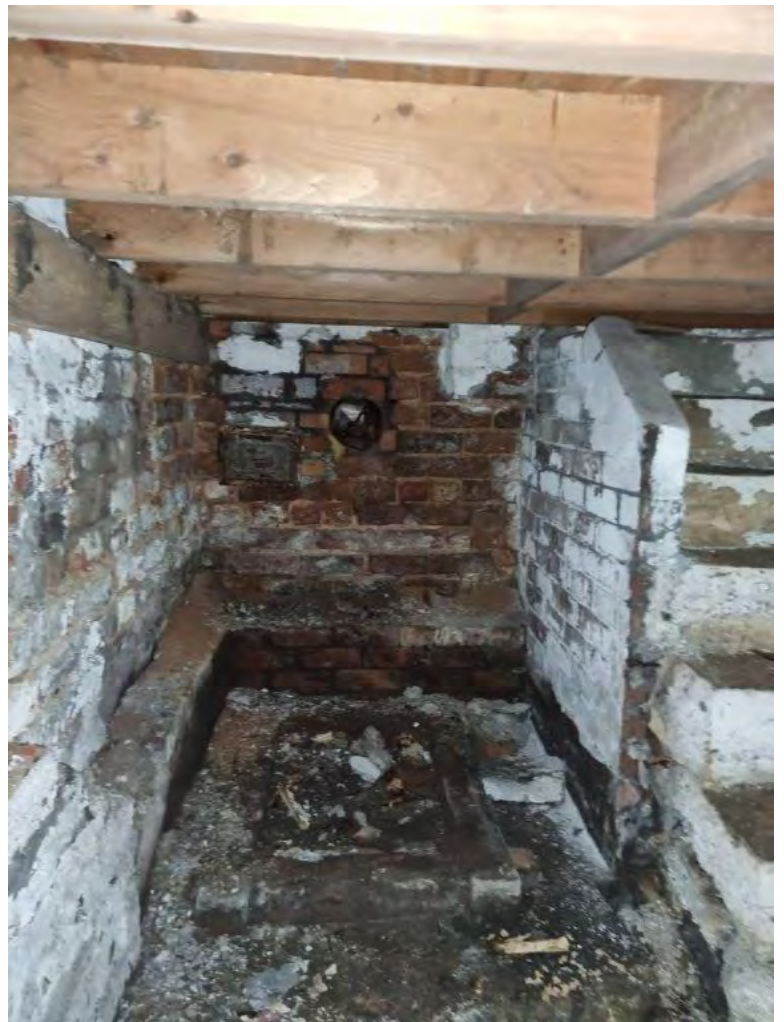
Plate 60. Small cellar below RG14, view west

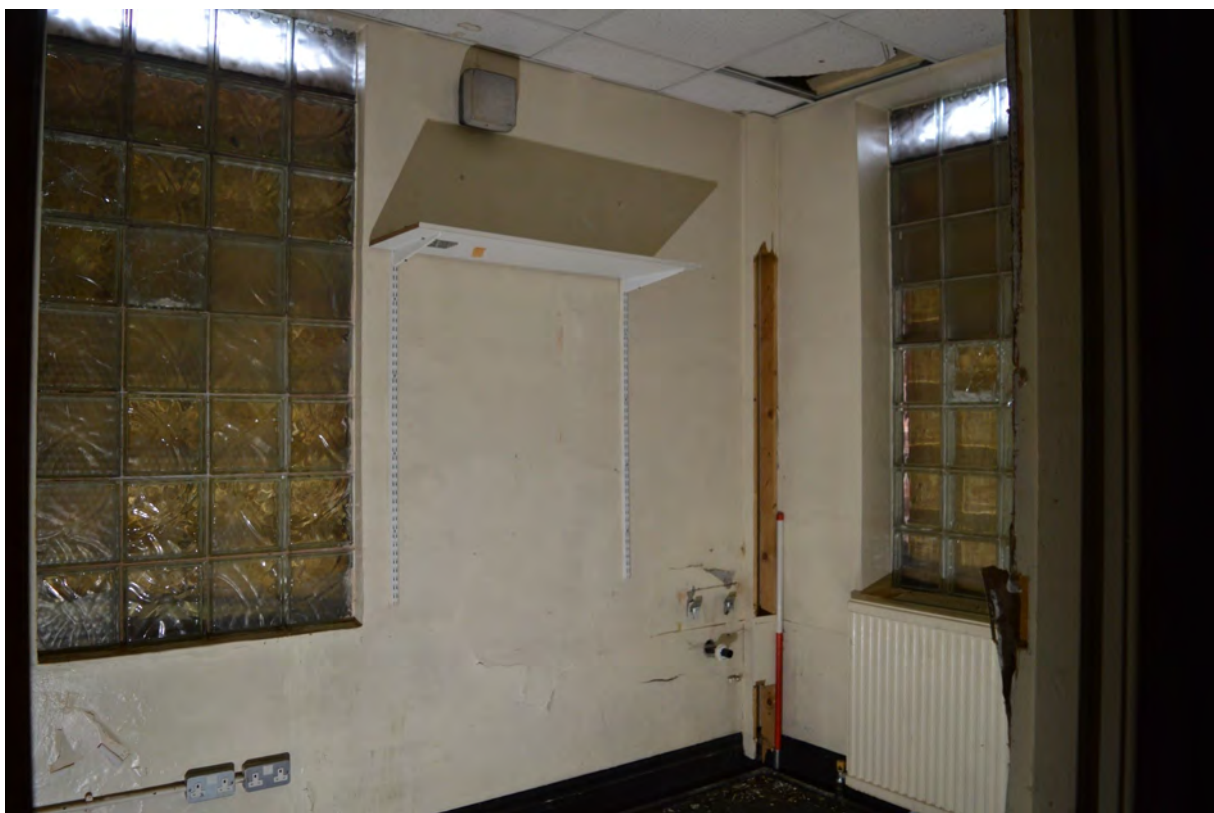
Plate 72. View north-east in former kitchen RG22, scale 1m

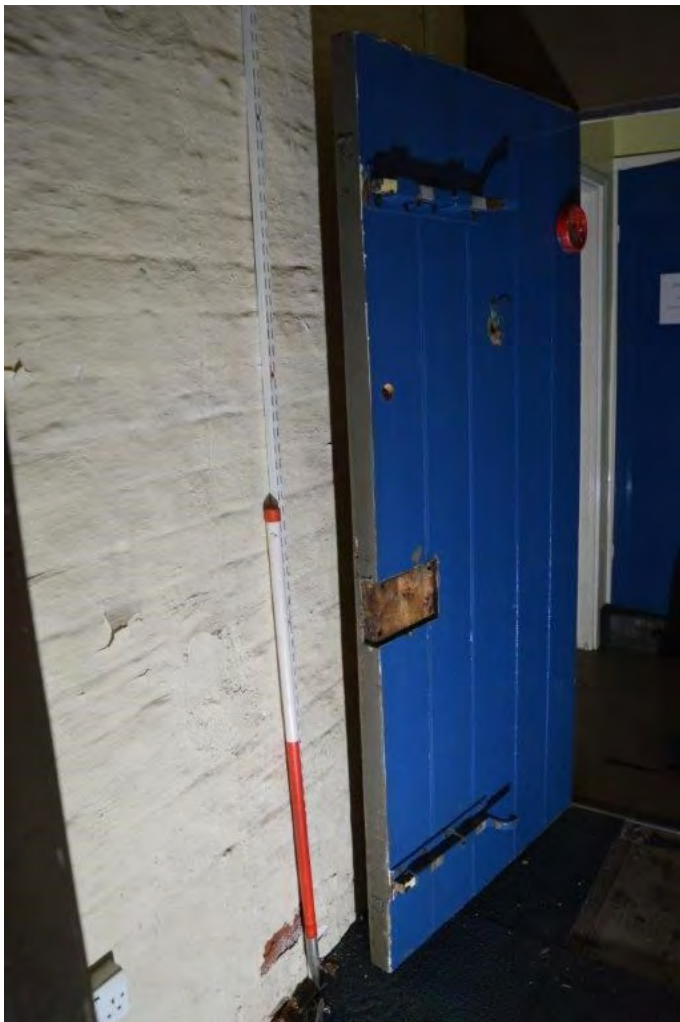
Plate 78. Heavy duty security door to south of RG25, scale 1m

**RG25** is an ante room to the south of the corridor, probably inserted for security reasons. It has a carpeted floor and full height brick walls to an open ceiling as in the corridor described above. It is accessed from the north by a modern door in a modern inserted wall. A substantial wooden plank door with two large external bolts and a door viewer leads to the corridor to the south (Plate 78). The rear of the door is faced with flush metal sheeting (Plate 79).

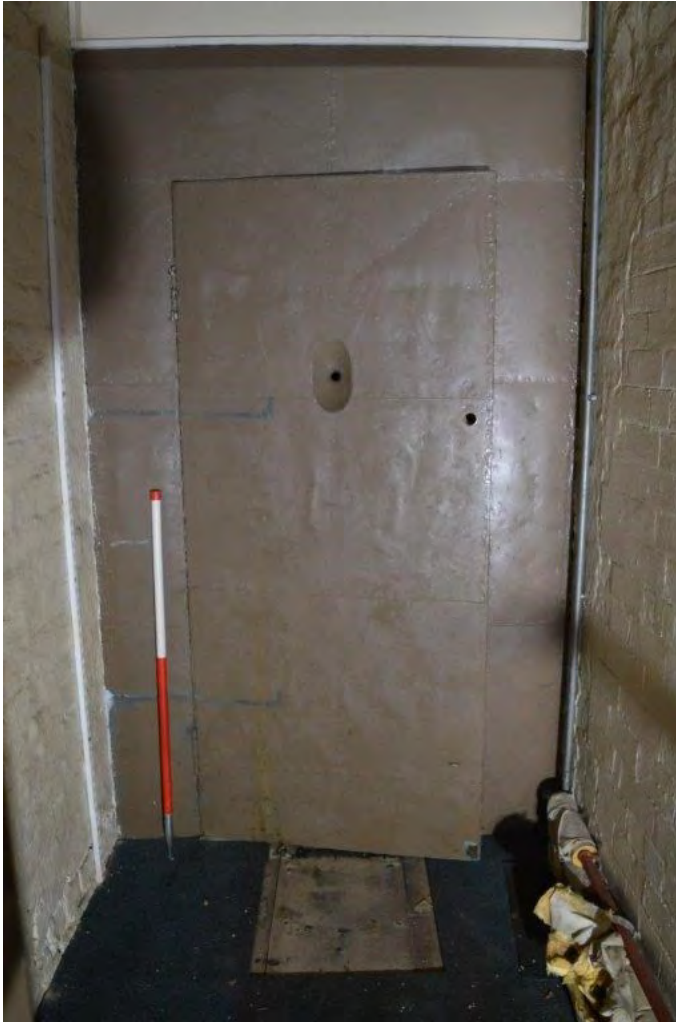
Plate 79. Metal plated rear of security door, scale 1m

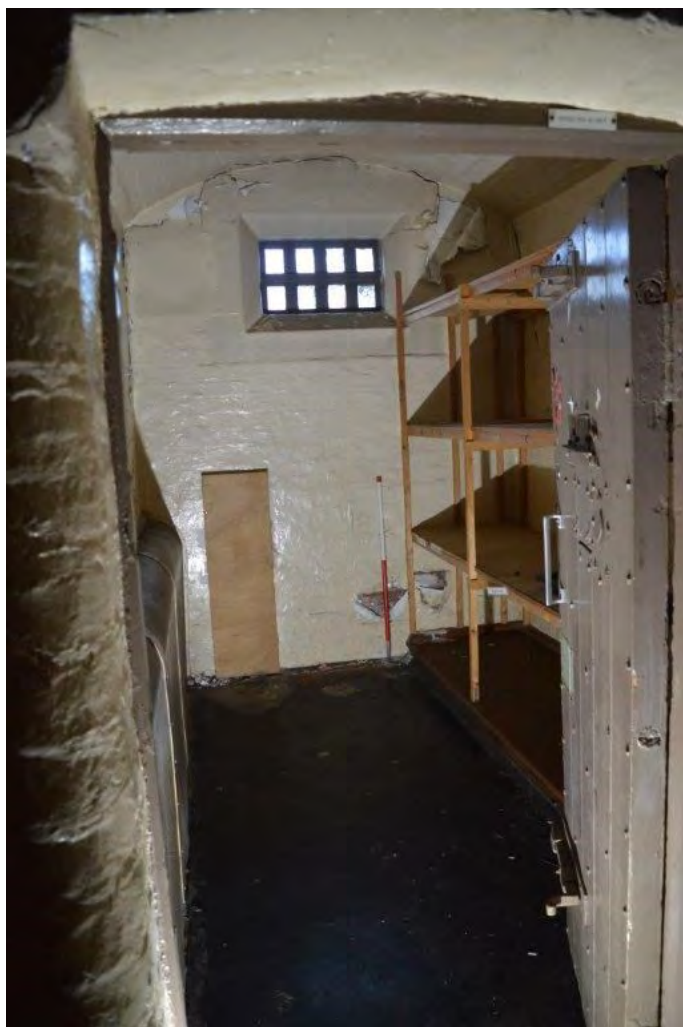
Plate 83. View west into former cell RG27,  
scale 1m

**RG27**, the central cell, is largely similar to RG26 (Plate 83). The location of a removed heating duct is evident on west wall.

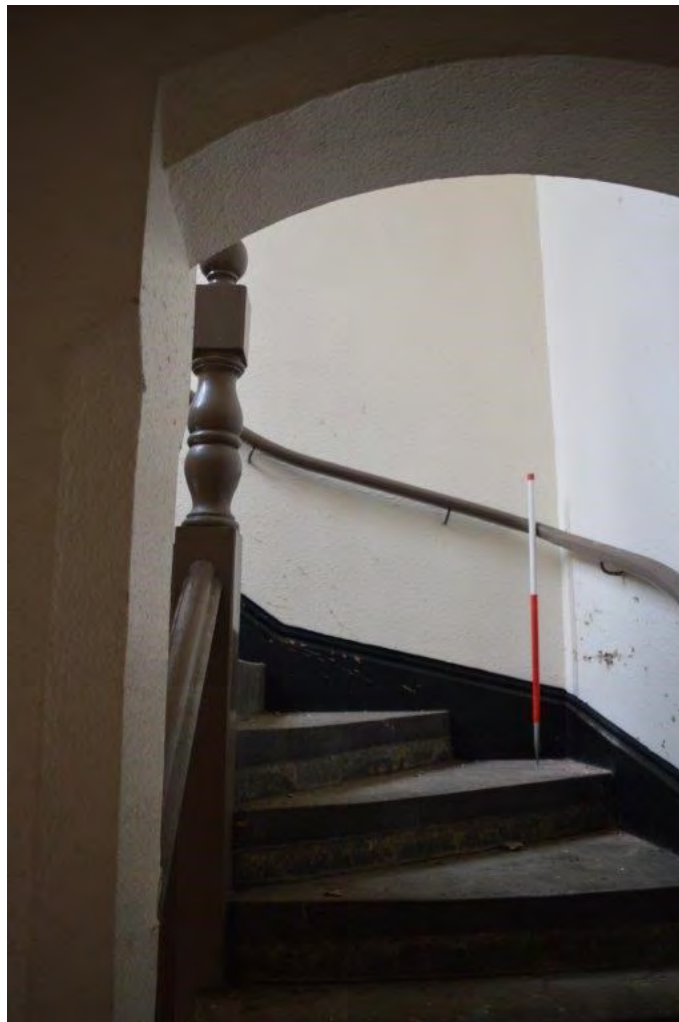
Plate 87. Stairwell RF01 facing east, scale 1m

**RF01** is the upper section of stairs RG17 leading to corridor RF02 (Plate 87). The stairs quarter turn westwards mid-flight and there is a level balustrade to the south adjacent to the doorway to RF03. The newel post has stopped chamfers and a ball cap and the moulded wooden hand-rail attached.

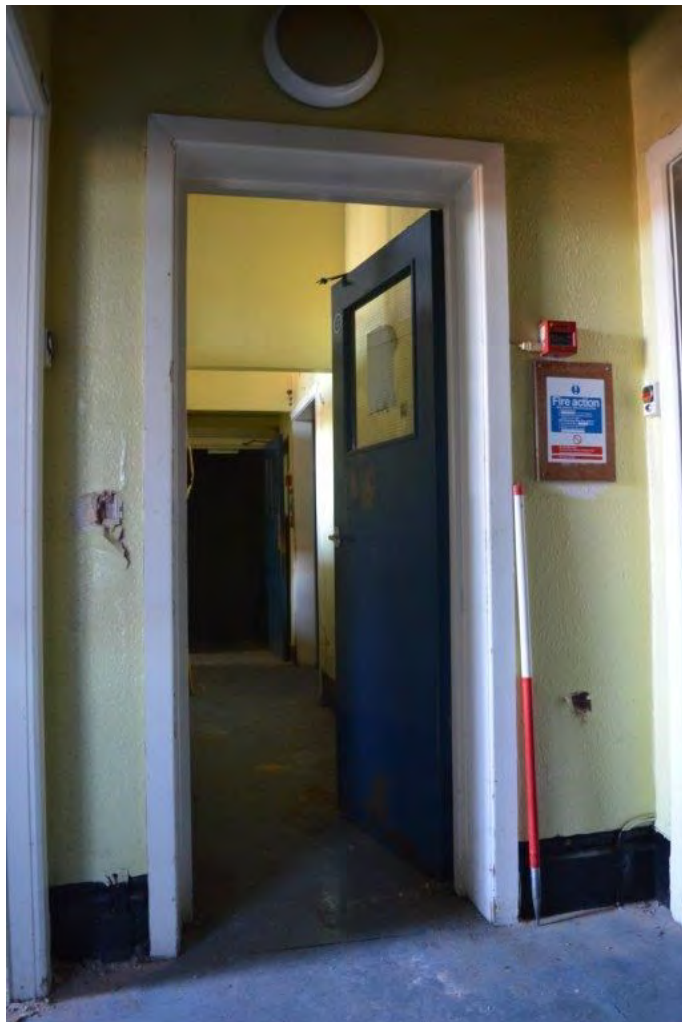
The doorway to the east of stairwell RF08 (Plate 98) is clearly a modern insertion and it is likely that RF07 and RF09 formed a self-contained apartment with a bathroom and WC to the rear (RF10 and RF11), very possibly for the sergeant.

Plate 98. Inserted doorway between RF08 and RF02, view east, scale 1m

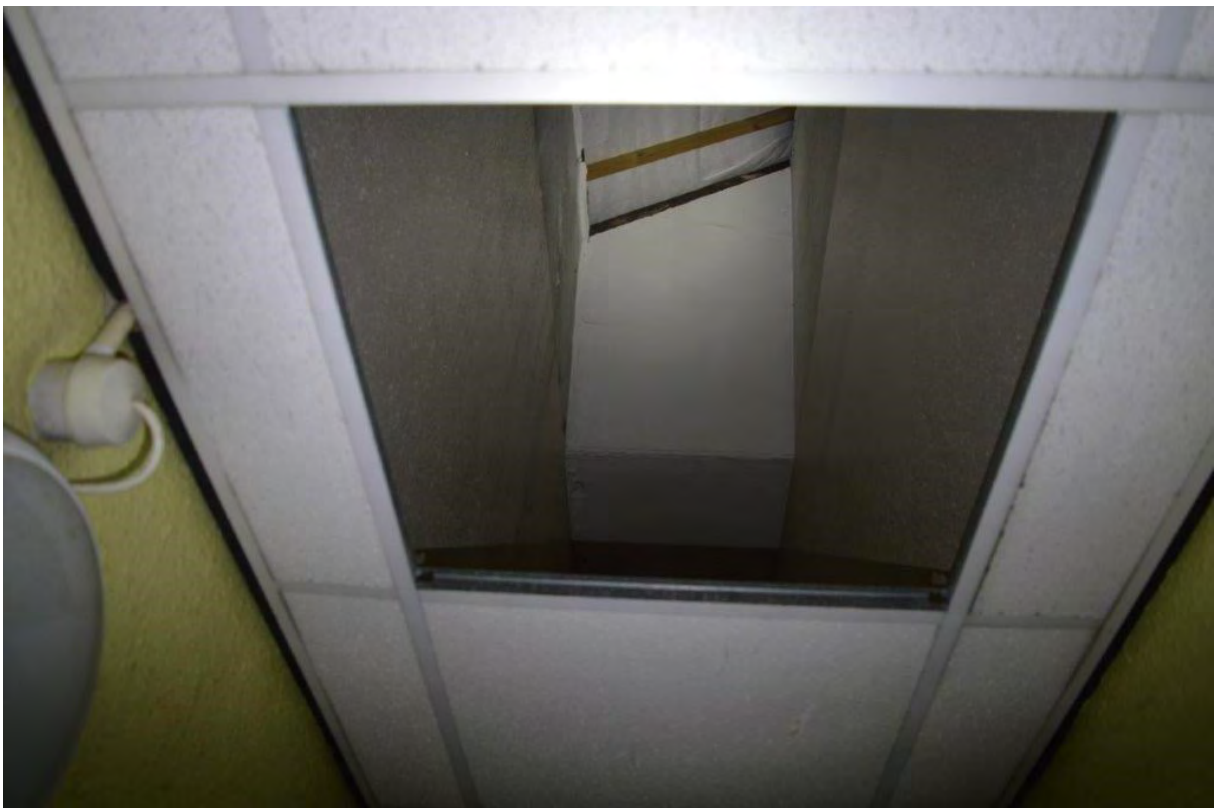
Plate 108. Roofline visible through suspended ceiling above RF13

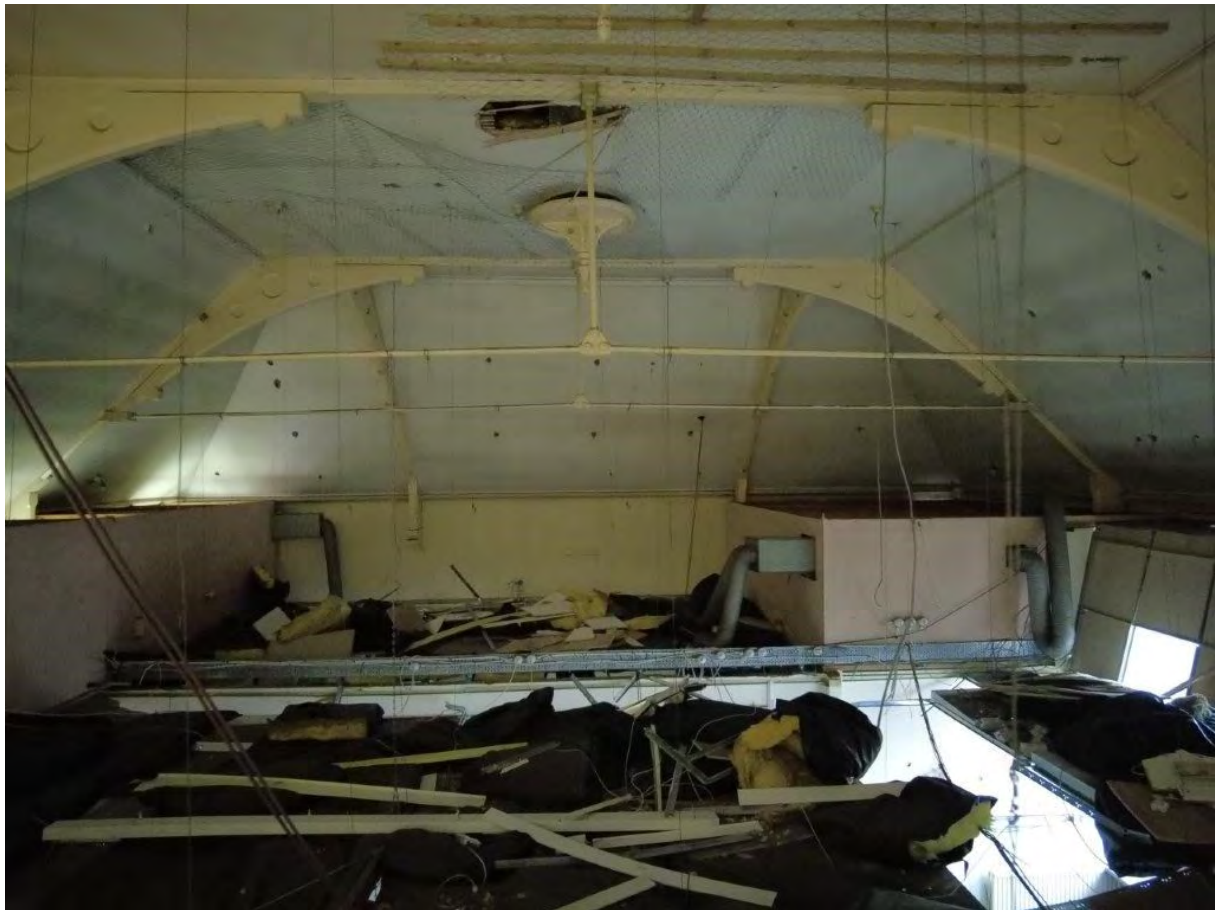
Plate 111. Roof structure of former courtroom above RF14, view north

- 4.14 The insertion of a mezzanine floor, with associated staircases, in the former courtroom wing will cause a moderate level of harm within the spectrum of less than substantial harm to the non-designated asset's significance. This is mitigated, to a degree, with the set back of the proposed floor from and retention of the original windows (no longer cut across by the twentieth-century inserted ceiling) and the visual opening up of the original ceiling and roof form currently obscured by the 1966 inserted ceiling.

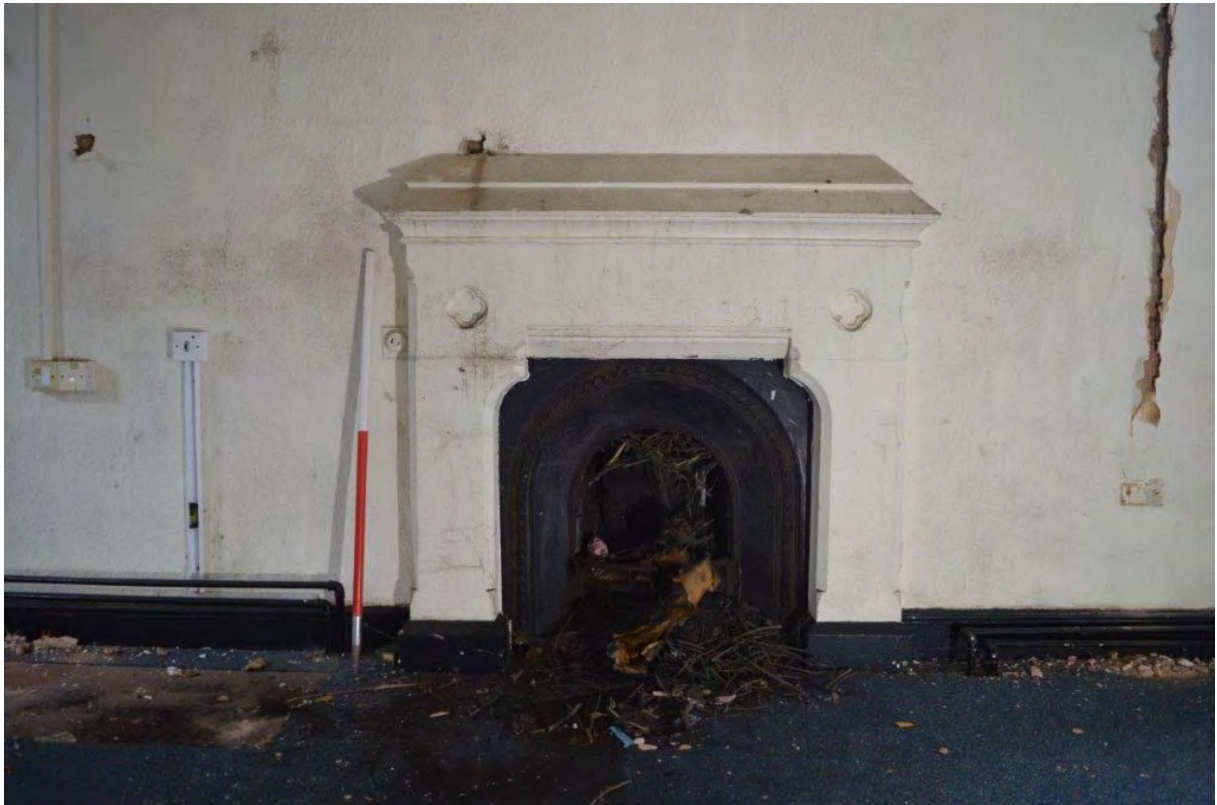
Plate 119. Fireplace in north wall of RF19, scale 1m

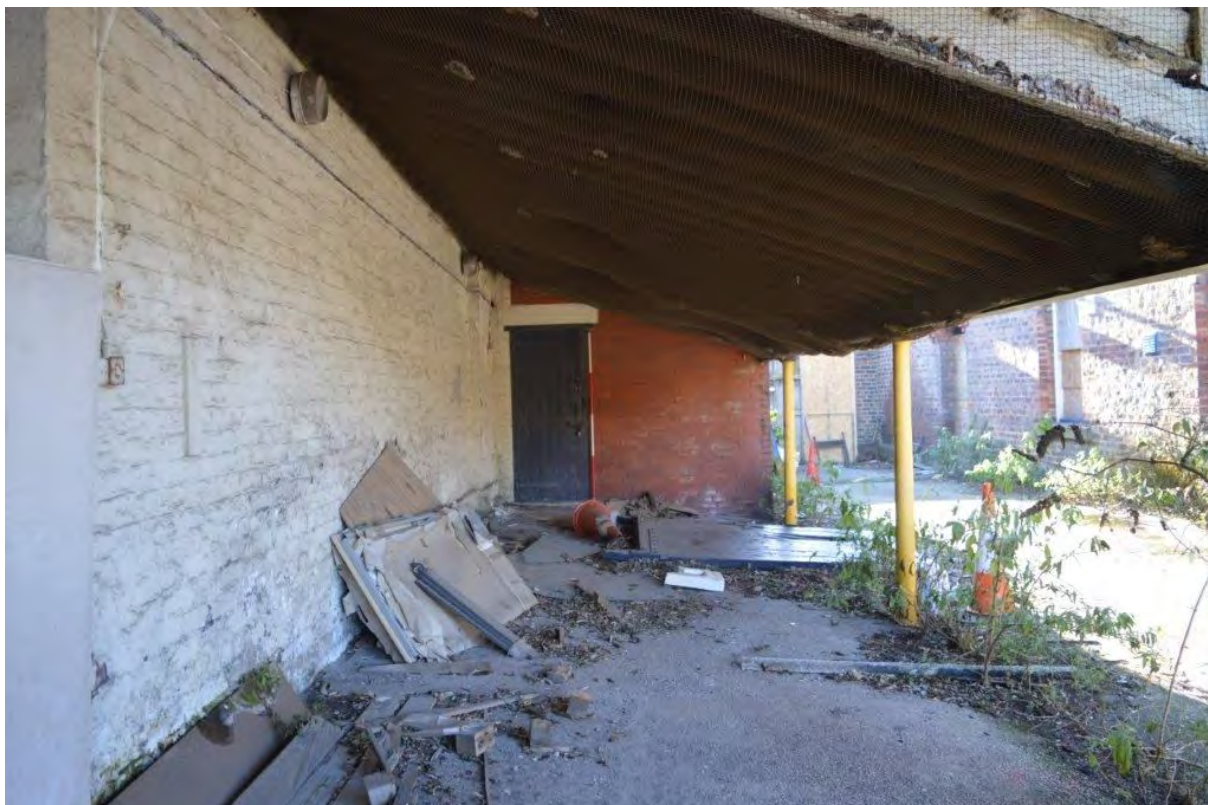
The slate roof continues northwards as a canopy (**Building B**) supported to the west by a steel joist on metal columns. It is open to the west with the rear formed of a white painted brick wall (Plate 123). The concrete floor is sloped with apertures for supporting bicycle wheels.

Plate 123. Building B view south, scale 1m
