# BUILT HERITAGE STATEMENT

Former Prescott Police Station, Derby Street, Prescott, Merseyside

HER00049  
v.2  
18 March 2024

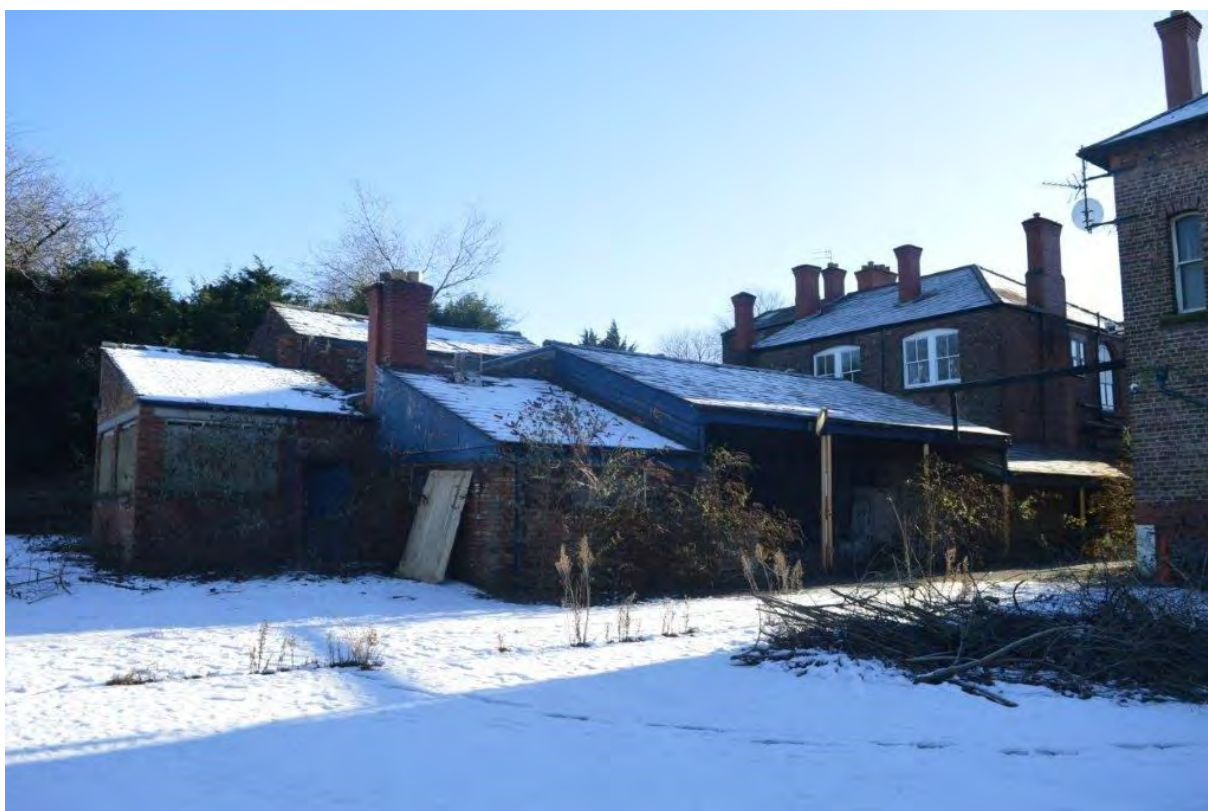
Further northwards as the property boundary extends eastwards, Buildings C-G form a conjoined group of structures to the east of the access road (Plates 124 and 125). Central to this, **Building C** has a canopy similar to Building B, but wider, slightly higher, formed of a gable pitched roof and supported on similar metal columns. It is divided into three bays by king post trusses with raking struts under which netting has been slung (Plate 126). The concrete floor is also sloped and a notice attached to the wall to the north denotes an area for car washing. The rear wall of the canopy is formed by the western wall of the brick building F which is accessed by a doorway beneath the canopy (Plate 127). The northern edge of this area is formed by buildings D and E which are also accessed from beneath the canopy. The canopy is joined to the northern end of the courtroom wing by a gantry supporting a central heating pipe.

Plate 124. Buildings B-G view south-east

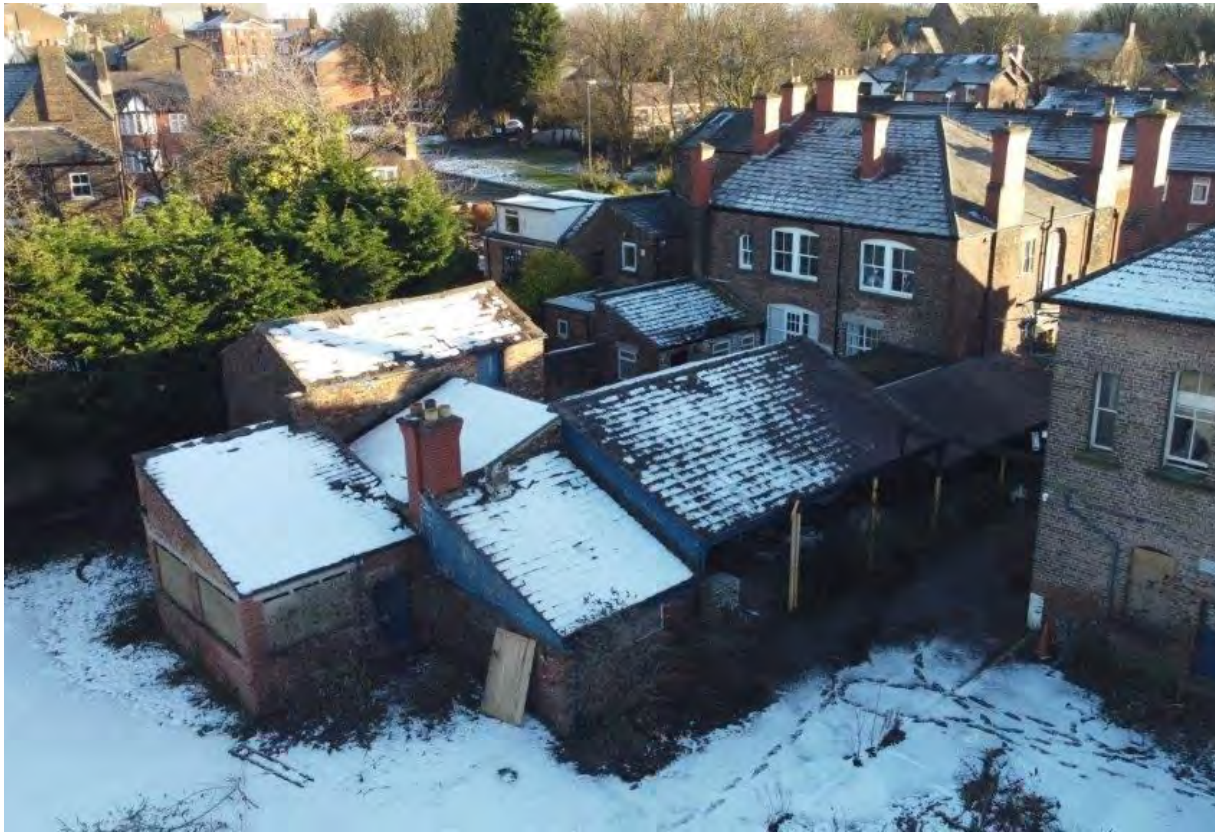
Adjacent to the east, **Building E** is also of brick with a mono pitched felt roof, though unlike other such buildings in this group, it rises to the south. As it is surrounded by buildings, it is only visible externally from the air (see Plate 125).

At first floor level (visible on Plate 125), another hatch at the southern end of the building faces west and another blocked hatch or window at this level is visible within Building E. The southern elevation of this building faces the area to the rear of the adjacent property and was not accessible during the survey.

Plate 125. low level aerial view of buildings B-G, view south-east

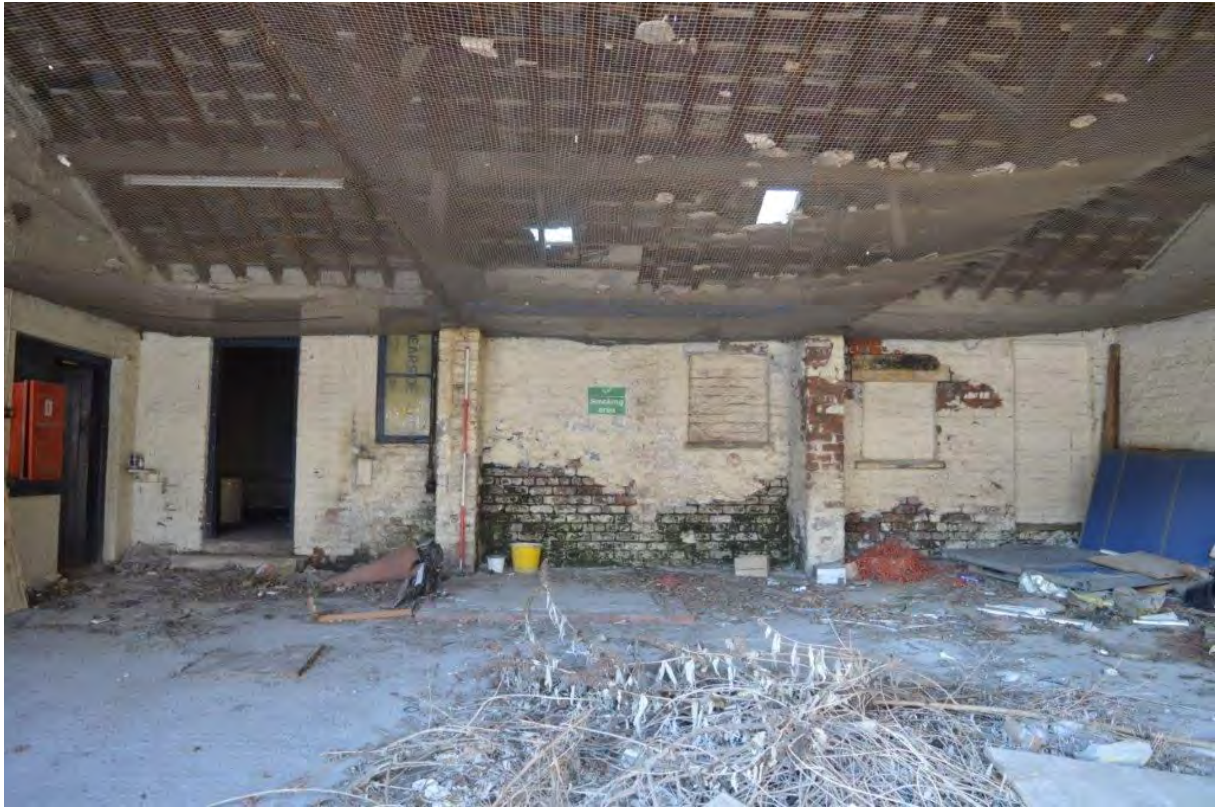
It is accessed through a doorway at the northern end of the canopy of Building C (see Plate 127), south of which is a two light fixed window. In the continuation of this wall to the south are two projecting brick buttresses and on either side of the southern buttresses are blocked windows beneath stone lintels at differing heights with a blocked doorway to the south. The blocked windows and doors, however, are south of Building F and must have served a building which no longer stands in the adjacent property.

Plate 127. Interior of Building C, view east to Building F (doorway and window to left) and wall to adjacent property (right), scale 2m

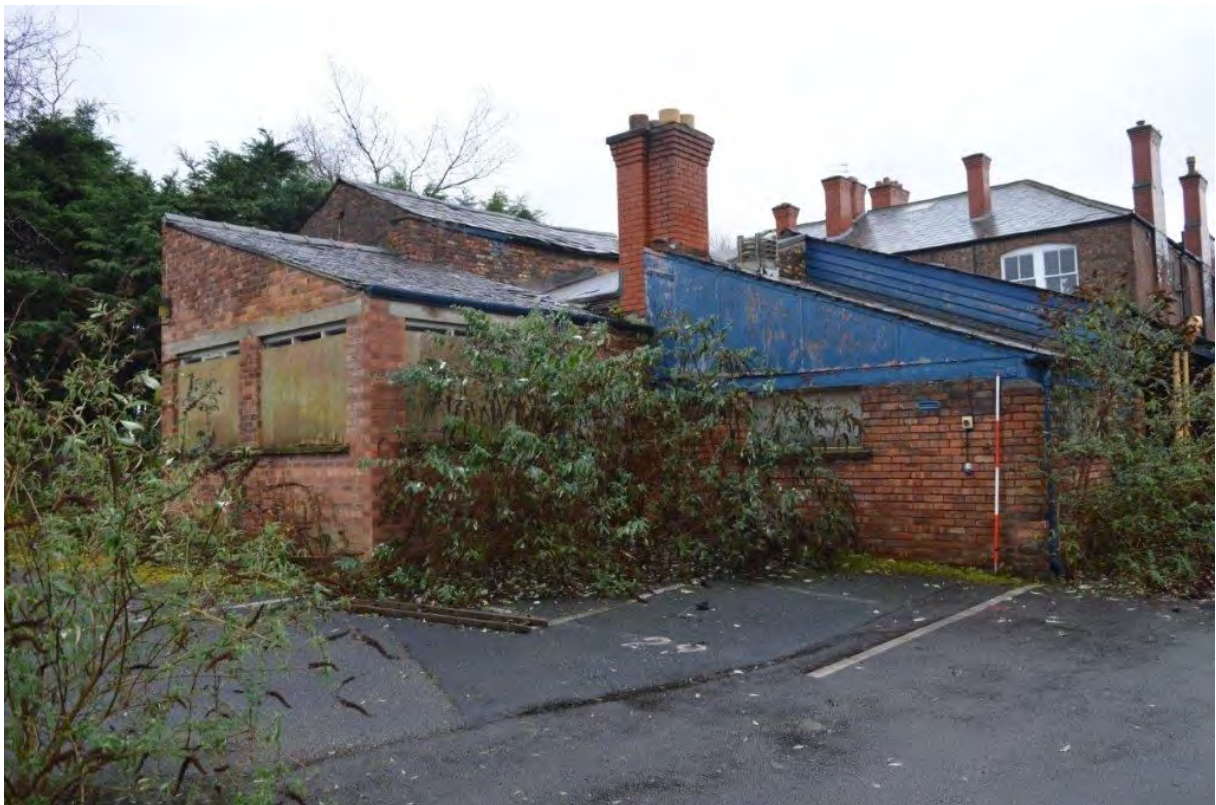
**Building D** is a brick rectangular structure 5m long east-west and 4.5m north to south. It has a mono pitch slate roof rising westwards, slightly lower than the adjacent canopy but with a similar pitch (Plate 128). There is a brick chimney at the ridge and a louvred vent below. The brick continues to the height of the eaves to the west, above which the gables are weatherboarded.

Plate 128. Buildings D and G, view south-west, scale 2m

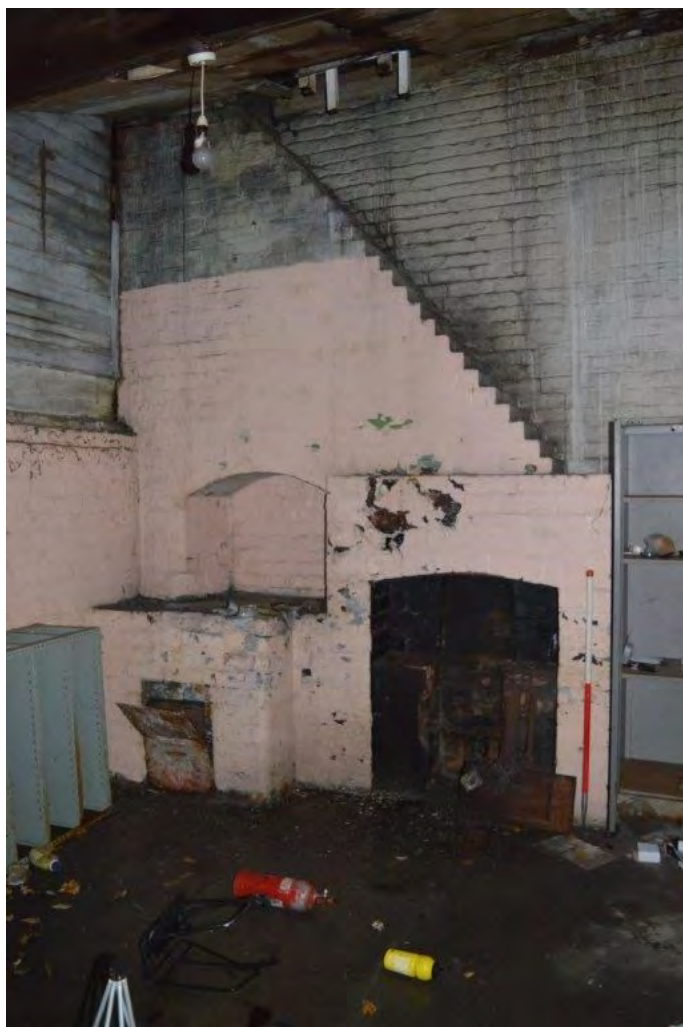
The doorway is plain with a ledged and braced door and there are fixed two light windows to the west and north. Internally, there is a brick chimney breast in the east wall, tapering northwards with a dilapidated cast iron fireplace beneath a segmental brick arch formed of two rows of headers (Plate 129). North of this, a projecting brick structure houses a solid fuel boiler above which is a recess below another segmental brick arch, the sill being the same height as the top of the boiler.

Plate 129. Interior of Building D, view north-east, scale 1m

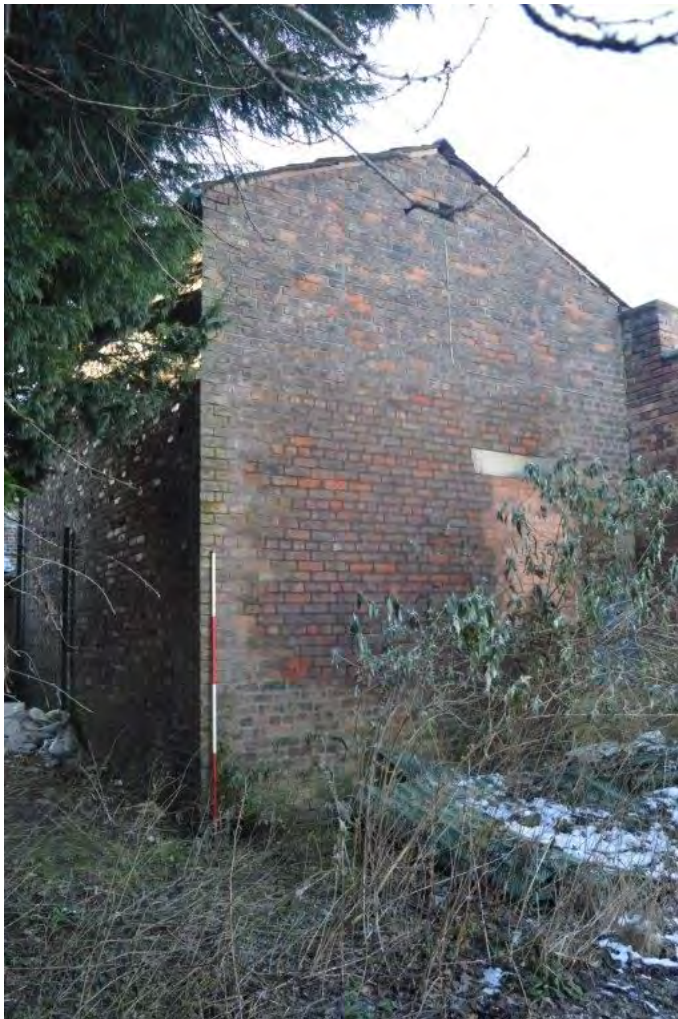
At the east of the group, **Building F** is a two-storey brick-built rectangular building (8m north south x 5m east-west) with pitched slate roof, the ridge line approximately north-south (Plate 132). The slates are larger and less regular than those on the other roofs in this complex.

Plate 132. Building F, view SSW, scale 2m

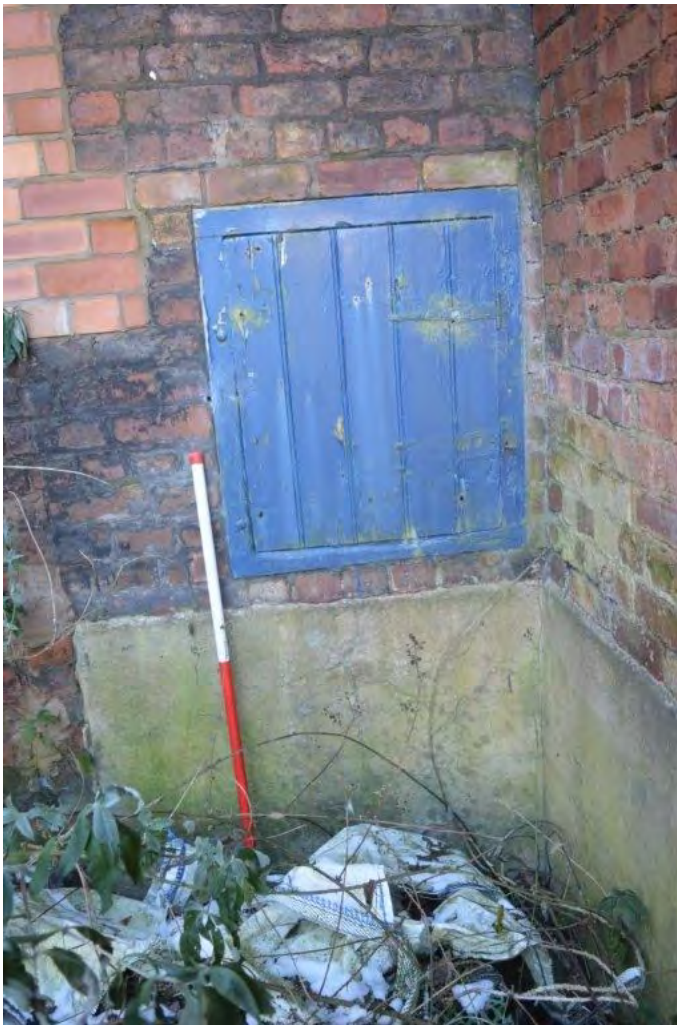
In the northern elevation there is a hatch at ground level (Plate 133) and a blocked window beneath a stone lintel and there are square vents at close to the apex of each gable.

Plate 133. hatch in northern wall of Building F,  
view SSE

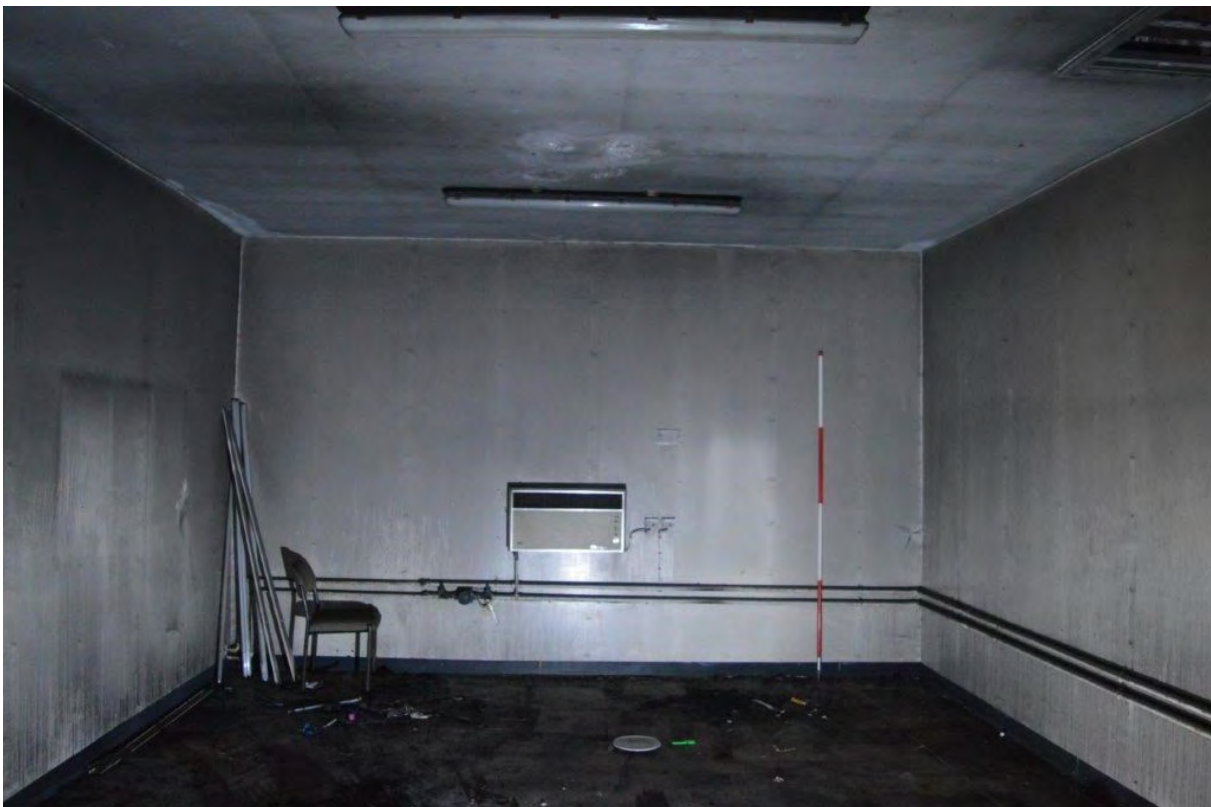
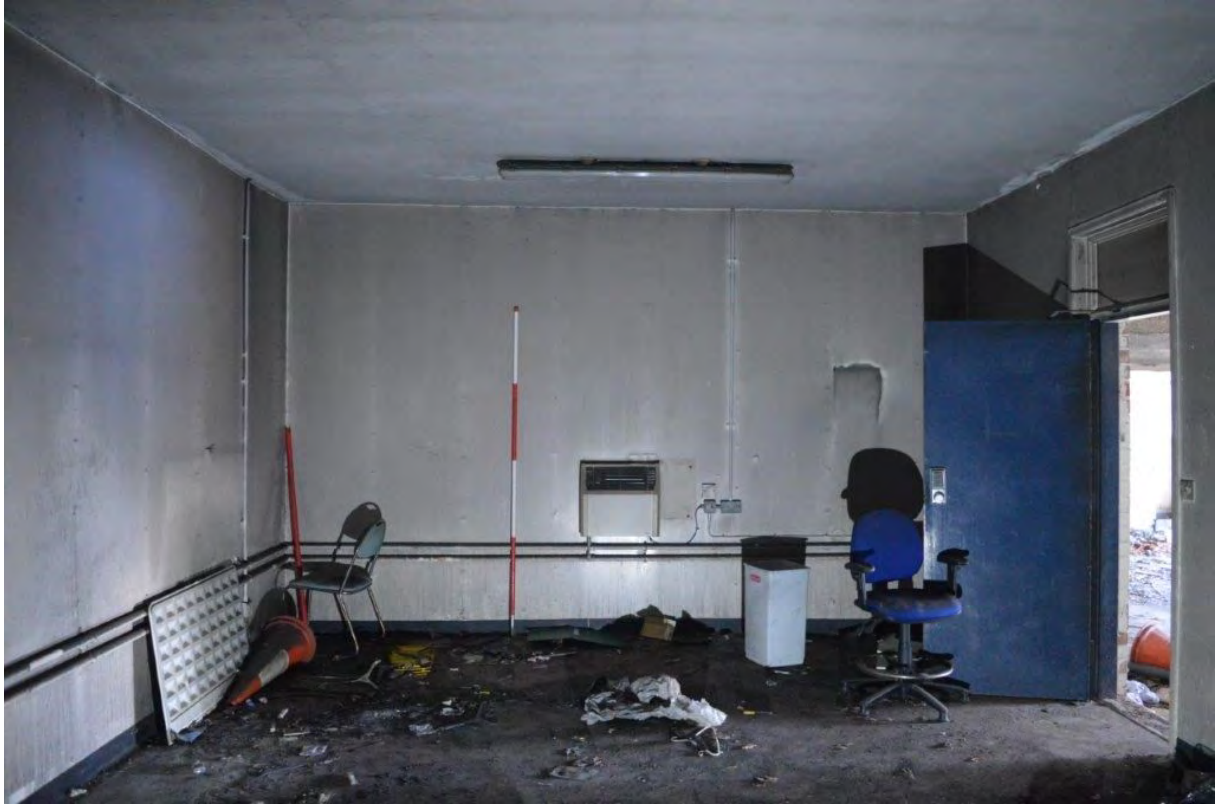
Internally the room's walls and ceiling are lined with laminated hardboard panels and floor is carpeted. There are no windows. Electric heaters are attached to the northern and southern walls. (Plates 134 and 135).

Plate 134. Interior of Building F, view NNW, scale 2m

Plate 135. Interior of Building F, view SSE, scale 2m

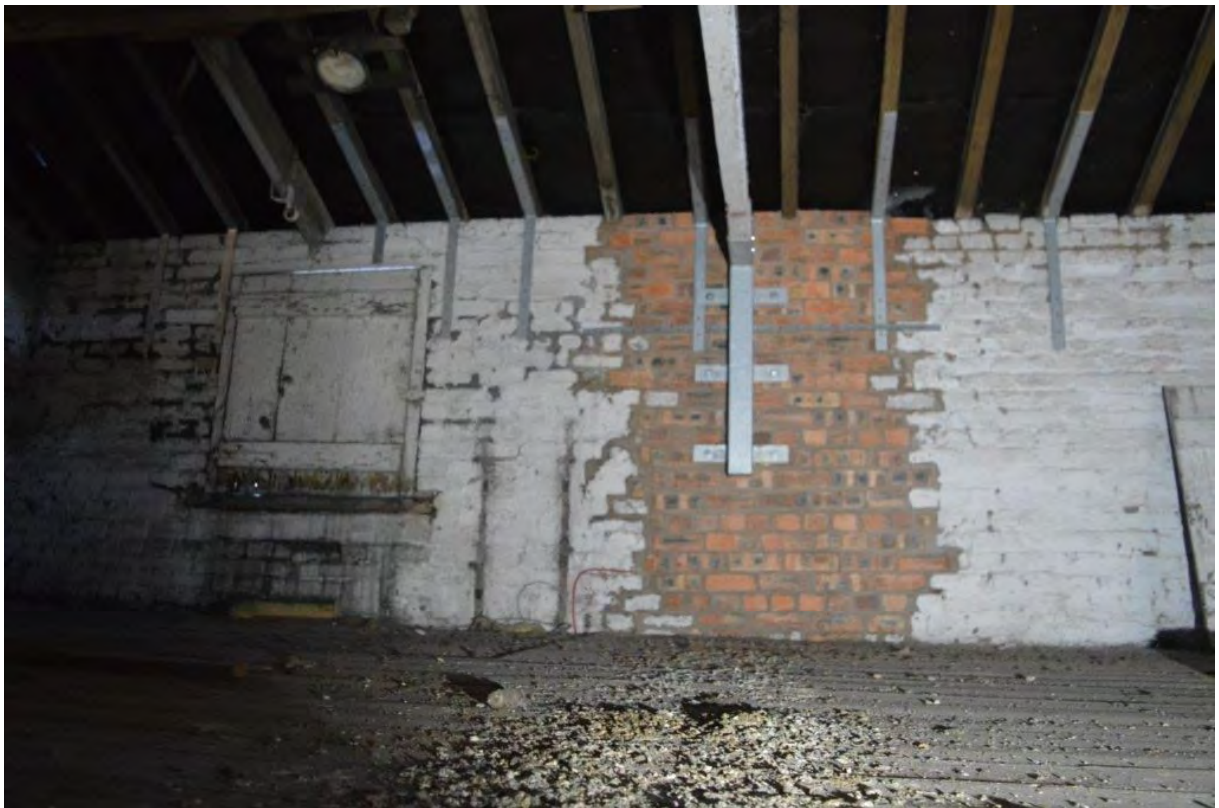
The hatch provides access to the attic space which is open to the unlined rafters, has wooden floorboards and bare white painted brick walls (Plate 136). A single central truss (structure not visible from the hatch) supported by metal brackets, defines two bays and the hatch in the eastern wall is apparent. At the northern end of the building, a square column formed of upright boards rises from the floor to the ridge of the roof (Plate 137). The function of this is not clear, it may have been a ventilation feature or may enclose a chimney or flue, however it does not correspond to an opening in the roof.

Plate 136. Upper Storey of Building F, view west

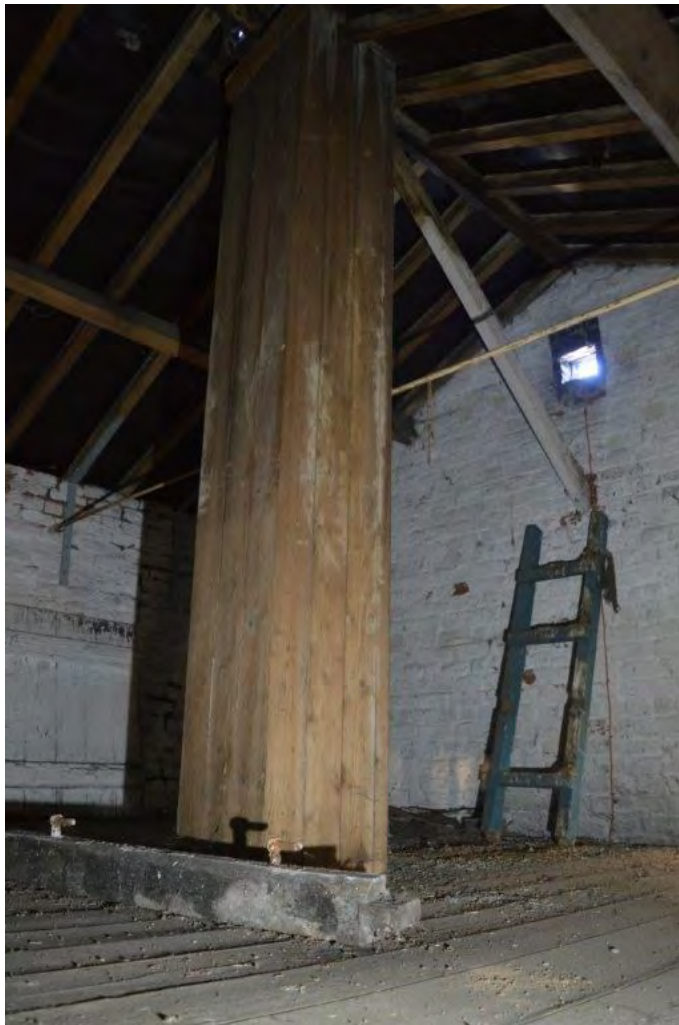
Plate 137. Upper Storey of Building F, view north-east

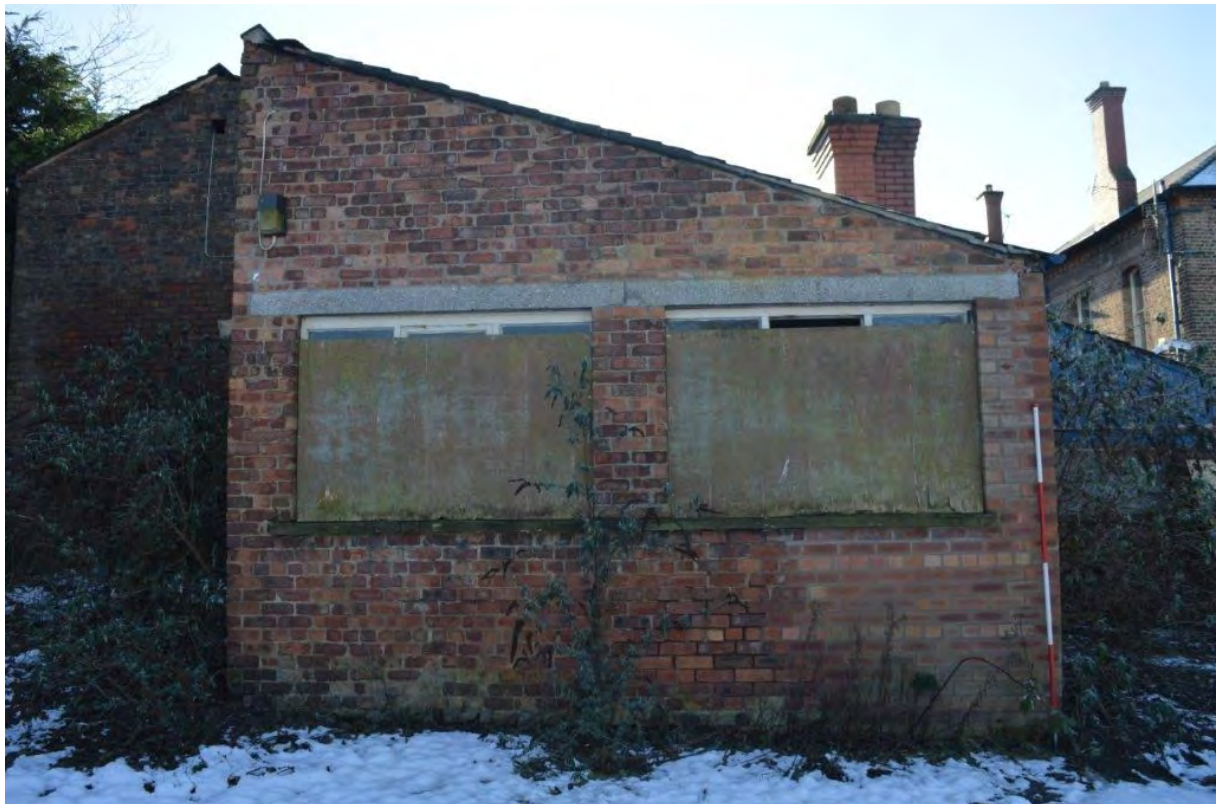
Plate 138. North facing wall of Building G, view SSE

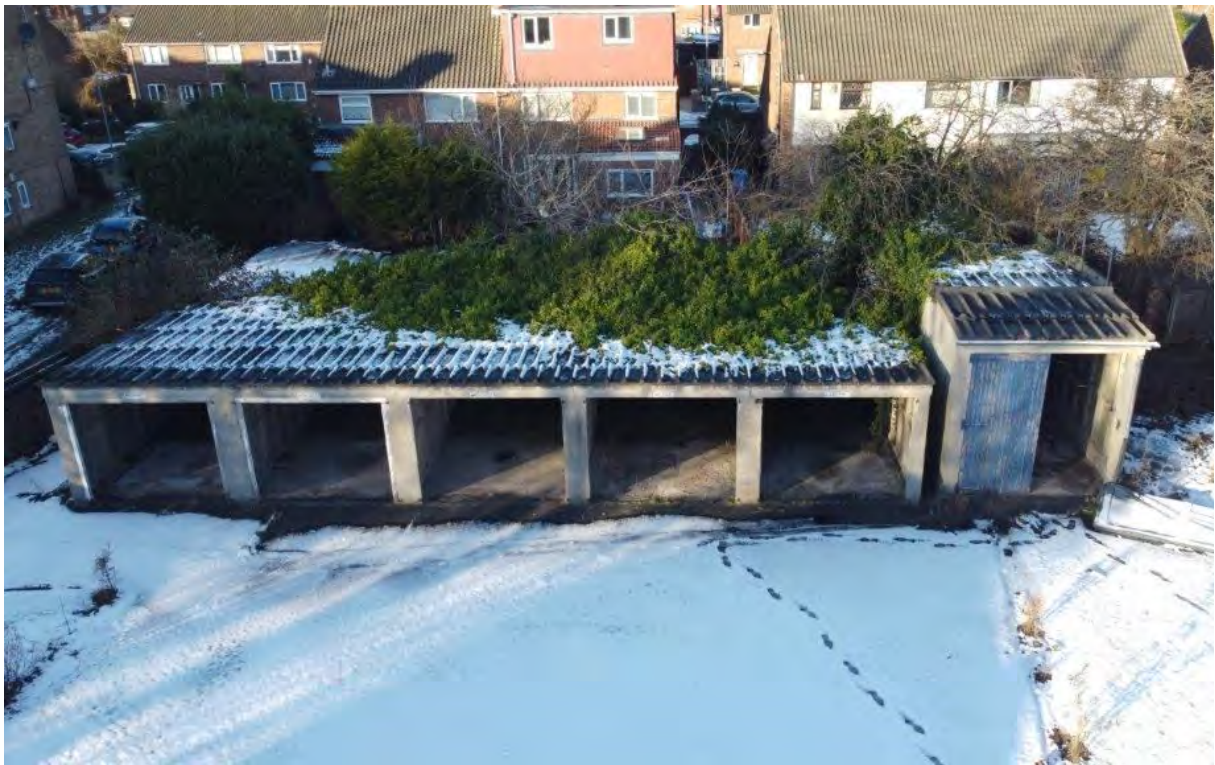
Plate 139. Low level aerial view of Buildings H (garages) and I (maintenance shed), view NNW

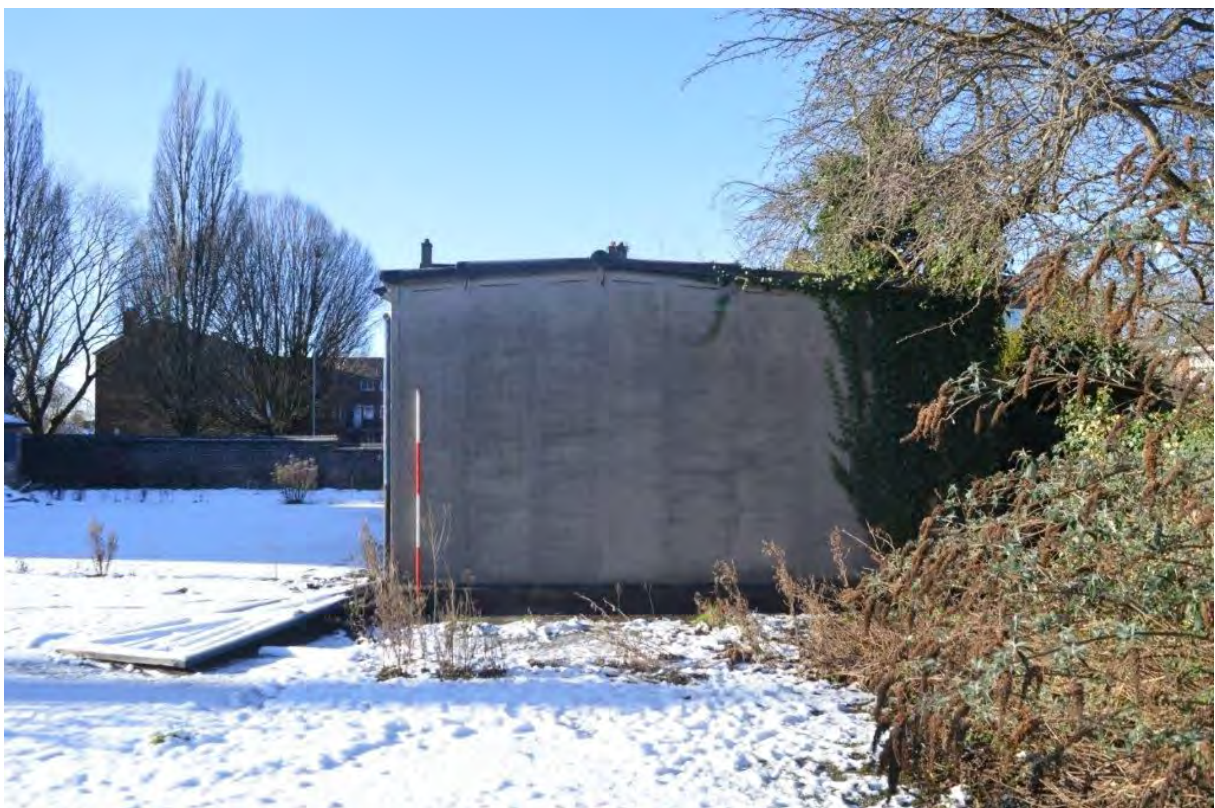
Plate 140. Building I, view WSW, scale 2m

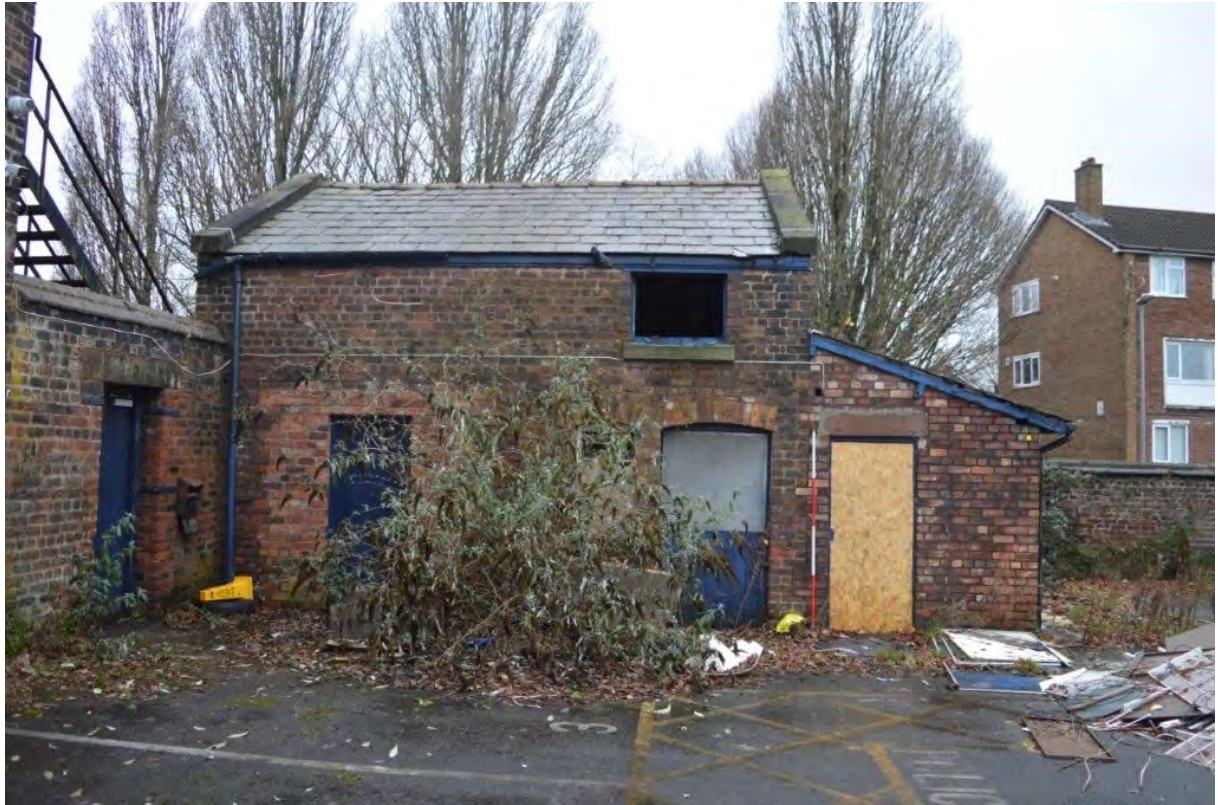
**Building J** is the former stables, a two-storey brick building forming the northern boundary of the courtyard and a section of the western boundary of the property. It is of brick in English Garden bond similar to that of the police station and the form and hue of the bricks are also similar. The roof is of slate with decorative ridge tiles and raised, capped barges (Plate 141).

Plate 141. Building J (former stables) view WSW, scale 2m

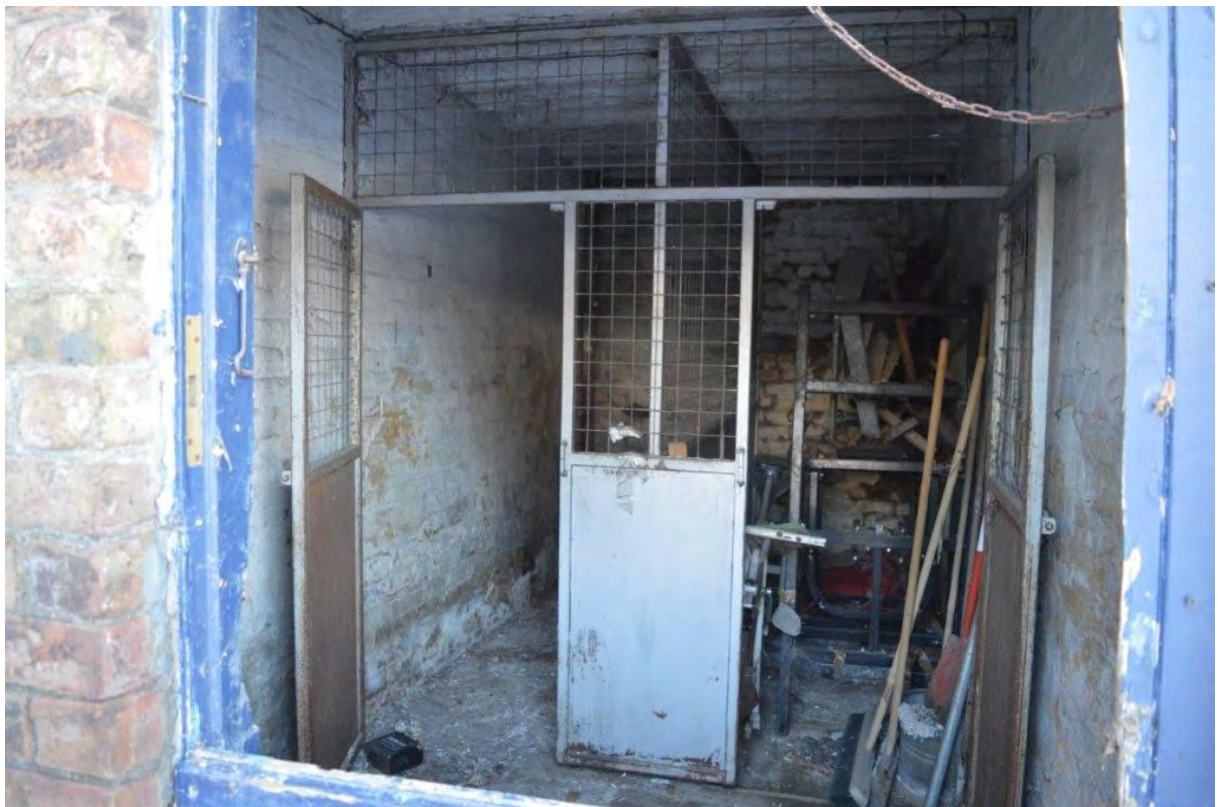
The ground floor is divided into two by a brick wall. The space to the north is narrower and divided into two stables by a metal frame (Plate 142). Each stable has a metal door with mesh above and there is mesh between and above the doors. The area to the south is a rectangular storeroom with a suspended hardboard ceiling, painted brick walls and a concrete floor (Plate 143). Freestanding metal shelving was installed on the north and south walls at the time of the survey. This may have been for housing some form of small carriage such as a trap or buggy.

Plate 142. Northern section of Building J. view WSW

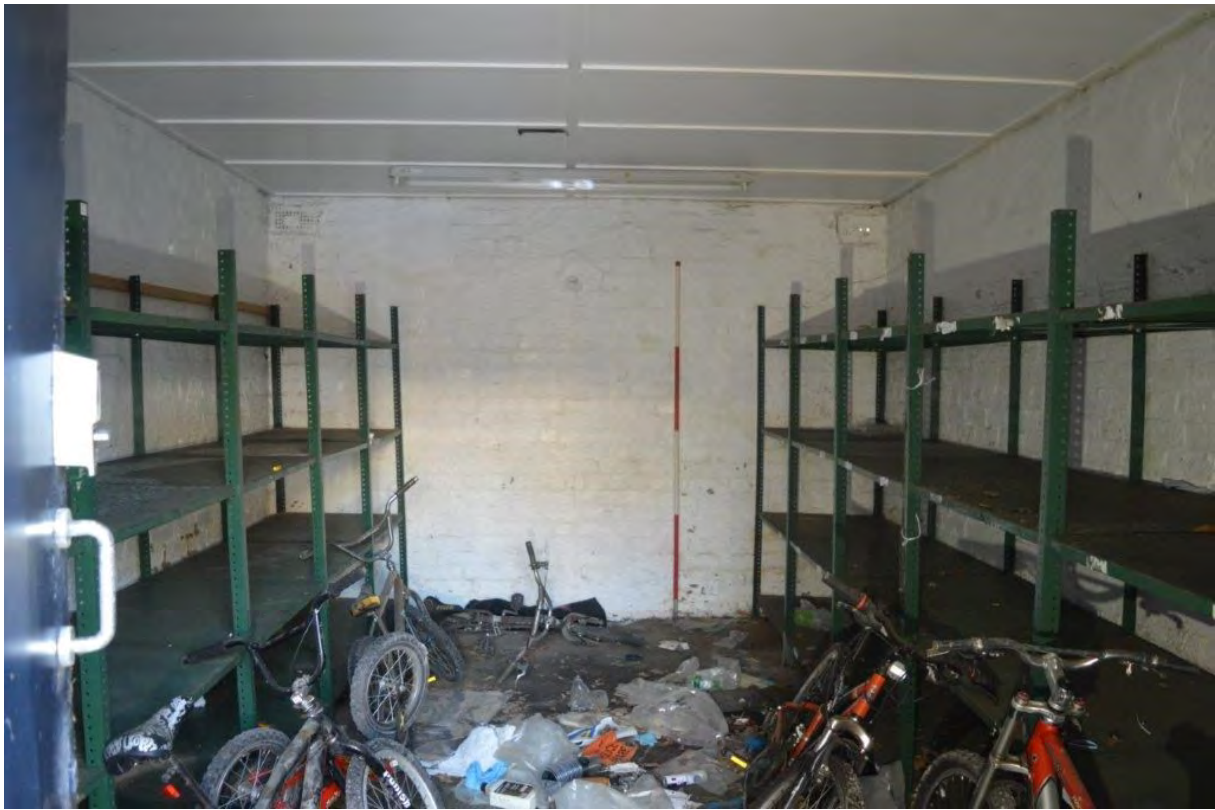
Plate 143. Southern section of Building J. view WSW

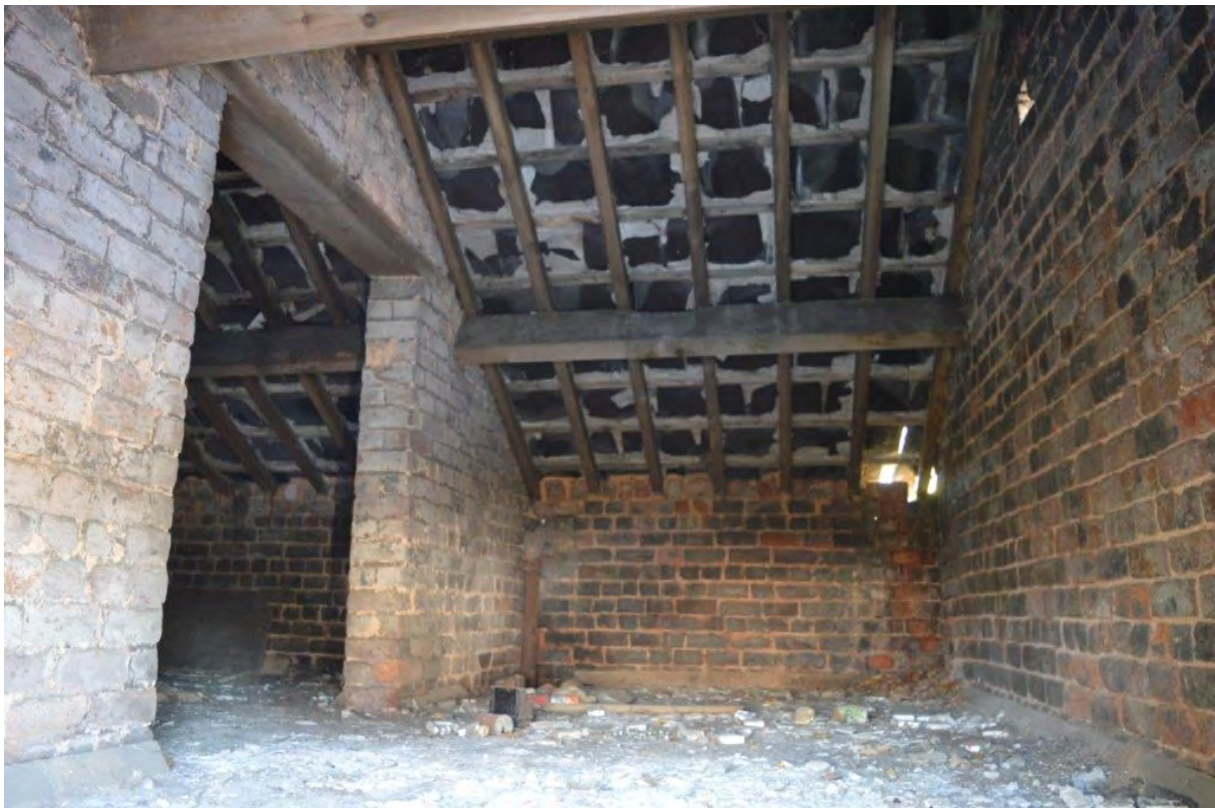
The upper floor of the building is accessed by a small hatch. The space was not fully accessed but the view from the hatch (Plate 144) demonstrates that the space is open to the roof and divided, as below, by a brick wall with an opening beneath a wooden lintel. It is probable that this was a hay loft.

Plate 144. Upper floor of stables, Building J, probable former hay loft

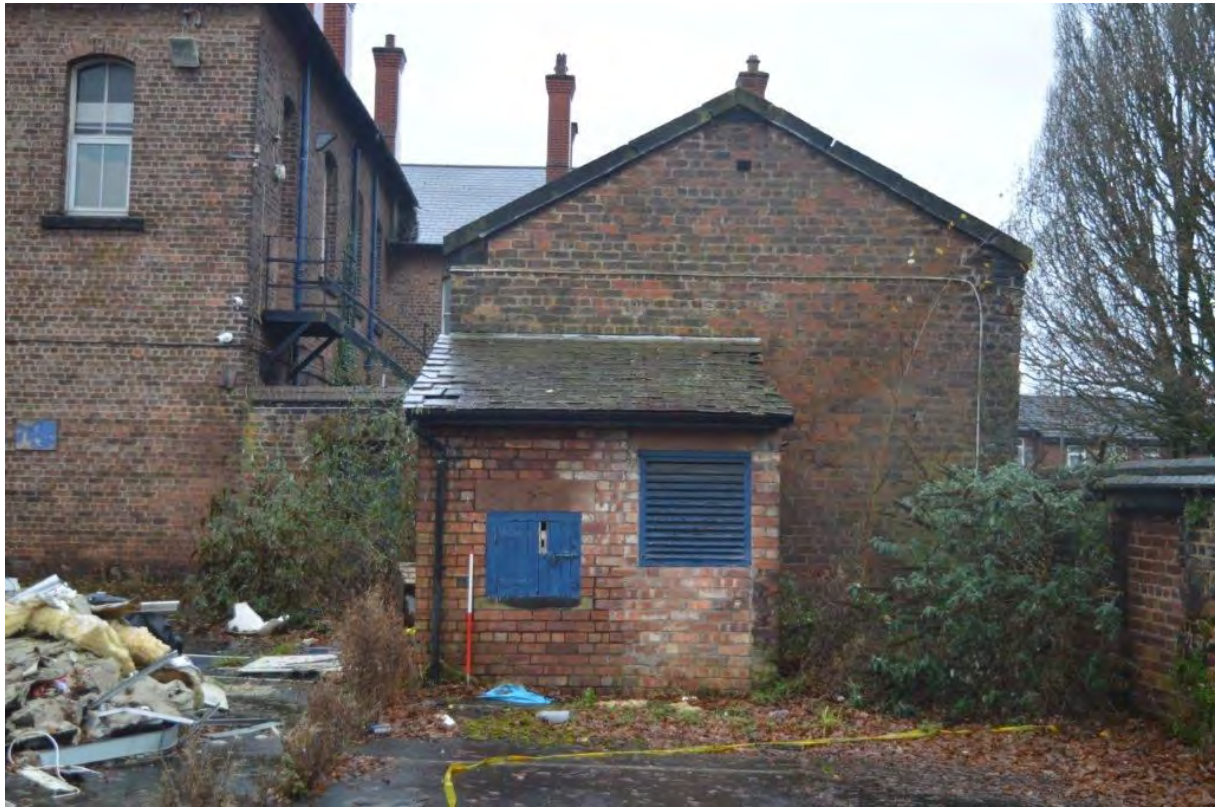
On the northern wall of the stables, a single storey brick lean-to extension (**Building K**) with mono pitch, north facing slate roof appears to be a later addition (Plate 145). This structure has a single doorway to the east and in the north wall a wooden hatch and louvred ventilation panel, both beneath large sandstone lintels. This houses a 'Lister' diesel driven generator, presumably used as an emergency power supply for the police station (Plate 146).

Plate 145. Building K, view south, scale 1m

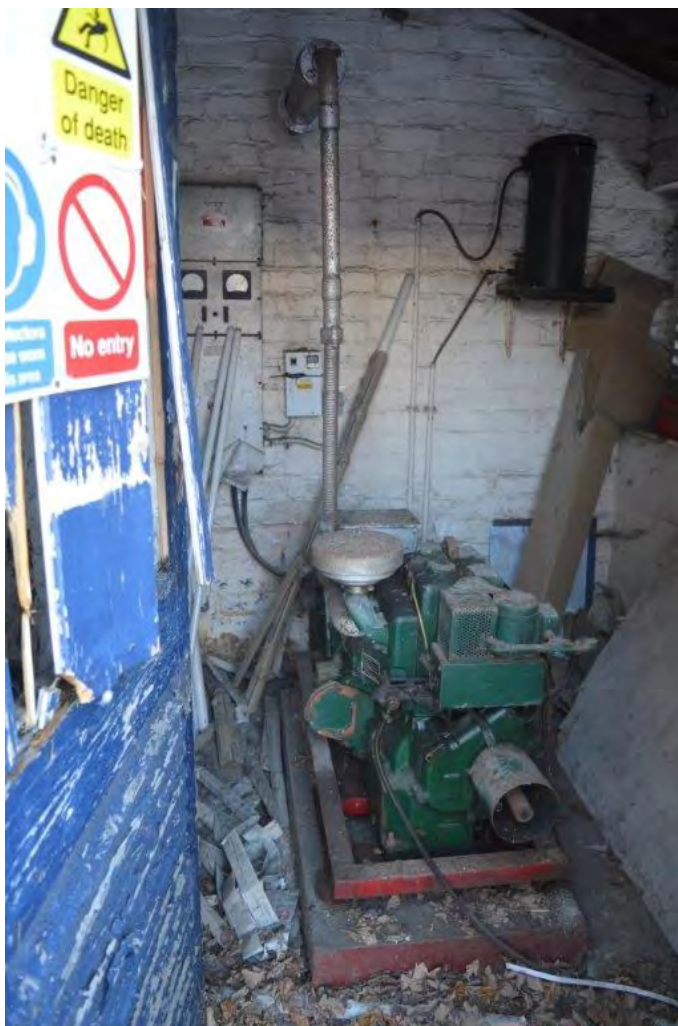
Plate 146. Interior of Building K, view WSW

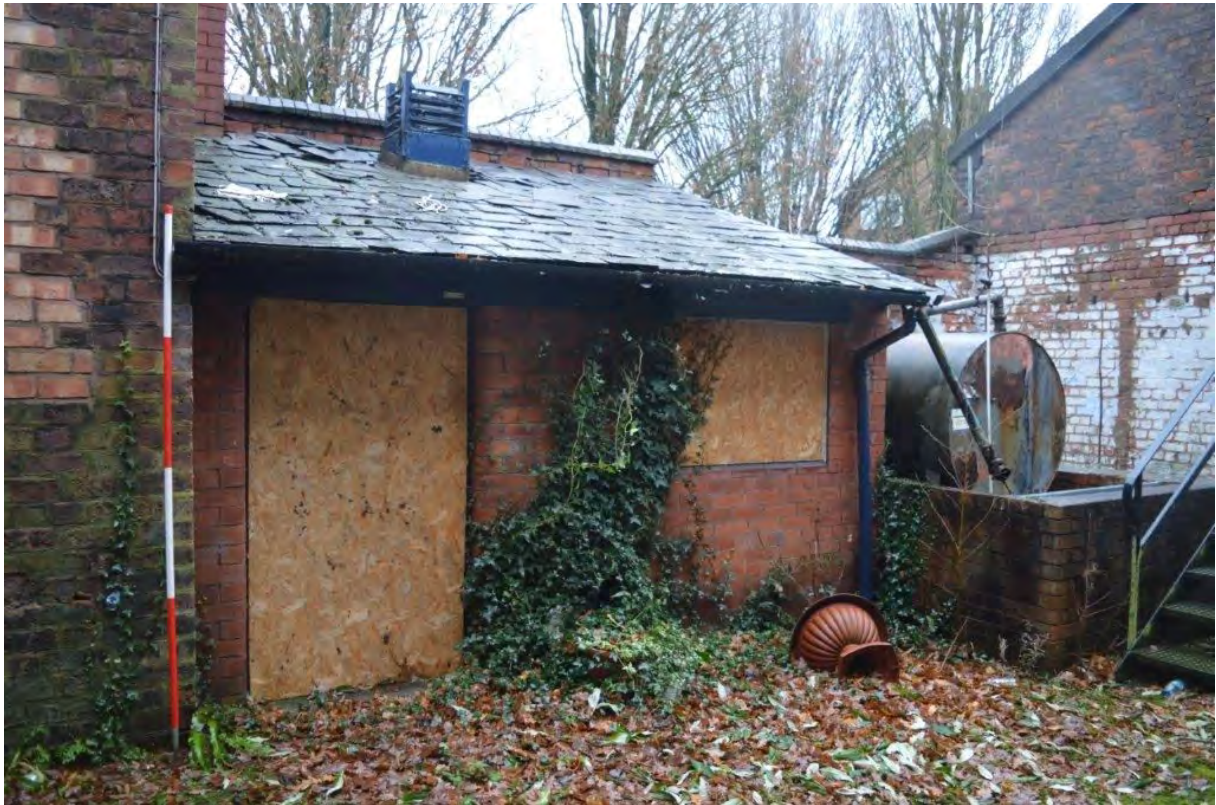
**Building L**, adjoining the projecting western wing of the police station on the west side of the courtyard, is the former boiler house (Plate 147). It is in brick with a mono pitch slate roof which rises westwards to the boundary wall with Elm House Service Road which has been raised to accommodate the height of the building. There is a brick chimney with 'bishop' ceramic chimney pot set against the adjacent wall and transversing the eaves and a louvred wooden vent below. The bricks are lighter in hue and more regular than the main body of the building and it is clearly a later addition as the wall has been raised with similar bricks. Conversely the slates are larger and less regular than on the roof of the police station. A brick chimney is set against the north wall of the extension and projects through the eaves.

Plate 147. Building L, former boiler house, view west, scale 2m

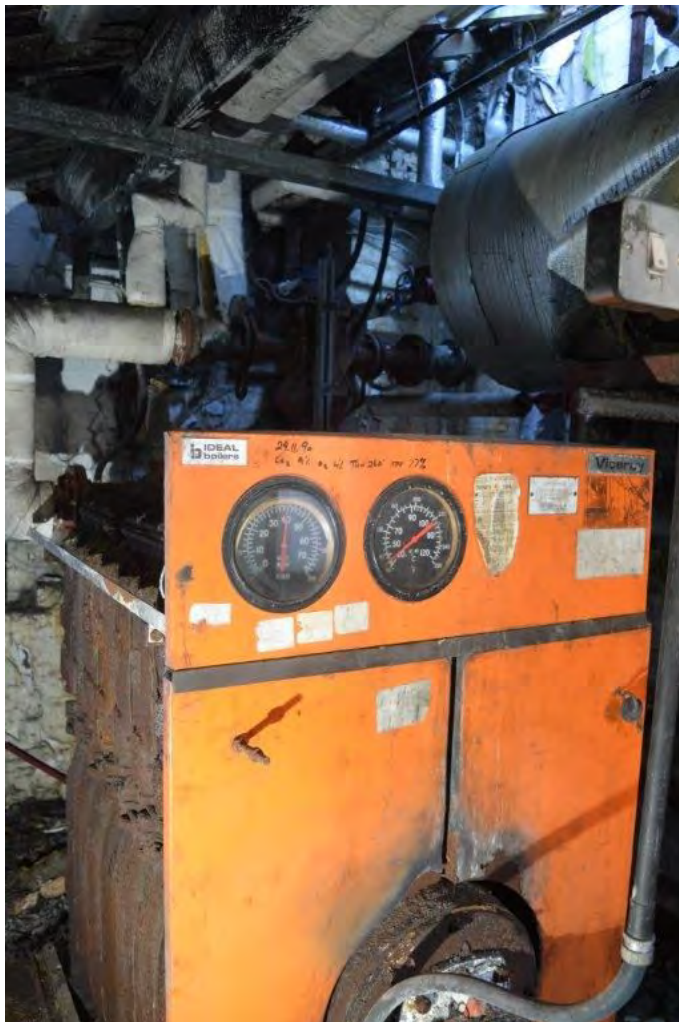
On the eastern elevation there is a doorway with rounded brick jambs and large, rectangular, fixed window while to the north is a two-light casement. The building houses an 'Ideal' boiler and associated apparatus including a framed diagram detailing the connections (Plate 148). A cylindrical metal oil tank stands surrounded by a dwarf brick wall immediately to the north.

Plate 148. Interior of Building L, view west

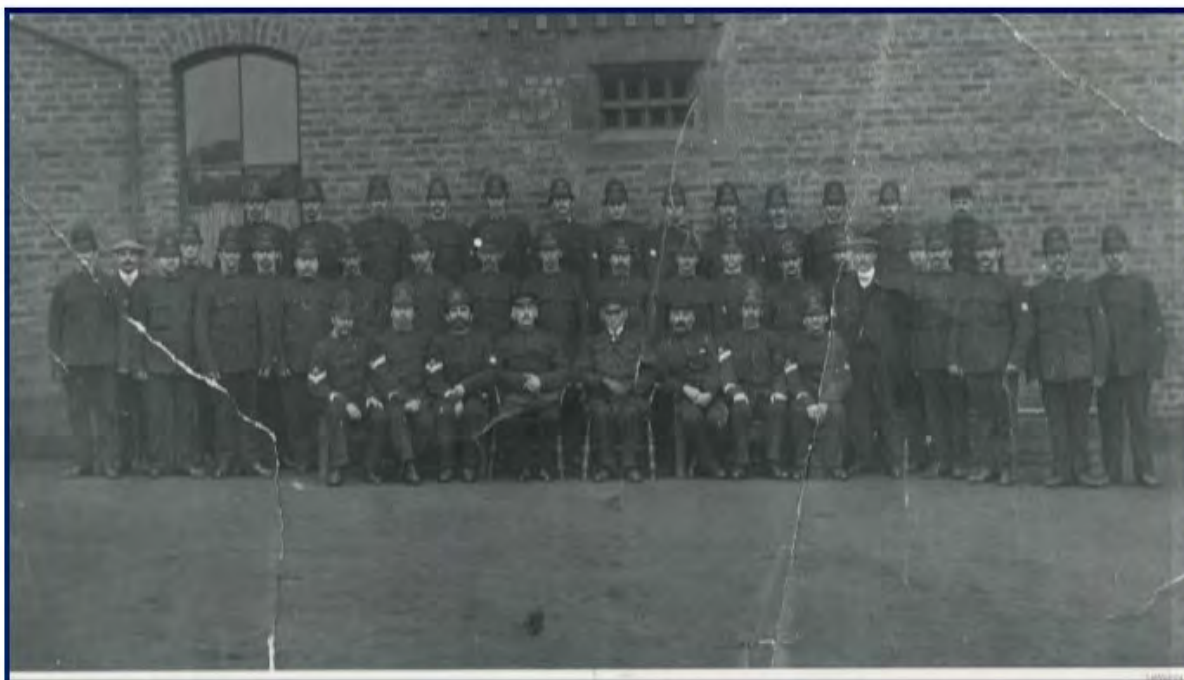
A photograph of Lancashire police lined up to the rear of the building c.1910 is reproduced as Plate 149. In this photograph, the door at the northern end of RG23 is not shown and the northern window in RG22 was originally a sash. The window at the northern end of the corridor which provides access to the cells (RG024) was formerly the high rectangular type used for the cells.

Plate 149. Lancashire Police to rear of Courtroom wing c. 1910
