# BUILT HERITAGE STATEMENT

Former Prescott Police Station, Derby Street, Prescott, Merseyside

HER00049  
v.2  
18 March 2024

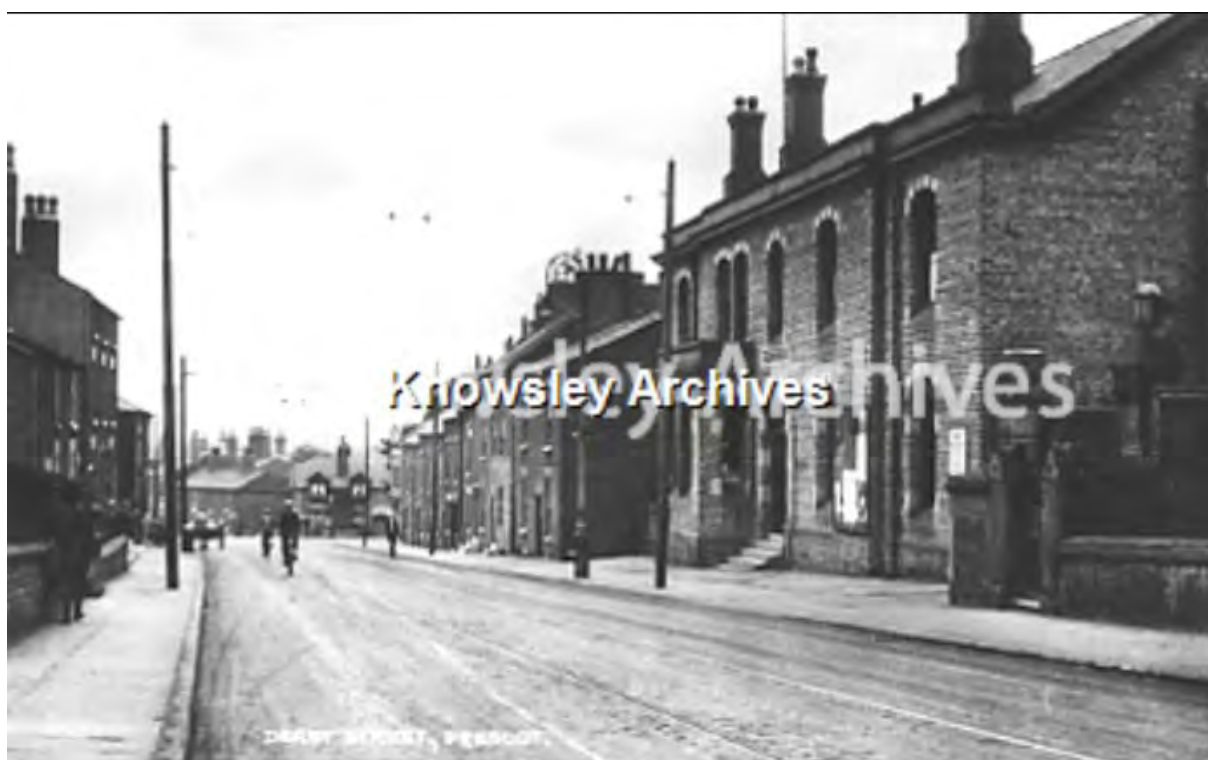
A ramp was installed at the front of the building to improve access in the 1990s. This replaced a set of steps which descended directly onto the pavement as shown on an undated photograph from Knowsley Archives, reproduced as Plate 150.

Plate 150. Undated view of police station from Derby Street from Knowsley Archives
