# Prescot Police Station Derby Street, Prescot

## Protected Species Scoping Report

4<sup>th</sup> August 2023

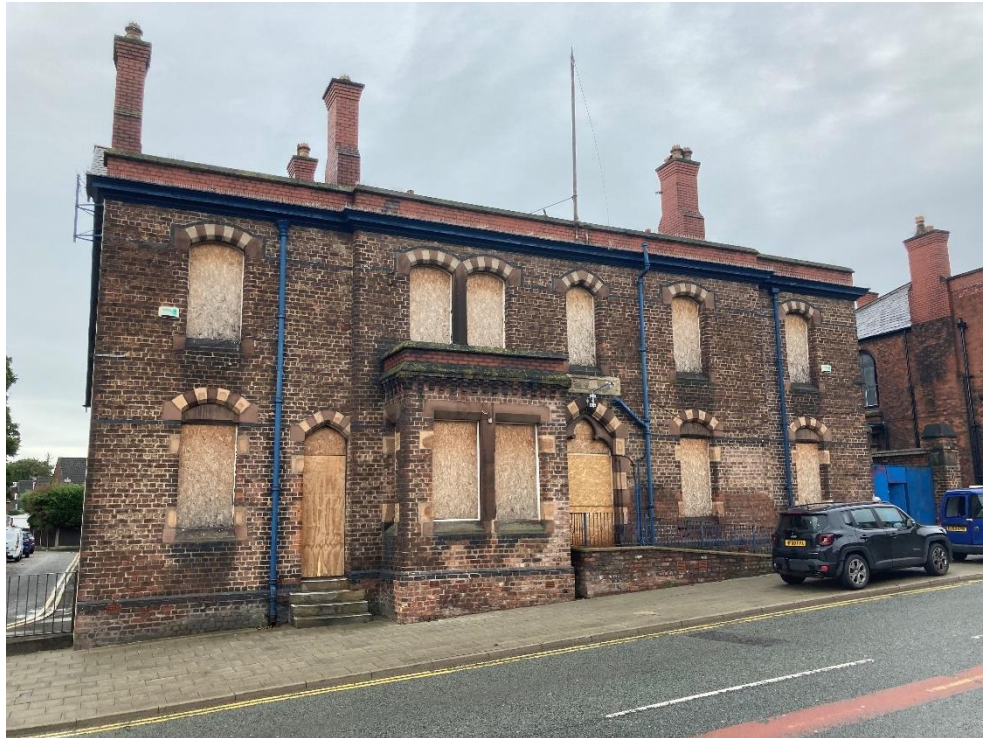
*Photograph 1- South face of Building 1*

The main Police Station Building (Building 1) is a large, two storey, detached, brick-built, Victorian structure. The building has a part hipped and gable ended roof clad in tightly fitted slate. The roof was replaced approximately 10 years ago and is lined internally with modern breathable roof membrane. The building has been disused for several years. The ground floor and front facing windows are boarded over.

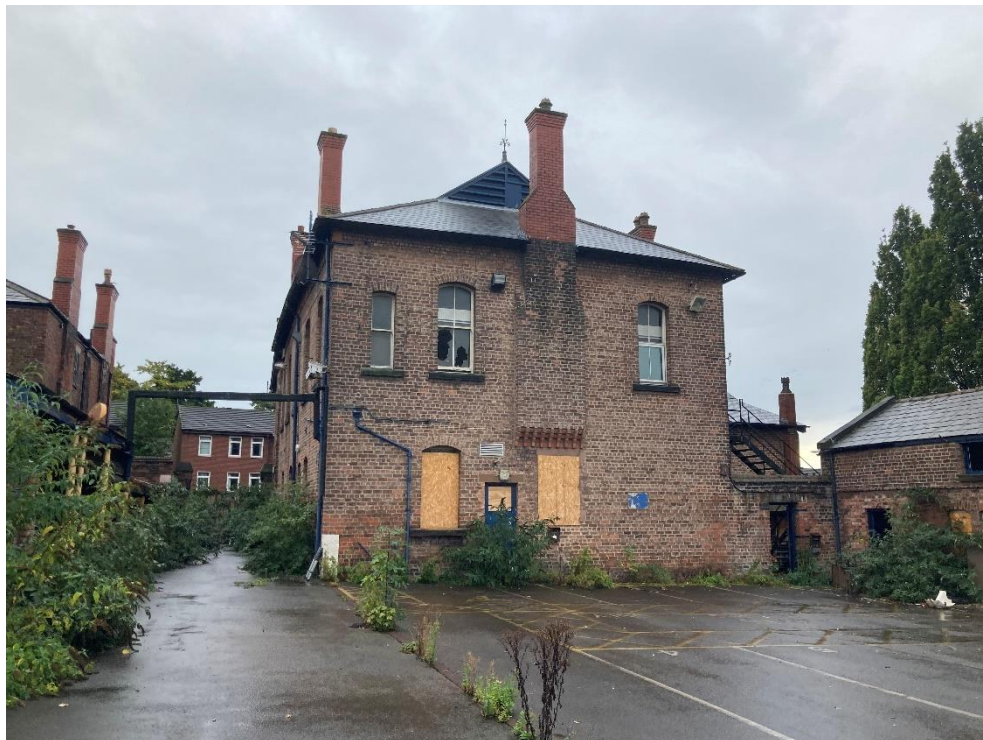
*Photograph 2- North face of Building 1*

Externally, the building has several upper floor, broken windows however these have been sealed with netting to prevent pigeons from accessing the building interior. As the roof has been recently replaced, the slates and ridge are tightly fitted and in good condition. There are no obvious gaps at the building's eaves or gable ends, which also appear tight and well-sealed. There is a short parapet wall extending above the height of the eaves on the building's south face with Derby Street and so this face is completely sealed.

There are some minor areas of lifting lead flashing located around the bases of the building's chimneys and around ventilation features which link to the void space above the main courthouse. Otherwise, no obvious potential bat roosting features were identified to the building's exterior. These small areas of lifting lead flashing could offer suitable roosting habitat for individual or low numbers of non-breeding bats.

The building was assessed as offering a '**low**' bat roosting potential. However, it is understood that the roof of the building will not be affected by development proposals, with works exclusively affecting the building interior. The internal rooms of the building are considered to be of negligible suitability for roosting bats.

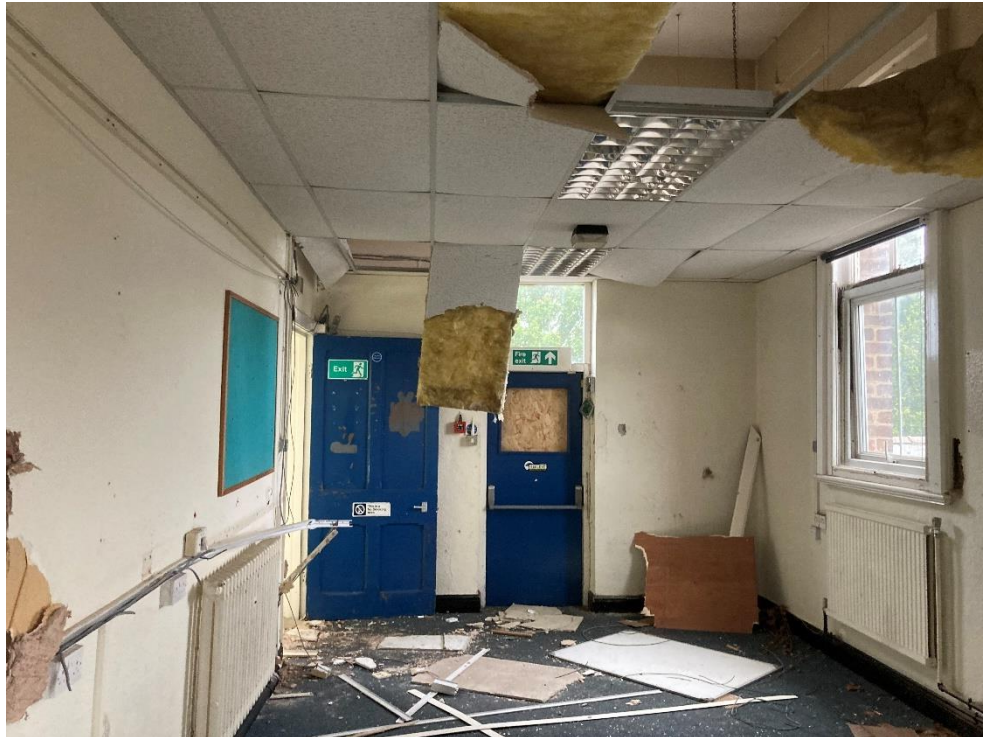
*Photograph 3- Interior of Building 1*

Internally, the police station rooms have plastered walls and ceilings with areas of polystyrene false-ceiling. During daylight hours, the interior of the upper floor of the building is brightly lit by glazed windows. The interior of the building has been damaged by vandals with broken upper floor windows throughout.

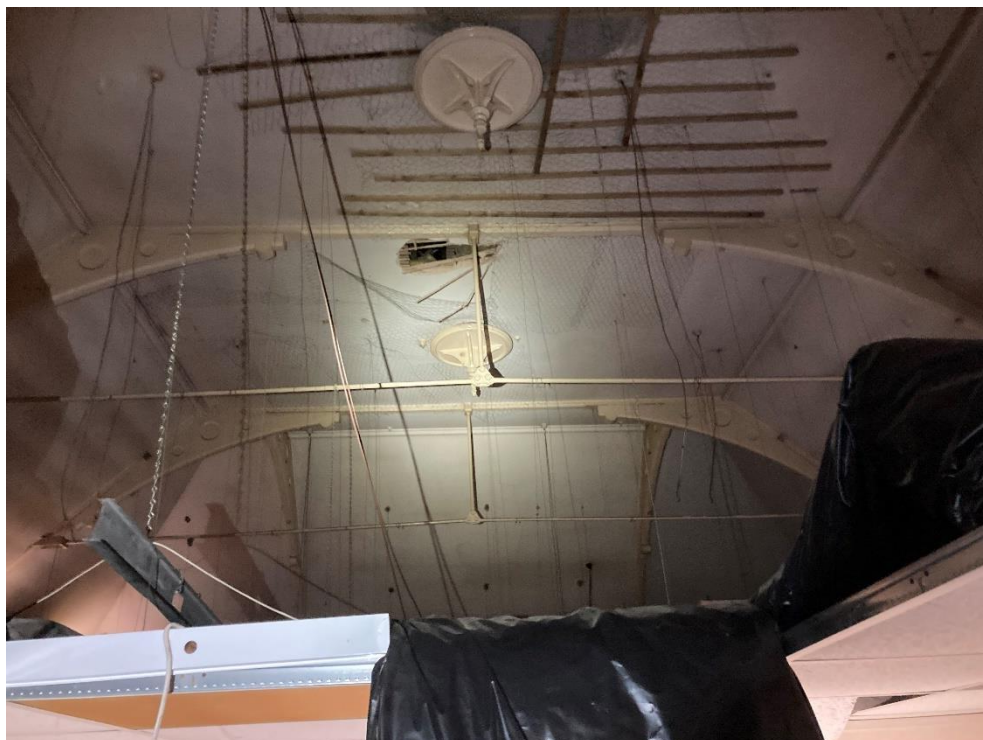
*Photograph 4- Vaulted ceiling of courthouse*

The main police station has a large central courthouse room which is approximately 6 m in height. There is a small, inaccessible void space above the vaulted ceiling of the courthouse. This small loft space is likely to be approximately 1 m in height. There are further loft spaces running above the gabled section of roof located alongside Derby Street. The loft spaces in this section are approximately 3m in height; the internal face of the roof is lined in modern breathable roof membrane and the loft spaces themselves are not insulated. No bat droppings or other bat field signs were found within the main building interior.

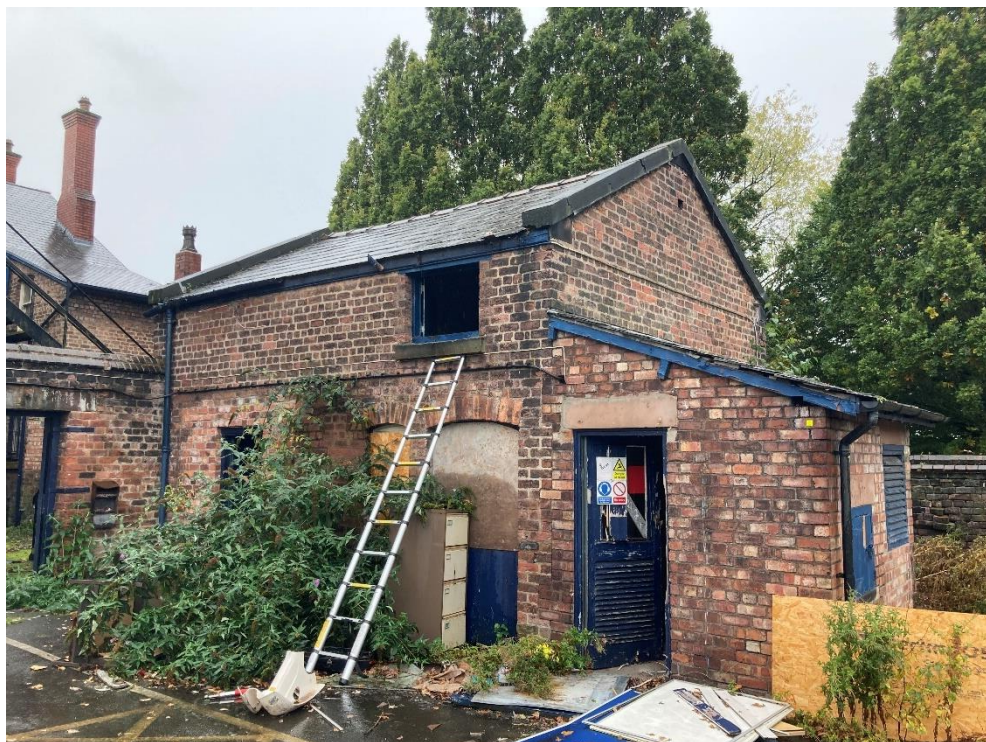
*Photograph 6- Exterior of Building 2*

Additional buildings at the site include two traditional, 19<sup>th</sup> century brick, slate-roofed outbuildings with upper floor haylofts (Buildings 2 and 4 of Figure 2). The buildings have 15 cm x 15 cm holes at the apexes of each gable. These holes provide potential bat and bird access to the building interiors. The internal faces of the roof are unlined and supported on the original roof trusses. The haylofts are approximately 3m in height. Two very old brown long-eared bat droppings were found within the hayloft of Building 4. Historic evidence of roosting feral pigeon was found throughout the upper floors of these buildings. However, no evidence of recent pigeon activity was observed.

No evidence of any recent bat activity was found within the interiors of these buildings. Both of the buildings were assessed as offering a '**moderate**' bat roosting potential. The interiors of the buildings were re-examined on 27<sup>th</sup> June 2023, no new/additional bat field signs were identified.

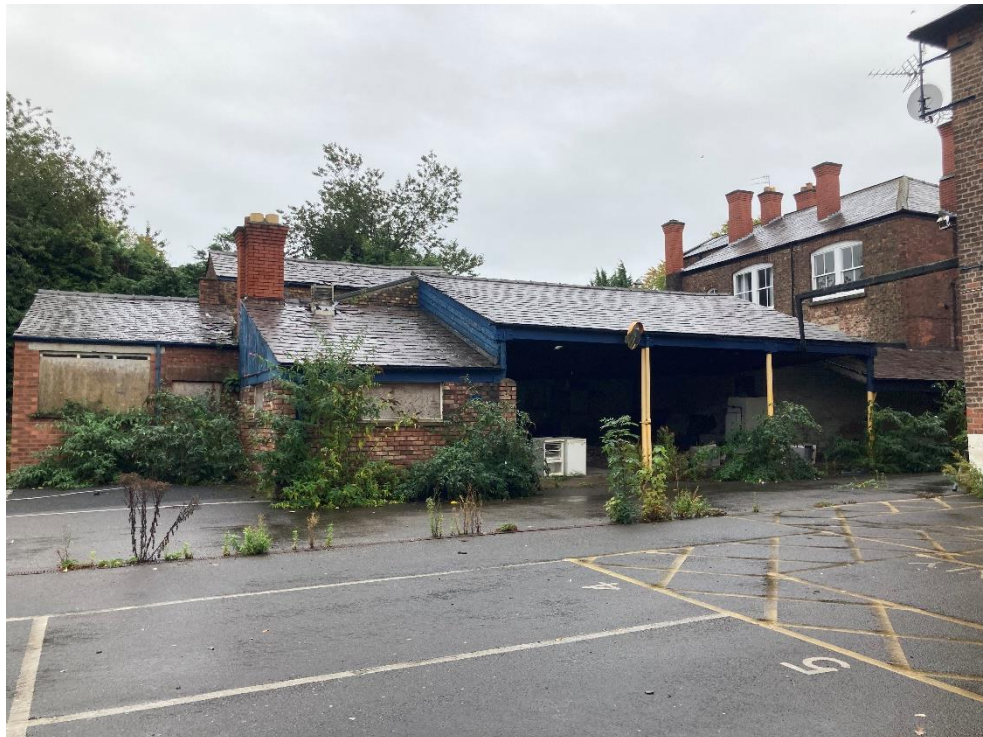
*Photograph 8- West face of Buildings 3, 4 and 6*

Further buildings at the site include an open sided, lean-to and single-storey brick outbuildings; all of which have mono-pitched roofs clad in slate (Buildings 3, 5 and 6). There are areas of loose and missing slate associated with the roofs of these buildings. The buildings are open and draughty, with the identified areas of loose slate considered to offer habitat of 'low' suitability for roosting bats. No old or recent bat field signs were found associated with these buildings.

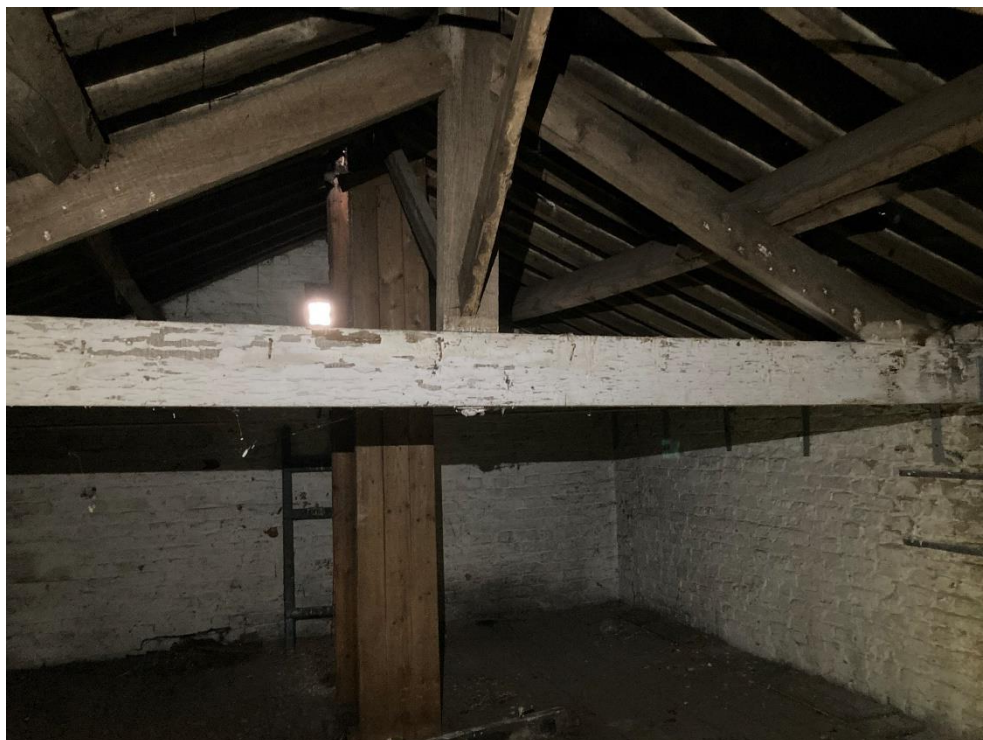
*Photograph 10- Interior of Building 4*

Two old brown long-eared bat droppings were identified within the interior of Building 4. However, these droppings were considered to be several years old; with no recent bat field signs recorded during either the October 2022 building inspections or the June 2023 building inspections.

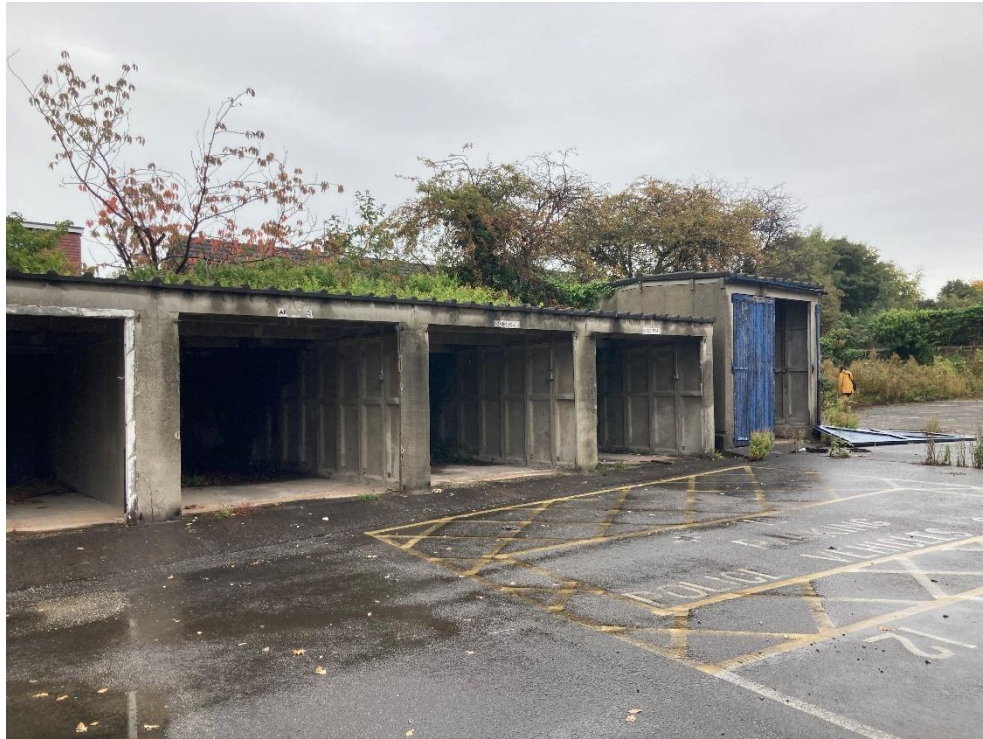
*Photograph 11- Buildings 7 and 8*

The remaining buildings at the site comprise of sets of concrete garages with flat-roofs clad in interlocking concrete tiles (Buildings 7 and 8). Both of these buildings were assessed as offering a 'negligible' bat roosting potential.

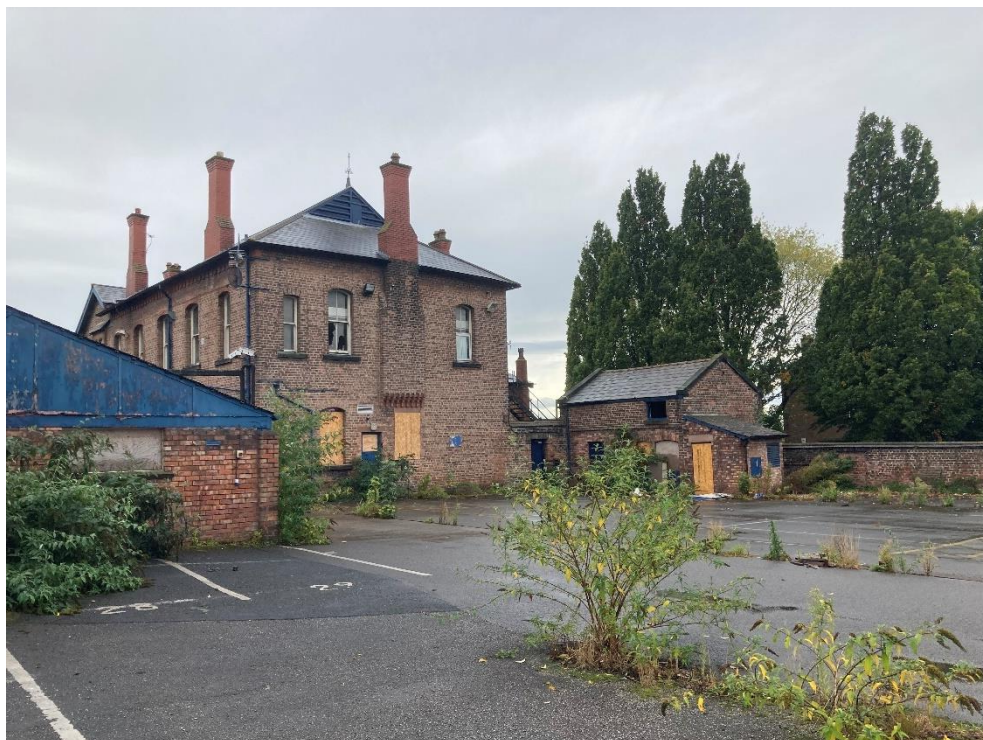
*Photograph 12- Habitats at the site*

The study area comprises of the former Prescot police station complex. The area comprises of the main former police station building plus a series of outbuildings and sheds. The area comprises principally of bare, hardstanding car park with scattered buddleia scrub which has started to colonise the site. Further vegetation includes scattered patches of tall herb typical of recently vacated urban sites and includes spear thistle, creeping thistle, broadleaved willow-herb, common ragwort, Canadian fleabane, red valerian, and ash saplings. There is a small stand of tall herb vegetation at north-east corner of site which comprises of nettle, great willowherb, Canadian fleabane, and rank grasses with cock's foot, Yorkshire fog and false oat-grass. There are no trees present at the site.

The patches of young scrub and the internal areas of the open buildings could be used by nesting birds during the breeding bird season.

It is therefore recommended that future development of the site including any vegetation clearance avoid taking place during the breeding bird season (March-September inclusive).
