Phase I Geoenvironmental Site Assessment  
Huyton Asphalt Ltd, Lees Road, Knowsley

Reference: 15-277-R1-2  
Date: September 2022

# PHASE I GEOENVIRONMENTAL SITE ASSESSMENT

Huyton Asphalt Ltd  
Lees Road  
Knowsley  
L33 7SE

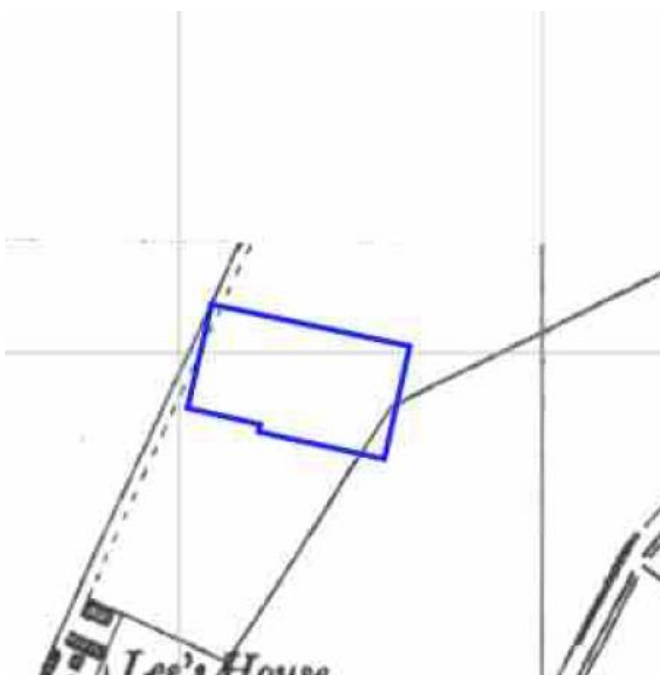
| MAP EDITION | HISTORICAL LAND USE | HISTORICAL MAP EXCERPT |
|---|---|---|
| <b>1938</b><br><b>1:10,560</b> | <p>There are no significant changes to the site.</p> | |

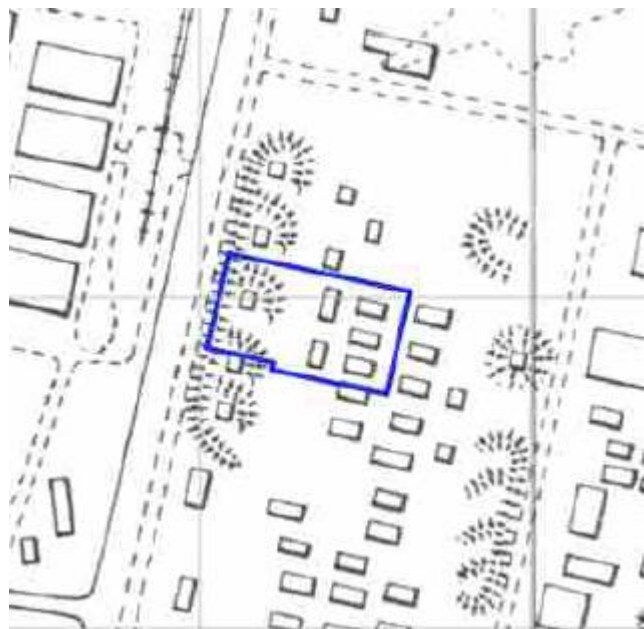
| MAP EDITION | HISTORICAL LAND USE | HISTORICAL MAP EXCERPT |
|---|---|---|
| <b>1956</b><br><b>1:10,560</b> | <p>The site is now located within Kirkby Industrial Park. Farm buildings to the south have been removed and multiple new structures now occupy the site. Structures appear to represent a camp with shelters/barracks.</p> <p>Map is labelled 1956 but looks to show army camp layout that was present from 1940 to around 1948. Anecdotal Information: Plate 01 shows aerial image of the site.</p> | |

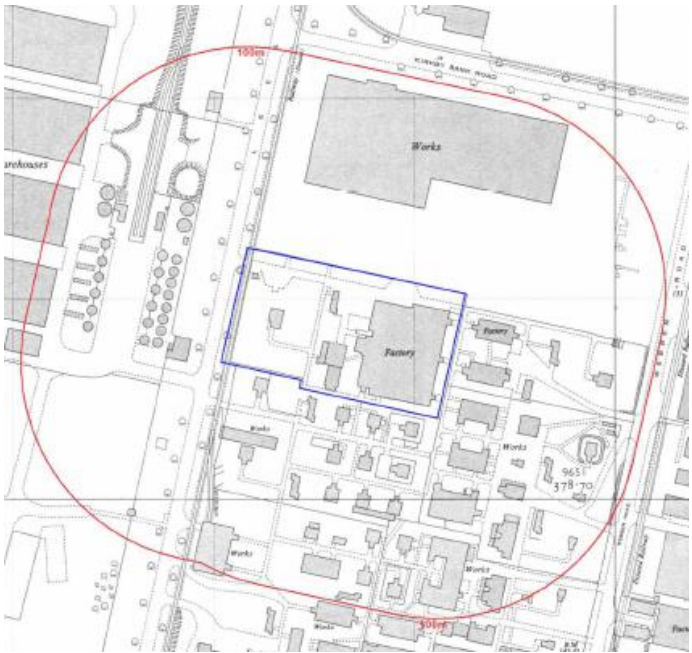
| MAP EDITION | HISTORICAL LAND USE | HISTORICAL MAP EXCERPT |
|---|---|---|
| <p><b>1960</b><br/><b>1:2,500</b></p> | <p>Large factory and multiple smaller surrounding buildings are present on site.</p> | |

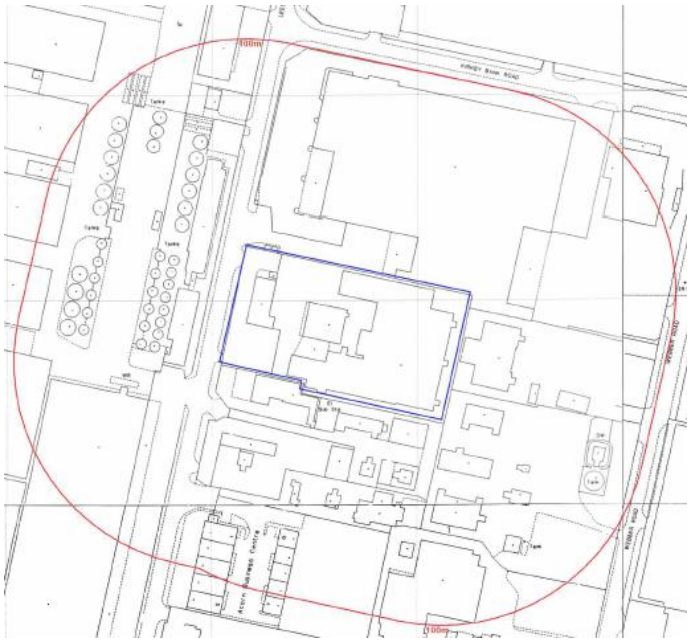
| MAP EDITION | HISTORICAL LAND USE | HISTORICAL MAP EXCERPT |
|---|---|---|
| <p><b>1994</b><br/><b>1:1,250</b></p> | <p>There are no significant changes to the site.</p> | |

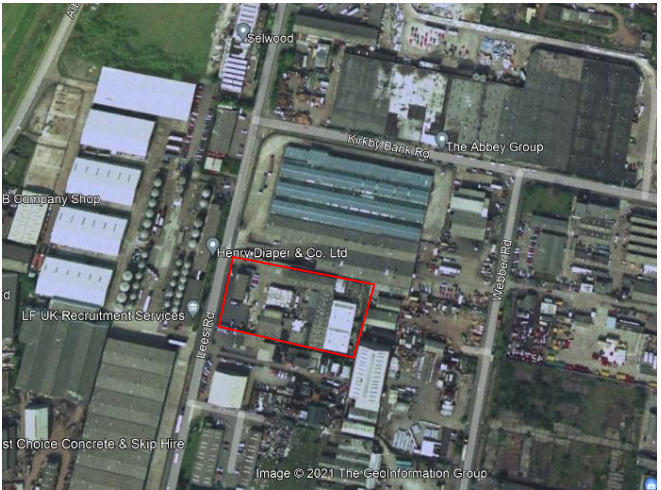
| MAP EDITION | HISTORICAL LAND USE | HISTORICAL MAP EXCERPT |
|---|---|---|
| <p><b>Google Aerial</b><br/><b>2000</b></p> | <p>The aerial image appears to show the site in the same configuration as the previous map.</p> <p>There appears to be a storage area in the centre of the site, with carparking in the west.</p> | |

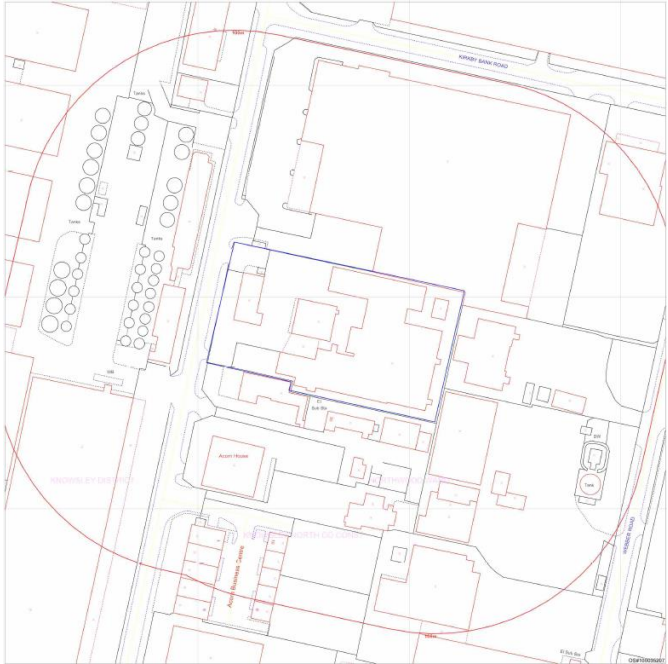
| MAP EDITION | HISTORICAL LAND USE | HISTORICAL MAP EXCERPT |
|---|---|---|
| <b>2003</b><br><b>1:1,250</b> | <p>There are no significant changes to the site.</p> | |

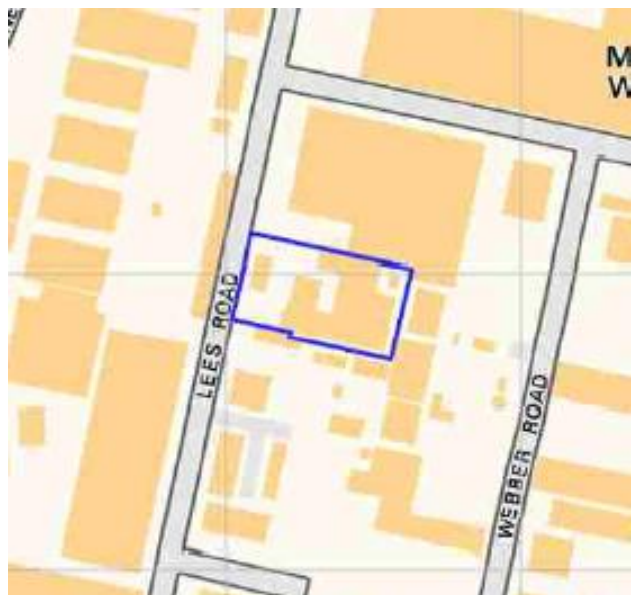
| MAP EDITION | HISTORICAL LAND USE | HISTORICAL MAP EXCERPT |
|---|---|---|
| <b>2010</b><br><b>1:10,000</b> | <p>There are no significant changes to the site.</p> | |

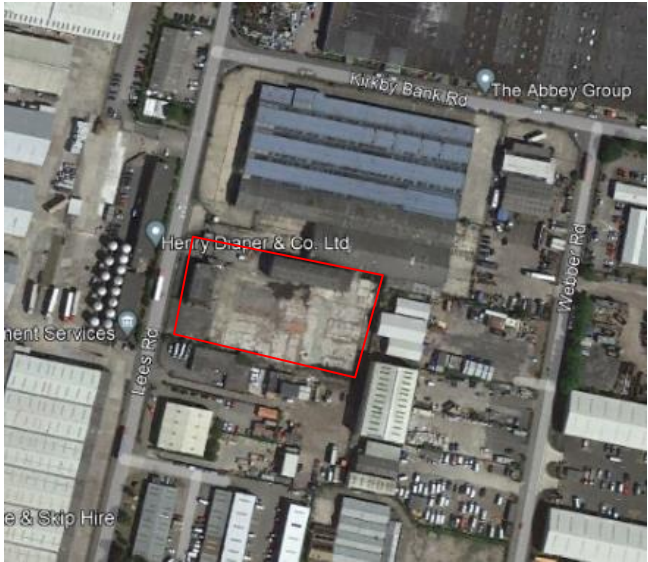
| MAP EDITION | HISTORICAL LAND USE | HISTORICAL MAP EXCERPT |
|---|---|---|
| <p><b>Google Aerial</b></p> <p><b>2018</b></p> | <p>The aerial image shows the majority of structures to have been demolished, with only one building remaining in the west of the site and another adjacent the northern boundary.</p> <p>This is consistent with the current site layout.</p> | |

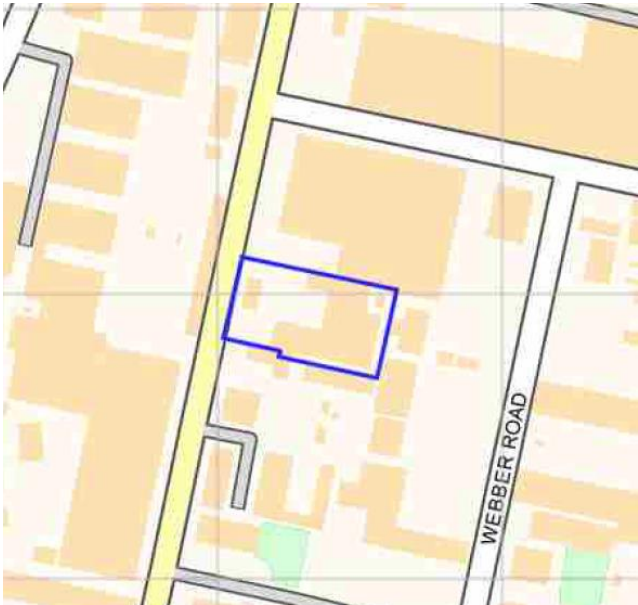
| MAP EDITION | HISTORICAL LAND USE | HISTORICAL MAP EXCERPT |
|---|---|---|
| <p><b>2021</b></p> <p><b>1:10,000</b></p> | <p>The map shows slight changes to the main building (demolition of a central portion) however google aerial imagery (see above) shows most of the canning factory was demolished between 2016-2018.</p> | |

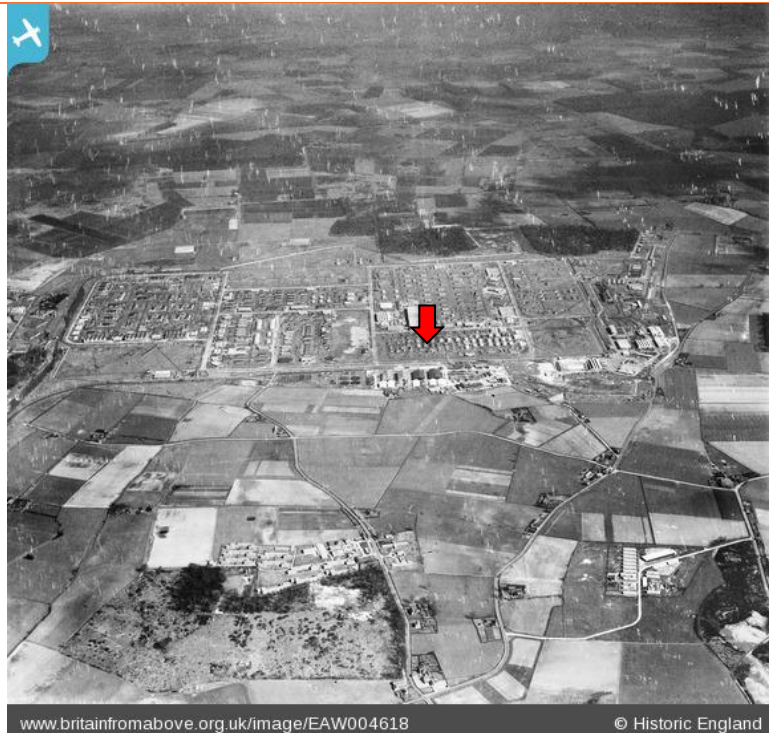
### PLATE 01 – KNOWSLEY INDUSTRIAL PARK, KIRKBY, 1947

An aerial image depicting the area that is now Knowsley Industrial Park post WWII. At the time named ROF Kirkby, the area was used as a munitions factory between September 1940 and March 1946, where it produced approximately 10% of WWII ammunition.

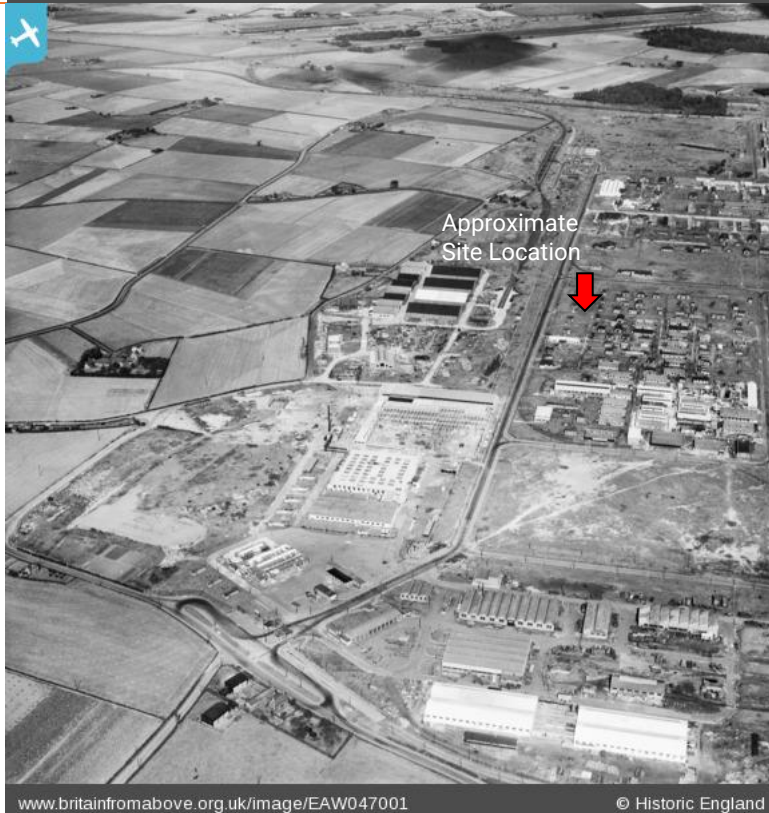
### The Kirkby Industrial Estate around Lees Road, Kirkby, 1952

ROF Kirkby employed up to 20,000 people from across the region and on the site could be found an administrative building, an engineering machine shop, a tailor's shop, a treatment room, chemical laboratories, a loading bay, a canteen and more.

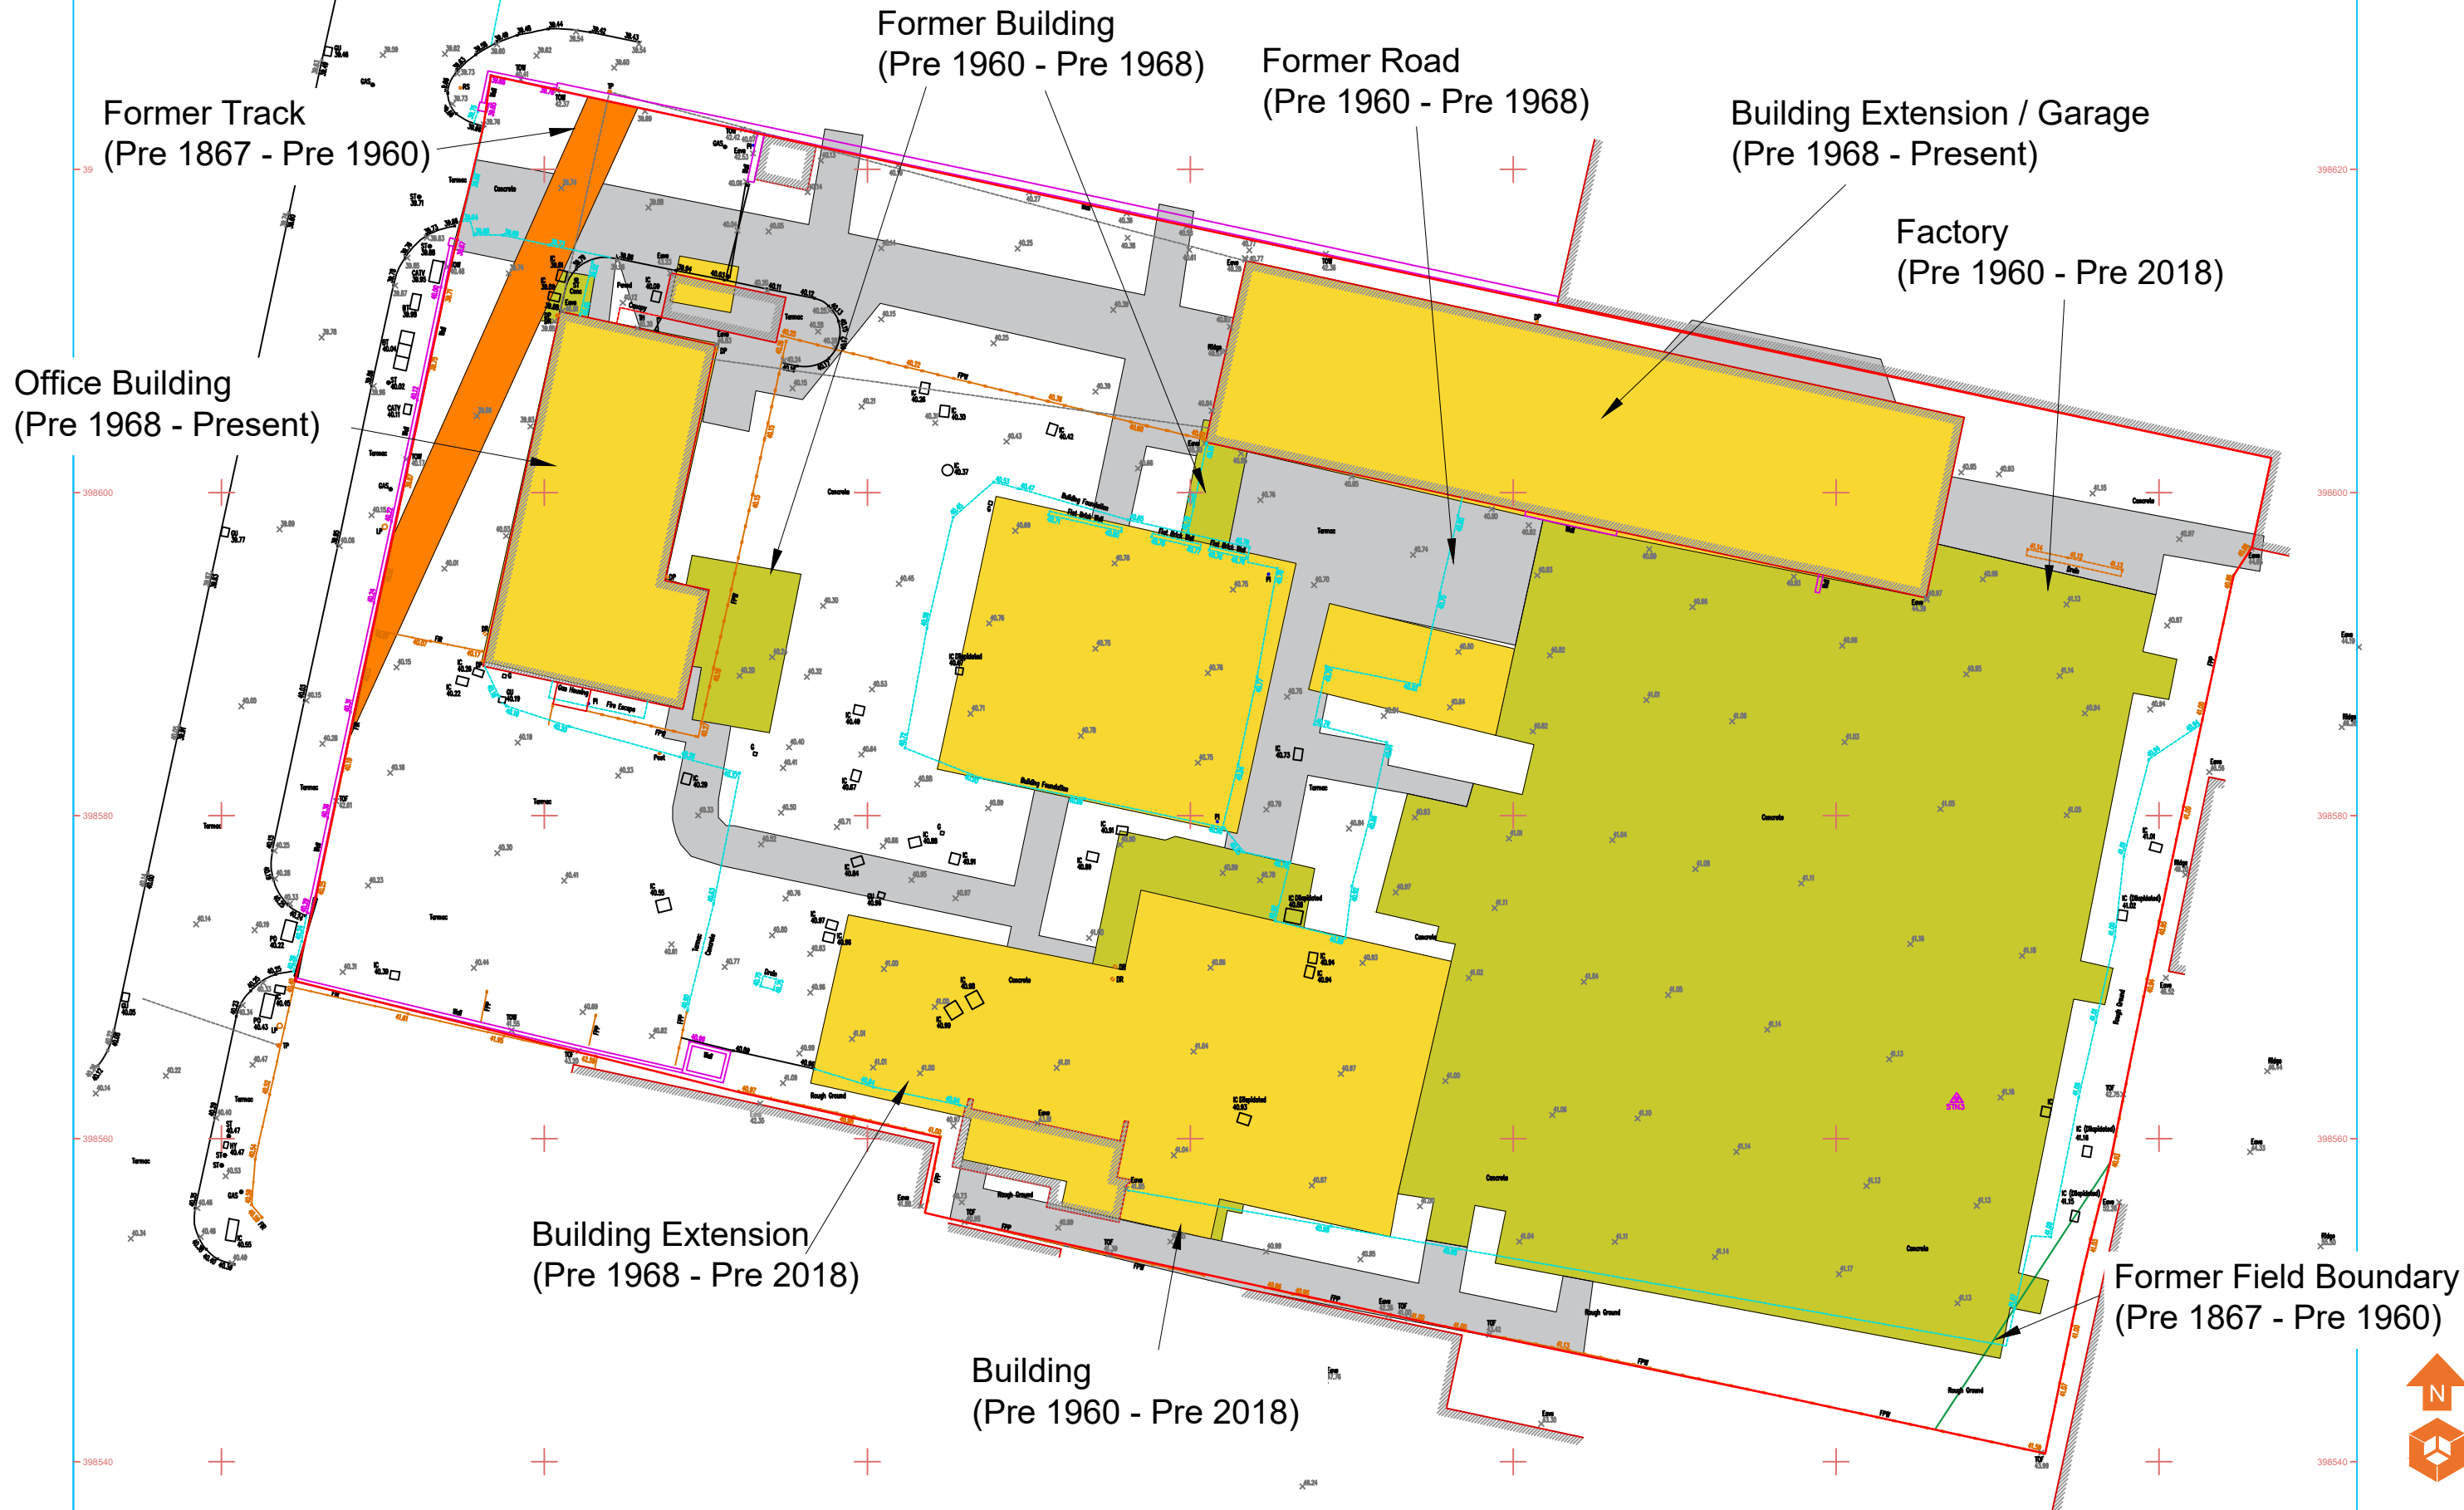
Historical Features

- Former Track (Pre 1867 - Pre 1960)
- Former Field Boundary (Pre 1867 - Pre 1960)
- Former Buildings (Pre 1960 - Pre 1968)
- Former Building Extension (Pre 1968 - Present)
- Former Road (Pre 1960 - Pre 1960)

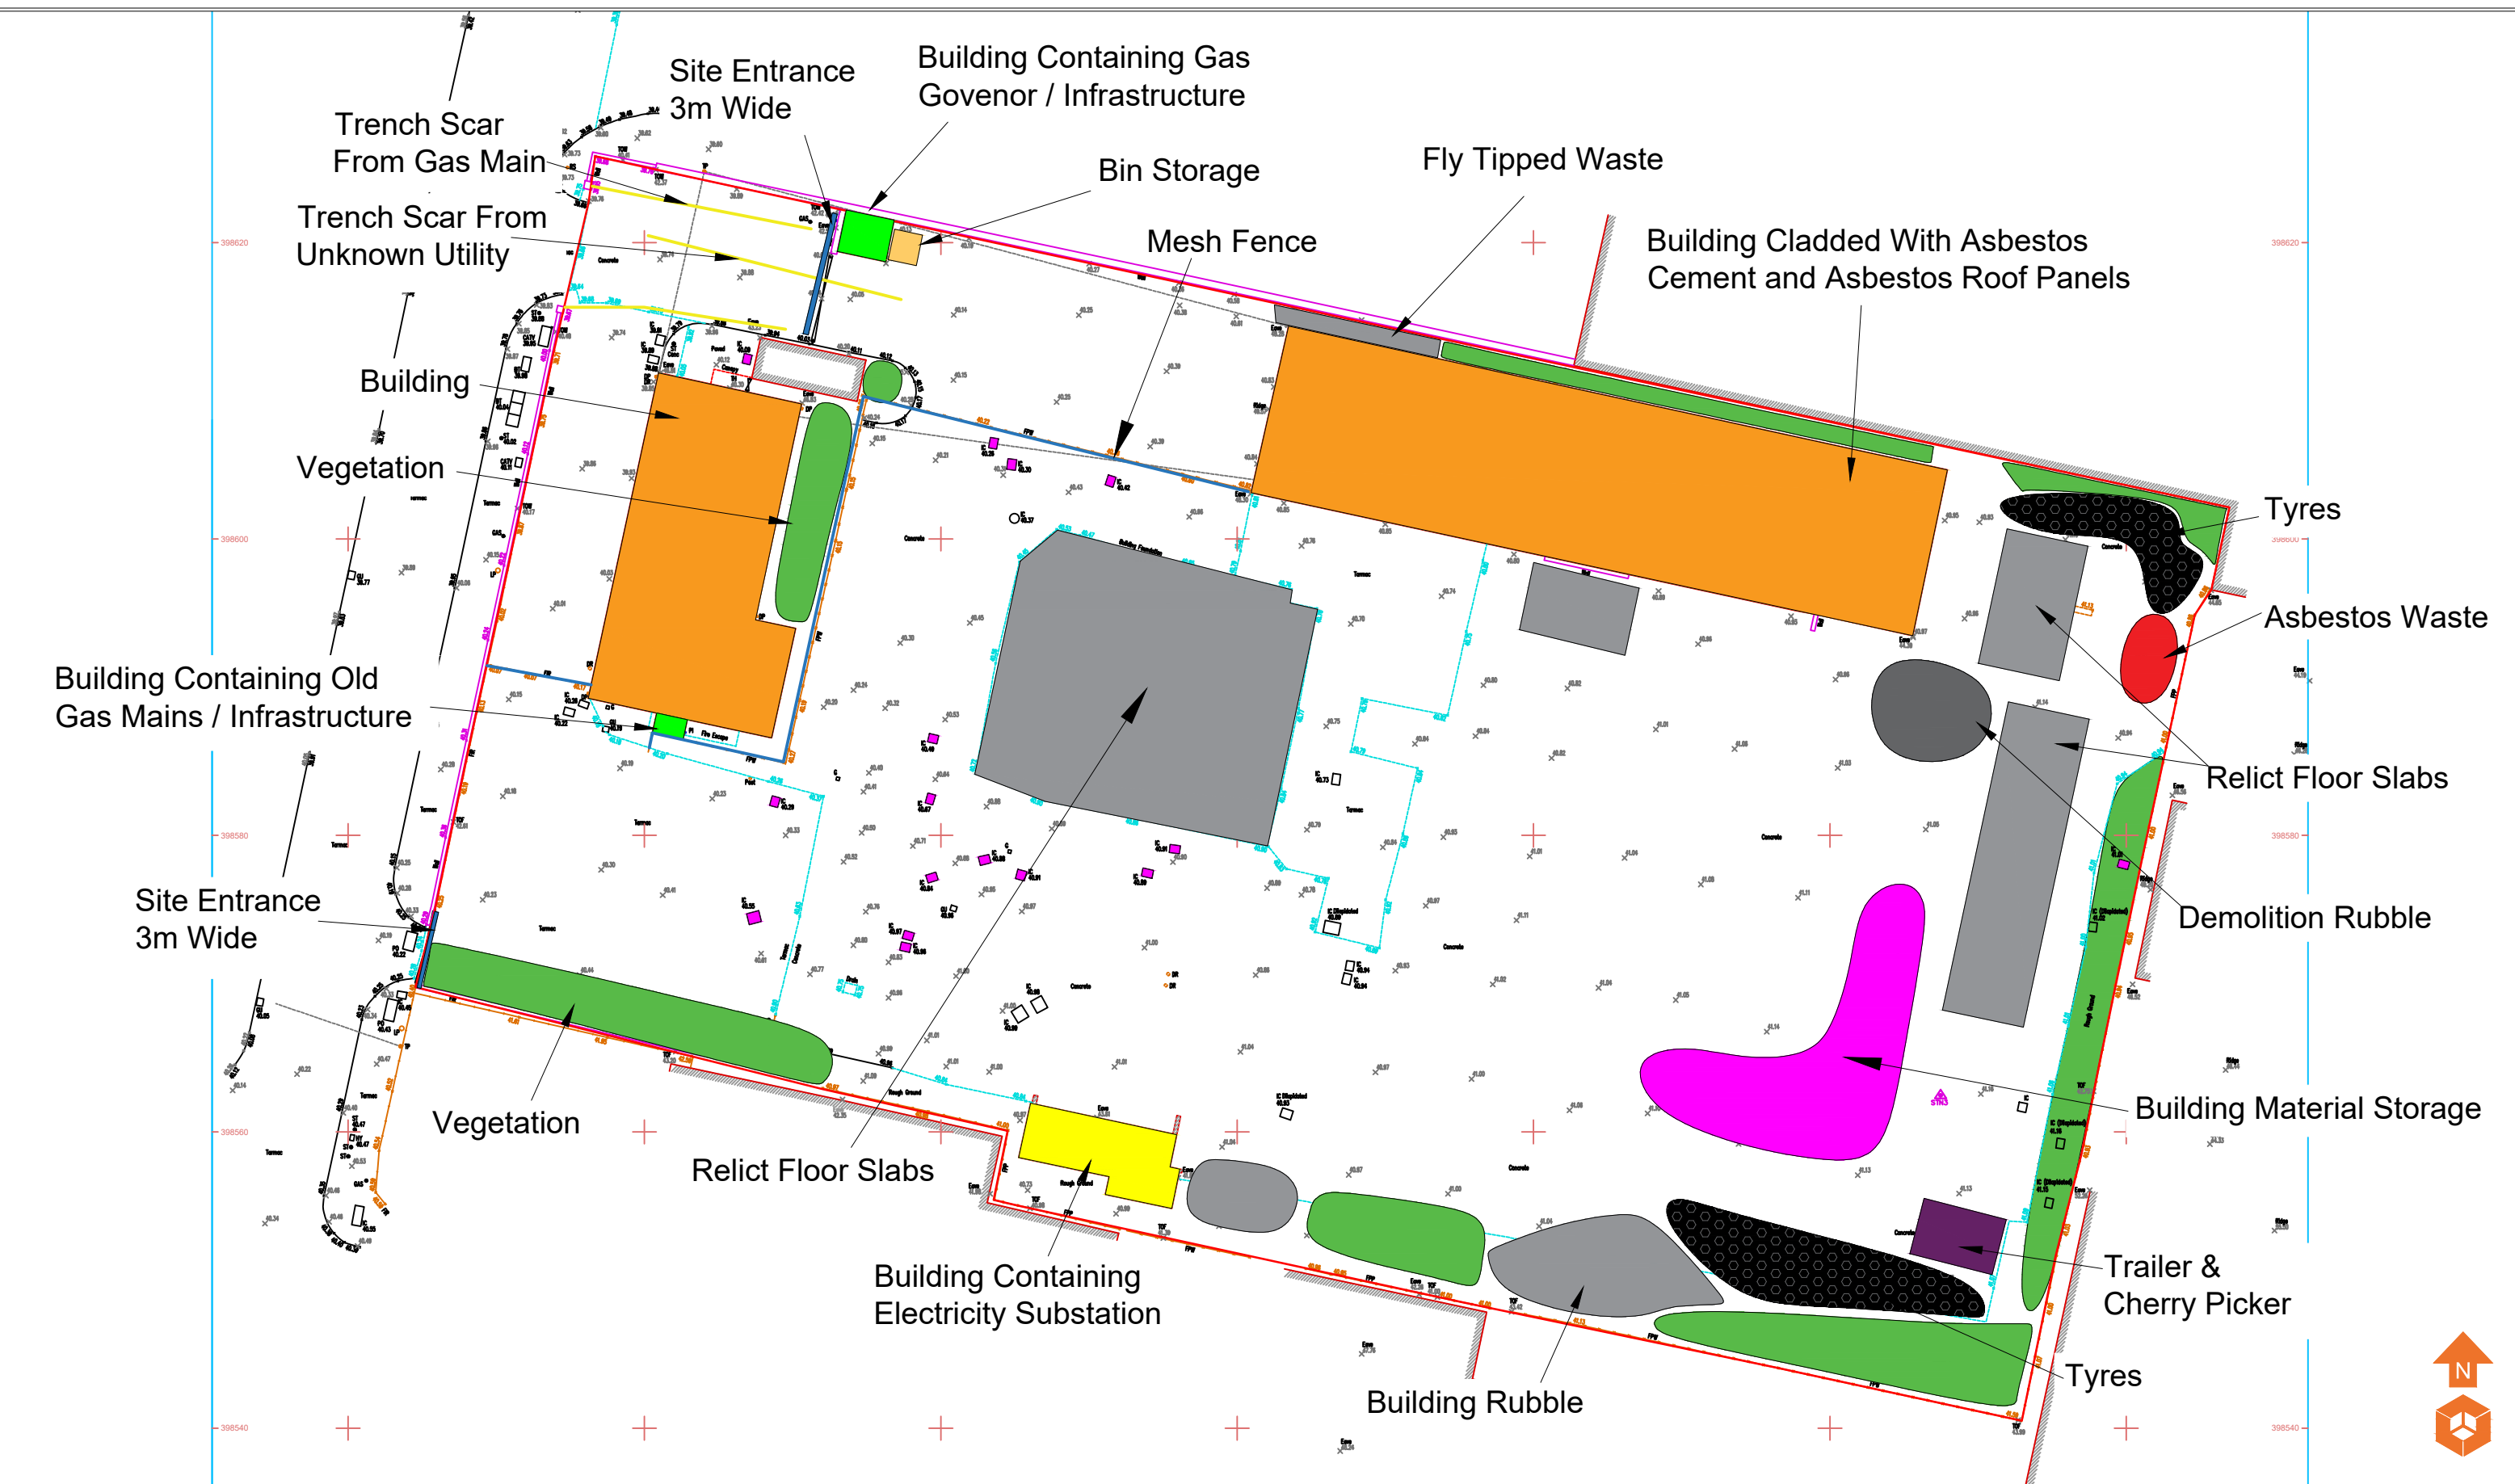
| <div>Site Features</div> <div><div><div>Vegetation</div><div>Utility Trench Scars</div><div>Site Entrance</div><div>Building Containing Electricity Substation</div><div>Building</div><div>Trailer &amp; Cherry Picker</div><div>Tyres</div><div>Building Containing Gas Mains / Infrastructure</div><div>Asbestos Waste</div></div><div><div>Bin Storage</div><div>Demolition Rubble</div><div>Relict Floor Slabs</div><div>Building Material Storage</div><div>Mesh Fence</div></div></div> | <div>Notes:</div> | | | | | <div>Client:</div> <div>AJP</div> | <div>Job No:</div> <div>15-277</div> | <div>Date:</div> <div>26.10.2021</div> | <div><div><div></div><div>e3p</div></div><div>Environmental Engineering Partnership Ltd<br/>Taylor Road, Trafford Park<br/>Urmston, Manchester, M41 7JQ<br/>Tel: 0161 707 9612<br/>E-mail: info@e3p.co.uk<br/>Website: www.e3p.co.uk</div></div> |

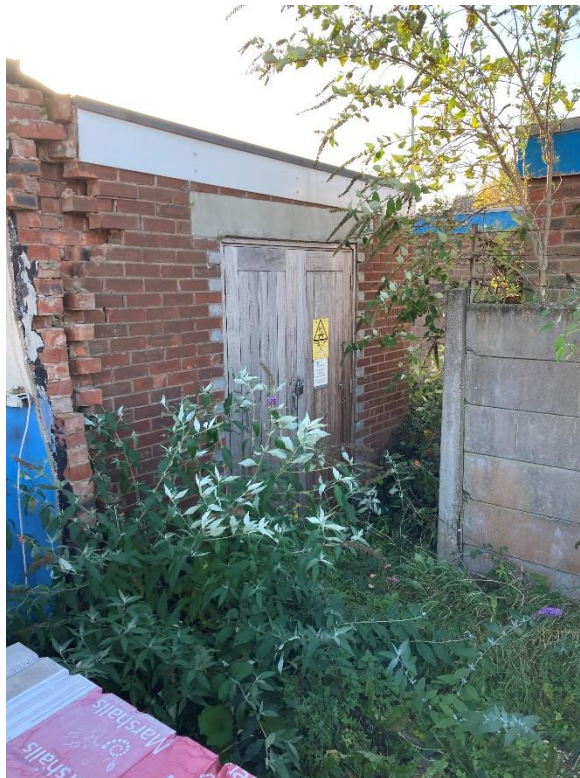
PLATE 1 ELECTRICITY SUBSTATION - BUILDING ON SOUTHERN BOUNDARY LOOKING SE

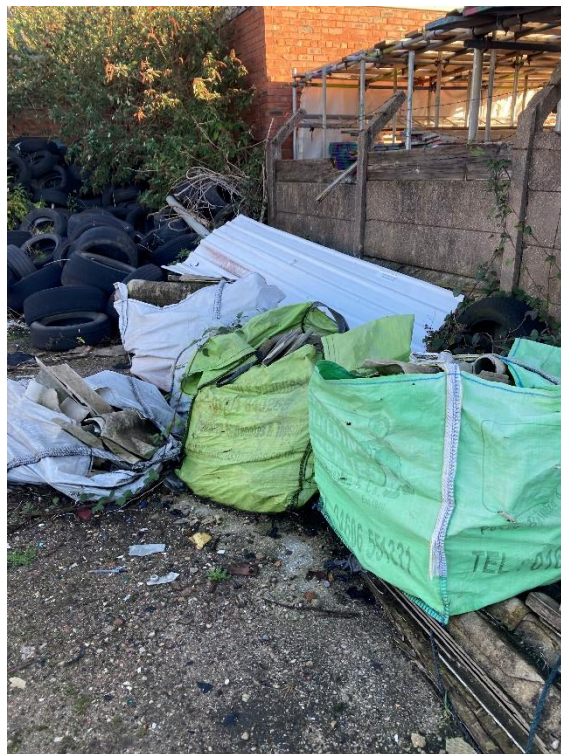
| <b>Waste Storage</b> | <p>ACM waste was found in the northeast corner of the site – potential risk associated with movement/disposal of ACMs.</p> <p>Large stockpiles of tyres are also present on-site, together with bunds of demolition rubble.</p> |

PLATE 2 BAGS CONTAINING ACM WASTE - NORTHEAST CORNER LOOKING NE

| POLLUTANT LINKAGE | CONTAMINANT (SOURCE) | PATHWAY | RECEPTOR | PROBABILITY | CURRENT RISK | RESIDUAL RISK AFTER MITIGATION |
|---|---|---|---|---|---|---|
| <b>Assessment:</b><br>Storage of waste ACM was observed in the northeast corner of the site, likely removed from former on-site structures prior to demolition. ACM roof panels were also observed on the garage building in the north of the site. Due to the age of the historical buildings on site, asbestos may have been used within the building fabric. Any Made Ground deposits associated with the demolition of the former buildings may therefore contain loose asbestos fibres and even ACM fragments. | | | | | | |
| <b>Recommendation:</b><br>Intrusive investigation should include asbestos screen and quantification. Risks to end users are significantly reduced where hardstanding will be present as there is no risk of direct contact. In soft landscaping areas, a suitable cover system will likely be required to mitigate the risk to site users and maintenance workers. | | | | | | |

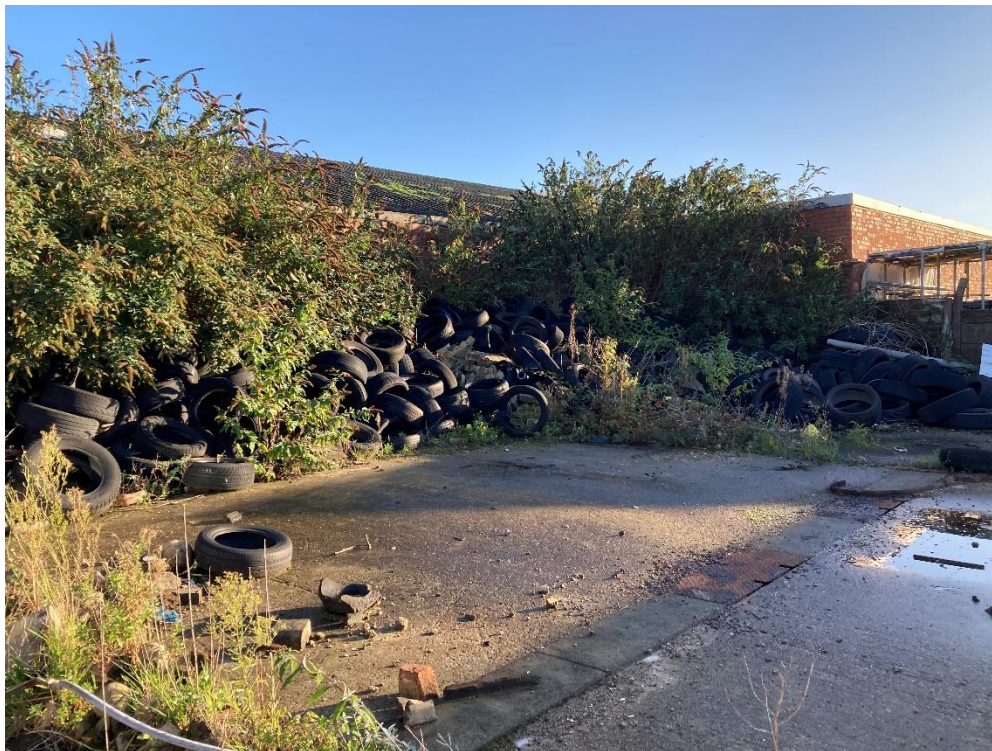
PLATE 3 TYRE WASTE - NORTHEAST CORNER LOOKING NE

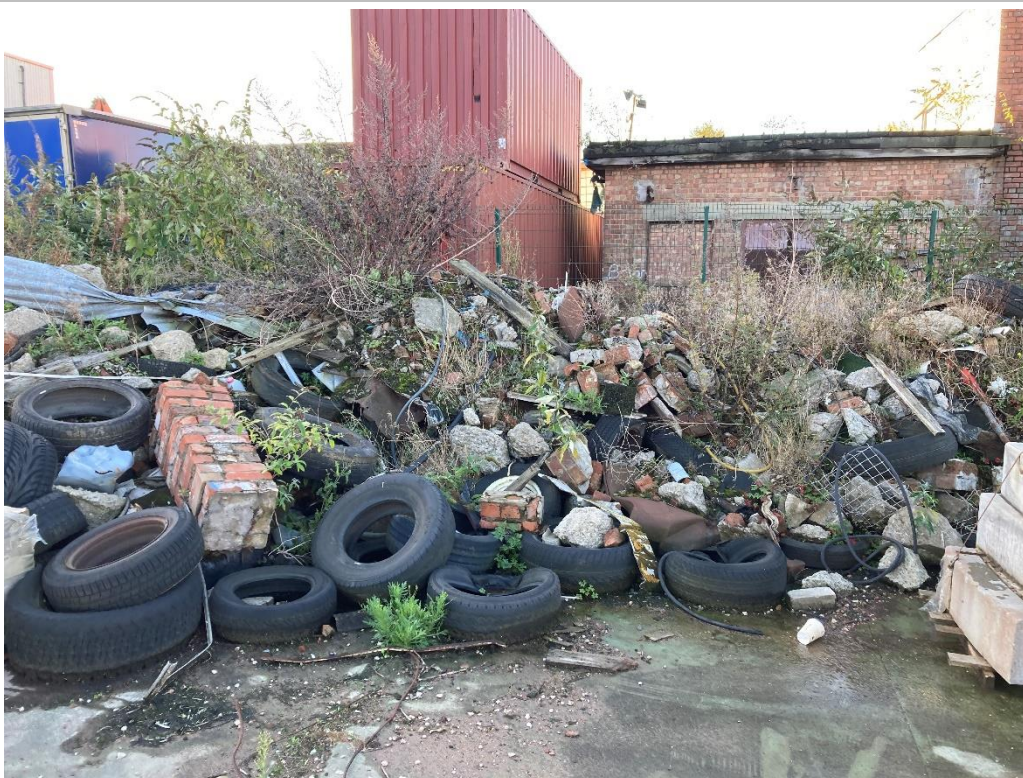
PLATE 4 TYRE WASTE AND DEMOLITION RUBBLE - SOUTHEAST CORNER LOOKING SE

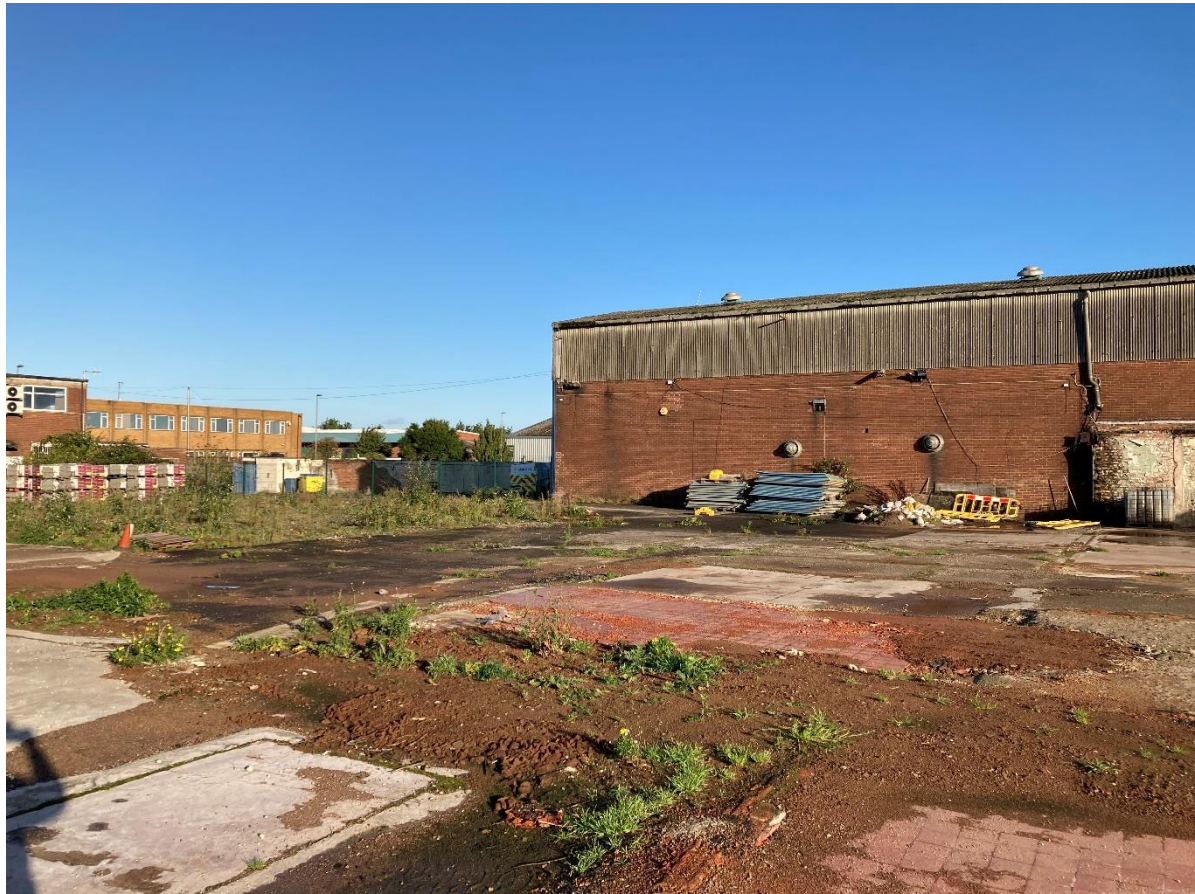
| <b>Asbestos-Containing Material (ACM)</b> | <p>Evidence of potential ACM was observed as cement roof panelling on the garage building. Given the age of the on-site structures (pre-2000 construction), ACM is likely to be present within the building fabric.</p> <p>Large bags of ACM cement board / cladding / panelling were also present in the northeast corner of the site, likely removed prior to the demolition of the former structures.</p> <p>Evidence of a previous pre demolition asbestos survey was found in the form of pipe labels in the demolition rubble in the centre of the site.</p> <p>A pre-demolition asbestos survey will be required within all existing buildings within the site boundary.</p> |

PLATE 5      VIEW NORTHWEST - ACM ON UPPER GARAGE, DEMOLITION RELATED MADE  
GROUND MIDDLE LEFT OF PHOTO (GRASSY AREA)
