# Site Asbestos Management Plan

Westshield Limited

Cherryfield Drive, Kirby, Liverpool, L32 8RX

**Project Title:** P-508411 – Land off Cherry Field Drive

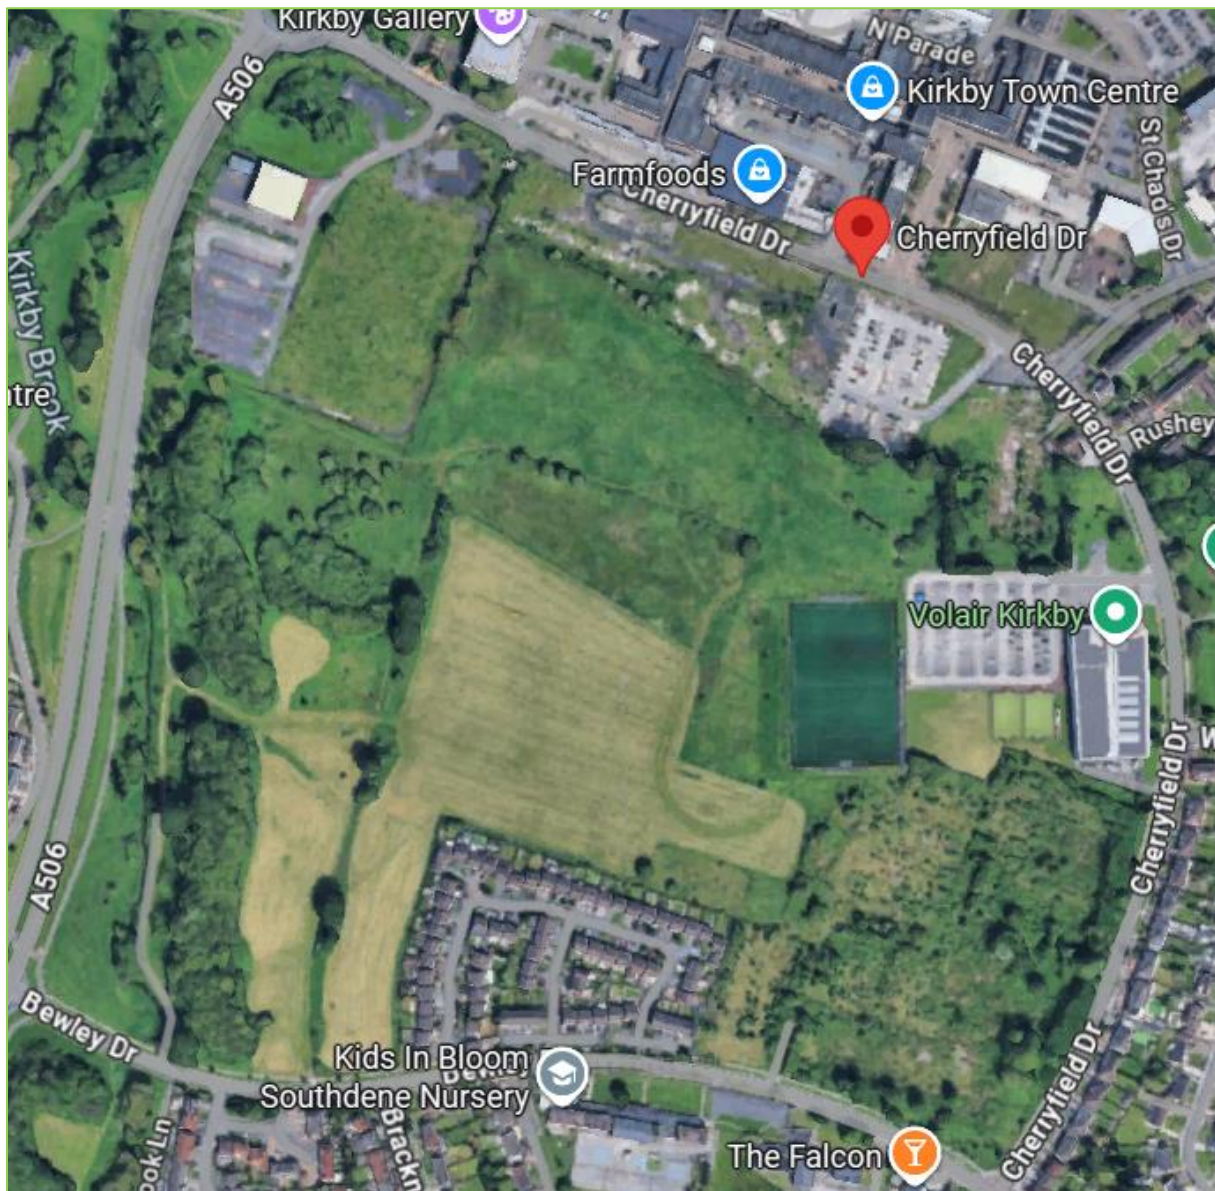
Figure 1: Site Overview

An overview of the site is shown in Figure 1 and Figure 2 below.

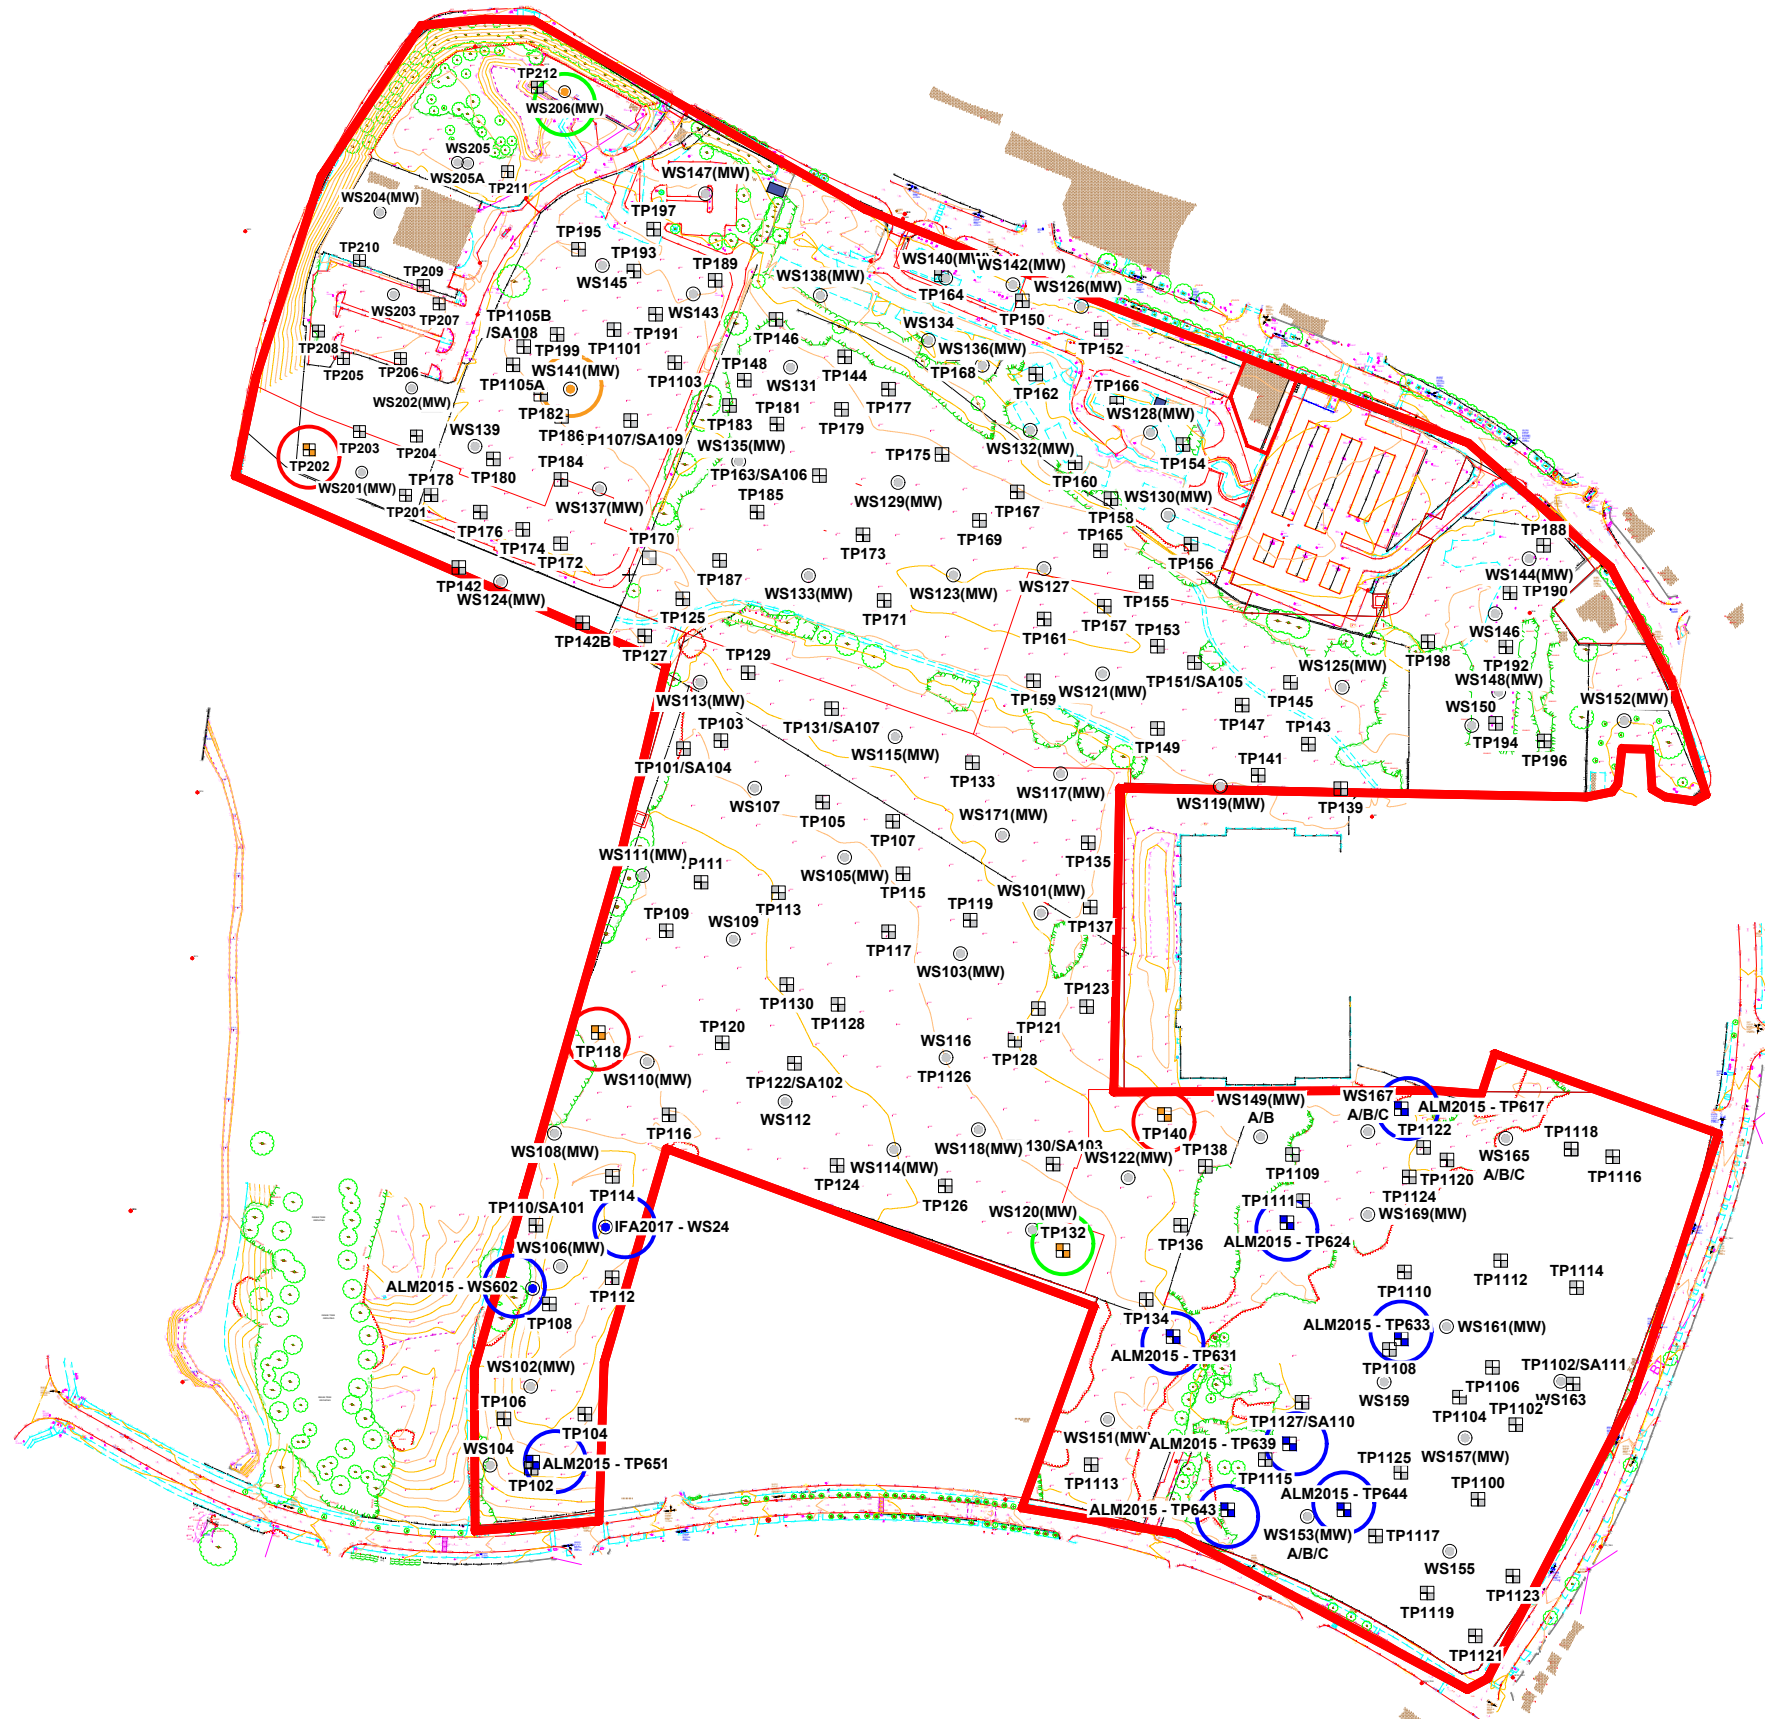
**Drawing 15-280 018: Contamination exceedances plan - asbestos**

**B – Location of asbestos-containing materials and asbestos hotspots**

1. Fragments of asbestos-containing material
  - a. Near WS 141 (Asbestos cement sheets)
2. Hotspots where the level of asbestos fibres is higher than < 0.001%
  - a. TP140 at 0.1m bgl (0.002%)
  - b. TP202 at 1.0m bgl (0.005%)
  - c. TP118 at 0.5m bgl (0.009%)
3. Low level loose asbestos fibres < 0.001% that have been assumed may be present generally within the made ground and also in
  - a. TP132 (< 0.001%)
  - b. WS206 (< 0.001%)

It should be noted that the following locations detailed in the Ian Farmer's Report are outside the current boundary of the proposed development and are therefore excluded from Table 3 and the plan in Appendix B:
