Phase I Geoenvironmental Site Assessment  
Carr Lane, Prescott

Reference: 14-245-R2  
Date: June 2022

# PHASE I GEOENVIRONMENTAL SITE ASSESSMENT

Land at Carr Lane,  
Prescot  
L34 1QL

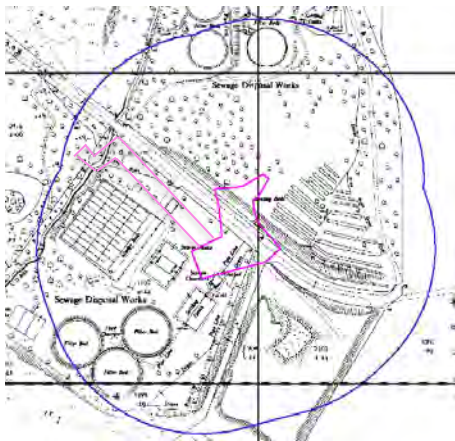
| MAP EDITION | HISTORICAL LAND USE | HISTORICAL MAP EXCERPT |
|---|---|---|
| <b>1955</b><br><b>1:2,500</b> | An embankment has been constructed along the northeast section of the road. No additional features have been identified. | |

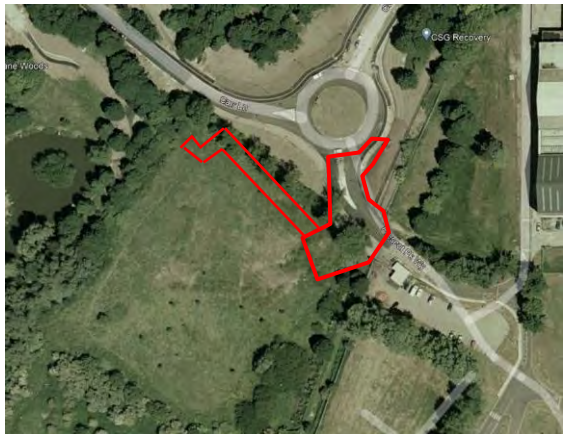
| MAP EDITION | HISTORICAL LAND USE | HISTORICAL MAP EXCERPT |
|---|---|---|
| <b>Historical Aerial Imagery Photography 2005</b> | The construction of a new road, recorded as Prescott Park Way has replaced the historical road located within the site. A roundabout structure is situated north of the site. | |

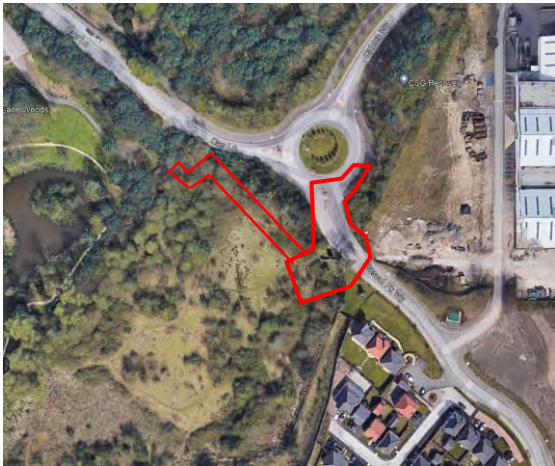
| MAP EDITION | HISTORICAL LAND USE | HISTORICAL MAP EXCERPT |
|---|---|---|
| <b>Aerial Imagery Photography 2021</b> | There have been no significant changes to the site. | |

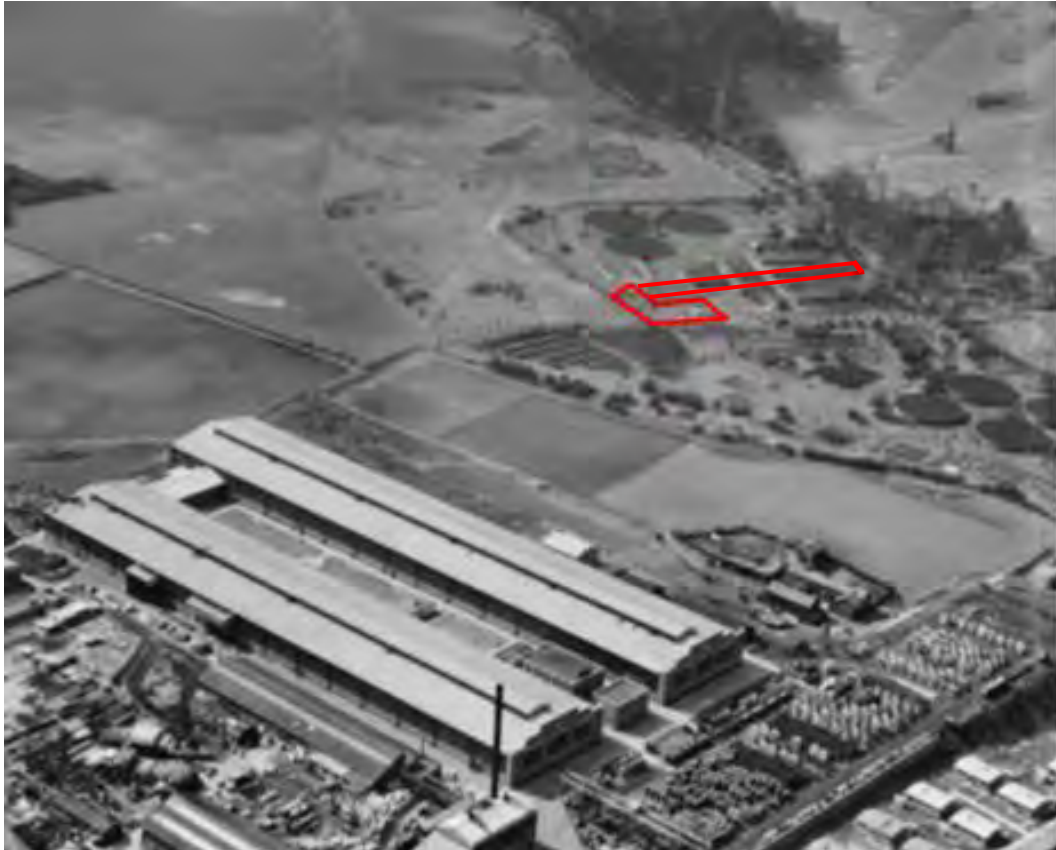
PLATE 1 – BRITAIN FROM ABOVE 1949 British Insulated Callender's Cable Works and the Sewage Disposal Works, Prescott, 1949 (EAW021949)

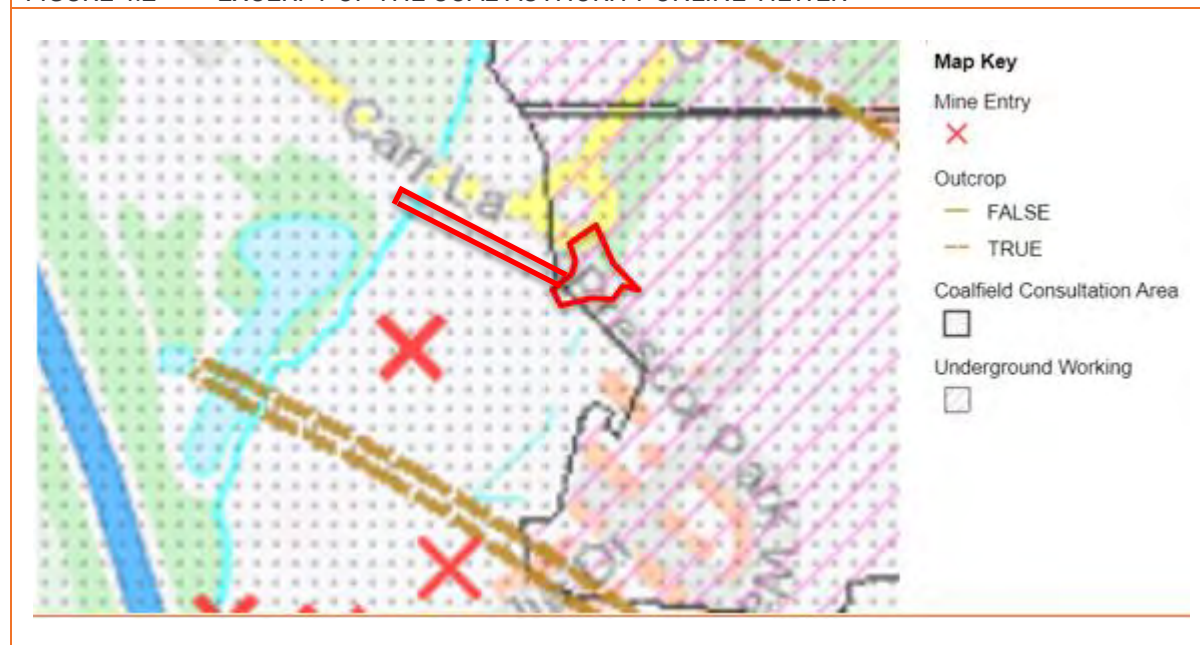
Furthermore, there are identified coal outcrops approximately 170 m west (Tenlands Coal) and 178 m north (Bastions Coal) of the site, the northern outcrop, appears to dip below the site. Using a dip of 6° as per the 1:50,000 geological mapping, this would indicate the noted coal seam, to be at depth circa 17.00 m bgl beneath the site. The eastern and northern site is in an area of underground working.

According to the Envirocheck search, there are several old coal pits, shafts, and collieries located in the surrounding area of the site, also indicated throughout historical Ordnance Survey maps pre-1850.

FIGURE 4.2 EXCERPT OF THE COAL AUTHORITY ONLINE VIEWER
