Taylor Wimpey (UK) Ltd

## Ground Investigation Report

Fox's Bank, Halsnead Garden Village

REPORT NO: 18TAY042/GI

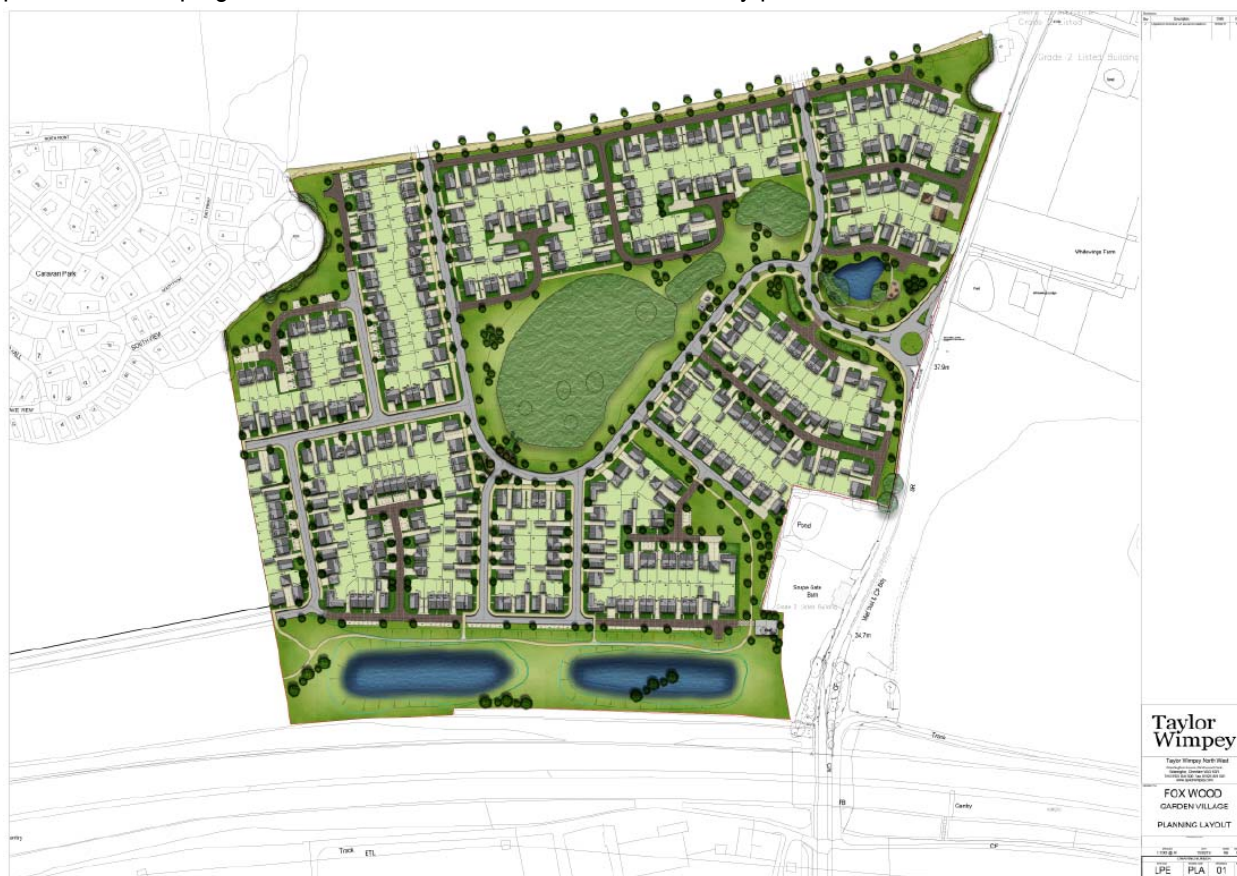
*Fox Wood Garden Village Planning Layout – Taylor Wimpey – 15.02.2019 – Dwg. No. LPE PLA 01*

This investigation was carried out on the instruction of Taylor Wimpey on behalf of Taylor Wimpey, Gino Frederick Fantin & Dawn Sara Fantin, Mrs K Mullin, Reynard Land Whiston Limited and Evo Living Limited 17. The applicant is hereafter referred to as 'Taylor Wimpey'. The purpose of the work was to carry out a ground investigation to provide geotechnical and contamination risk information for the demolition of existing farm buildings and erection of 337 residential dwellings together with new vehicular access, SUDs ponds, landscaping and other associated works. A site boundary plan can be seen below;

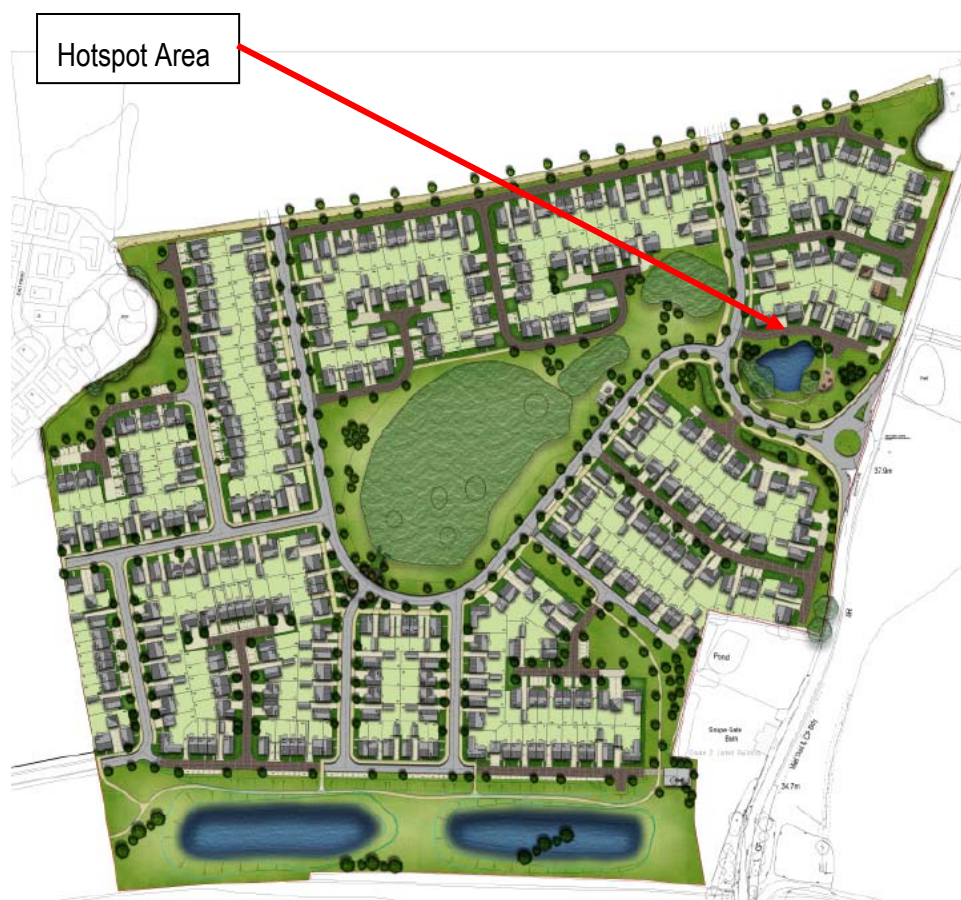
Both elevations were located within the Made Ground found in TP1 at 1.10mbgl. Statistical analysis indicates that this area is classed as a hotspot (both for arsenic and lead) and will therefore require further delineation. It is important to note that TP1 was in close proximity to an existing pond, and is therefore a results of probable historical infilling.

Based on the current site layout and the fact the contaminated strata was identified at depths of between 0.90mgl – 1.70mbgl, it may be possible to leave this material in-situ due to the area being proposed as public open space (depending on the results of the delineation). The hotspot area is shown as a red dot on extract below.

No significantly elevated contamination was encountered across the remainder of the site. It is therefore likely that a minimum thickness of 300mm of debris-free soil within garden areas to provide a growing medium will be required as per NHBC guidance; this is likely to be made up of site-won subsoil and topsoil.

If delineation finds the hotspot to extend under proposed plots/residential gardens, then it is likely that either:

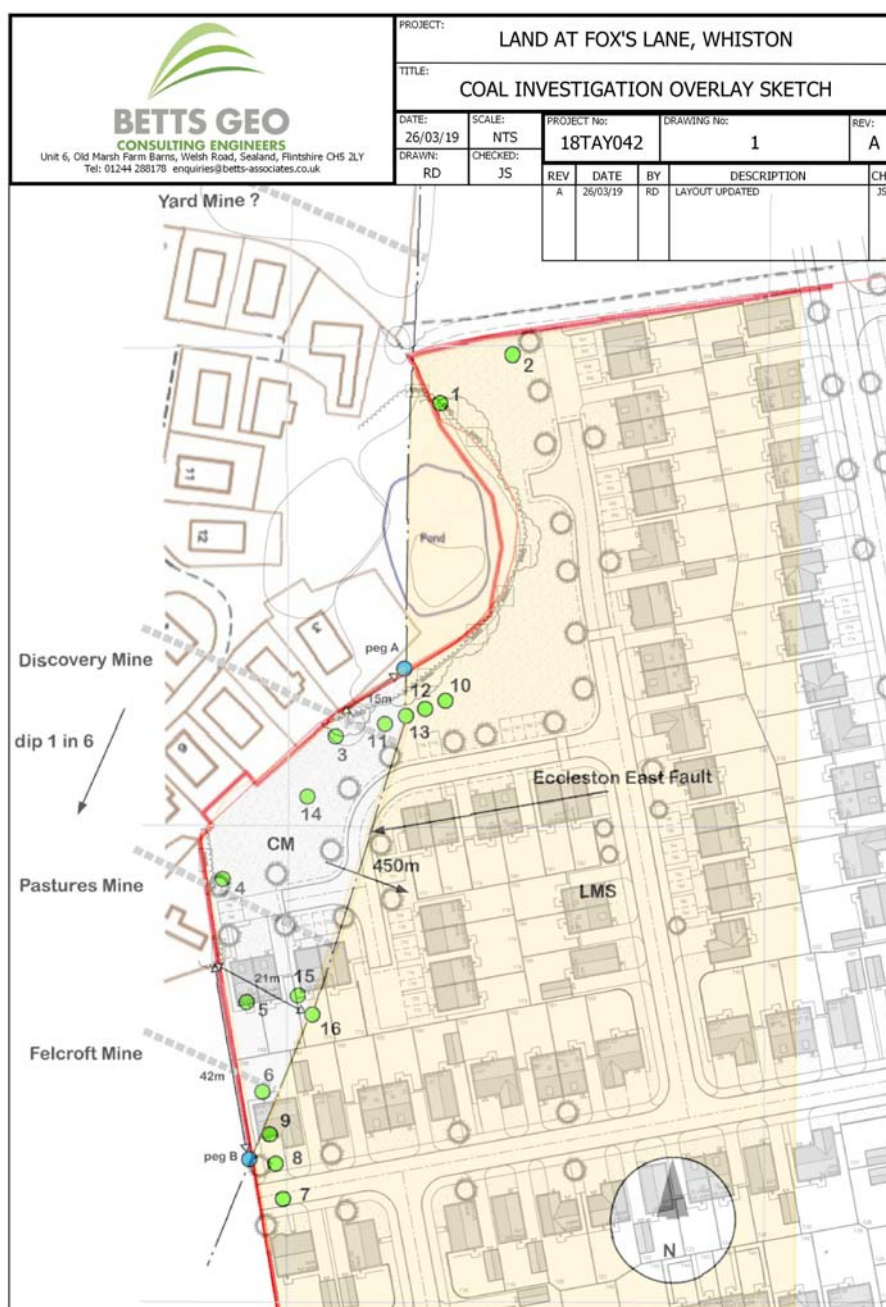
An extract of the coal mining borehole plan overlain the site layout can be seen below. This also shows the fault line identified.

It is important to note that due to shallow bedrock and a defined fault line in the west of site, reinforcing of foundation footings with mesh in this locality is advised.

Due to shallow bedrock and defined fault line in the west of site, reinforcing of footings with mesh in this locality is advised. Foundations should be excavated wholly on one stratum. Should proposed foundations span different strata, trenching and stepping of foundations and/or nominal reinforcement will be required.
