**Document name:** 230342-EDGE-XX-XX-R-G-000\_SI[R01]

## SITE INVESTIGATION FOR 230342 – DYE HOUSE

05 May 2023

**Coal Mining Risk Assessment Report**

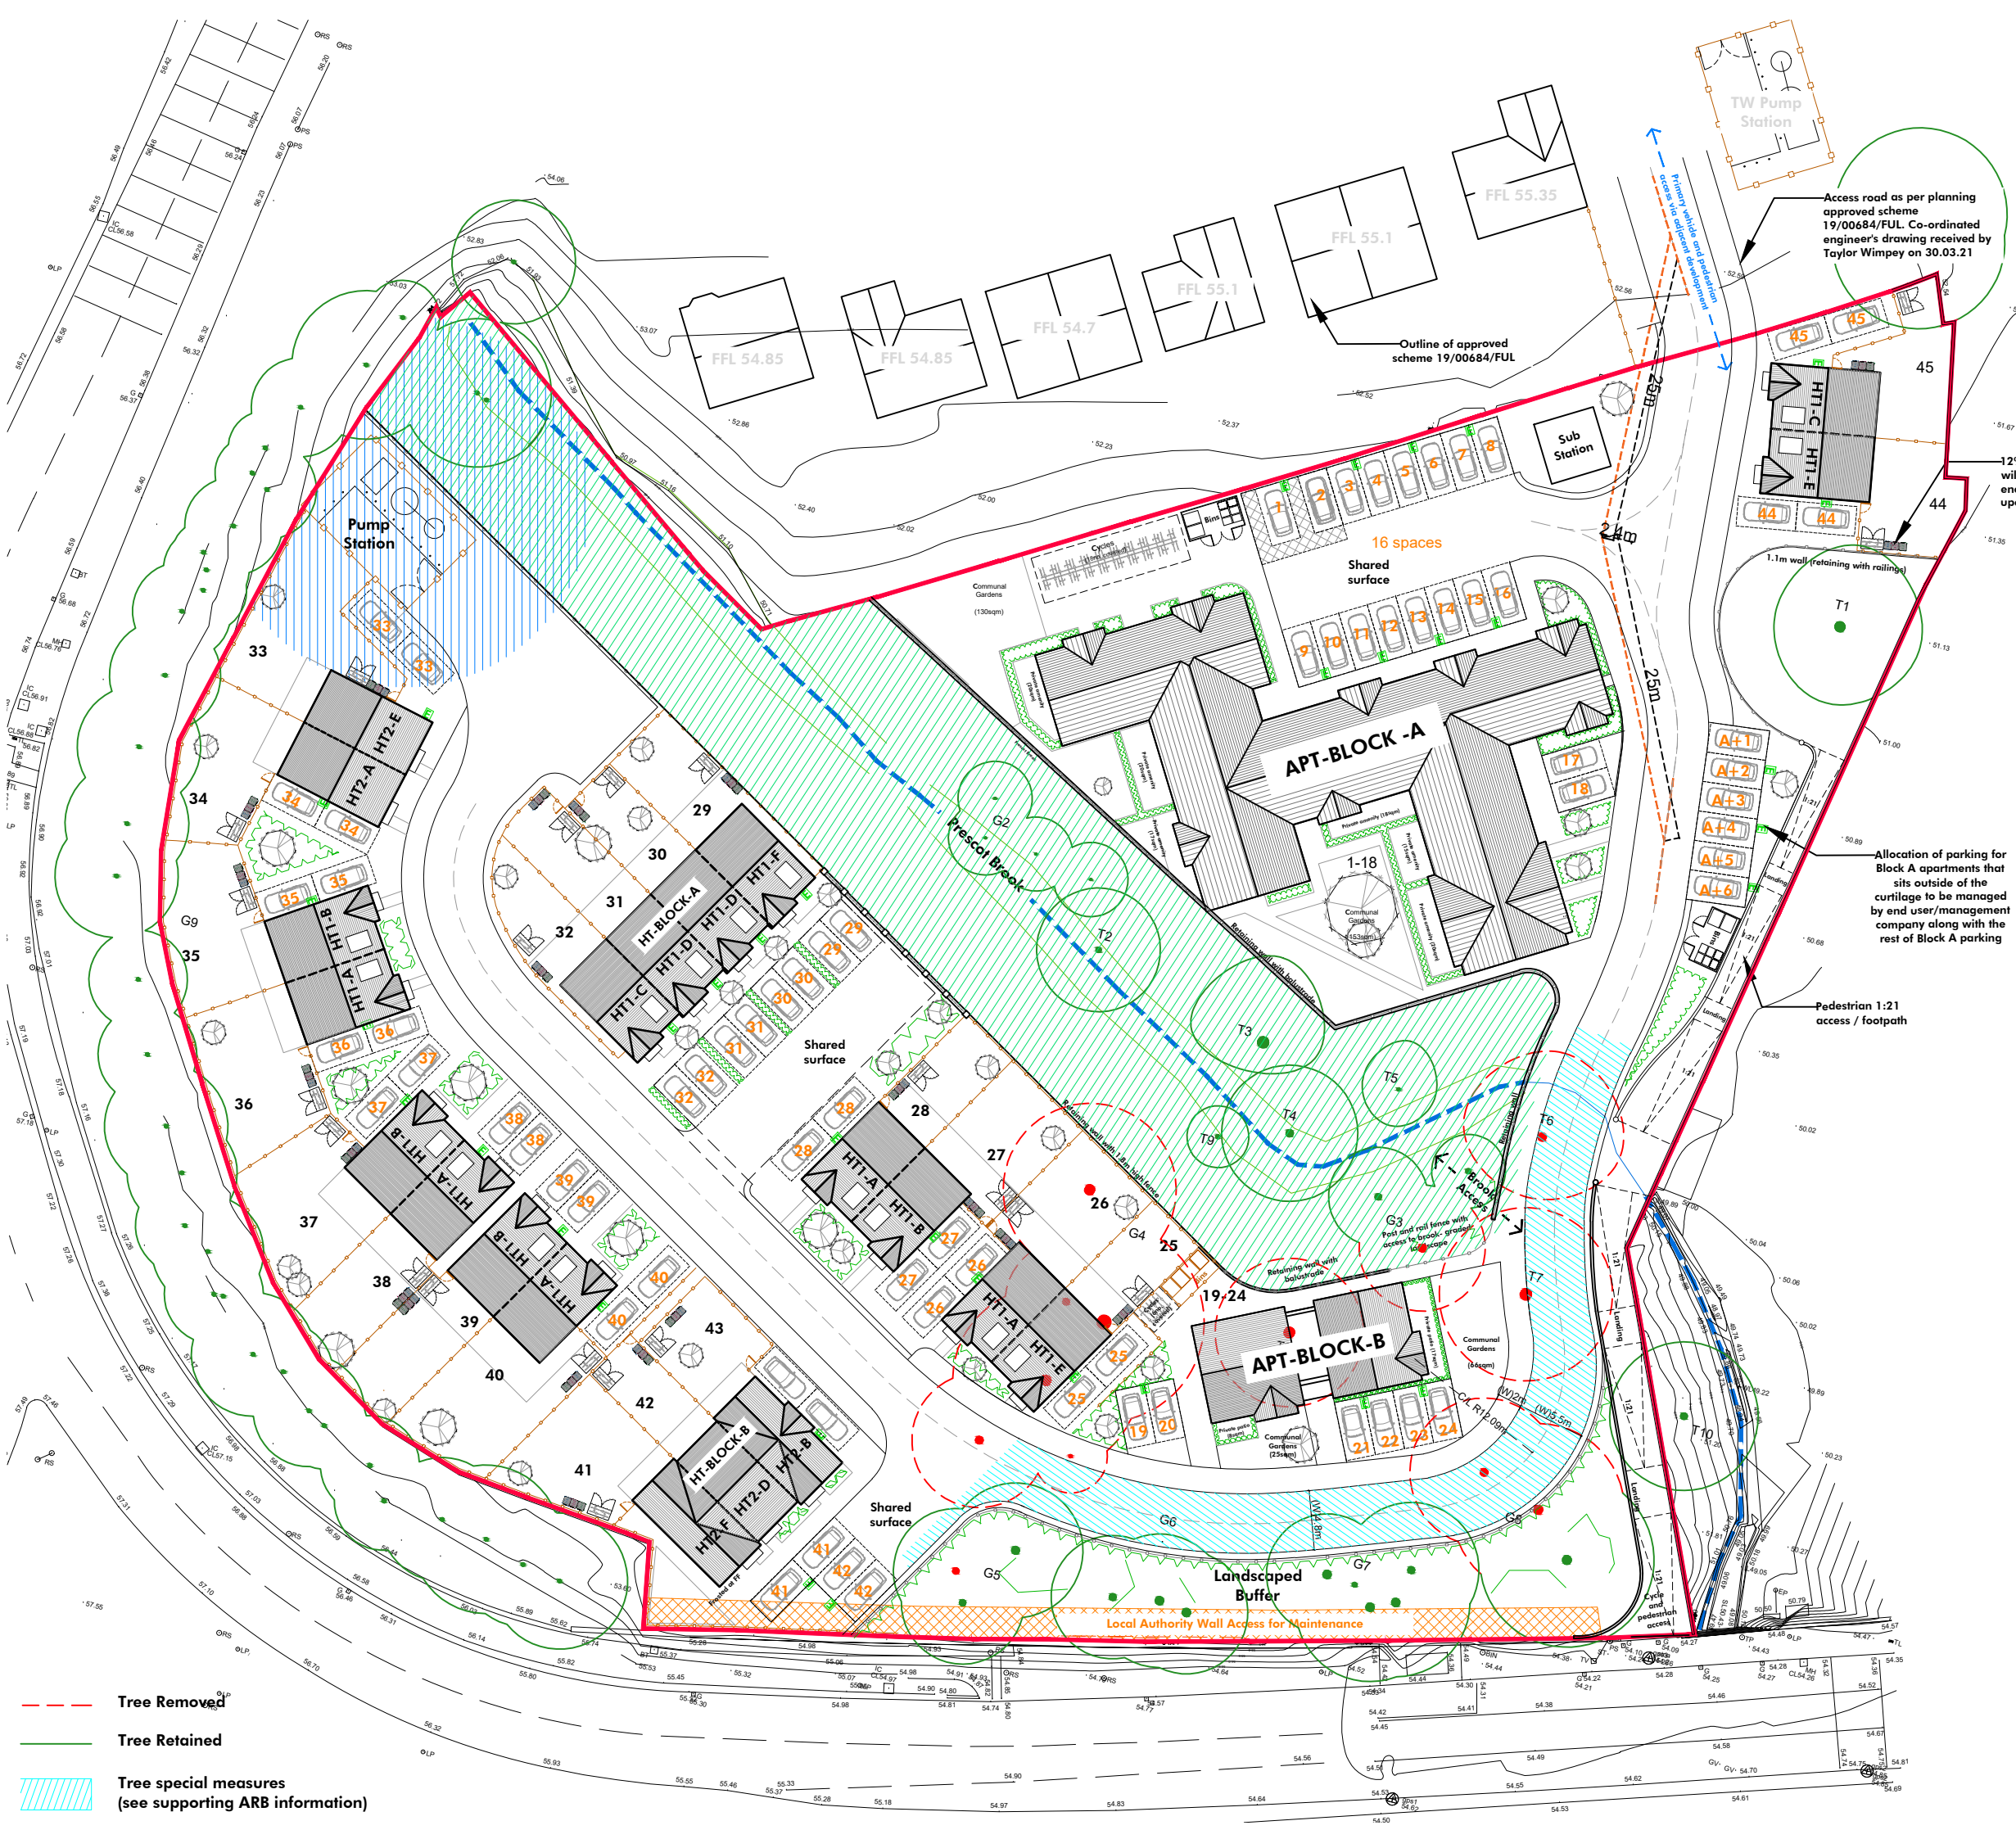
PROPOSED SITE PLAN - ROOF

DYE HOUSE, PRESCOT

The site is proposed to be redeveloped with two apartment blocks and twenty one housing plots as shown on Group D Developments Ltd Drawing No GDD2020-GDA-ZZ-RF-DR-A-2220-P06 presented in Annex I.

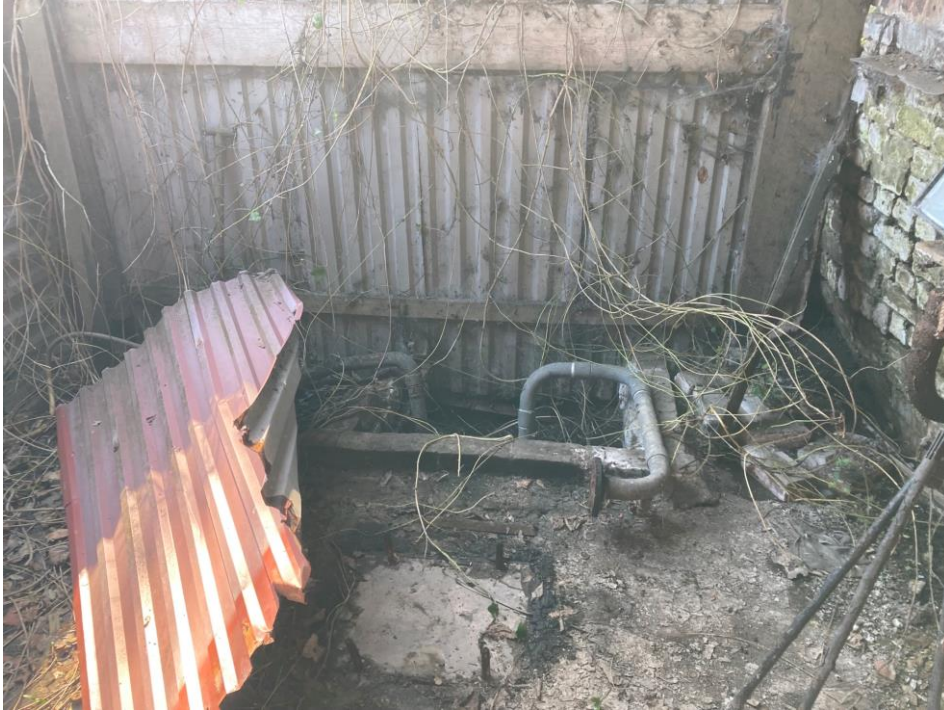
Photograph 1: Well in shed immediately to east of site.

During the search for the 'well', a septic tank was encountered in the east of the site with the well itself identified in a small shed immediately to the east of the site. These features are shown on the exploratory hole location plan in Annex I with photographs shown in Annex VI.

The well as identified on historical plans was found in a small shed immediately to the east of the site. EDGE can confirm that this feature does in fact appear to be a well and not a mine shaft. Although there is no evidence of mine entries at the site, the presence of entries cannot be ruled out.

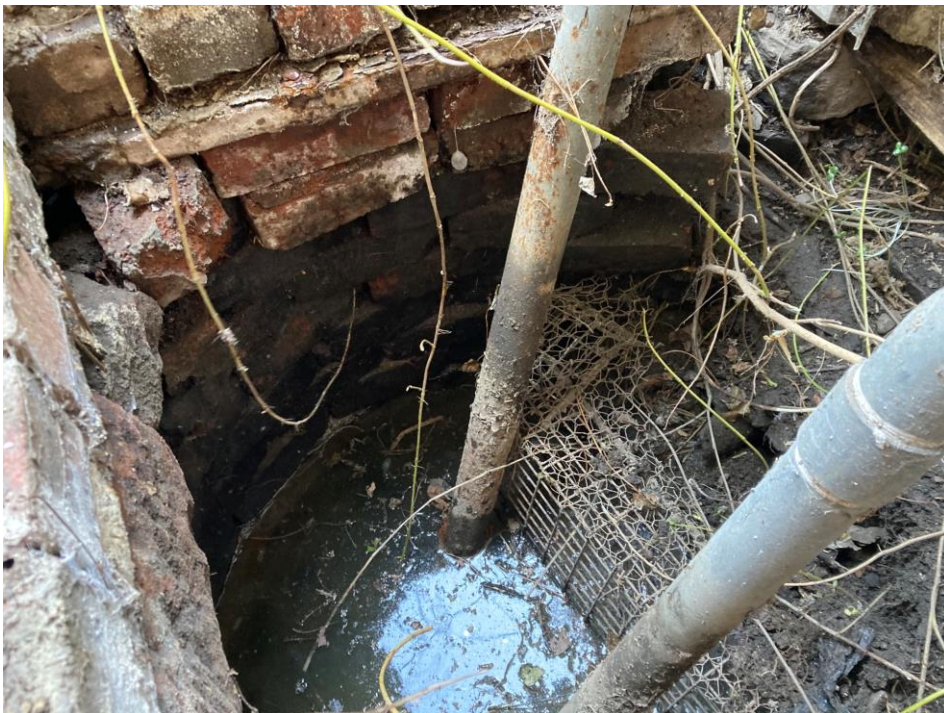
Photograph 2: Closer view of well.

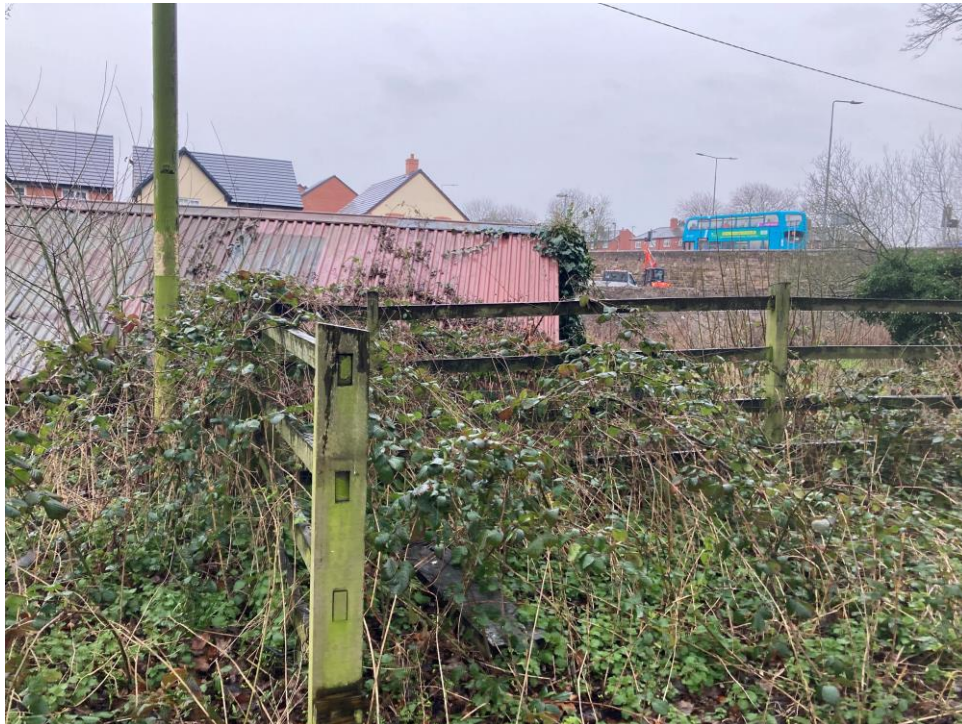
Photograph 3: View of shed on adjacent site which contains well.

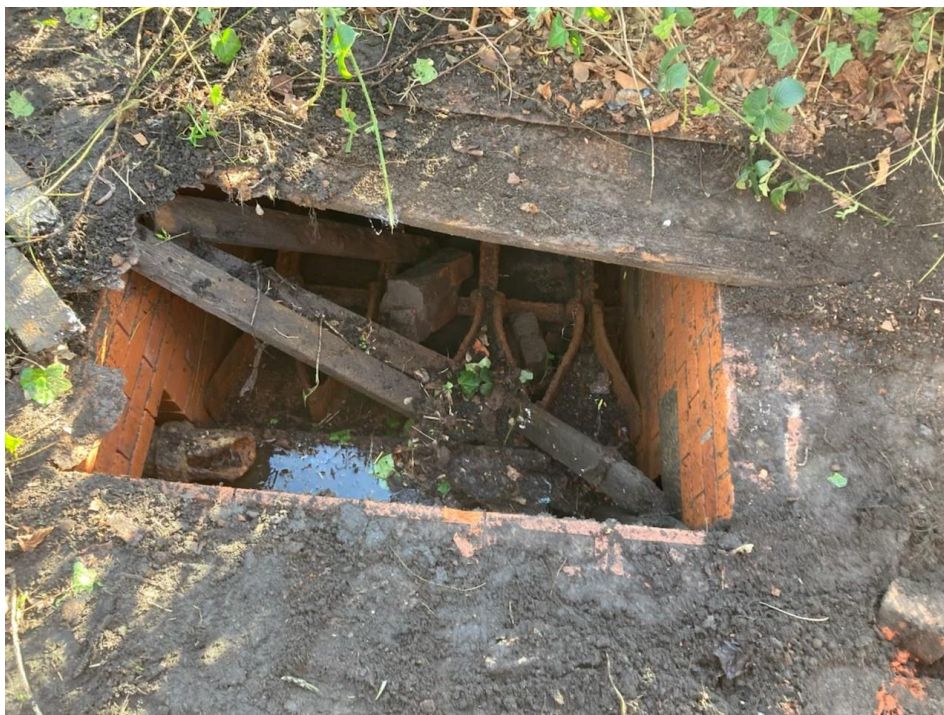
Photograph 4: View of septic tank.
