**Redrow Homes (NW)**

**Ground Investigation Report**

**Lower Road, Halewood**

REPORT NO: 17RED147/GI

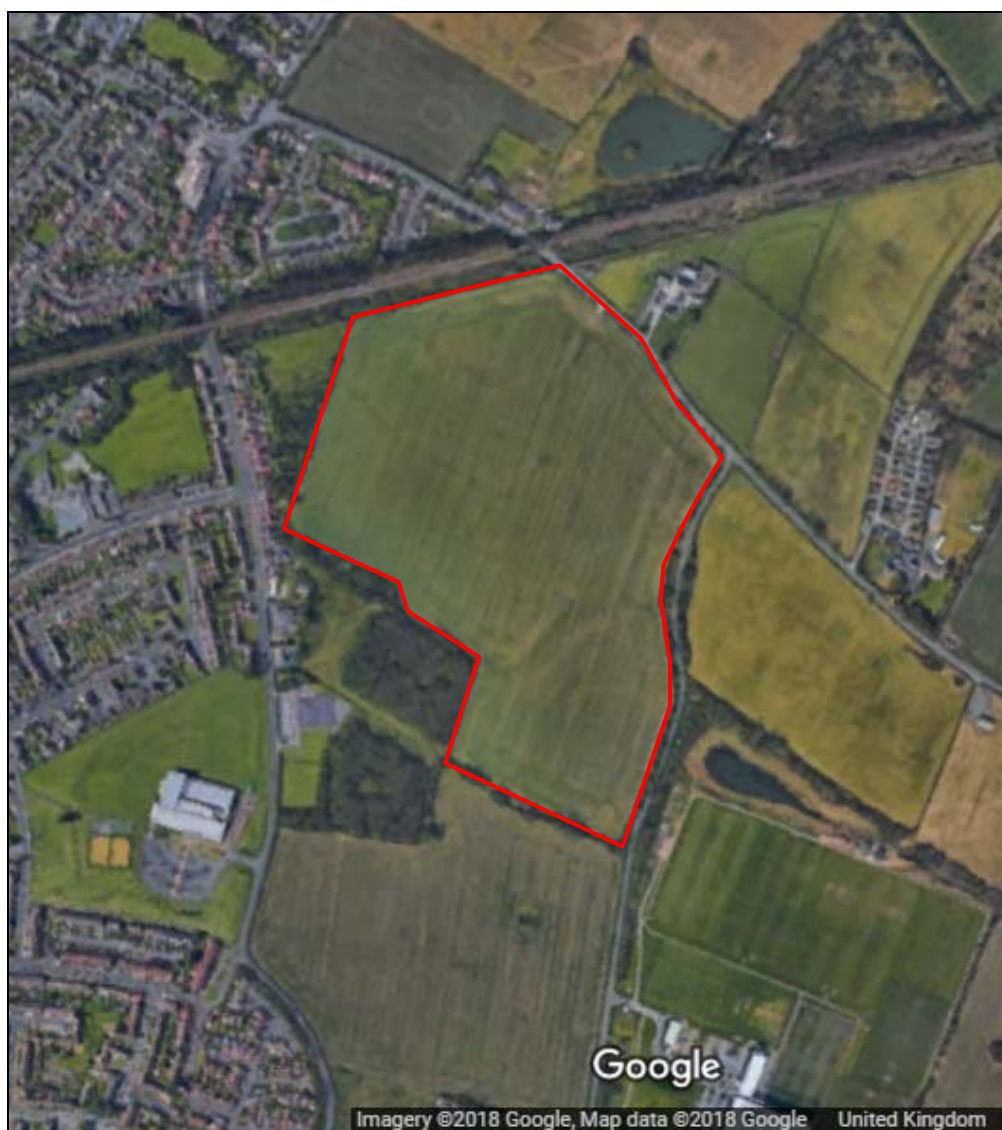
The site is located to the south of Lower Road and to the west of Finch Lane. The closest postcode is L26 3UA. The coordinates on National Grid are 345680, 385460. The proposed site is approximately 20.17 hectares (Ha) in total. See Site Location Plan in Appendix A.

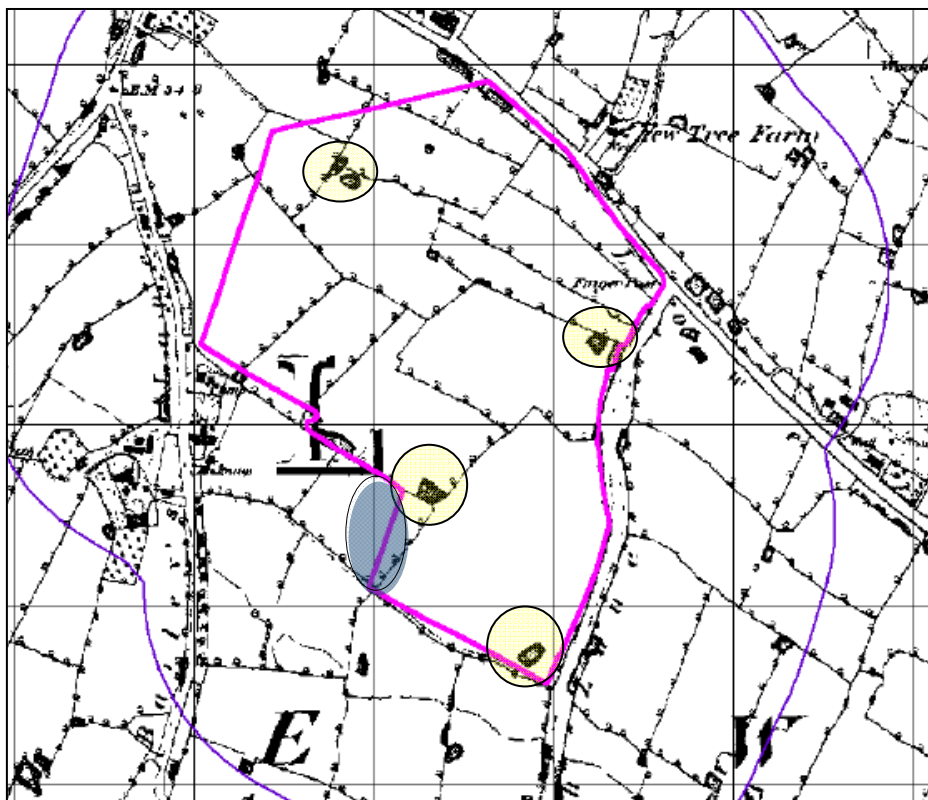
1849 1:10,560 map

The earliest map is the 1849 1:10,000 map which shows the site as undeveloped and consisting of several open grass fields. The map shows several ponds on site and a ditch. An extract of this is shown below;

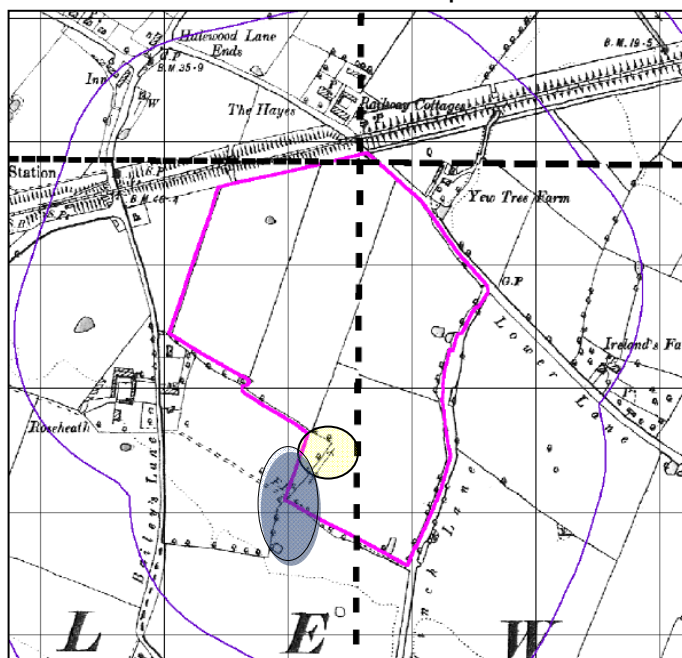
1894 1:10,560 map

Circa 1894, the pond in the highlighted area is not shown any more on site. Mapping also shows possible change in shape and size of remaining ponds. The ditch is shown as a stream. An extract of this is shown overleaf;

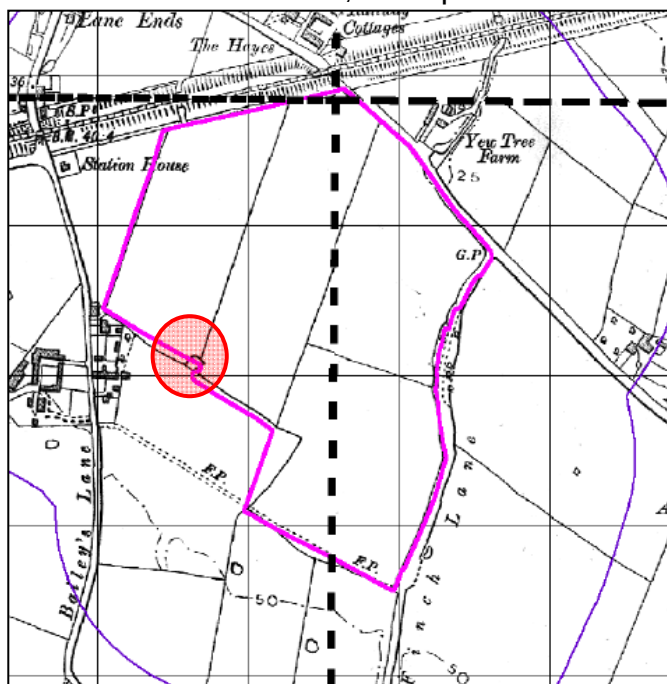
1908 1:10,560 map

Circa 1908, the rest of the ponds of site are no longer shown. However, a possible pond is shown in the west of the site. An extract of this is shown below;

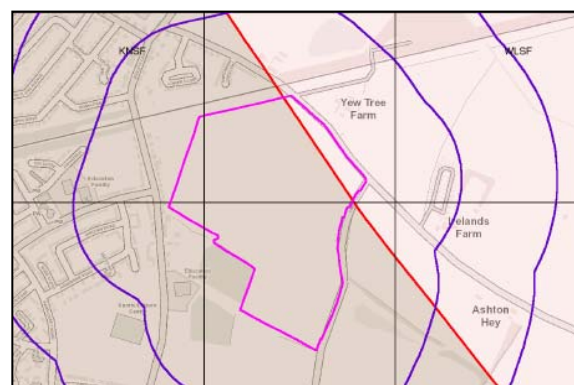
Bedrock Geology

| Map Colour | Lex Code | Rock Name | Rock Type | Min and Max Age |
|---|---|---|---|---|
| | ETM | Etruria Formation | Mudstone, Sandstone and Conglomerate | Westphalian - Westphalian |

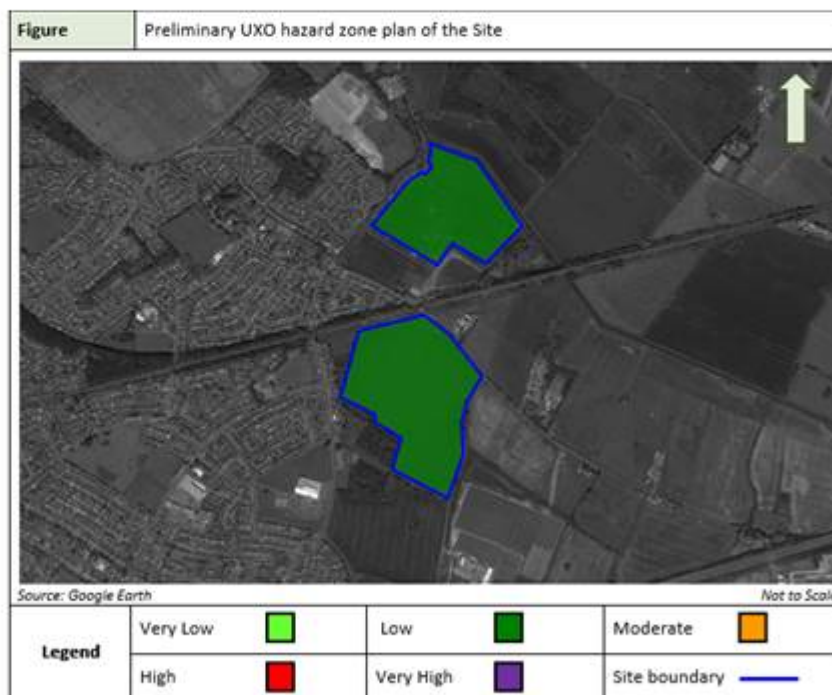
At this stage of the research, it is considered that the Site has a low UXO hazard level, as shown on the preliminary UXO hazard zone plan below.

This preliminary hazard assessment will be subject to confirmation or amendment in the final report.

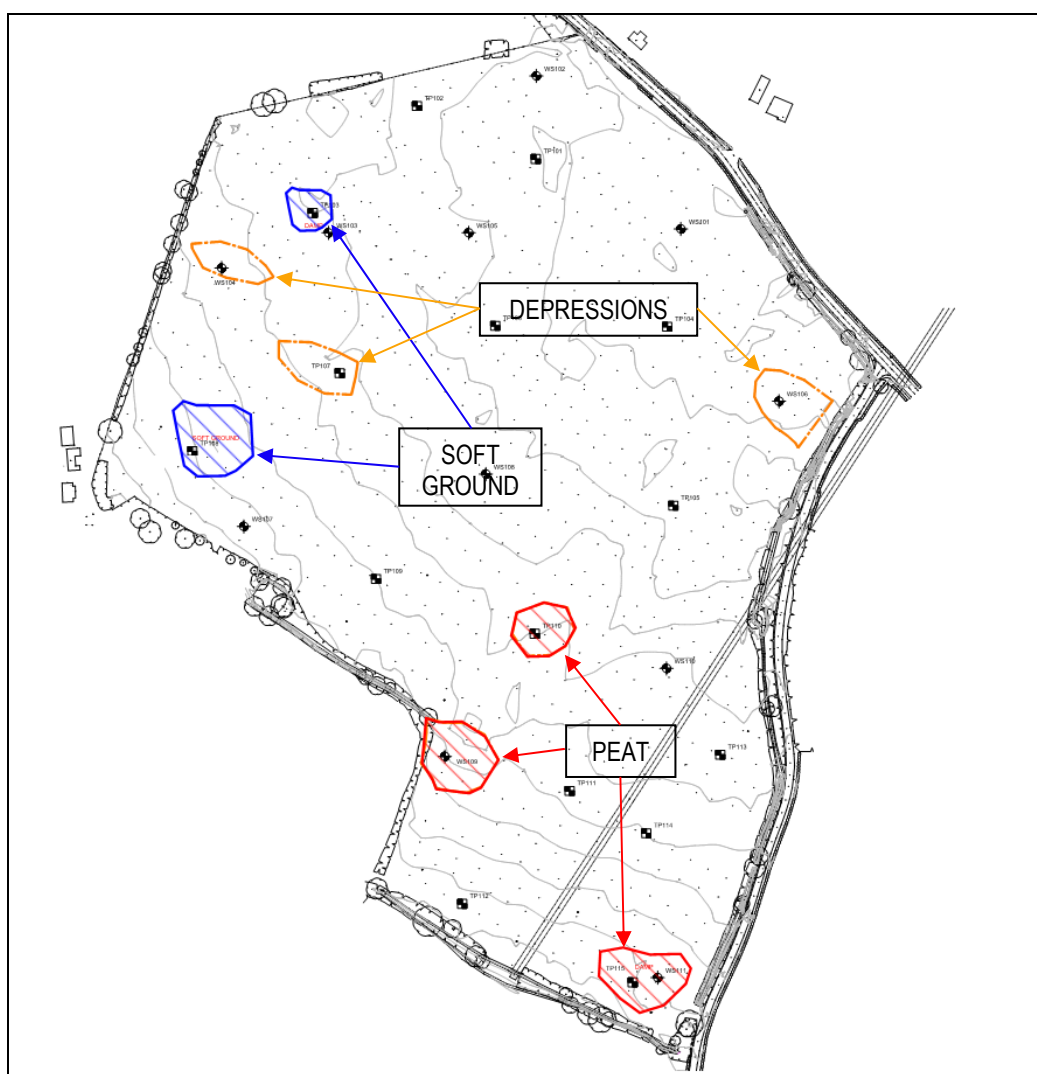
| PEAT | Peaty inclusions / Soft black spongy fibrous PEAT. (TP110 and TP115 only) | 1.20 | 2.20 |

The plan below shows the areas of peat and soft ground;

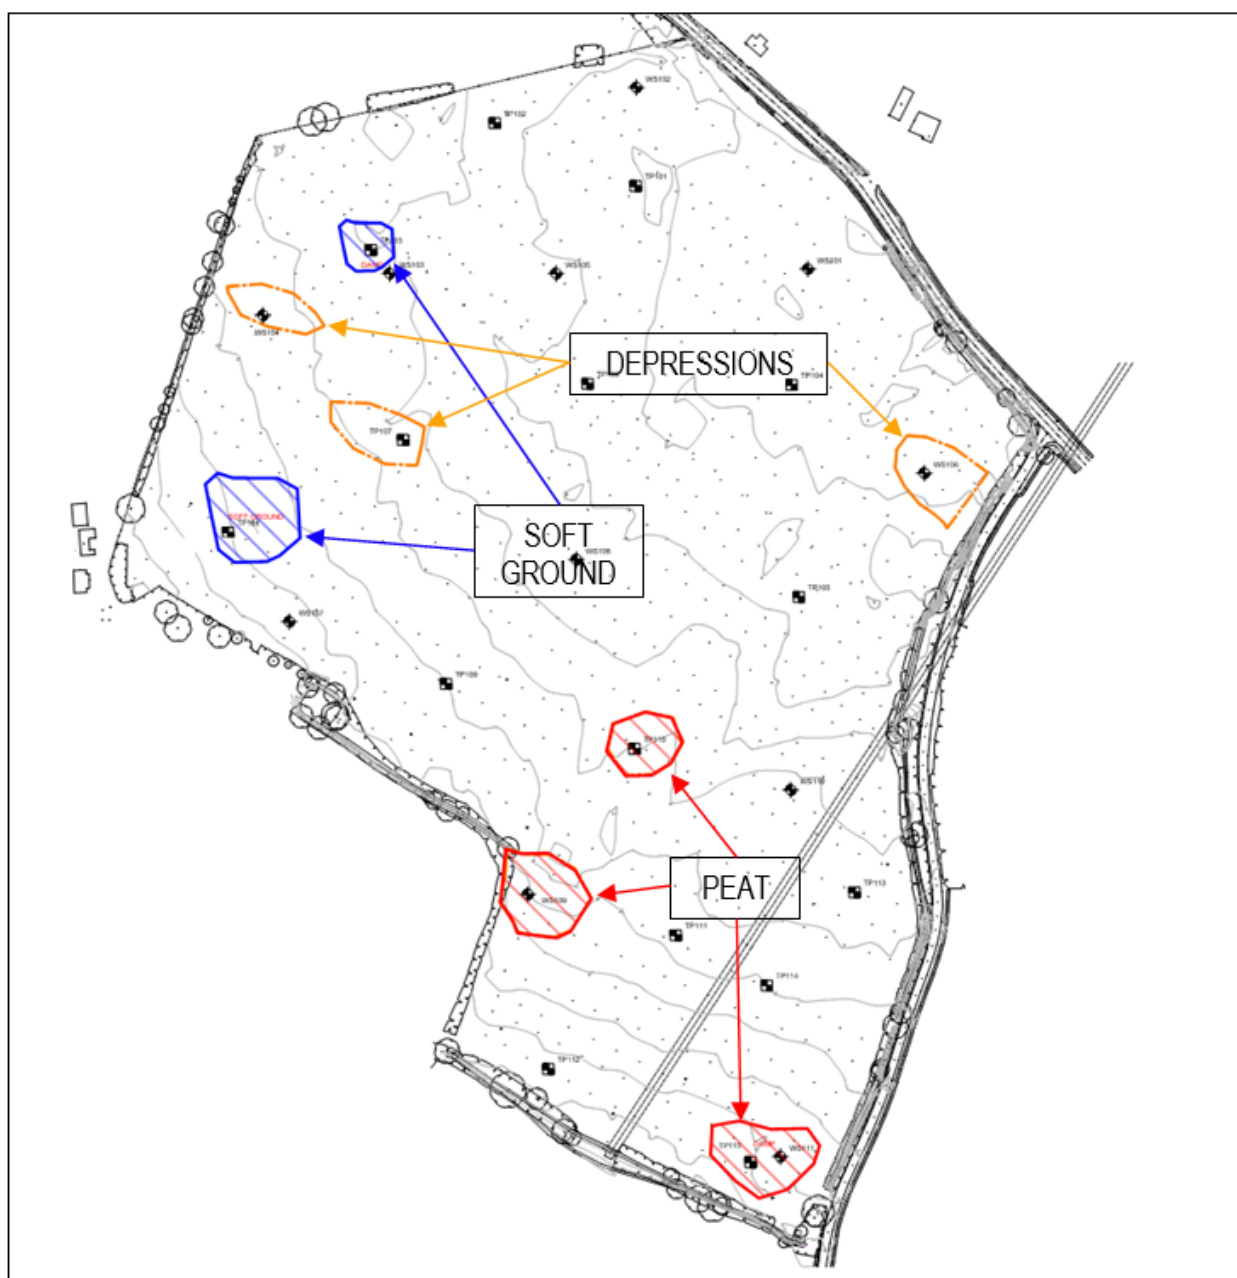
Areas of soft ground conditions such as soft SILT and PEAT have been identified on the site. In these areas, or others where similar conditions are found, the plots in these locations may require piling. A specialist piling contractor should be consulted with regards to pile design. The sketch below shows the approximate possible locations of these weaker ground conditions;

Areas of soft ground conditions such as soft SILT and PEAT have been identified on the site. In these areas, or others where similar conditions are found, the plots in these locations may require piling. A specialist piling contractor should be consulted with regards to pile design.

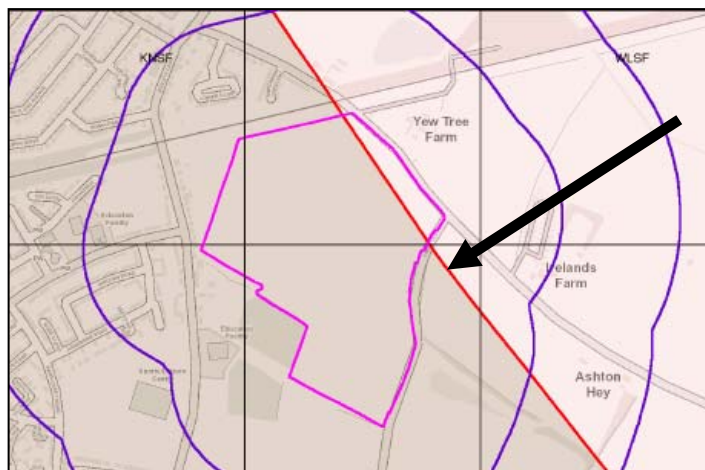
Consideration should also be made to the fault line located on the north of the site. As shown below;
