Land at Chapel Lane, Widnes

# FLOOD RISK ASSESSMENT

AJP Ref: 219-114

Prepared for Taylor Wimpey UK Ltd

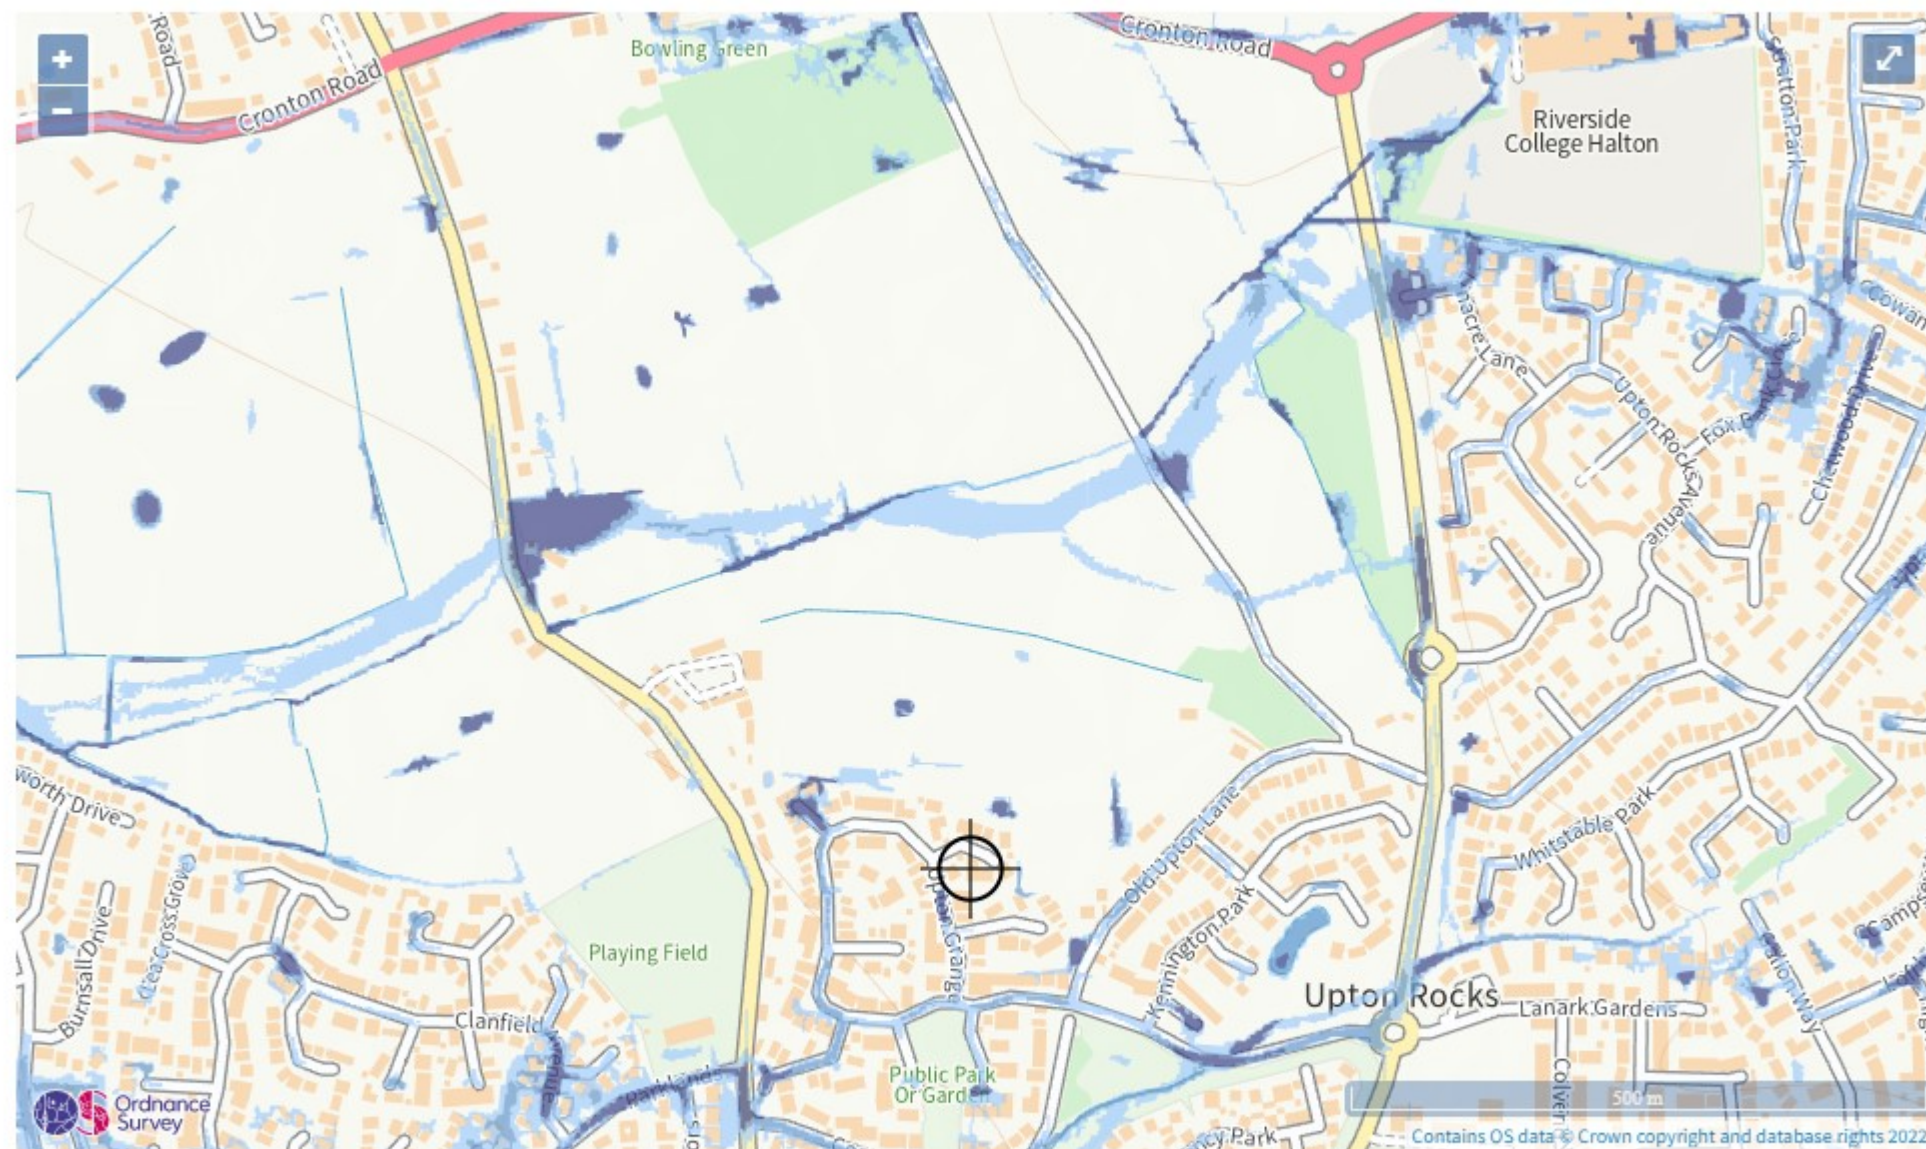
Extent of flooding from surface water

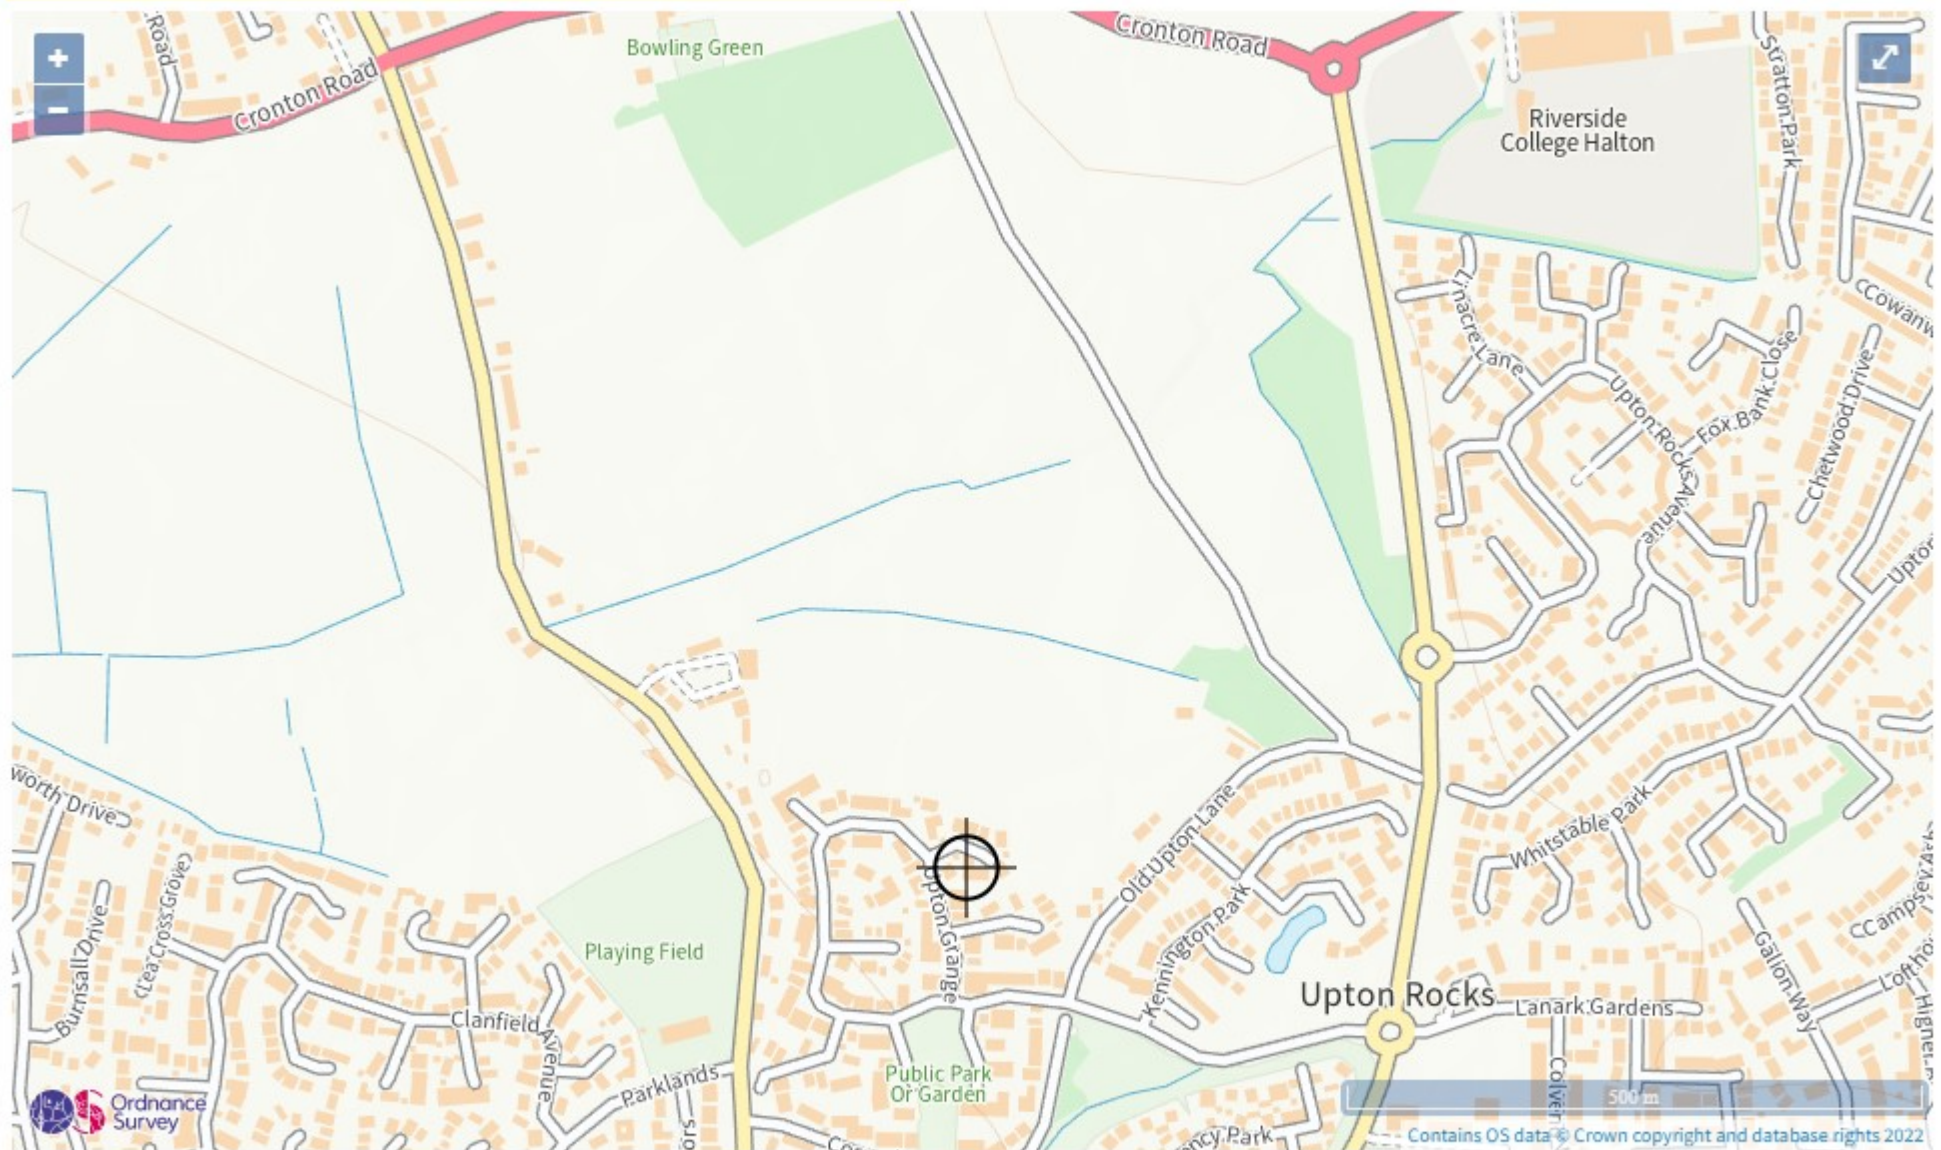
Extent of flooding from rivers or the sea

The nearest watercourse feature is on the northern boundary, identified as Dog Clog Brook on the northern boundary of the development area. The site is located in Flood Zone 1, as an area identified by the Environment Agency (EA) not at risk of flooding from rivers and streams.

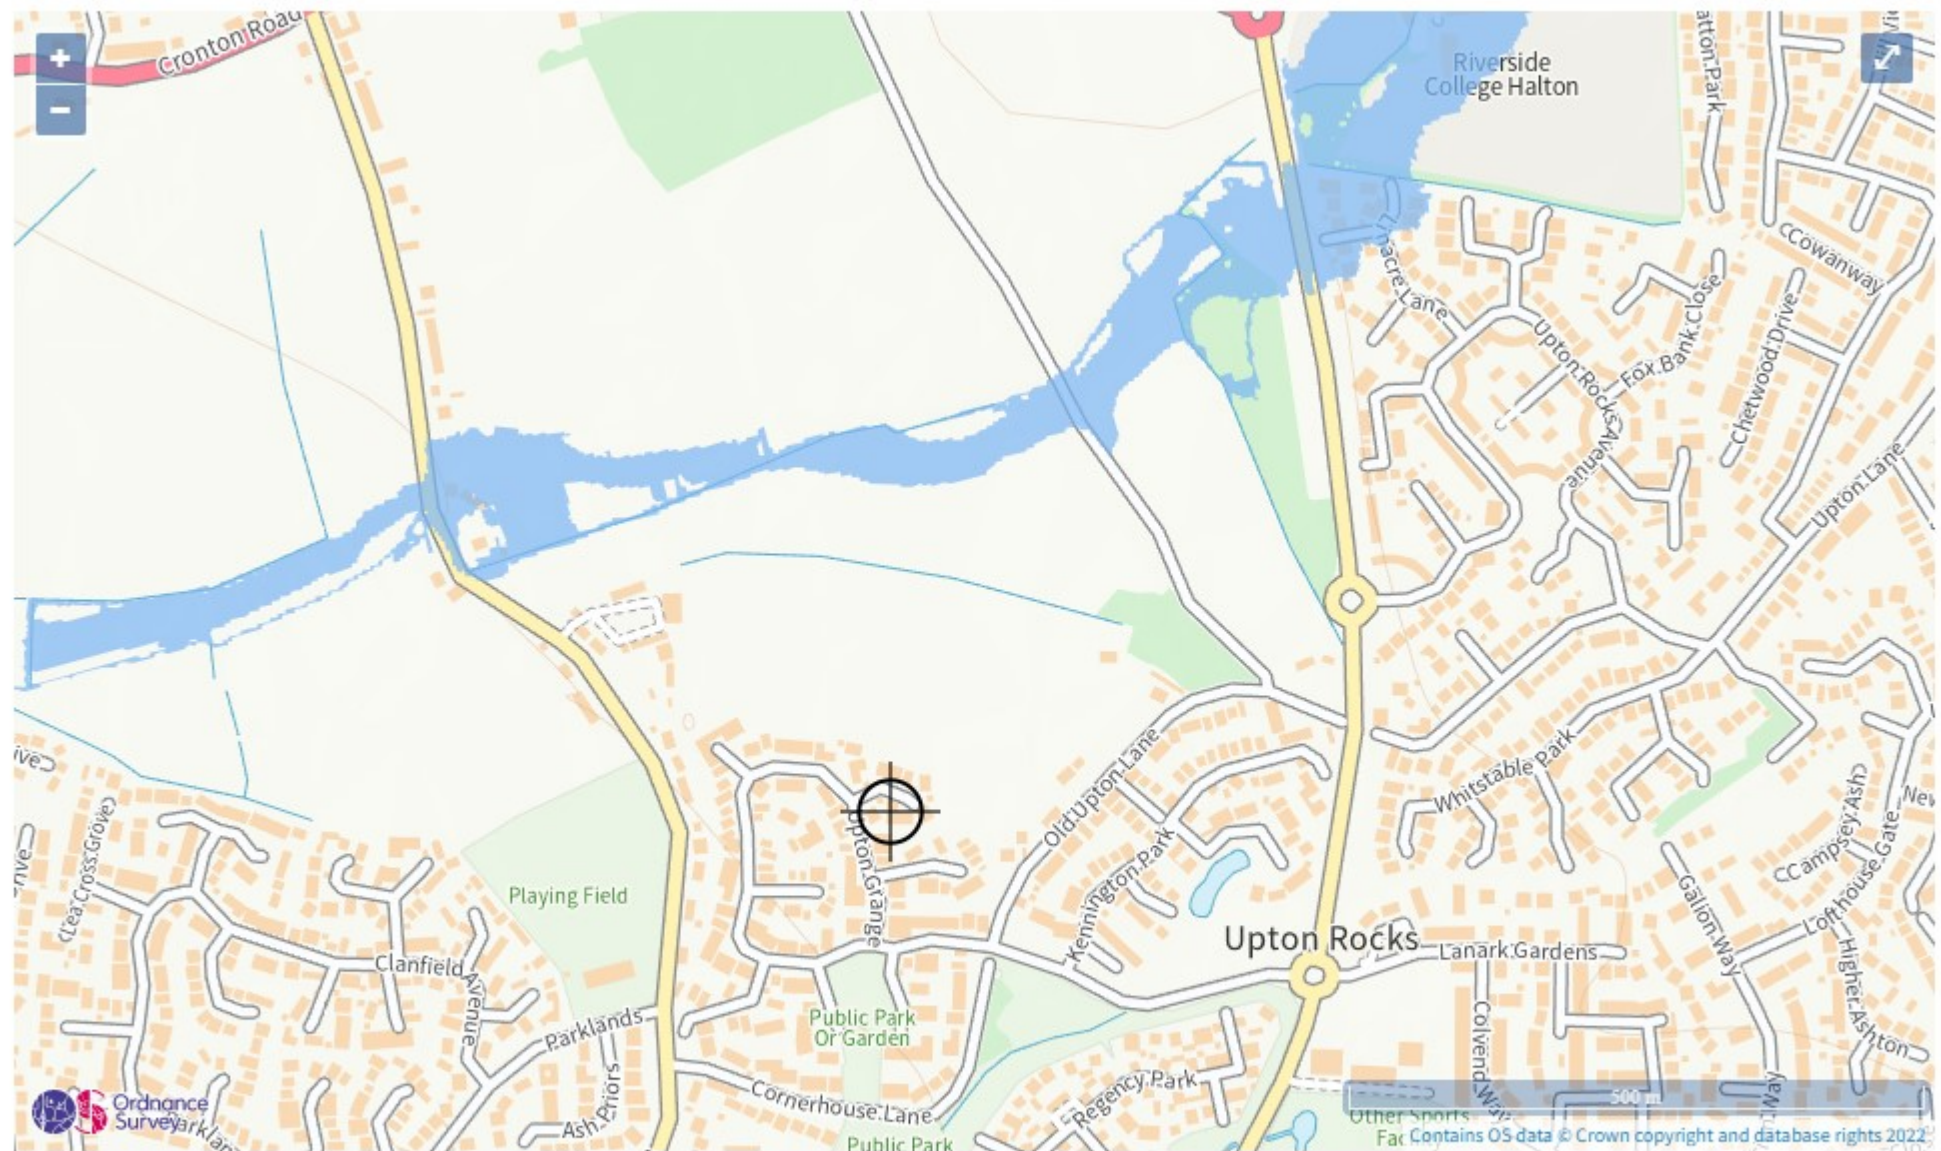
Maximum extent of flooding from reservoirs:

The reservoir flood maps are used to identify the extent of flooding caused in the event of a catastrophic failure event and therefore the site is considered to be at low risk of flooding from reservoirs.

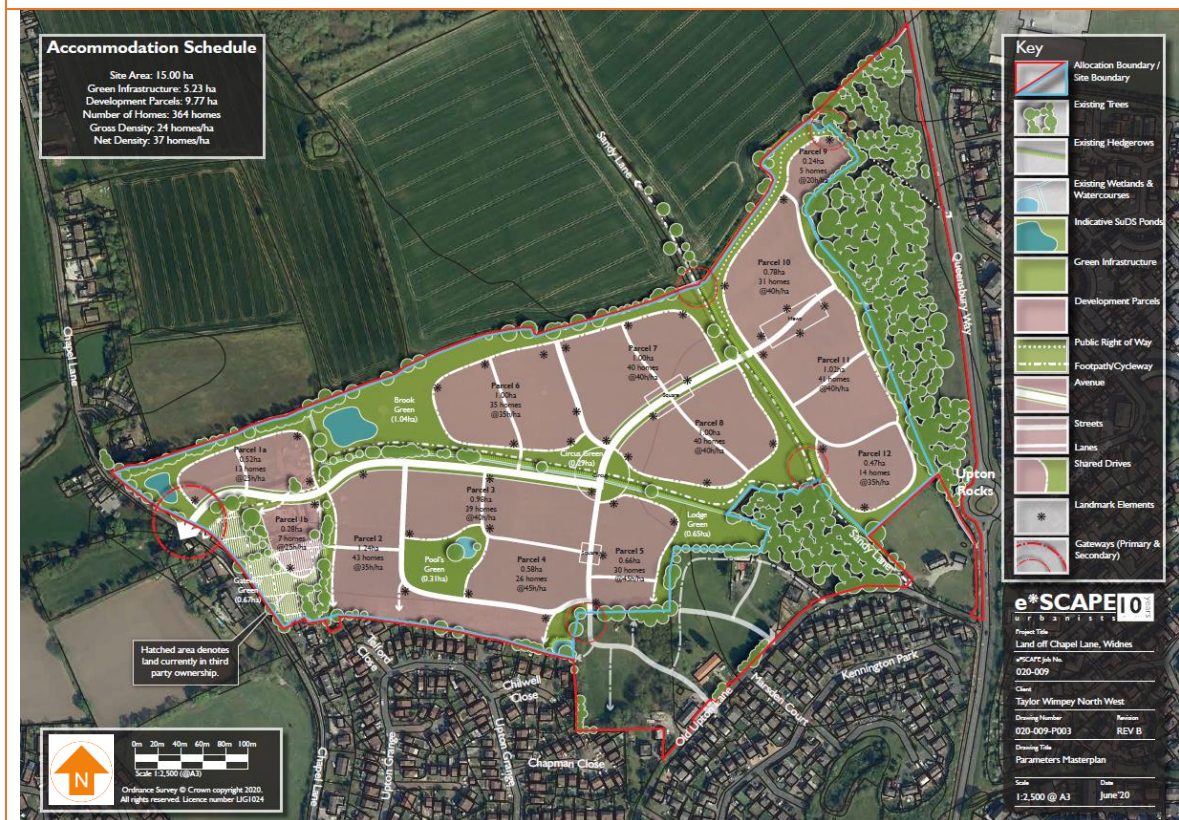
FIGURE 1.1 SNAPSHOT OF PROPOSED DEVELOPMENT MASTERPLAN

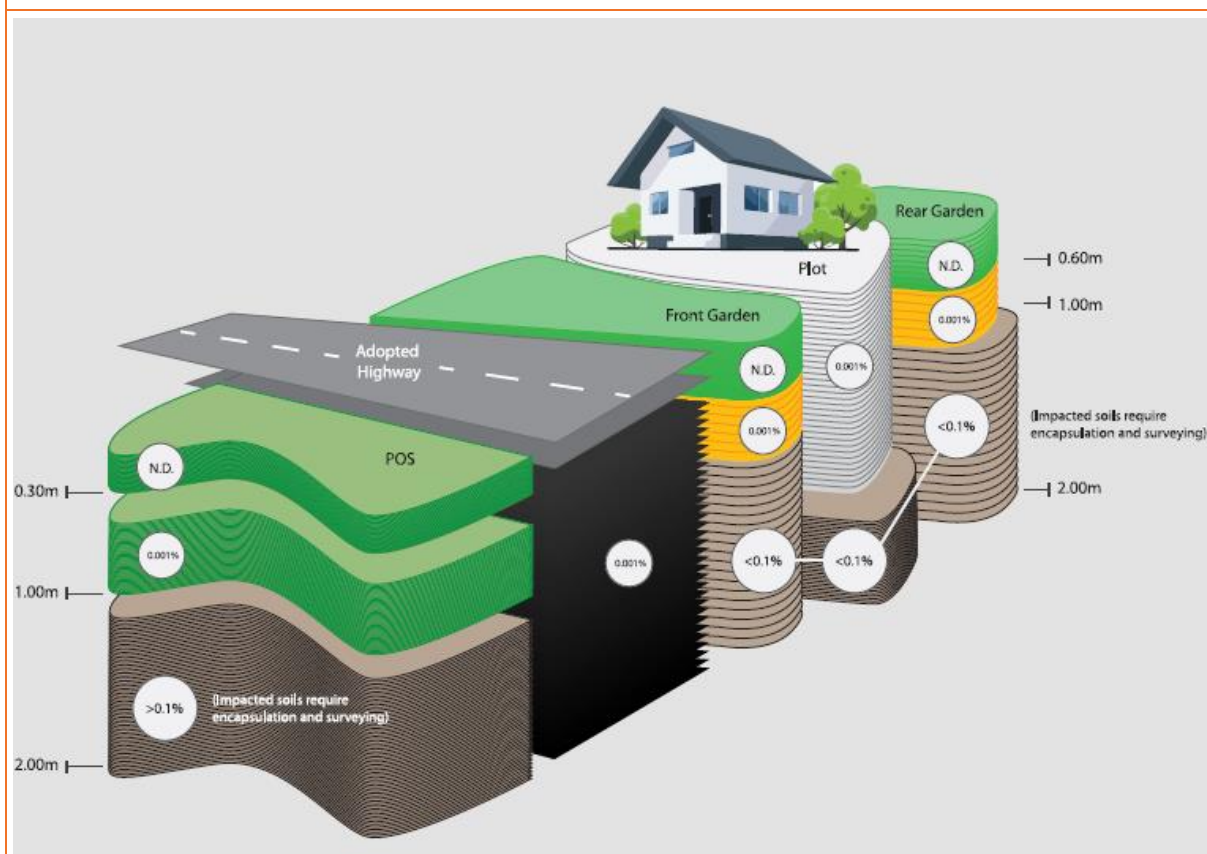
FIGURE 4.1 ASBESTOS RISK MITIGATION CONCEPTUAL SITE MODEL

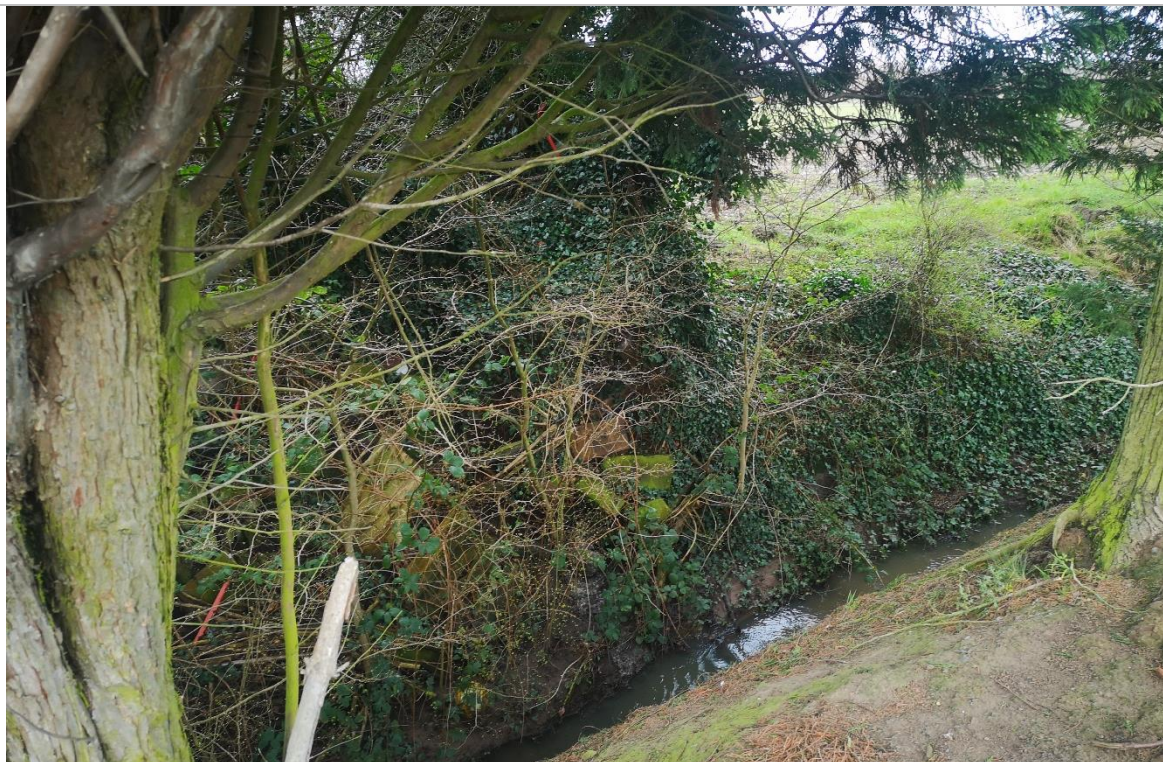
PLATE 1 UNNAMED BROOK ADJACENT TO NORTHERN BOUNDARY

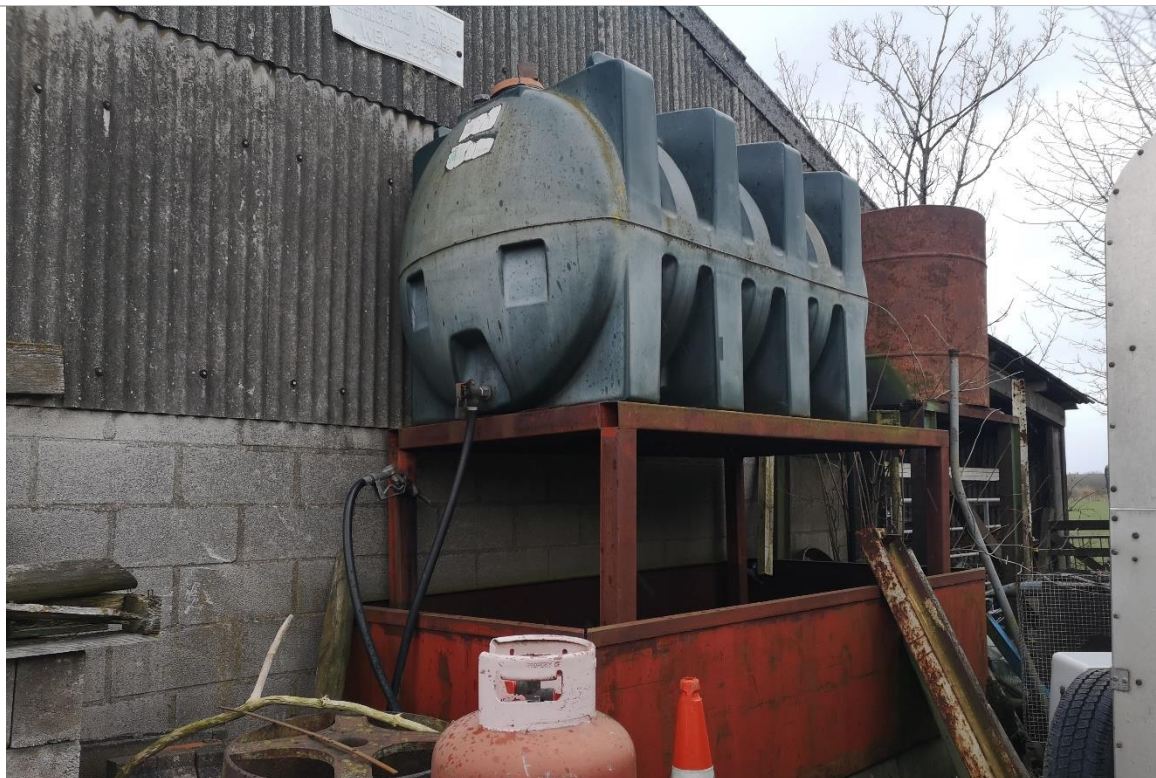
PLATE 3 ABOVE GROUND SOTRAGE TANK ADJACENT TO FARM BUILDING

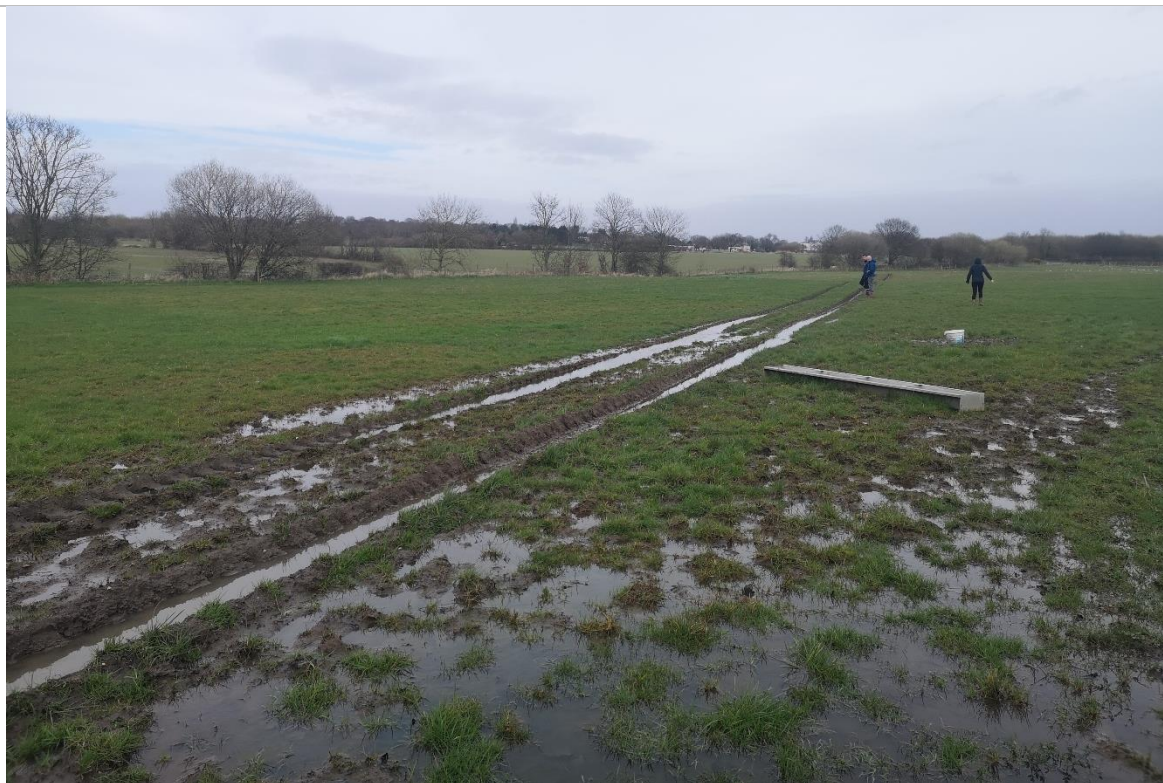
PLATE 4 WATERLOGGED FIELD

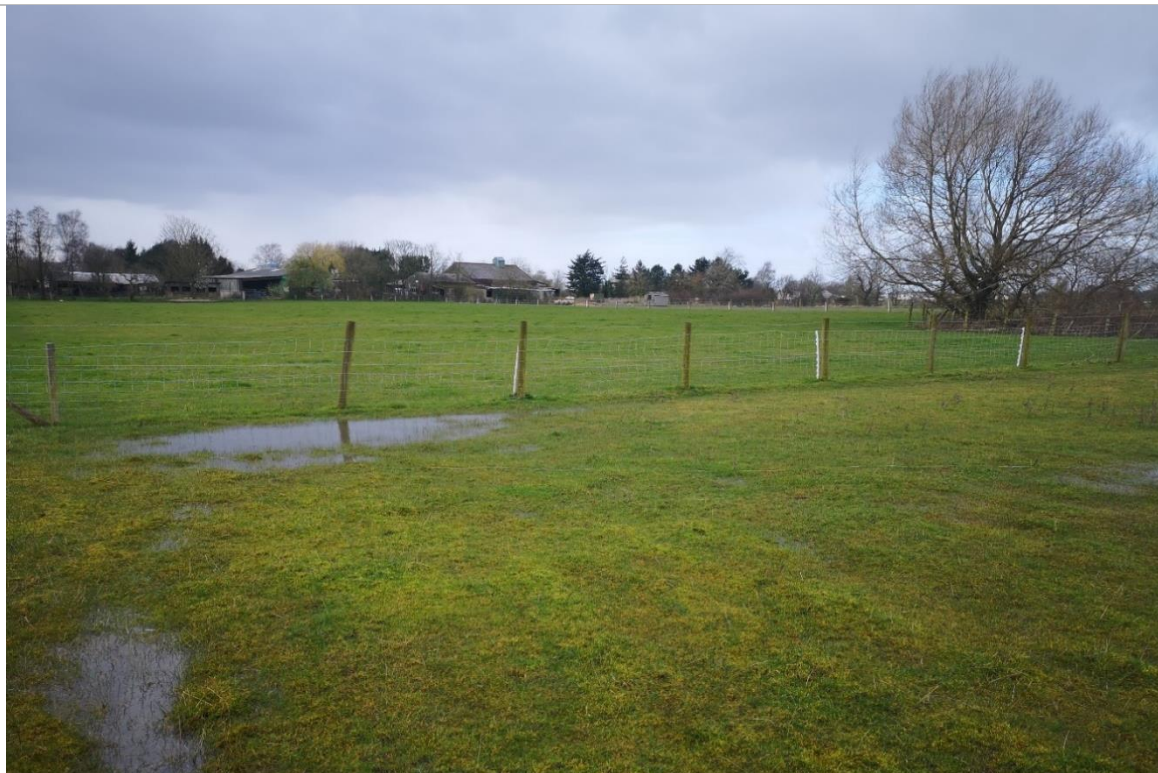
PLATE 5 POOR DRAINAGE WITHIN CATTLE GRAZING FIELD (WEST)

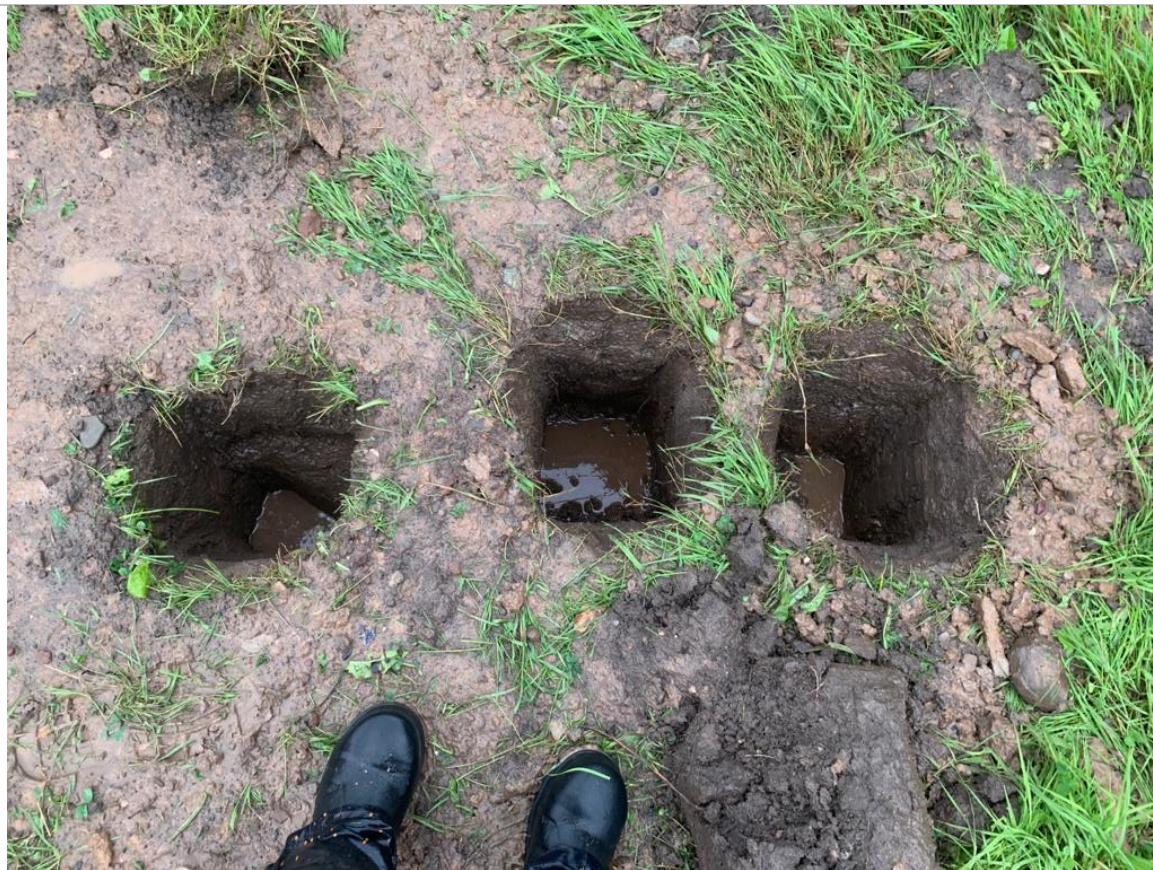
PLATE 7      HP101 LOCATING SURFACE WATER PIPE WITHIN CENTRAL FIELD

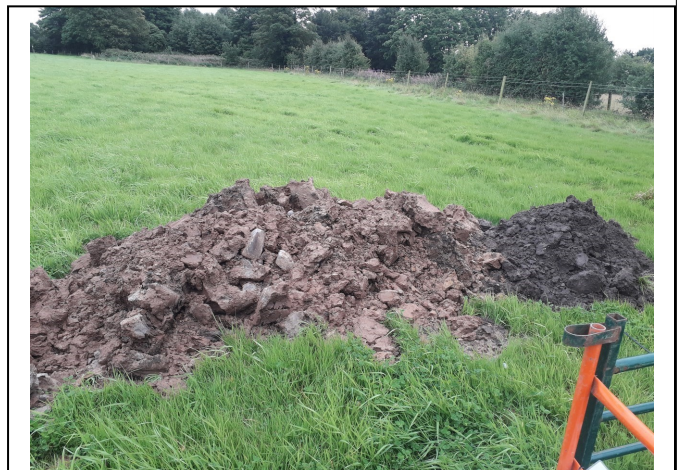
Trial Pit 106/ Soakaway 104 Spoil

Remarks: 1. Complete 2. Hand shear vane could not be obtained due to brittle CLAY.

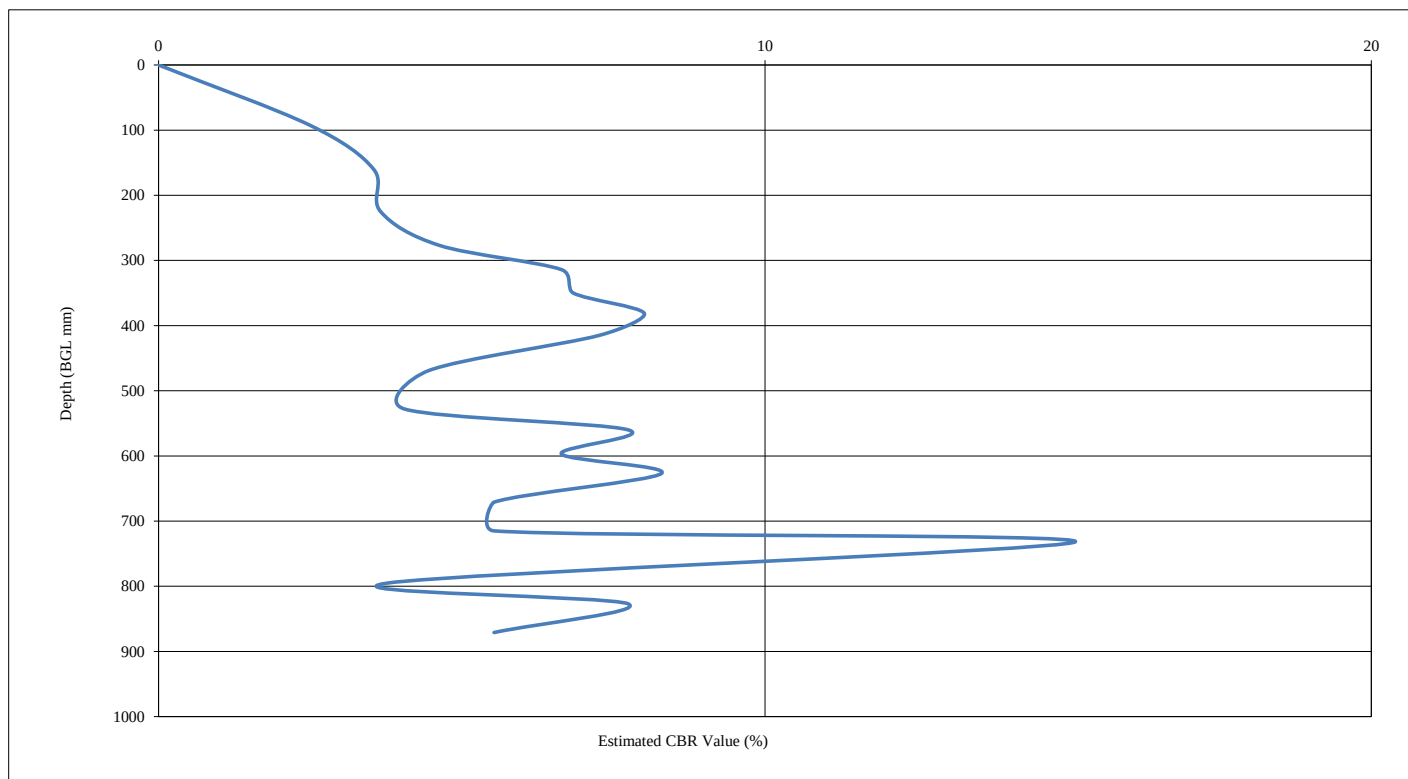
### Estimated California Bearing Ratio Graph

| Start Depth (mm) BGL | Finish Depth (mm) BGL | No. of Blows | Blows Per Layer | DCP mm/Blows | Ave Estimated Layer (CBR %) |
| 0 | 381 | 7 | 7 | 54.43 | 4.42 |

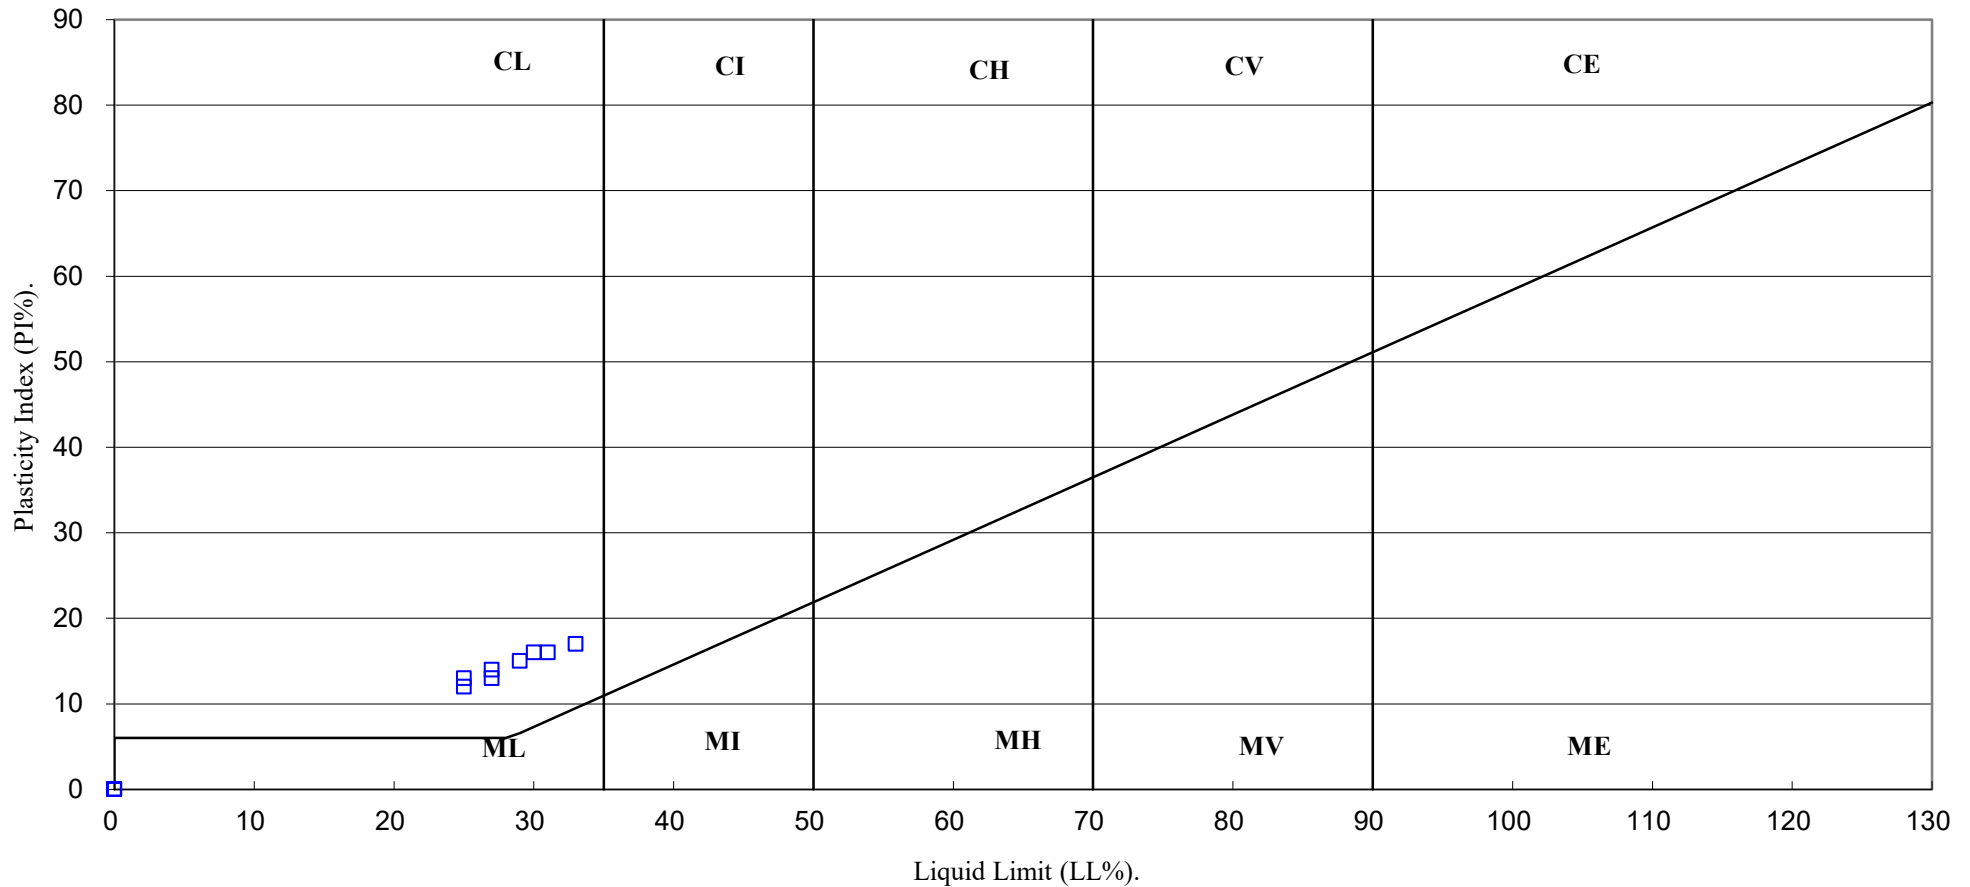
# PLASTICITY CHART FOR CASAGRANDE CLASSIFICATION.
