**REPORT NO: ZZ25061-3**  
**DATE: AUGUST 2025**

**KIRKBY VALLEY GOLF CLUB**  
**INGOE LANE, LIVERPOOL**

**GROUND INVESTIGATION**

**PREPARED FOR**  
**GREEN CIRCLE VENTURES LTD**

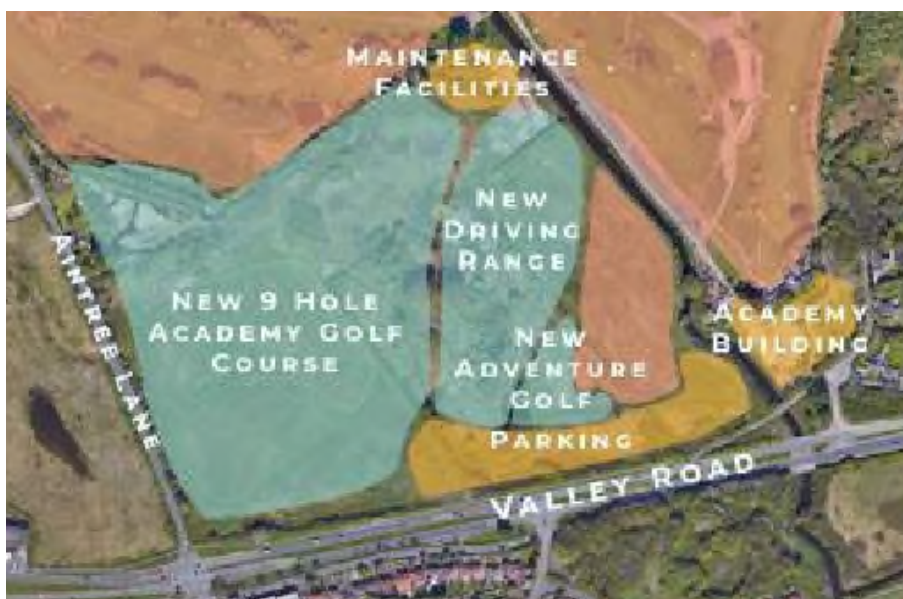
**Figure 2 – Site Layout**

The approved development layout is shown on International Design Group (IDG) Drawing No G935 003 presented at Appendix D & in schematic terms on Figure 2.

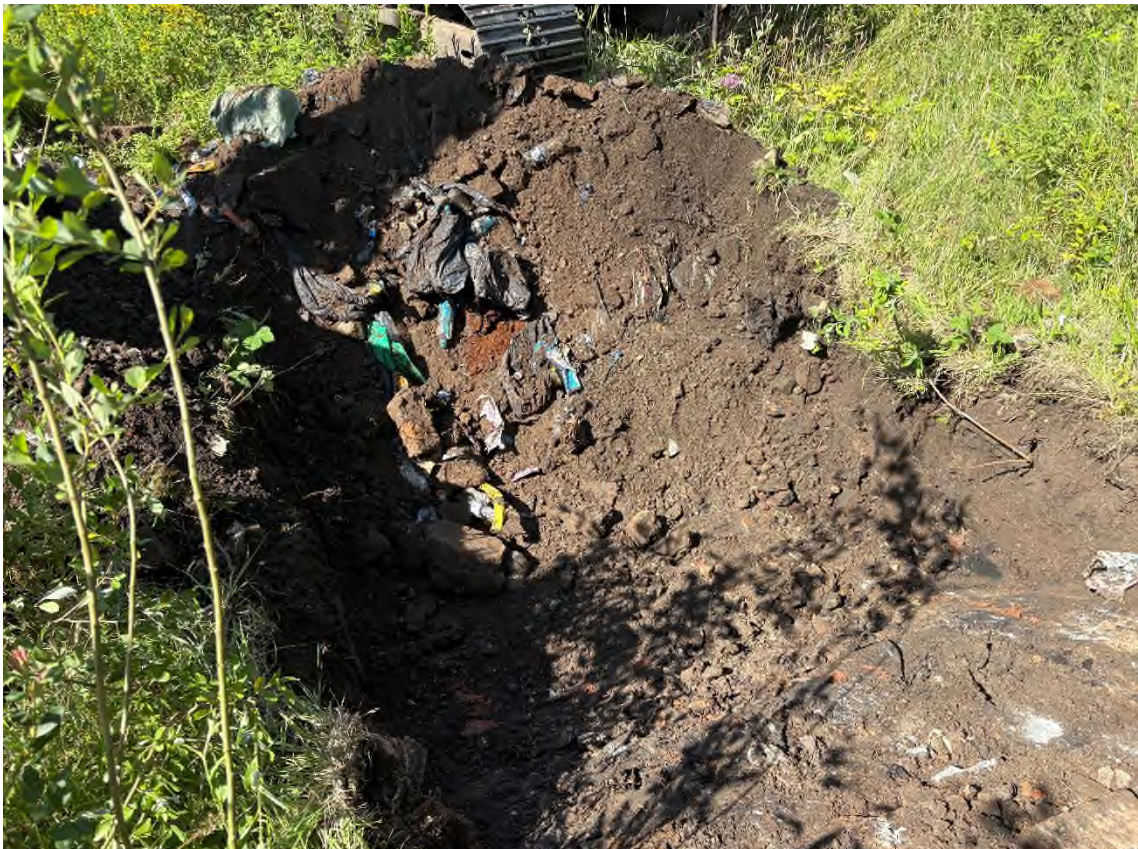
TRIAL PIT 4

| Receptor | Risk Rating | Notes |
|---|---|---|
| Human Health | Low | <p>No contamination has been identified within the existing soils or the former Council inert, uncontaminated soil landfill. Some largely non biodegradable refuse has been identified at one location (Trial Pit 4).</p> <p>It is proposed to import and place suitable soil in this area to construct the par-3 course, thus capping any potential existing contamination, including the former landfill.</p> |

As a result, limited remediation and or mitigation is required ie the excavation and removal of the golf club refuse.
