## Pilch Lane, Liverpool

### Phase 2 Geo-Environmental Investigation Report

For: Breck Homes

| <b>Report Reference:</b> | | <b>4399-02B</b> |

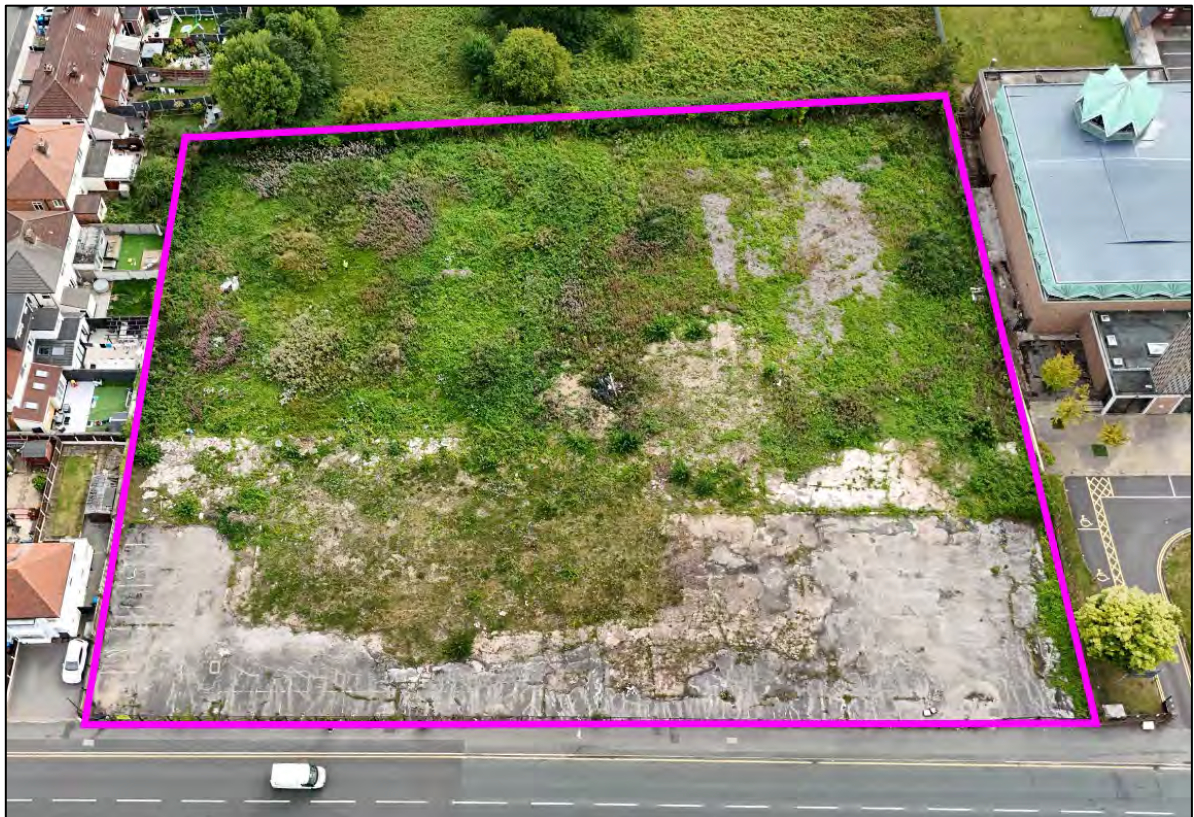
Figure 1: Drone image of the site dated August 2025, looking south to north. The site boundary is highlighted in pink.

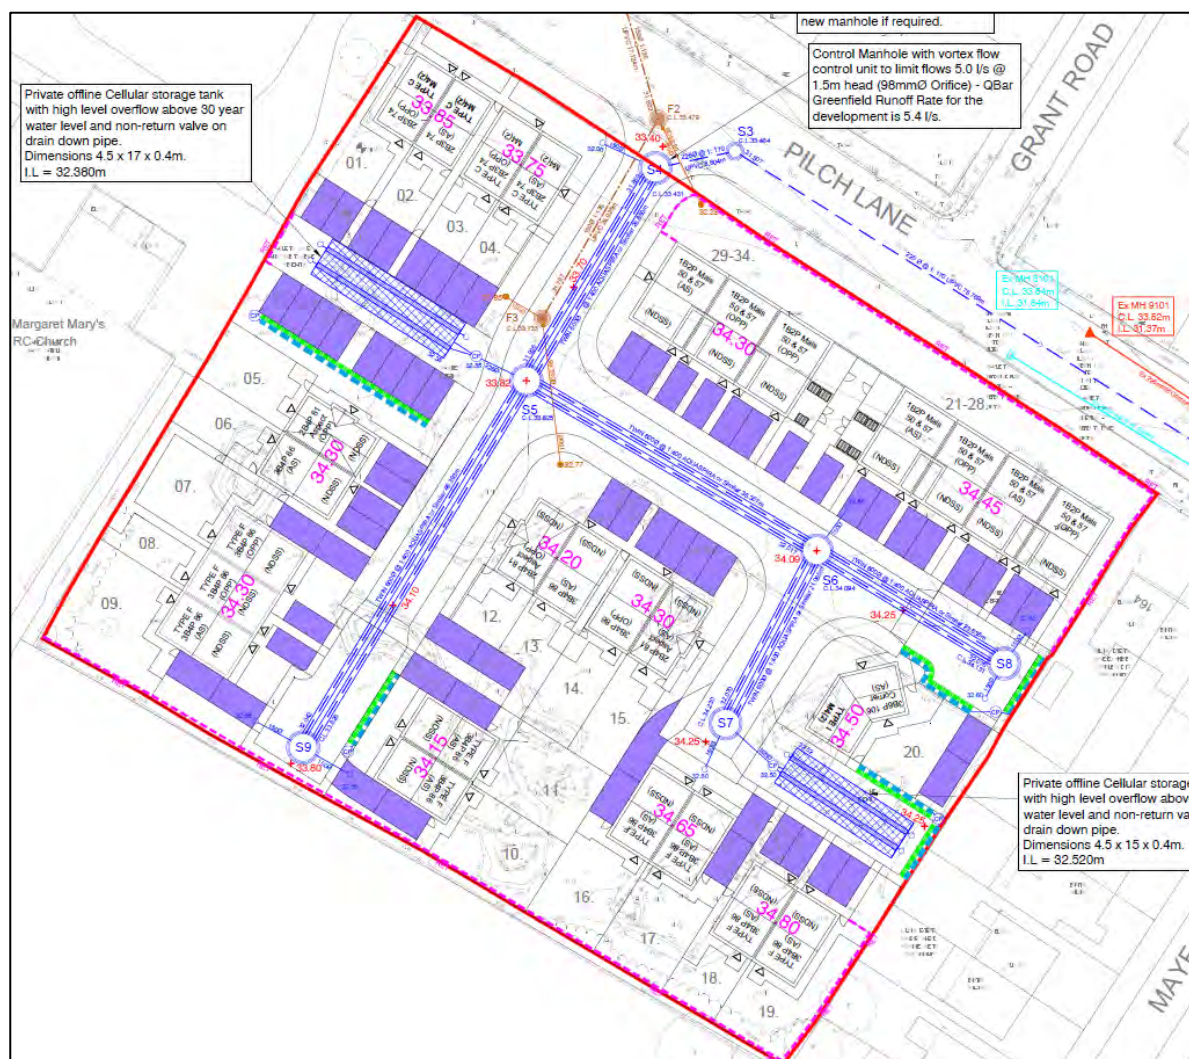
Figure 2: An extract of the proposed development plan '30686\_100C Preliminary Drainage Layout'

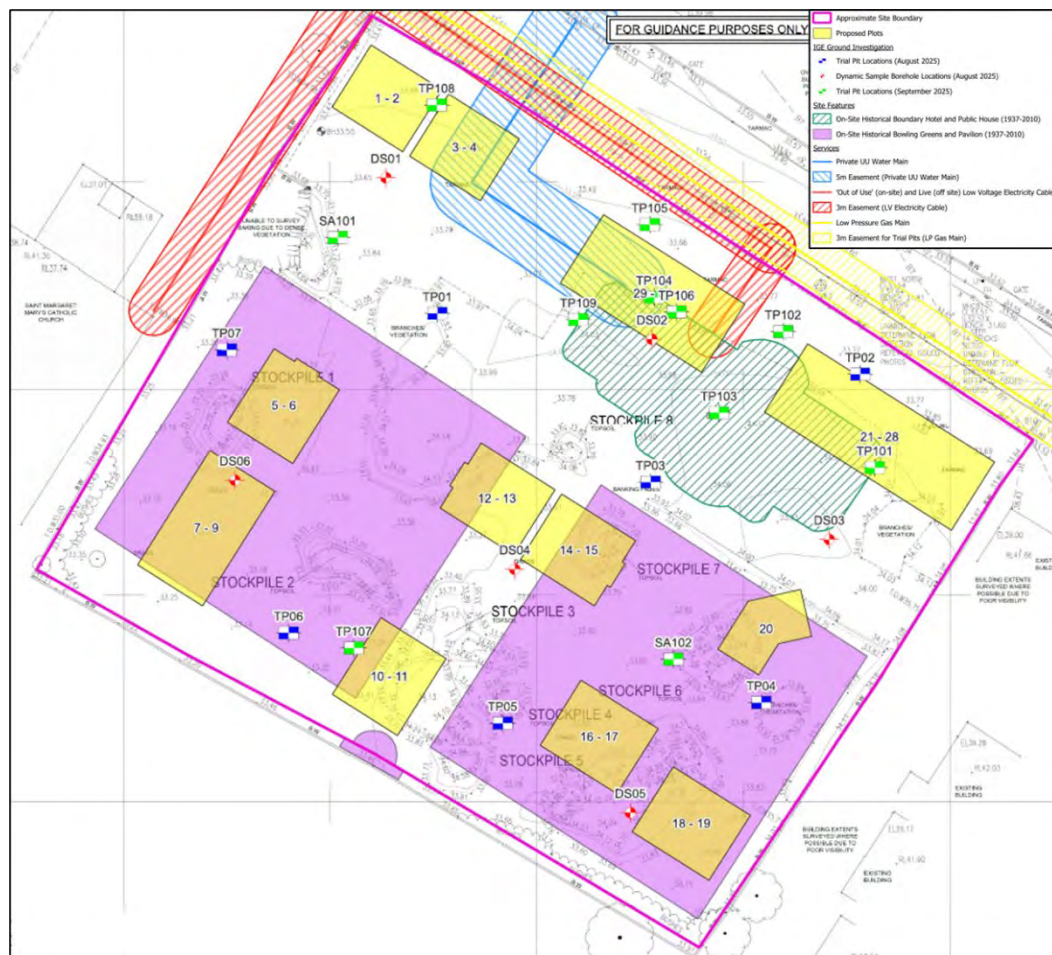
Figure 3: An extract of the exploratory hole location plan.

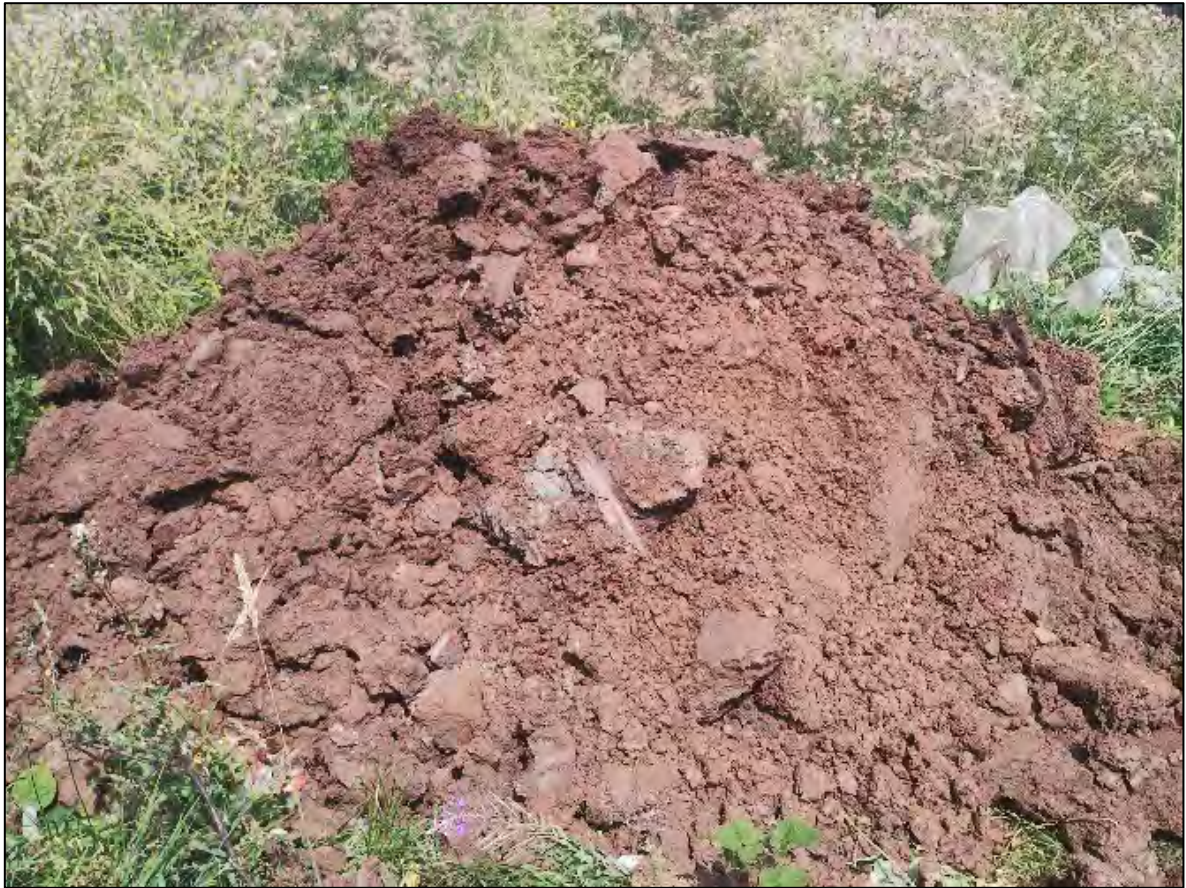
*Figure 4: Typical Glacial Till encountered in TP03.*

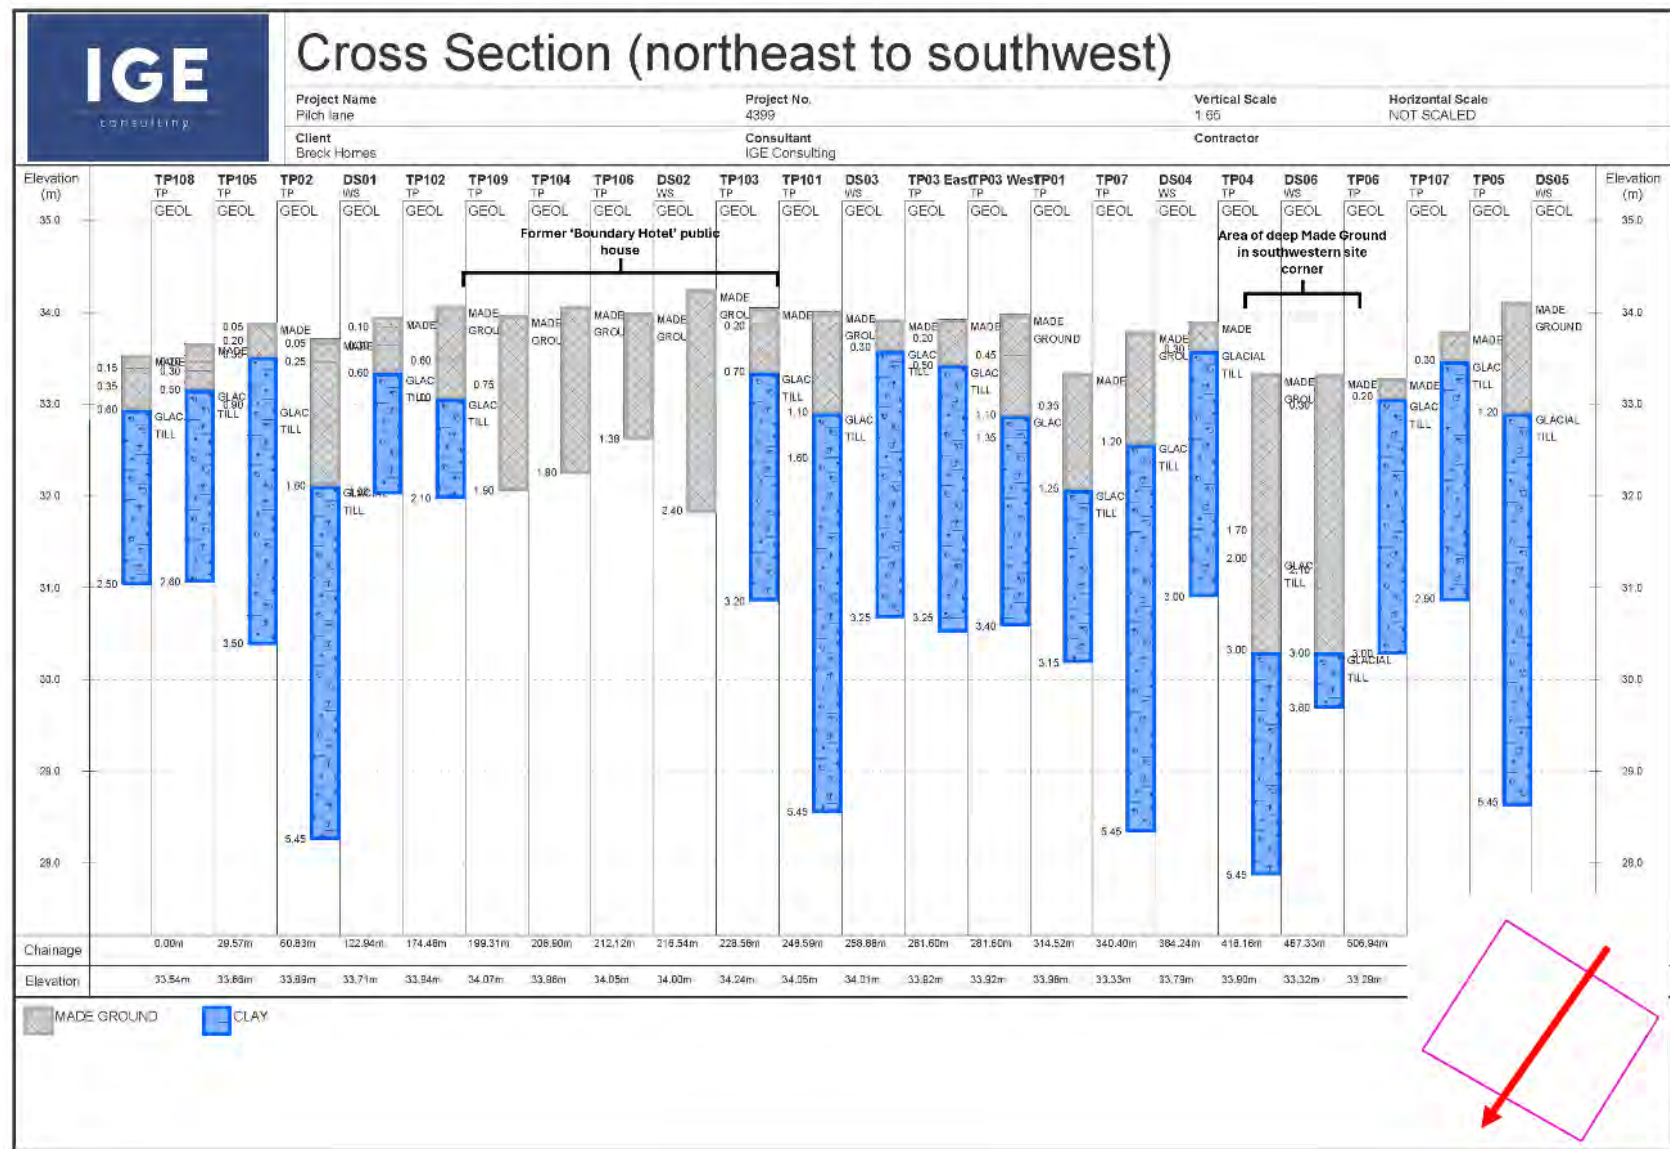
The cross section presented in Figure 5, below, highlights the recorded depths of Made Ground across the site from northeast to southwest. Deeper Made Ground associated with the former Boundary Hotel public house in the northeastern site section is highlighted below. Detailed cross sections are included in Appendix 2

Figure 5: Indicative Cross Section from northeast to southwest.

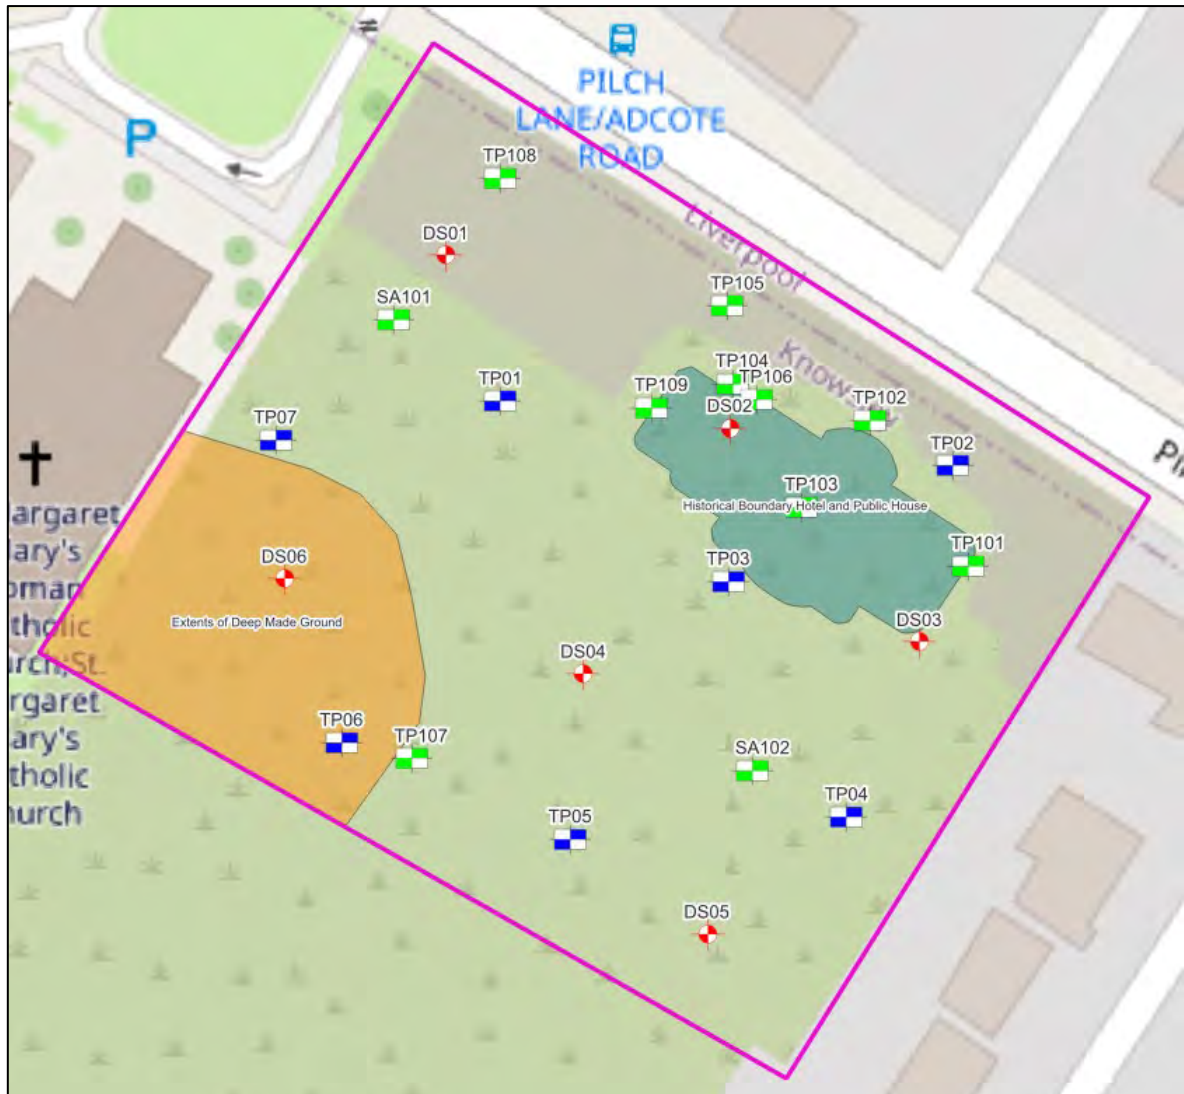
Figure 6: QGIS extract detailing the exploratory hole locations and notable exceptions encountered within the ground conditions.

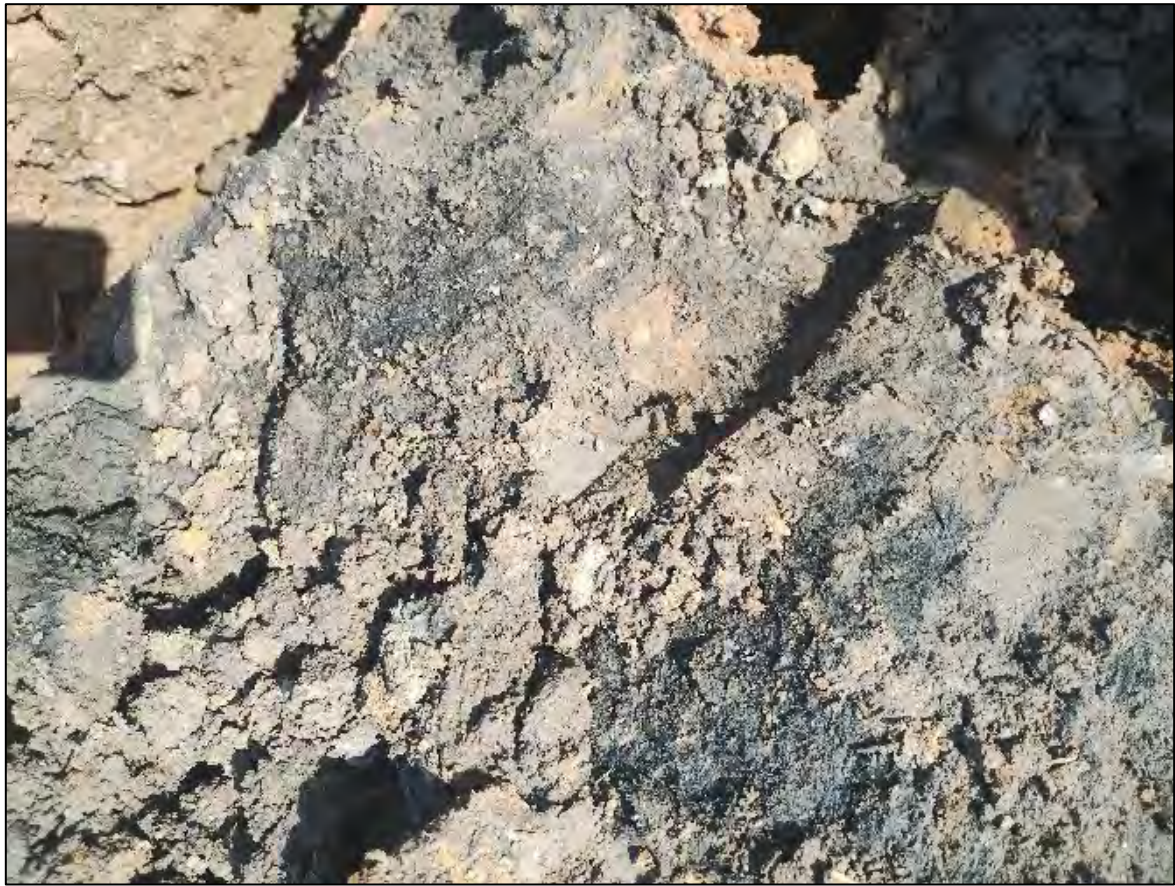
Within DS06 and TP06 only, **Made Ground** comprising firm, orangish brown mottled grey, slightly gravelly slightly sandy CLAY was encountered to a depth of 2.00m and 2.10m bgl (31.32m and 31.19m AOD) respectively, underlain by soft, dark brown, slightly gravelly, sandy CLAY with occasional plant remains to a depth of 3.00m bgl (30.29m and 30.32m AOD). The Made Ground encountered between 2m and 3m bgl may be associated with the construction of the Former Boundary Hotel, installation

*Figure 7: Deep Made Ground with plant remains encountered within TP06 and DS06 only.*

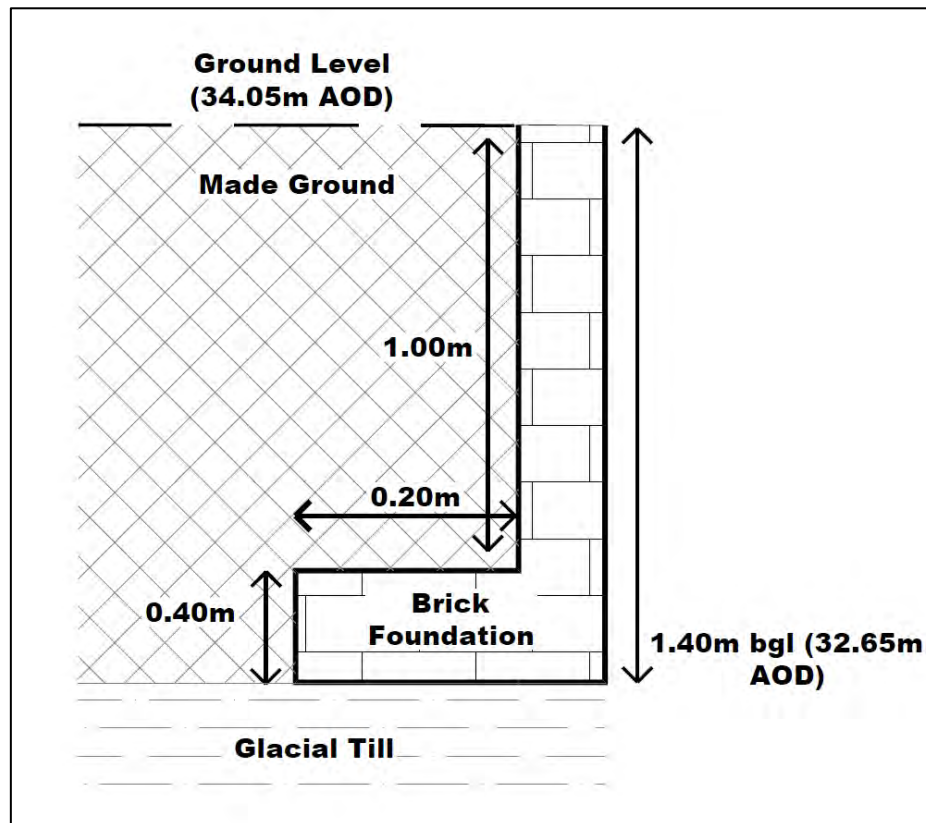
firm Glacial Till, as encountered across the remainder of the site. A schematic of the encountered foundation is included below:

Figure 8: Cross Section of the foundation encountered in TP101.

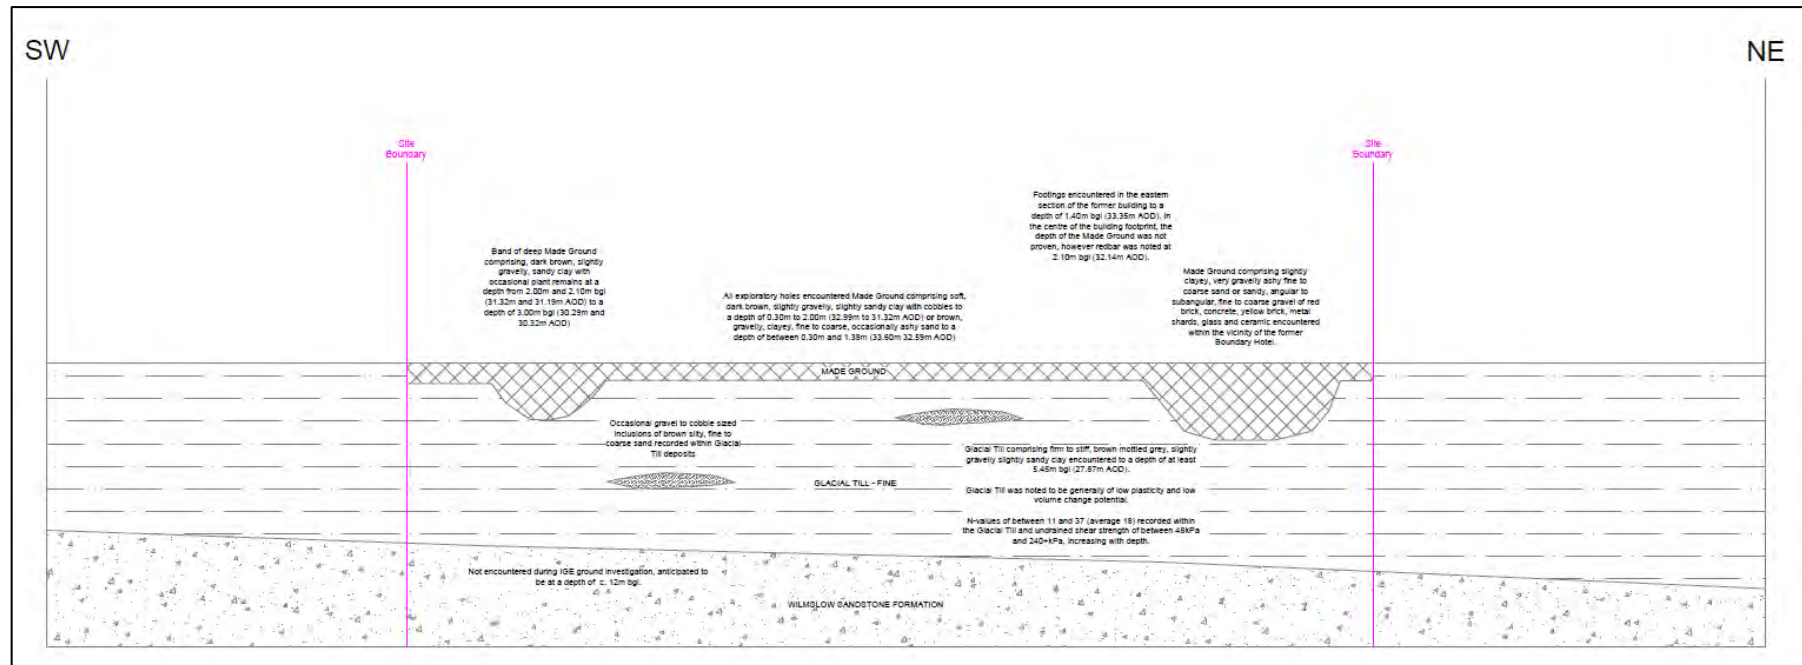
The findings of the Phase 2 ground investigation works have been used to create a conceptual ground model of the site. The conceptual ground model demonstrates the consistent geological strata encountered across the site:

Figure 9: Extract of the conceptual ground model for the site.

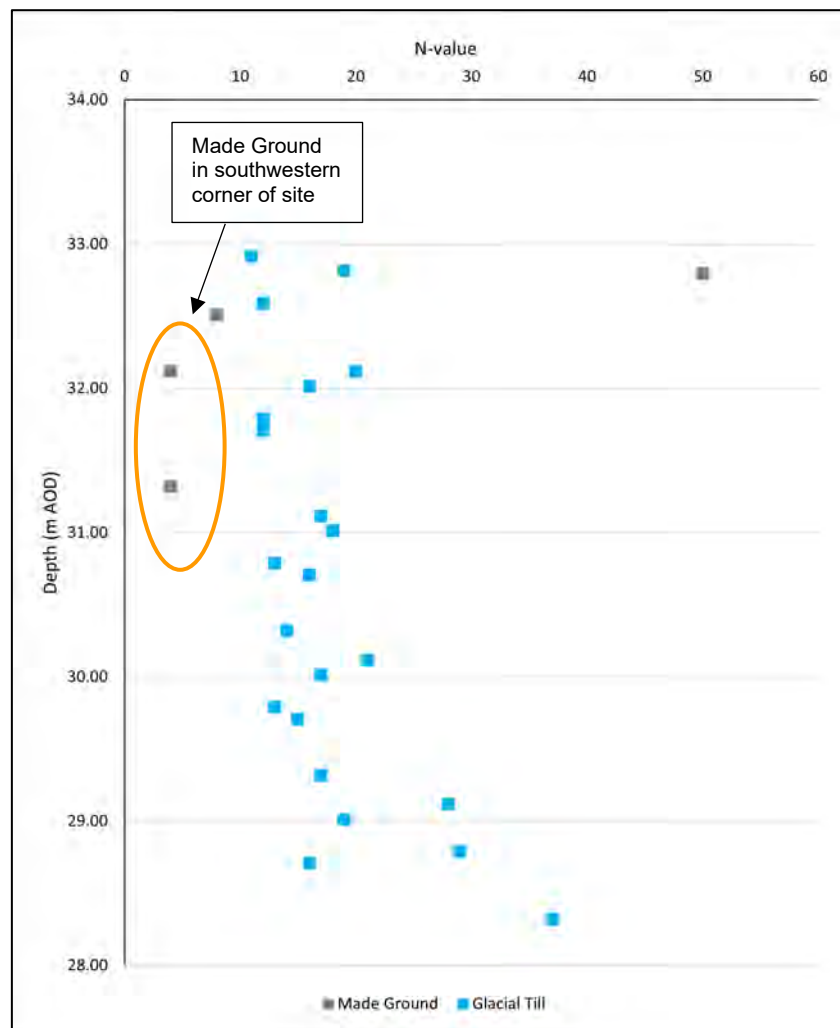
The following scatter graph shows that there was a general positive correlation between increasing uncorrected N-value with depth.

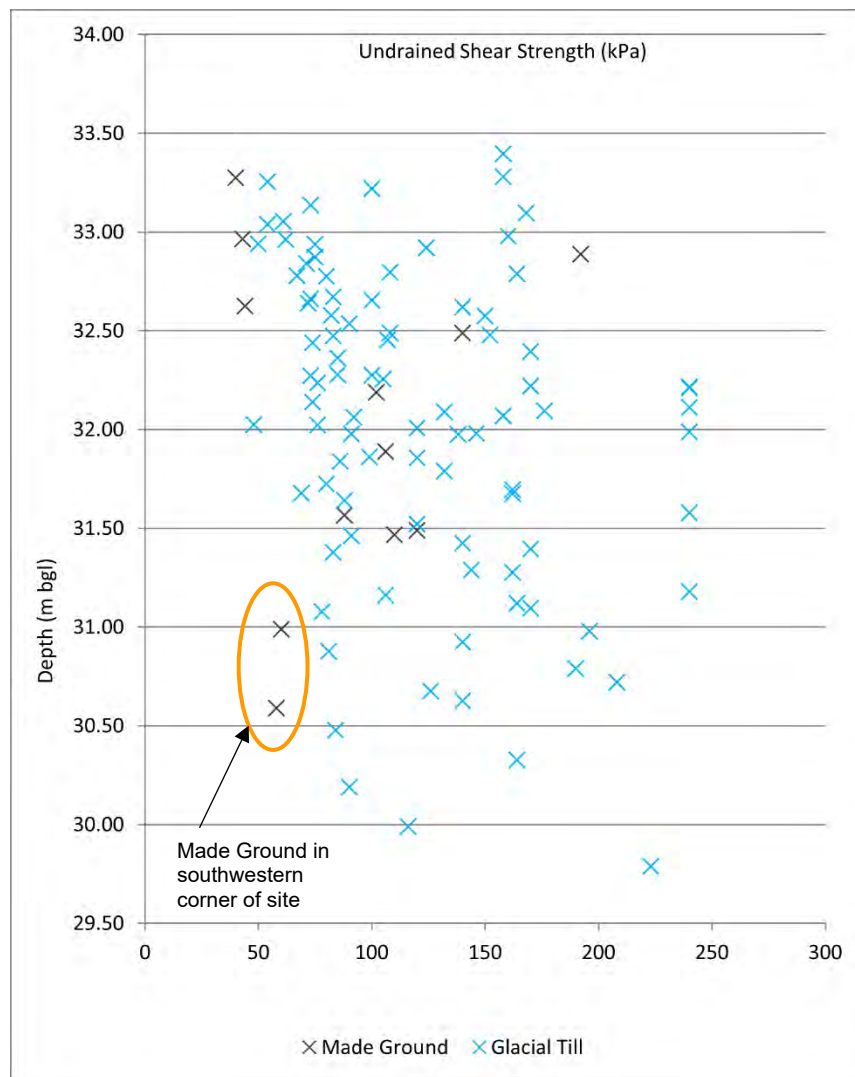
The graph indicates that there is generally a positive correlation between hand shear vane reading and depth.

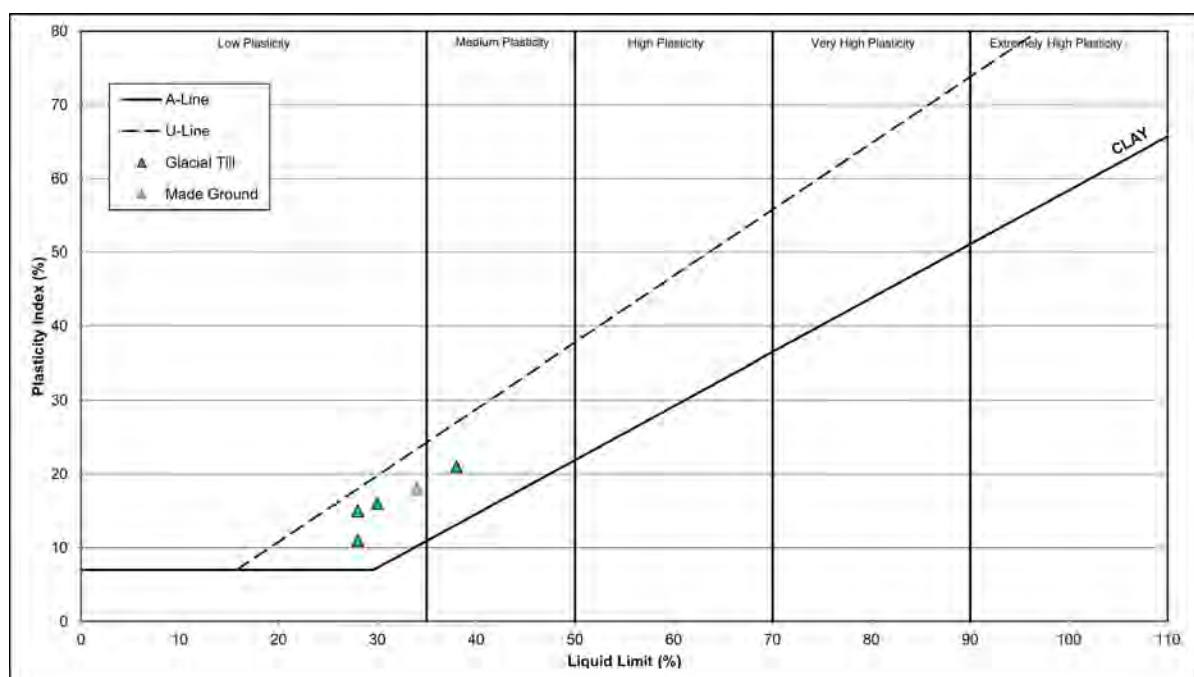
The Atterberg Limit tests indicate that the Made Ground and Glacial Till deposits are generally of low plasticity with the exception of the Glacial Till in the eastern site section (TP04) which is of medium plasticity in-line with BS14688 Part 2.

The Glacial Till and Made Ground are generally of low volume change potential, with the exception of the sample from TP04 in the eastern site section which is of moderate volume change potential in-line with NHBC Chapter 4.2 guidance.

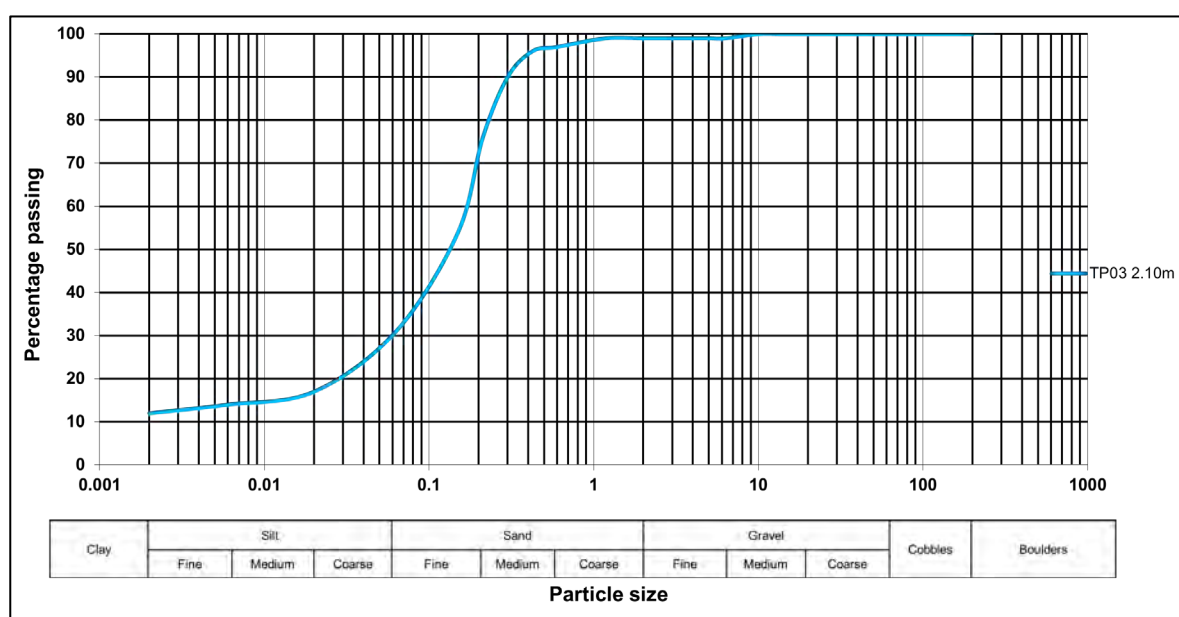
A single particle size distribution test was undertaken on a sample of Glacial Till from a gravel to cobble sized inclusion within TP03.

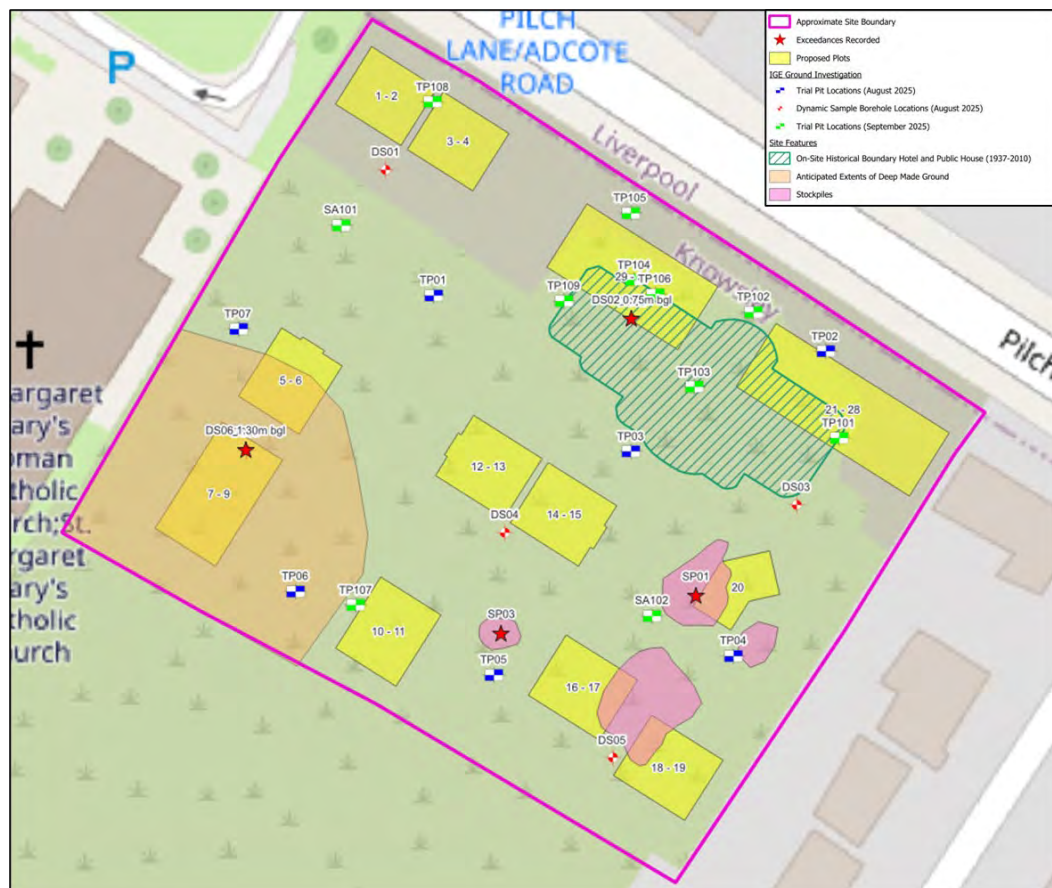
Figure 10: QGIS Extract detailing areas of exceedances: former Boundary Hotel (blue), Stockpiles (pink) and area of deeper Made Ground (orange). Red stars indicate the location of exceedances encountered on site.

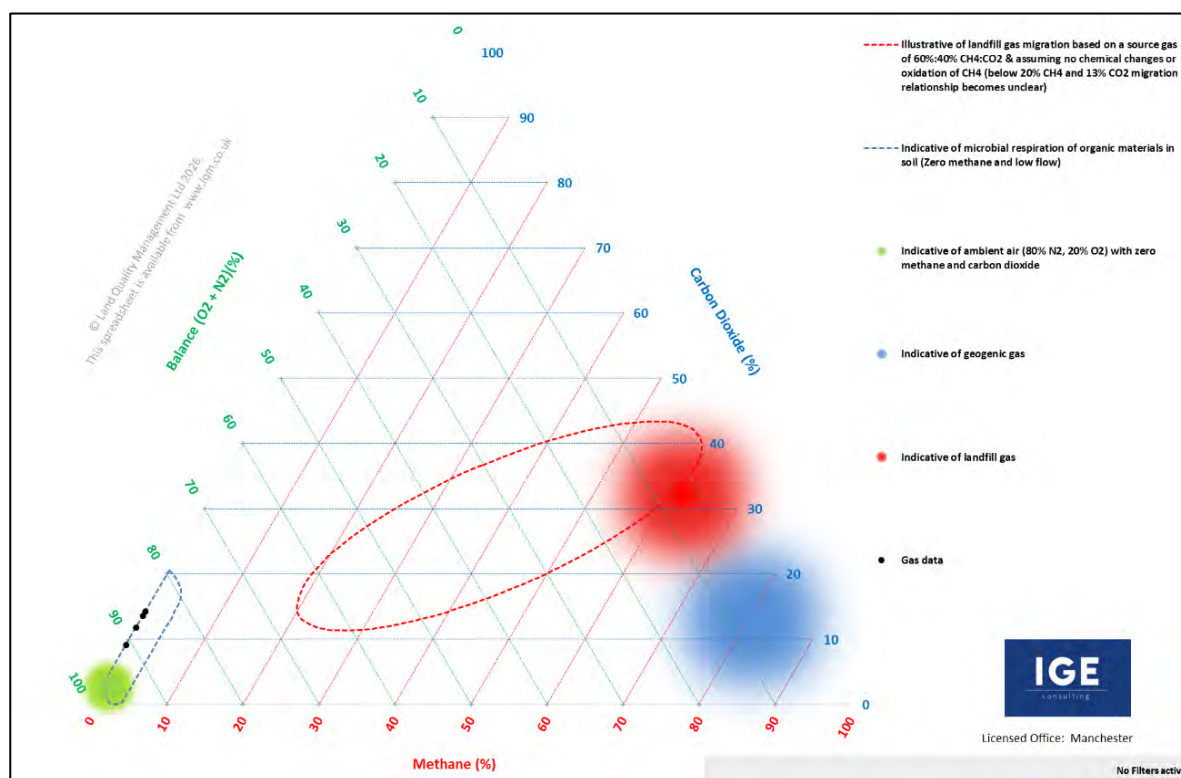
The ternary plot below shows the ground gas monitoring data from DS06 and concurs that the ground gas concentrations in DS06 is indicative of microbial respiration of organic material, represented by methane concentrations and flow rates below detection limit.

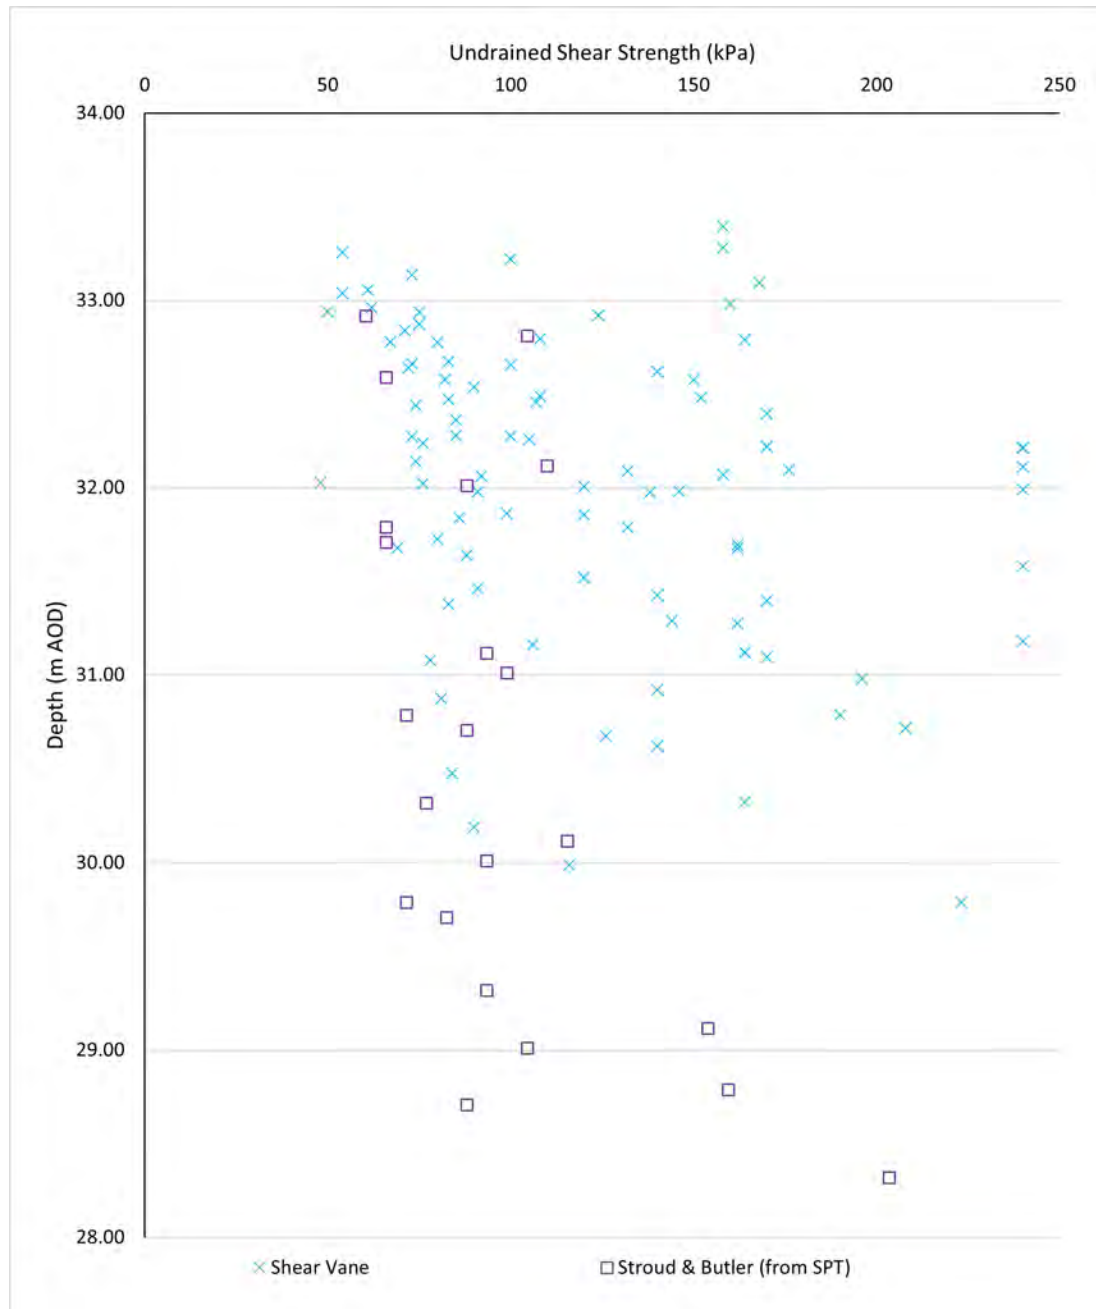
204kPa, with an approximate average of 98kPa. These are slightly lower values than those obtained through direct measurement (shear vane testing), but the graph below shows good general agreement between the two datasets. The graph indicates that there is generally an increase in undrained shear strength with depth.

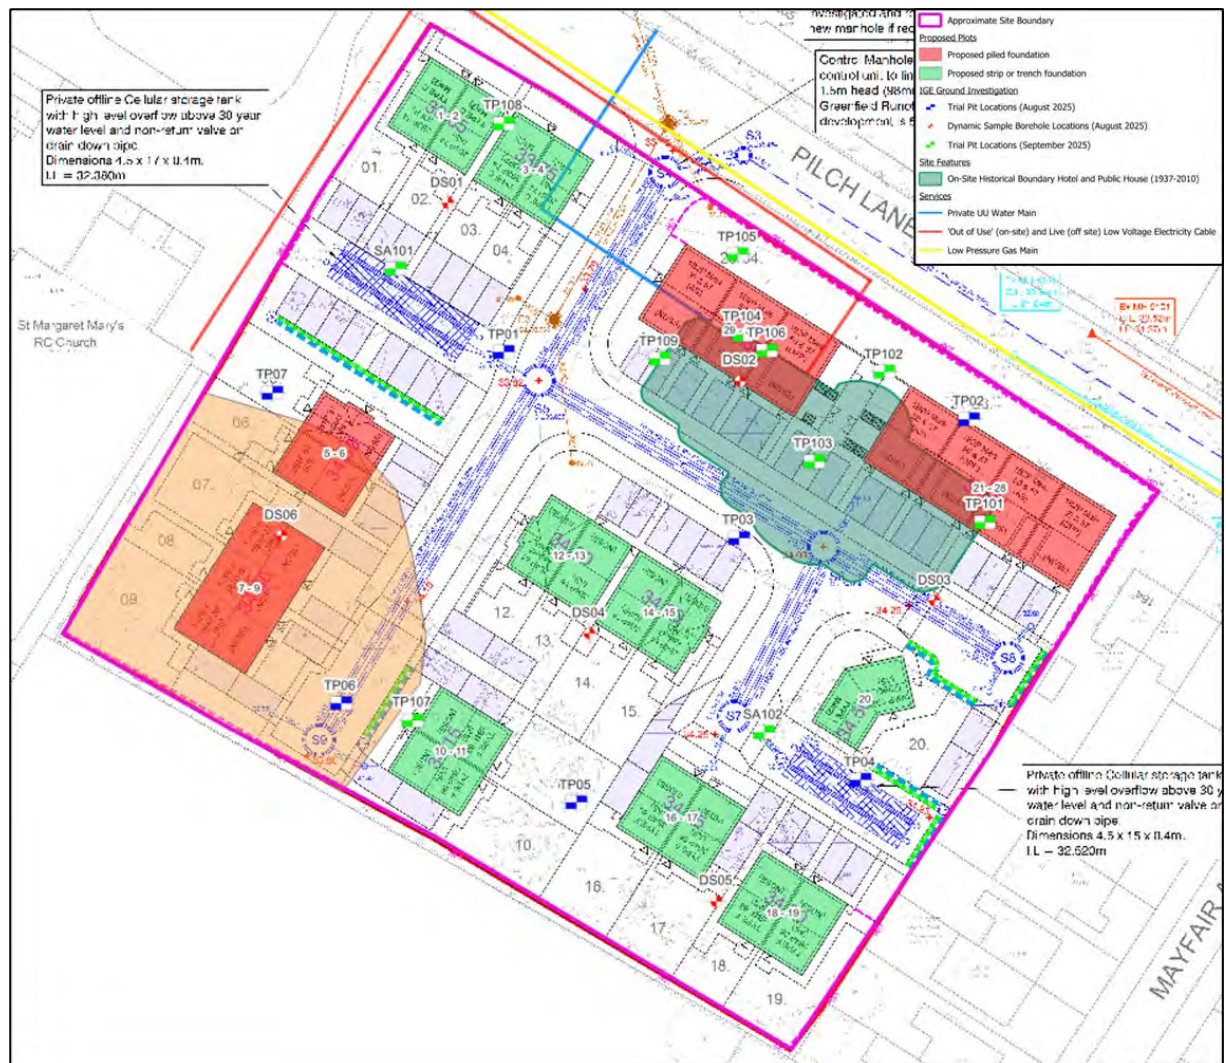
Figure 11: Extract of '30686\_100C Preliminary Drainage Layout' including services and historical features including the former Boundary Hotel extents (blue). Orange indicates the approximate area of deep Made Ground in the southwestern section.
