## Structural Survey

For the conversion of Agricultural Building

85 Baileys Lane,  
Halewood,  
Liverpool,  
L26 0UA

Our ref: SJ/WGB/LM 34494

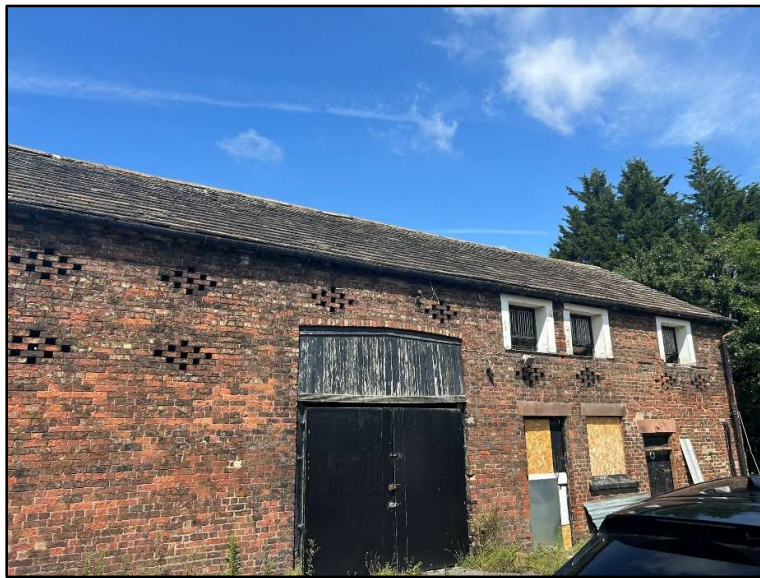
- 5.1 For the purpose of this report when using the terms left and right, the building will be referred to as viewed externally from the front which is adjacent to the car park area and depicted in Photograph 1.
- 5.2 The agricultural building is a part single storey structure to the left with a two-storey area to the right, which is approximately 18m x 8m on plan. The external walls comprise of 215mm solid brickwork walls. Eaves level of the building is approximately 4.3m from external ground level. Externally there are solid stone lintels over the majority of the window and door openings.

*Photograph 1- Front elevation*

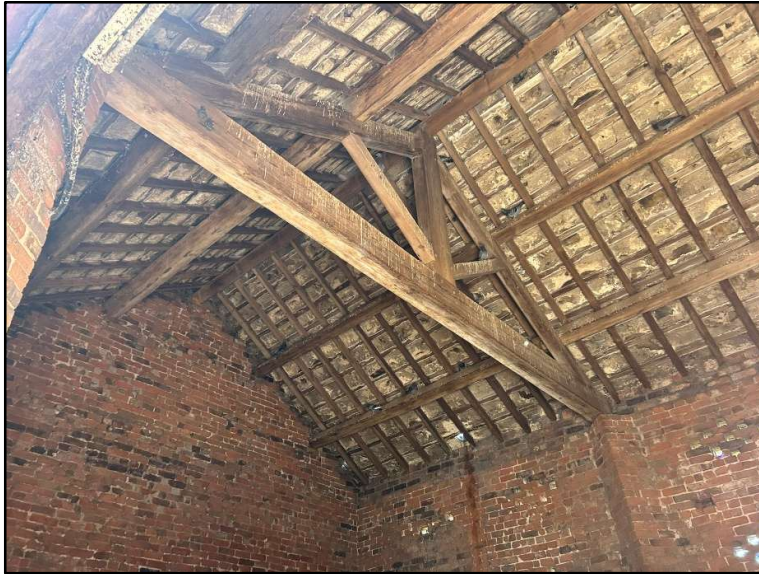
- 5.2 The roof is a traditional duo-pitched and comprises of timber trusses with timber purlins spanning between the trusses supporting timber rafters at regular centres. There are timber battens spanning between the rafters supporting the roof finishes. The ends of the roof trusses are embedded into the external walls along the front and rear elevations. The purlins are embedded into the external walls along the gable elevations. The roof trusses are supported on internal triangular brick piers.

*Photograph 2- Timber roof trusses spanning between the front and rear elevation*

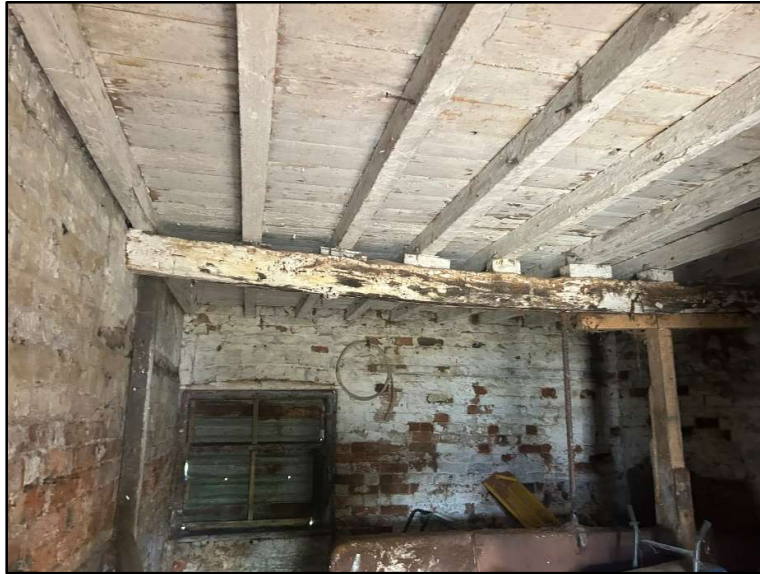
- 5.4 To the right hand section there is a first floor that covers approximately half of the internal floor area. The timber first floor structure is constructed from timber joists spanning onto larger timber support beams supported between the right-hand gable external wall and internal masonry dividing walls. These timber beams are also supported at mid span with a timber post.
- 5.5 The ground floor comprises of mix of solid concrete construction and brick tile floor to the 2-storey portion of the building. The finished level of the floor appears to remain consistent throughout.

*Photograph 3- taken from ground floor level showing 1<sup>st</sup> floor structure*

- 5.6 There was slight bowing of the right-hand gable wall above eaves level, the remainder of the elevations are free for distortions.
- 5.7 The timber beams supporting the first-floor joists have deflected as shown in Photograph 3.
- 5.8 There were no significant cracks observed within the masonry of the barn.
- 5.9 Generally there were no significant defects in the timber trusses or roof structure.

- 5.9 The ground floor has been subjected to agricultural loading. Residential use of the building will result in lower loading and therefore the slabs may continue in service subject to upgrading requirements for new building regulations
- 5.10 The first floor structure will require strengthening, but this can easily be achieved with new steel support beams
- 5.11 The external masonry is in good condition apart from the slight bowing of the right-hand gable wall. However, the wall is still in tolerance and we would suggest new strapping to the floor and roof structure to prevent further movement.
- 5.11 The roof structure is substantial and is showing no signs of significant defects.
- 5.12 Trial holes are required to confirm existing foundations and depths.
