# Arboricultural Impact Assessment

**Redevelopment of Deacon Business Park**

**14th February 2023**

TG Report No. 15353\_R01a\_BV\_CW

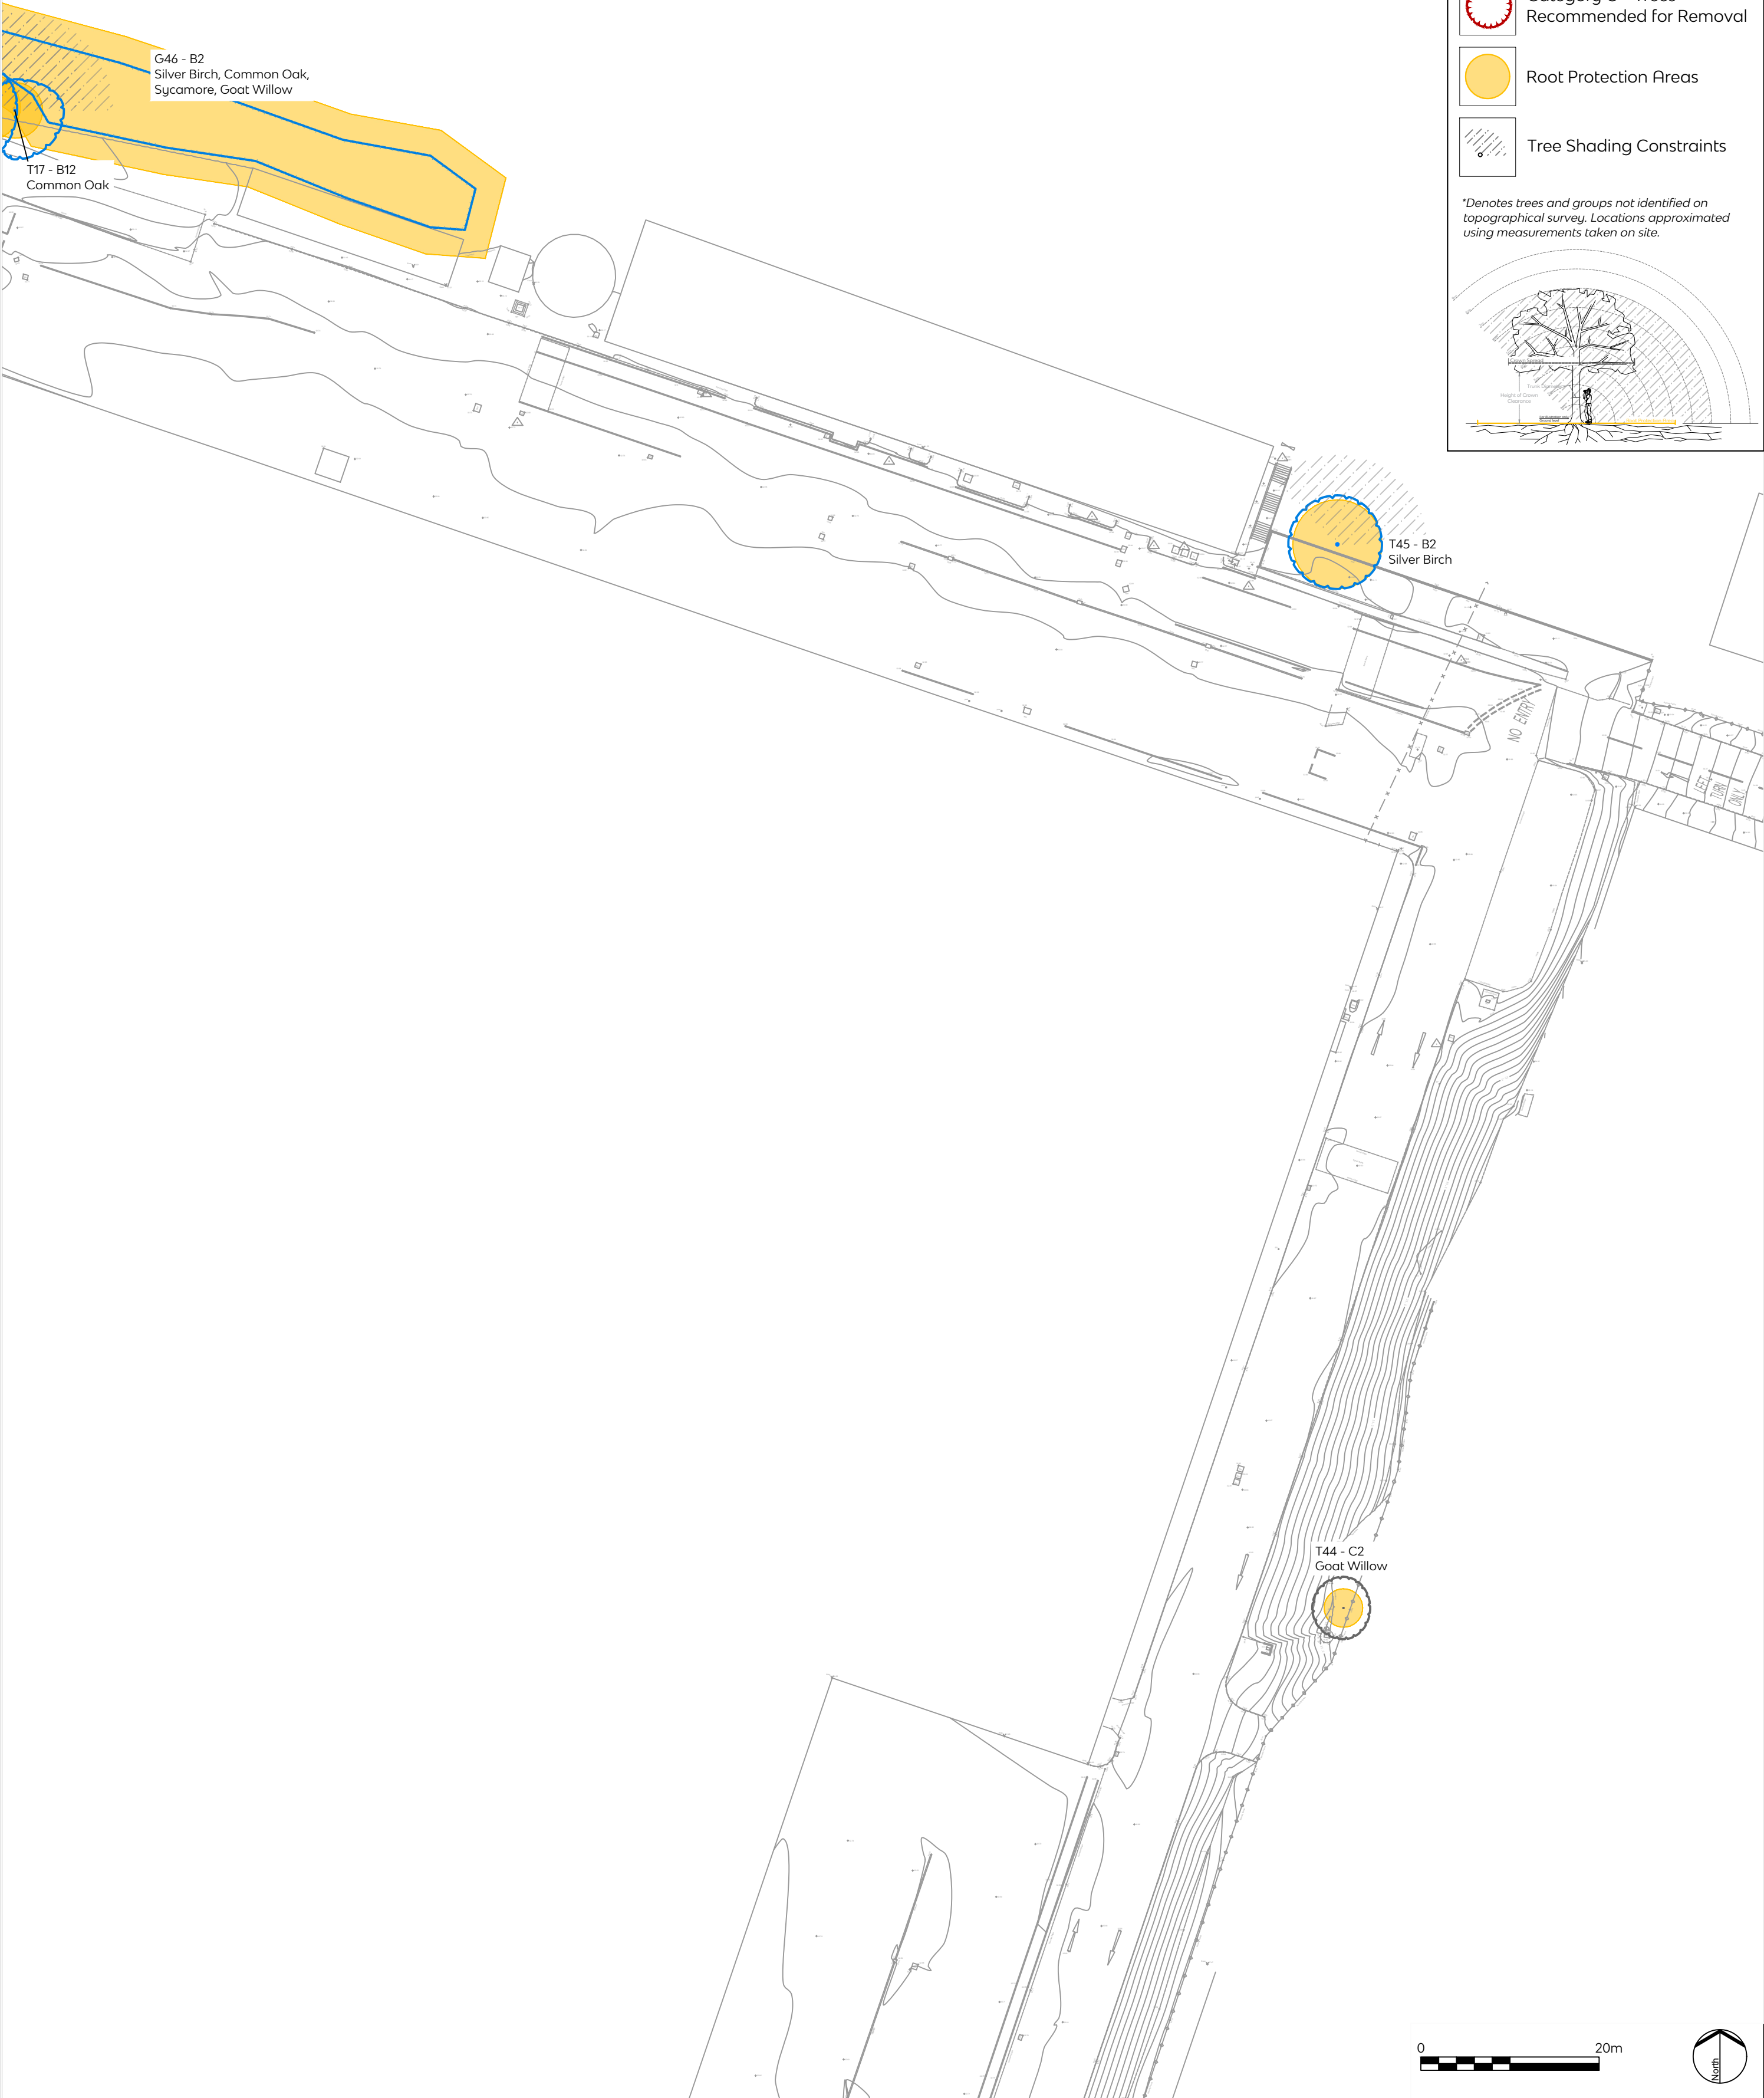
Plan 2: Tree Retention and Removal Plan (TRRP), (15353/P02)

- 3.1. Trees to be retained and removed are shown on the TRRP. Table 4 below describes the tree losses required to facilitate the development and provides recommendations for compensation.

- 3.3. Proposed new tree planting is shown on the TRRP and appears to implement a total of 19no. trees in designated tree pits within the new car parking area.
- 3.4. We recommend that a separate soft-landscaping scheme is prepared which details the exact tree specifications and prescribes suitable long-term management actions to ensure the longevity of the newly planted trees. This scheme may also include supplementary trees situated elsewhere on site (as recommended in Table 4), in less confined rooting areas away from hard surfaces, to provide planting opportunities to further compensate for the removal of trees due to the development, and to securely adhere to the replacement tree policy of 2:1 (see Appendix 1 for details).
- 3.5. Despite the proposed tree losses, it is anticipated that a net-gain in tree canopy and green infrastructure at the site will be achieved in the long-term.
