**CCG-C-23-14178**

**GROUND INVESTIGATION AT**

**HUYTON TOWN CENTRE**

**FACTUAL REPORT**

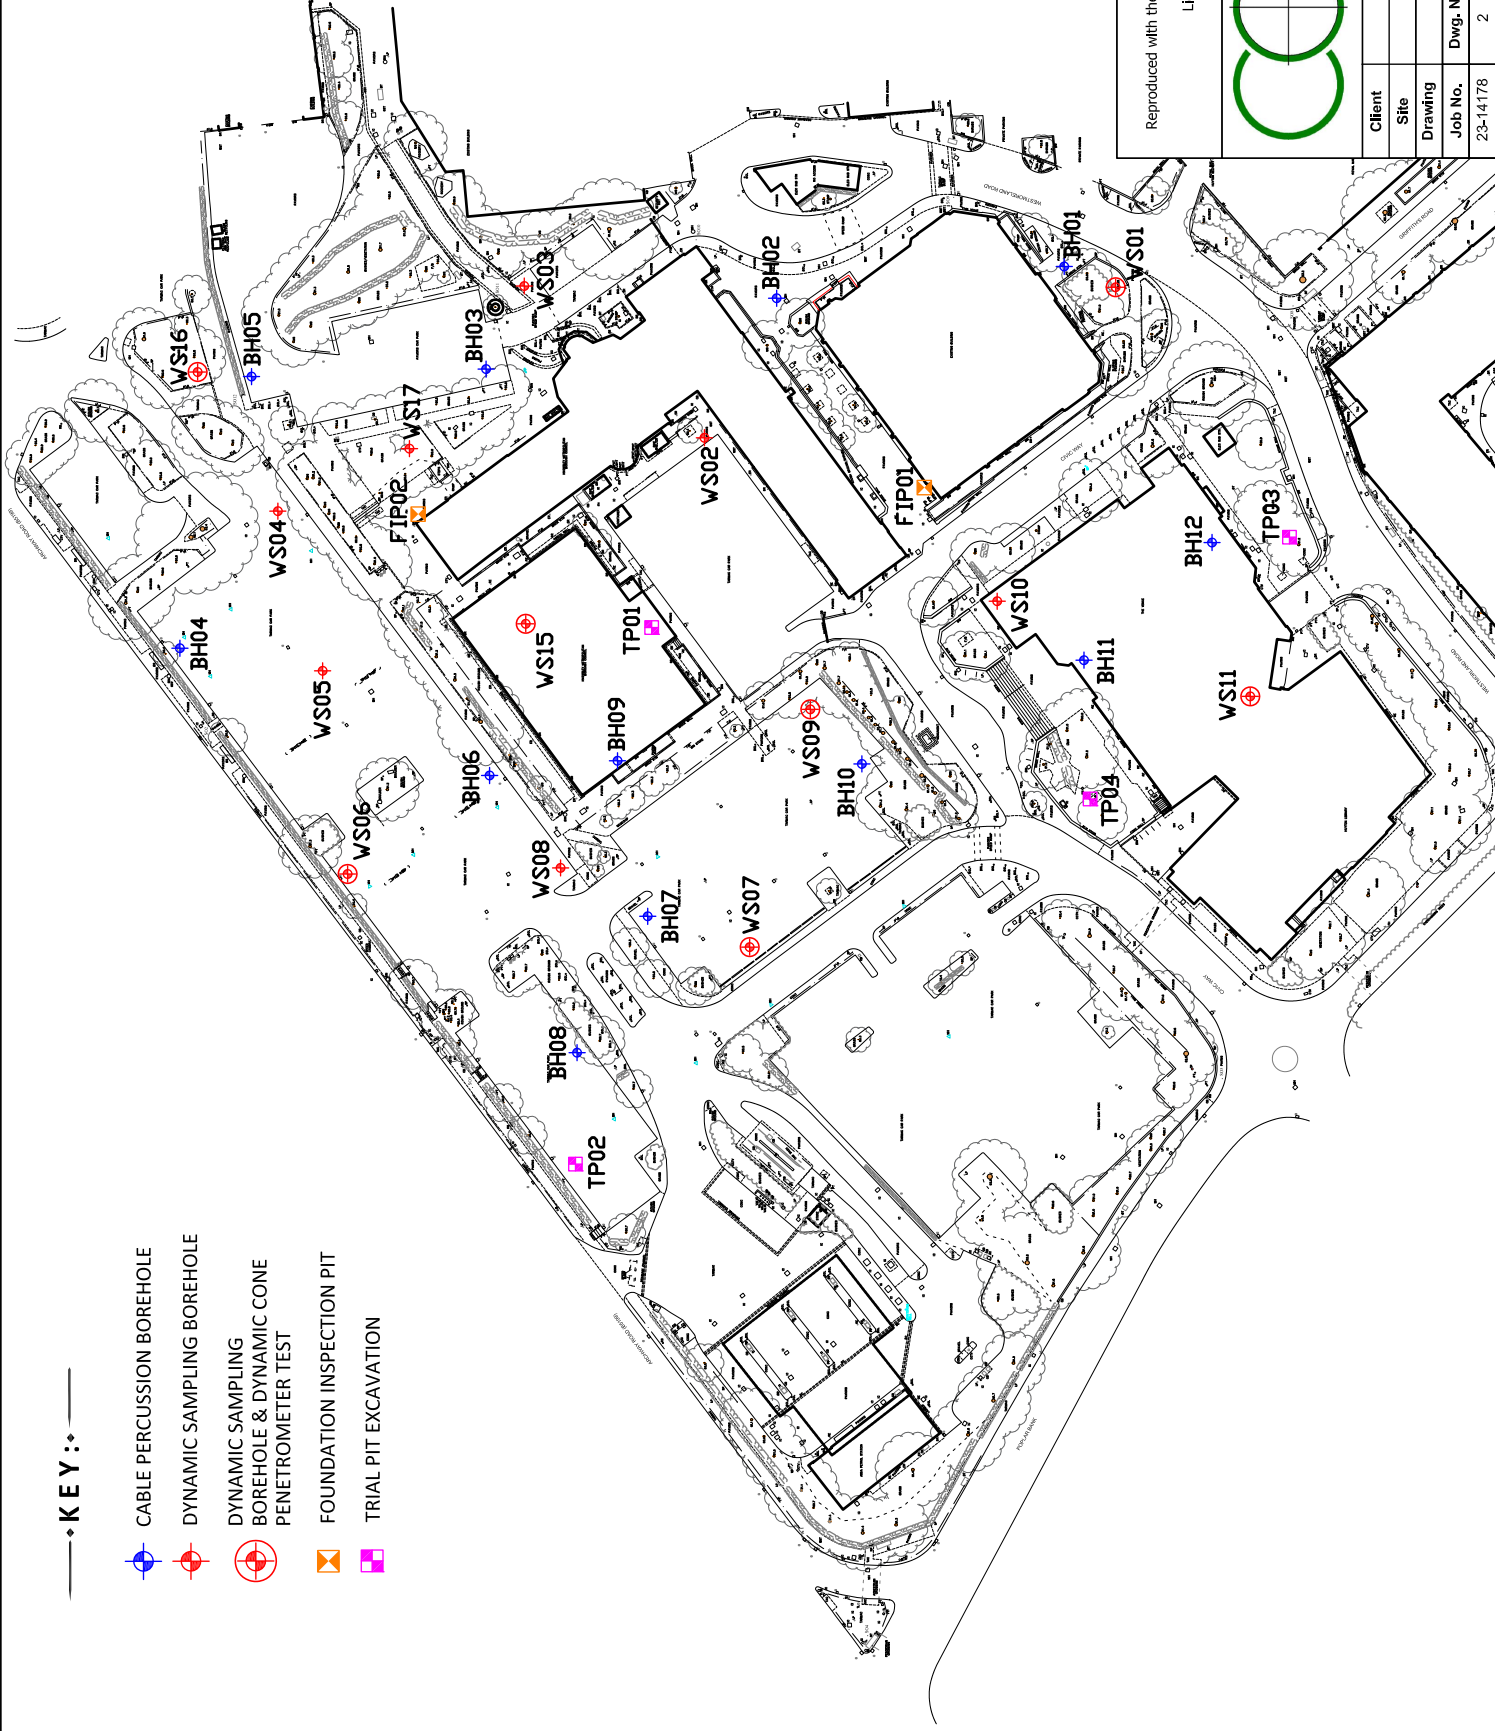
- CABLE PERCUSSION BOREHOLE
- DYNAMIC SAMPLING BOREHOLE
- DYNAMIC SAMPLING BOREHOLE & DYNAMIC CONE PENETROMETER TEST
- FOUNDATION INSPECTION PIT
- TRIAL PIT EXCAVATION

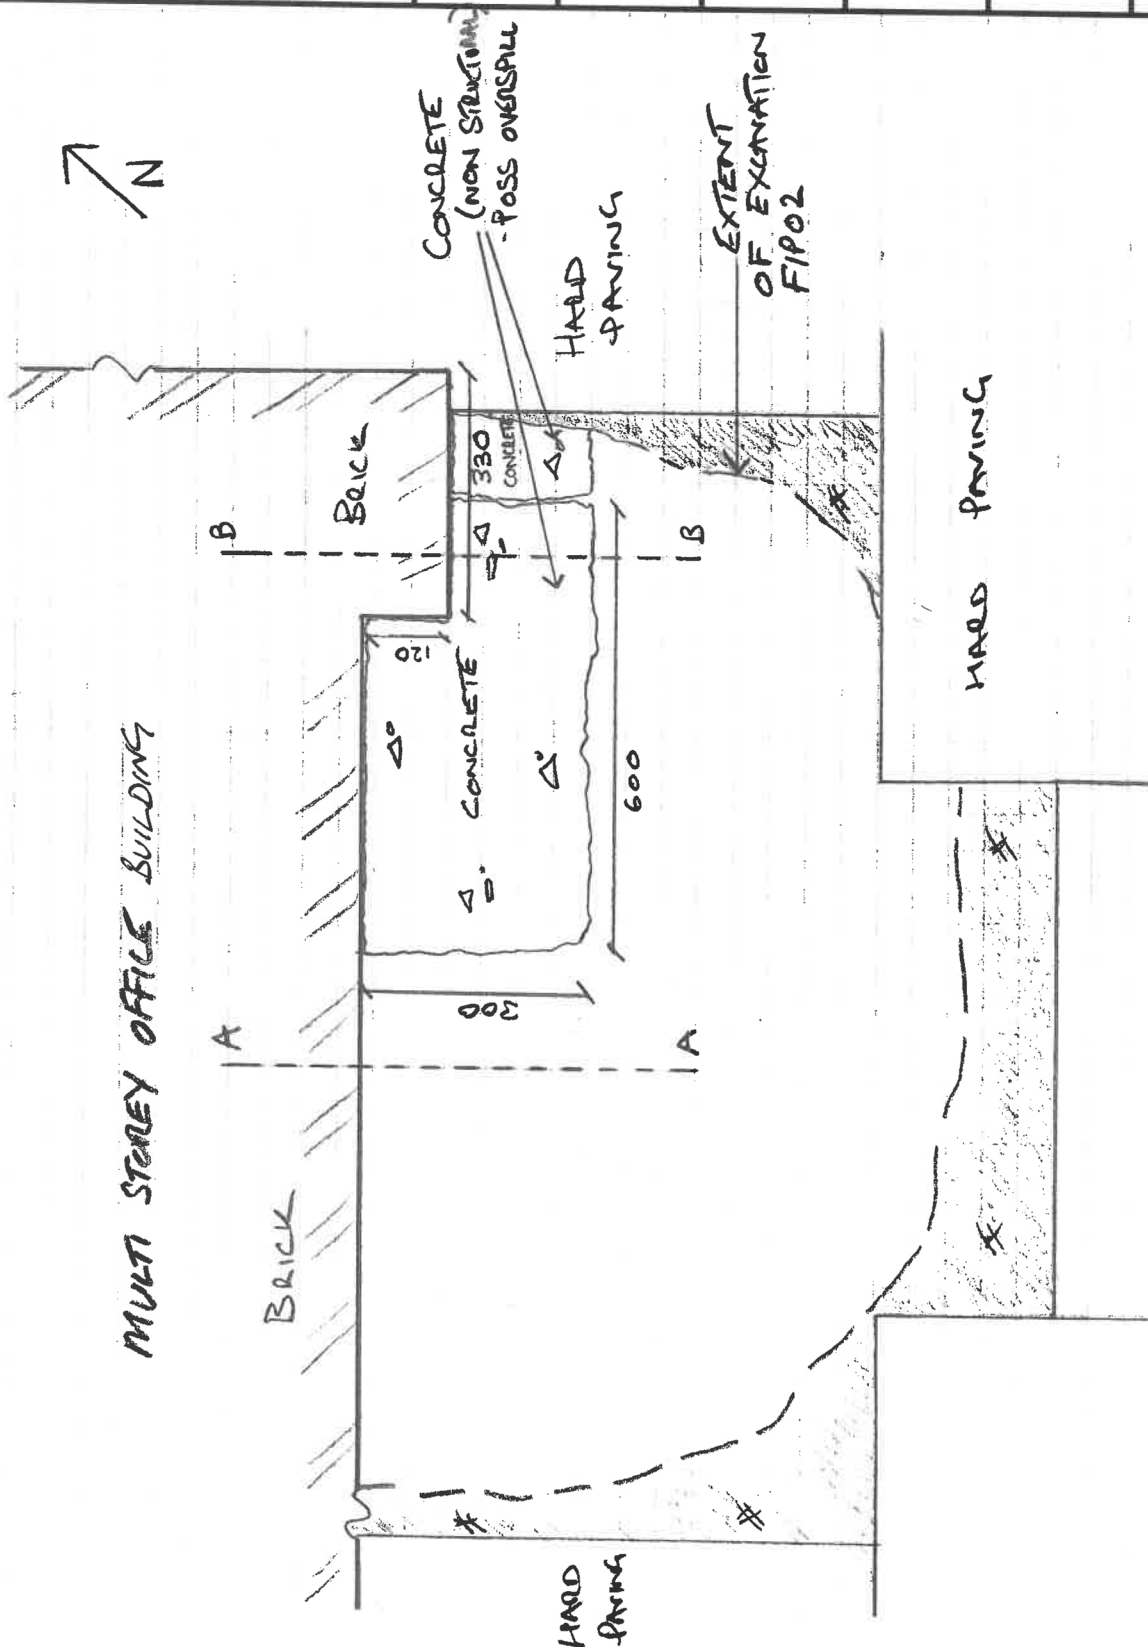
4178-FIP02

PLAN VIEW - EXCAVATION FIP02  
SEE SECTIONS A-A & B-B.  
ALL DIMENSIONS ARE GIVEN IN MM  
UNLESS STATED OTHERWISE.

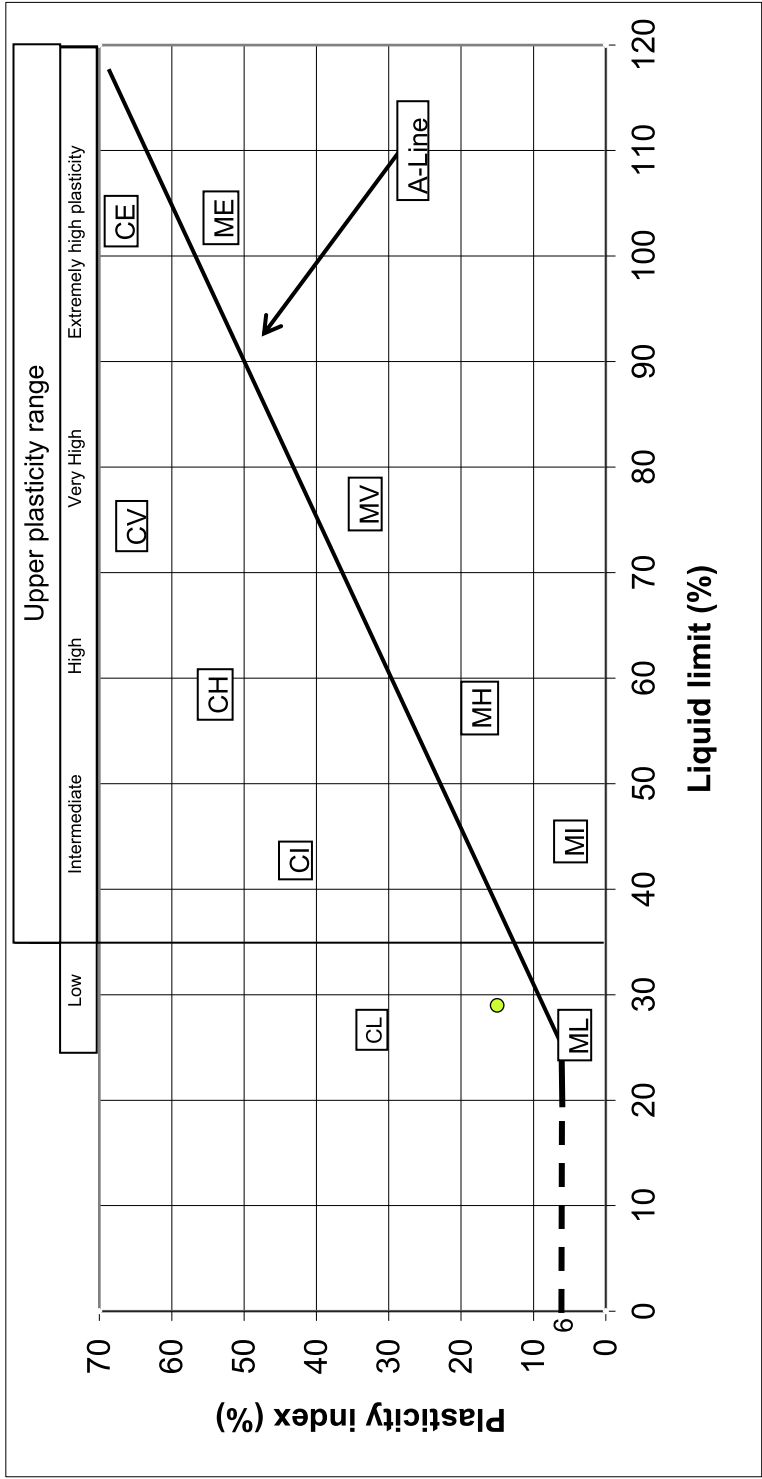
**ATTERBERG TEST RESULT SHEET**  
BS 1377:Part 2:1990:cl 4.4,5

SILT (M-SOIL), M plots below A-Line, CLAY,C, plots above A-Line, M and C may be combined as FINE SOIL, F.

| BH01 | 0.60 | 29.0 | 15.0 |

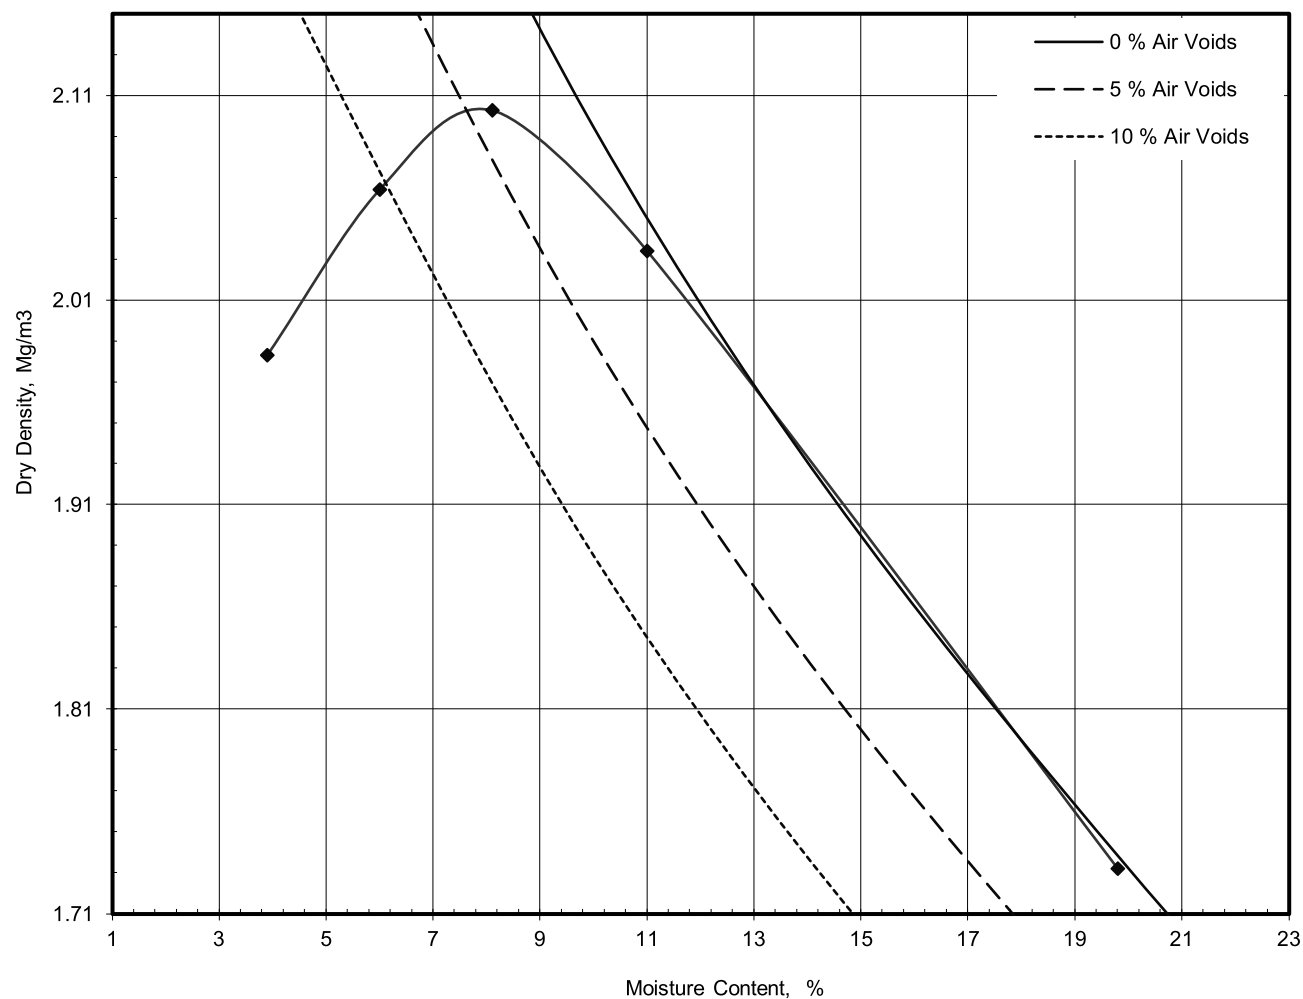
# Dry Density / Moisture Content Relationship Heavy Compaction

| Mould Type | CBR |
| Optimum Moisture Content | %8.1 |

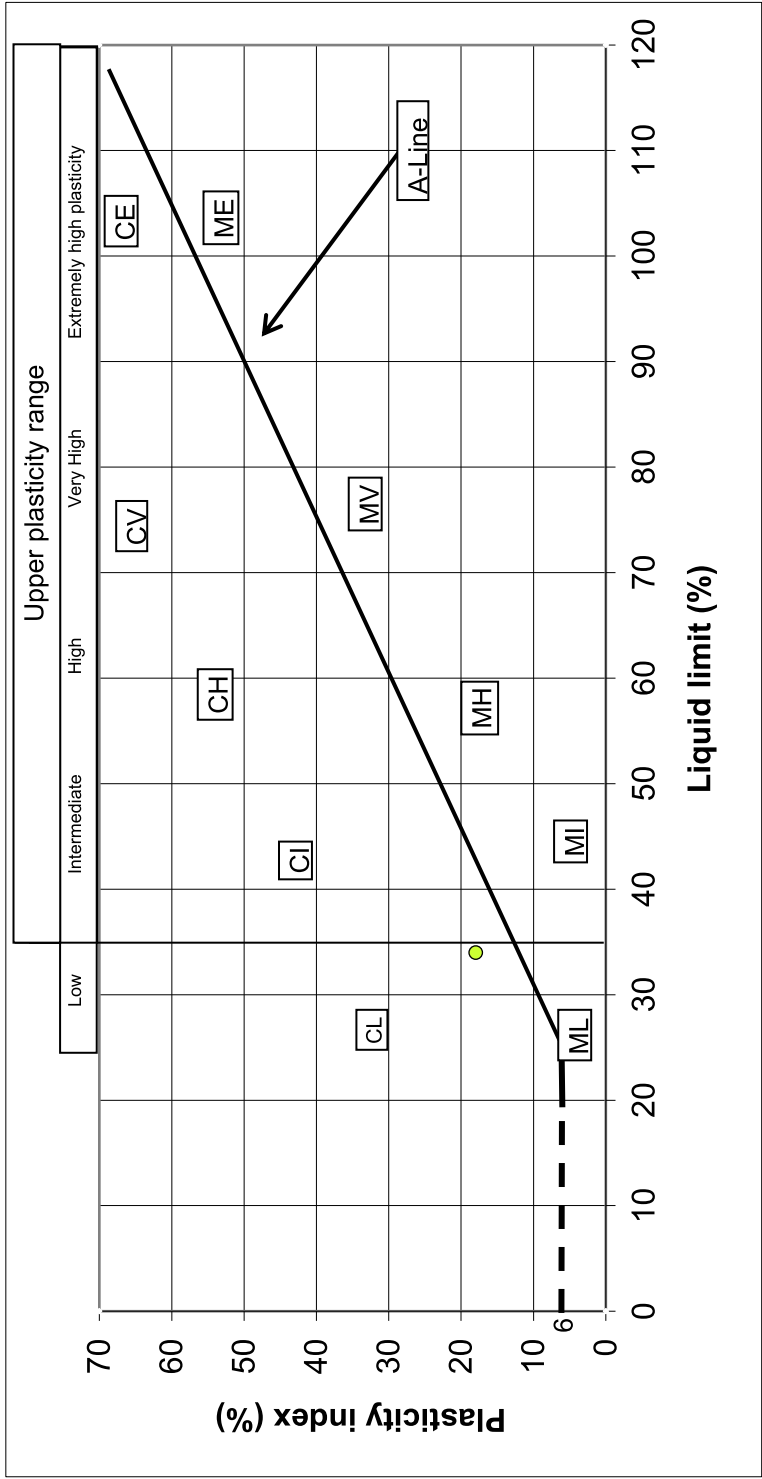
**ATTERBERG TEST RESULT SHEET**  
BS 1377:Part 2:1990:cl 4.4,5

SILT (M-SOIL), M plots below A-Line, CLAY,C, plots above A-Line, M and C may be combined as FINE SOIL, F.

| BH | Sample Depth | Liquid limit | Plasticity index |
|---|---|---|---|
| BH03 | 0.60 | 34.0 | 18.0 |

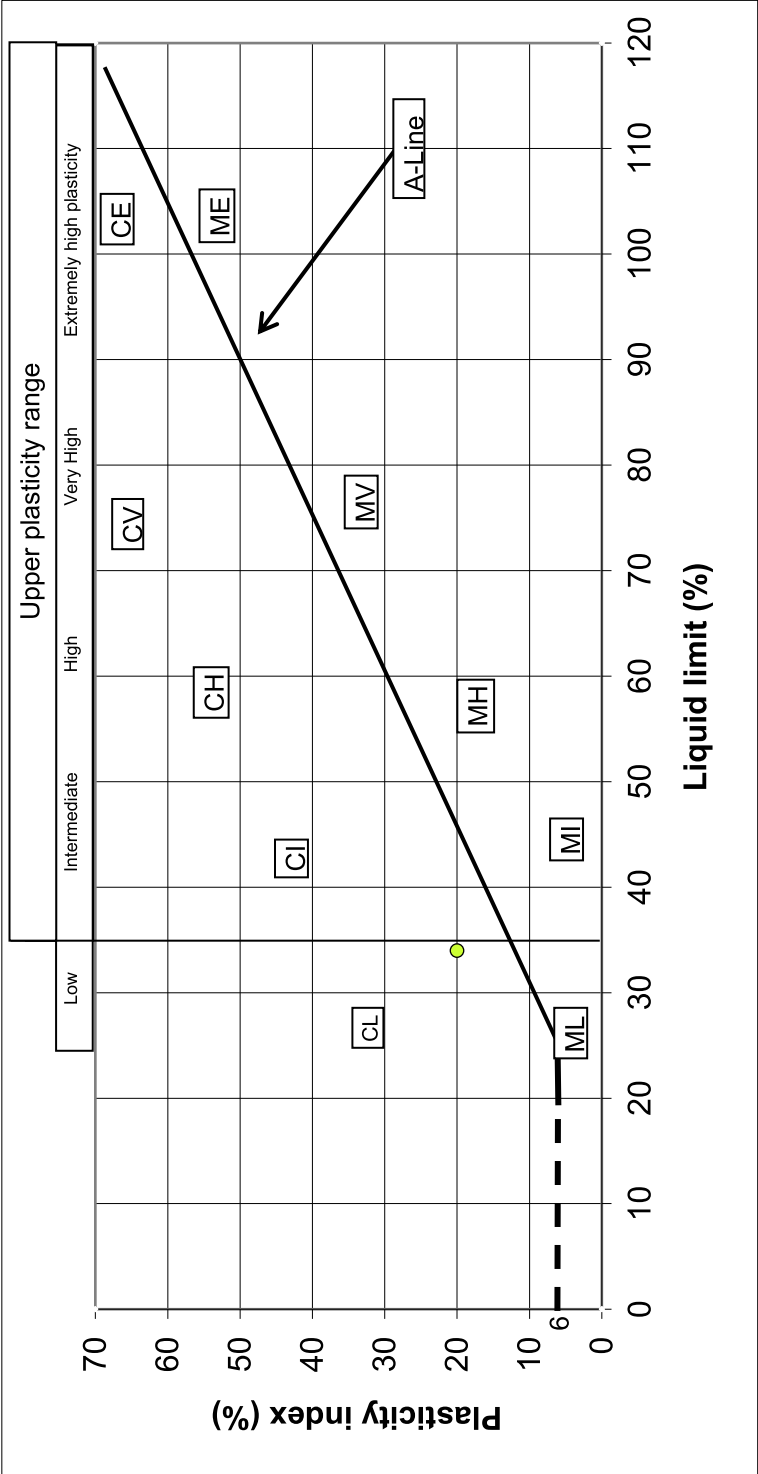
**ATTERBERG TEST RESULT SHEET**  
BS 1377:Part 2:1990:cl 4.4,5

SILT (M-SOIL), M plots below A-Line, CLAY,C, plots above A-Line, M and C may be combined as FINE SOIL, F.

| BH04 | 1.20 | 34.0 | 20.0 |

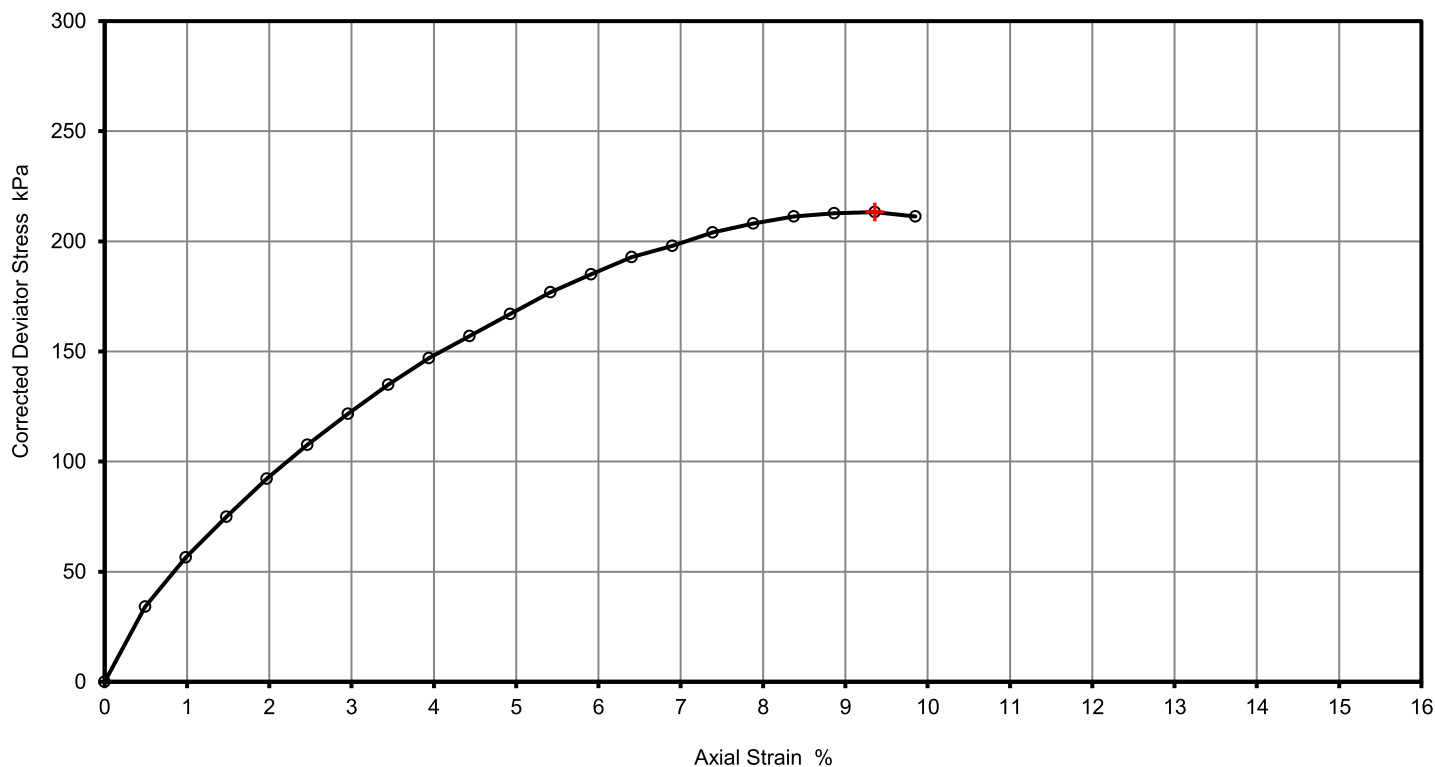
### Deviator Stress v Axial Strain

0.5mm membrane, correction factor = 1.07
