## PRA Cover Pages

Project St Michael's Place  
Subject Phase I Preliminary Risk Assessment Cover Pages  
Project no 051610  
Date 24 October 2025  
Ref 051610-BHE-XX-XX-RP-GE-0001

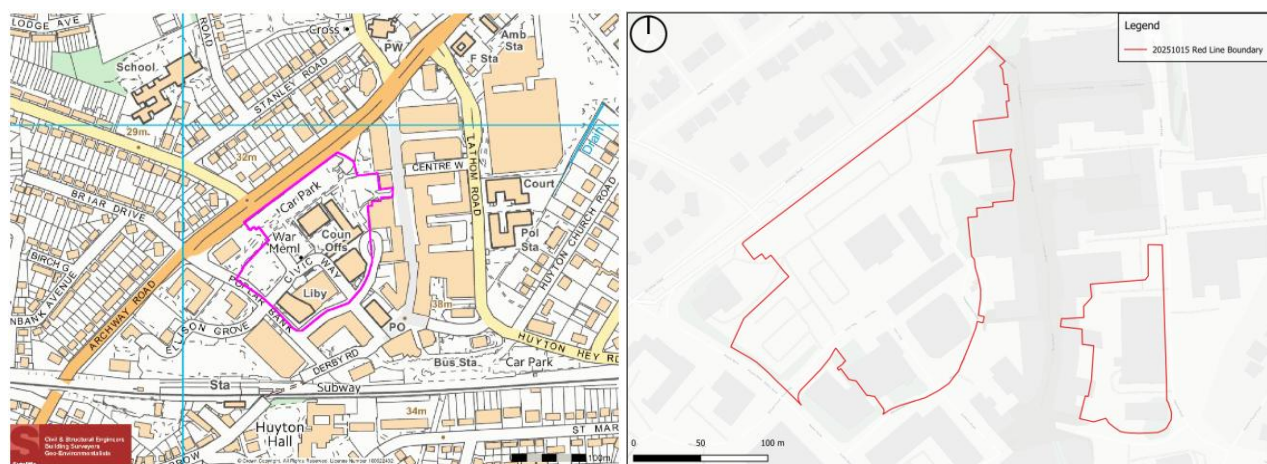
Figure 1—2: (Left) Red line boundary from the Sutcliffe PRA, and (Right) proposed to be used in the planning application

The latest red line boundary plan dated 15 October 2025 has a minor alteration to the boundary edge along the northern section of the main plot. The Lathom Road boundary remains the same.

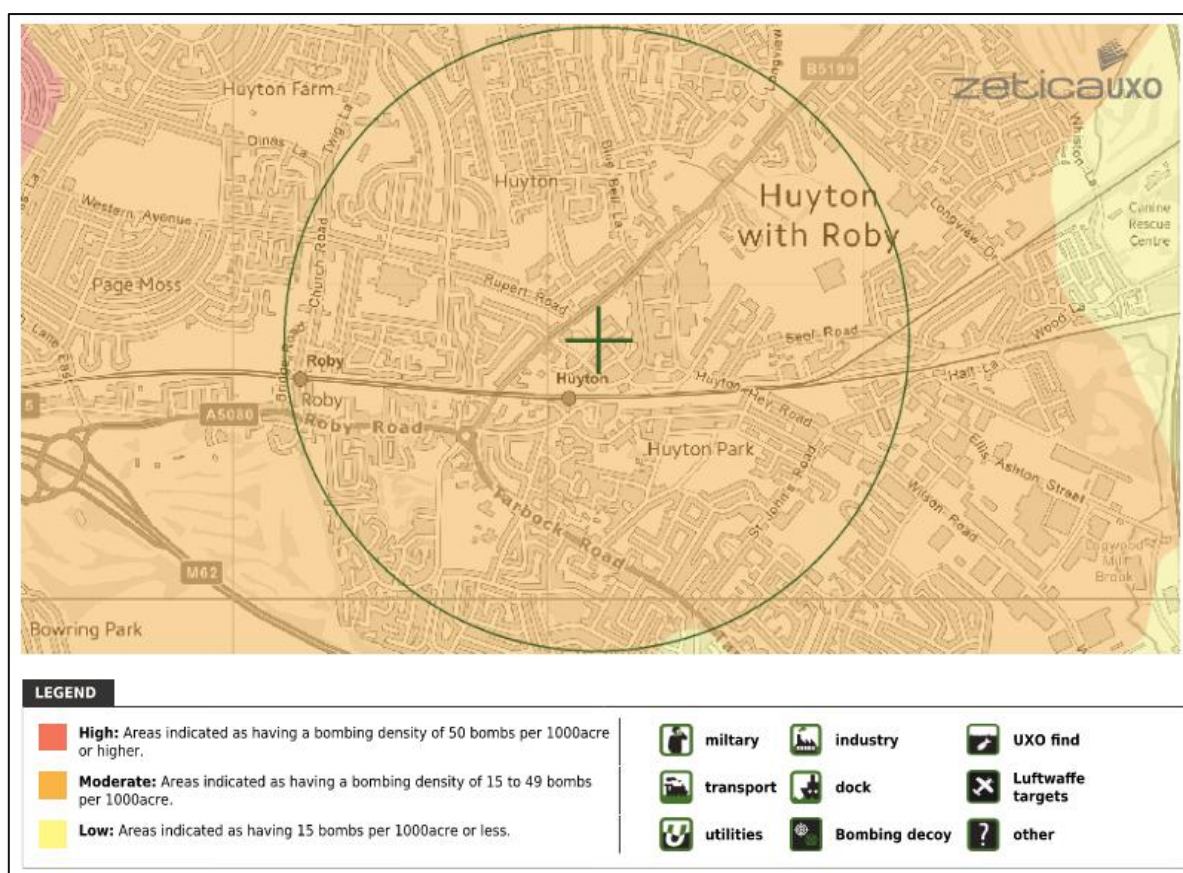
Figure 1—3: Zetica UXO risk map.

The detailed assessment concludes that the risk to the site from UXO is low to moderate: low around the edge of the site where undamaged wartime structures were present, and low-moderate in the centre of the site which was a grassy undeveloped area at the time of WWII. The assessment also considers the significant degree of post-war redevelopment across the whole site. The report recommends that UXO safety awareness briefings should be undertaken prior to all intrusive works commencing to mitigate the risk to ALARP level (as low as reasonably practicable). No further mitigation requirements for intrusive works are recommended in both low and low-moderate areas.

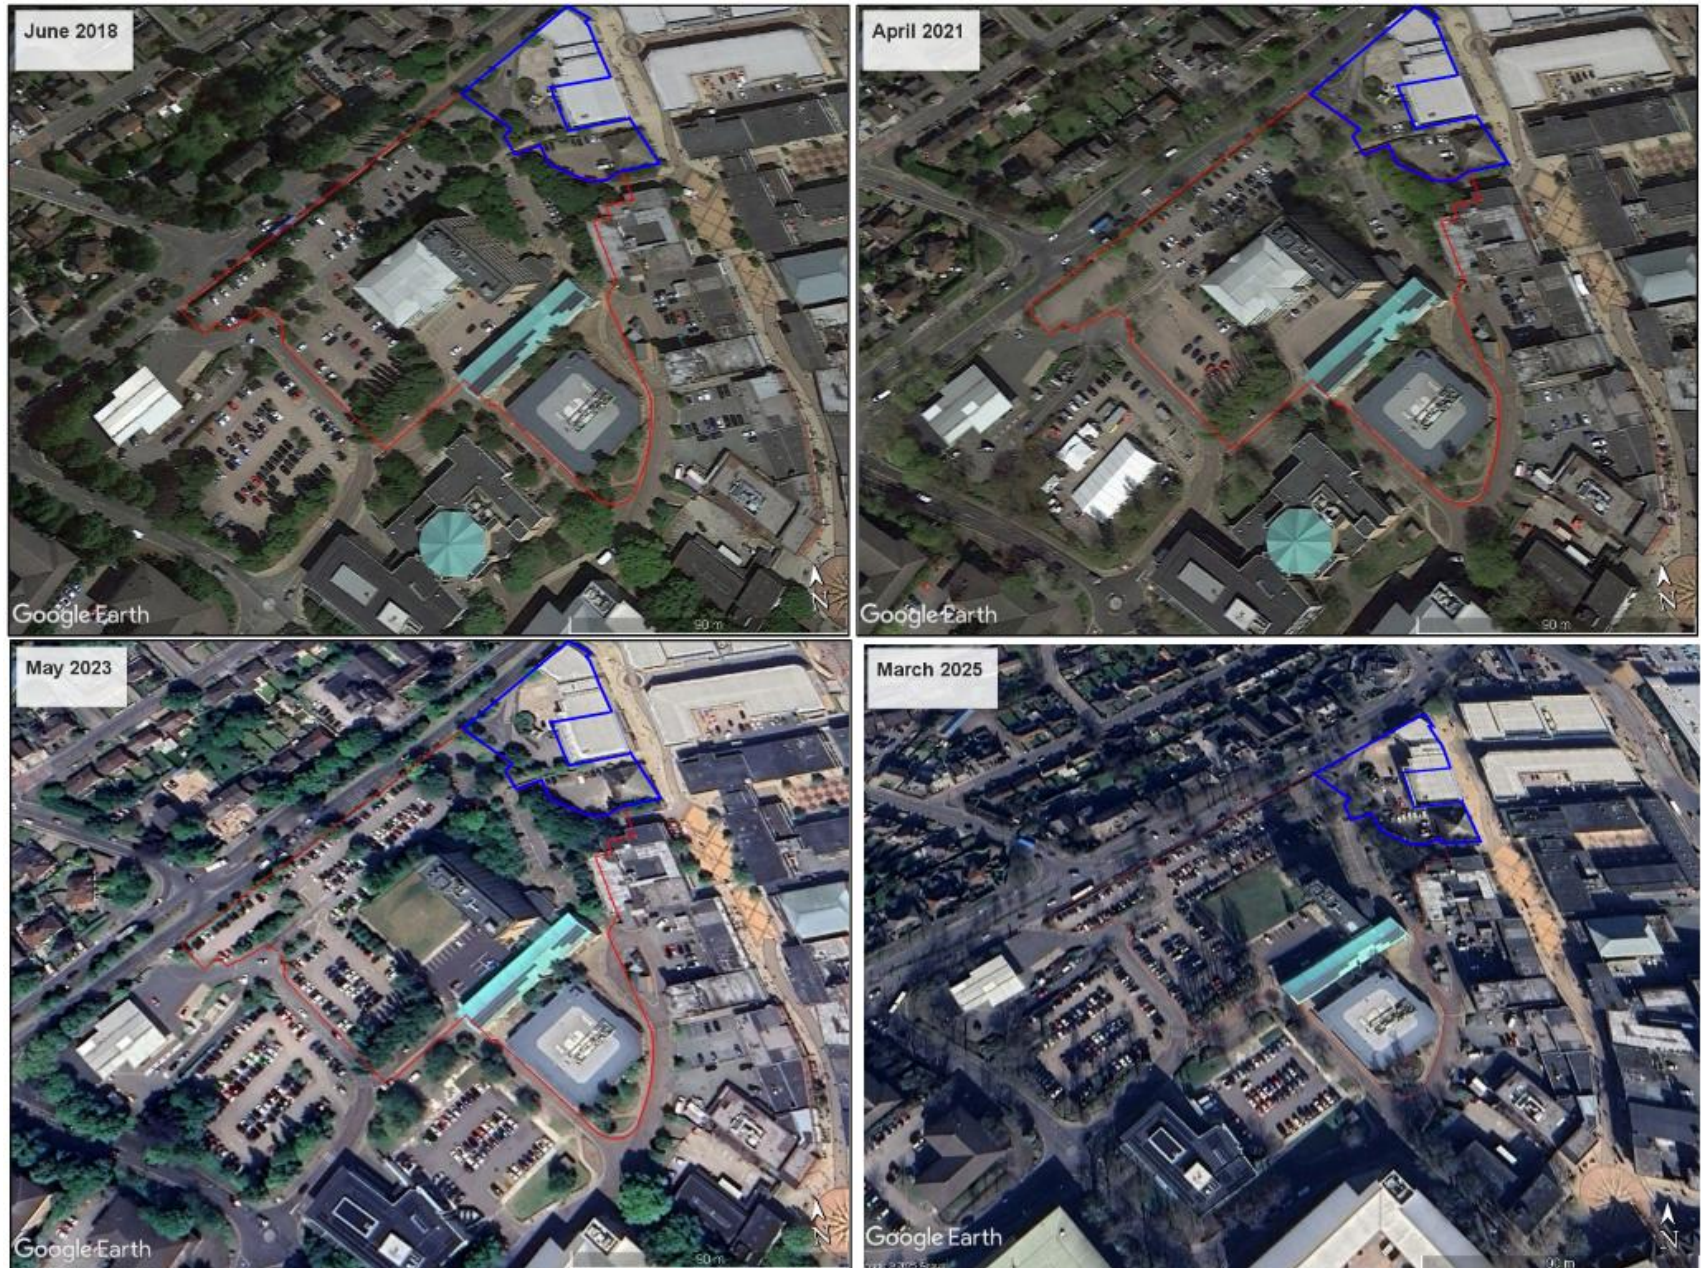
Figure 1—5: Site history between 2018 and 2025. The additional retail buildings are outlined in blue. Source: Google Earth.

- March 2022: Two buildings have been demolished and replaced with surface car parking. A number of trees to the south of one of these buildings have also been removed.

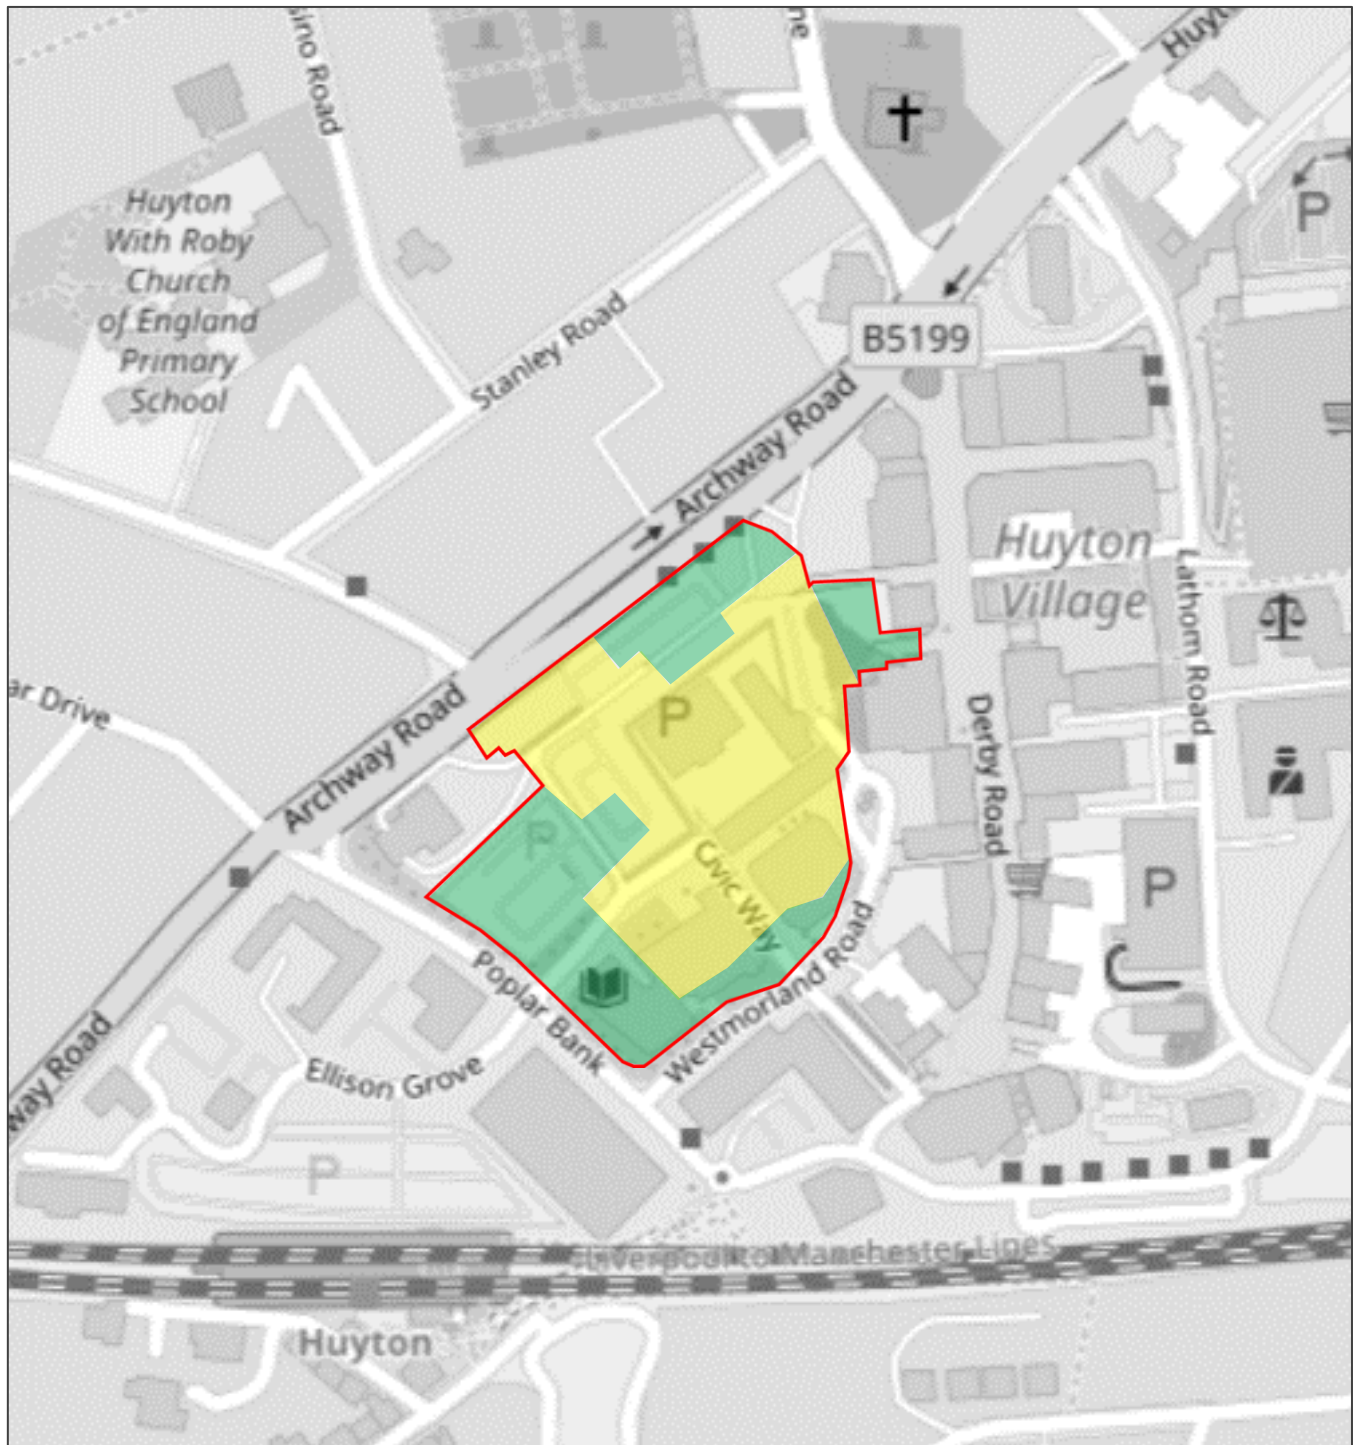
RISK MAP:

LOW risk from German UXBs and HAA shells

LOW-MODERATE risk from German UXBs and HAA shells

- In light of the abovementioned factors, the risk of encountering UXO on Site has been assessed to vary. Within locations of undamaged wartime structures, where wartime conditions are considered to be conducive to the obvious detection of UXBs, and adjacent well-kept garden areas, the risk has been assessed as **Low**. However, given the concentration of incidents in the wider study area, as the centre of the Site consisted of undeveloped ground, wherein conditions present could have feasibly resulted in a UXB strike falling unnoticed i.e. overgrown vegetation, a **Low-Moderate** risk of encountering UXO has been assessed. A 15m J-curve buffer has been included in the **Low-Moderate** zone.

- Note, the well-maintained nature of the **Low-Moderate** zone, as evidenced in the aerial photography, means that a likelihood of encountering UXBs is not considered significantly elevated, although a UXO Safety Awareness Briefing prior to works commencing is recommended. This variation in risk has been presented in the form of a risk map; see **FIGURE 9**.

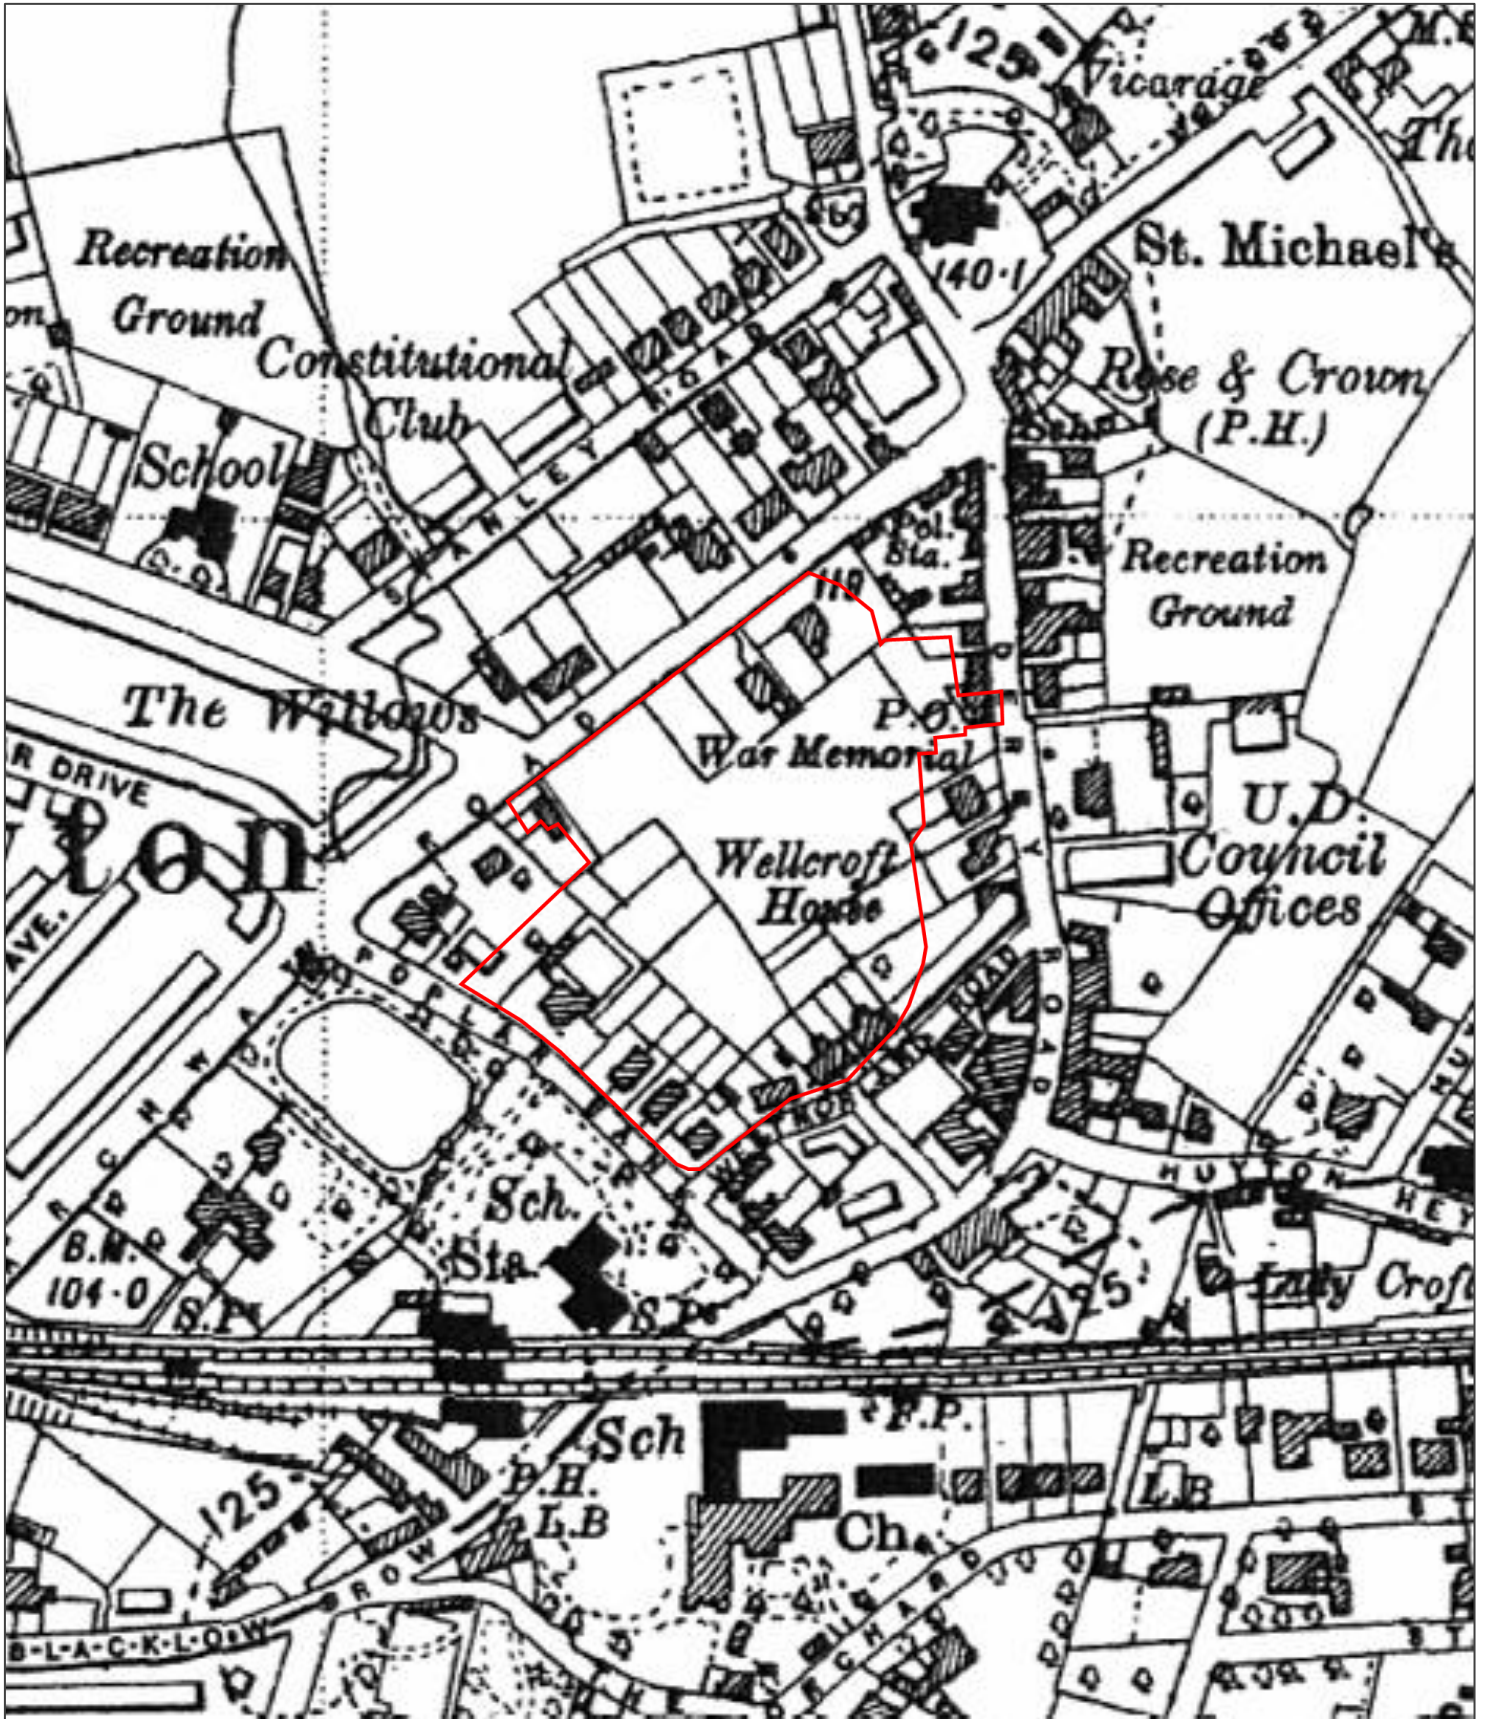
FIGURE: 4.1

Historical OS Mapping – 1938

| Period | Map Date | Map Scale | Review |
|---|---|---|---|
| Pre-WWII | 1938 | 1:10,560 | <b>FIGURE 4.1:</b> Although this map is of small scale and lacks detail, it can be said that no significant changes have occurred on Site. |

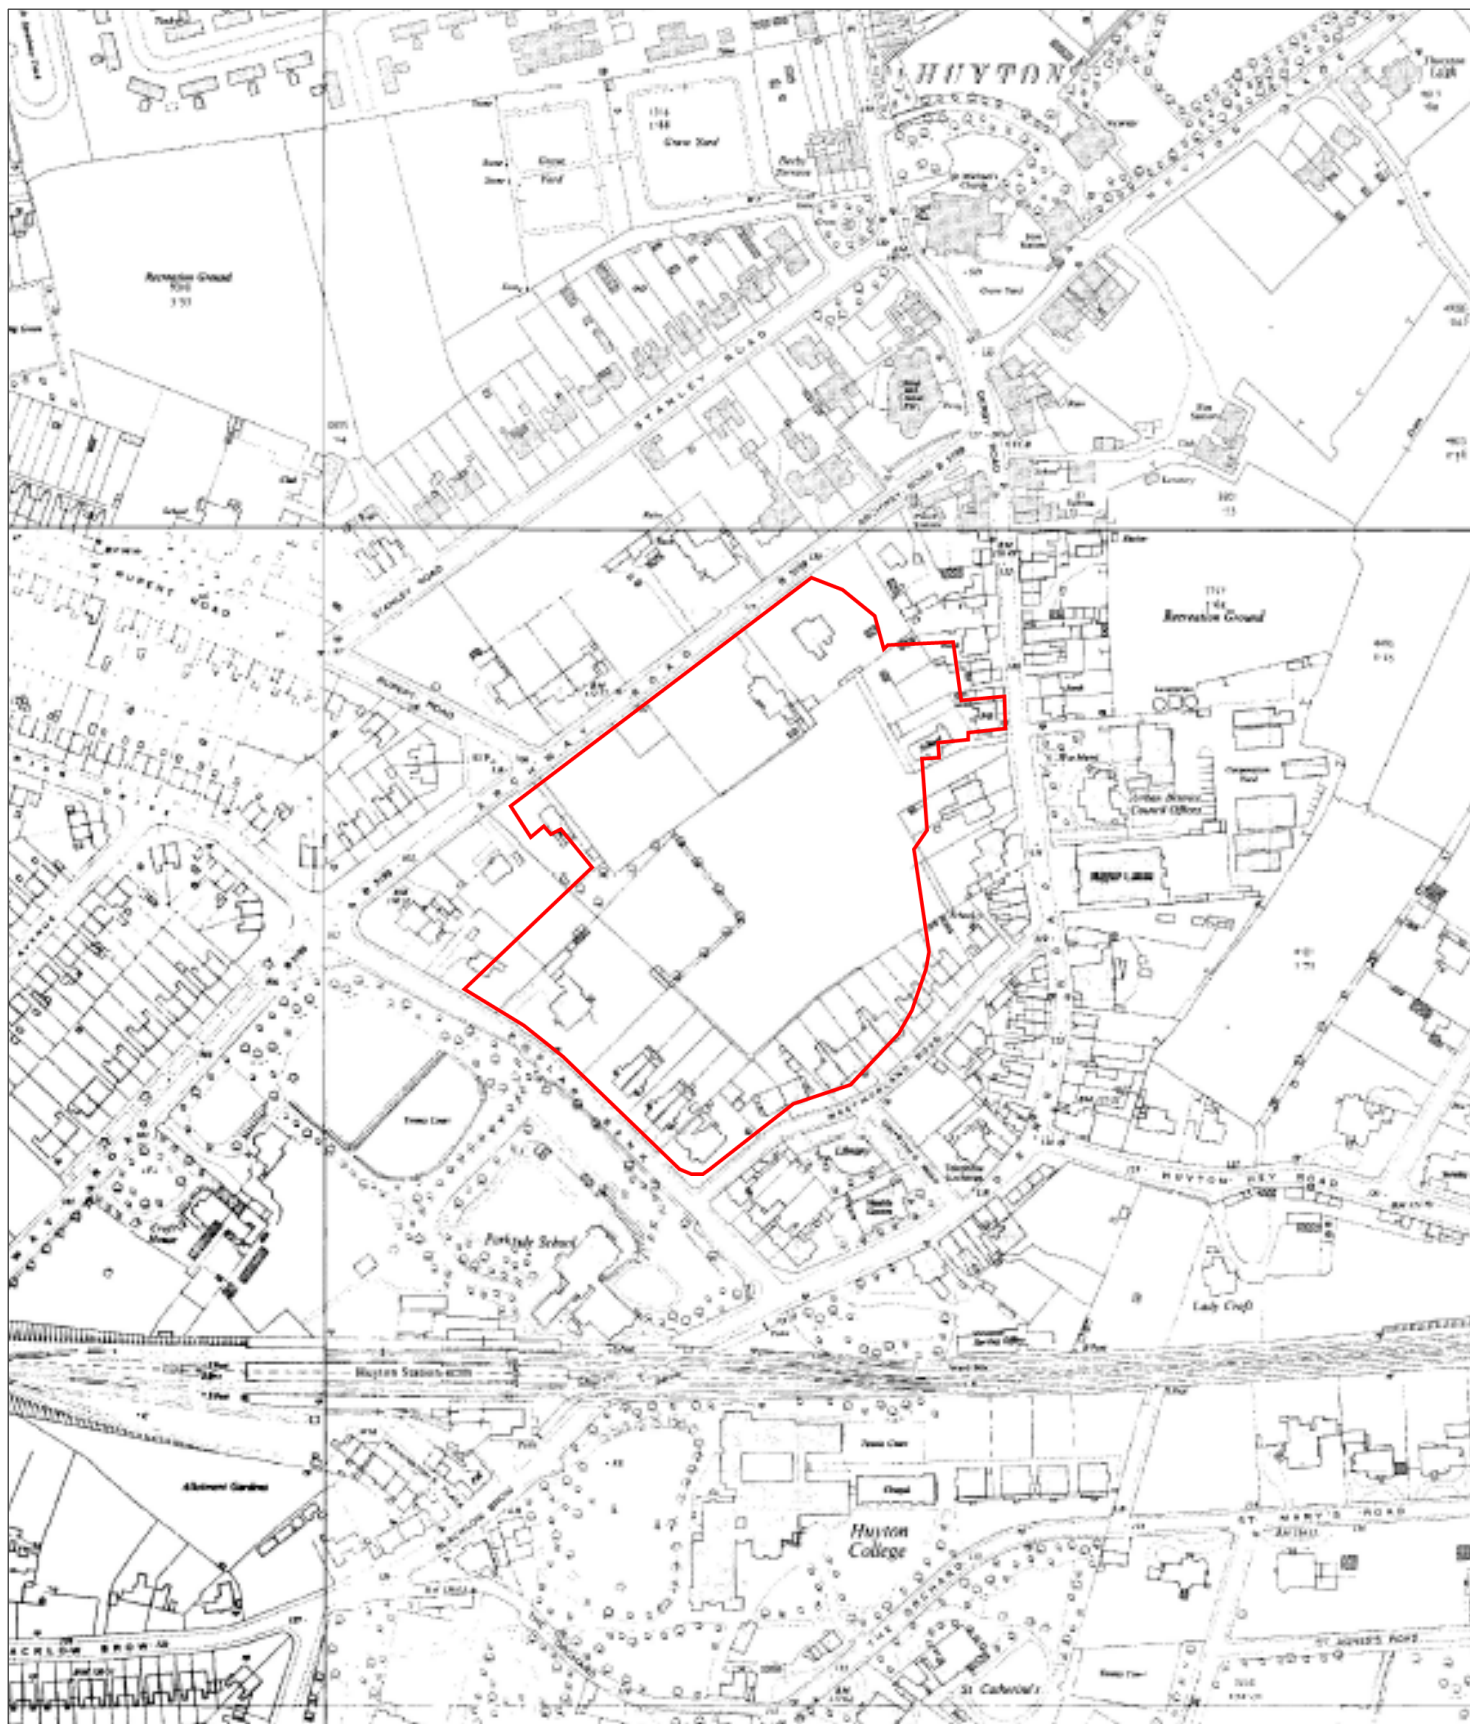
FIGURE: 4.2

Historical OS Mapping – 1952-1953

| Period | Map Date | Map Scale | Review |
|---|---|---|---|
| Post-WWII | 1952-1953 | 1:2,500 | <b>FIGURE 4.2:</b> No significant changes have occurred on Site.<br>Further residential structures were developed in the south-east to the Site. |

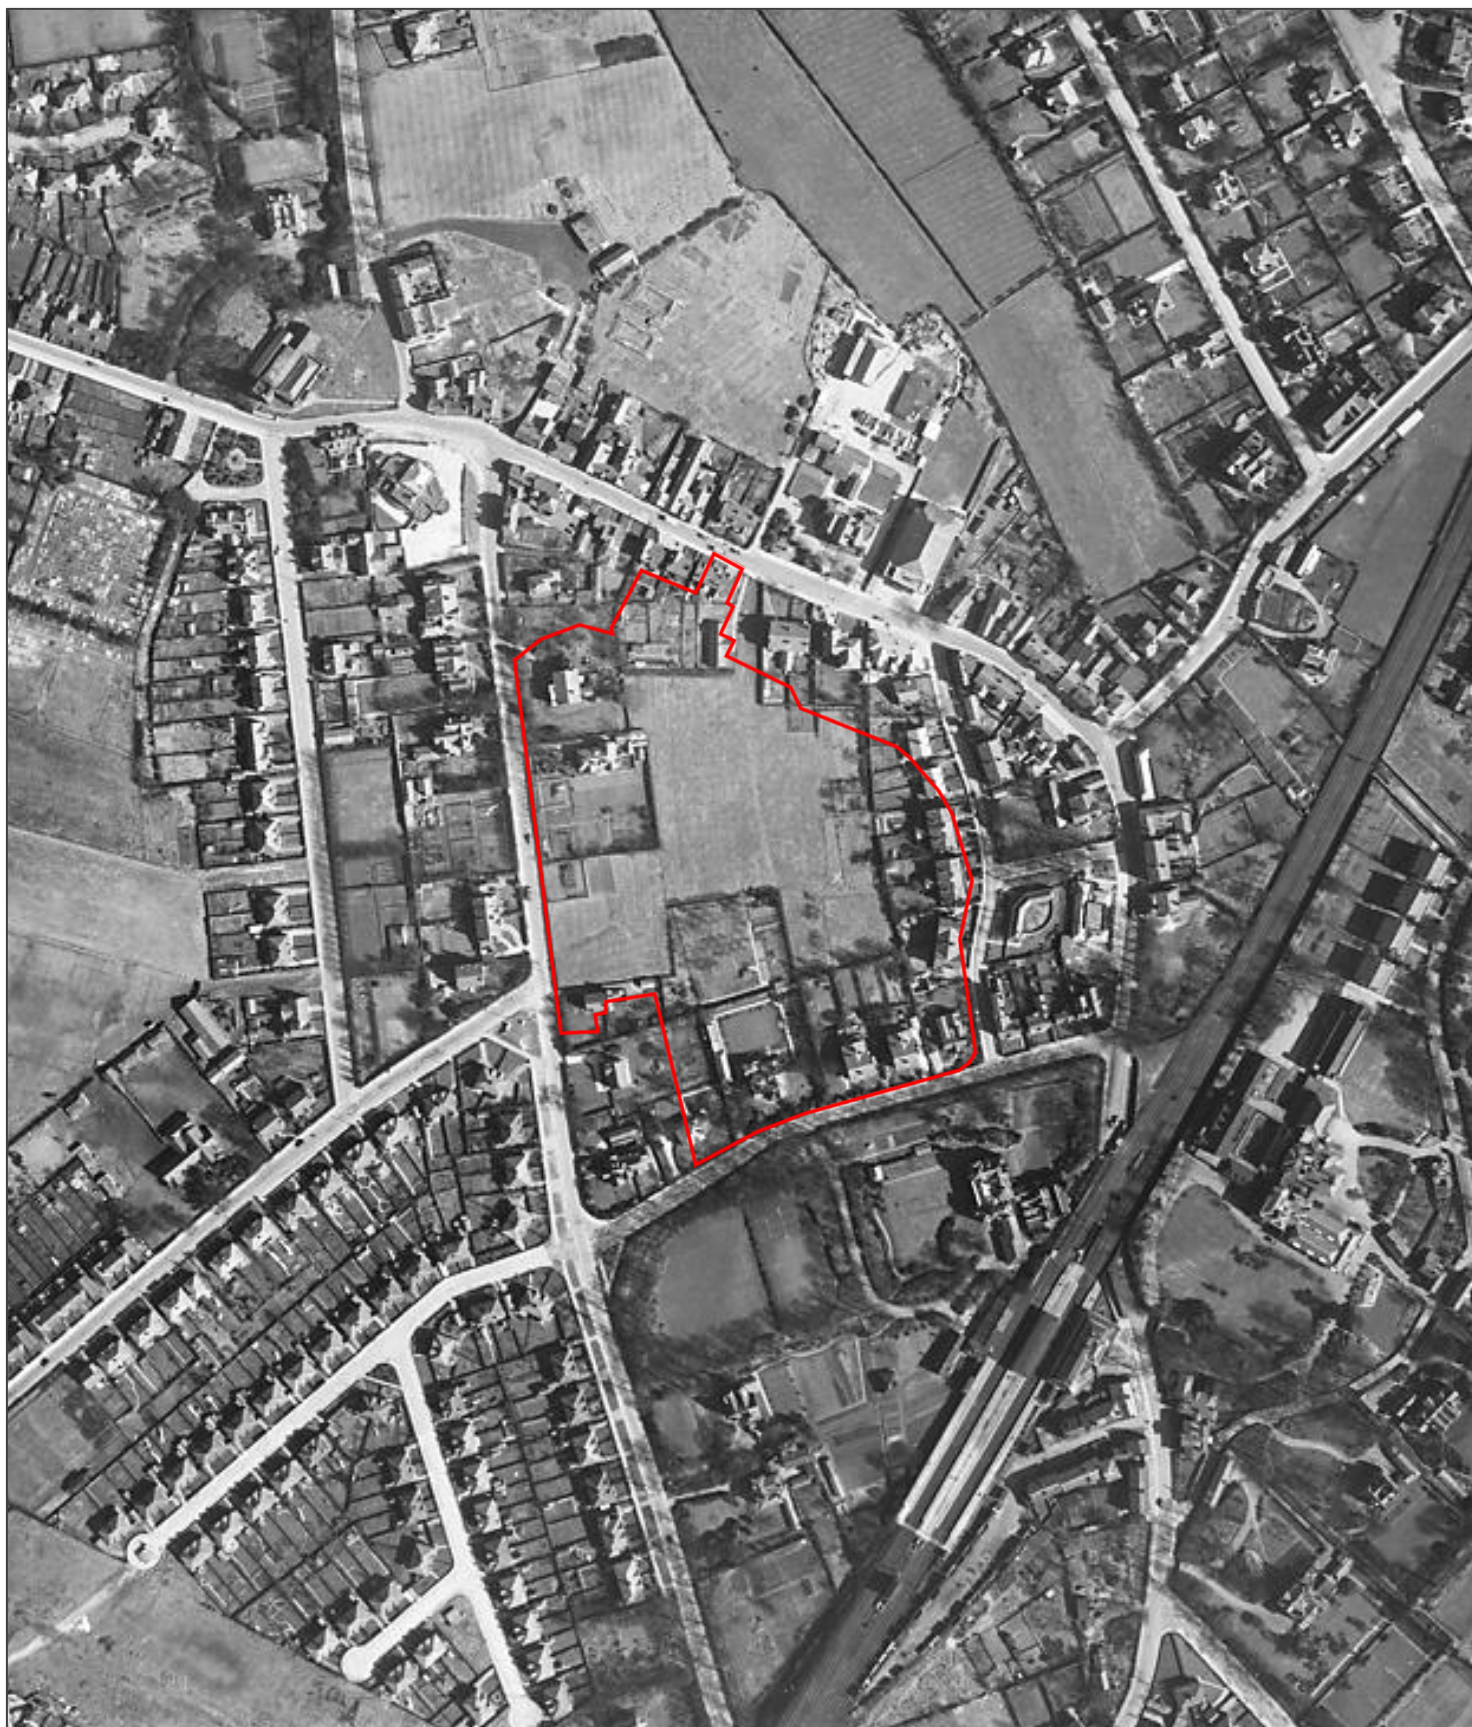
FIGURE: 5.1

Historical Aerial Photography – 26th March 1946

| Period | Photo Date | Review |
|---|---|---|
| Pre-WWII | 26 <sup>th</sup> March 1946 | <b>FIGURE 5.1:</b> This photograph was taken approximately one year after the end of WWII. No immediately obvious damage can be seen to the structures on or nearby the Site. The undeveloped ground occupying the Site appears to have been well maintained with no ground disturbances visible. |

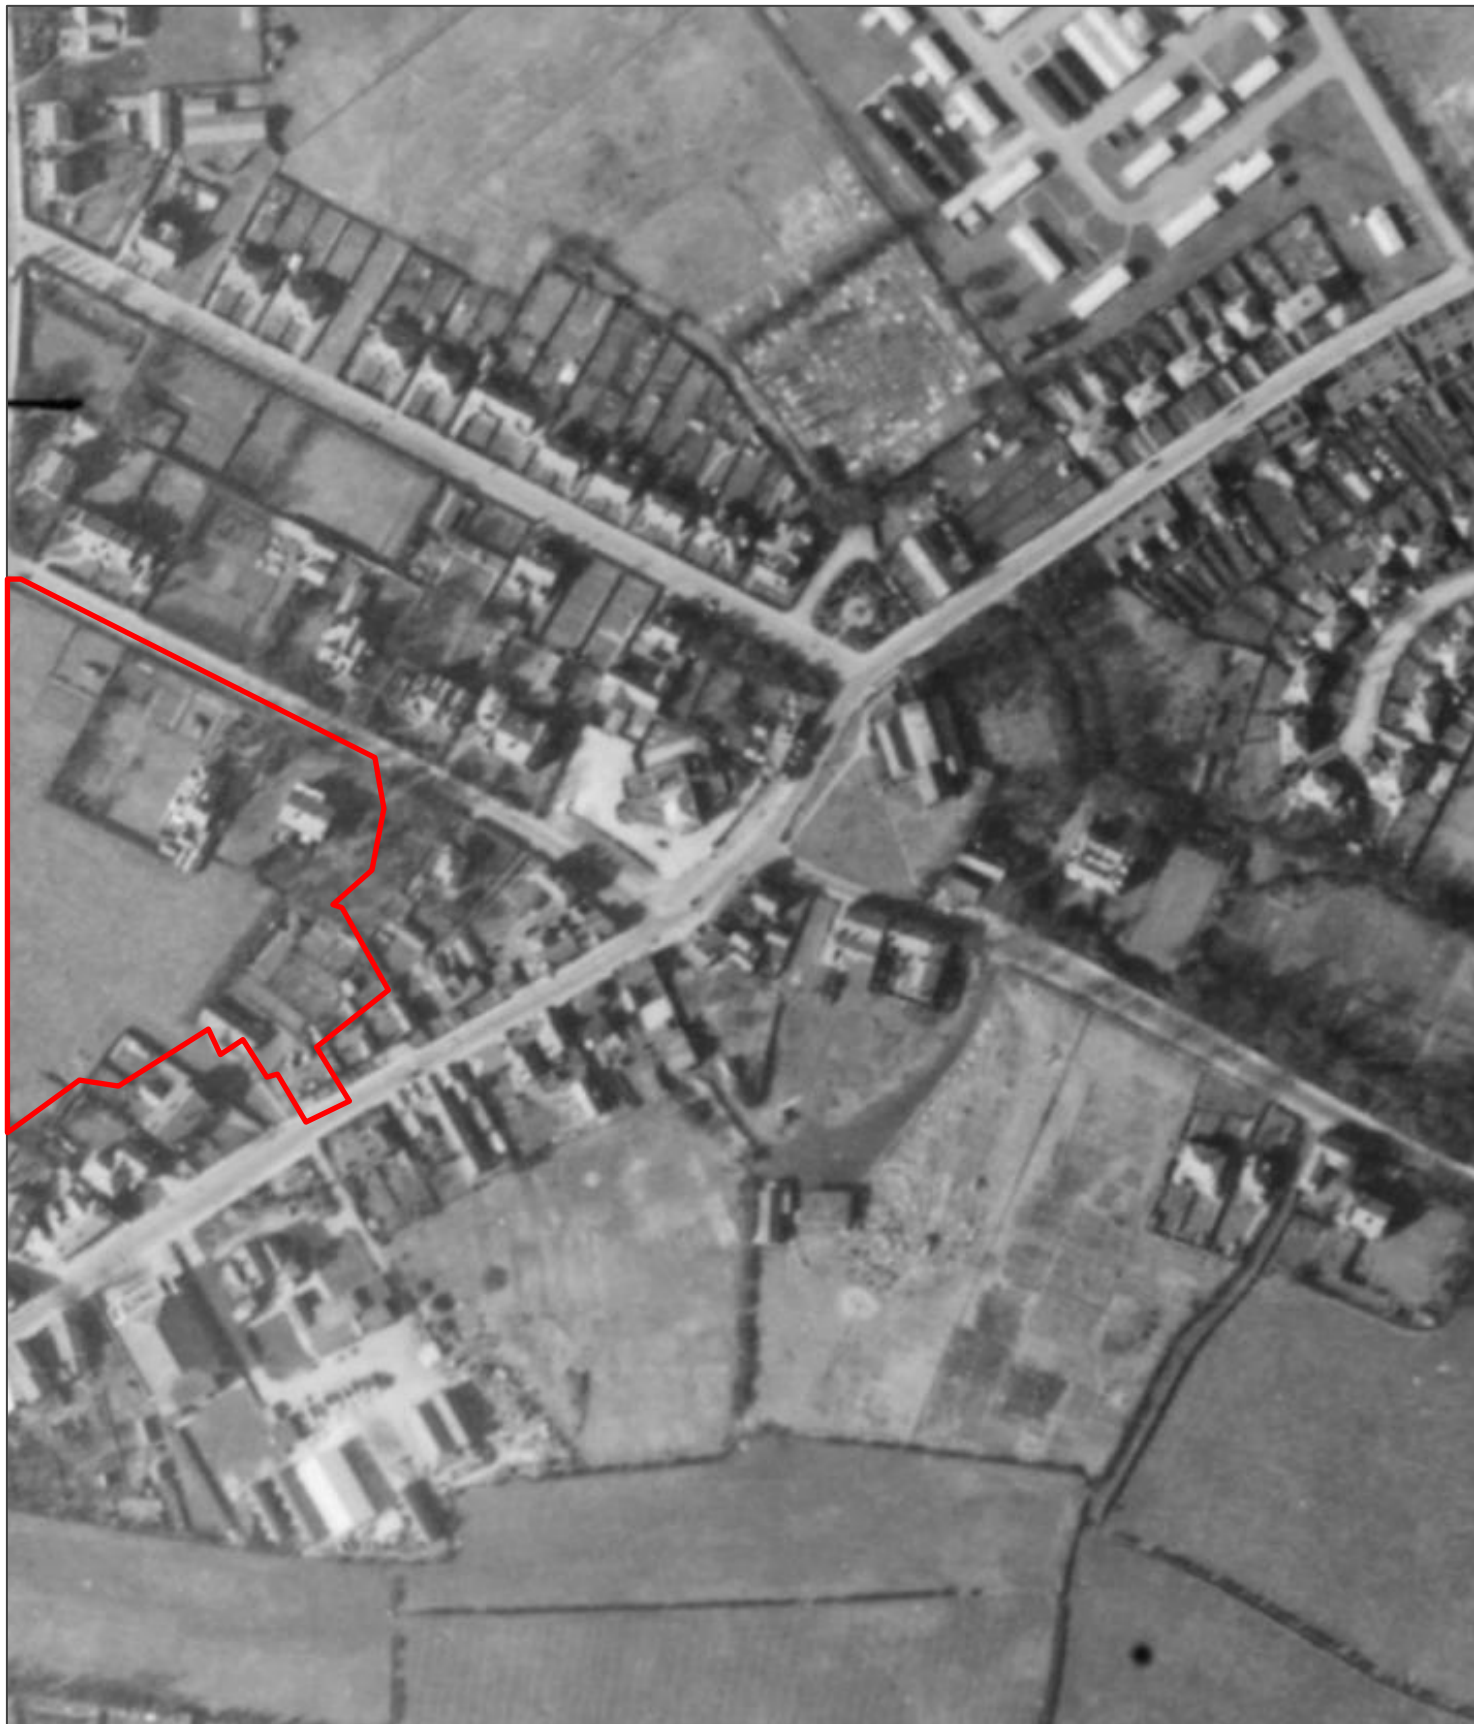
FIGURE: 5.2

Historical Aerial Photography – 9<sup>th</sup> March 1948

- Although post-WWII aerial photography does not display any immediately obvious evidence of bomb damage occurring on Site, the image consulted only displays the northern extent of the Site. Therefore, it has not been possible to determine whether the southern extent sustained damage. High-resolution aerial photography of the Site area will be required in order to establish this.

| Period | Photo Date | Review |
|---|---|---|
| Post-WWII | 9 <sup>th</sup> March 1948 | <b>FIGURE 5.2:</b> This photograph was taken three years after the end of WWII and only covers the northern section of the Site. No immediately obvious damage / ground disturbances are visible to the structures and undeveloped but well-maintained ground on Site. The same can be said about the surrounding structures and nearby roads. |

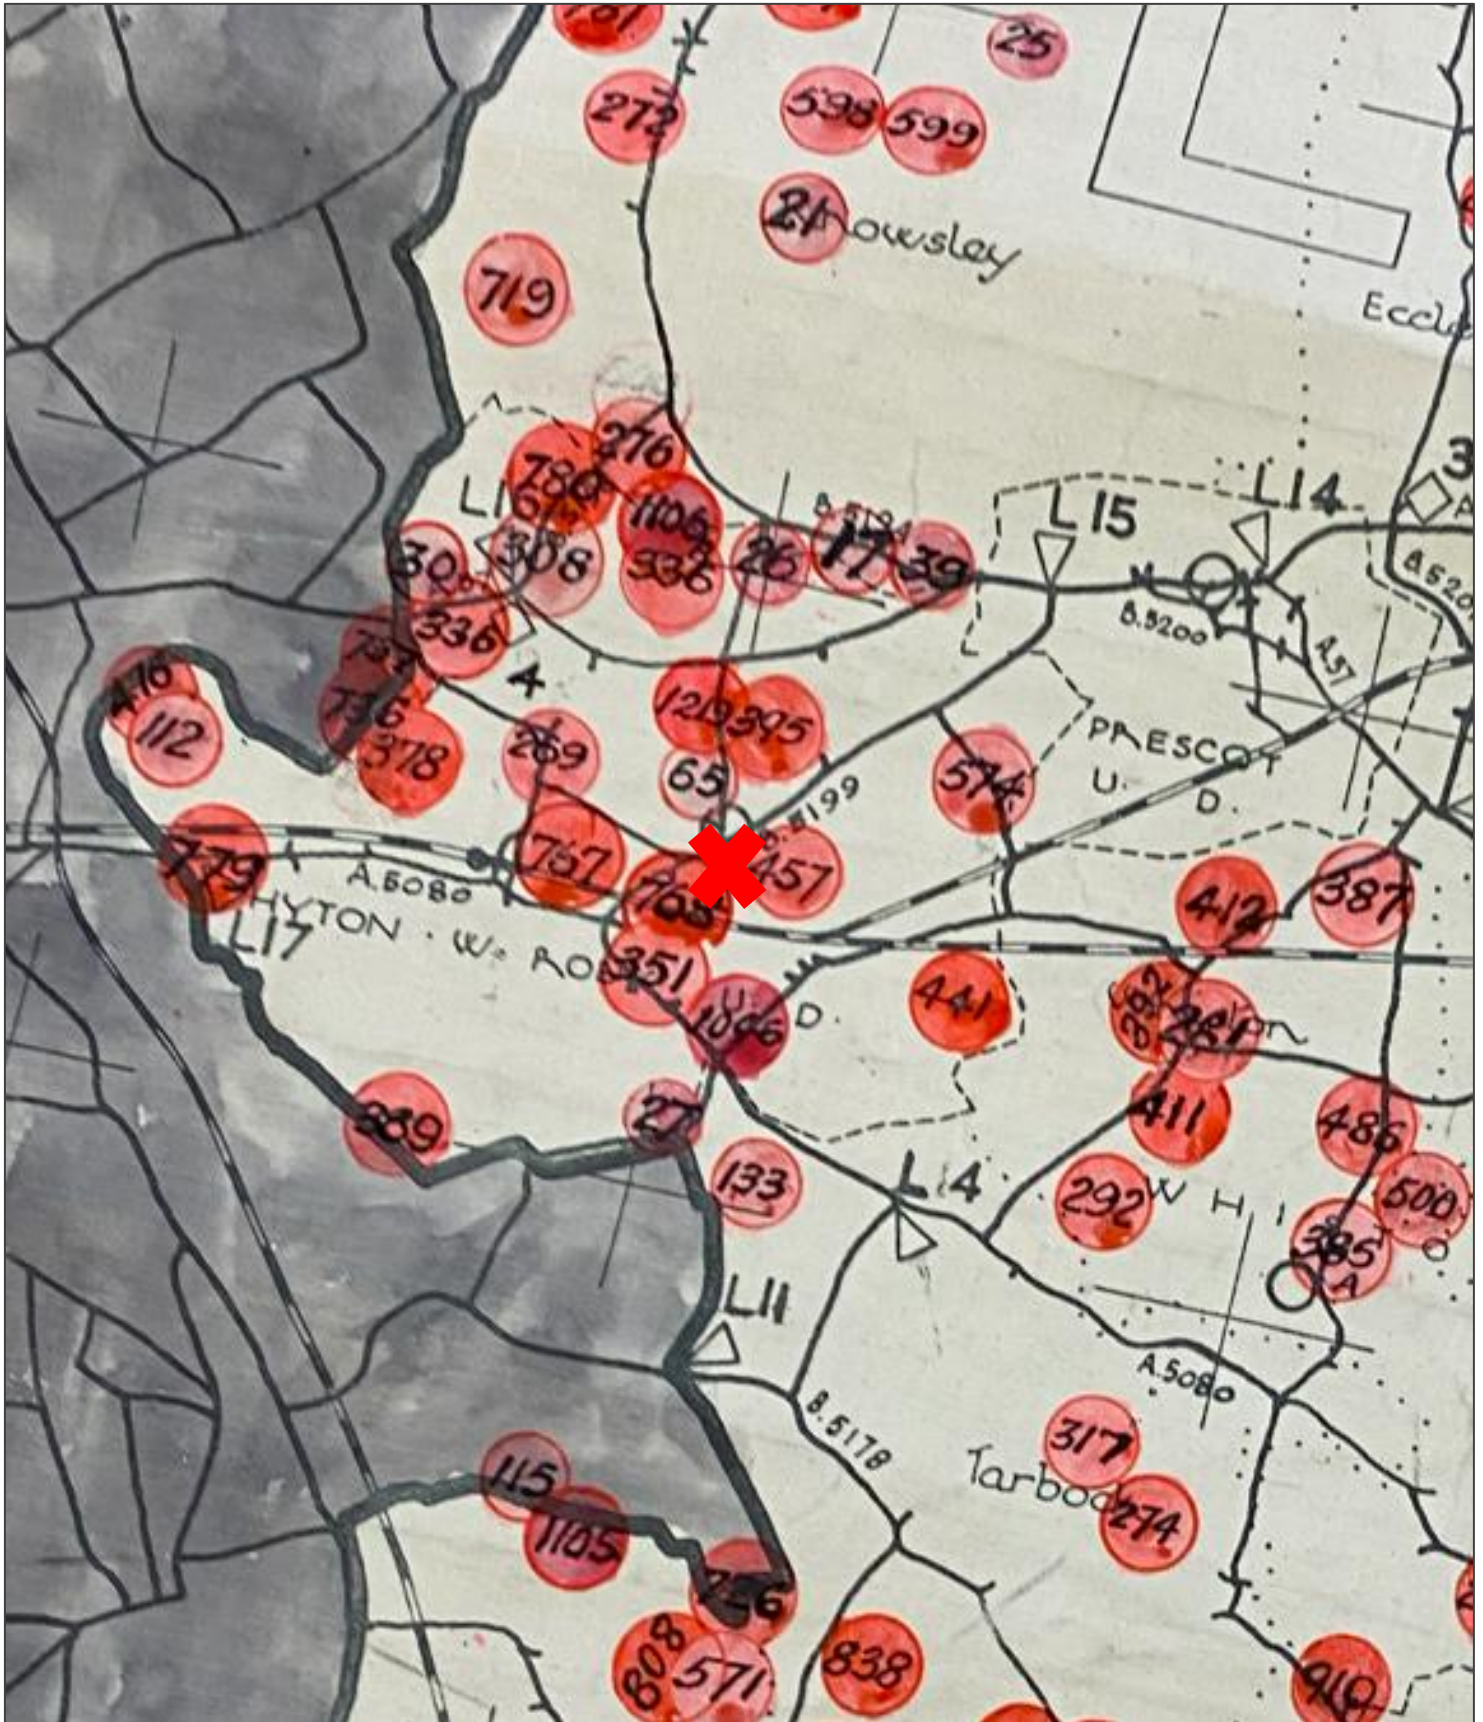
FIGURE: 6

Lancashire ARP Bomb Map

| | | Evidence of Bomb Strikes / Damage | An ARP bomb map for Lancashire records numerous incidents in proximity to the Site footprint, including one potentially on Site. However, this map is of a small scale and therefore, the precise locations of bombing incidents cannot be discerned at a preliminary stage. Consultation of written records will be required to establish whether any of the local incidents occurred within / adjacent to the Site area.<br>An in-house geodata set plotting incidents on Merseyside records an incident approximately 55m south-east of the Site at Huyton Telephone Exchange on Derby Road, occurring on 9/10 <sup>th</sup> January 1941; no further details were provided.<br>Post-WWII aerial photography displaying the northern extent of the Site footprint does not display any immediately obvious evidence of bomb damage occurring i.e. structural clearance, cratering. However, it has not been possible to analyse the southern extent of the Site for evidence of damage at this stage due to a lack of suitable resources, namely aerial photography. |

Brimstone has reviewed a countywide map for WWII-era Lancashire, held at Lancashire Archives. This small-scale map covers all boroughs / districts throughout the WWII-era county aside from County Boroughs and relates to a set of written ARP incident records (discussed in the following section). Each plot point on the map is thought to represent one incident; due to the size of the plot point, the precise location of each incident is not discernible. A relevant section of the map is displayed at **FIGURE 6**.

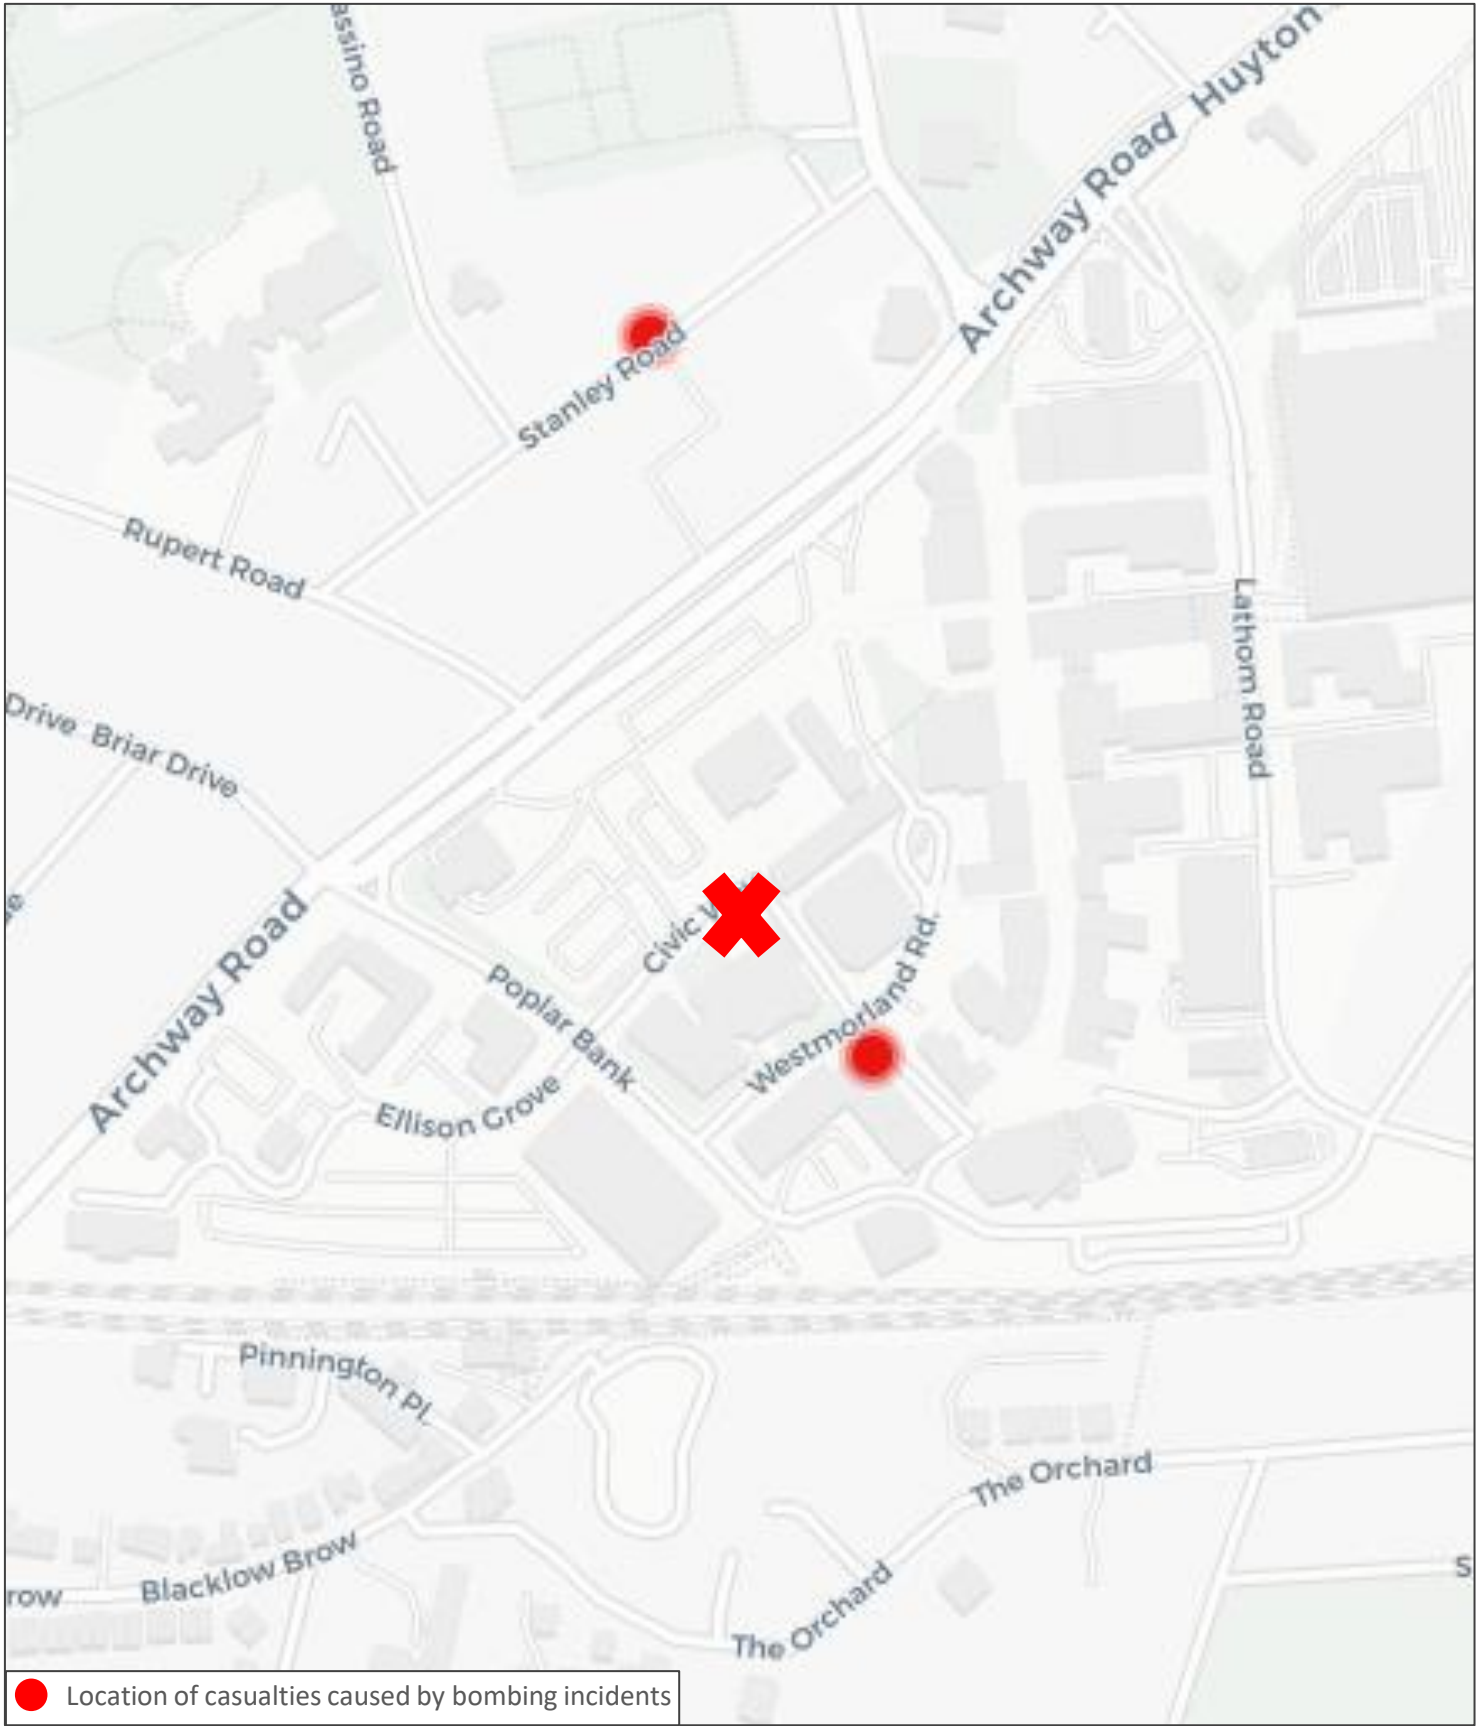
FIGURE: 8

Liverpool Echo Casualties Map

Brimstone has reviewed a contemporary map of Liverpool recording the locations of bombing incidents that resulted in at least one fatality, recently published by the Liverpool Echo and presented in **FIGURE 8**. This map was compiled using data from the Commonwealth War Graves Commission.
