## PRA Cover Pages

Project St Michael's Place  
Subject Phase I Preliminary Risk Assessment Cover Pages  
Project no 051610  
Date 24 October 2025  
Ref 051610-BHE-XX-XX-RP-GE-0001

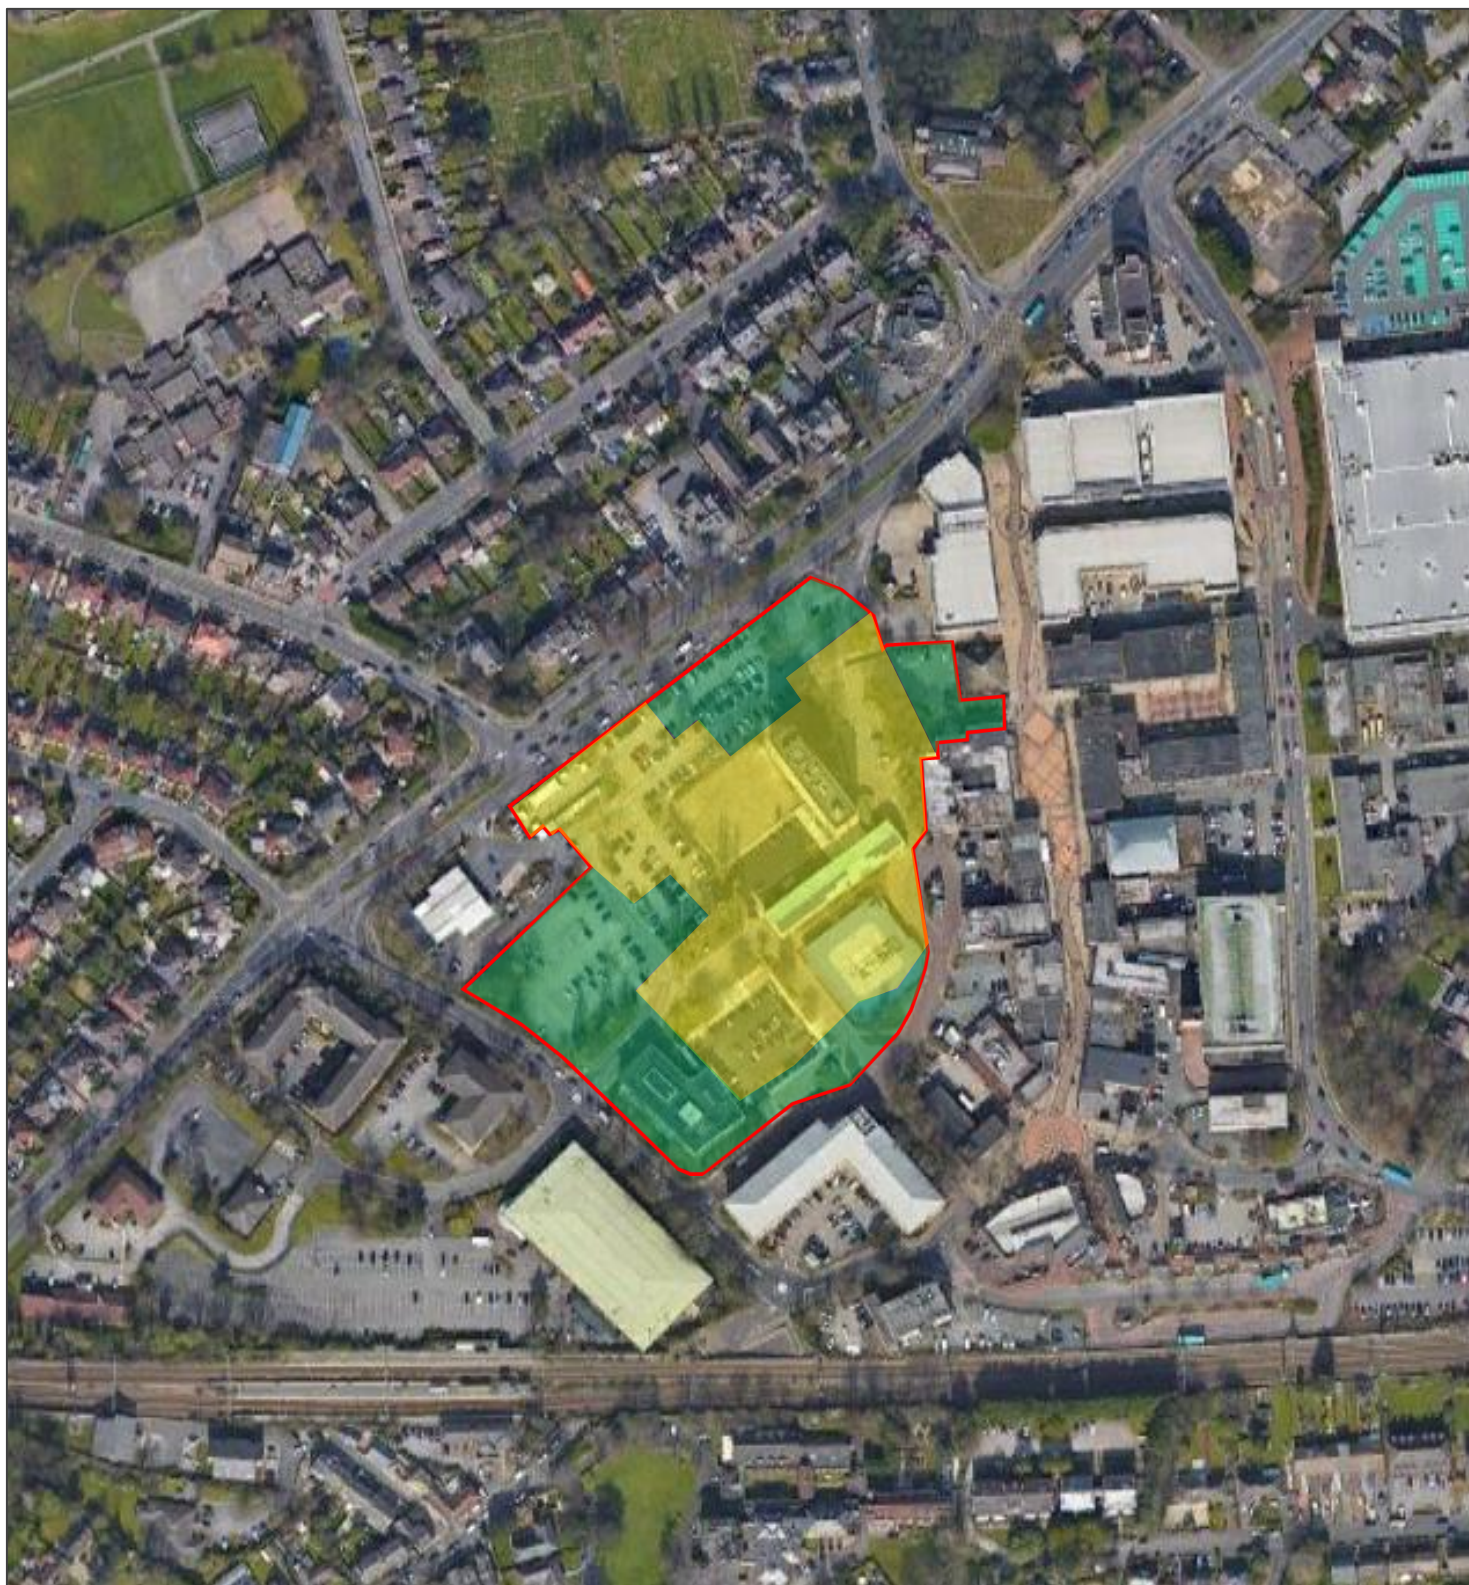
FIGURE: 9.1

**LOW** likelihood of a UXO encounter - L

**LOW-MODERATE** likelihood of a UXO encounter - LM

- Note, the well-maintained nature of the **Low-Moderate** zone, as evidenced in the aerial photography, means that a likelihood of encountering UXBs is not considered significantly elevated, although a UXO Safety Awareness Briefing prior to works commencing is recommended. This variation in risk has been presented in the form of a risk map; see **FIGURE 9**.

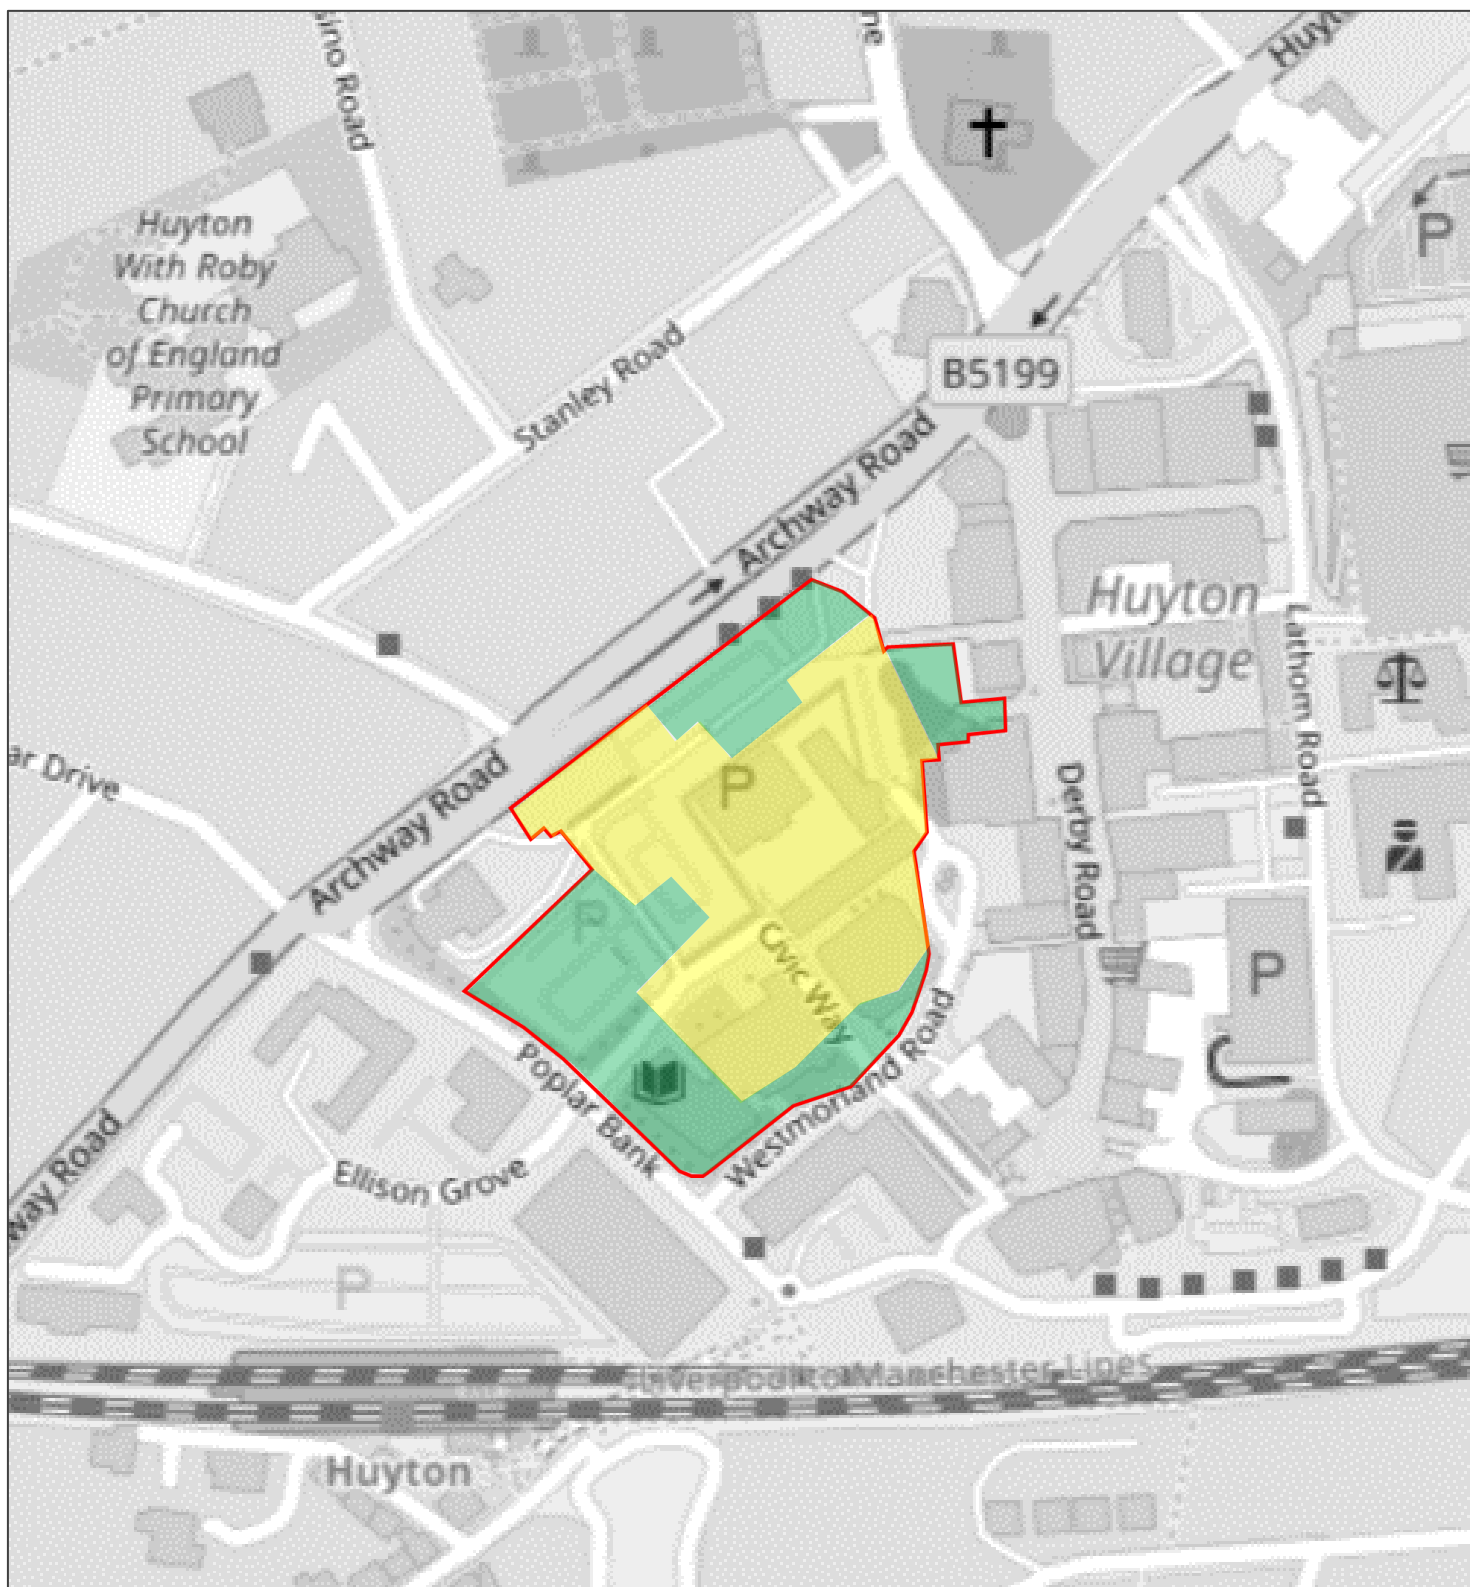
FIGURE: 9.2

**LOW** risk from German and HAA shells

**LOW-MODERATE** risk from German and HAA shells

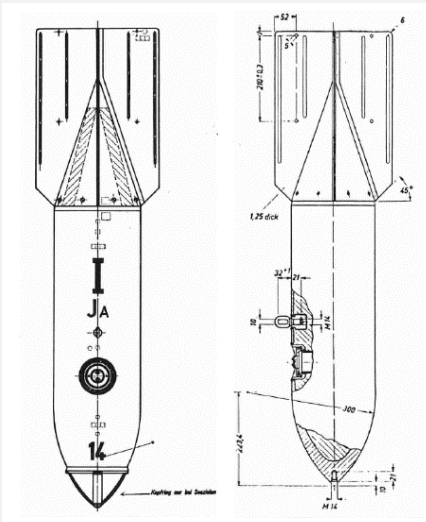
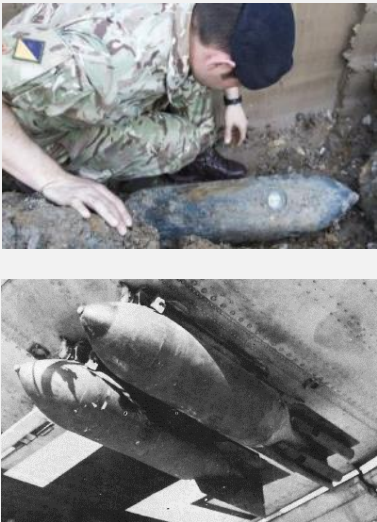
SC 50

**Bomb Weight:** 40-54kg (110-119lb)  
**Explosive Weight:** 25kg (55lb)  
**Filling:** TNT, Amatol or Trialen  
**Charge/Weight Ratio:** 46%  
**Fuse Type:** Electrical impact fuse or mechanical delayed action fuse  
**Body Dimensions:** 1,100mm length x 200mm diameter  
**Appearance:** Bomb body and tail painted grey/green with a yellow stripe on the tail unit. Steel construction.  
**Variants:** 8 x variants. Additional fittings: Kopfring nose for limited penetration and Stabbo nose for dive-bombing.

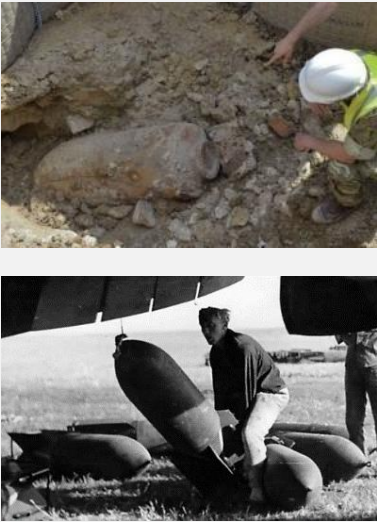
SC 250

**Bomb Weight:** 245-256kg (540-564lb)  
**Explosive Weight:** 125-130kg (276-287lb)  
**Filling:** TNT, Amatol and Trialen mix  
**Charge/Weight Ratio:** 44%  
**Fuse Type:** 1 or 2 electrical impact fuse(s) or mechanical delayed action fuse(s)  
**Body Dimensions:** 1,173mm length x 368mm diameter  
**Appearance:** Bomb body and tail painted grey/green with a yellow stripe on the tail unit. Steel construction.  
**Variants:** 8 x variants. Kopfring nose for limited penetration. Stabbo nose for dive-bombing.

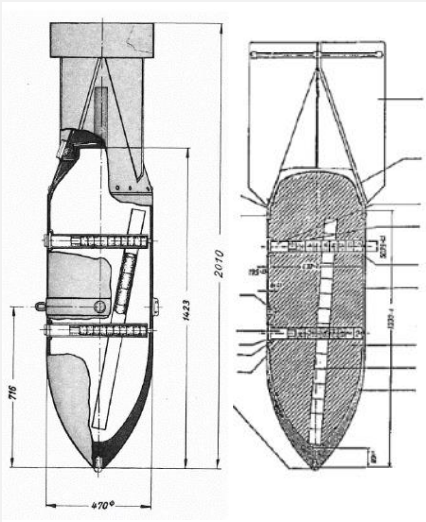
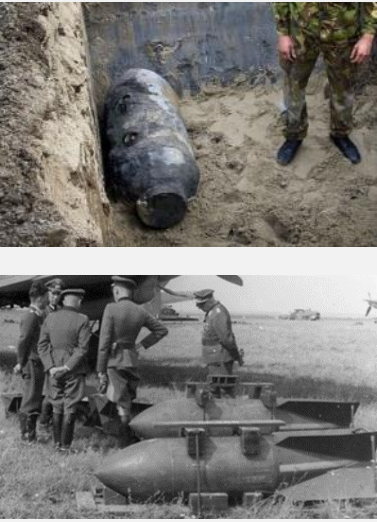
SC 500

**Bomb Weight:** 480-520kg (1,058-1,146lb)  
**Explosive Weight:** 220kg (485lb)  
**Filling:** TNT, Amatol and Trialen mix  
**Charge/Weight Ratio:** 44%  
**Fuse Type:** 2 electrical impact fuses or mechanical delayed action fuses  
**Body Dimensions:** 1,423mm length x 470mm diameter  
**Appearance:** Bomb body and tail painted grey/green or buff with a yellow stripe on the tail unit. Steel construction.  
**Variants:** 3 x variants. Kopfring nose for limited penetration.

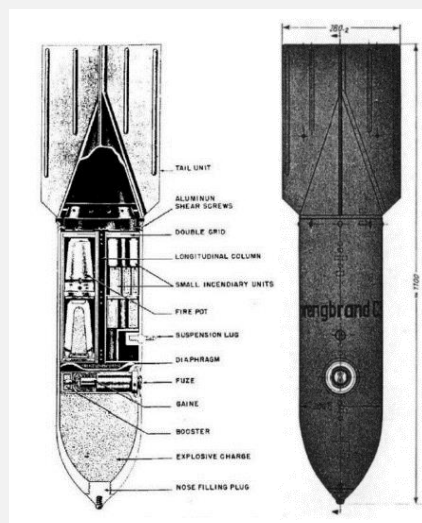
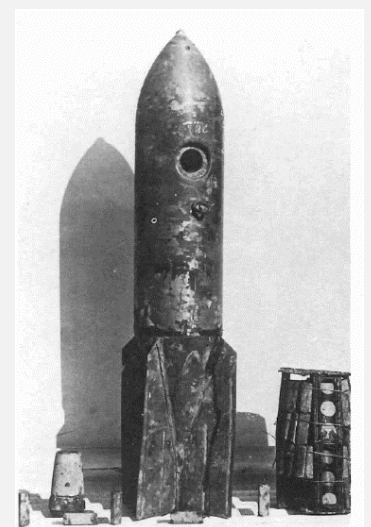
### Sprengr-Brand C50 - Fire Pot

| <b>Appearance:</b> | Bomb body and tail painted grey/green or pale blue with red base plug and red or green incendiary markings. Steel construction. |
| <b>Operation:</b> | A charge blows off the base plate, firing a plume of incendiary mixture 100 yds. Approx 1 second later the HE charge detonates. |

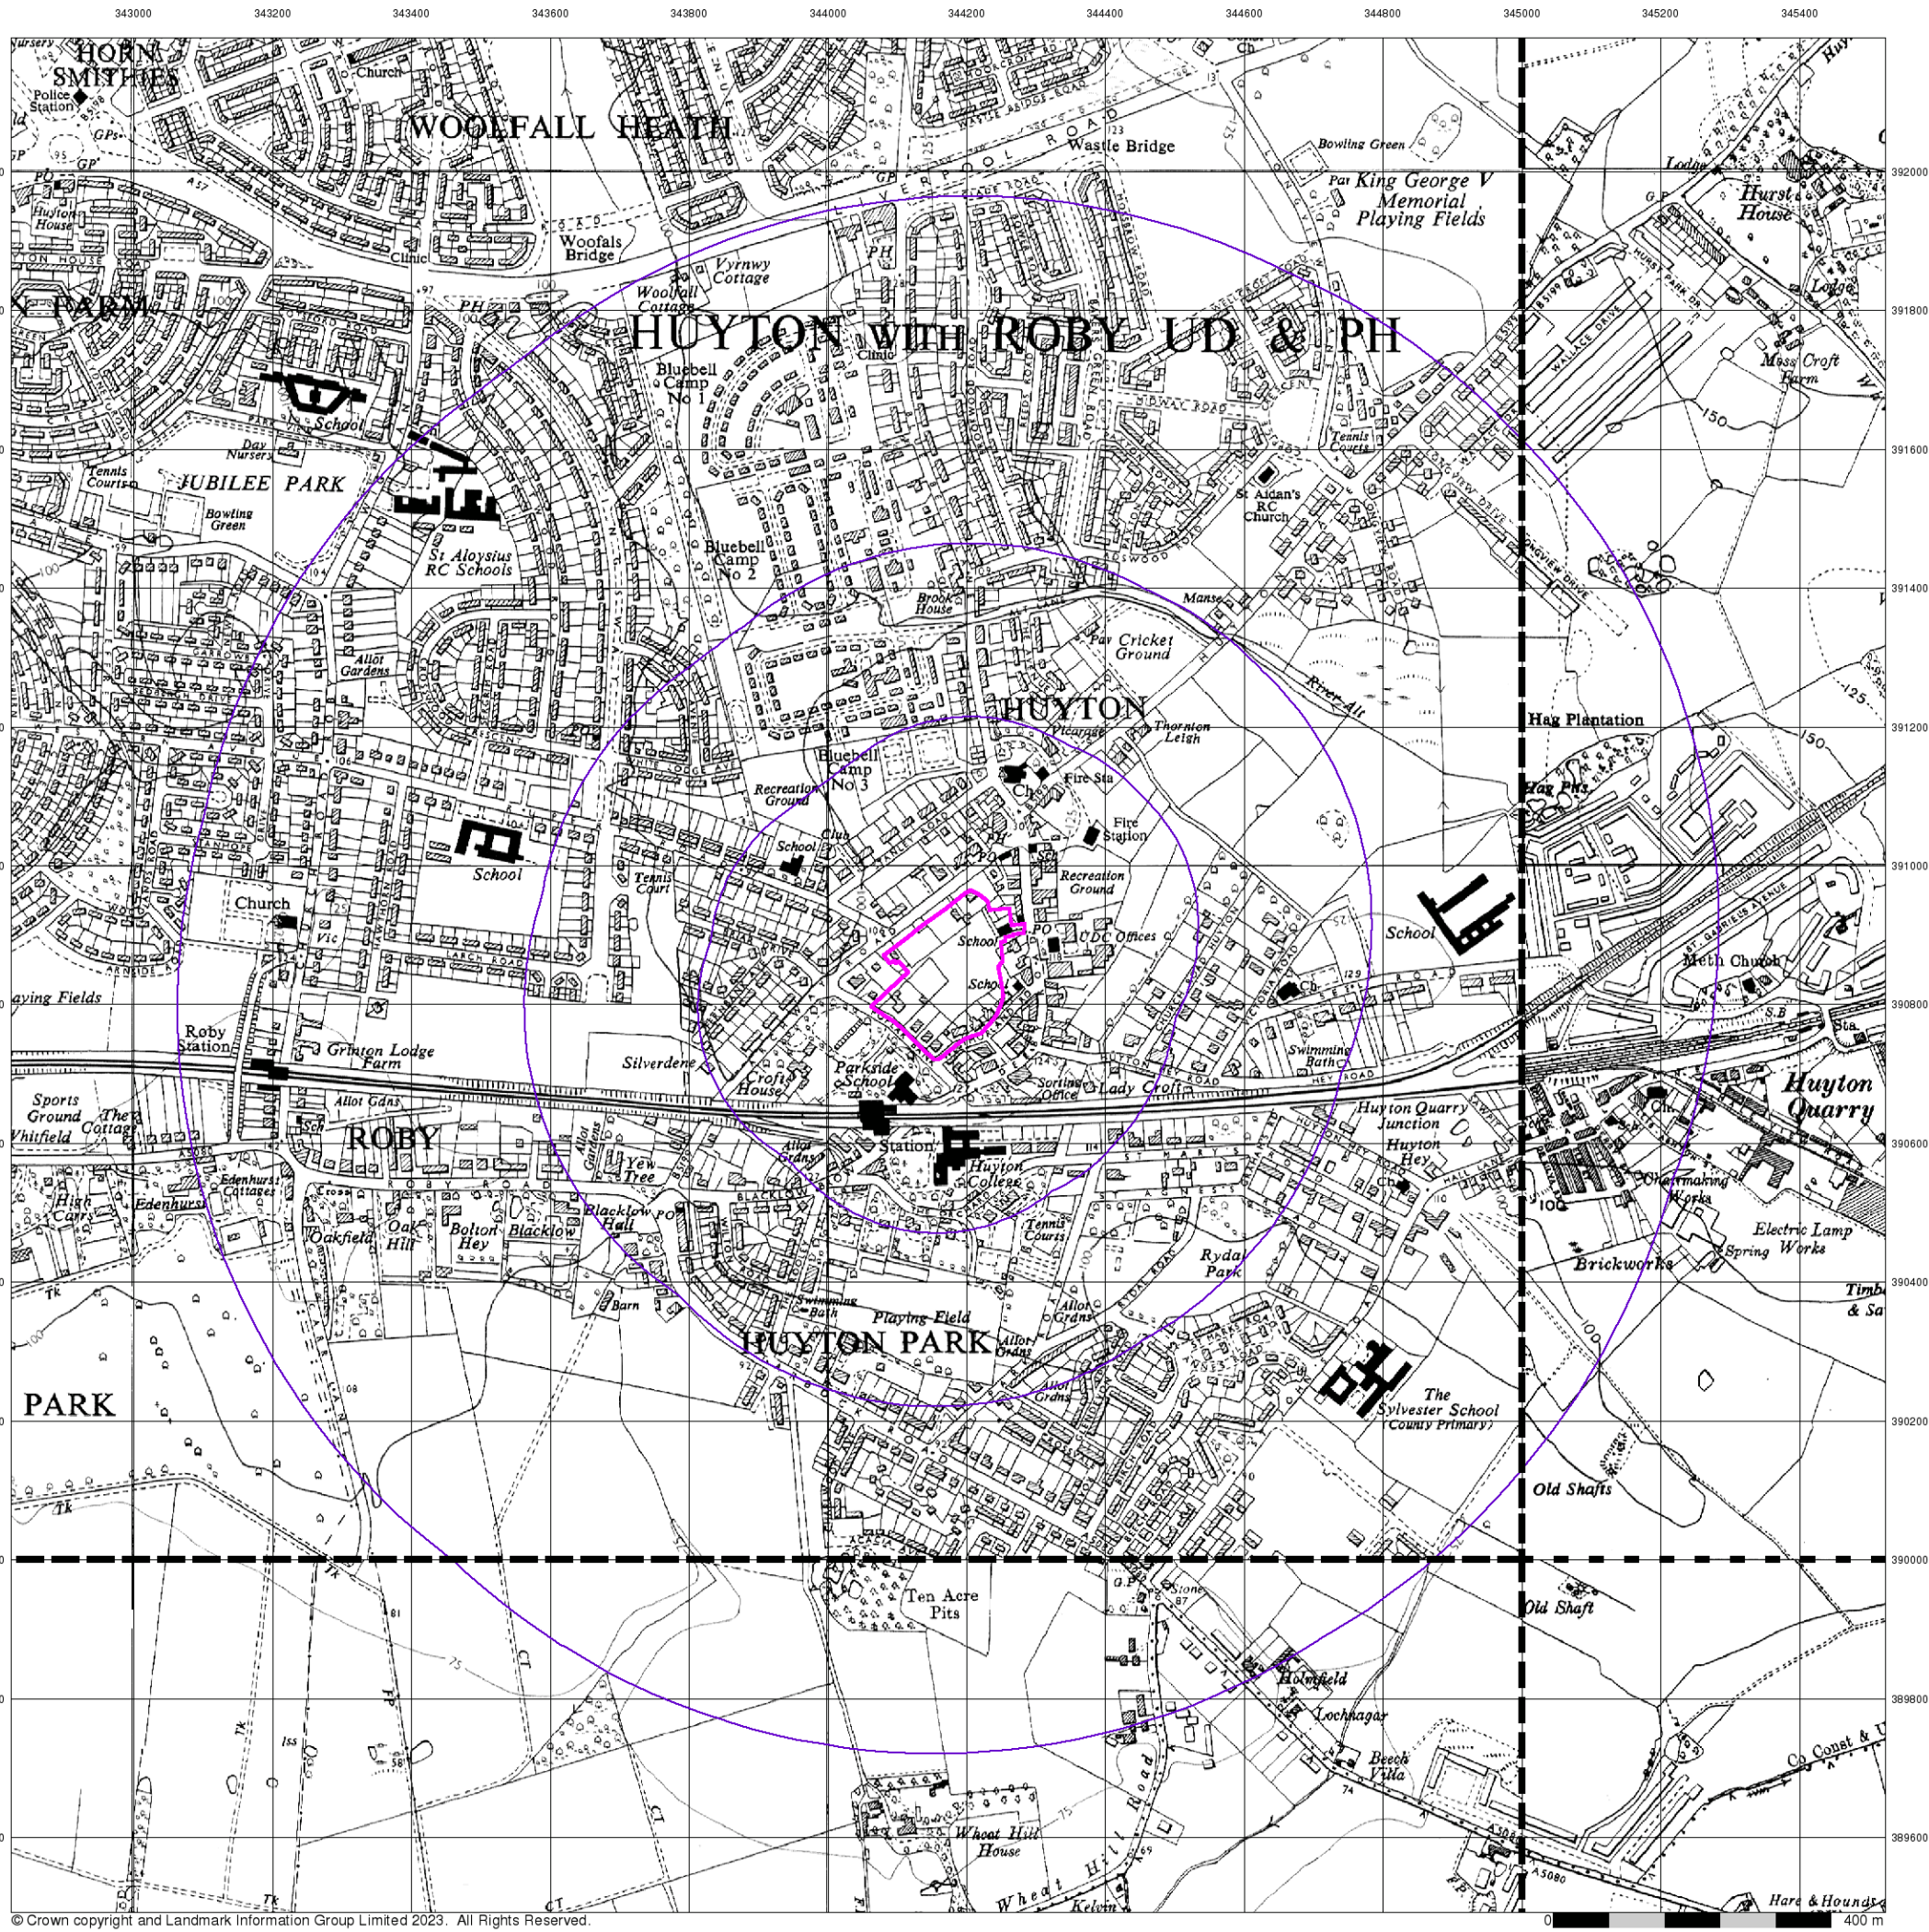
## Ordnance Survey Plan

Published 1955 - 1956

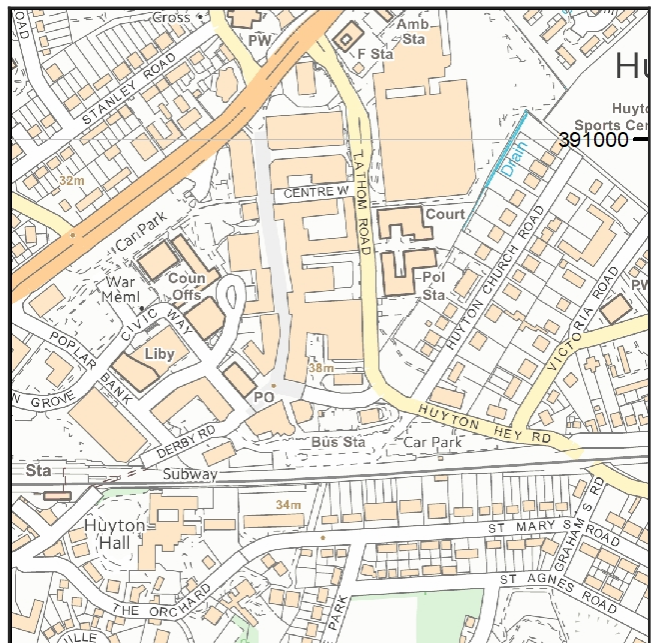
Approximate position of property
