### Existing Track Geo-environmental Desk Study, Skelmersdale Rail Link

# **Existing Track Geo- Environmental Desk Study**

Skelmersdale Rail Link

**Document reference:** 139606-MMD-REP-EGE-000001

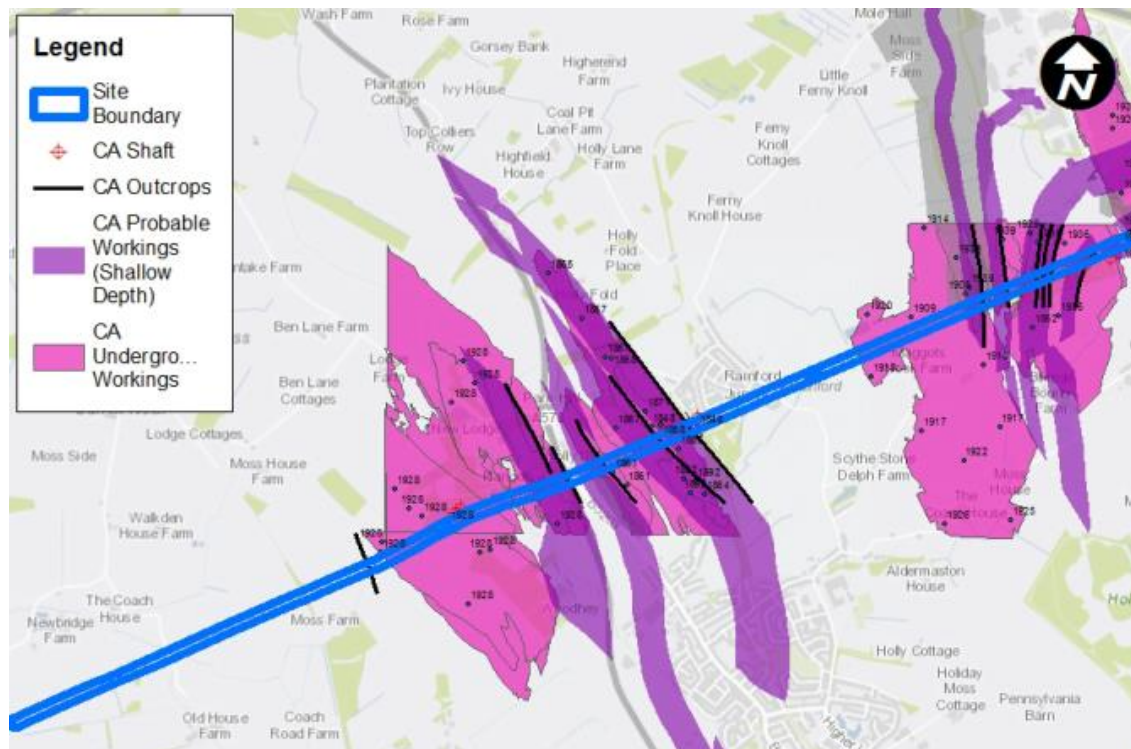
**Figure 13: Map Extract from Network Rail Mining Report**

One of the sets of mining plans are for Holland Colliery, which appears to be operational until the late 1930s. They show there to have been two pits (No. 6 and No. 9) on the southern side of the railway and another two No. 8 and Day-Eye. All of the pits are connected to tunnels and/or workings directly beneath the rail corridor which work a range of coal seams including the Arley, Park, Rushy and Earthy seams. A plan and cross section is shown in Figure 14 and Figure 15 which show the succession of coal seams and depths from the surface at No. 6 and No. 9 pits. Whilst only shown to be partly worked by 1920, the Earthy seam is the shallowest and was worked at a depth of 59m at No. 9 Pit. The seam could have been further worked since the plan was produced, with potential shallow workings from No. 9 Pit to the east of No. 6 Pit where the seam outcrops. Underlying seams in the Park Mine, Rushy Park Mine and Arley Mine are shown to be completely worked to the east of No. 6 Pit by 1920, with workings becoming increasingly shallow to the east. Workings or tunnels to the west of No. 9 Pit are also shown to be as shallow as 35m, and Albert Mine to the west of Duke's Wood Lane appear to indicate workings as shallow as 15m from the surface beneath the track.

It should be noted that the information given on the plans is variable, referenced to historic roads/features and in some cases very limited. It should also be remembered that typically their purpose was quantity measurements rather than survey accuracy and could be inaccurate due to deliberate intent (e.g. avoidance of royalties) (CIRIA C758). However, they do indicate that mining has been undertaken around two localities beneath the railway line.

There are significant areas of coal mine workings beneath the rail corridor. Records suggest that workings rarely come within distance of the ground surface to affect the proposed works ( $\leq 25\text{m bgl}$ ) but there are at least two examples at Holland Colliery of tunnels which appear to directly underlie the corridor at depths of up to  $15\text{m bgl}$ . There are also a number of shafts proximal to the corridor. The remedial status of all shafts, tunnels and workings is currently unknown. The proposed works mainly take the form of track bed renewal, which is not expected to cause significant loading or disturbance of the ground surface such that subsidence or ground collapse would occur where shallow voids are present. Where more intrusive/disturbing construction methods are required, such as at Rainford Station where platform extension is proposed, there are not shown to be any potential shallow workings or shafts in the area. Nonetheless, the overall risk to the proposed works is considered to be high due to the potential impact of collapsing ground. Once the final proposals are known a mining risk assessment should be carried out to further define the risk.
