# LAND AT ACORNFIELD ROAD, KNOWSLEY

GEOENVIRONMENTAL  
APPRAISAL  
(PHASE 2 ASSESSMENT)

S2405/02, JAN 2026  
FINAL, ISSUE 2.0

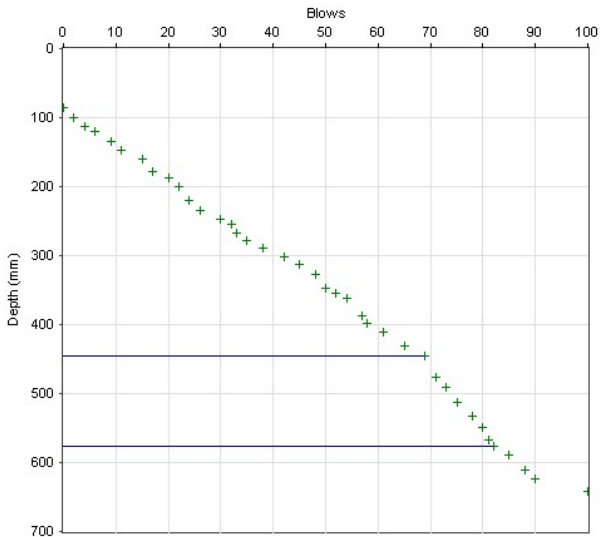
Layer Boundaries Chart

Layer Boundaries: Chainage 2.000

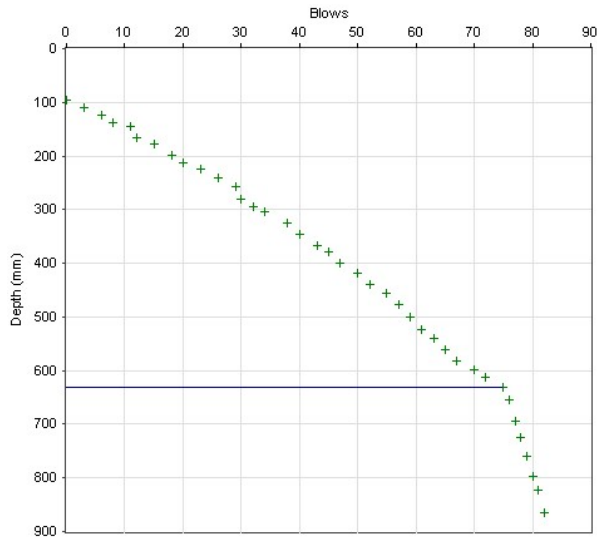
Layer Boundaries Chart

Layer Boundaries: Chainage 4.000

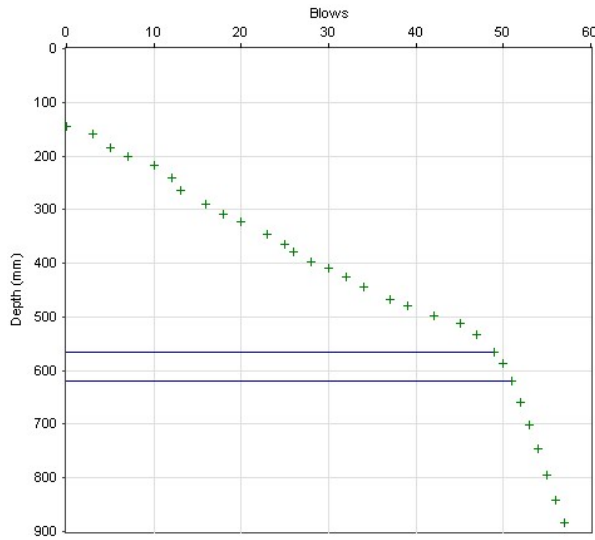
Layer Boundaries Chart

Layer Boundaries: Chainage 5.000
