**MATERIALS MANAGEMENT PLAN  
PENRHYN ROAD, KNOWSLEY  
MERSEYSIDE  
GMI CONSTRUCTION GROUP  
MMP-30050-25-476  
DECEMBER 2025**

- Investigative Reports
- Bromododecane Spill Investigation, Amec 2012
- GCO Environmental Consultants Interpretative Desk Study and GI
- GJ224-03-R002-DQRA-V1
- IPP Desk Study - AIG 1999
- Portway Remediation Phase 1 Validation Report August 2025
- Preliminary Site Investigation Report - Cremer and Warner 1993
- Trade Effluent Overspill Sampling Report - Entec UK 2011

| Report Title | Contract Chemicals, Knowsley Site Investigation Interpretative Report | Site Address | Former Contract Chemicals Ltd, Penrhyn Road, Knowsley Business Park, Knowsley, L34 9HY |

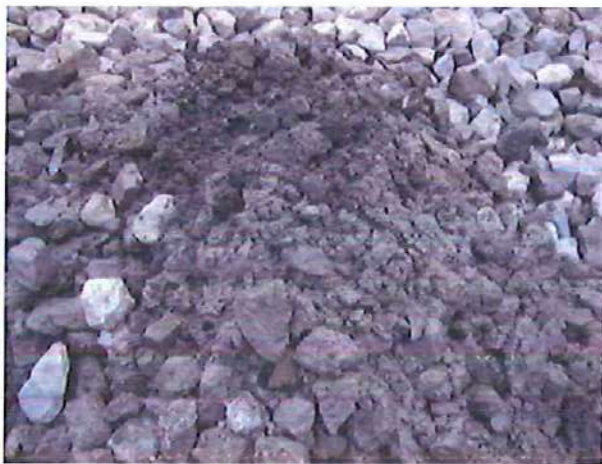
Arisings from HDP01

Soil arisings at HDP01 were noted to have a light to strong chemical odour from throughout the exploratory hole (from surface to 0.70m bgl).

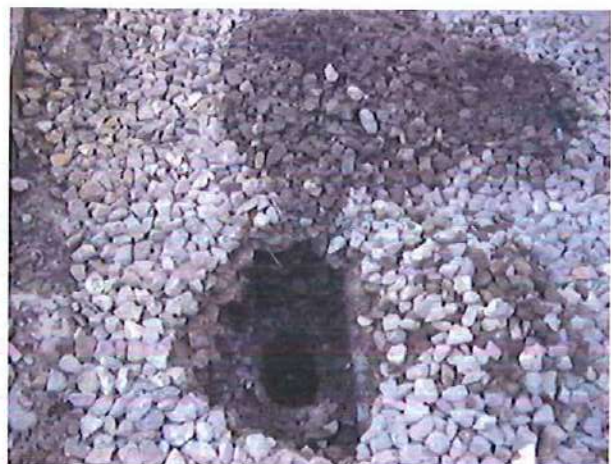
HDP01 excavation (duct  
visible to right of image)

Black plastic ducting was noted at 0.50m bgl in the centre of hand dug pit HDP02, trending approximately north-south. This was considered likely to be associated with the perimeter sensors, however was not identified during service clearance. No damage was done to the ducting during excavation. It was noted that the orientation of the duct appeared to lead directly beneath the marked position of HDP03, which was subsequently repositioned approximately 1m towards the south to avoid damage to the duct. No other exploratory holes were required to be repositioned as a result of the duct.

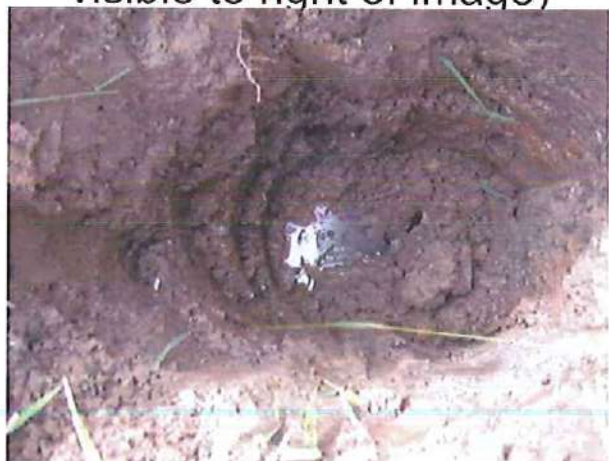
HDP02 excavation  
(black duct visible)

During the exploratory works on 27 June, standing water was noted within HDP02 at a level of 0.4m bgl, after a period of approximately two hours. A sample of this was collected and submitted for chemical analysis alongside the soil samples.

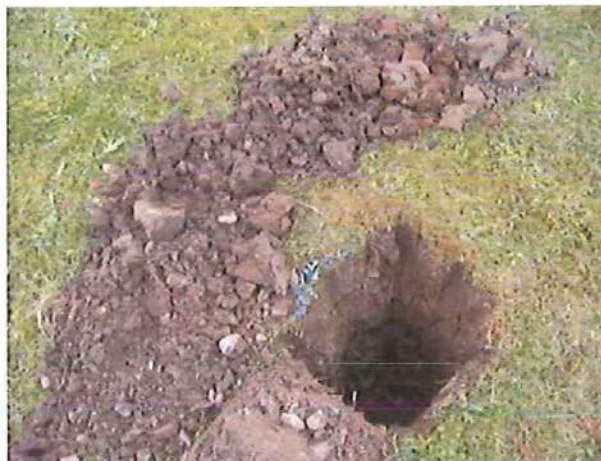
Arisings from HDP04

Soil arisings from HDP04 between surface and 0.20m bgl were noted to have a possible chemical odour.

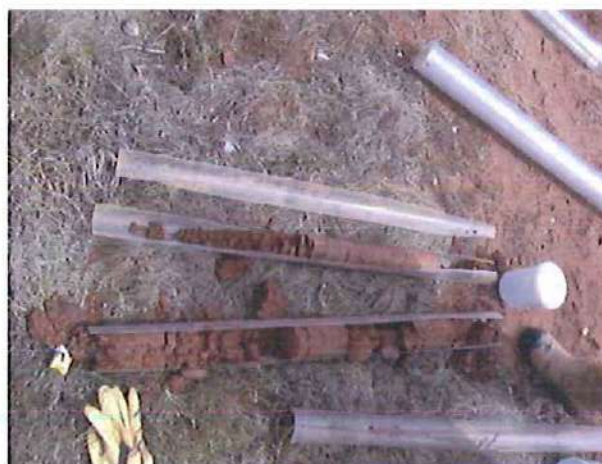
Arisings from WS01

Soil arisings from WS01 taken from between the surface and 0.60m bgl were noted to have a chemical odour.

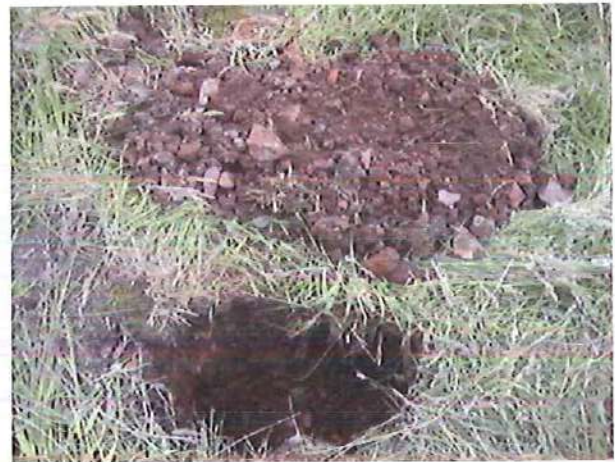
WS03 excavation and  
arising

Proposed dynamic window sampling hole WS03 was intended to be installed for groundwater sampling. However, due to ground conditions making hand excavation difficult, the service inspection pit was halted at 0.40m bgl. As the service inspection pit was of insufficient depth, the hole was not advanced by mechanical means.

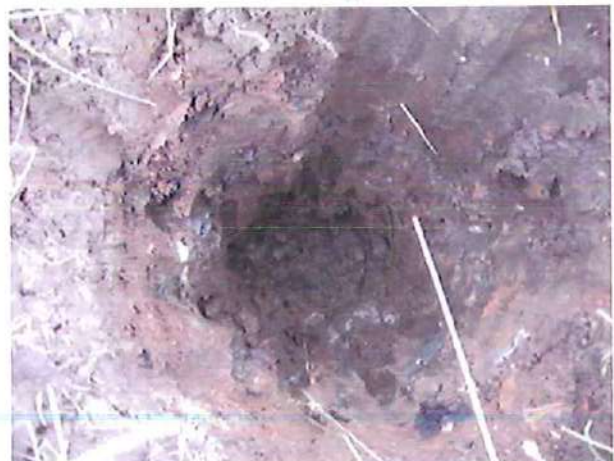
WS04 excavation

Sampling location WS04 was originally intended to be advanced as a hand dug pit, but following the abandonment of WS03 as a dynamically sampled hole this was selected as a substitute. Ground conditions, although enabling easier excavation than those at WS03, were also difficult and it was not possible to advance the service inspection pit past 0.80m bgl. This was considered to be insufficiently protective to allow for continuation of the hole by dynamic window sampling methods, however, was of sufficient depth to allow the installation of a monitoring standpipe.

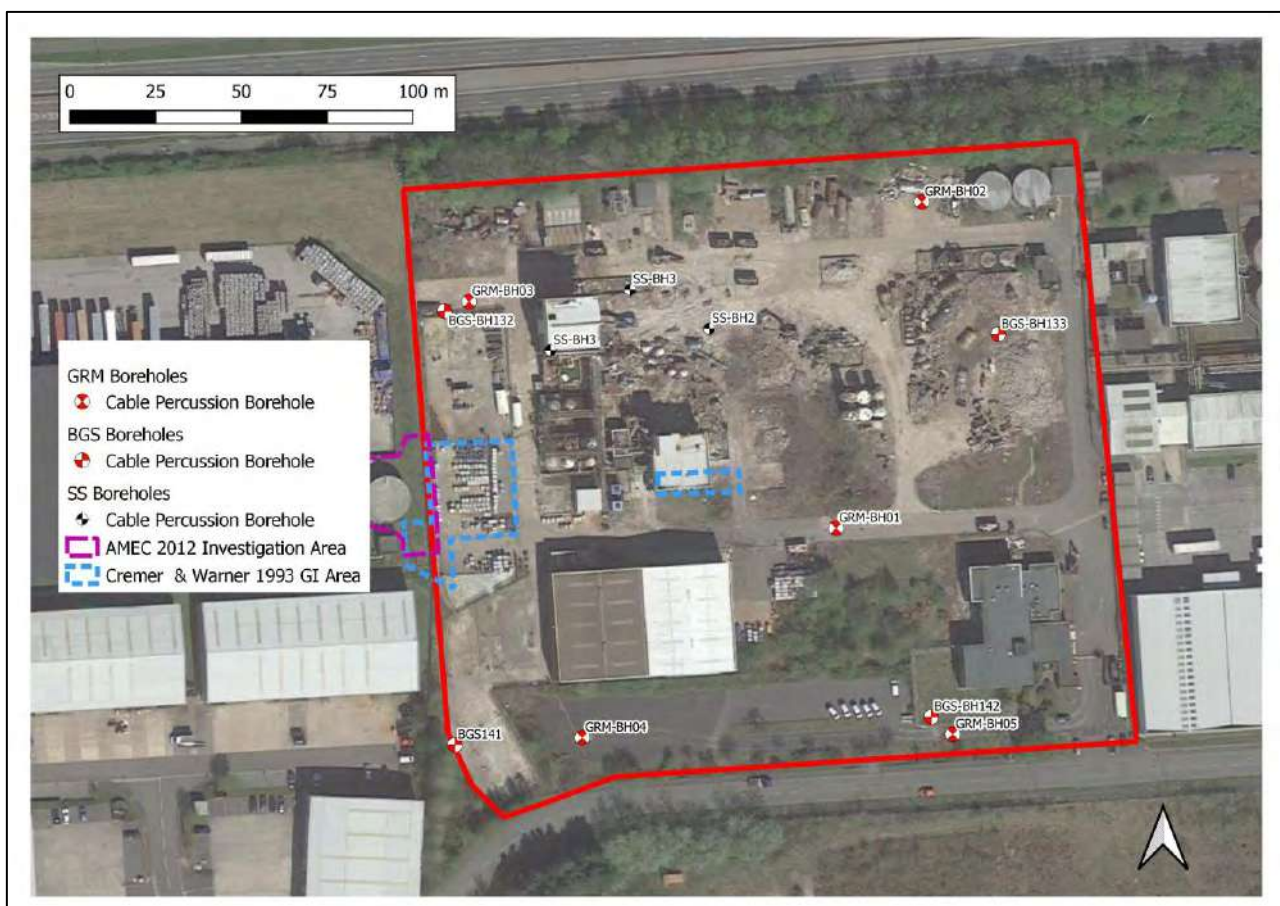
Figure 2.4 Selected previous exploratory holes

The following sections provides a brief overview of each intrusive investigation, including a summary of the geotechnical and environmental testing undertaken. A plan showing the locations of selected previous exploratory holes and investigation areas is provided in Figure 2.4, below.

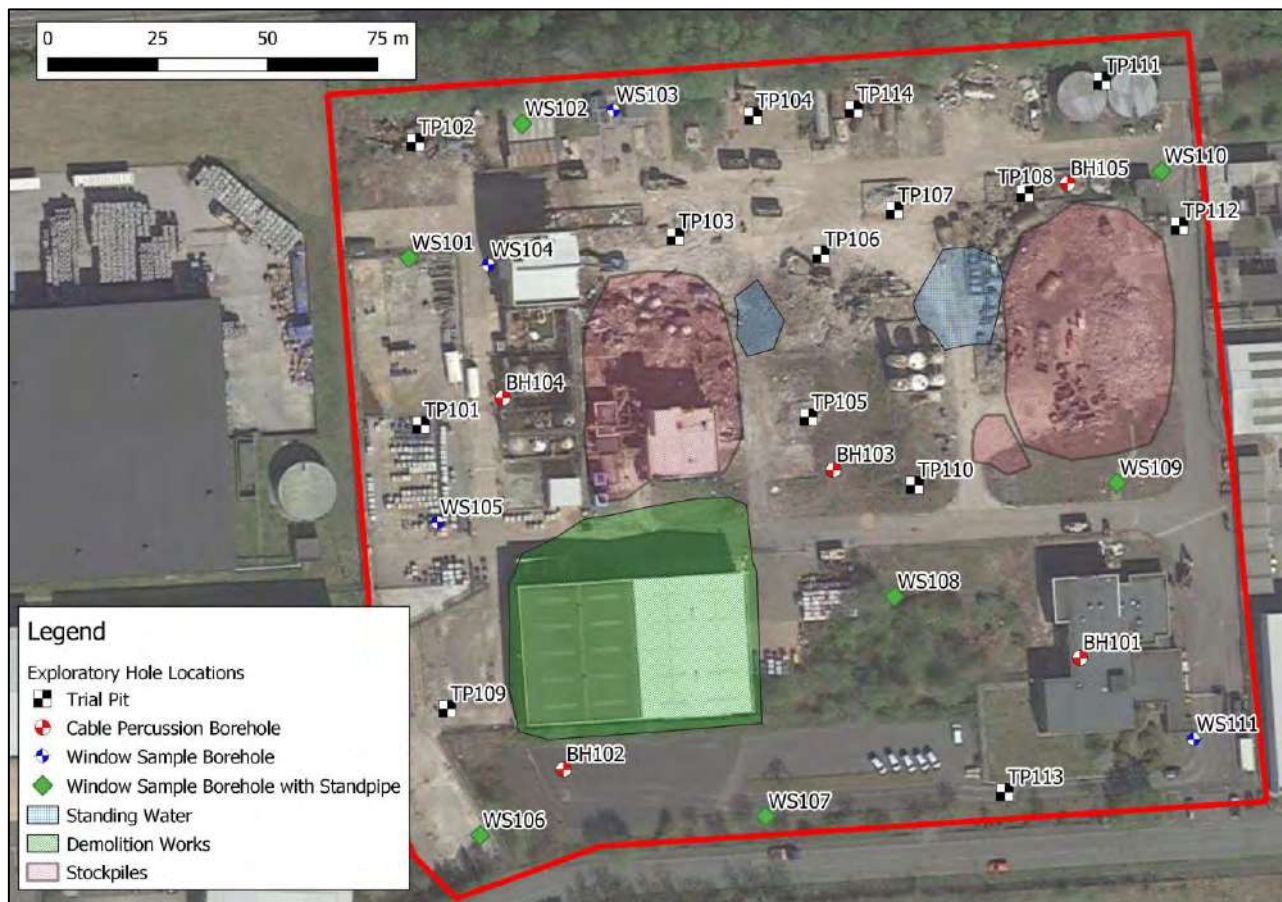
Figure 3.1 Exploratory hole locations

The exploratory hole locations were determined to target the main potential source areas described in Section 2.3.4, and to provide a good overall coverage of the site. However, the locations were also significantly influenced by site constraints including underground services (most notably the culverted stream the runs beneath the north of the site), remaining structures, stockpiles, standing water and ground conditions. The exploratory hole locations are shown in Figure 3.1, below, and Appendix B.

Exploratory hole locations were cleared and marked out prior to the investigation.

Standard Penetration Tests were generally carried out in the cable percussion and window sample boreholes at 1.0m intervals. The results of these tests are given as a Standard Penetration "N" value or as a blow count for a given penetration at the appropriate position on the borehole logs presented in Appendix B.

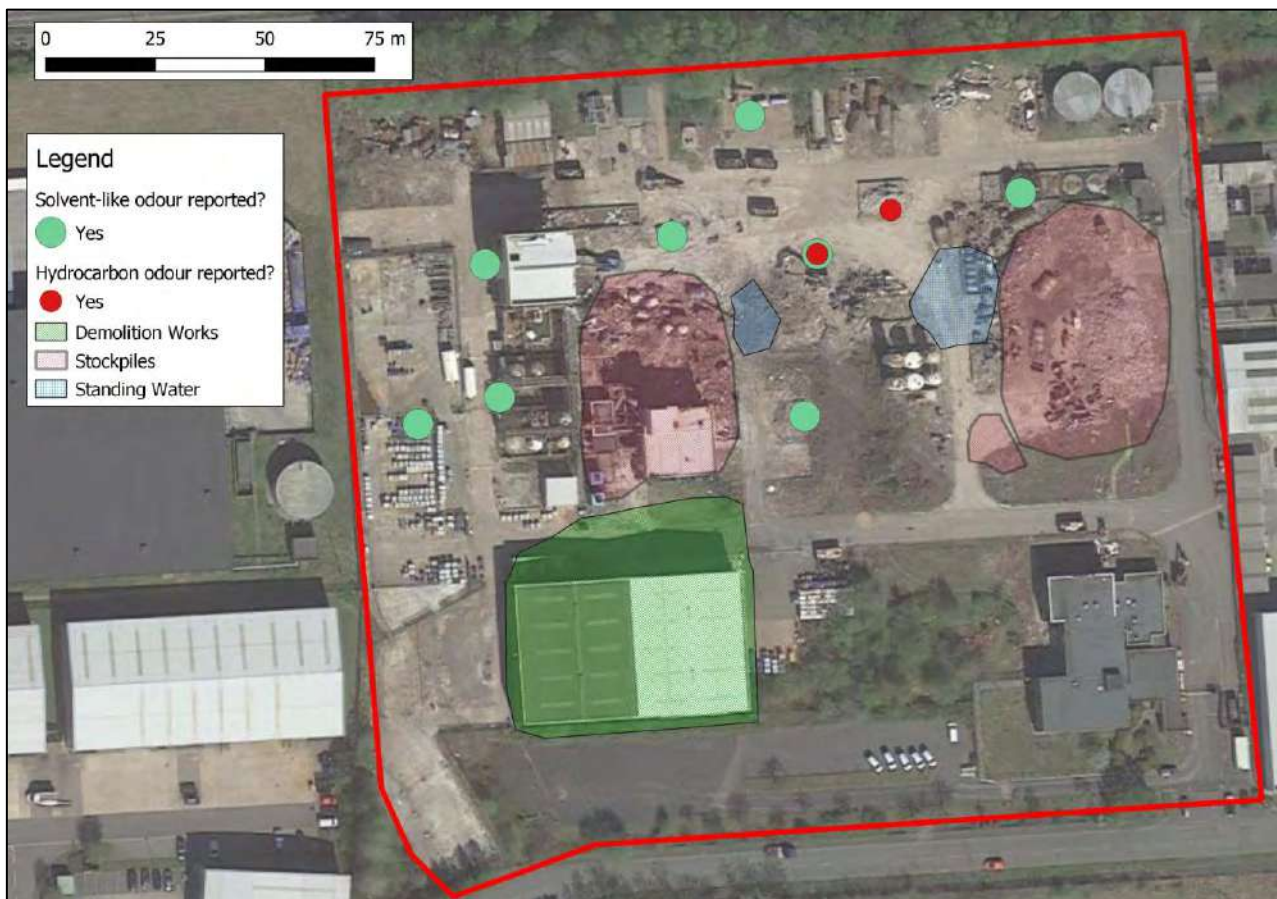
Figure 4.3 Evidence of Contamination

A 'solvent odour' was reported in the Made Ground in exploratory holes WS104, BH104, TP101, TP103 to TP106 inclusive, and TP108. A 'hydrocarbon odour' was reported in the Made Ground in exploratory holes TP106 and TP107. All of these exploratory holes were located in the northern half of the site. . Figure 4.3, below summarises the distribution of these reported odours.
