Kirkby Brook adjacent to the Former All Saints School, Cherryfield Drive, Kirkby L32 5TQ

## **ECIA ADDENDUM: WATER VOLE AND OTTER PRESENCE / ABSENCE SURVEY 2024**

October 2024

ERAP (Consultant Ecologists) Ltd ref: 2021-296e

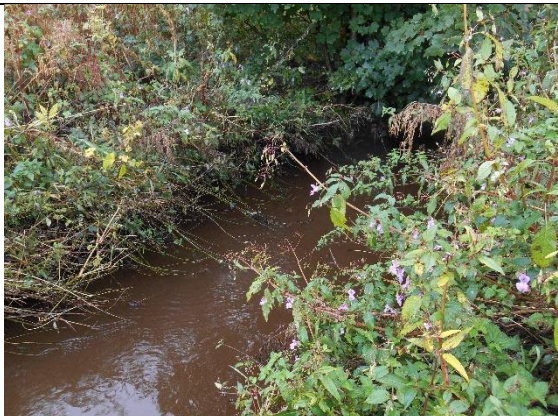
**Table 6.2: Kirkby Brook Cross-Section A-a**

| Photo | | | |
|---|---|---|---|
| Channel | | | |
| Width (m) | 3 | | |

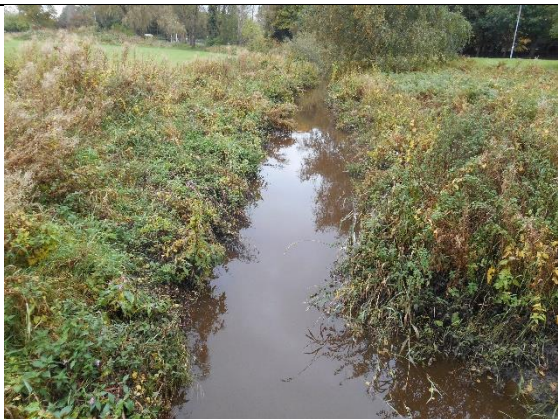
**Table 6.3: Kirkby Brook Cross-Section B-b**

| Cross-Section | Ordnance Survey Grid Reference Location | Notes |
|---|---|---|
| B-b | SJ 40753 98771 | At location of proposed surface water outfall |

| Photo | | | |
|---|---|---|---|
| Channel | | | |
| Width (m) | 3 | | |

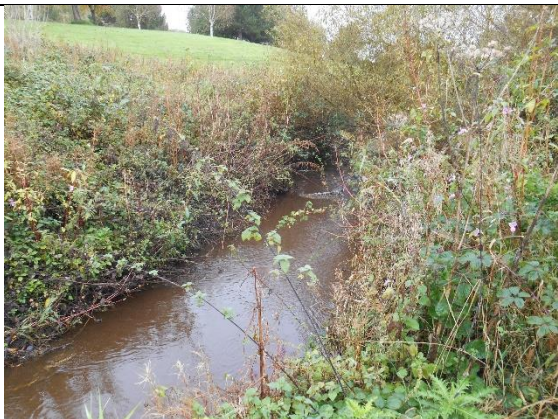
**Table 6.4: Kirkby Brook Cross-Section C-c**

| Photo | | | |
|---|---|---|---|
| Channel | | | |
| Width (m) | 5 | | |
| Suitability for water vole | Suitable but poor owing to spatey conditions and high cover of Indian Balsam which will reduce availability of cover in the winter months | | |

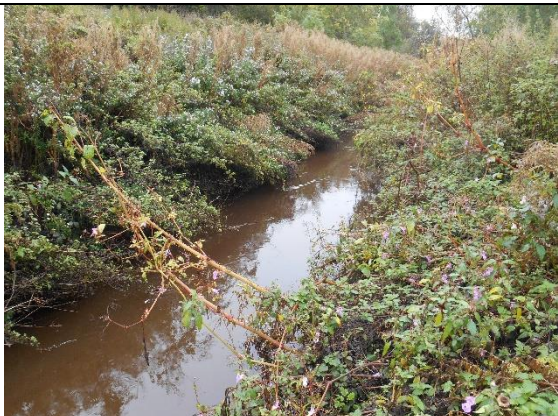
**Table 6.5: Kirkby Brook Cross-Section D-d**

| Photo | | | |
|---|---|---|---|
| Channel | | | |
| Width (m) | 4 | | |
| Suitability for water vole | Suitable but poor owing to spatey conditions and high cover of Indian Balsam which will reduce availability of cover in the winter months | | |

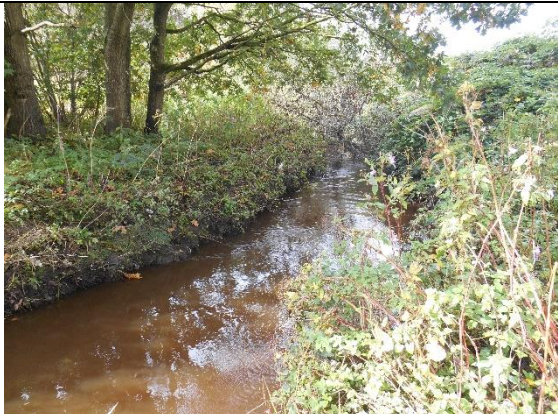
**Table 6.6: Kirkby Brook Cross-Section E-e**

| Photo | | | |
|---|---|---|---|
| Channel | | | |
| Width (m) | 5 | | |

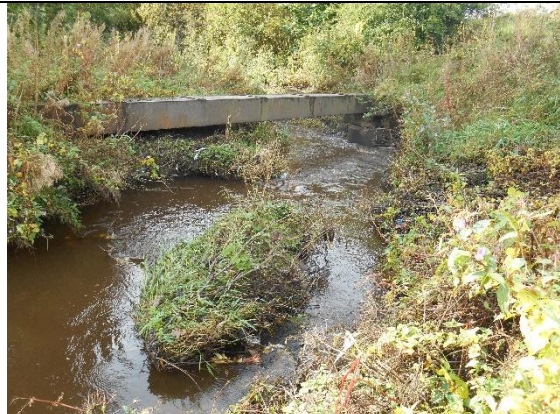
**Table 6.7: Kirkby Brook Cross-Section F-f**

| Photo | | | |
|---|---|---|---|
| Channel | | | |
| Width (m) | 7 | | |

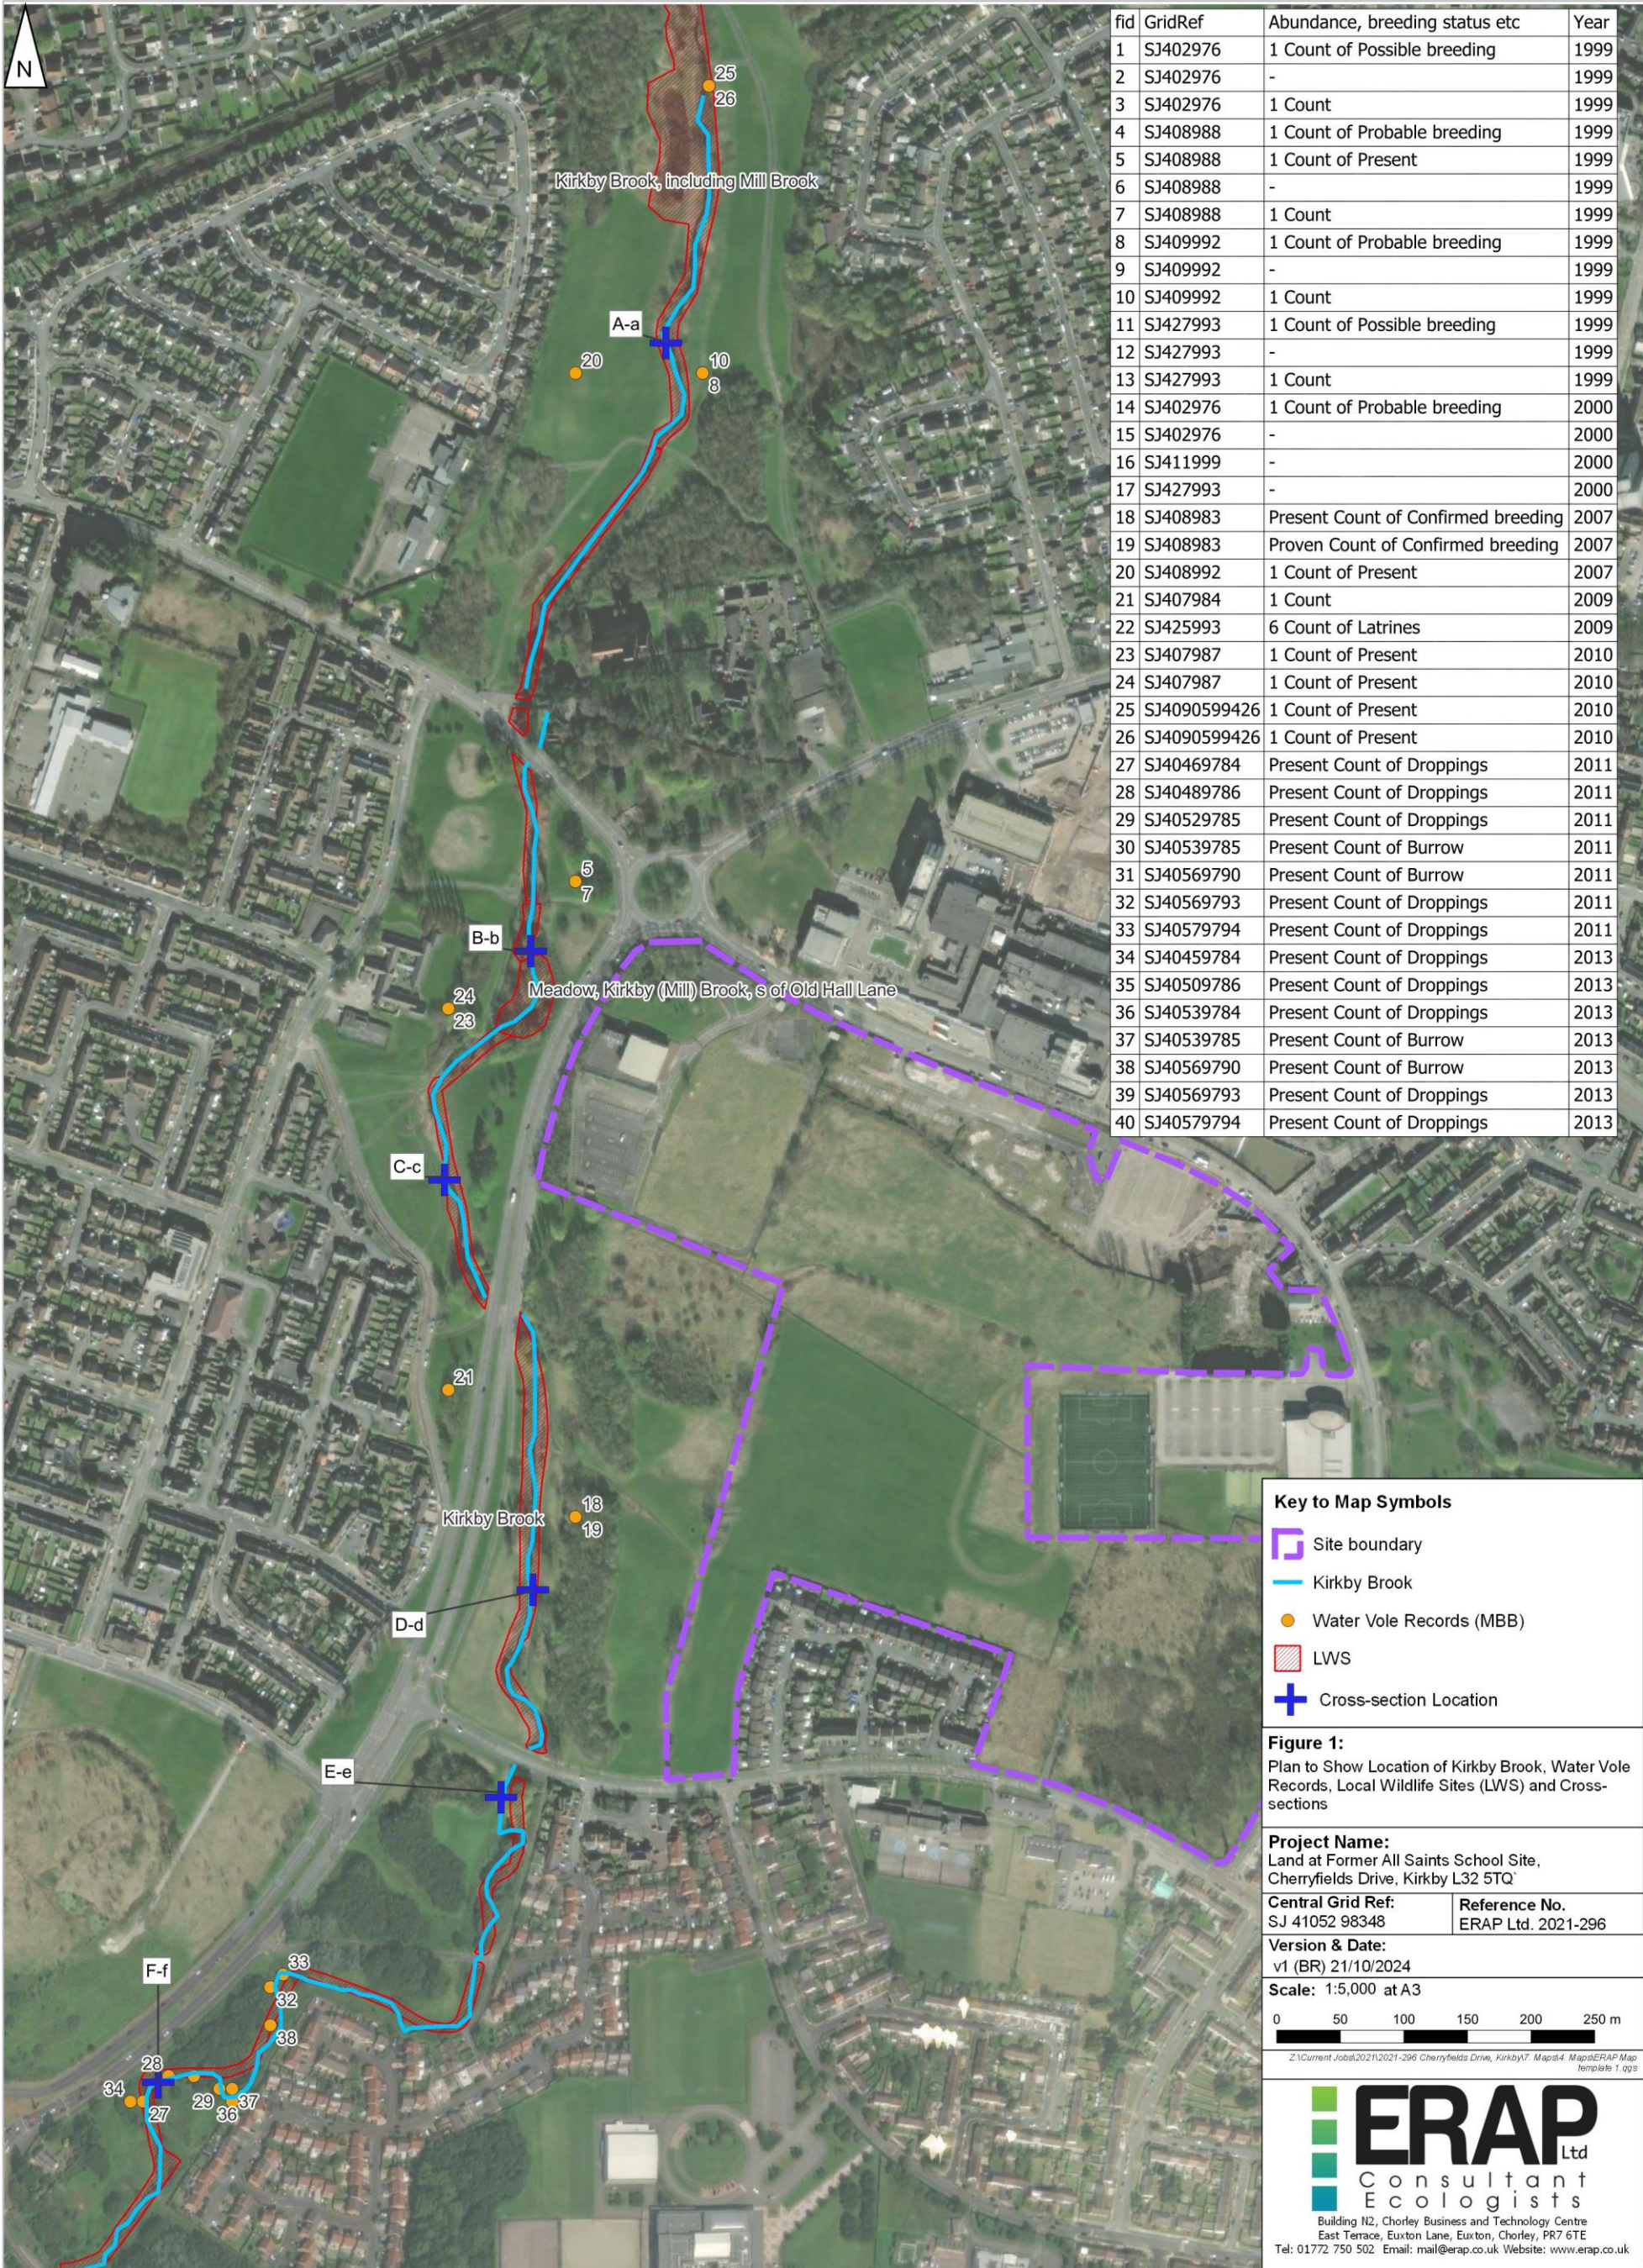
Figure 1: Plan to Show Location of Kirkby Brook, Water Vole Records, Local Wildlife Sites (LWS) and Cross-sections

2.2.1 The survey for evidence and field signs of water vole and otter covered the following search area to total a length of 2.172 kilometres of open channel (also identified on **Figure 1**):

- 2.4.1 To inform the assessment of habitat suitability for these protected species the conditions at the following six cross-sections of Kirkby Brook were recorded, refer to **Figure 1** and **Tables 6.2 to 6.7**, appended:

- 3.1.1 Consultation of the data provided by Merseyside BioBank reported 40 records of water vole at Kirkby Brook dated between 1999 and 2013 (refer to **Figure 1**).
- 3.1.2 The closest record is located 71 metres from the north-western site boundary and dated 1999 and the most recent record dated 2013 and located 340 metres from the site boundary (downstream).
- 3.1.3 No records of otter were reported for Kirkby Brook and the surrounding 2 kilometre radius.
