## LAND TO THE REAR OF 1-3 LAKESIDE VIEW, HALEWOOD

### Site Investigation & Ground Assessment

Report Ref: BEK-23116-2

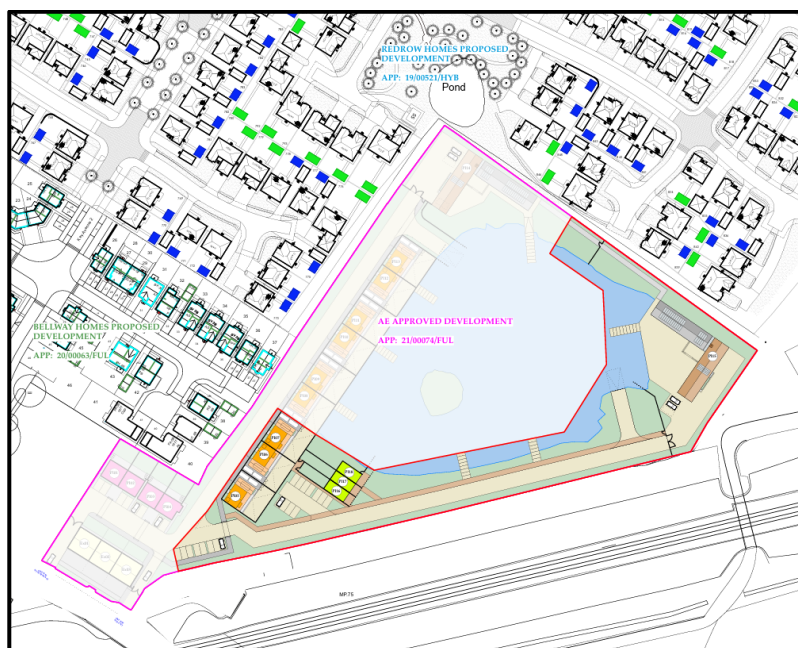
Figure 1: Extract from the Proposed Development

1.2.1 This report has been produced to support a planning application for the construction of No. 18 residential dwellings including associated access, car parking, and other amenities at the Halewood site.

1.2.2 The proposed layout is presented on Architectural Emporium Drawing No 2.002 entitled 'Proposed Site Plan 02' dated 25<sup>th</sup> August 2023, a copy of which is presented in Appendix E and an extract of which is provided below.

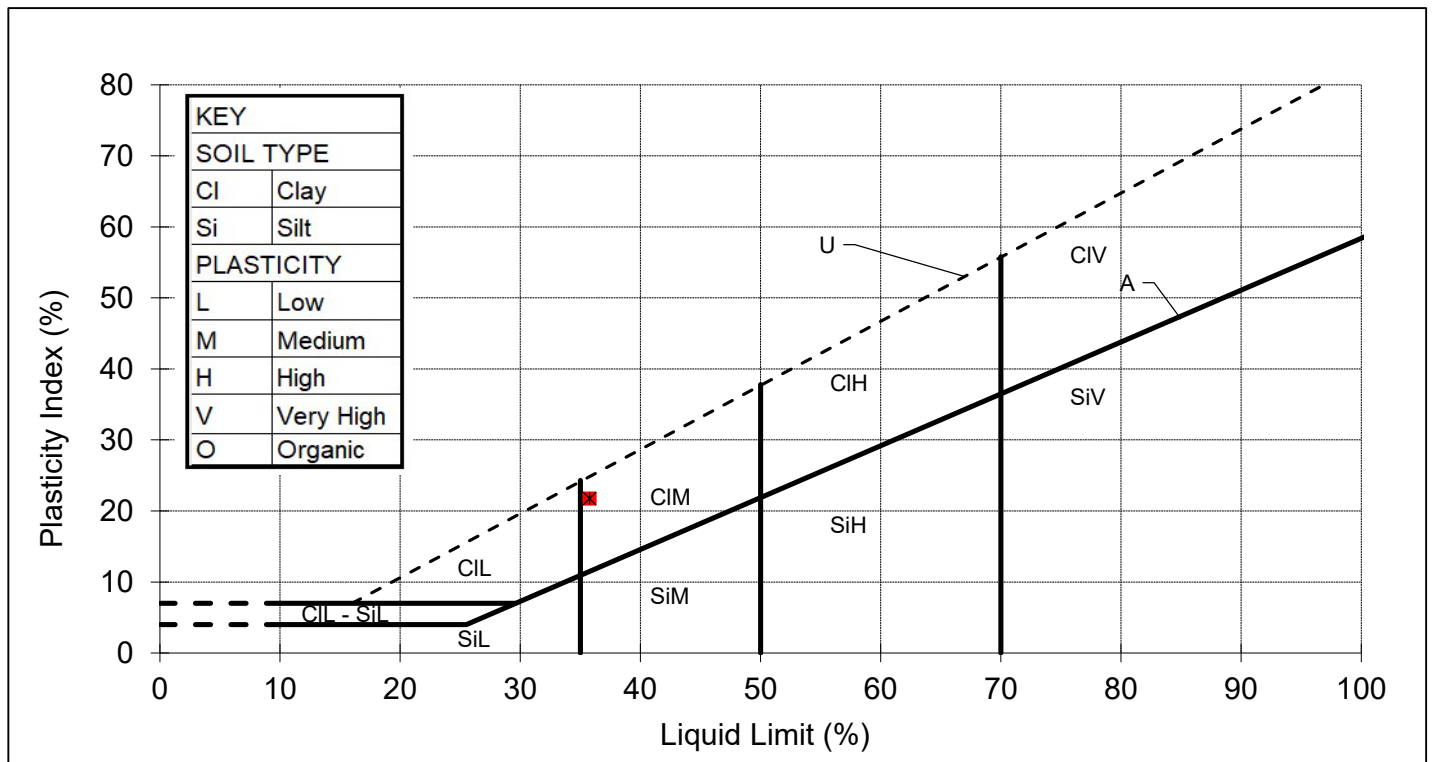
| Natural Moisture Content (%) | Liquid Limit (%) | Plastic Limit (%) | Plasticity Index (%) | Passing 425 micron (%) |
| 18.7 | 36 | 14 | 22 | 91 |

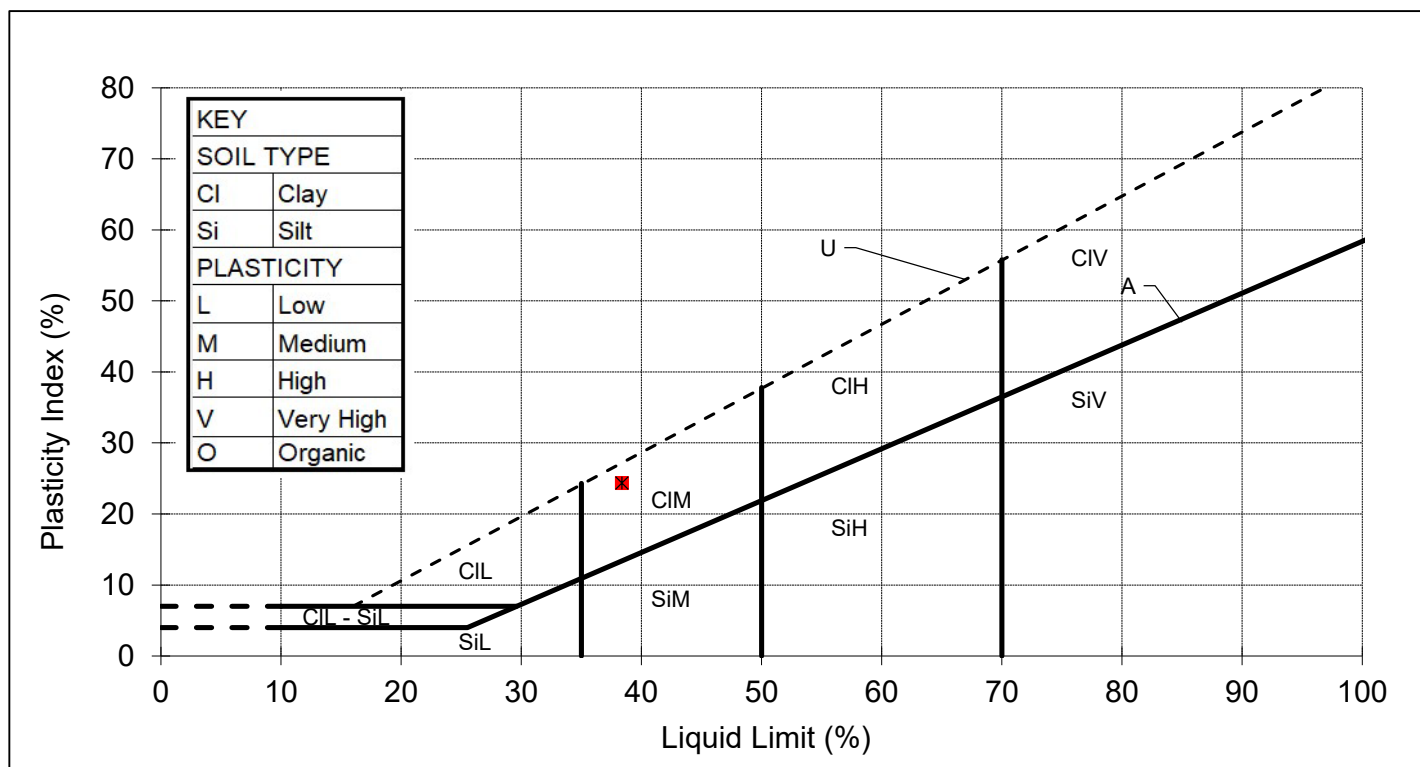
| Natural Moisture Content (%) | Liquid Limit (%) | Plastic Limit (%) | Plasticity Index (%) | Passing 425 micron (%) |
| 14.7 | 38 | 14 | 24 | 85 |

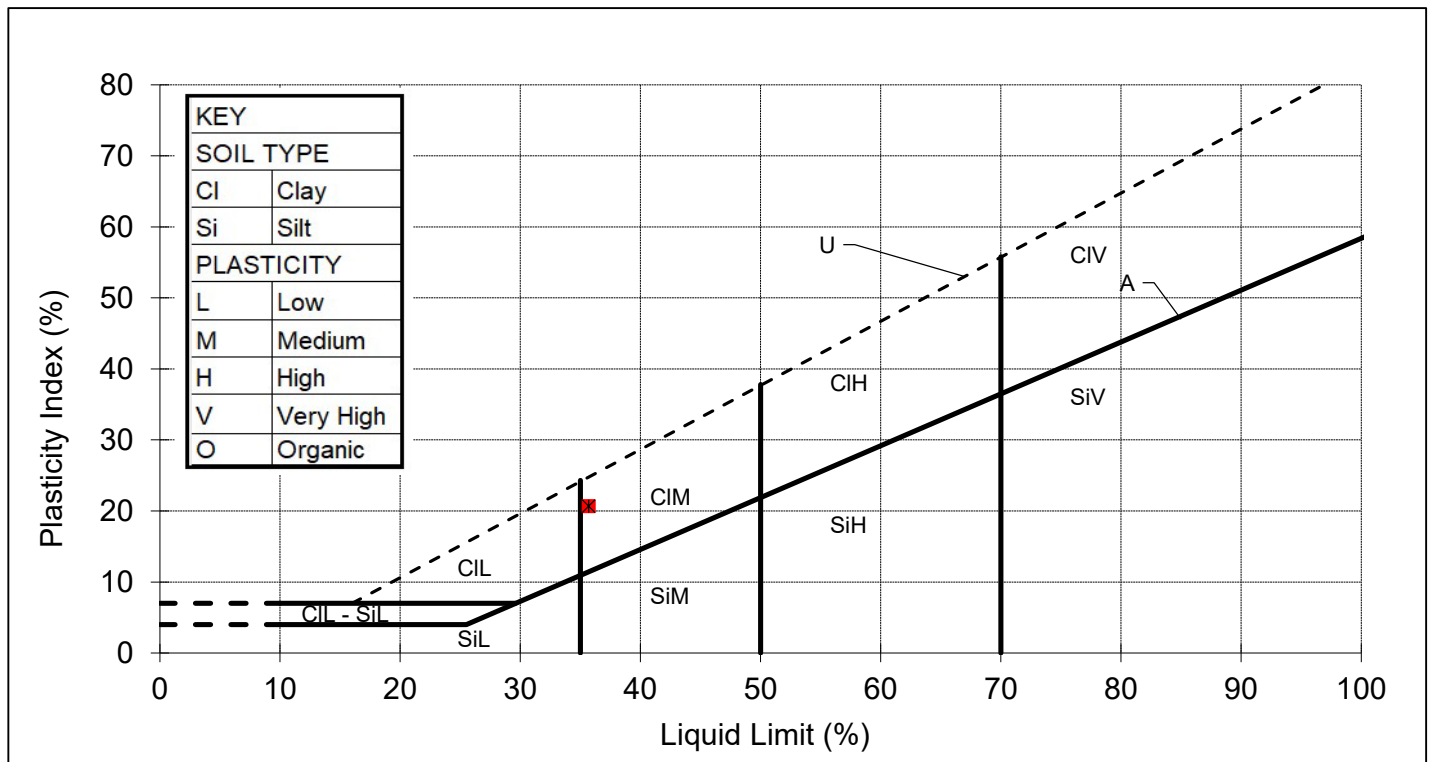
| Natural Moisture Content (%) | Liquid Limit (%) | Plastic Limit (%) | Plasticity Index (%) | Passing 425 micron (%) |
| 12.5 | 36 | 15 | 21 | 80 |

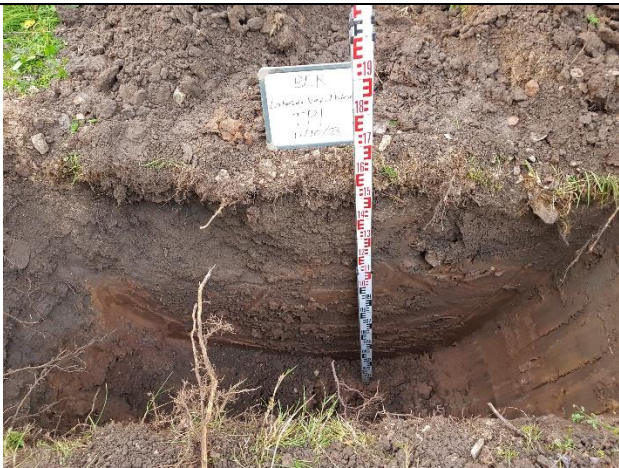
'Brown slightly sandy slightly gravelly CLAY' Sand is fine to course. Gravel is fine to course brick, concrete and stone of mixed lithologies' – This strata was encountered in Trial Pits TP1, TP2, TP3, TP7, TP8 & TP9, as well as at the surface of Borehole No WS1, WS2 & WS4. This strata was noted to contain varying proportions of whole/broken brick, pottery and plastic.

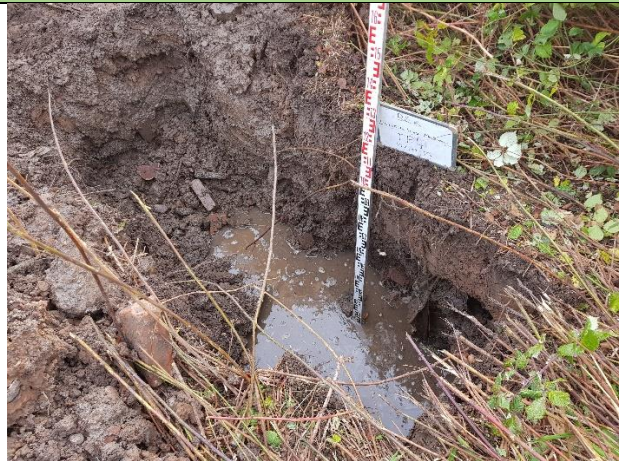
'Brown sandy gravelly CLAY. Sand is fine to course. Gravel is fine to course brick, concrete, glass and pottery. Occasional concrete cobbles' – This strata was encountered at the surface of Trial Pits TP4, TP5 & TP9 and was noted to contain frequent whole/broken brick in Trial Pits TP4 and TP9 and varying proportions of wood, plastic, metal, rags and fabric within each trial pit.

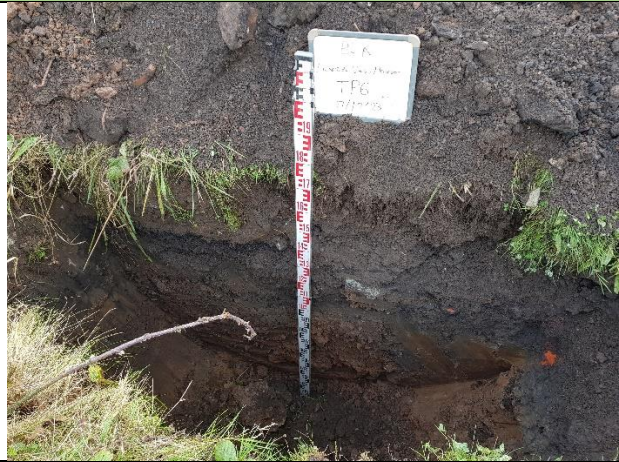
3.5.8 Made ground encountered within Trial Pits TP6, TP10 & TP11, as well as within Borehole No WS5 & WS6 contained varying proportions of ash and clinker. A slight hydrocarbon odour was noted within made ground at Trial Pit TP10 comprising '*partially broken hardstanding of concrete, tarmac and brick with sticky bituminous material*'.

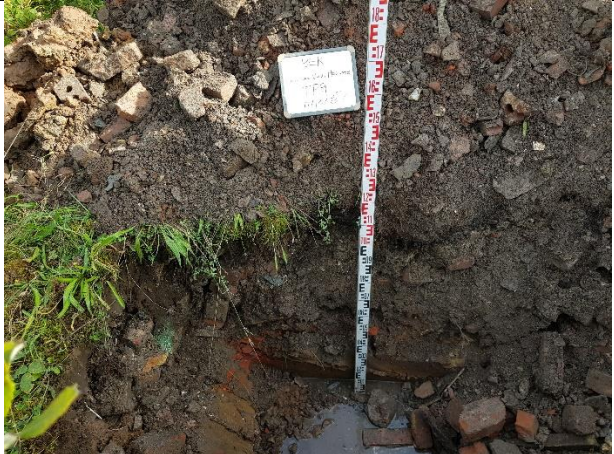
- 4.2.14 It can be seen from the above table that the sample recovered from Trial Pit TP9 contained an asbestos concentration of 0.079 %. The majority of asbestos present was found to be asbestos board at 0.079%, whilst loose asbestos fibres were found to be at trace (<0.001%).

- 4.2.16 From this assessment it can be seen that the combined hazard, receptor and exposure ranking for the asbestos encountered within Trial Pit TP9 is low. Based on the testing carried out work on the soils/made ground within the vicinity of Trial Pit TP9 should be regarded as non-licensed work.

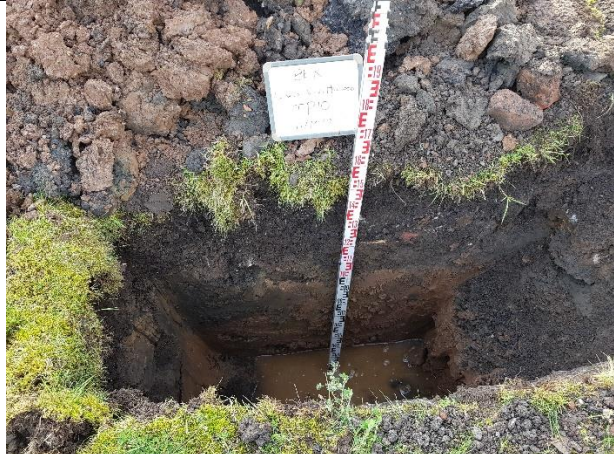
'Brown/Blackish brown ashy clayey sandy gravel. Sand is fine to course. Gravel is fine to course brick, concrete and clinker' – This strata was encountered at the surface of Trial Pit TP10 to a depth of 0.2 m, as well as below ground in Trial Pits TP10 and TP11 to depths varying from 0.5 m (Trial Pit TP10) to 0.6 m (Trial Pit TP11). This strata was noted to contain fragmented sandstone and whole brick within Trial Pit TP11.

'Partially broken hardstanding of concrete, tarmac and brick with sticky bituminous material. Slight hydrocarbon odor' – This strata was encountered within Trial Pit TP10 between 0.2 m and 0.3 m depth.

- 4.2.10 Elevated speciated total petroleum hydrocarbons (Aro >C12-C16) were encountered within Trial Pit TP10 (0.3 m) within made ground described as *‘partially broken hardstanding of concrete, tarmac and brick with sticky bituminous material’*. This correlates with olfactory observations within the strata described as a ‘slight hydrocarbon odour’.
- 4.2.11 Given that this specific fraction of hydrocarbons is regarded as relatively non-volatile and the principal route of exposure is through the ‘consumption of homegrown produce and attached soil’ and the ‘ingestion of soil and indoor dust’, the mitigation measures for this contaminant will also comprise a robust capping system in soft landscaped areas.
