# Phase 2 Ground Investigation

Client: Lidl Great Britain  
Ltd

Report No: 1373.02.01

April 2025

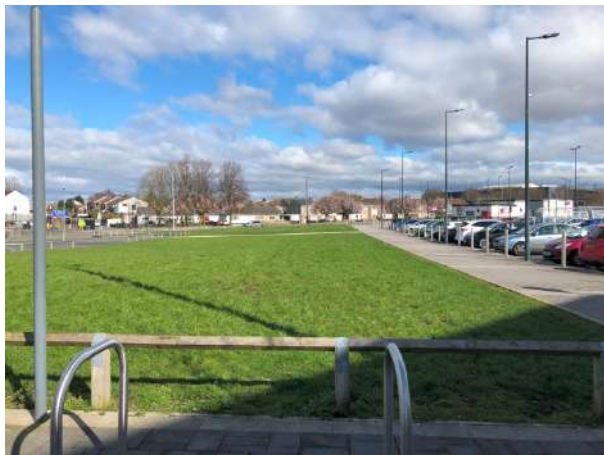
**Photo 2:** A view towards the north-east with areas of soft landscaping and the car park associated with Kirkby Retail Park to the right.

The opportunity was taken to inspect the site of the proposed Lidl store site on 12<sup>th</sup> March 2025 by Krysia Szybut of Remada Ltd during the intrusive works, as recorded in the photographs below. There were no visual or olfactory indicators of contamination.

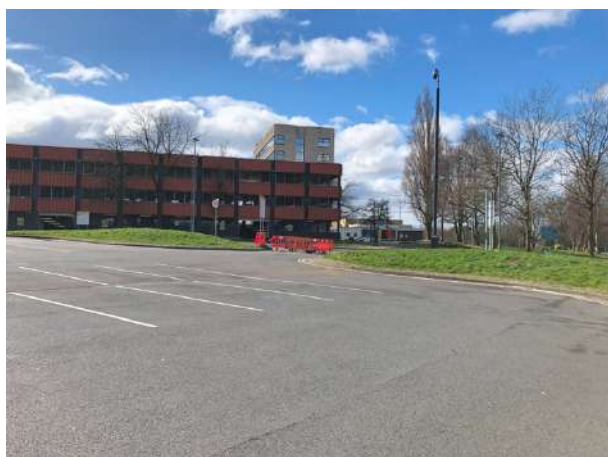
**Photo 3:** The western portion of the site showing the site access with two shallow bunds.

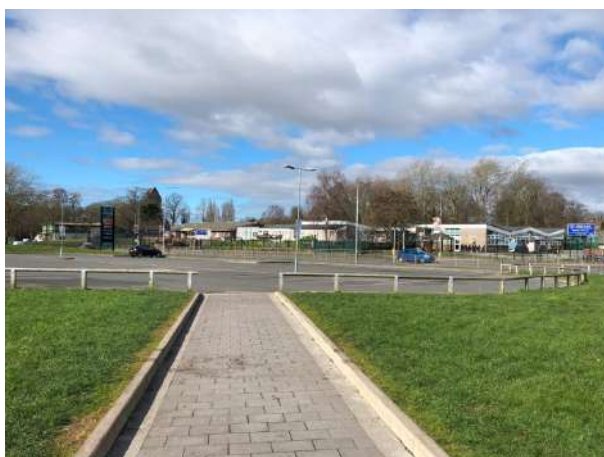
**Photo 4:** A view westwards, showing the car park, soft landscaping and footpath towards Kirkby Retail Park.
